Site Management Plan

(Tier 1, Low Risk)

WDID - 1_12CC418891

9/8/2021

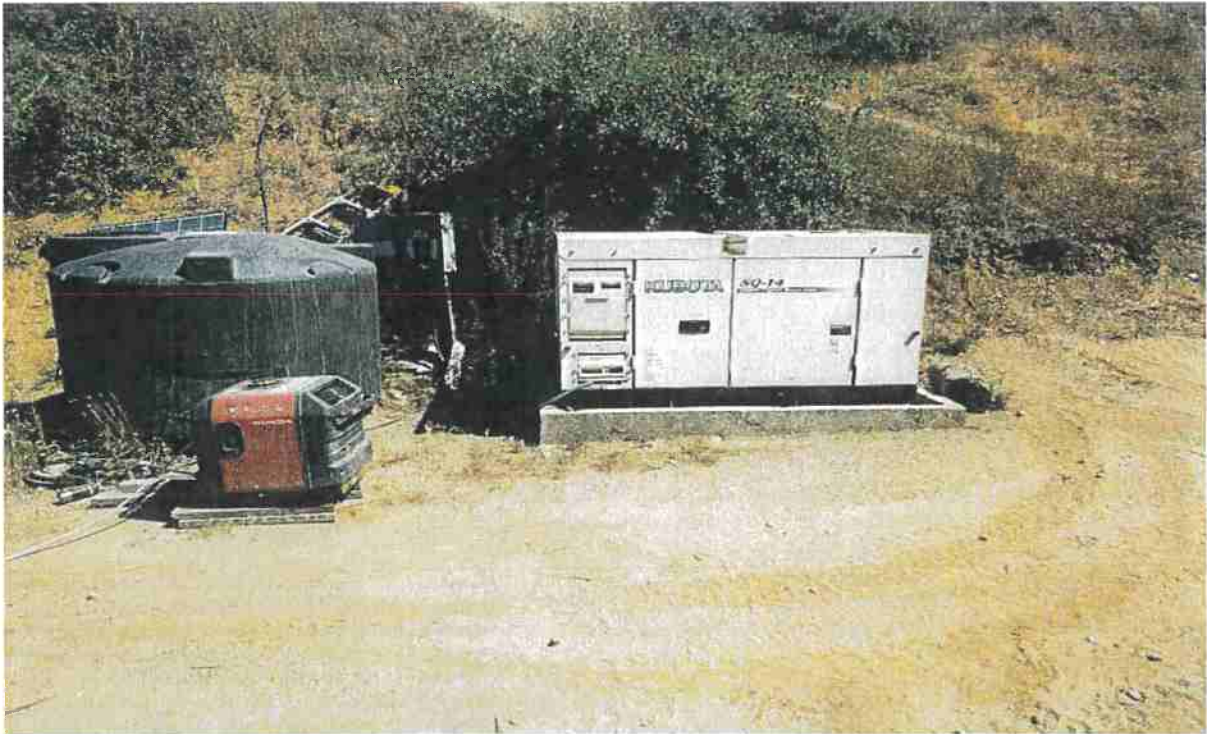
Photo looking at gasoline and diesel generators without proper containment at Site 01.

Unique Point	Lat-Long NAD 83	Road Type	Mitigation Planned	Monitor	1600	Treatment Priority	Date Completed
Site 01	-124.003436 40.254575	Permanent	X	-	-	Prior to 10/15/21	
Current Condition: A diesel and gasoline generator located next to Cultivation Area A does not have proper secondary cover.						Prescribed Action: Provide proper covering for generator and store away in the winter. See attached BMPs: Generator, Fuel, and Oil Management for further details. All petroleum products are required to be used and stored per Cannabis Cultivation Policy, Att. A, Sec. 2, - Term 103 - 110, and 116 - 118 attached.	
Unique Point	Lat-Long NAD 83	Road Type	Mitigation Planned	Monitor	1600	Treatment Priority	Date Completed
Site 02	-124.002989 40.254733	Permanent	X	-	-	Prior to 10/15/22	
Current Condition: Permanent road leading down to Cultivation Area A contains an erosional gully that extends up to the parking lot of the residence. The road is currently outsloted with dirt surfaces.						Prescribed Action: Regrade the road with gentle outsloting from Site 01 to Site 03 then install a waterbar per the specifications outlined in the attached BMPs: Waterbar Construction, General Operations BMPs, and General Erosion Control specifications. Maintain as needed per Cannabis Cultivation Policy, Att. A, Sec. 2, - Term 1 - 29.

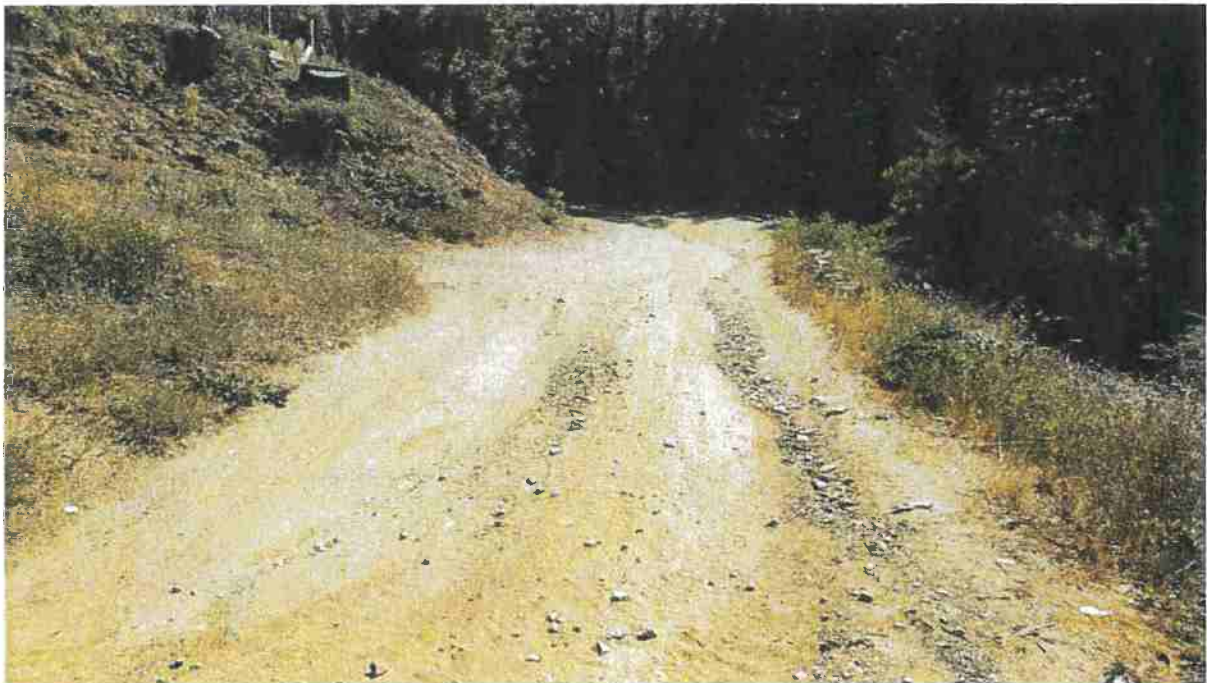
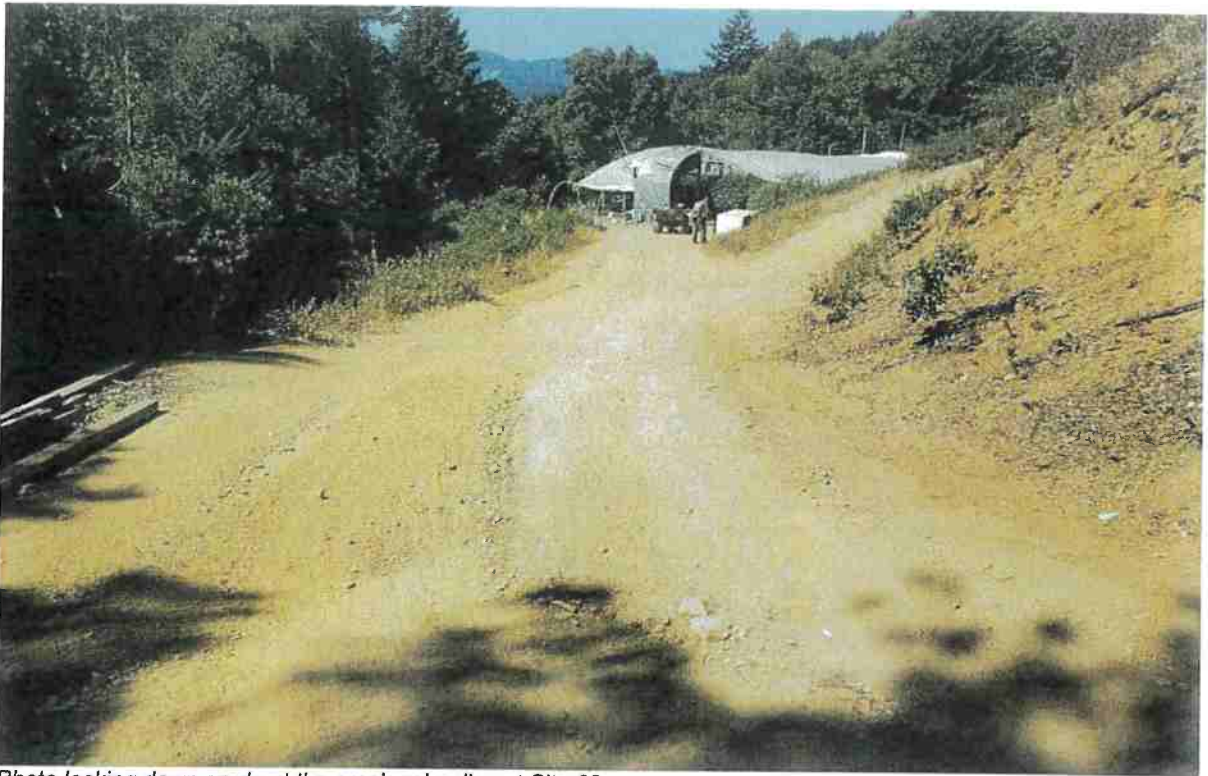
Photo looking up grade at the erosional gully at Site 02.

Photo looking down grade at the erosional gully at Site 02.

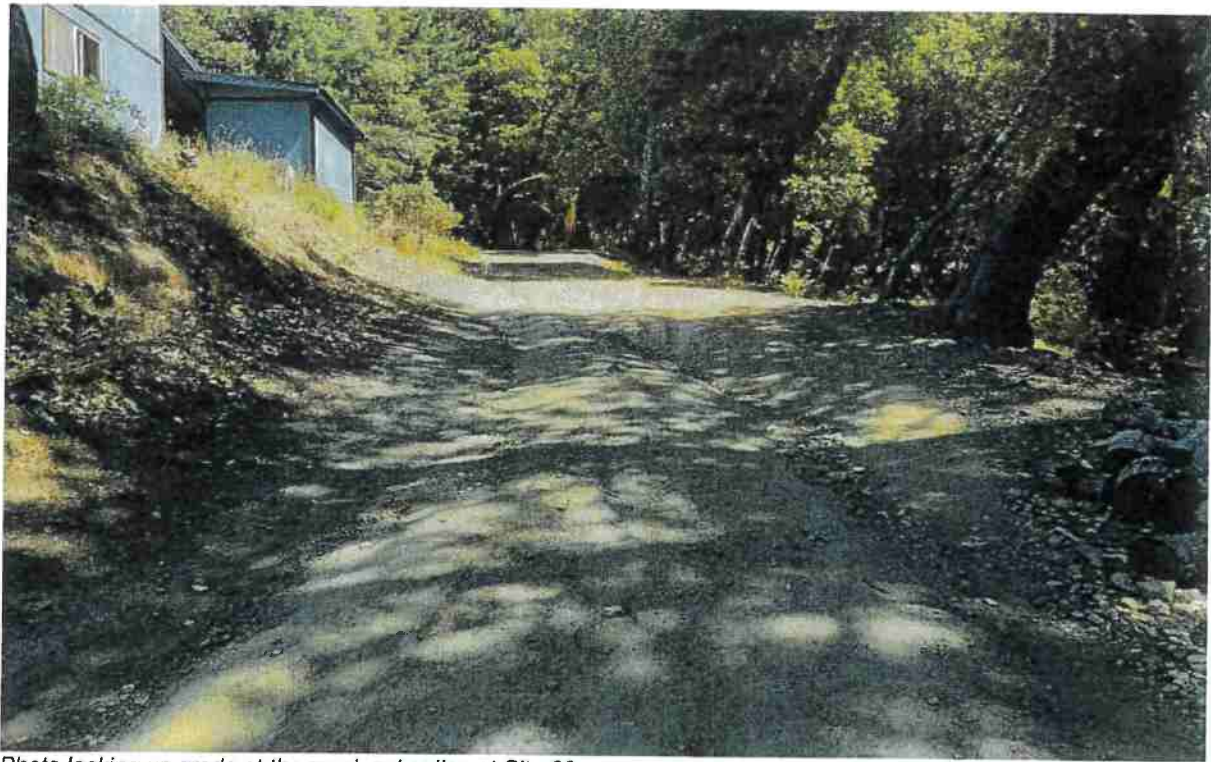
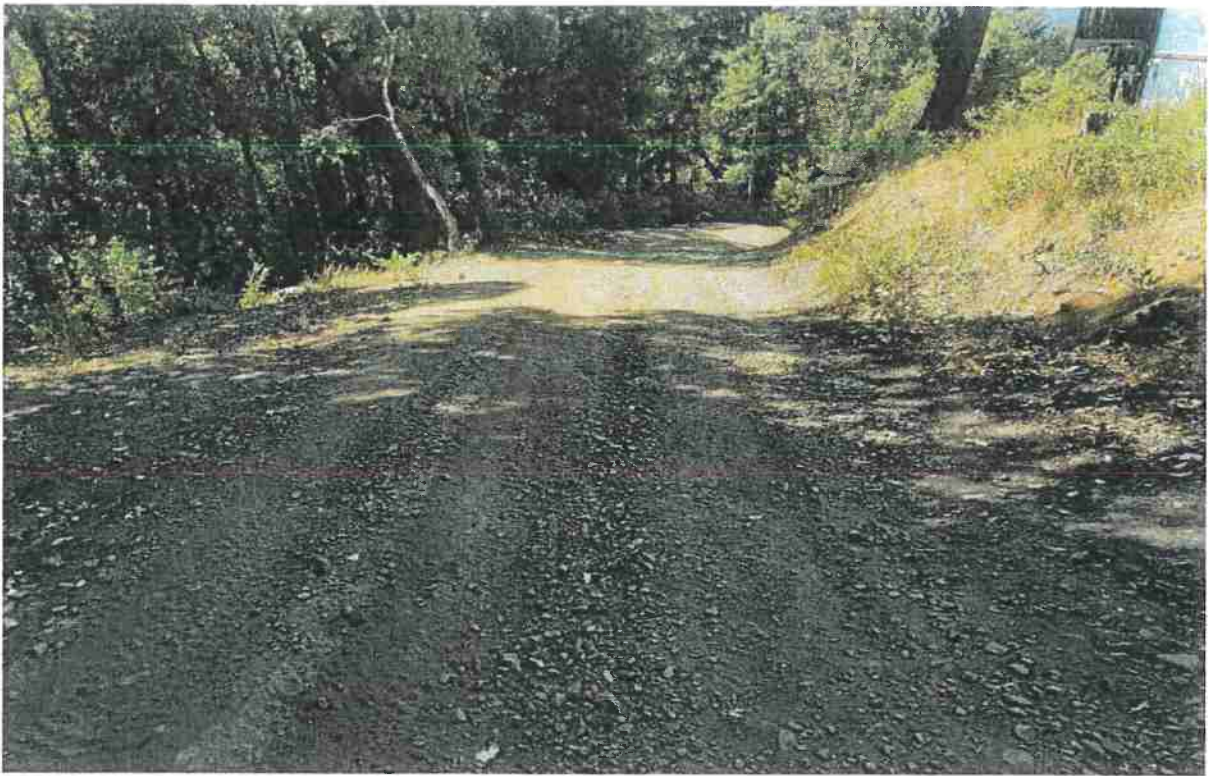
Photo looking up grade at the erosional gully at Site 03.

Photo looking down grade at the erosional gully at Site 03.

Unique Point	Lat-Long NAD 83	Road Type	Mitigation Planned	Monitor	1600	Treatment Priority	Date Completed
Site 03	-124.002912 40.254908	Permanent	X	-	-	Prior to 10/15/22	
Current Condition: Permanent road leading down to Cultivation Area A contains an erosional gully that extends up to the parking lot of the residence. The road is currently outsloted with dirt surfaces.						Prescribed Action: Regrade the road with gentle outsloting from Site 01 to Site 03 then install a waterbar per the specifications outlined in the attached BMPs: Waterbar Construction, General Operations BMPs, and General Erosion Control specifications. Maintain as needed per Cannabis Cultivation Policy, Att. A, Sec. 2, - Term 1 - 29.	
Unique Point	Lat-Long NAD 83	Road Type	Mitigation Planned	Monitor	1600	Treatment Priority	Date Completed
Site 04	-124.002689 40.255078	Permanent	X	-	X	Prior to 10/15/22 pending the approval of any required permits

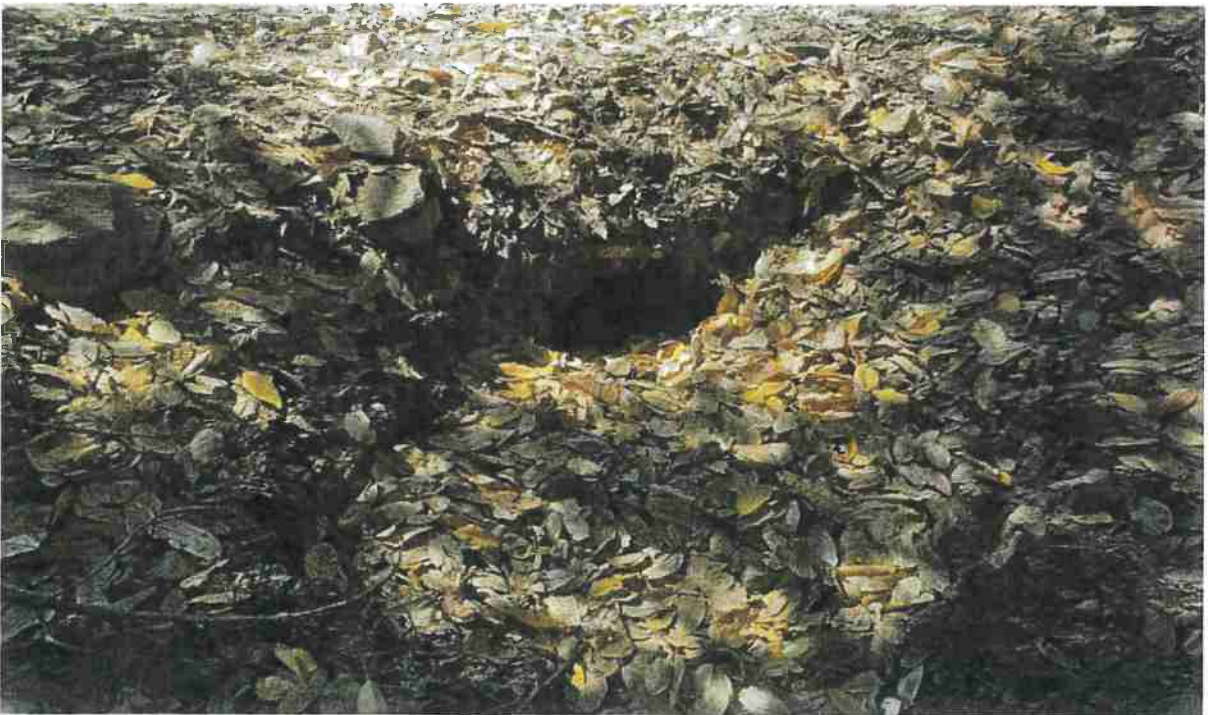
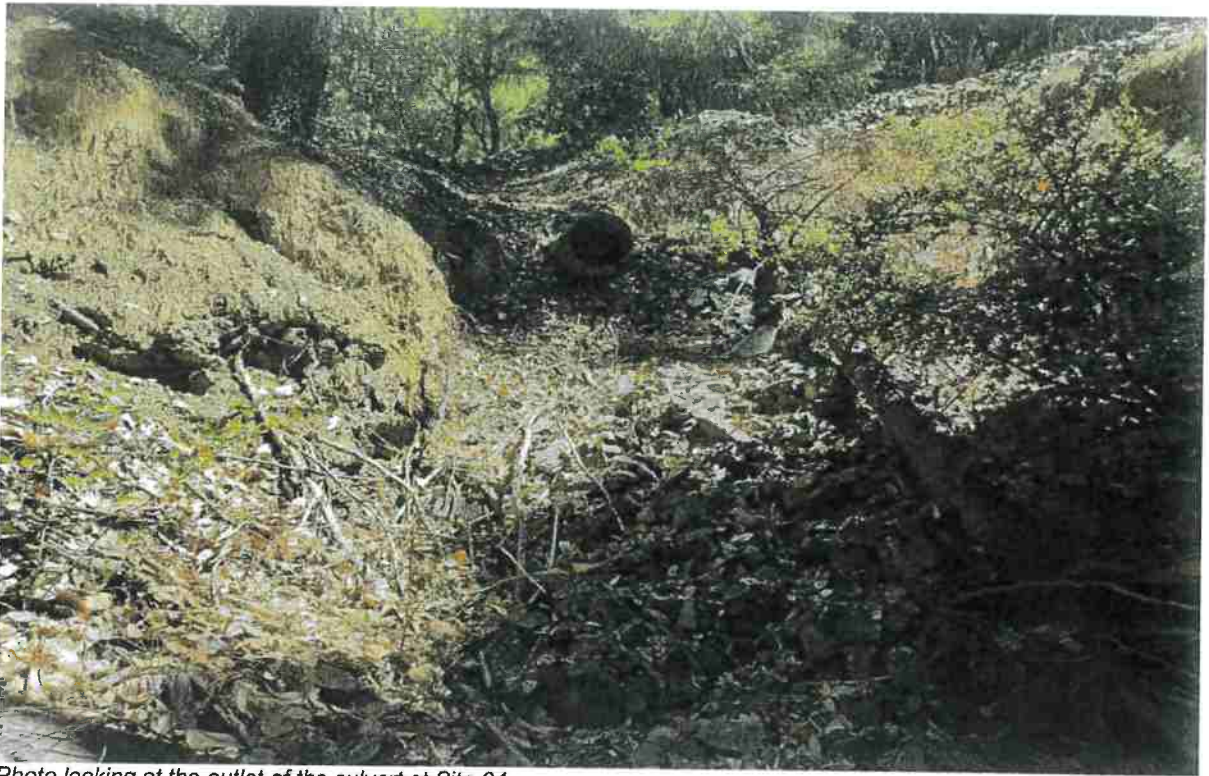
Current Condition: Existing 18-inch diameter corrugated metal culvert on a Class III watercourse. Culvert is undersized, shot-gunned, and partially plugged with forest litter at the inlet.						Prescribed Action: Clean-out inlet then upgrade culvert to minimum 36-inch diameter culvert that is installed to grade, aligned with the natural stream channel, and long enough that it extends lengthwise completely beyond the toe of fill. The crossing upgrade will require the excavation and temporary displacement of approximately 44 cubic yards of fill (30 feet long by 10 feet deep by 4 feet wide) and 120 ft ² of overall disturbance (30 feet length and 4 feet width) per the LSAA #1600-2019-0447-R1.

Photo looking at the inlet of the culvert at Site 04.

Photo looking at the outlet of the culvert at Site 04.

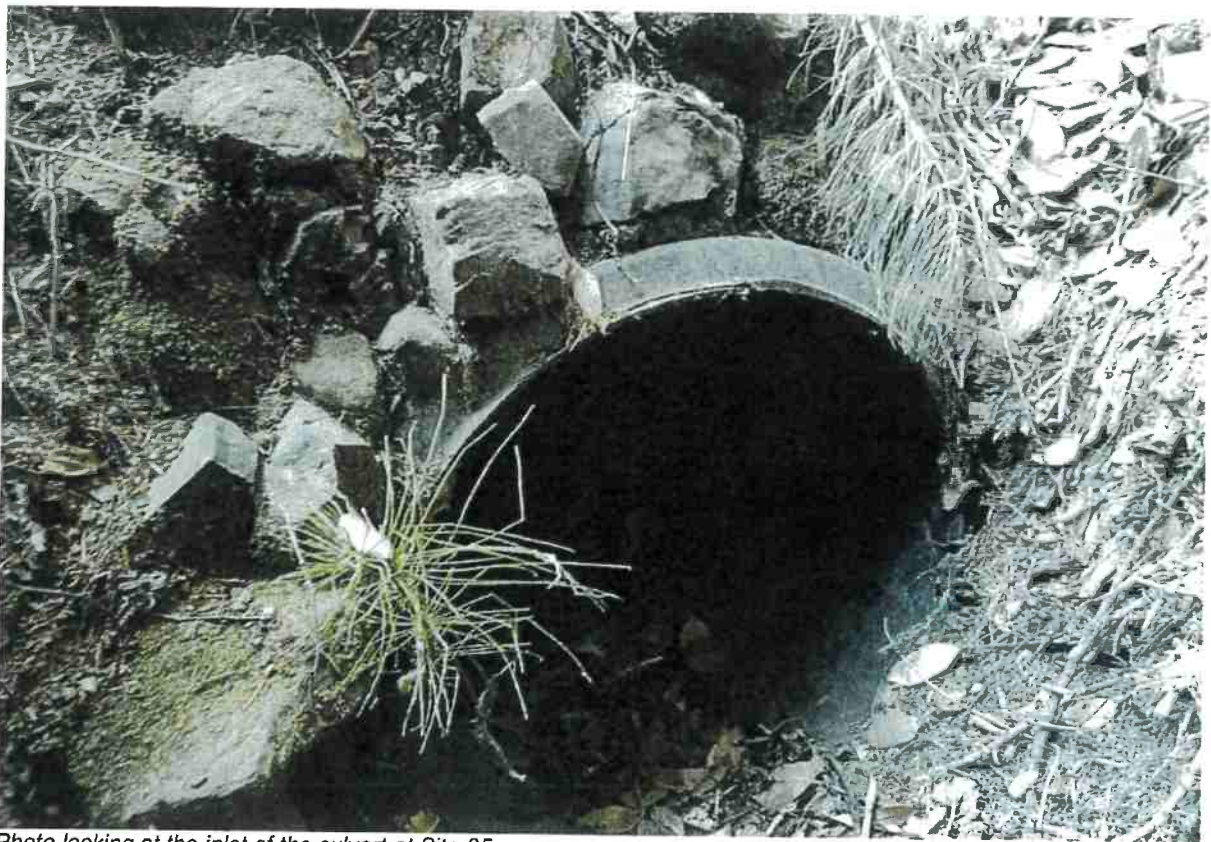
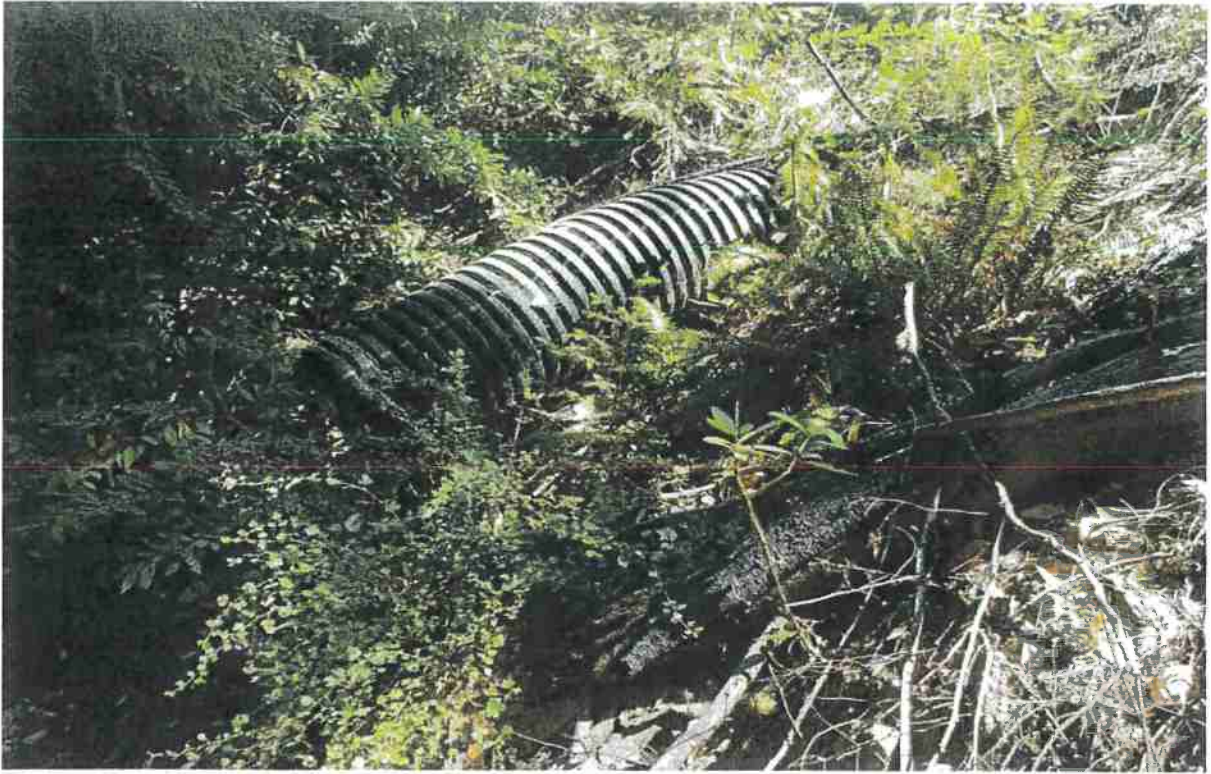
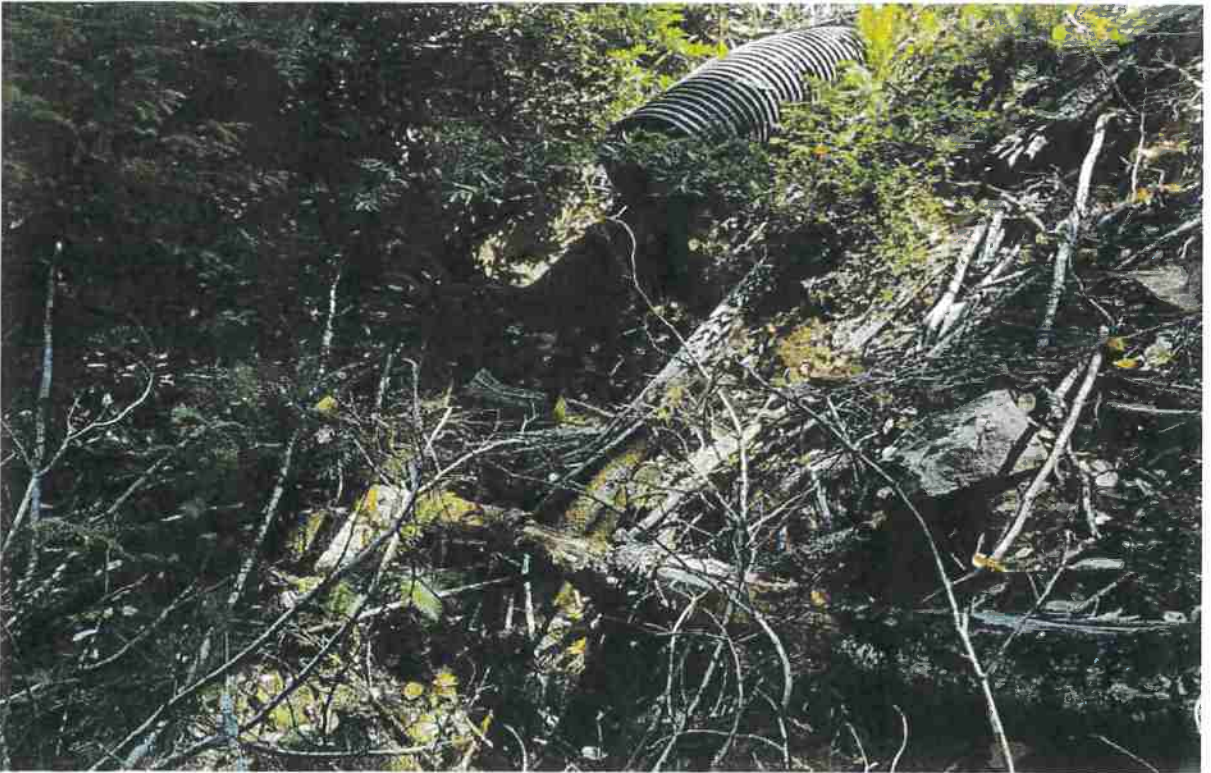
Photo looking at the inlet of the culvert at Site 05.

Photo looking at the outlet of the culvert at Site 05.

Unique Point	Lat-Long NAD 83	Road Type	Mitigation Planned	Monitor	1600	Treatment Priority	Date Completed
Site 05	-124.002172 40.25481	Permanent	X	-	X	Prior to 10/15/22 pending the approval of any required permits	
Current Condition: Existing 24-inch diameter corrugated plastic culvert on a Class III watercourse. The culvert is undersized, too short, and shot-gunned.						Prescribed Action: Upgraded to a 30-inch diameter culvert to grade, aligned with the natural stream channel, and long enough that it extends lengthwise completely beyond the toe of fill. The crossing upgrade will require the excavation and temporary displacement of approximately 41 cubic yards of fill (35 feet long by 8 feet deep by 4 feet wide) and 140 ft ² of overall disturbance (30 feet length and 4 feet wide) per the LSAA #1600-2019-0447-R1.	
Unique Point	Lat-Long NAD 83	Road Type	Mitigation Planned	Monitor	1600	Treatment Priority	Date Completed

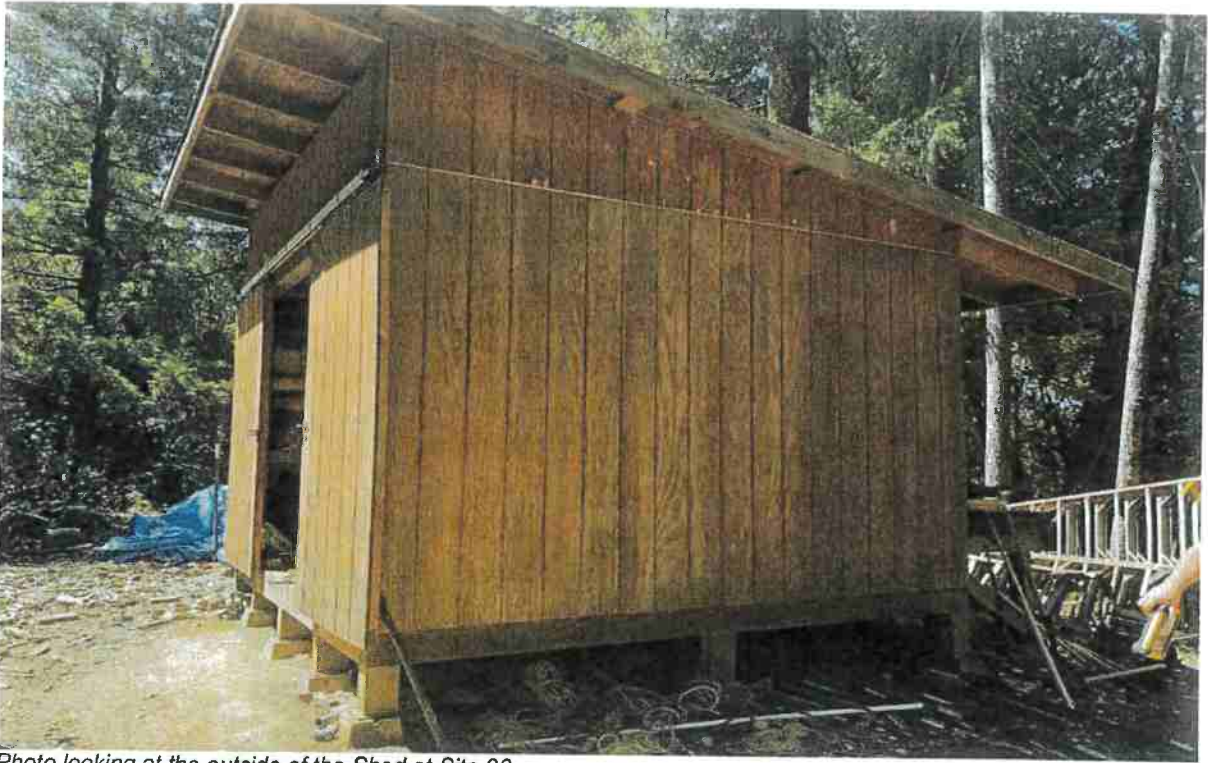
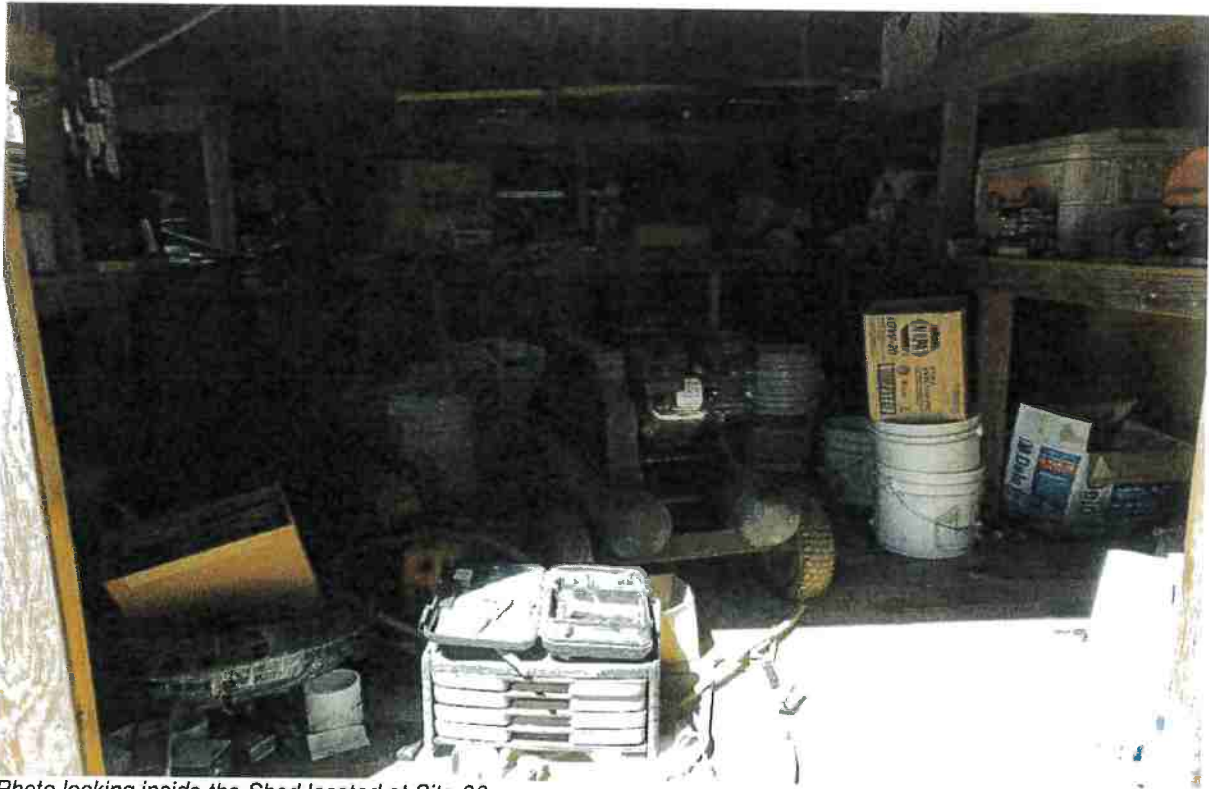
Photo looking at the outside of the Shed at Site 06.

Photo looking inside the Shed located at Site 06.

Site 06	-124.002108 40.254772	Permanent	X	-	-	Prior to 10/15/21	
Current Condition: Shed used for storage of petroleum products is located within the riparian setback of a Class III watercourse. The shed has wooden floors and adequate cover, but petroleum products are not in proper secondary containment.						Prescribed Action: Put all petroleum products in proper secondary containment. See attached BMPs: Generator, Fuel, and Oil Management for further details. All petroleum products are required to be used and stored per Cannabis Cultivation Policy, Att. A, Sec. 2, - Term 103 - 110, and 116 - 118 attached.	
Unique Point	Lat-Long NAD 83	Road Type	Mitigation Planned	Monitor	1600	Treatment Priority	Date Completed
Site 07	-124.001691 40.254495	Permanent	X	-	X	Prior to 10/15/22 pending the approval of any required permits	
Current Condition: Existing 24-inch diameter corrugated plastic culvert on a Class III watercourse. The culvert is adequately sized, slightly shot-gunned, and the inlet is partially buried.						Prescribed Action: Replace 24-inch diameter corrugated plastic culvert with 24-inch diameter corrugated metal culvert that is set to grade and aligned correctly. Rock armor the inlet and outlet with appropriately sized rock per the LSAA #1600-2019-0447-R1.

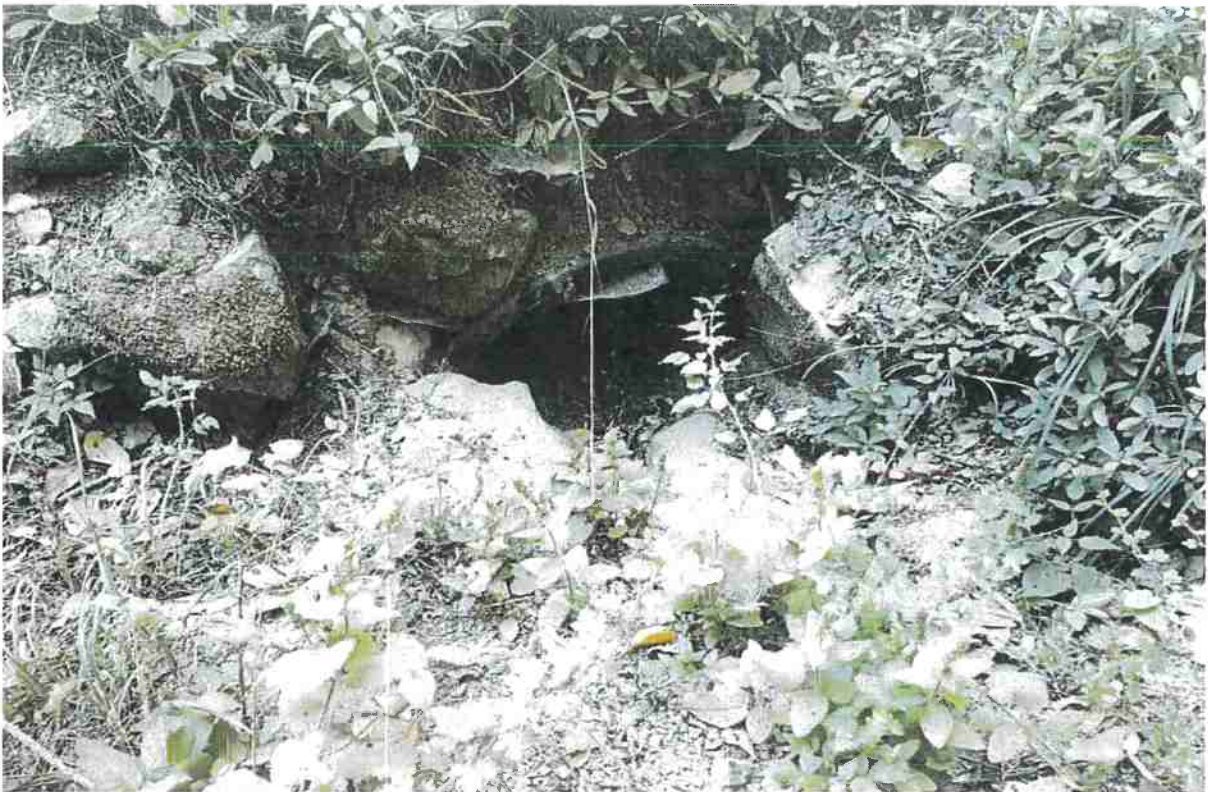
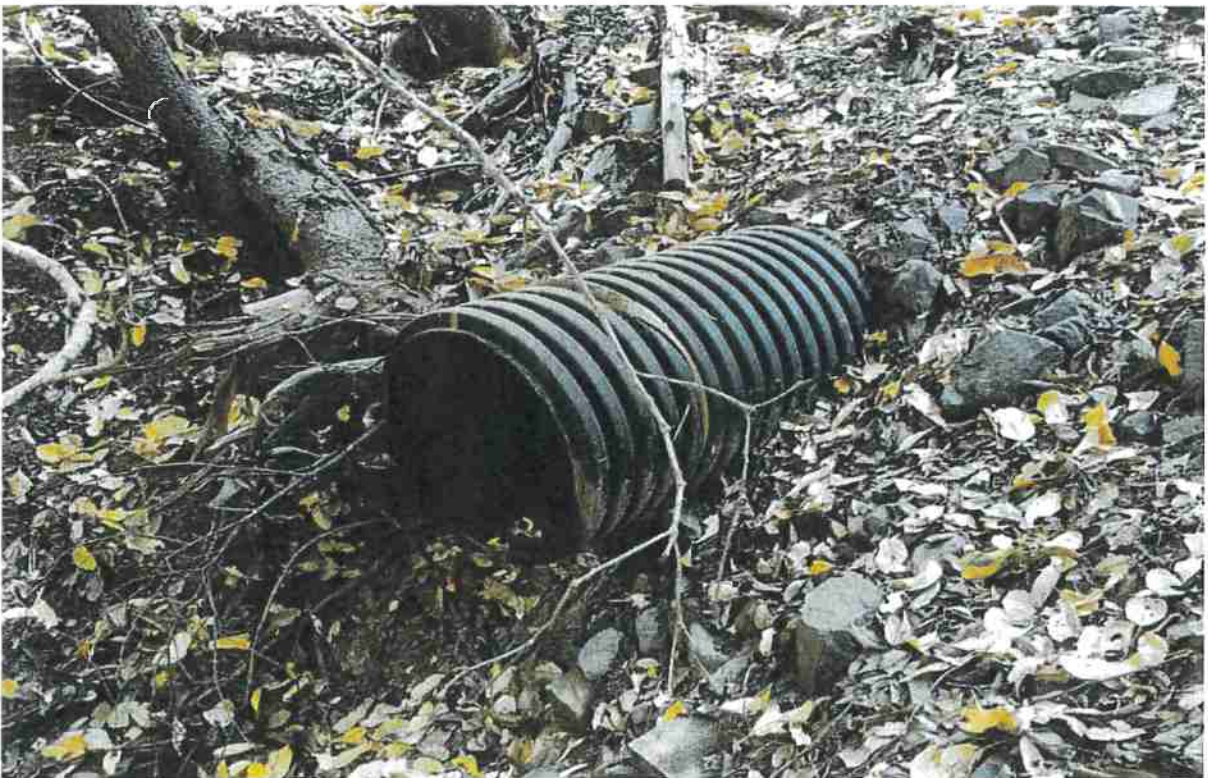
Photo looking at the inlet of the culvert at Site 07.

Photo looking at the outlet of the culvert at Site 07.

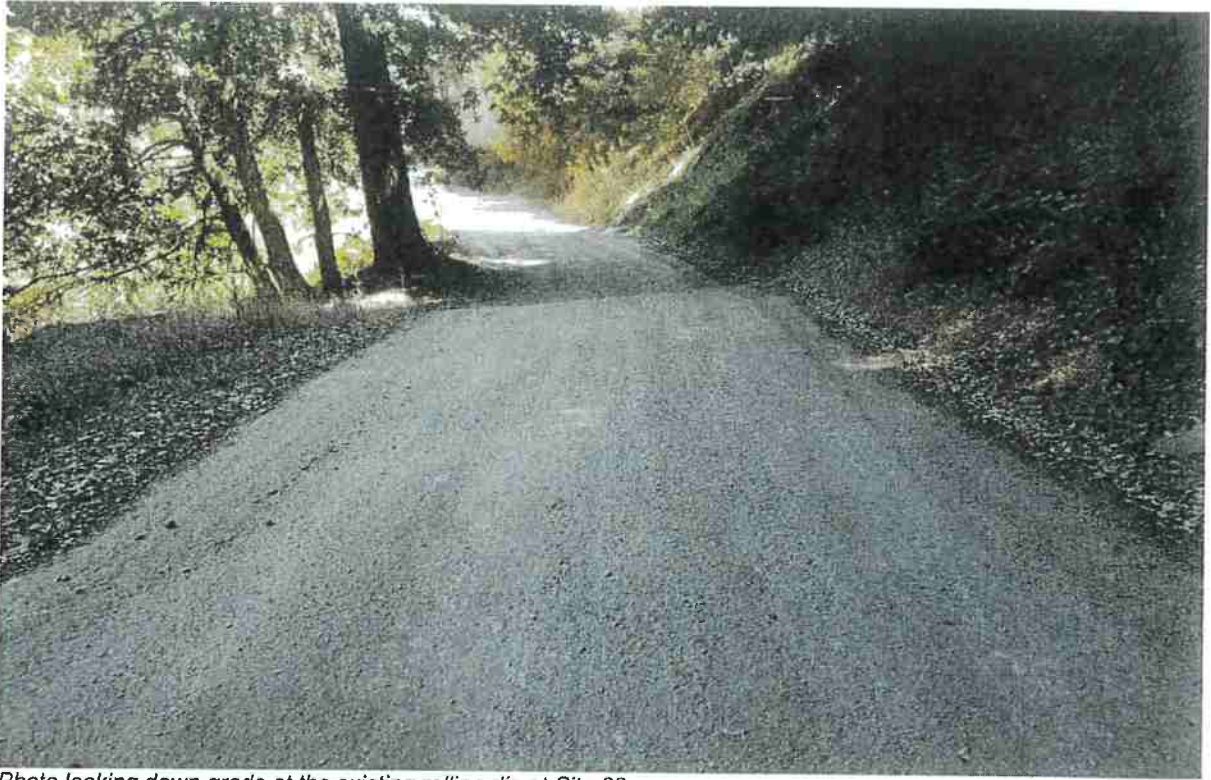
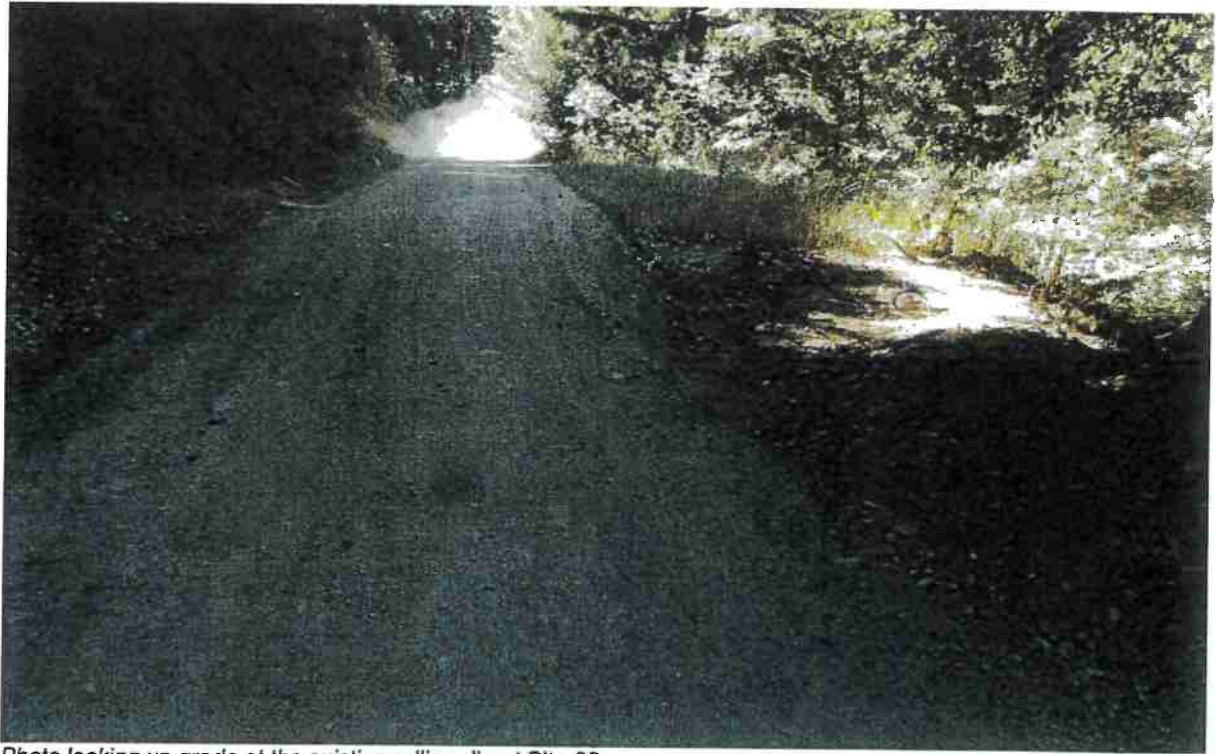
Photo looking down grade at the existing rolling dip at Site 08.

Photo looking up grade at the existing rolling dip at Site 08.

Unique Point	Lat-Long NAD 83	Road Type	Mitigation Planned	Monitor	1600	Treatment Priority	Date Completed
Site 08	-124.001611 40.253792	Permanent	-	X	-	Annually prior to 10/15	
Current Condition: Existing rolling dip is installed correctly and functioning adequately.						Prescribed Action: Monitor and maintain as needed. See "Rolling Dip Design and Placement" in the attached BMP's. See Cannabis Cultivation Policy, Att. A, Sec. 2, - Term 1 - 29 that is attached for specifications.	
Unique Point	Lat-Long NAD 83	Road Type	Mitigation Planned	Monitor	1600	Treatment Priority	Date Completed
Site 09	-124.001374 40.254099	Permanent	-	X	-	Annually prior to 10/15	
Current Condition: Existing rolling dip is installed correctly and functioning adequately.						Prescribed Action: Monitor and maintain as needed. See "Rolling Dip Design and Placement" in the attached BMP's. See Cannabis Cultivation Policy, Att. A, Sec. 2, - Term 1 - 29 that is attached for specifications.

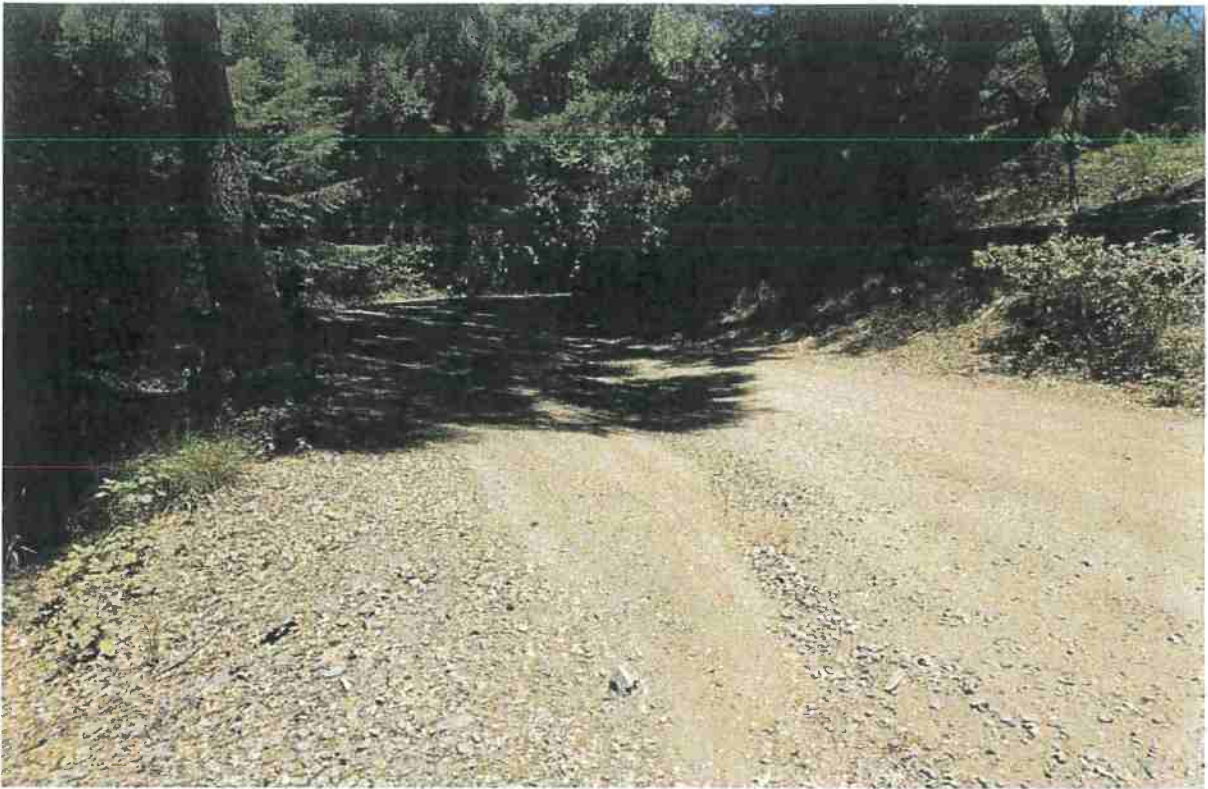
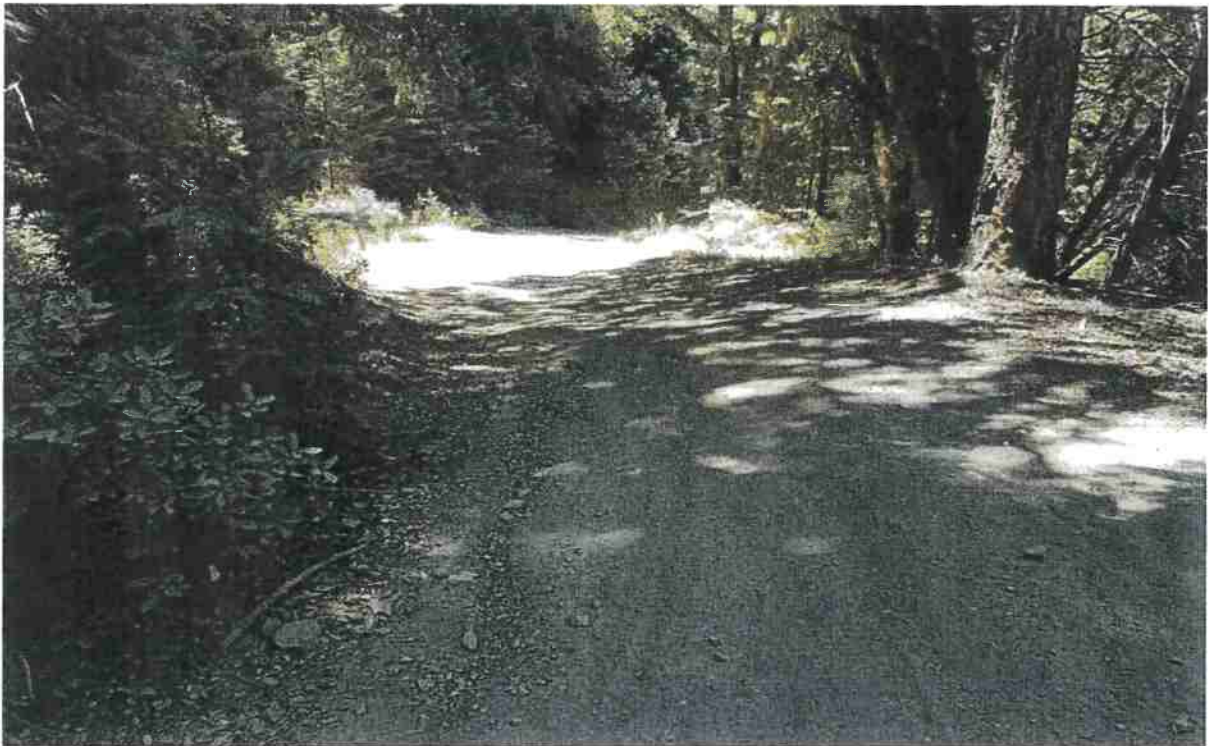
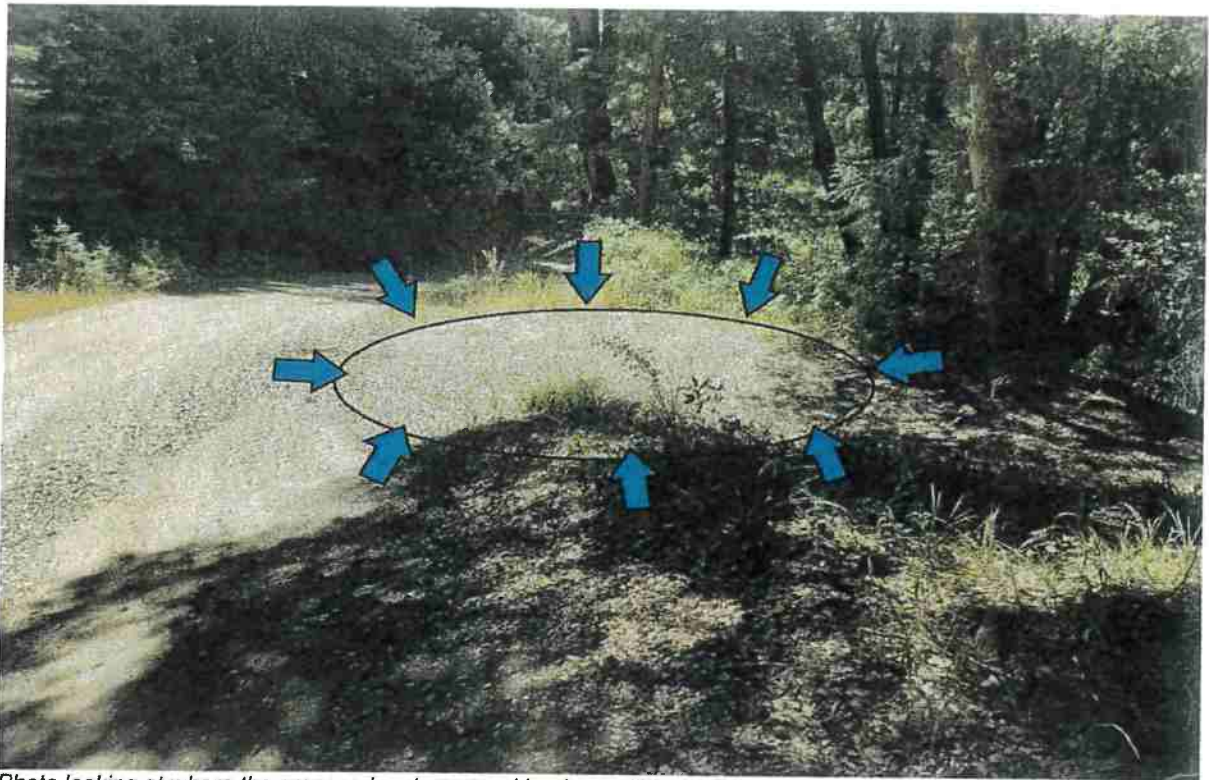
Photo looking up grade at the erosion at Site 11.

Photo looking down grade at the erosion at Site 11.

Photo looking at where the proposed rock armored lead out will be at Site 11.

Unique Point	Lat-Long NAD 83	Road Type	Mitigation Planned	Monitor	1600	Treatment Priority	Date Completed
Site 11	-124.001157 40.255205	Permanent	X	-	-	Prior to 10/15/22	
Current Condition: Erosional gully exists on a permanent road downhill of Cultivation Area B. The section of road with erosion occurring is located within riparian setbacks of two separate Class III watercourses and has the potential of becoming hydrologically connected to both watercourses.						Prescribed Action: Regrade the road from Site 11 to Site 13 with gentle outsloping then install a rolling dip along with a 8' x 8' leadout that is rock armored with adequate sized rock. See "Rolling Dip Design and Placement" in the attached BMP's. See Cannabis Cultivation Policy, Att. A, Sec. 2, - Term 1 - 29 that is attached for specifications.	
Unique Point	Lat-Long NAD 83	Road Type	Mitigation Planned	Monitor	1600	Treatment Priority	Date Completed

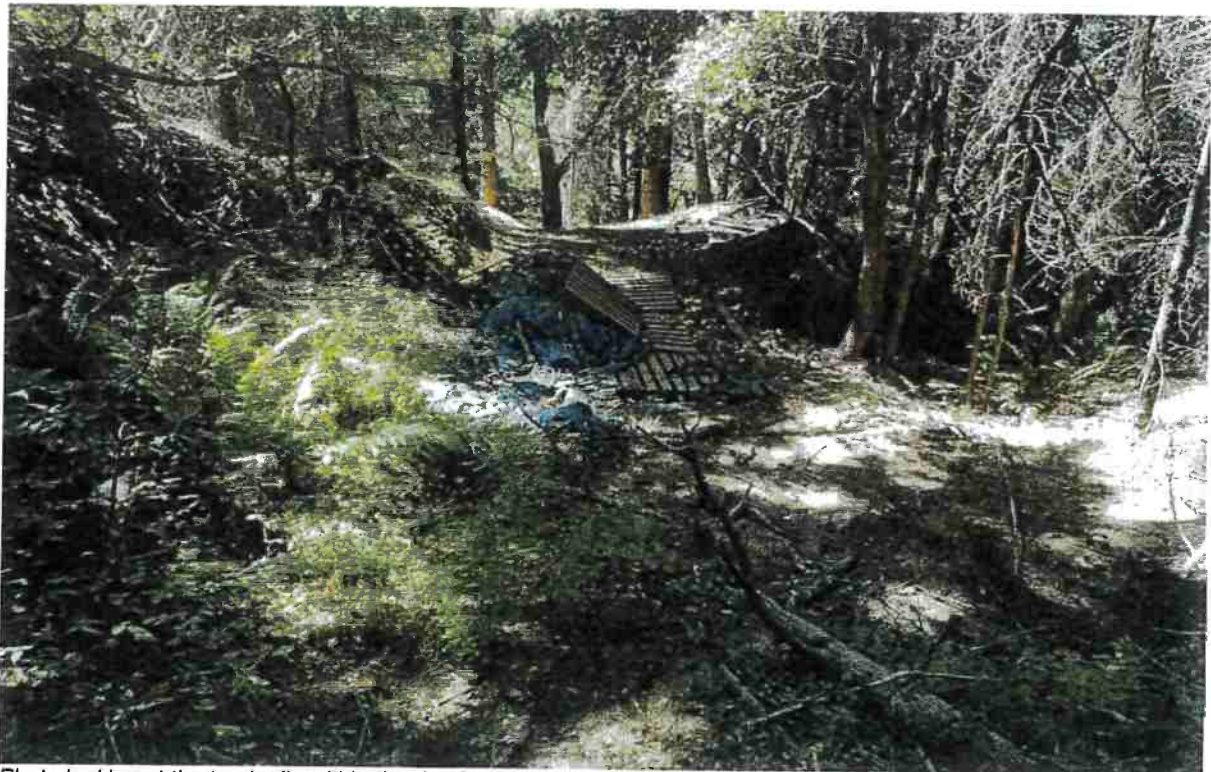
Photo looking at the trash pile within the riparian setback of a Class III watercourse at Site 12.

Site 12	-124.00116 40.255235	Permanent	X	-	-	Immediately	
Current Condition: A pile of cultivation related debris is within the riparian setback of a Class III watercourse.						Prescribed Action: Cultivation-related wastes shall be removed and stored in a manner where they cannot be transferred into a watercourse. See Cannabis Cultivation Policy, Att. A, Sec. 2, - Term 119 - 125 that is attached for specifications.	
Unique Point	Lat-Long NAD 83	Road Type	Mitigation Planned	Monitor	1600	Treatment Priority	Date Completed
Site 13	-124.00106 40.255266	Permanent	X	X	-	Prior to 10/15/22	
Current Condition: Erosion at the outfall of a roadside ditch that is just outside the riparian setback of a Class III watercourse that extends up to Site 14.						Prescribed Action: Rock armor the entire roadside ditch with adequately sized rock as well as the outfall of the roadside ditch per the specifications outlined in the attached BMPs: General Operations BMPs and General Erosion Control specifications. See Cannabis Cultivation Policy, Att. A, Sec. 2, - Term 1 - 29 that is attached for specifications.
