Site Management Plan

(Tier 1, Low Risk)

WDID - 1_12CC418891

9/8/2021

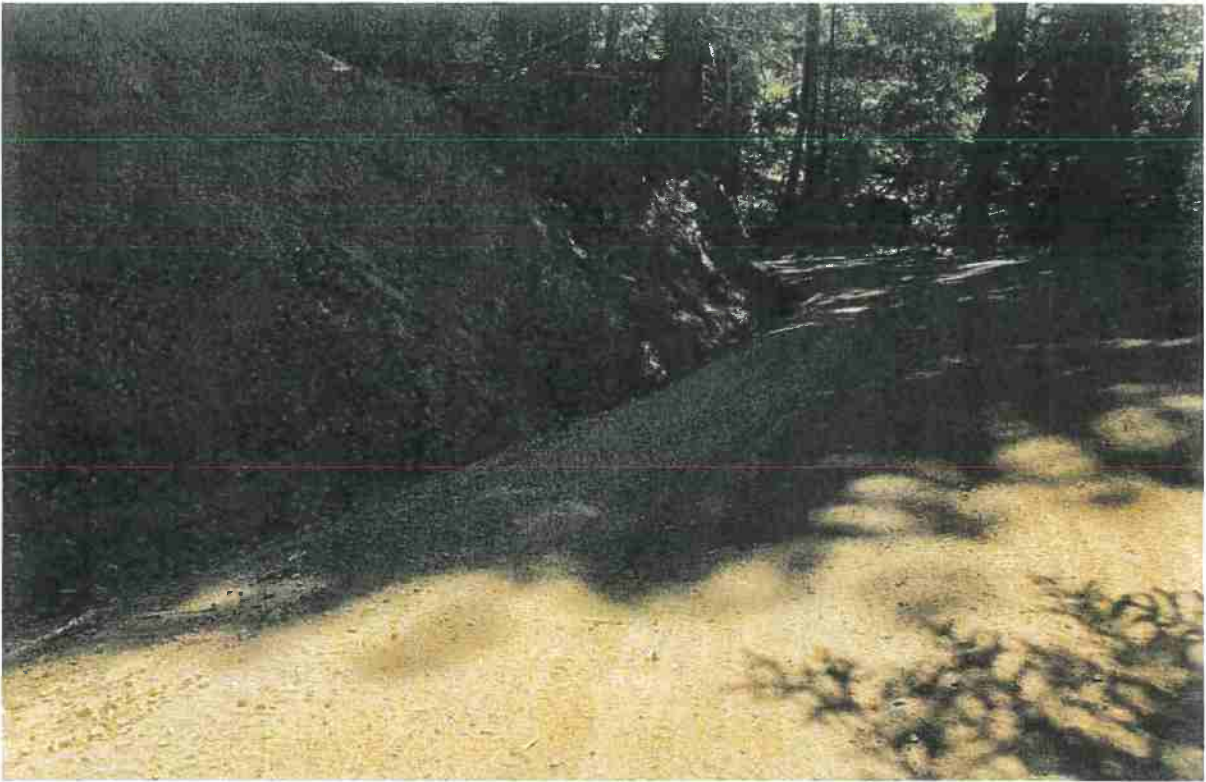
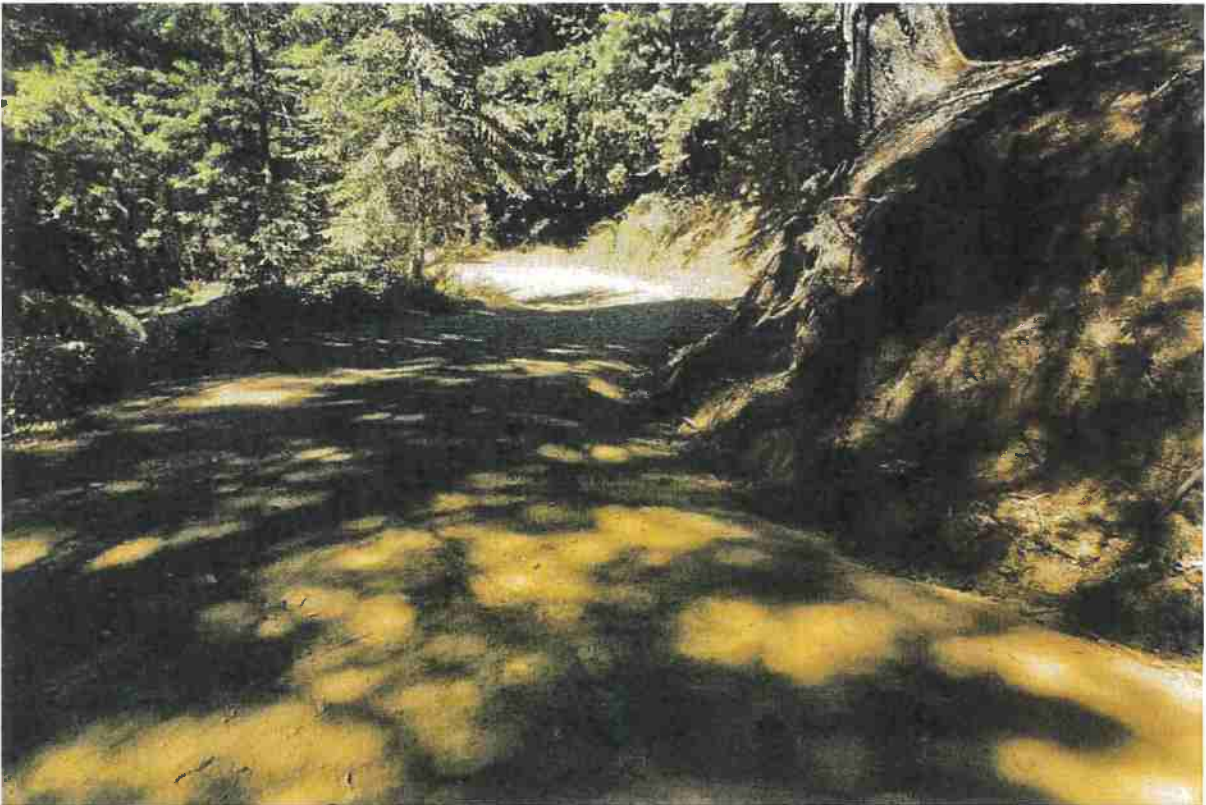
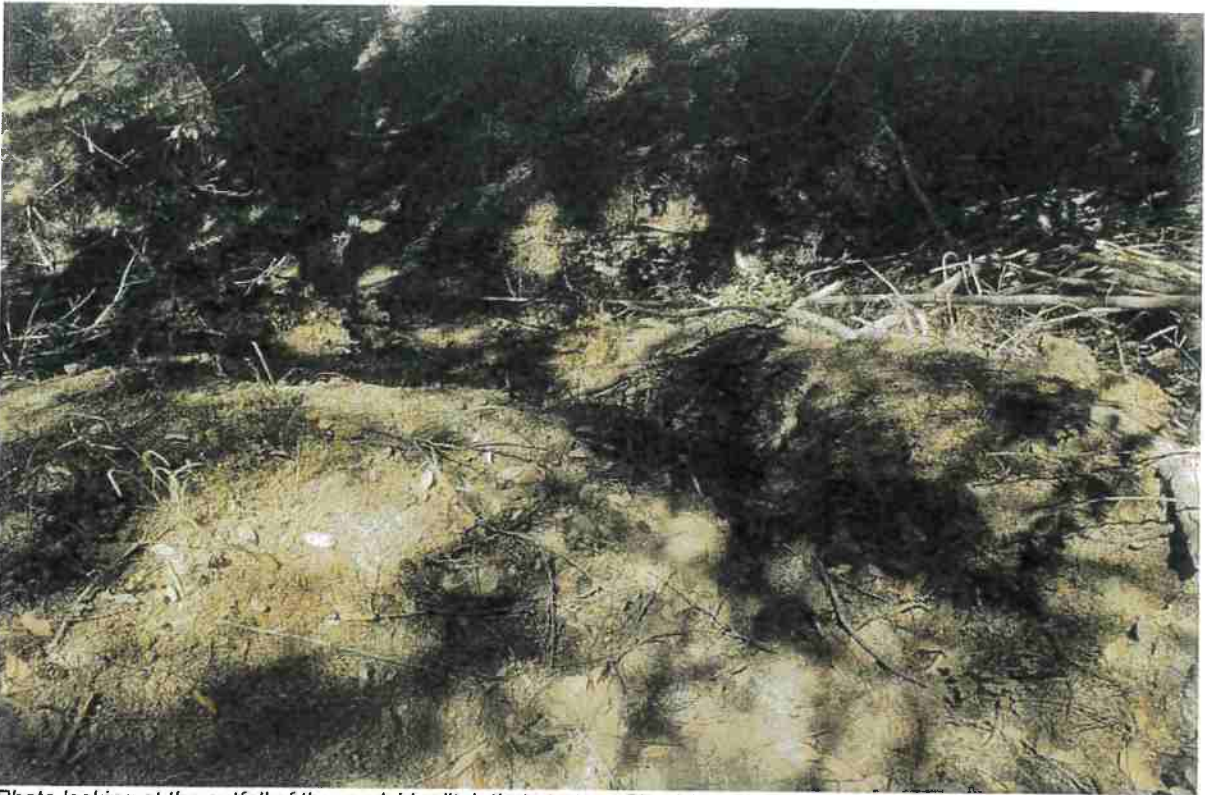
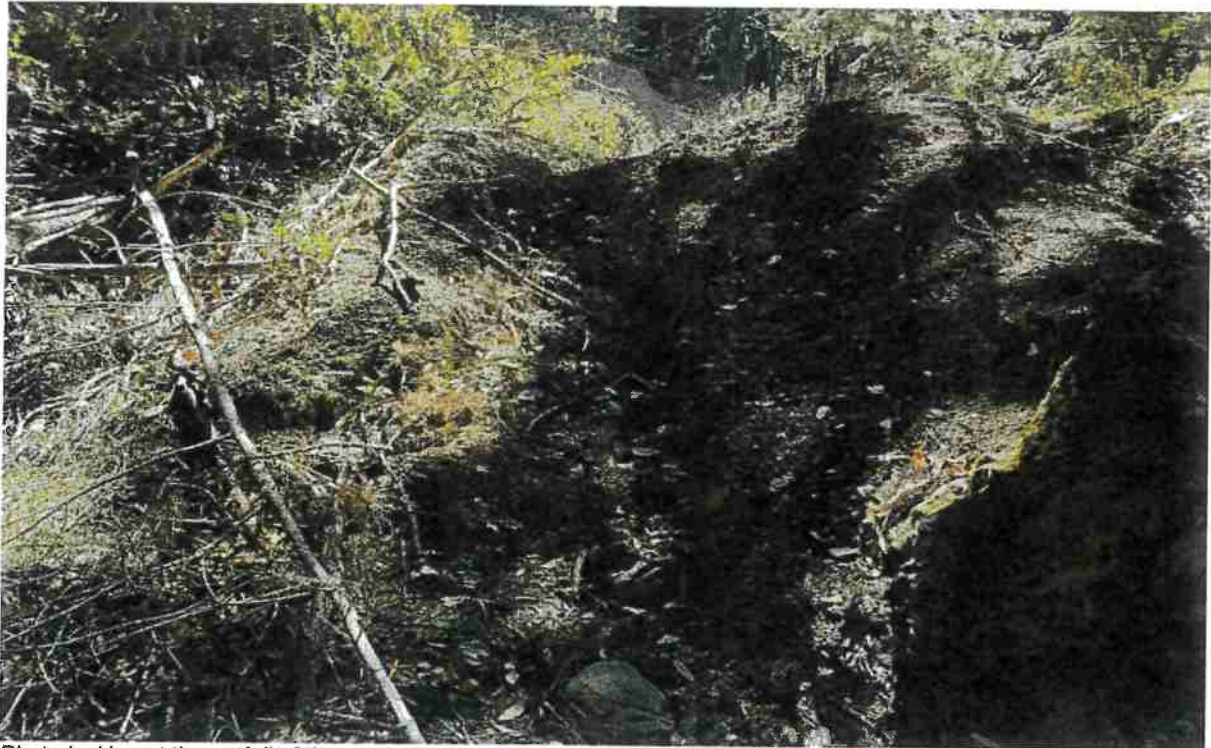
Photo looking up grade at the inside ditch that starts at Site 14 and extends down to Site 13.

Photo looking down grade at the inside ditch that starts at Site 14 and extends to Site 13.

Photo looking at the outfall of the roadside ditch that starts at Site 14 and extends down to Site 13.

Unique Point	Lat-Long NAD 83	Road Type	Mitigation Planned	Monitor	1600	Treatment Priority	Date Completed
Site 14	-124.000612 40.255264	Permanent	X	X	-	Prior to 10/15/22	
Current Condition: Start of a roadside ditch that leads down to Site 13 is hydrologically connected to a Class III watercourse.						Prescribed Action: See Site 13	
Unique Point	Lat-Long NAD 83	Road Type	Mitigation Planned	Monitor	1600	Treatment Priority	Date Completed
Site 15	-124.000378 40.255548	Permanent	-	X	-	Annually prior to 10/15	
Current Condition: French drain extending to Site 16 is installed correctly and functioning properly.						Prescribed Action: Monitor and maintain as needed.	
Unique Point	Lat-Long NAD 83	Road Type	Mitigation Planned	Monitor	1600	Treatment Priority	Date Completed
Site 16	-124.001033 40.255925	Permanent	-	X	-	Annually prior to 10/15	
Current Condition: See Site 15						Prescribed Action: See Site 15

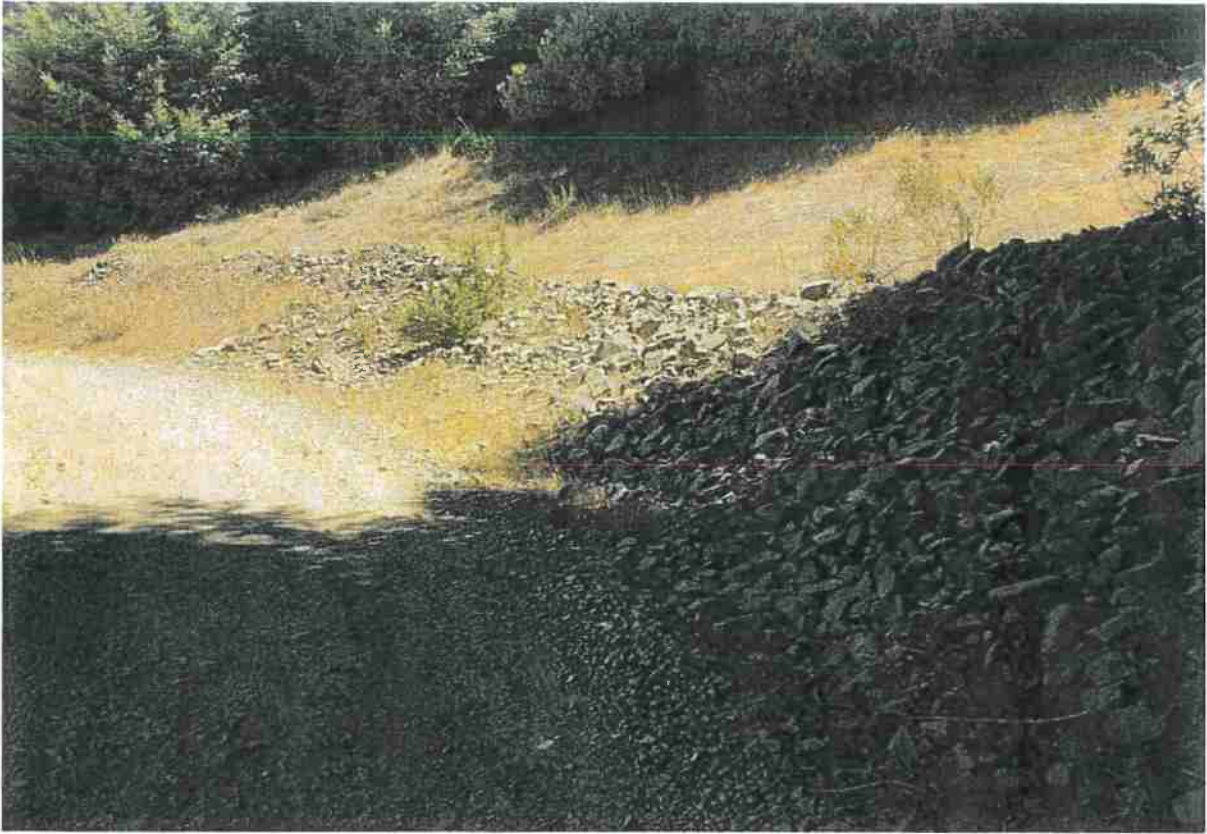
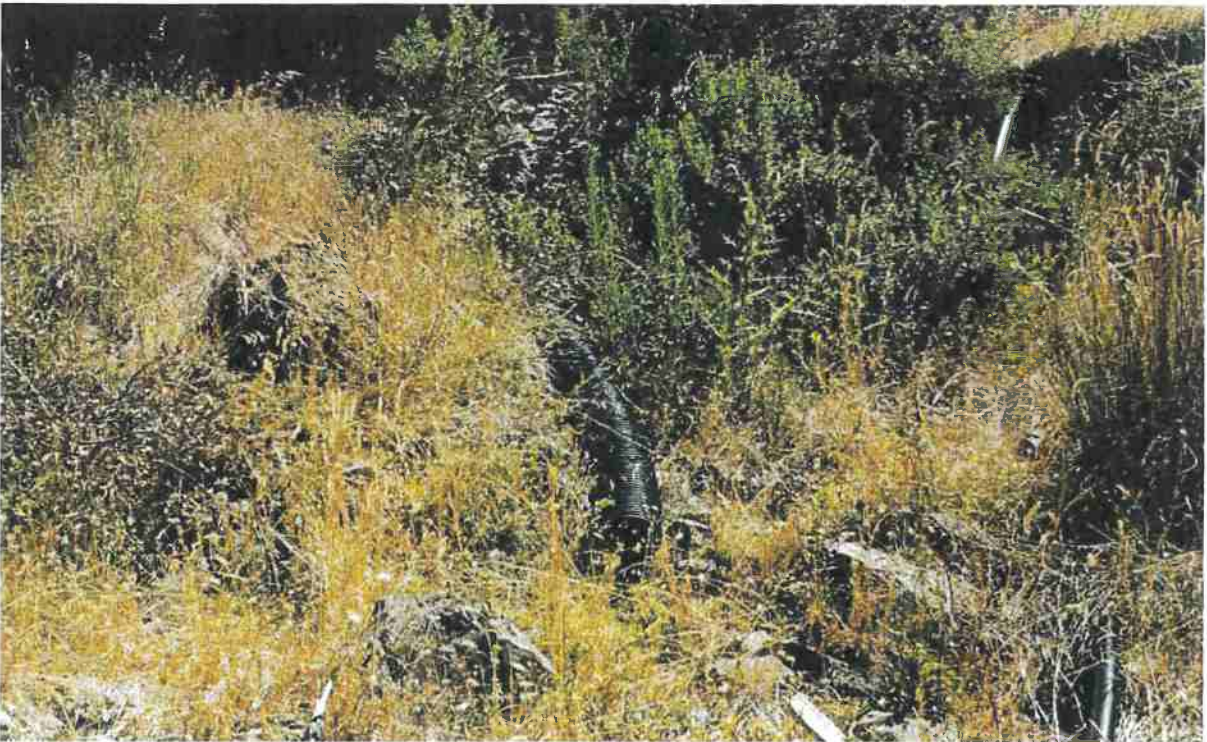
Photo looking at the French drain starting at Site 15 and extending to Site 16.

Photo looking at the outlet of the French drain at Site 16.

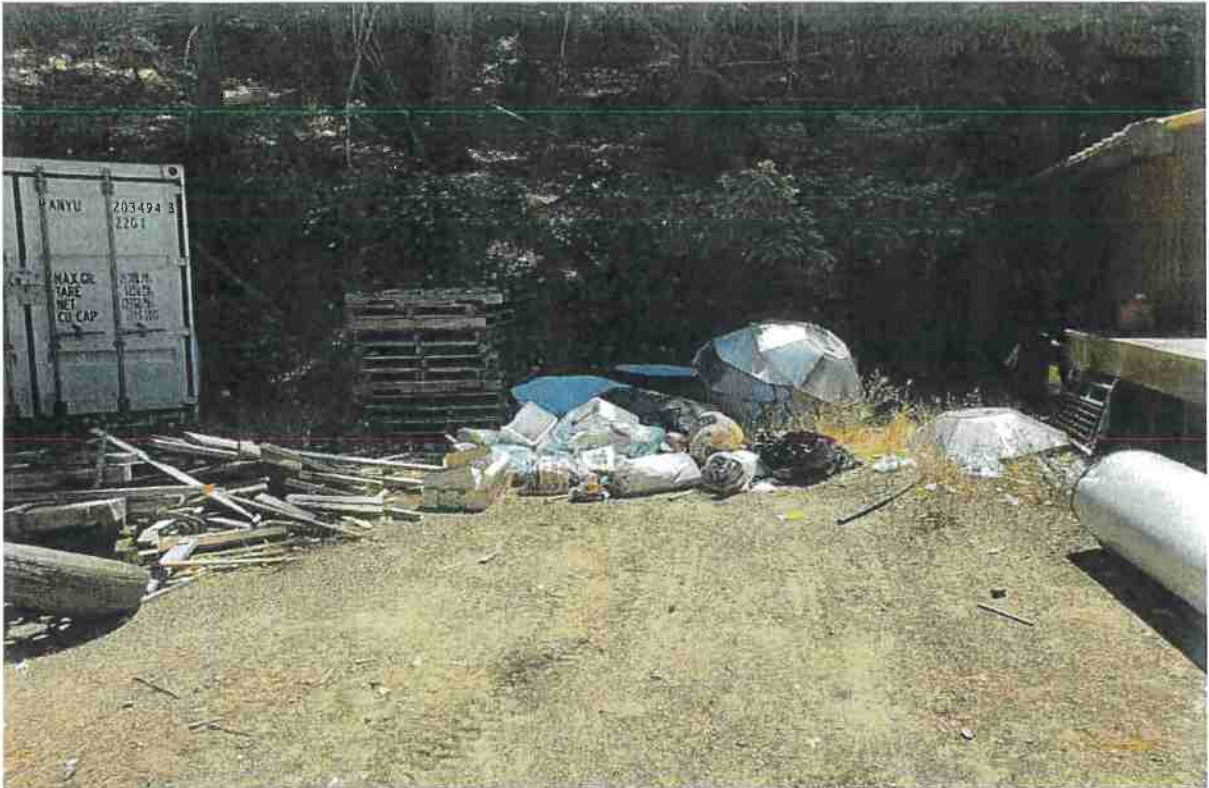
Photo looking at the cultivation related waste at Site 18.

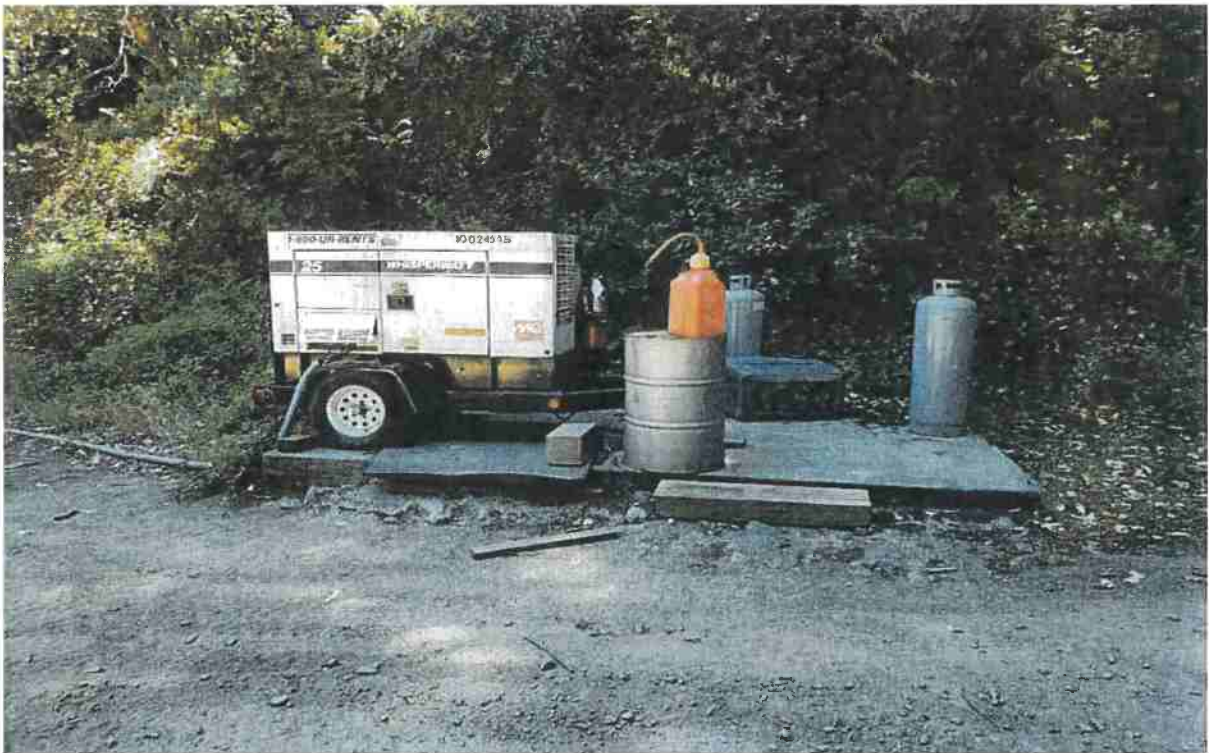
Photo looking at the uncovered diesel generator at Site 20.

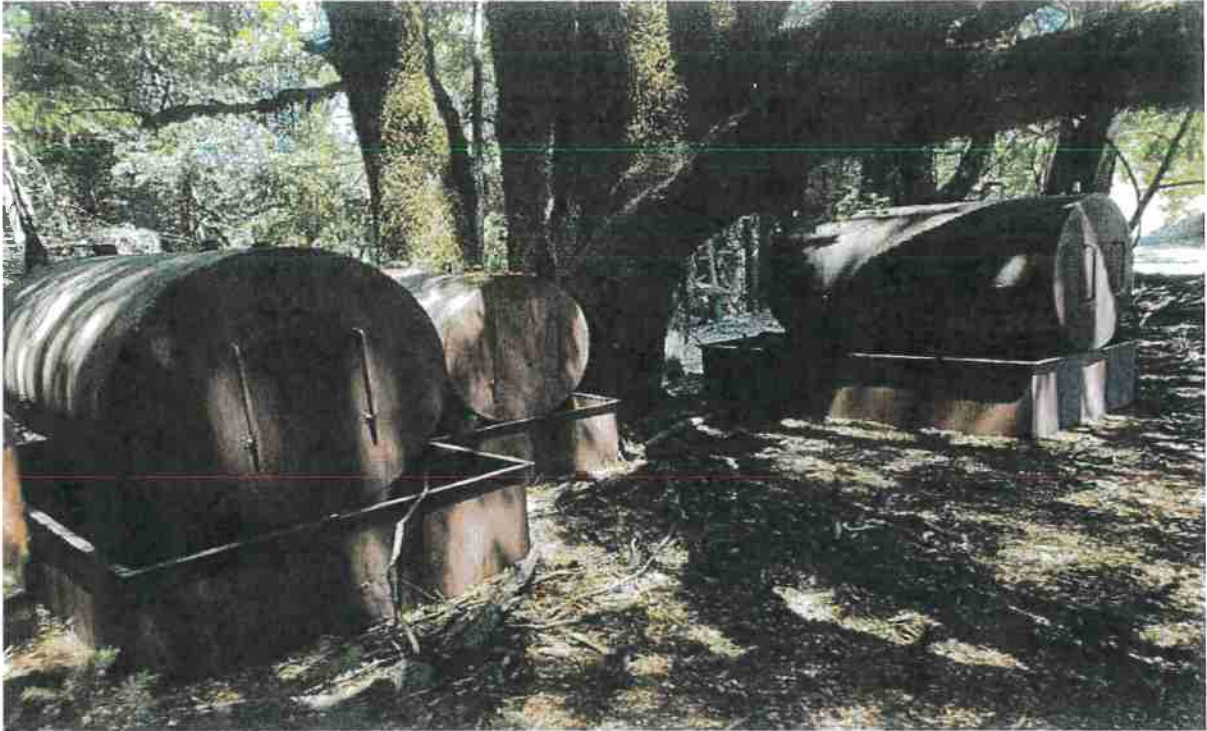
Photos looking at the petroleum tanks that don't have proper cover at Site 21.

Unique Point	Lat-Long NAD 83	Road Type	Mitigation Planned	Monitor	1600	Treatment Priority	Date Completed
Site 21	-124.000514 40.253043	Permanent	X	-	-	Prior to 10/15/21	
Current Condition: Two 500-gallon diesel tanks and one 500-gallon gasoline tank that have proper secondary containment but no secondary cover.						Prescribed Action: See attached BMPs: Generator, Fuel, and Oil Management for further details. All petroleum products are required to be used and stored per Cannabis Cultivation Policy, Att. A, Sec. 2, - Term 103 - 110, and 116 - 118 attached.	
Unique Point	Lat-Long NAD 83	Road Type	Mitigation Planned	Monitor	1600	Treatment Priority	Date Completed
Site 22	-123.999952 40.253427	Permanent	X	-	-	Prior to 10/15/21	
Current Condition: Existing soil pile is uncovered. The soil shows no signs of migration away from the pile is located outside of riparian areas.						Prescribed Action: The soil pile shall be properly cover prior to a rain event and throughout winter per Cannabis Cultivation Policy, Att. A, Sec. 2, - Term 57 - 62 attached.

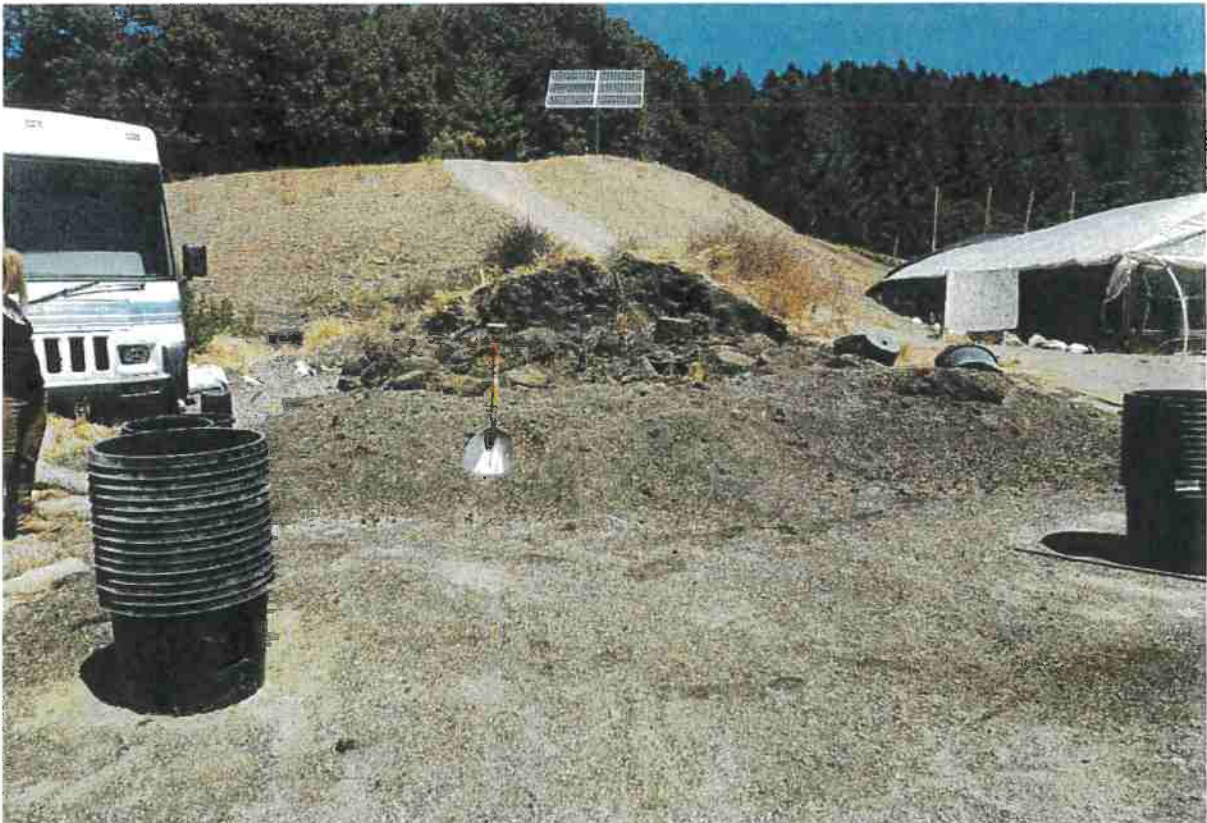
Photo looking at the uncovered soil pile at Site 22.

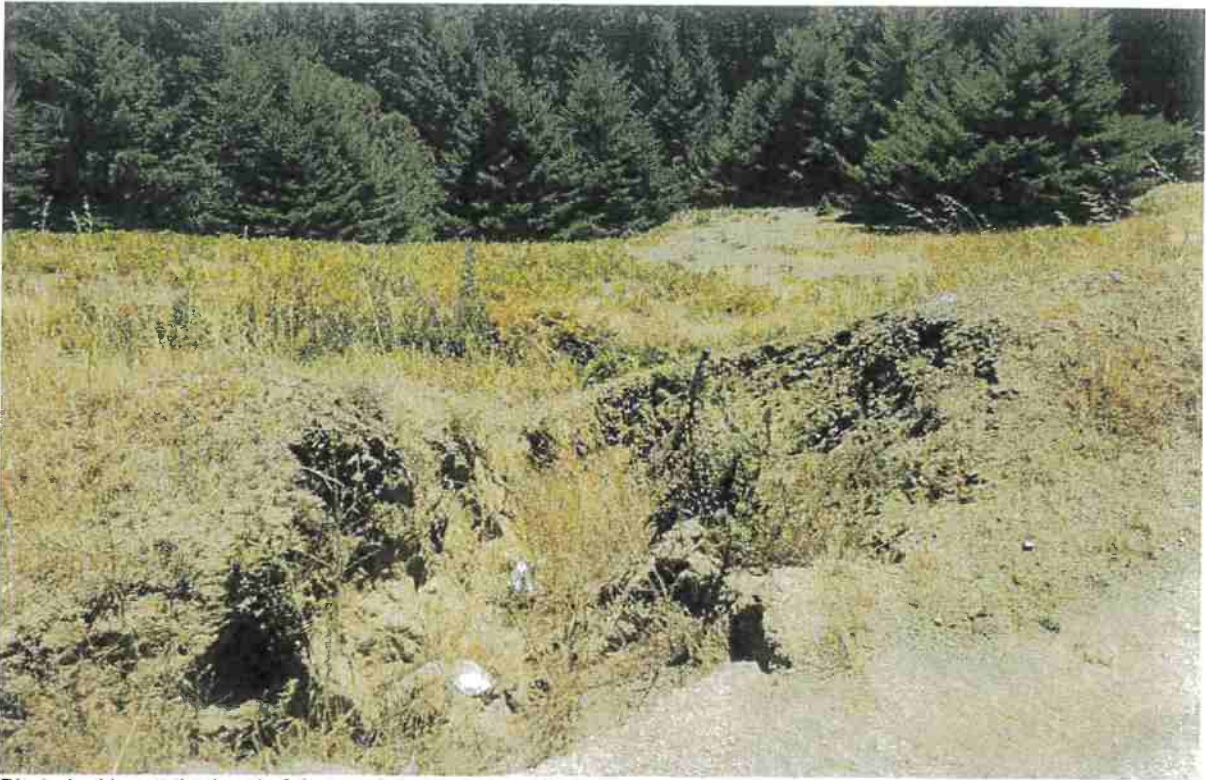
Photo looking at the head of the erosional gulley at Site 23.

Unique Point	Lat-Long NAD 83	Road Type	Mitigation Planned	Monitor	1600	Treatment Priority	Date Completed
Site 23	-123.999479 40.253731	Permanent	X	X	-	Prior to 10/15/22	
Current Condition: Erosion gully starts at the roads edge and extends east downslope 200'.						Prescribed Action: Rock armor the head of the gully at the roads edge with adequate sized rock and maintain the rolling dip up grade at Site 24.	
Unique Point	Lat-Long NAD 83	Road Type	Mitigation Planned	Monitor	1600	Treatment Priority	Date Completed
Site 24	-123.999448 40.253931	Permanent	-	X	-	Annually prior to 10/15	
Current Condition: A series of existing rolling dips are installed correctly and functioning adequately.						Prescribed Action: Monitor and maintain as needed. See "Rolling Dip Design and Placement" in the attached BMP's. See Cannabis Cultivation Policy, Att. A, Sec. 2, - Term 1 - 29 that is attached for specifications.

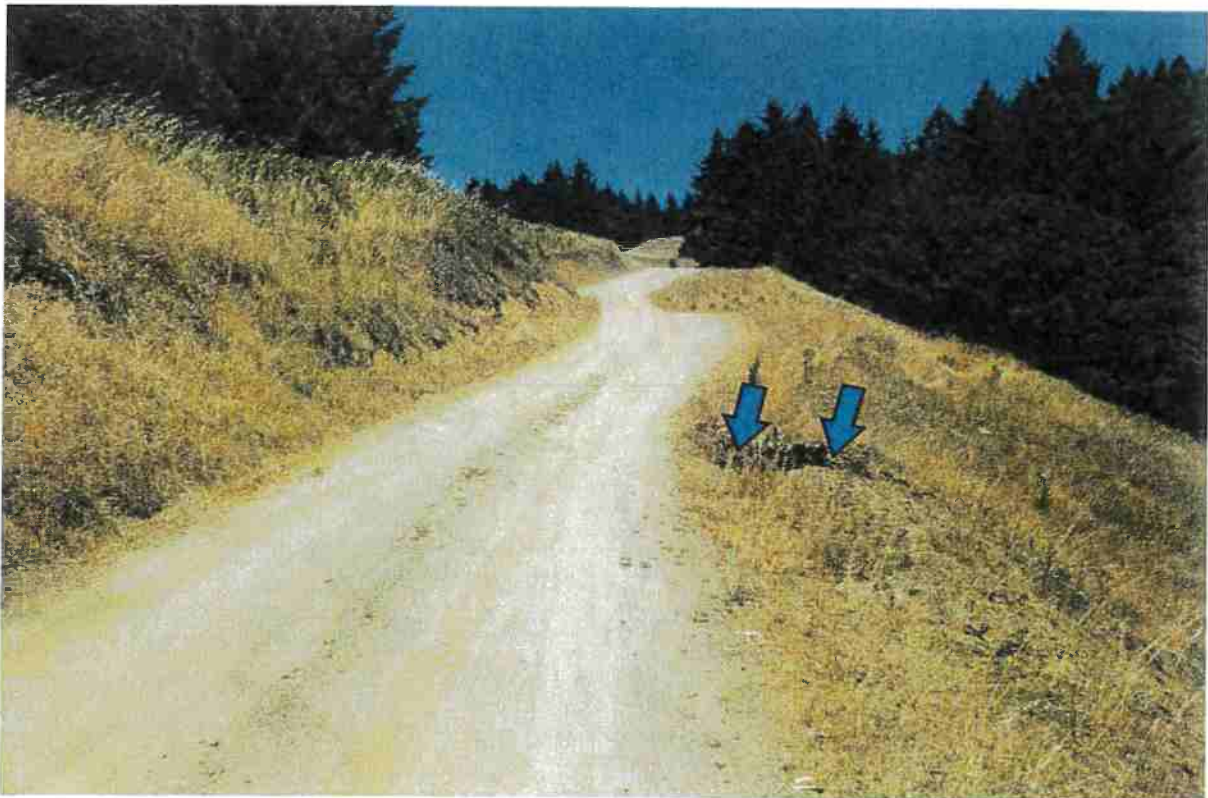
Photo looking at the head of the erosional gulley (indicated by the blue arrows) at Site 24.

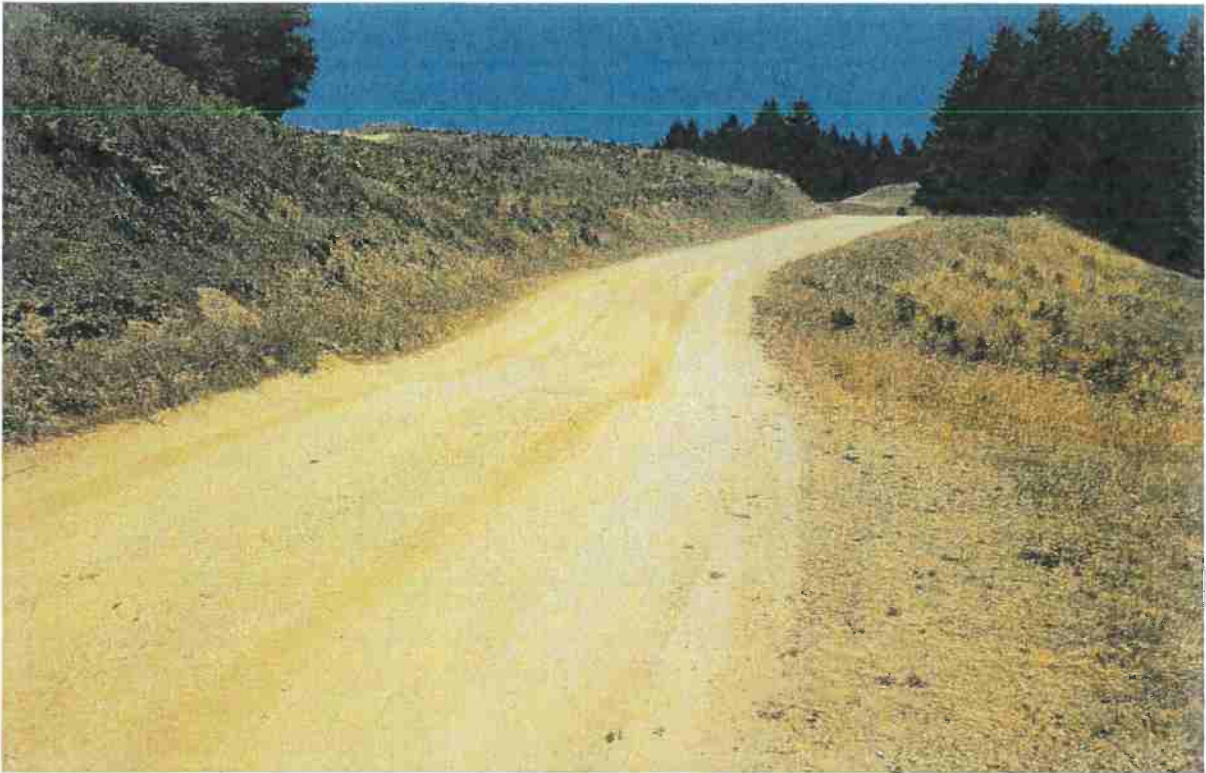
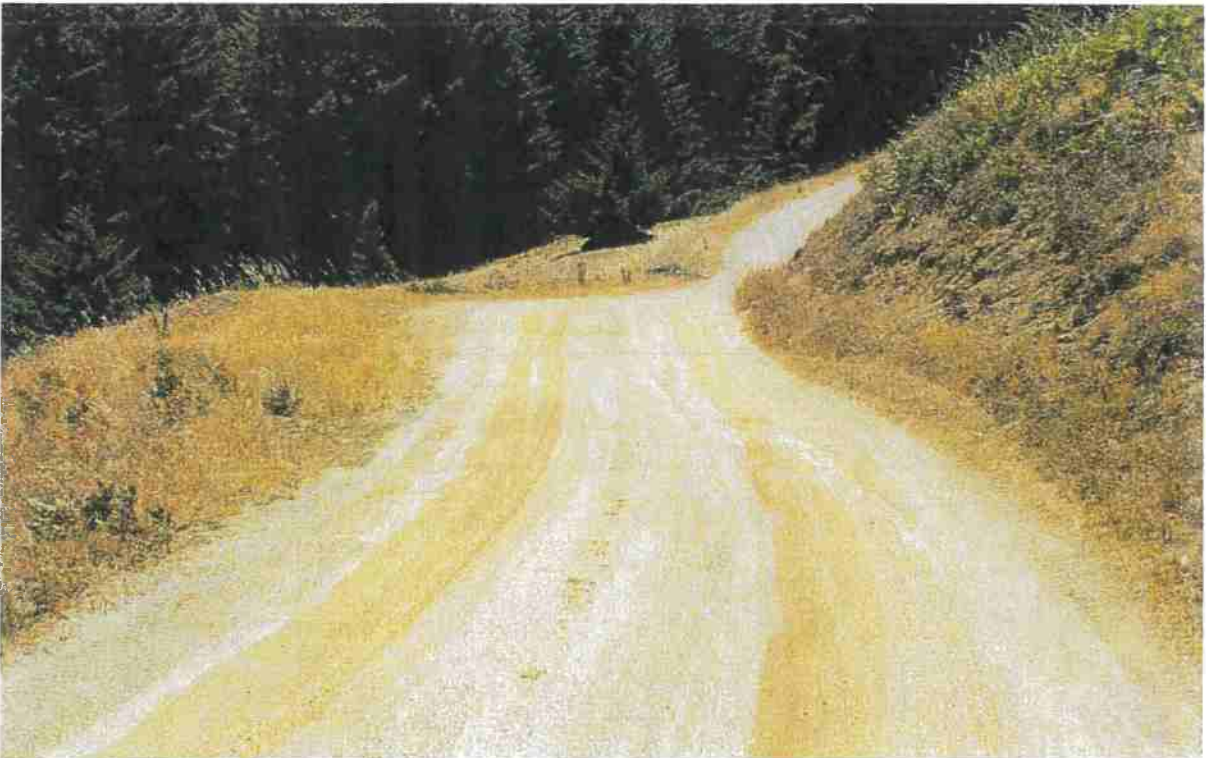
Photo looking up grade at the existing rolling dip at Site 24.

Photo looking down grade at the existing rolling dip at Site 24.

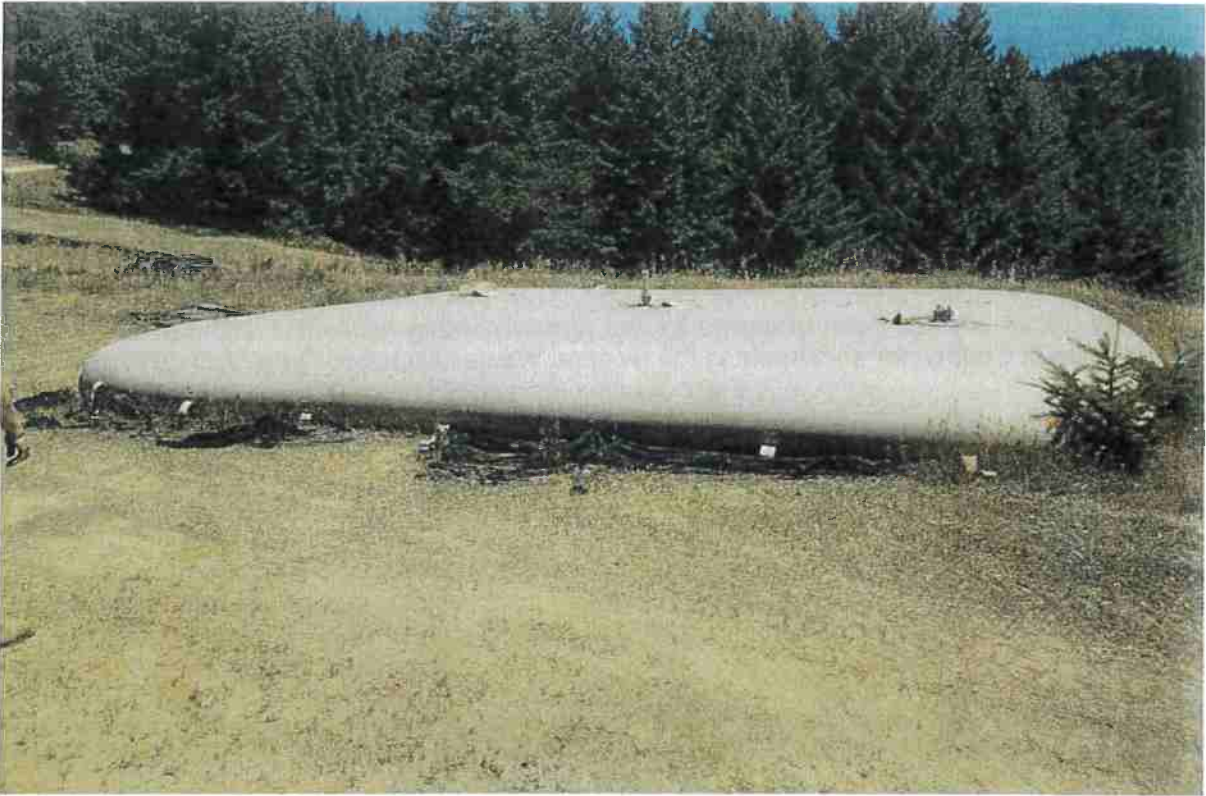
Photo looking at the active bladder at Site 25.

Unique Point	Lat-Long NAD 83	Road Type	Mitigation Planned	Monitor	1600	Treatment Priority	Date Completed
Site 25	-123.999656 40.254345	-	X	X	-	Prior to 10/15/22	
Current Condition: A large active bladder is not properly stored in secondary containment.						Prescribed Action: Provide proper secondary containment for the existing bladder per Cannabis Cultivation Policy: Attachment A, Section 2, No. 87 - 89 for cannabis cultivators.	
Unique Point	Lat-Long NAD 83	Road Type	Mitigation Planned	Monitor	1600	Treatment Priority	Date Completed
Site 26	-123.998768 40.255448	Permanent	-	X	-	Annually prior to 10/15	
Current Condition: Existing series of rolling dips are installed correctly and functioning adequately.						Prescribed Action: Monitor and maintain as needed. See "Rolling Dip Design and Placement" in the attached BMP's. See Cannabis Cultivation Policy, Att. A, Sec. 2, - Term 1 - 29 that is attached for specifications.
