Waters Investigation Report

Humboldt County APN 104-321-010-000

February 1, 2021

Natural Resources Management Corporation

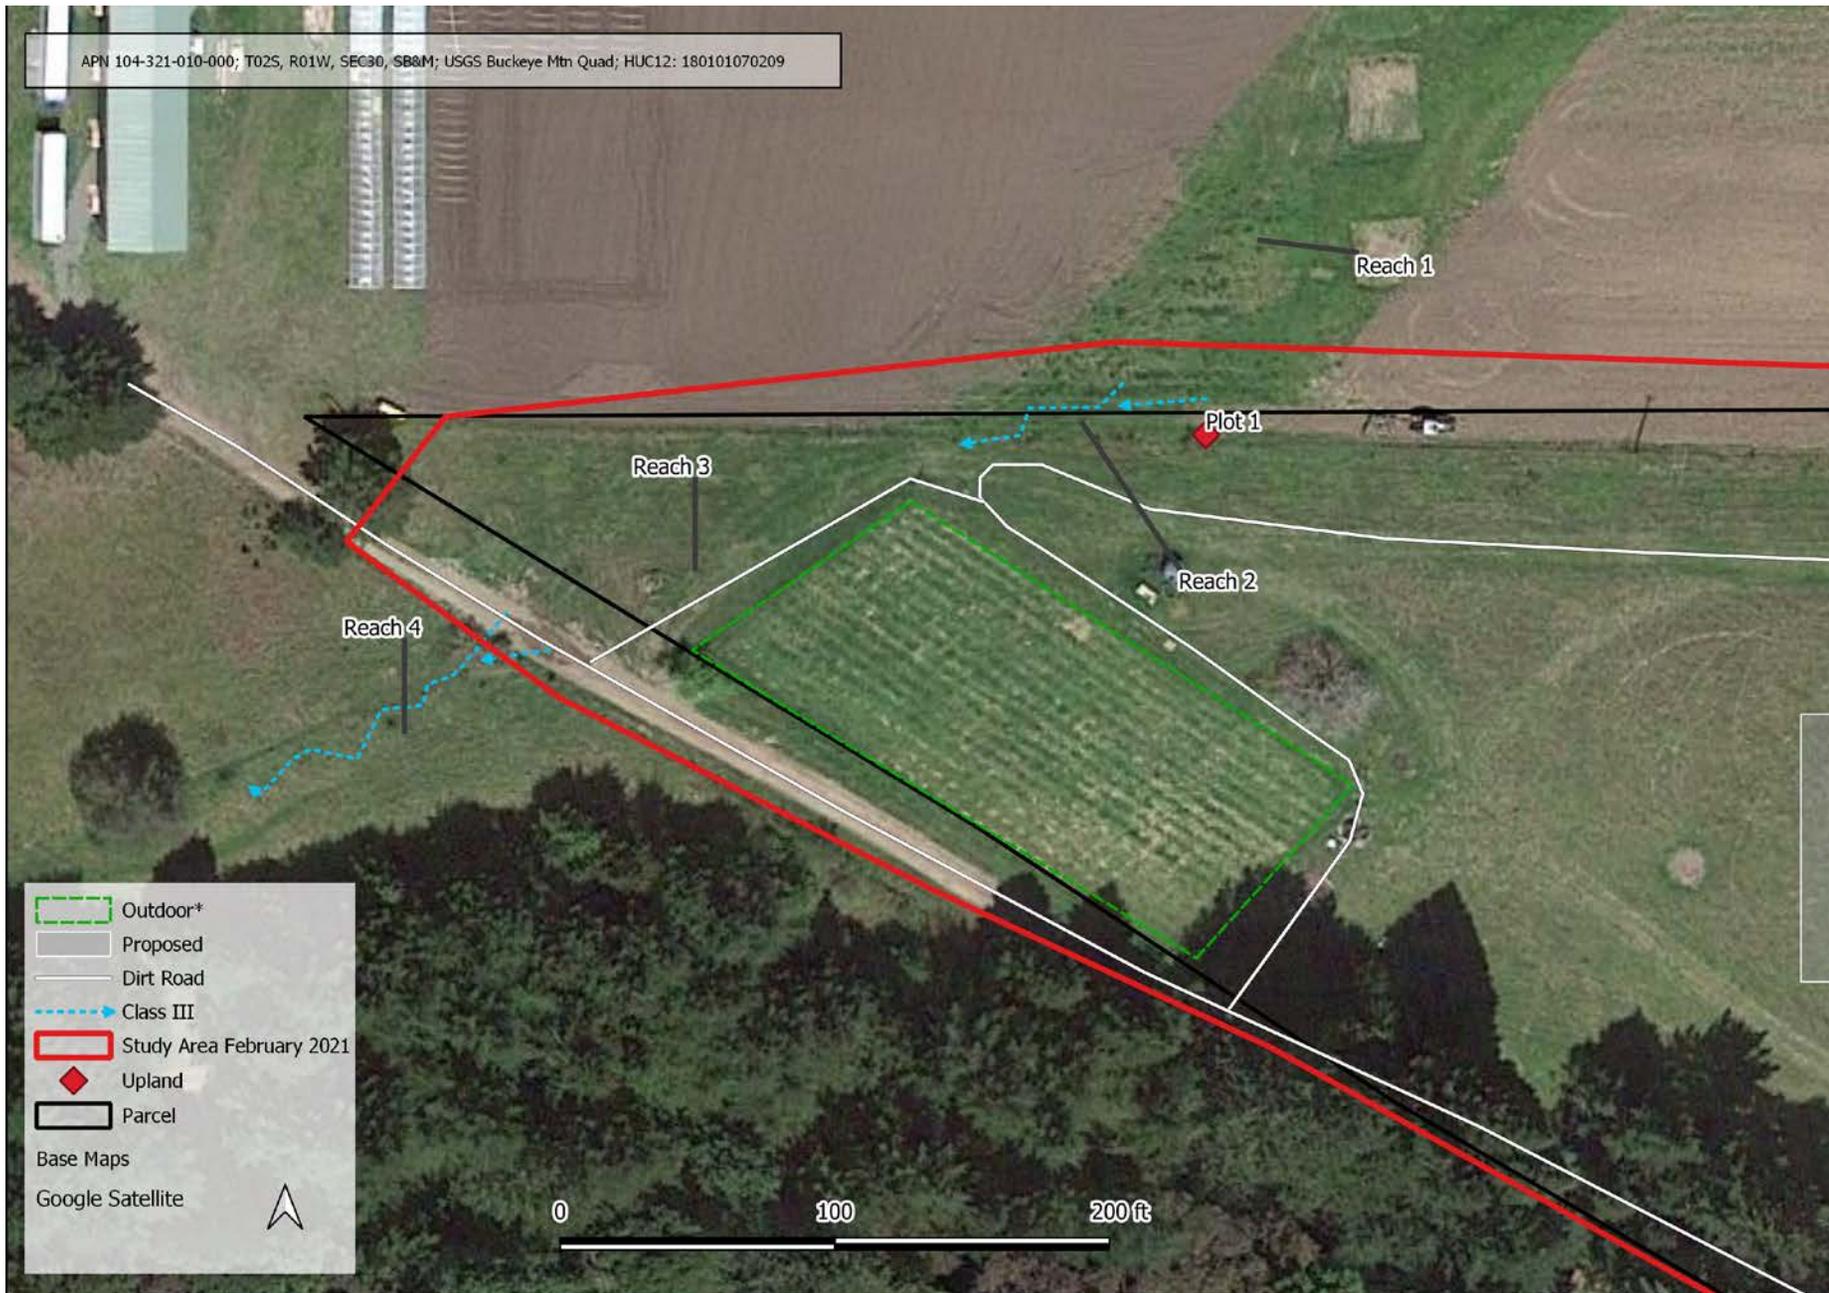
The feature currently consists of four reaches, defined here as Reach 1, 2, 3 and 4. Reaches 3 and 4 are on the Goforth property.

Figure 3. Watercourse Reach Delineation. * Denotes existing greenhouses, outdoor space, and infrastructure related to existing cannabis cultivation activities which will be removed and relocated to the 'Proposed' growing location at the center of the property.

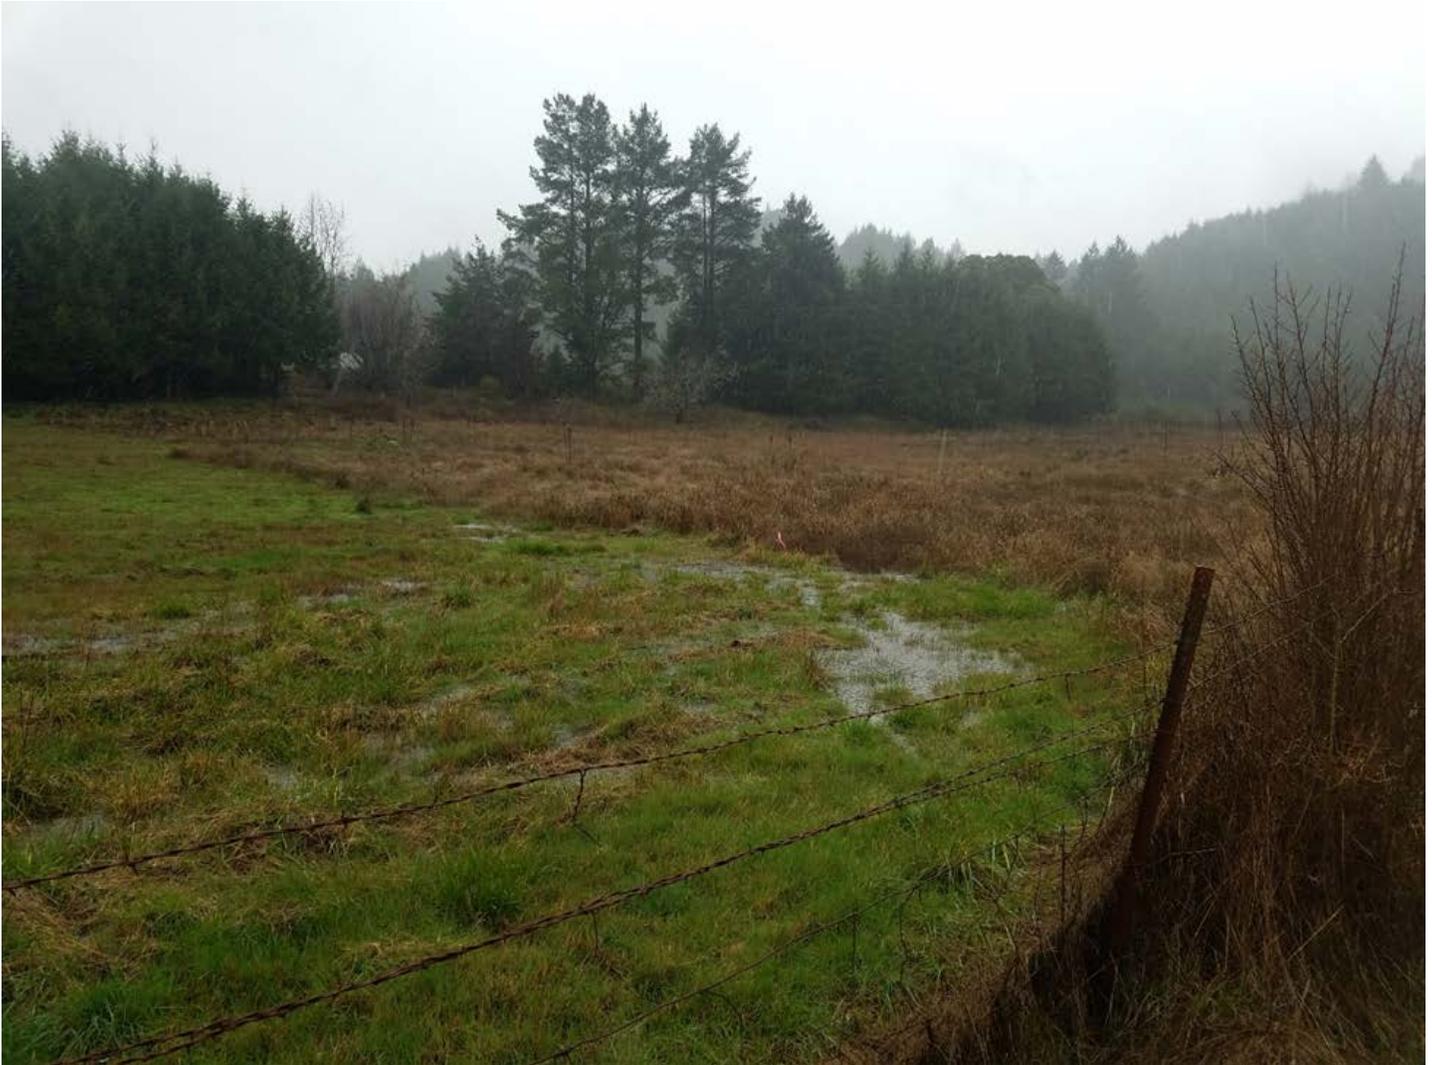
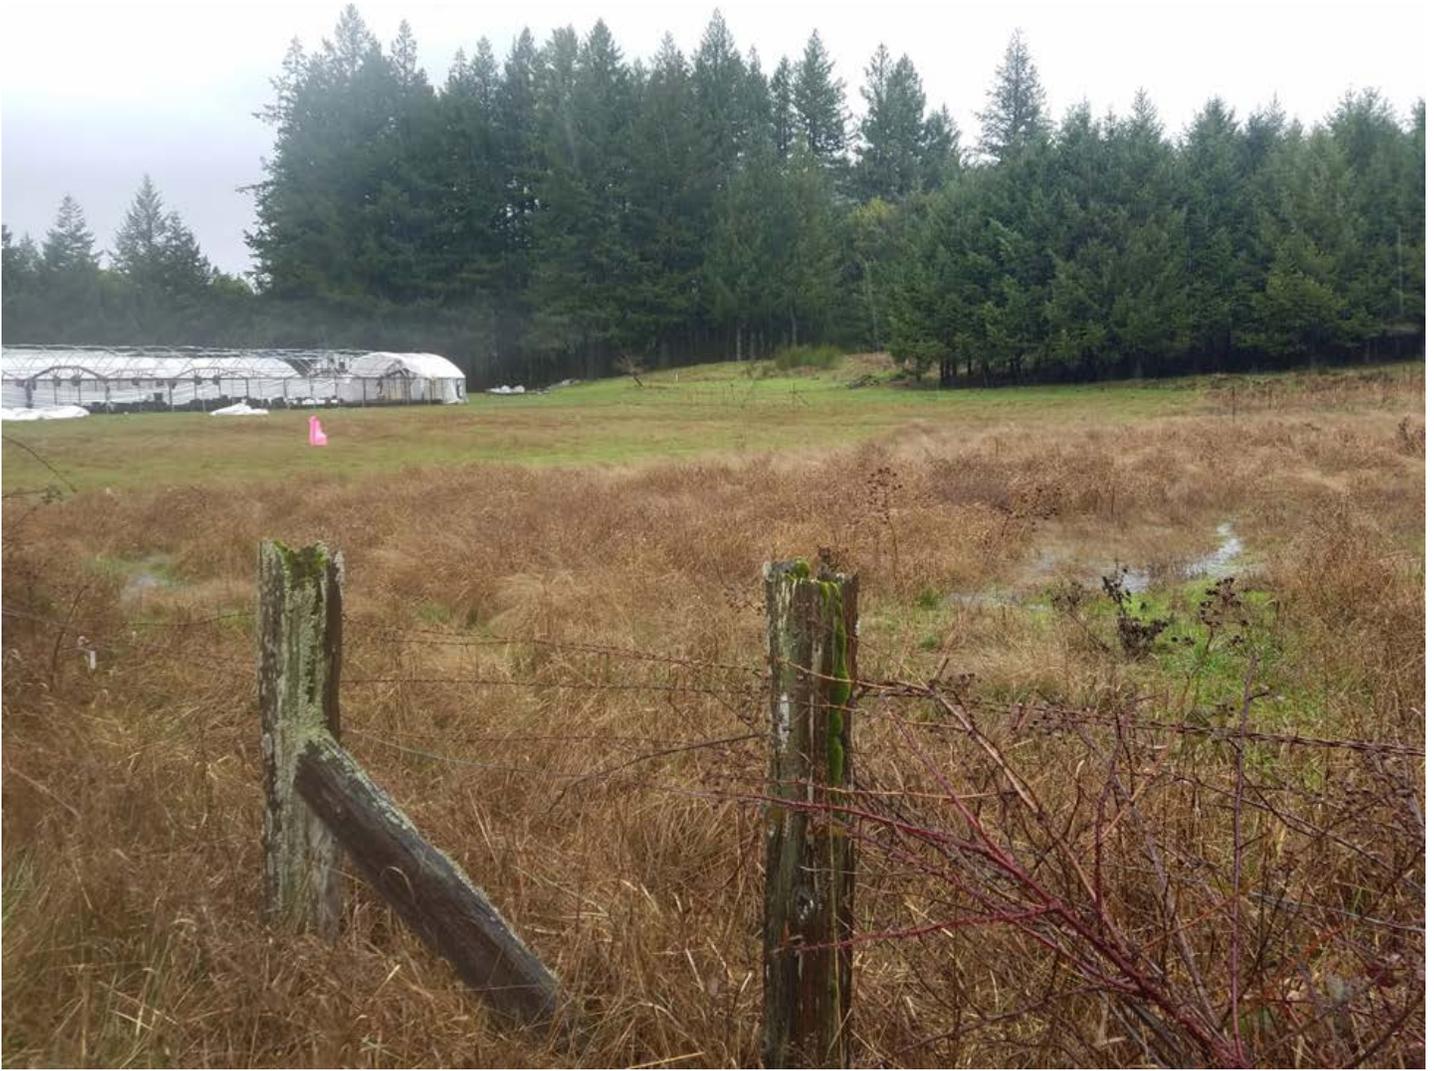
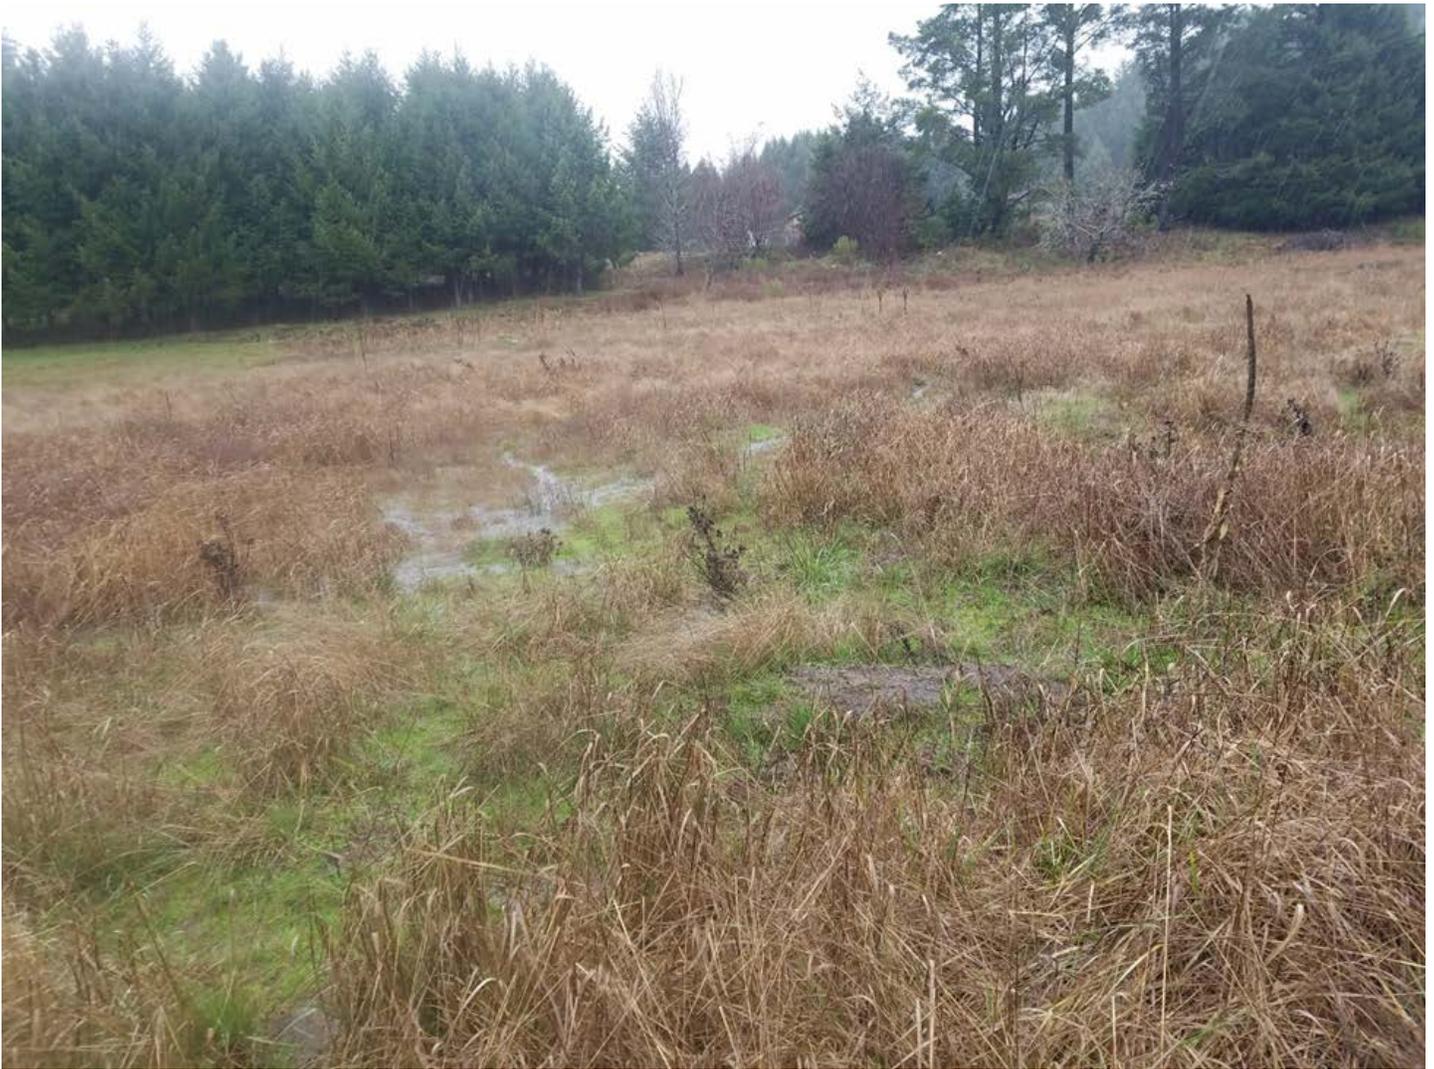
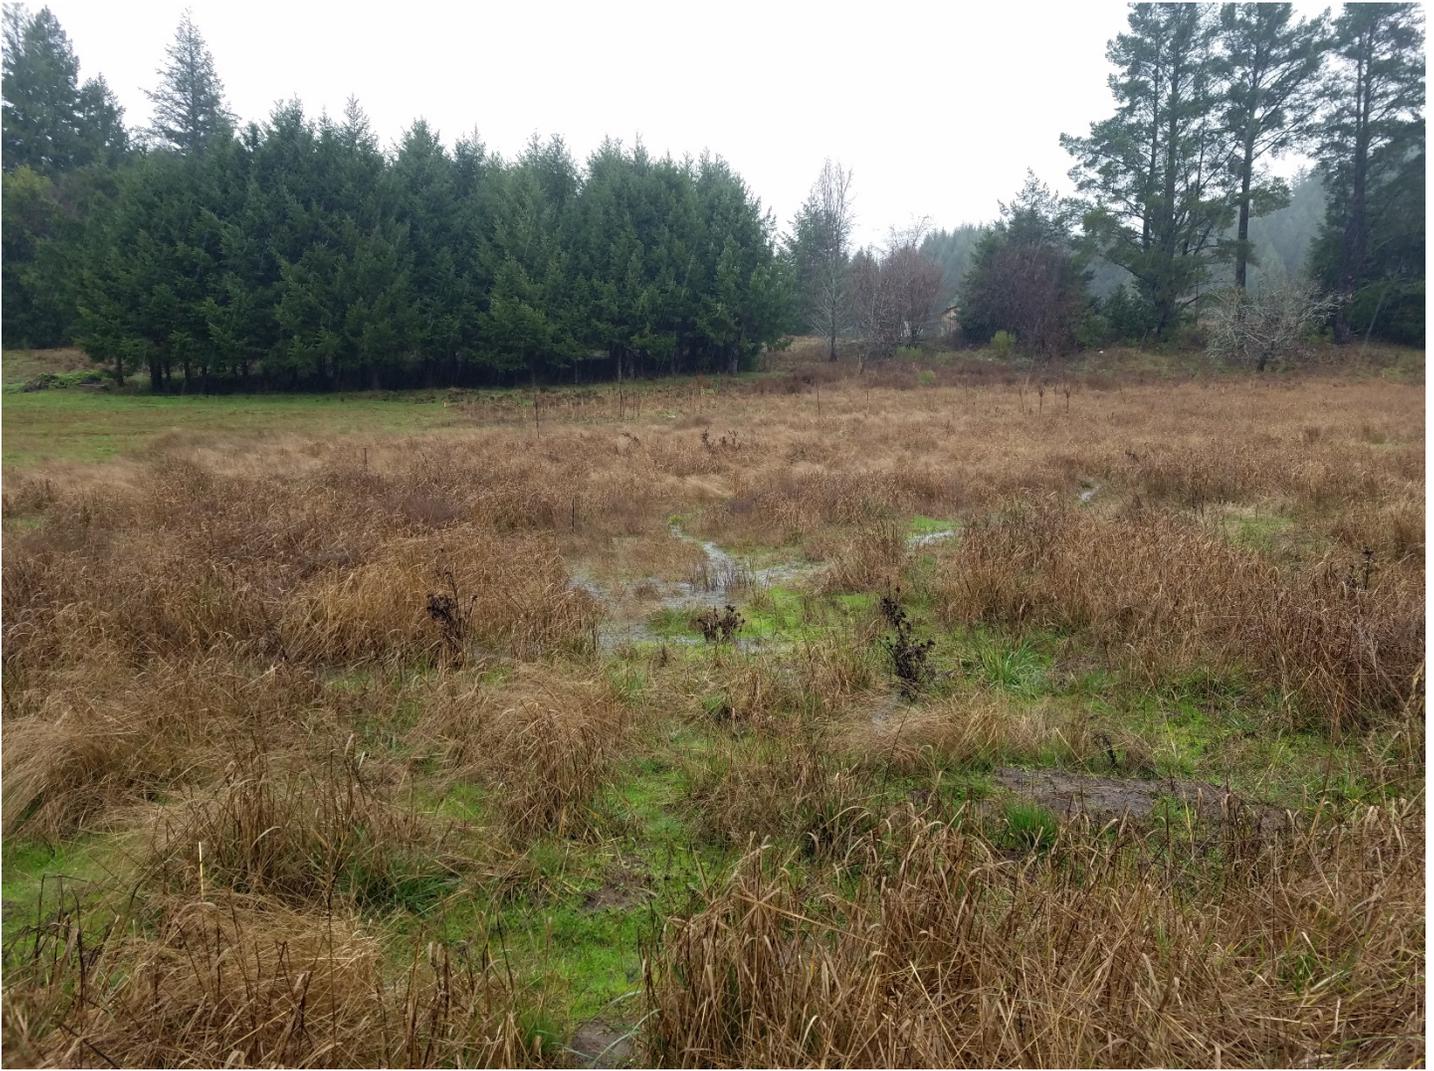
Reach 1 is on the parcel to the north (APN 104-321-001) and appears to be primarily an area of concentrated overland (sheet) flow. The area appears to have been tilled in recent aerial imagery (within the last 5 years) but is thickly vegetated with pasture grasses. The area may have had a defined channel prior to tillage but does not currently appear to be defined by a bed and bank. Some channelization may exist, but due to the thick vegetation and lack of access, this was undetermined during the site visit. The slope of Reach 1 is approximately 10%

Photo 1. Reach 1 flowing southwest across parcel to the north (APN 104-321-001-000). Looking northeast from property line

Photo 2. Reach 1 flowing southwest across parcel to the north (APN 104-321-001-000). Looking northwest from property line.

Photo 3. Reach 1 flowing southwest across parcel to the north (APN 104-321-001-000). Looking north from property line

Photo 4. Reach 1 flowing southwest across parcel to the north (APN 104-321-001-000). Looking northwest from property line

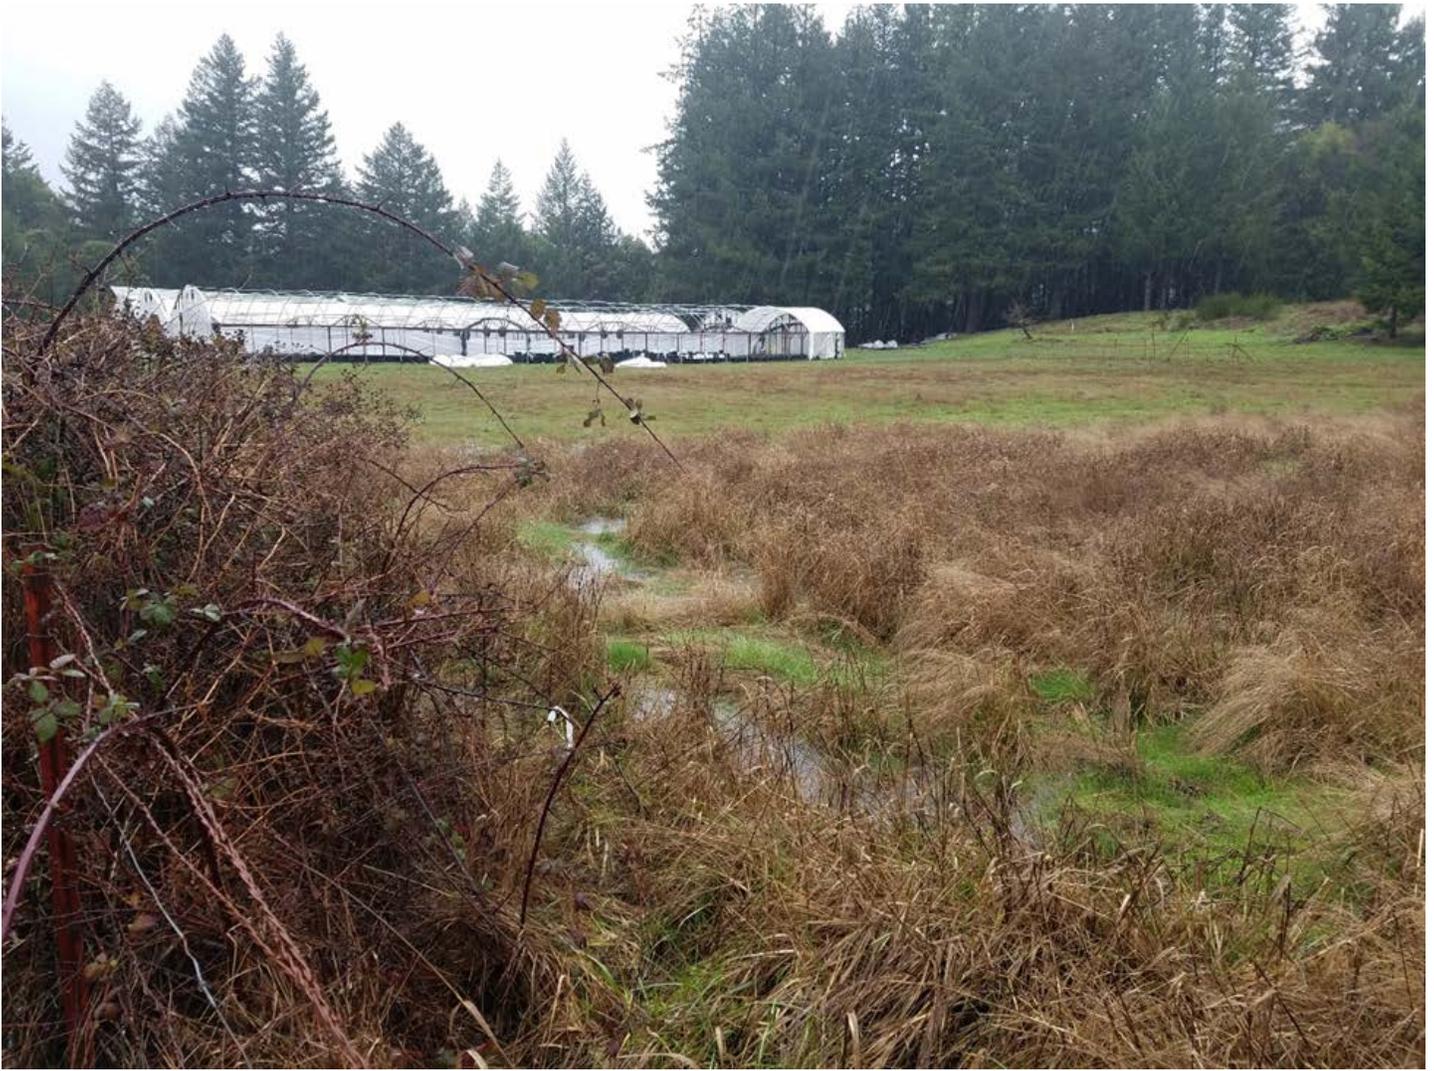
Reach 2 is where the concentrated sheet flow somewhat channelizes into a Class III ephemeral stream before crossing on to the Goforth property. There is still not a well-developed bed and bank, but flow is concentrated in a linear, vegetated area. A slight berm running east-west along the property boundary fence causes the sheet flow from the north to concentrate and pool along the boundary, but it drains onto the Goforth property via Reach 2. The slope of Reach 2 is approximately 5%.

Photo 5. Reach 2 flowing southwest across parcel to the north (APN 104-321-001-000). Looking west/northwest along property line

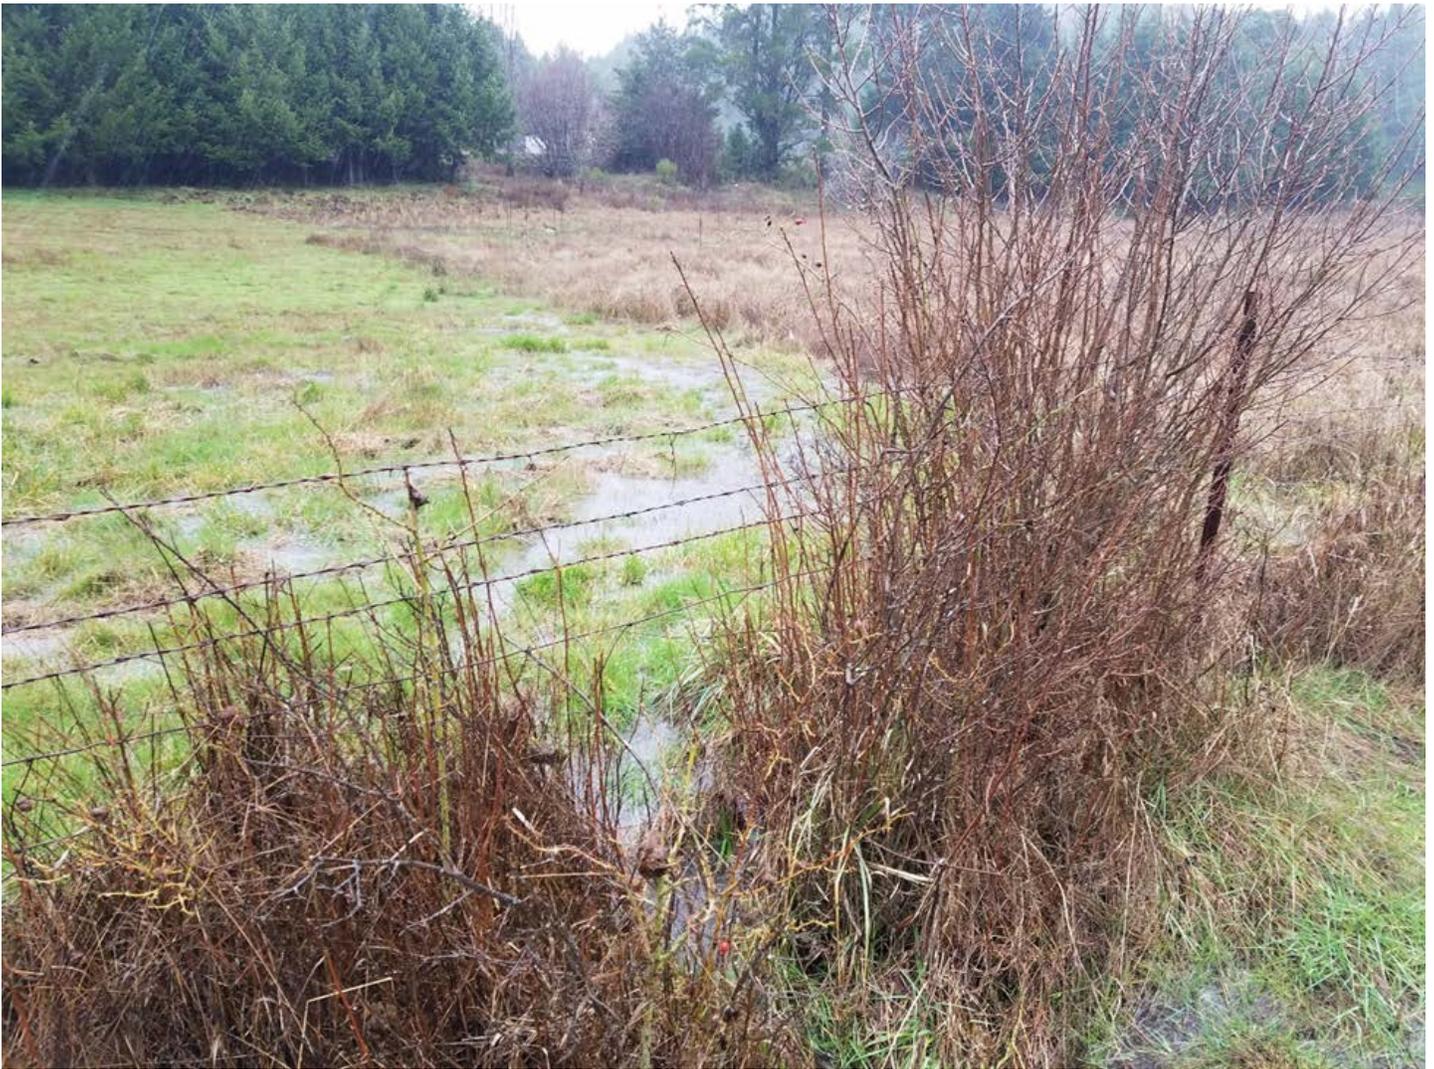
Photo 6. Reach 2 flowing southwest across parcel to the north (APN 104-321-001-000). Looking northeast at point where flow crosses property line onto APN 104-321-010-000

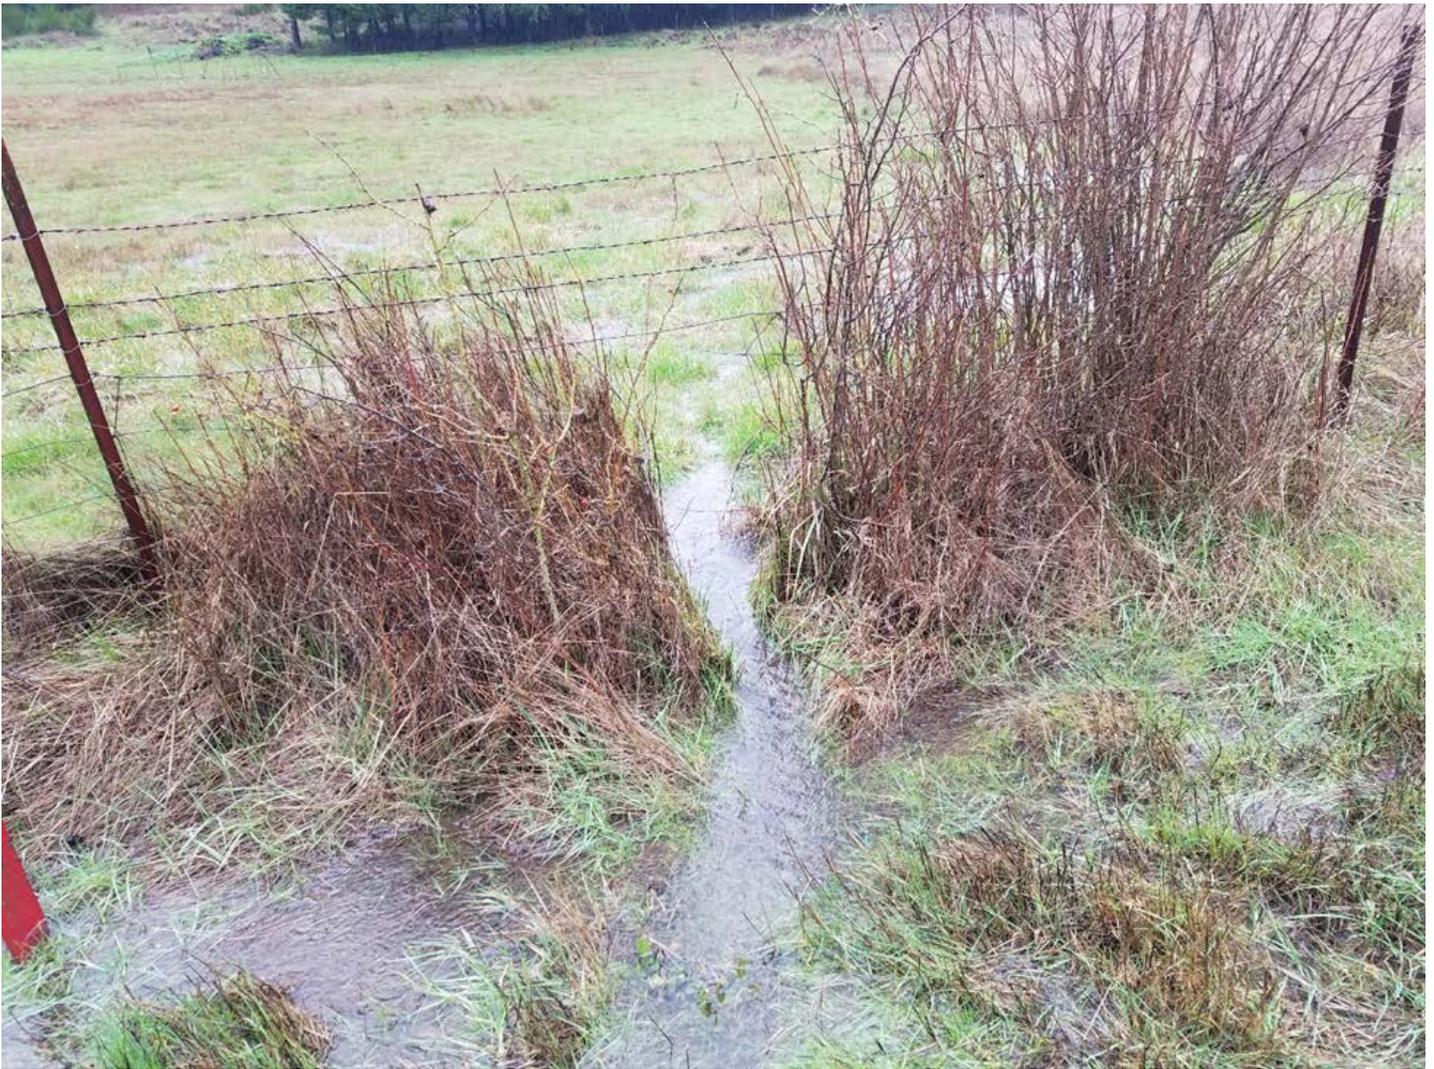
Photo 7. Reach 2 flowing southwest across parcel to the north (APN 104-321-001-000). Looking northeast at point where flow crosses property line onto APN 104-321-010-000

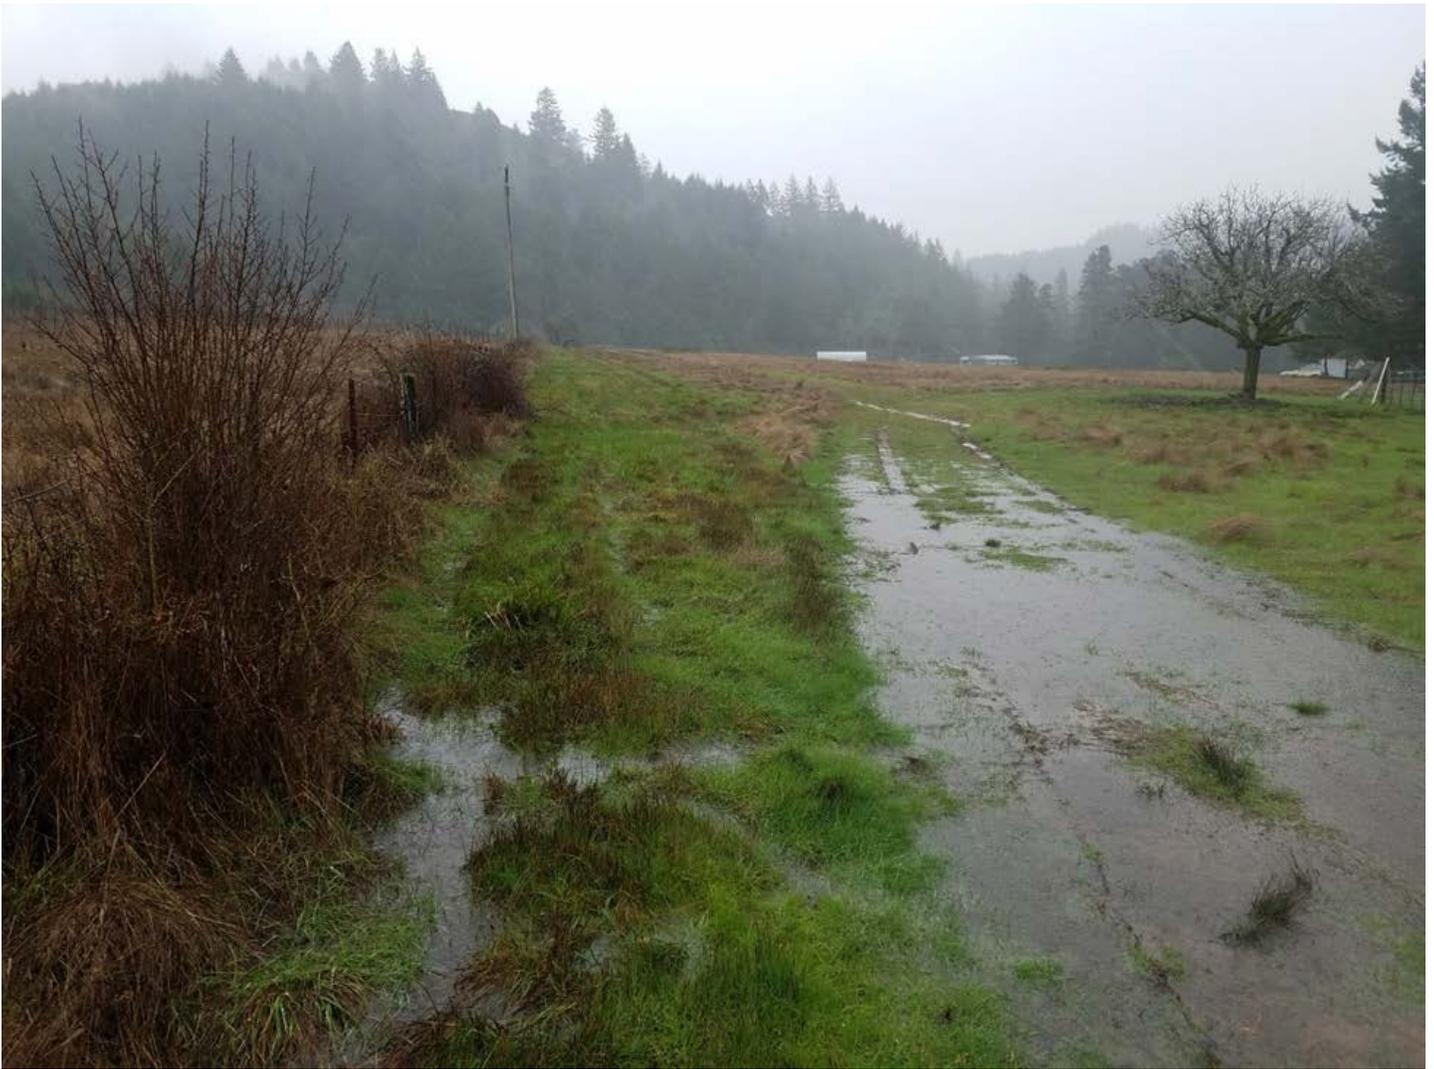
Photo 8. Looking east along property line at point where Reach 2 crosses property line onto APN 104-321-010-000. Storm runoff/ sheet flow from road/hillslope to east in photo right.

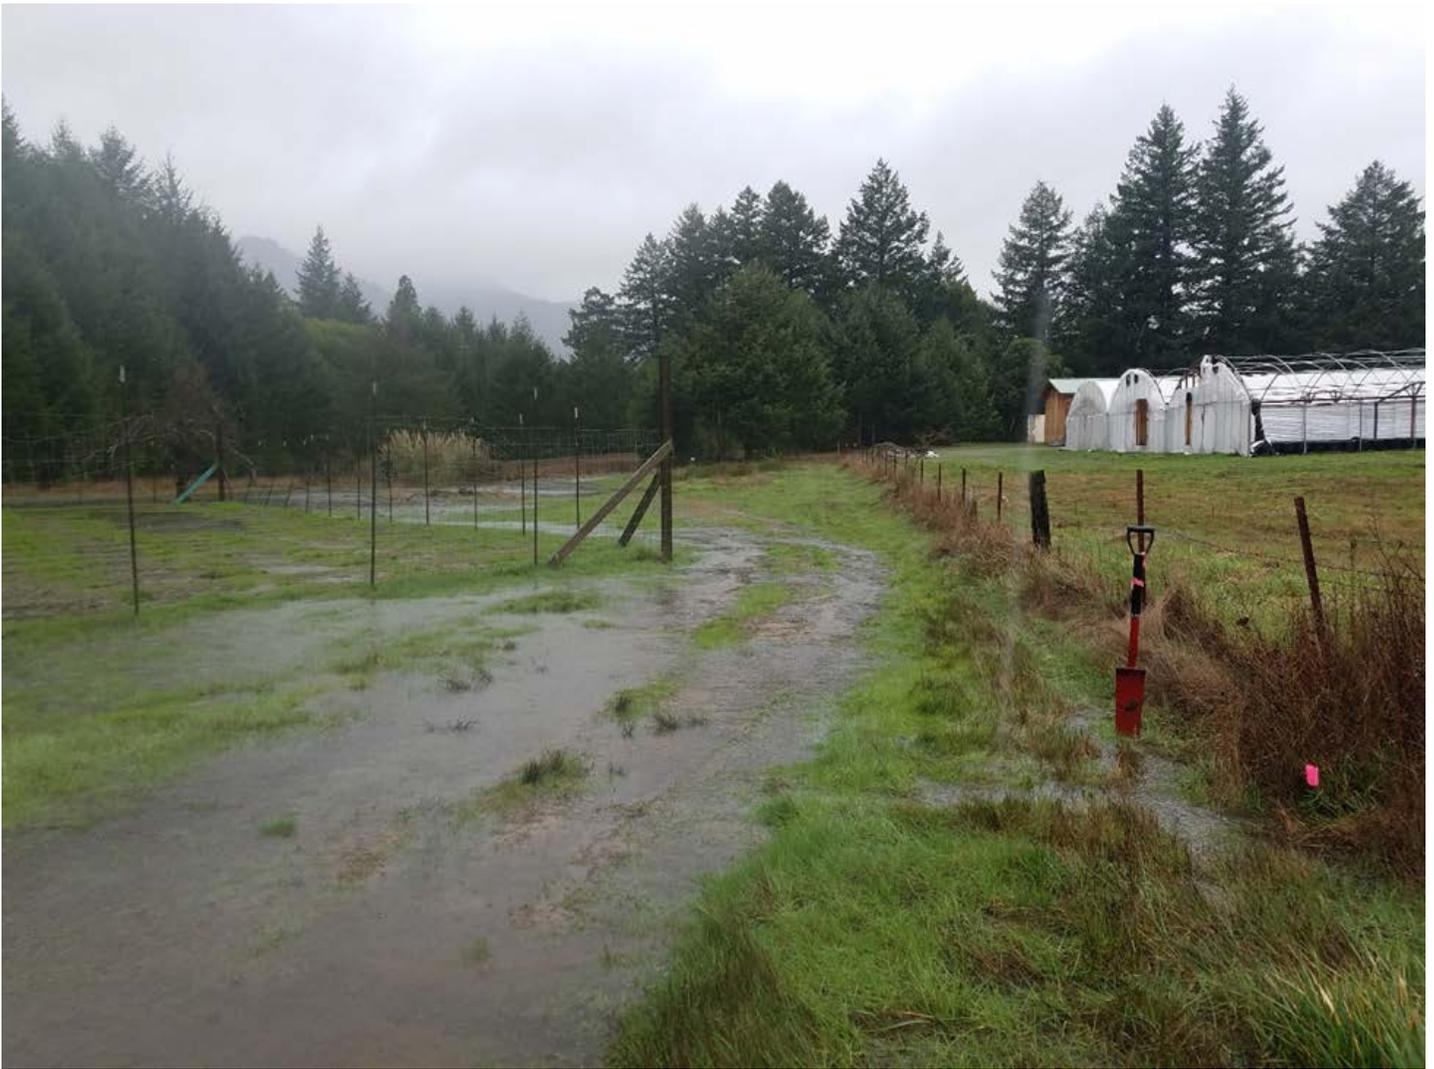
Photo 9. Looking west along property line at point where Reach 2 crosses property line onto APN 104-321-010-000 (at pink flag). Storm runoff/ sheet flow from road/hillslope to east JOINS flow from Class III in photo left.

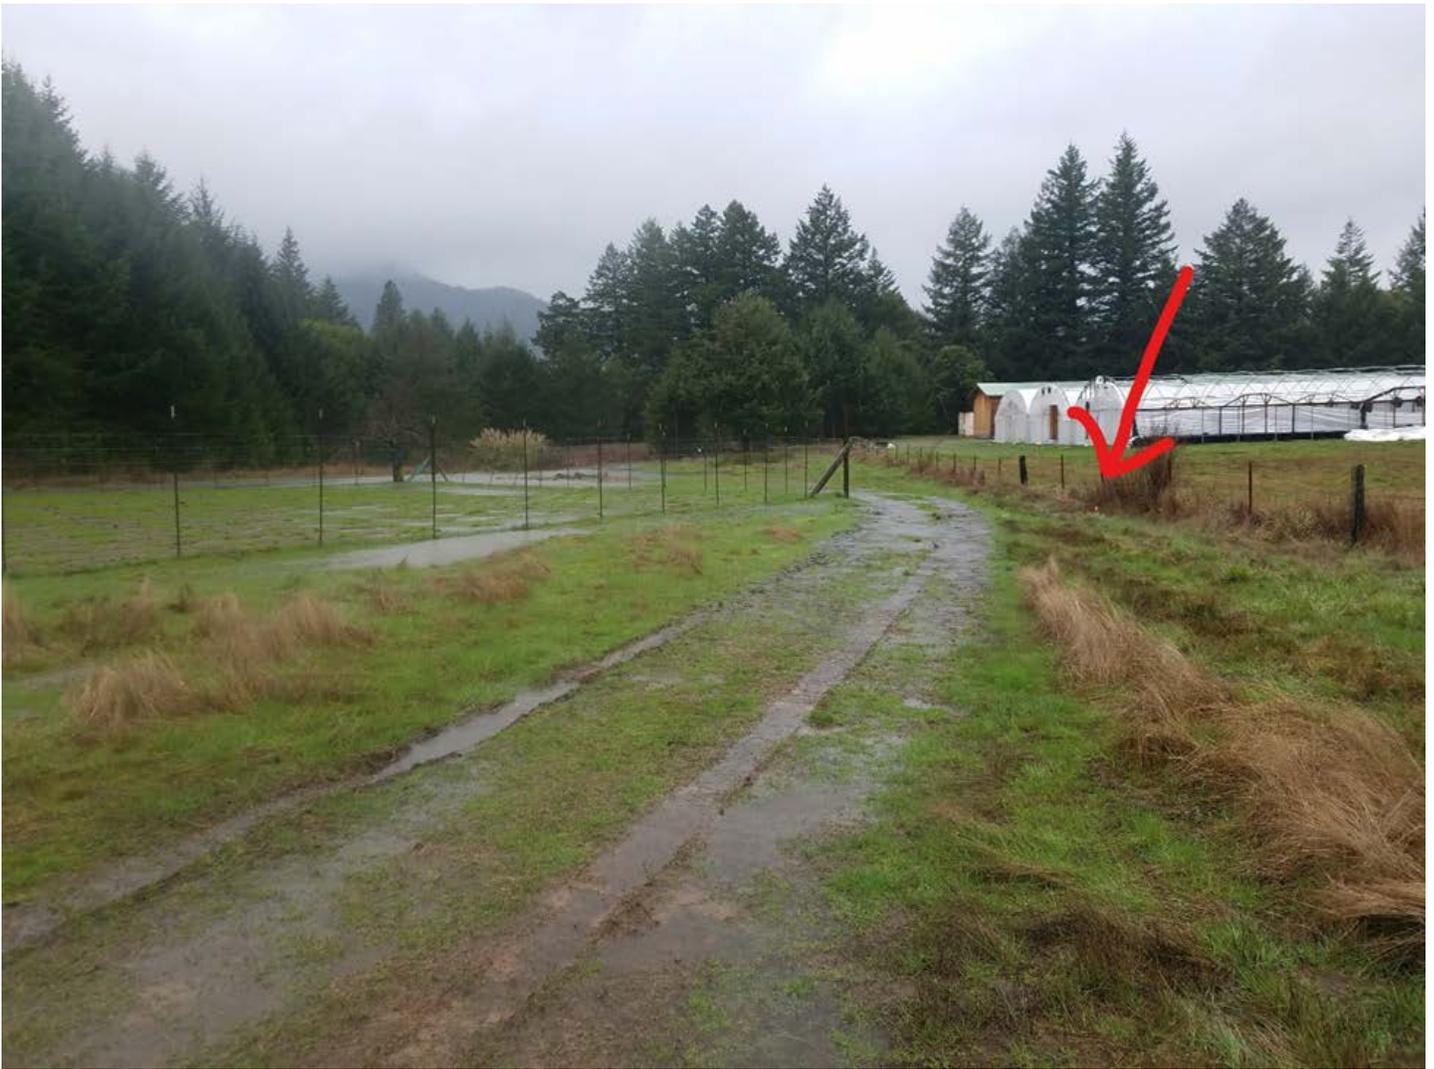
Photo 10. Looking west along property line toward point where Reach 2 crosses property line onto APN 104-321-010-000 (at red arrow). Storm runoff/ sheet flow from road/hillslope to east JOINS flow from Class III in photo center, across from red arrow.

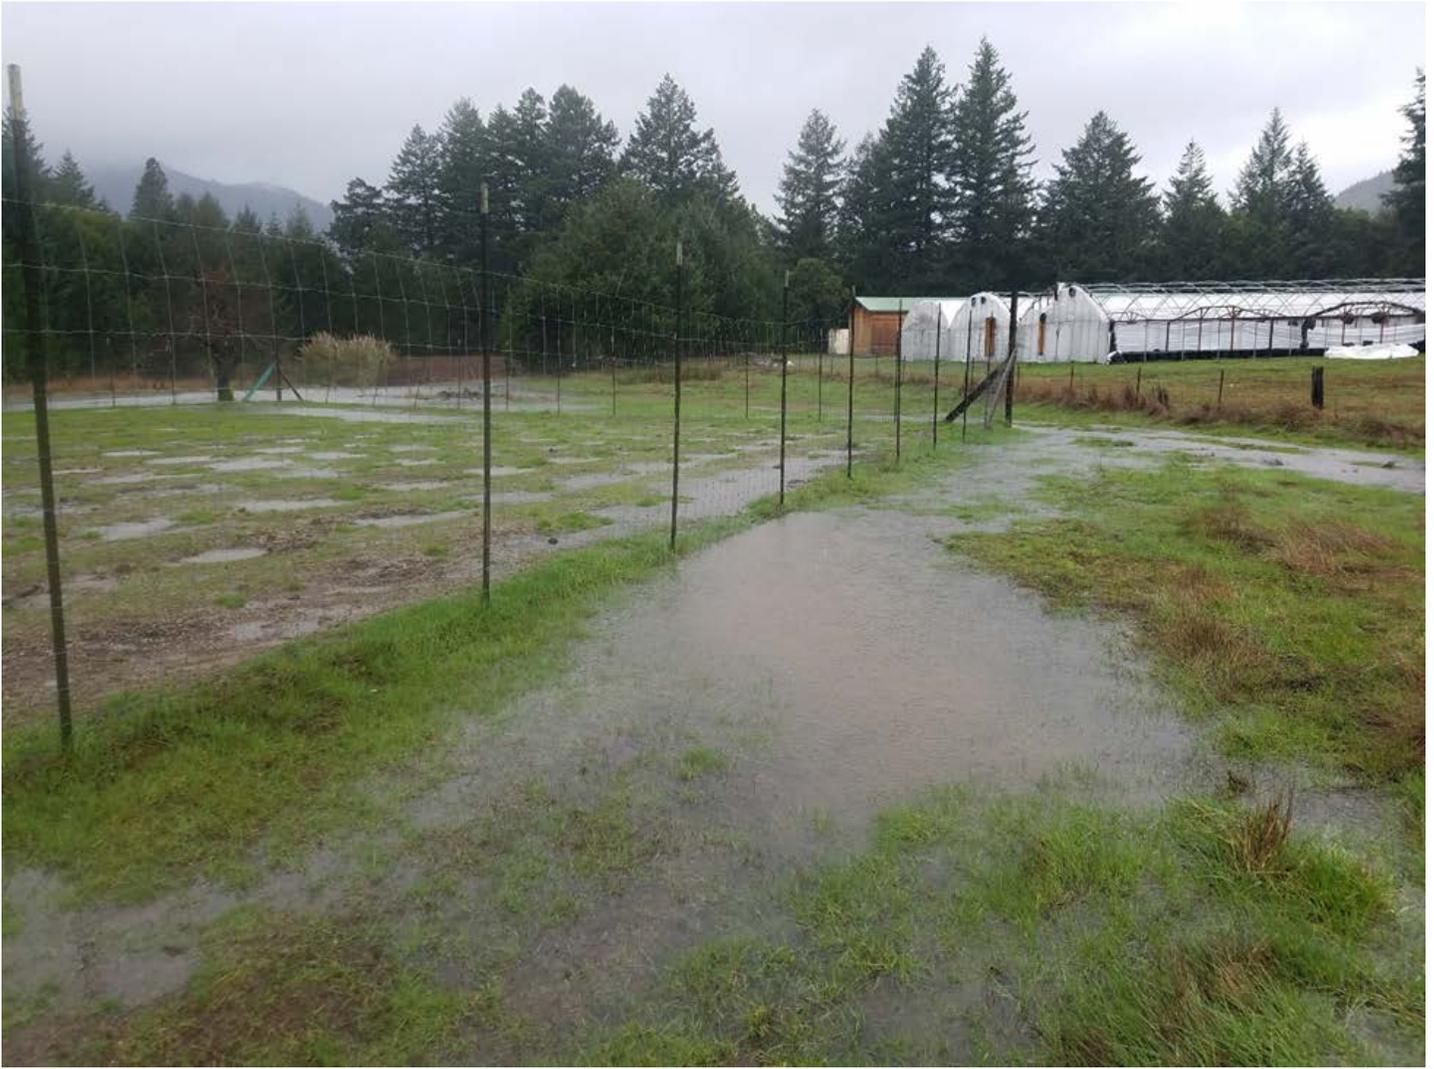
Photo 11. Pooled storm runoff/sheet flow on north side of outdoor cultivation area. Looking west.

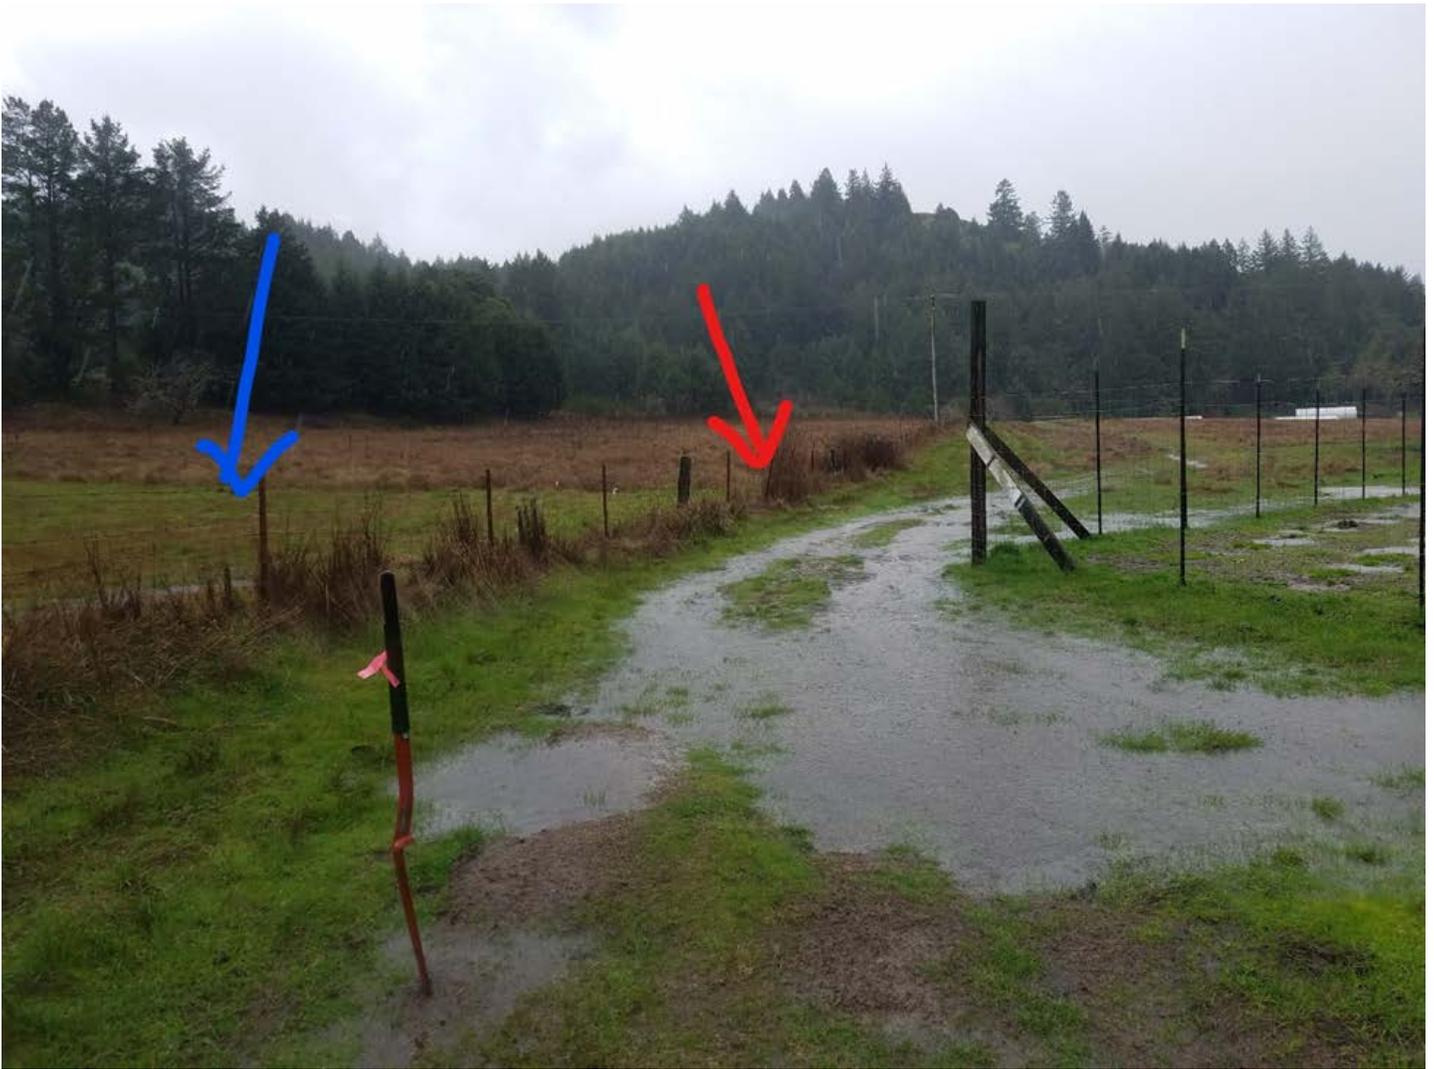
Photo 12. Looking east towards point where reach 2 (red arrow), joins sheet flow, and becomes Reach 3 (sheet flow without a defined channel) on west side of cultivation area. Blue area points to where water is pooled on APN 104-321-001-000. A slight berm along fence line prevents water from flowing onto APN 104-321-010-000 except at red arrow (Reach 2).
