Waters Investigation Report

Humboldt County APN 104-321-010-000

February 1, 2021

Natural Resources Management Corporation

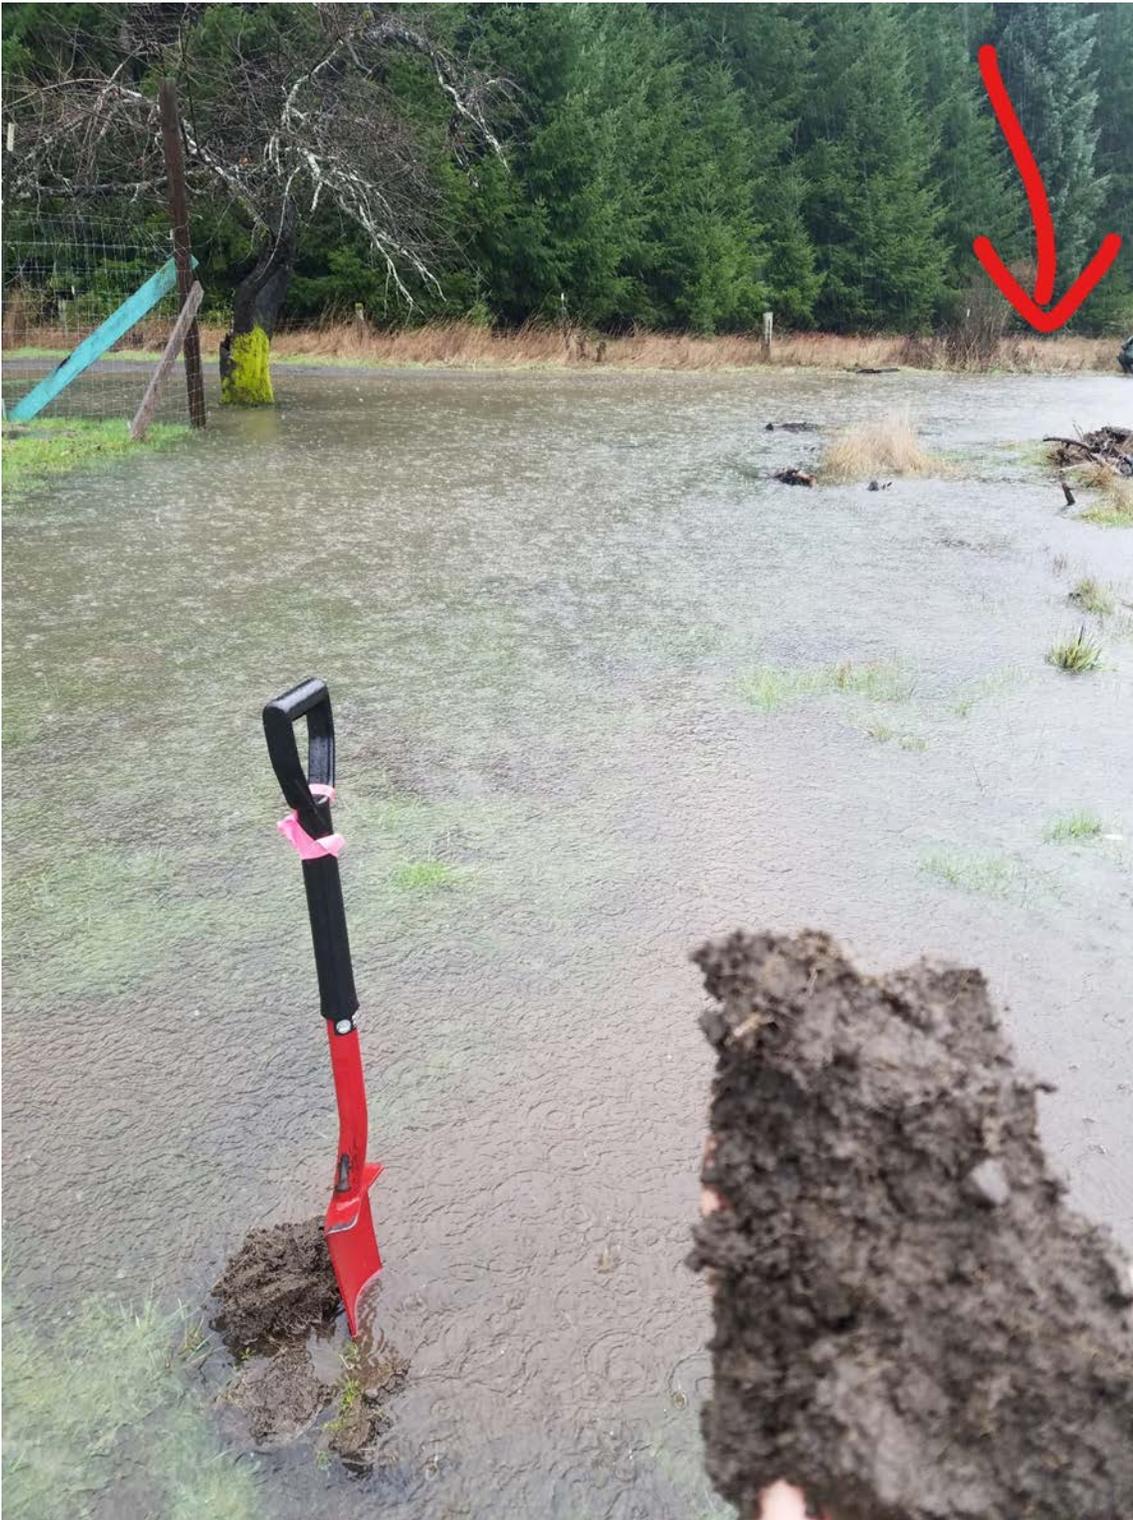
At Reach 3, the discharge from Reach 2 dissipates back into a sheet flow and is joined by additional overland flow from the western slope of the Goforth parcel. This sheet flow runs along a dirt road on the west side of a cultivation area, then concentrates and pools along a berm on the outboard edge of the neighbor's (APN 104-321-001) deeded access road. At the time of the site visit, there was over 1 foot of standing water on the road against the berm. The slope of Reach 3 is approximately 8%.

Photo 13. Looking south along direction of Reach 3 on the west side of cultivation area. Tree in Photo left is on north side of neighbor's access road, where water is also pooled. Red arrow indicates where water flows off the road (bottom of Reach 3).

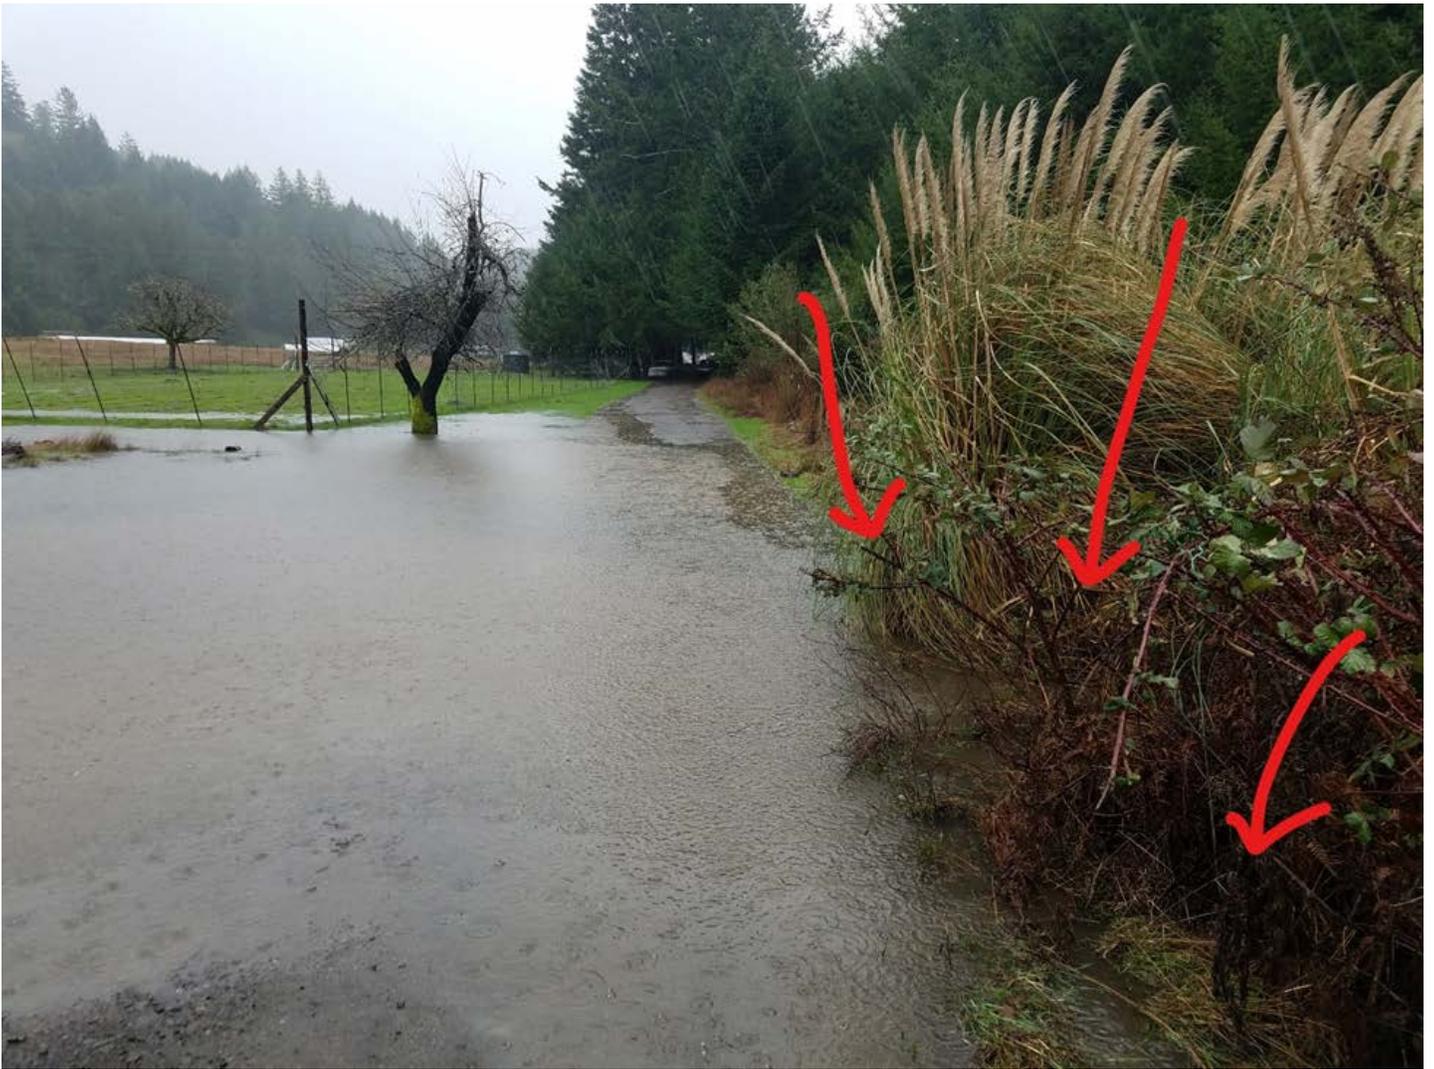
Photo 14. Looking east along property line, where water is pooled against slight berm on outboard road edge, and flows over at the red arrows (Bottom of Reach 3).

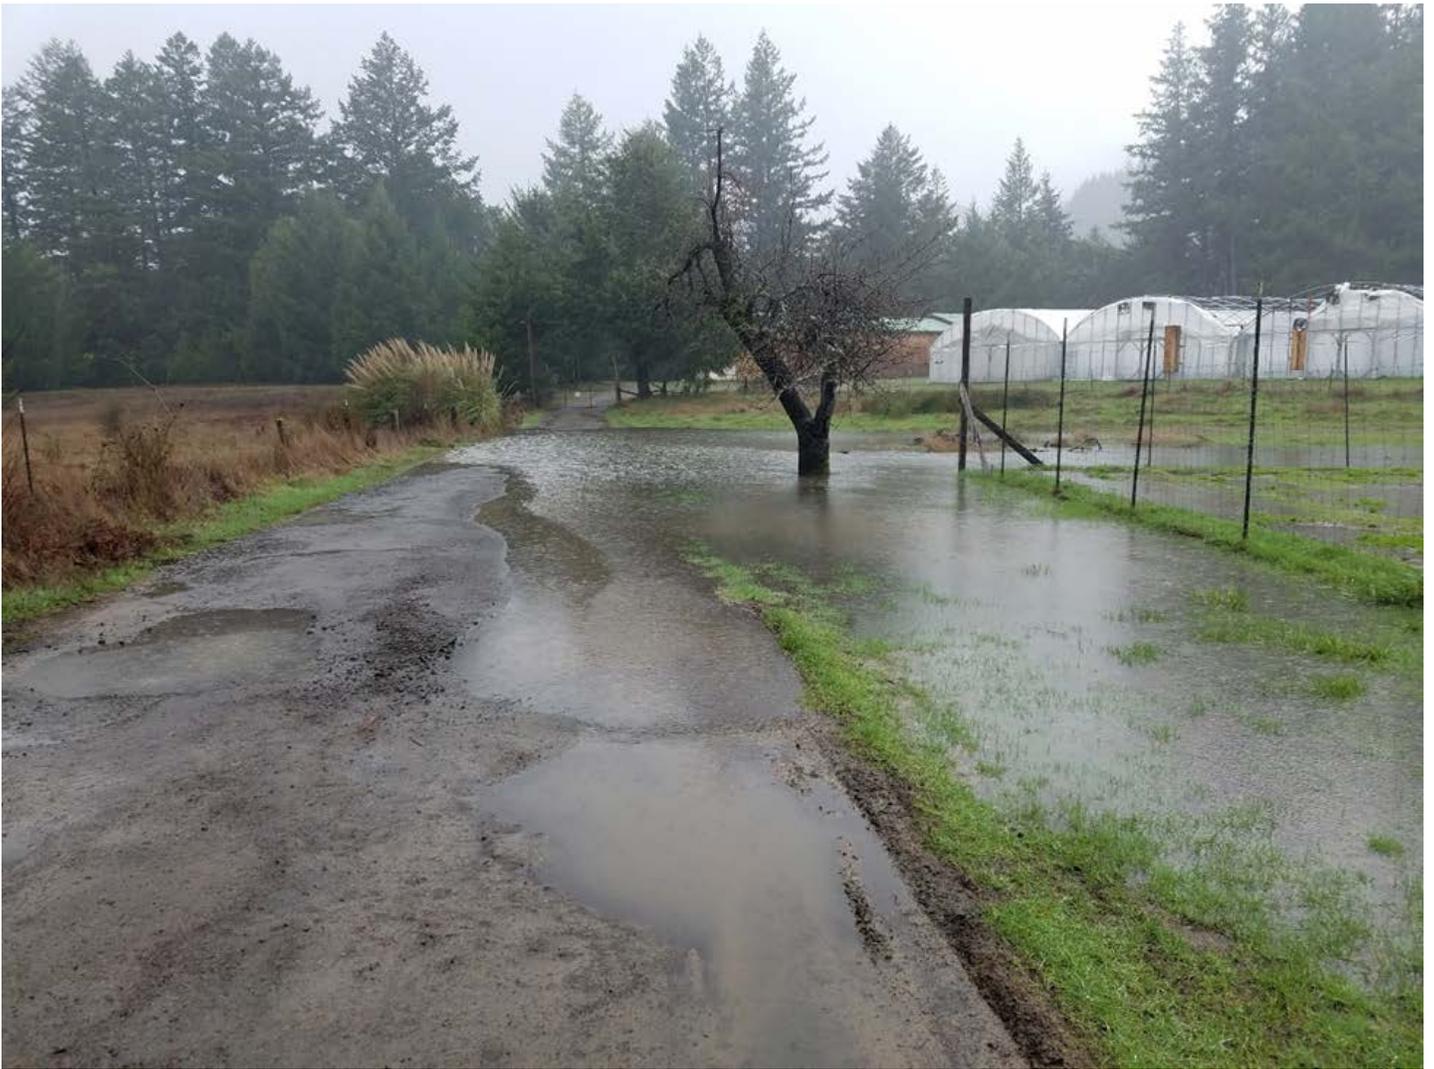
Photo 15. Looking west at water from Reach 3 where it comes together with additional overland flow from the east and is pooled against road berm on southern property line.

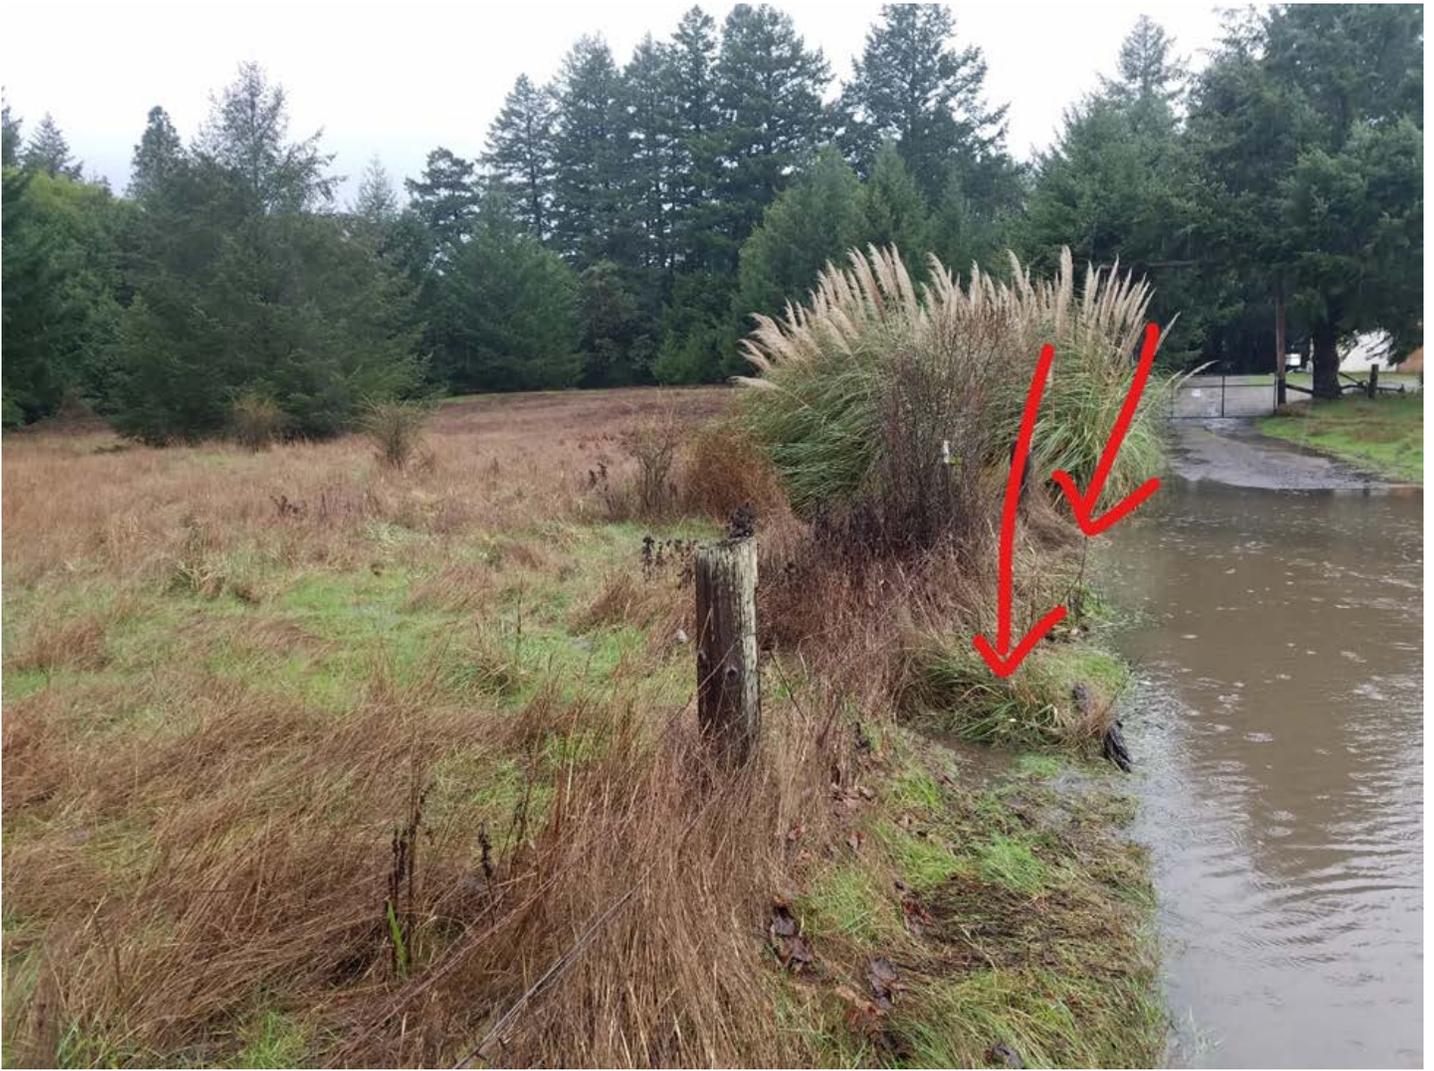
Photo 16. Looking west at transition from Reach 3 to Reach 4 (at red arrows) along outboard side of access road.

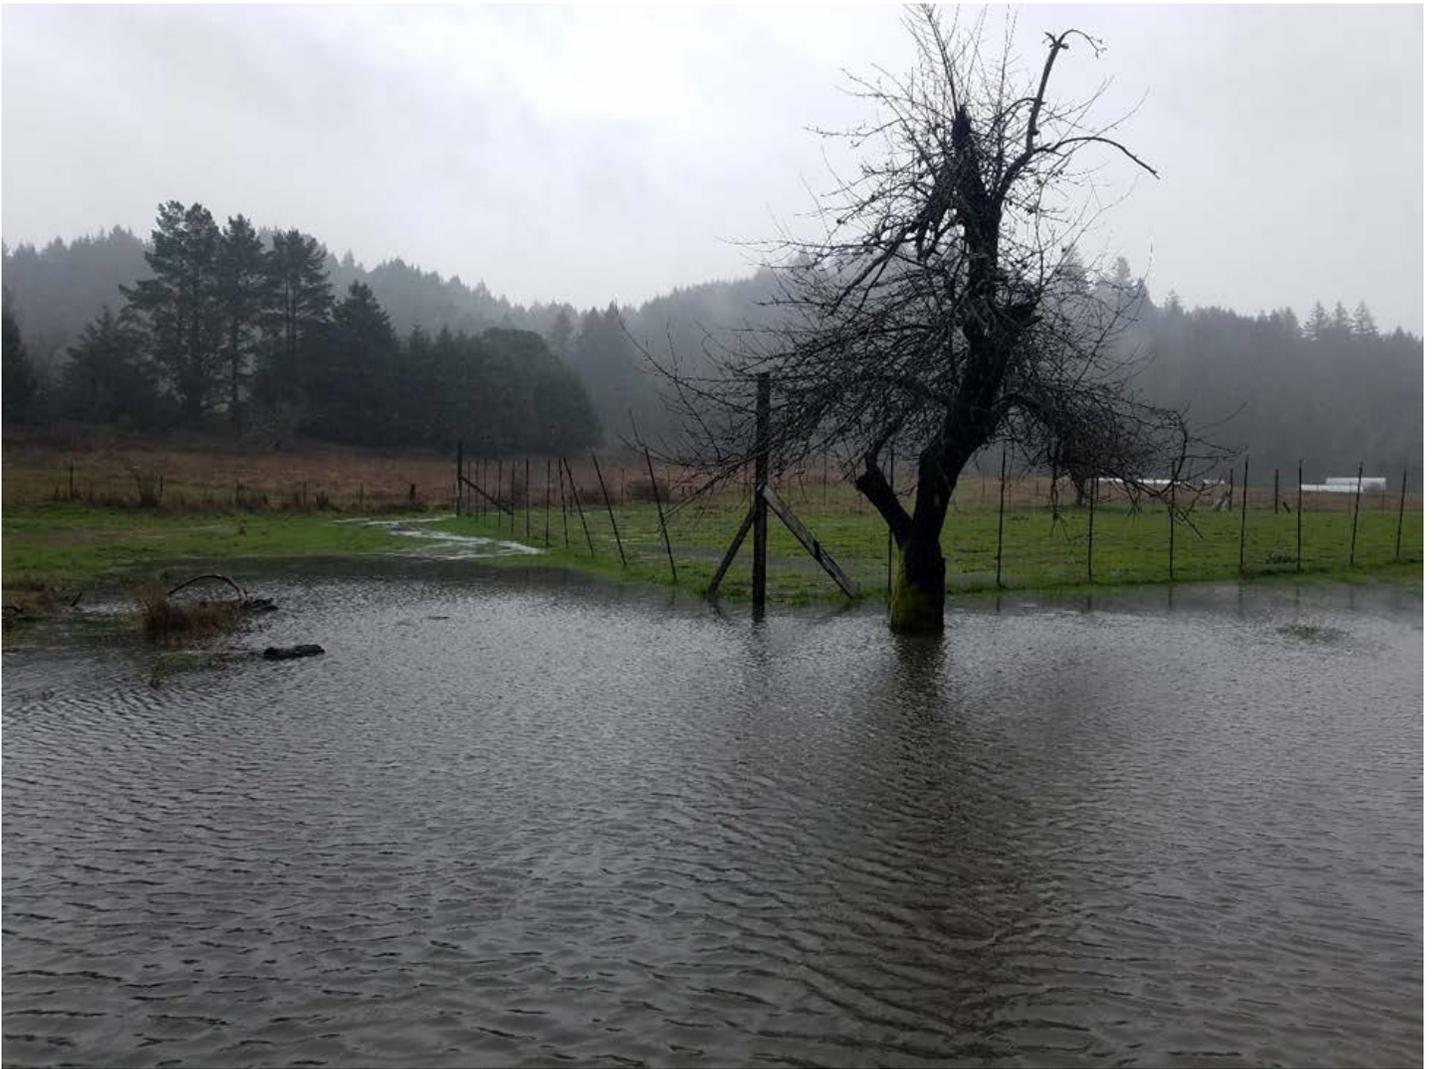
Photo 17. Looking northeast across Reach 3, towards reach 2 and southwest corner of cultivation area.

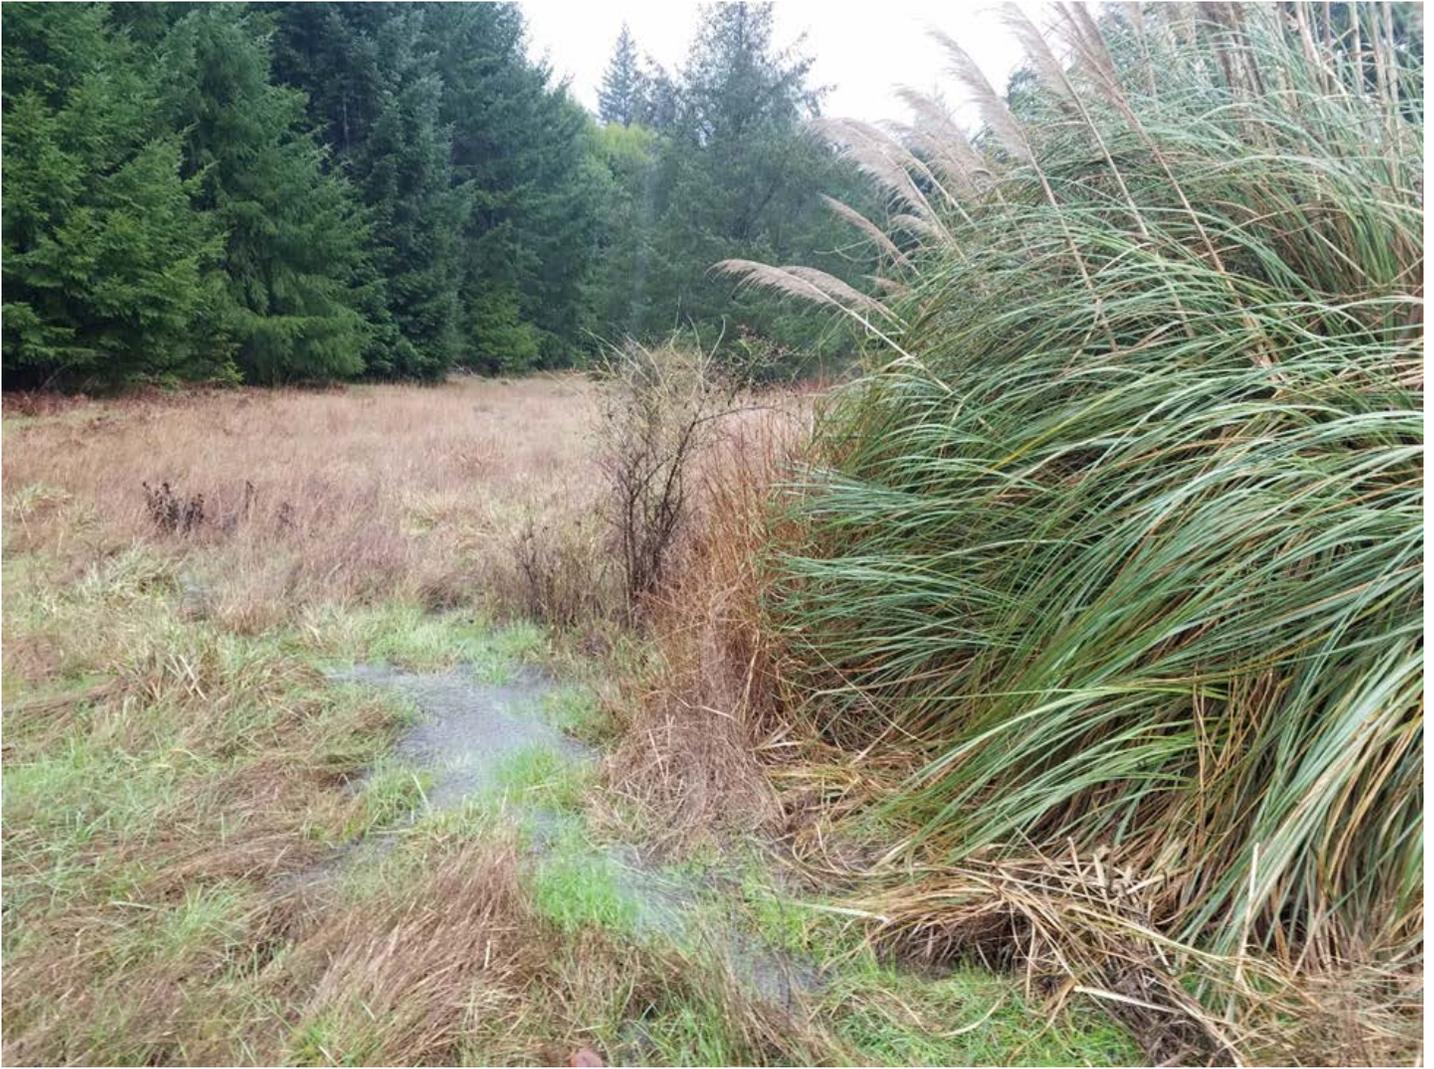
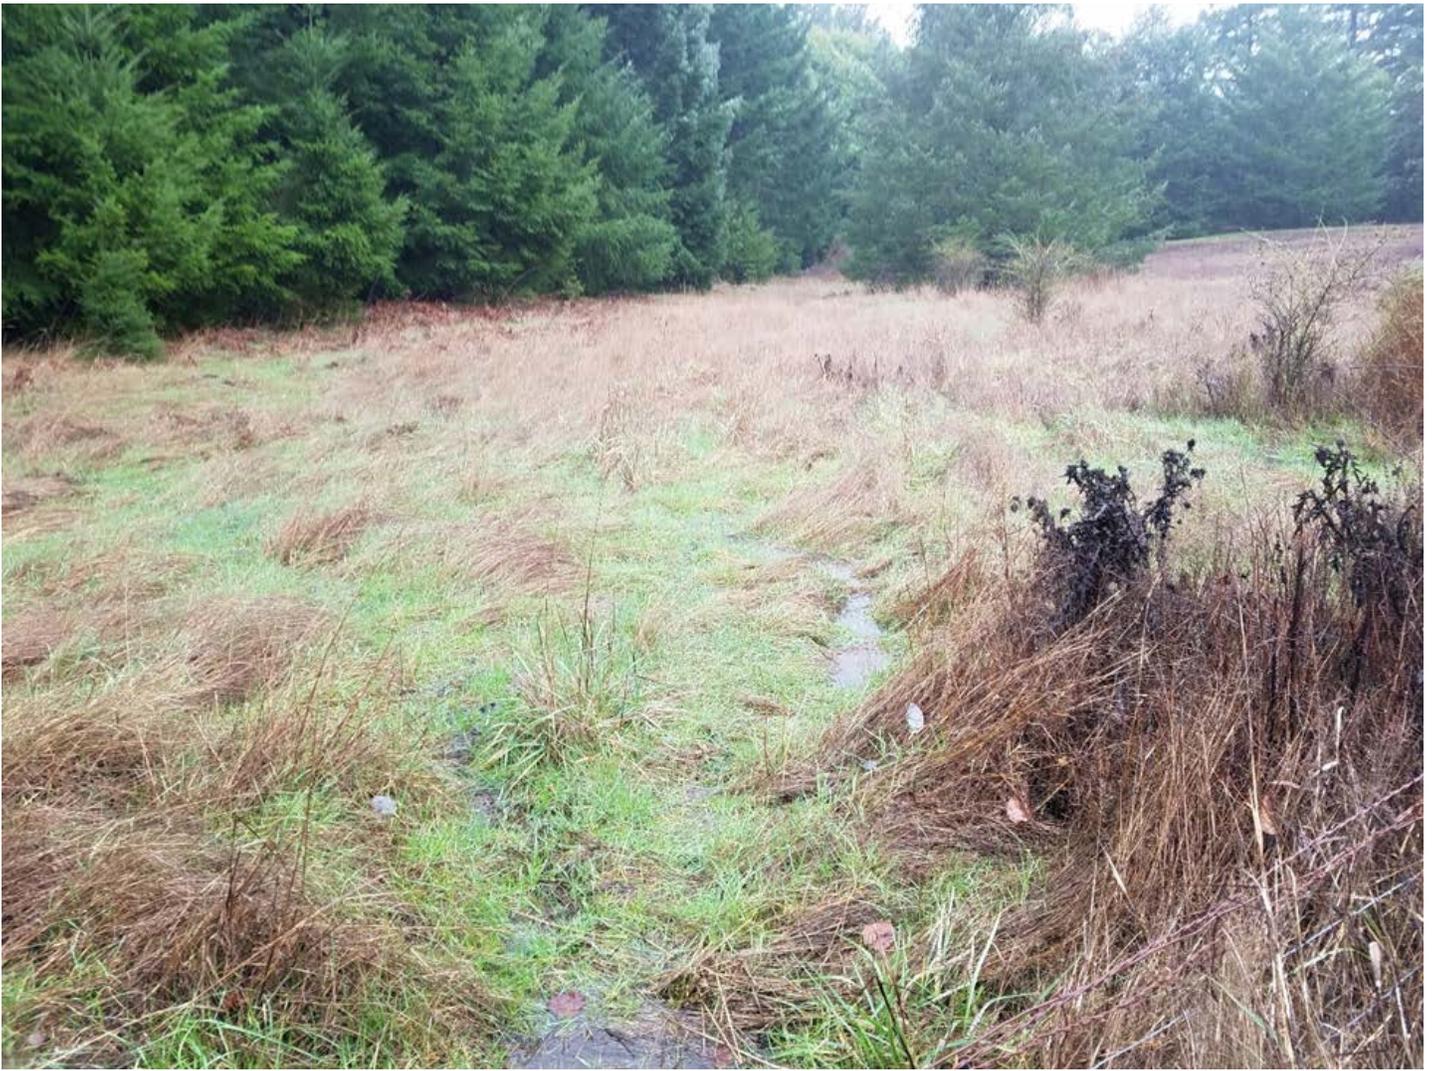
At Reach 4, the discharge from Reach 3 flows over the berm along the access road and continues down the topographic swale on the parcel to the south, APN 104-301-007. Reach 4 appears to be a braided Class III channel with some defined bed and bank. However, the thick vegetation, abundant sheet flow, and lack of access made this difficult to determine.

Photo 18. Looking southwest along Reach 4 on APN 104-301-007

Photo 19. Looking southwest along Reach 4 on APN 104-301-007

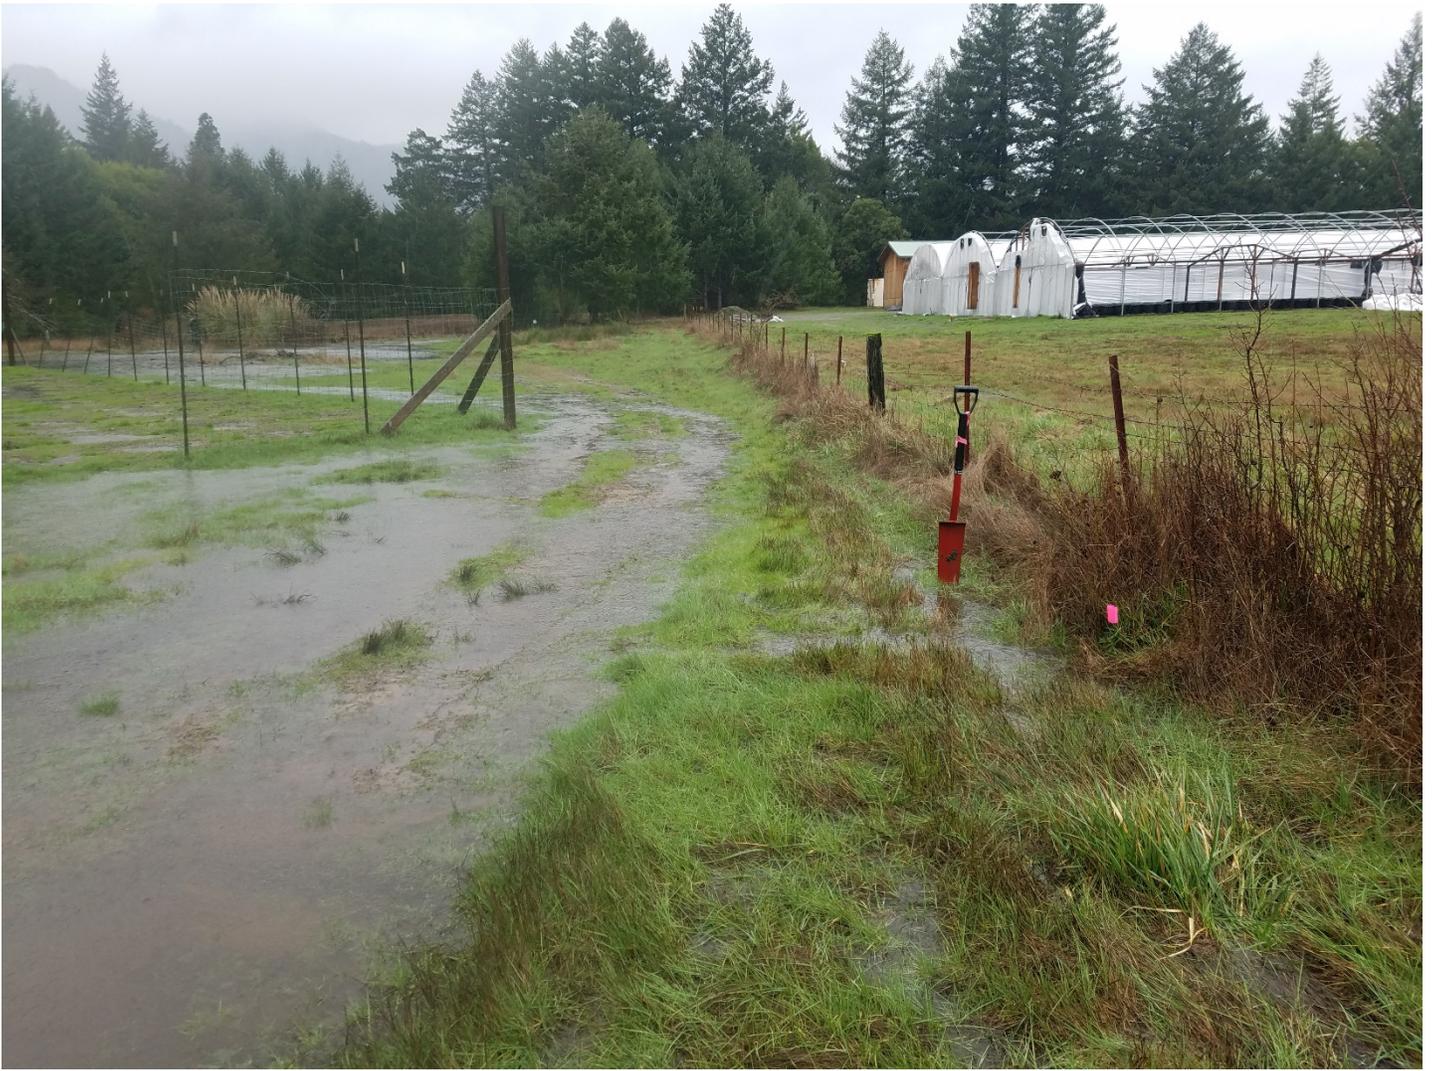
even within Reach 3 where there was 1 ft of standing water. At Plot 1, standing water and active storm runoff were present, but it was difficult to determine the depth of the water table (since storm water runs into the test pits). Additional investigations after periods of dryer weather would be needed to determine water table depth. See Wetland Determination Dataform below.

Photo 20. Site of Wetland Investigation Plot 1.

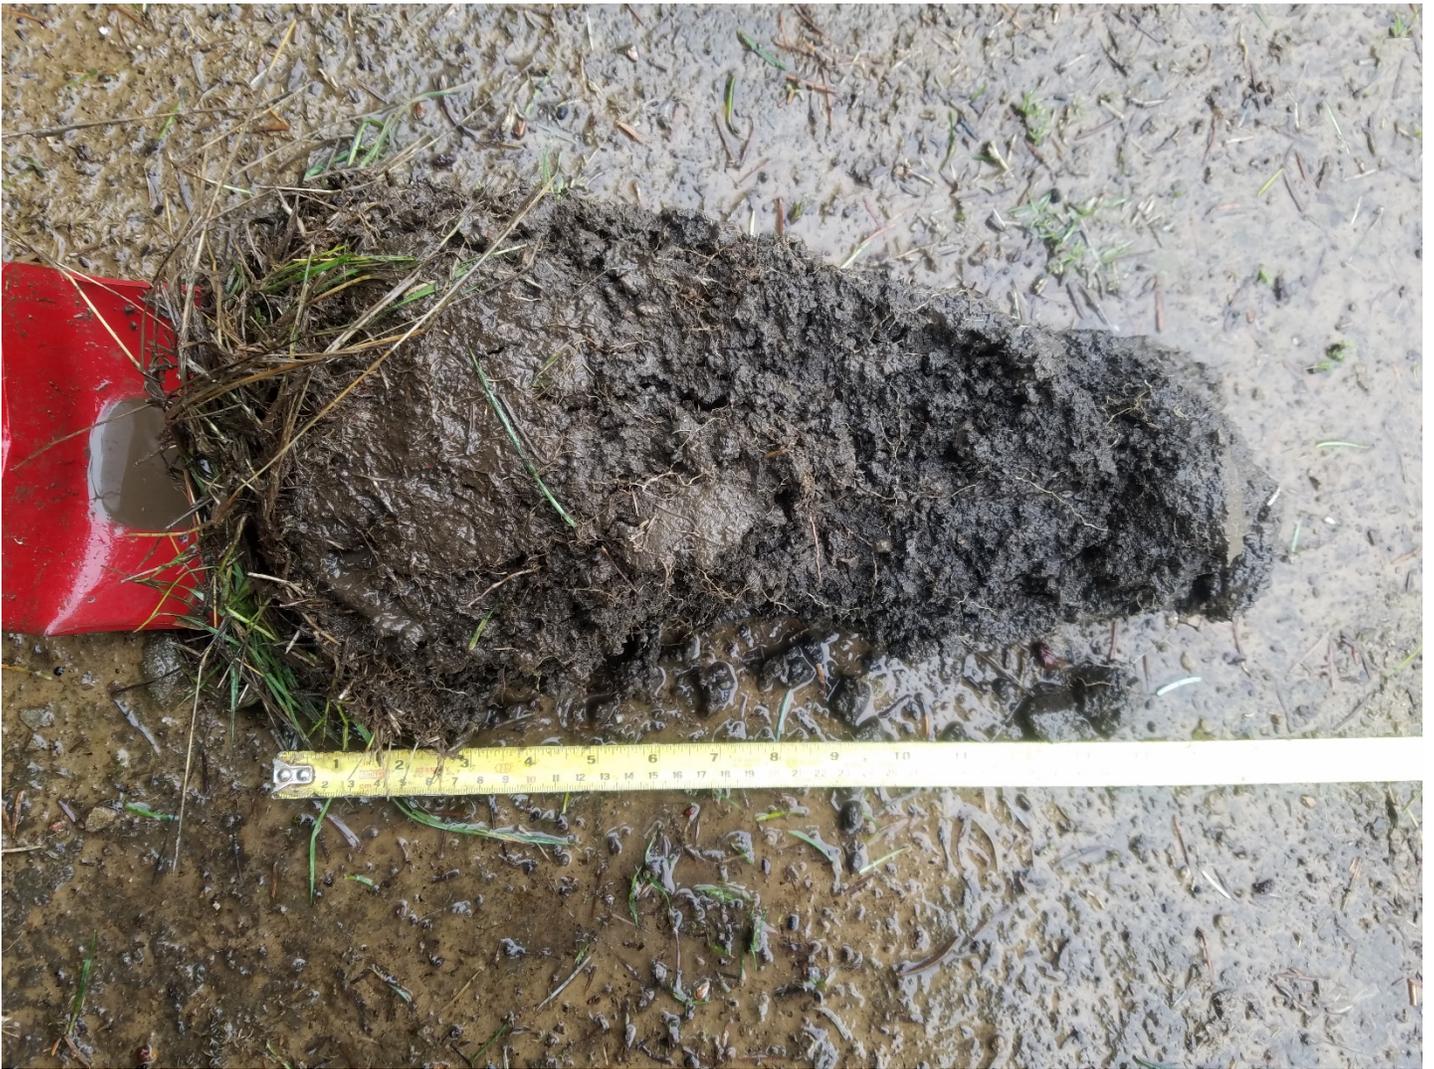
Therefore, it appears that while stormwater concentrates in the area, soil saturation does not persist long enough to develop wetland conditions.

Photo 21. Partial profile of soils at Plot 1.

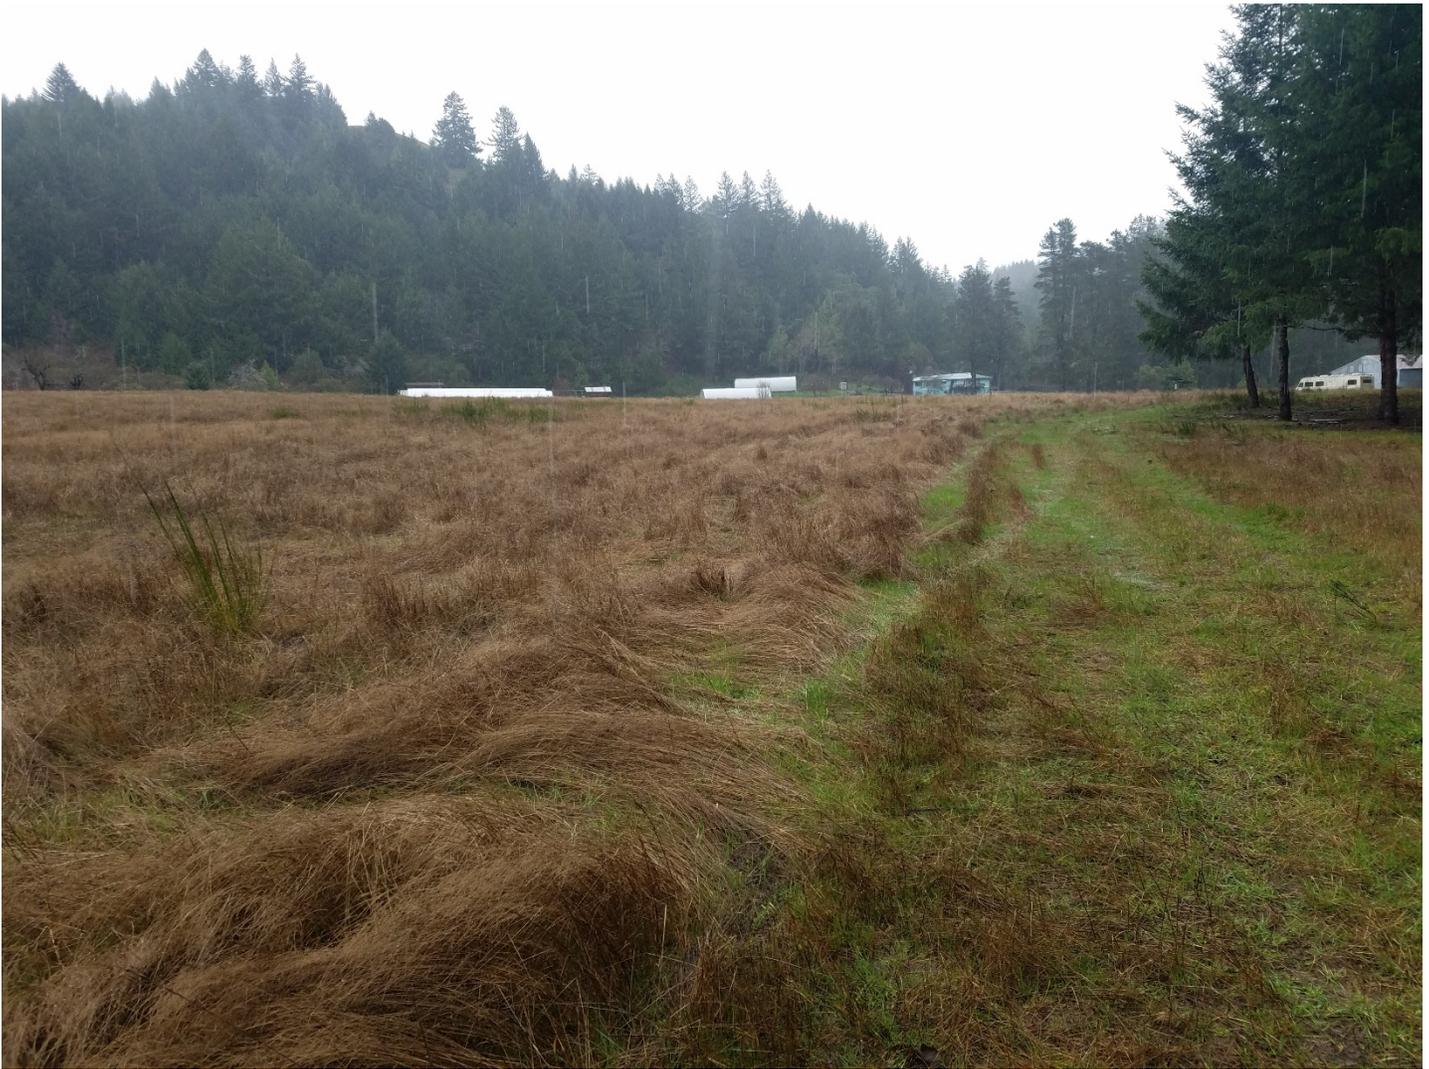
Photo 22. Looking east across south-central portion of Goforth parcel. No watercourse present in this area

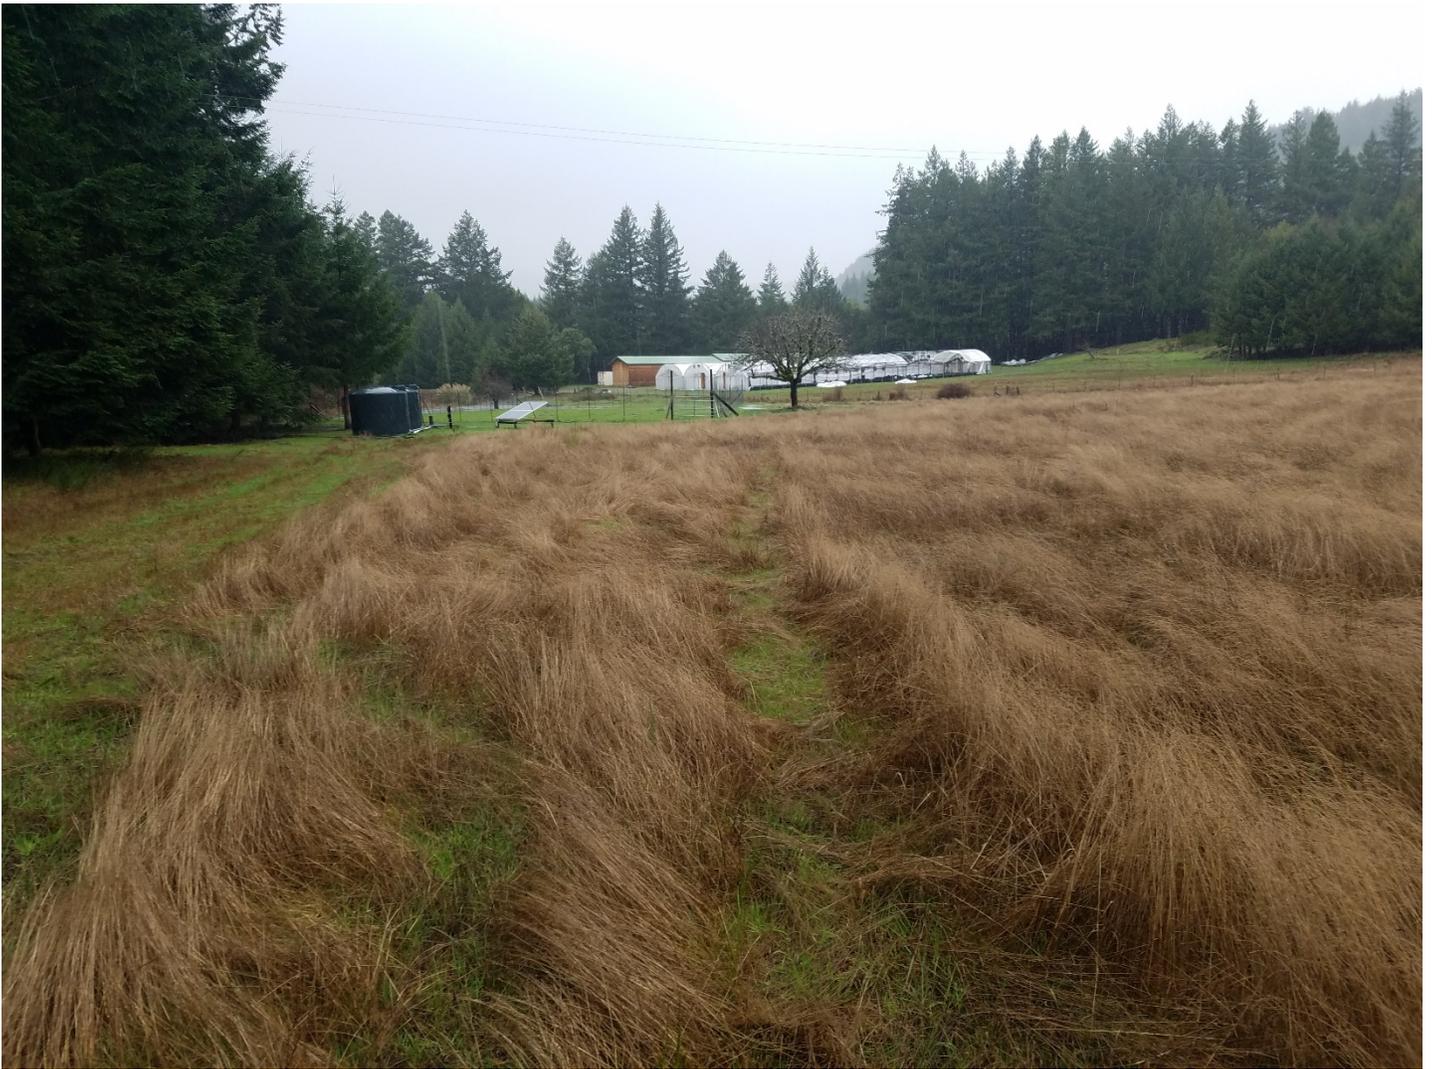
Photo 23. Looking west across south-central portion of Goforth parcel. No watercourse present in this area.

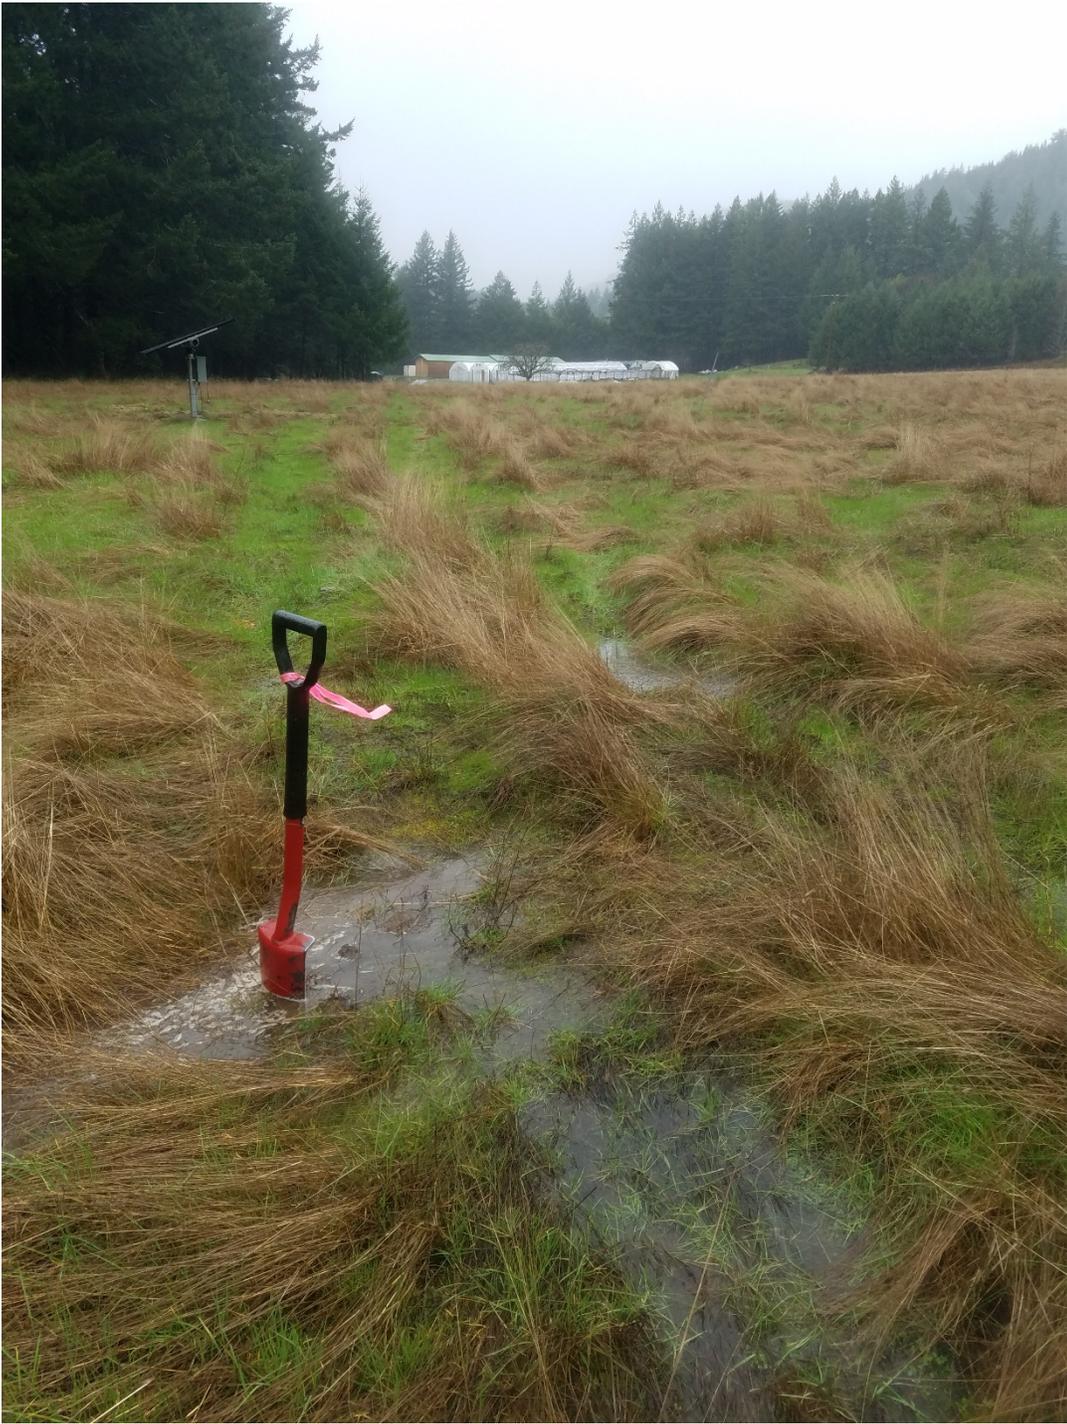
Agency correspondence during January of 2021 had indicated the potential presence of an additional unmapped watercourse running approximately east west through the central-southern portion of the parcel. No such watercourse was identified. A faint quad track was present, and stormwater was pooled in tire tracks at a few distinct points. Soils investigations down to a depth of approximately 17 inches revealed no hydric soil indicators or indications of prolonged saturation.

Photo 24. Water pooled in tire track along central-southern portion of the Goforth parcel. No wetland indicators or directional flow identified.
