Evaluation of oak restoration possibilities within APN: 210-072-009

APN: 210-072-009 - Oak Restoration Evaluation

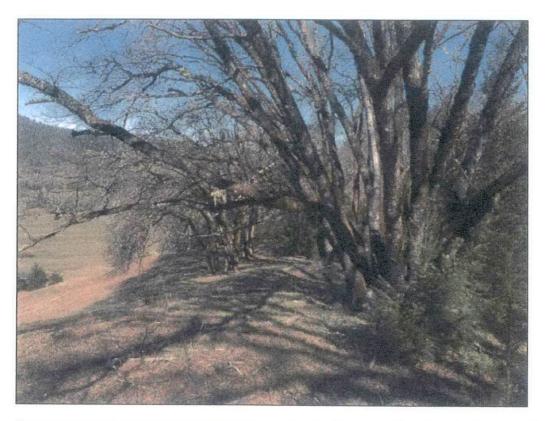
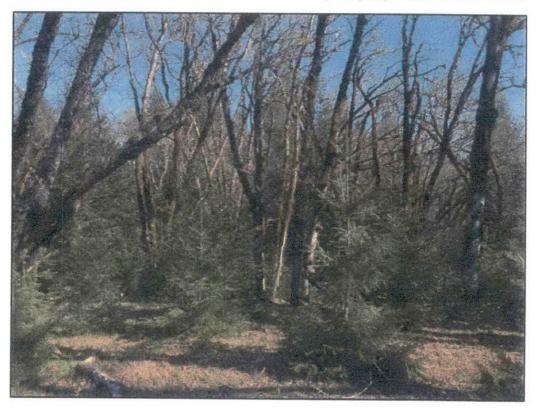
Oregon white oak and California black oak woodland with encroaching Douglas-fir trees. Above & below

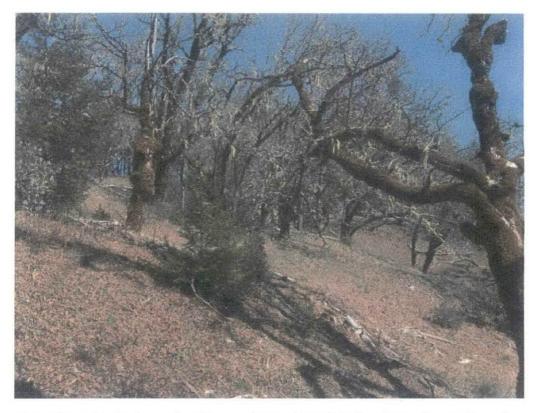
These areas consist of a dominant overstory of true oak species. The understory consists of a young cohort of very dense Douglas-fir regeneration, generally 5-25 feet tall. Little if any overtopping is occurring and most if not all of the Douglas-fir is sub-merchantable. If no action is taken, these stands will inevitably transition into conifer stands as soon as 20 years.

Above Example of oak woodland Encroachment Stage 1. Below Encroachment Stage 2.

- Remove Douglas-fir regeneration via hand crew (chain saws). Cut all Douglas-fir trees up to 12" DBH.
 Removal target is 80% or more of Douglas-fir stems. The cut needs to be made a low as possible on the stem, below the lowest live branch. Trees that are too difficult to fell safely can be girdled.

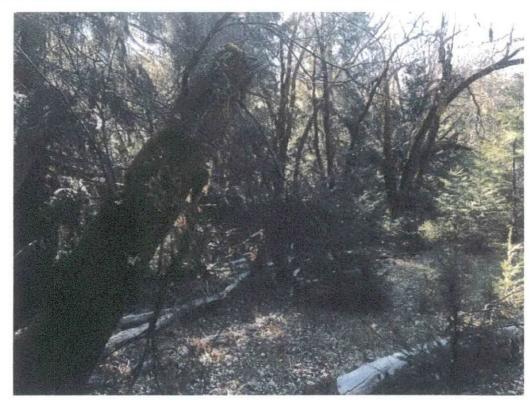
These areas consist of an overstory made up of pre-dominant and dominant oak trees and younger sapling to pole sized Douglas-fir which currently range from co-dominant to dominant in the canopy layer. The understory is generally dense with young Douglas-fir regeneration. Oak trees within this type are beginning to show 'funnel' shaped crowns as Douglas-fir trees shade out the lower canopy.

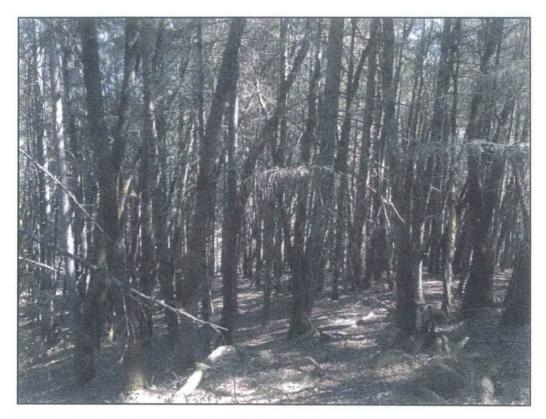
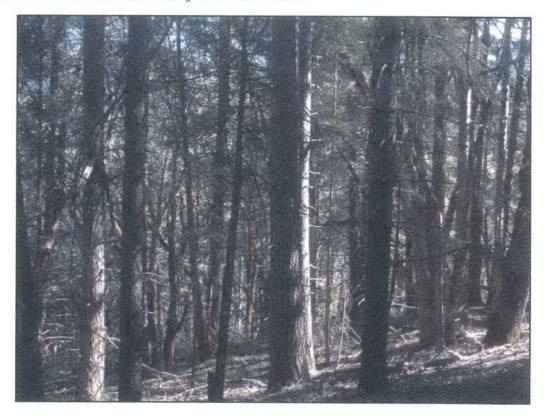
These areas consist of an overstory made up of pre-dominant oak trees and younger pole to small timber sized Douglas-fir trees in the dominant crown position. The average conifer diameter is approximately 15 inches at breast height, and basal area ranges from 75-250 ft² per acre. Sapling sized Douglas-fir trees occupy the intermediate crown positions, and the understory is generally sparse.

Example of oak woodland Encroachment Stage 3. Above & below
