ENGINEERING GEOLOGIC SOILS REPORT

GEOLOGIC HAZARDS AND DEVELOPMENT CLASS R2

Randal Rand
Site APN: 111-211-023
Site Address: 62 Cove View Drive,
Whitethorn CA 95589
Humboldt County

July 31, 2024
Job# 24-6073-2

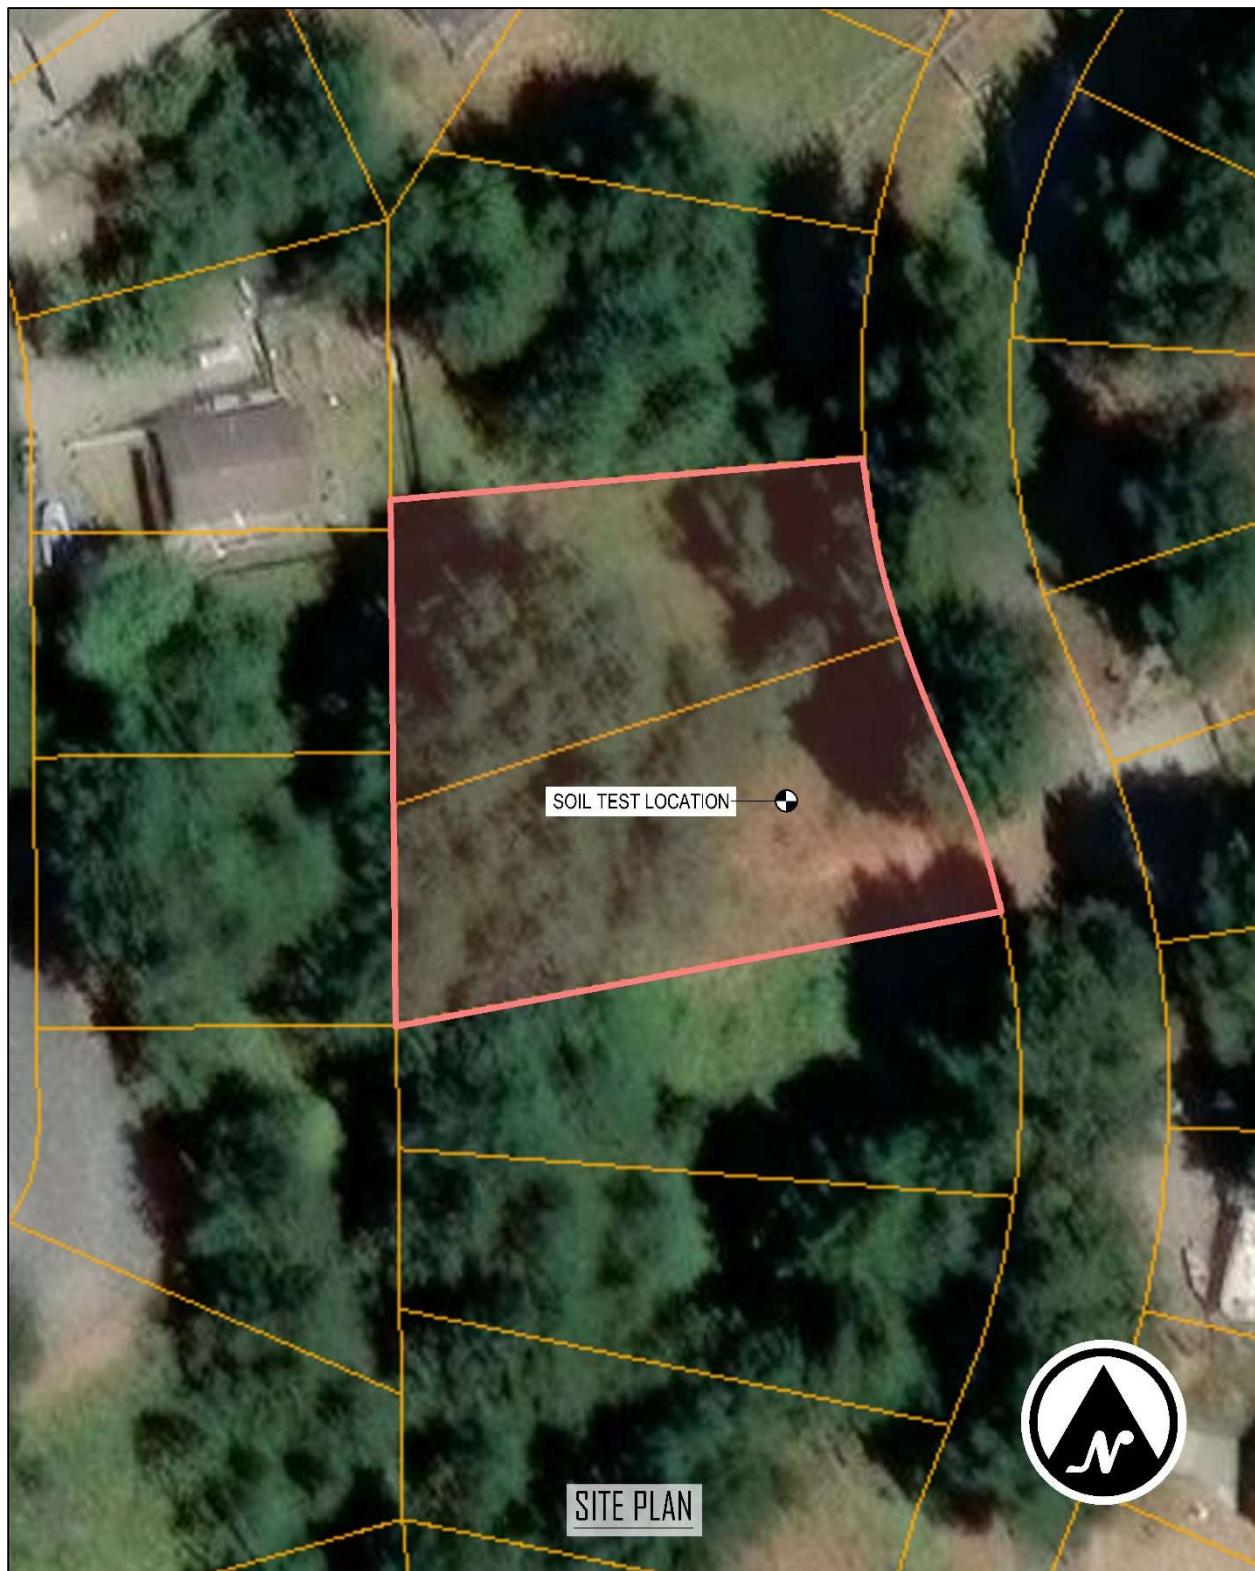
Site Plan

A test hole was excavated to a depth of approximately 2 feet near the proposed building site on the southern-most parcel (see Site Plan, attached). A soil sample was taken from the bottom of the test hole. Field texturing and laboratory analyses were performed on the sample.

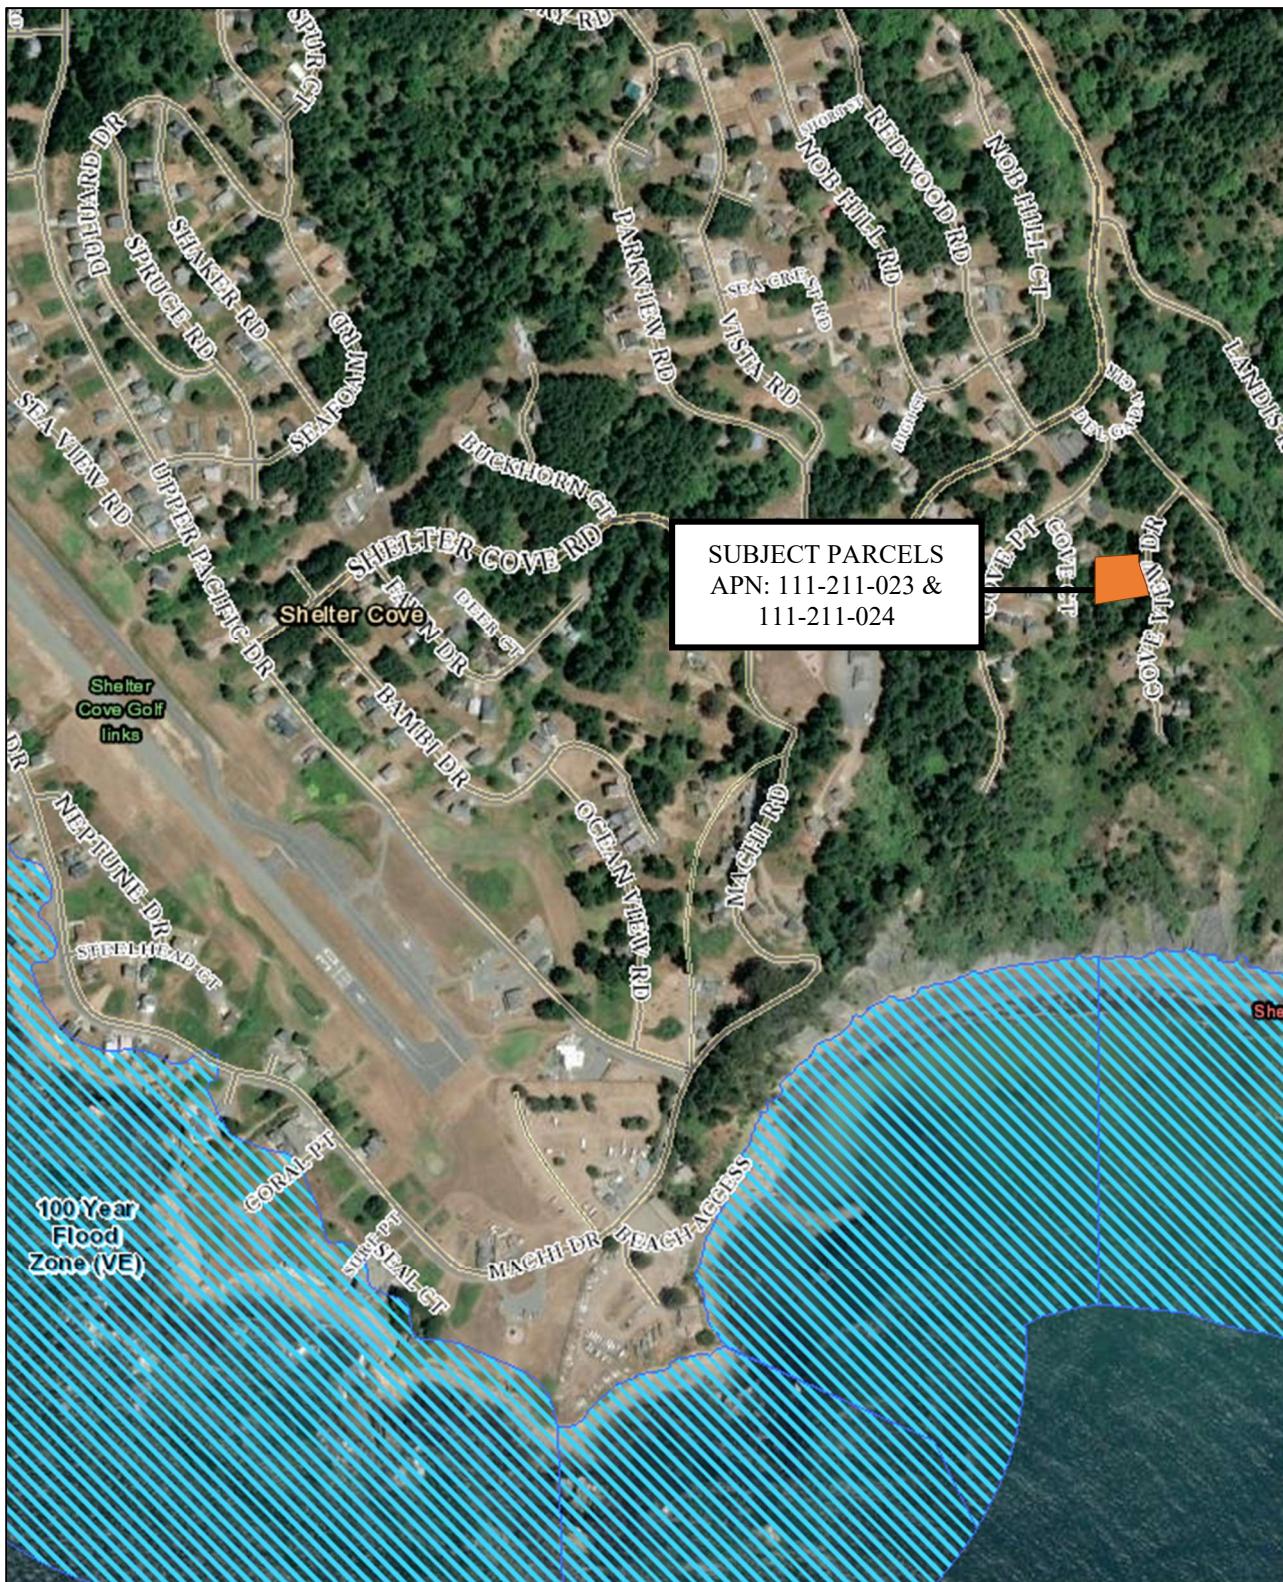
Flood Map, 100-yr

The site is not located within the 100-yr flood zone (see Flood Map, attached).

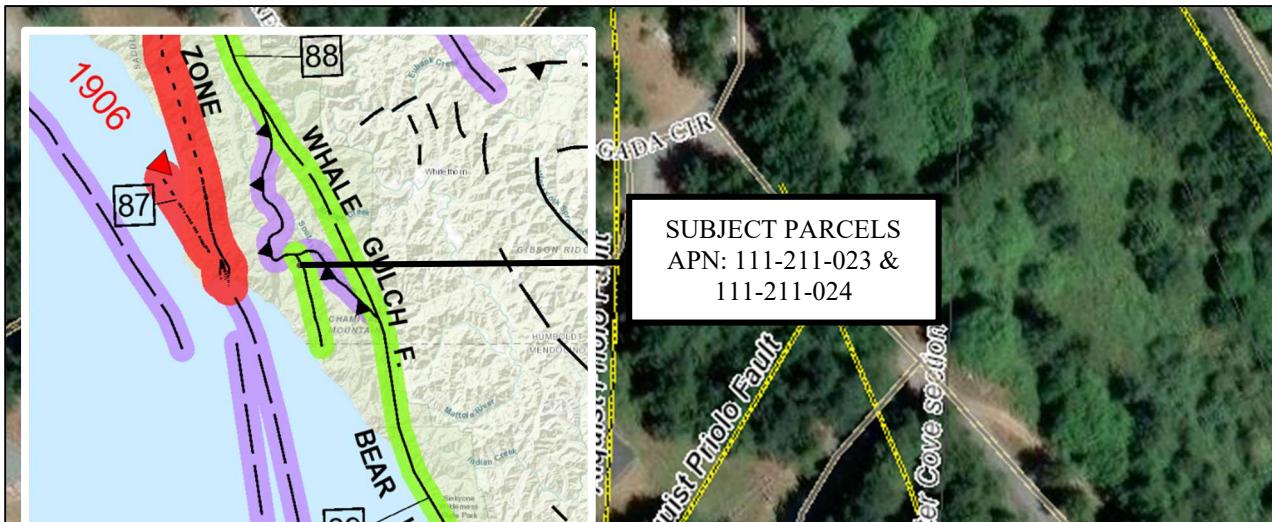
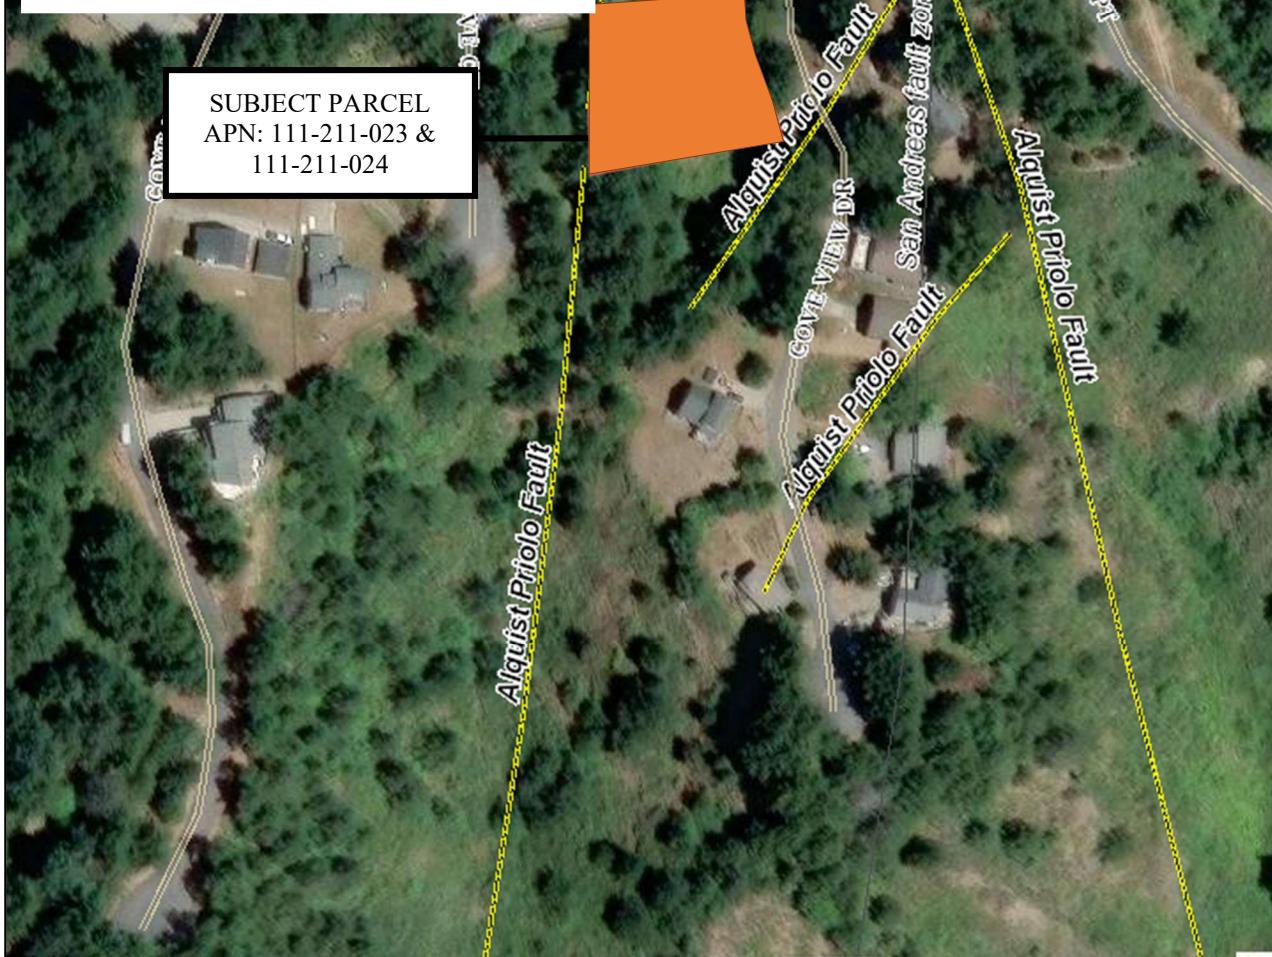
Fault Activity Map

According to the California Department of Conservation and the Humboldt County General Plan, this parcel is located in a special studies earthquake zone within 2 kilometers of the active Class A San Andreas Fault (North Coast), and within 25 kilometers of the Type B Garberville Fault. Recent research conducted by the USGS has concluded that the San Andreas Fault is not exclusively located offshore of Shelter Cove but that "... a significant Quaternary fault is located onshore ...", actually running through the residential areas of Shelter Cove and extending past Kaluna Cliff (Prentice, et. al., 1999). The proposed building site is located approximately 60 feet east of this fault trace indicated in the Geological Society of America article, which runs nearly adjacent to Shelter Cove Road and out to the ocean. A map of this trace showing the property location is enclosed for reference (see Fault Activity Map).

The soil on site is capable of supporting a load of 1,500 pounds per square foot (psf). No expansive soils were encountered during this investigation that require specific recommendations. Multi-level structures are suitable uses for this property, provided they are a minimum of 50 feet away from the mapped fault trace that runs along the rear property boundary of the aggregate property. Settlement is not anticipated to be detrimental provided considerations are given to the recommendations presented herein:
