Preliminary Engineering Geologic Report

Proposed Grading and Development Project

3852 Thomas Road

Miranda, California

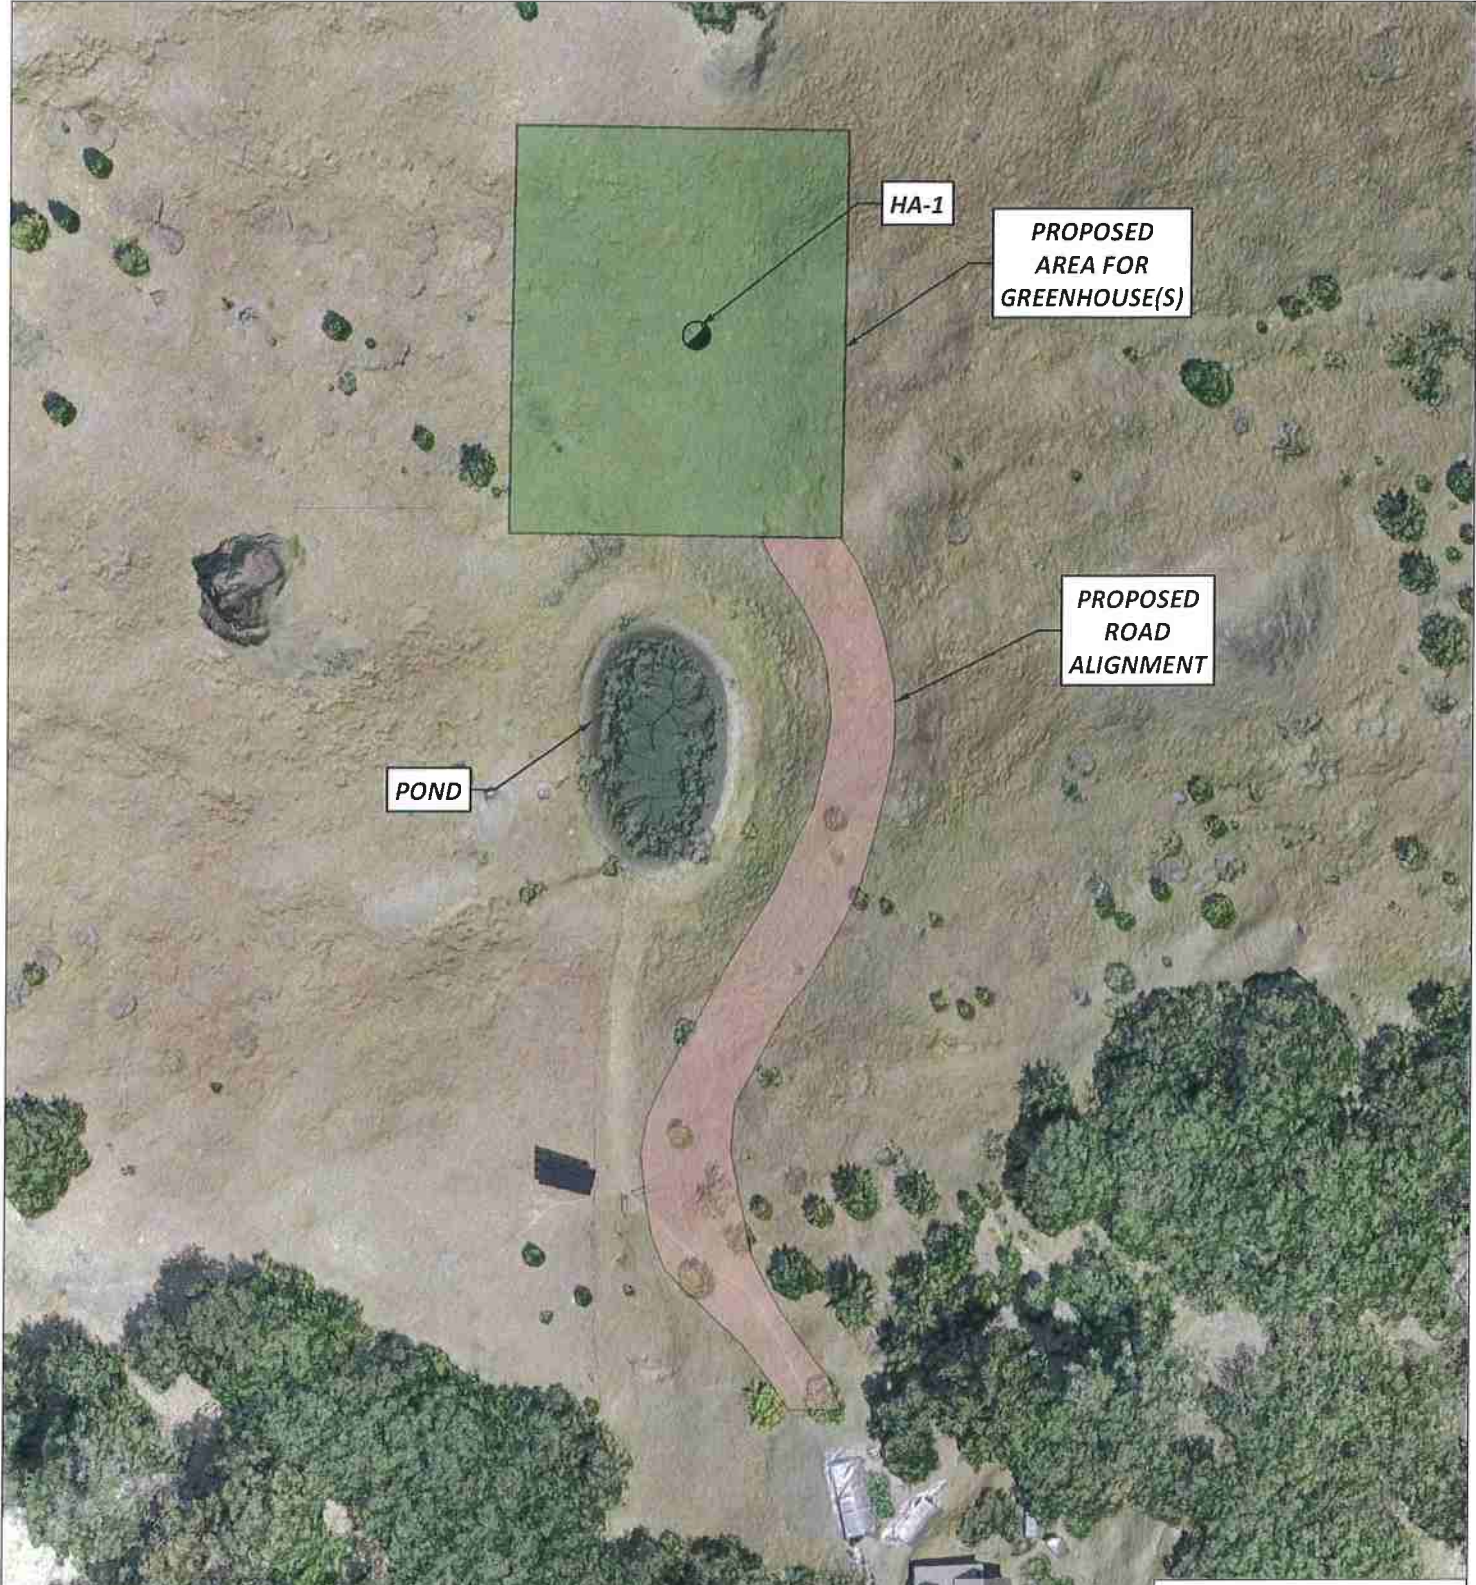
Figure 2

On July 12, 2019, a project geologist from SHN met with the owner at the project site and discussed the conceptual design of the proposed improvements. SHN conducted a reconnaissance inspection of the project site, evaluated the existing conditions of the surrounding slopes, and logged and sampled a shallow hand-augered boring at the project site. The boring was excavated to a depth of 5 feet below existing ground surface (BGS) in a location considered to be representative of the onsite soils. The boring was located within the proposed footprint of the graded pad that would support future greenhouses (Figure 2).

During our site reconnaissance, we reviewed exposed native soils in cut slopes and stream bank exposures. We also installed a hand-augered boring (HA-1; Figure 2) within the vicinity of the proposed new greenhouse pad. The results of our subsurface investigation and review of exposures indicate that the site is underlain by a mixture of weathered bedrock and a matrix material consisting of silty clay with variable amounts of gravel. Based on our field observations, we characterize the shallow subsurface materials that would support structures to be medium dense to medium stiff. The site soils are anticipated to vary laterally and with depth, with some areas primarily soil like, and others consisting of fractured rock. In some places, deep cracks in near surface soils were observed. These cracks are interpreted to be shrinkage cracks that may be indicative of expansive soils.

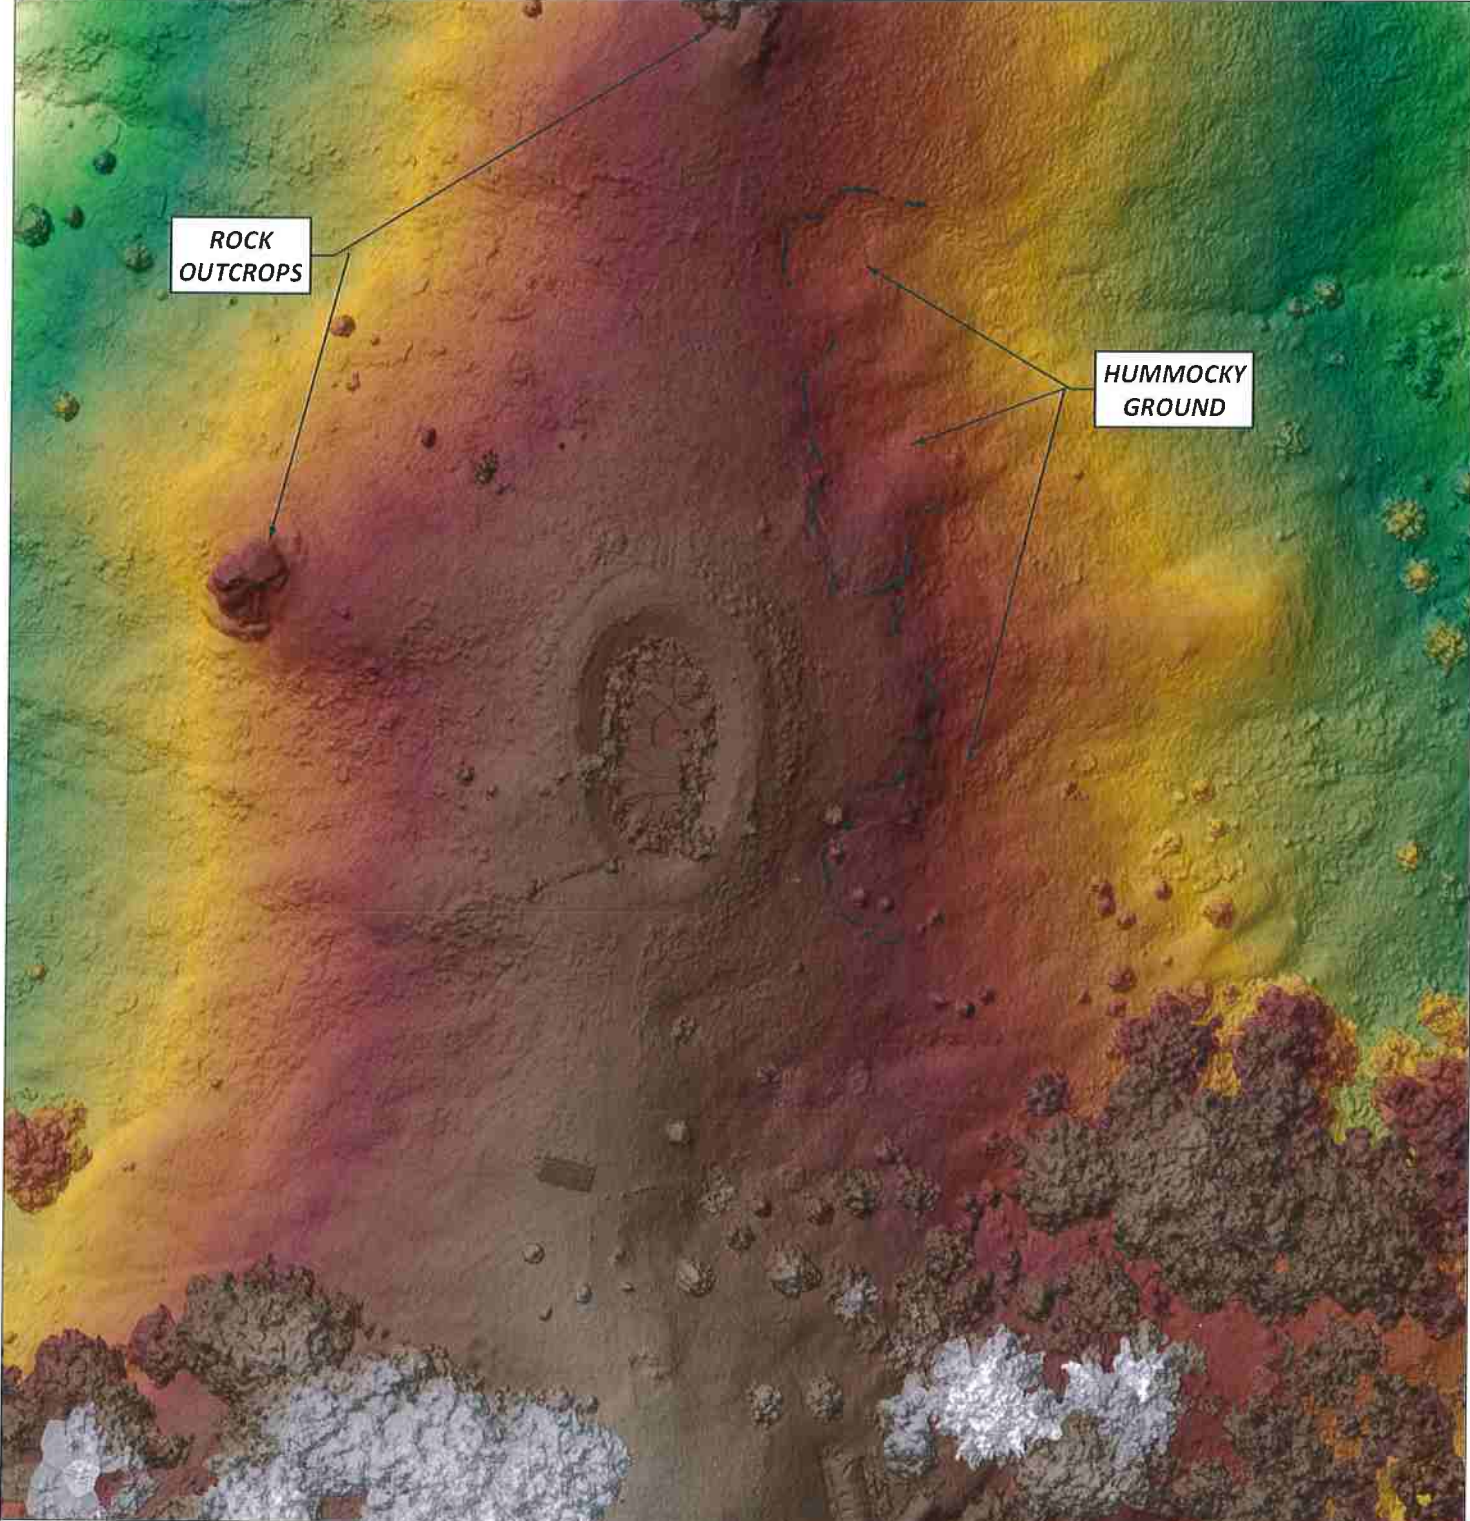
An unmanned aerial vehicle (UAV) was used to map the existing conditions of the project site and vicinity. The digital surface model derived from the processed UAV data is shown on Figure 3 and highlights the geomorphic features of the project site.

in isolated areas and within stream drainages. Rock outcrops are found scattered across the landscape, and tend to form resistant landforms. Rock outcrops were observed immediately north and southwest of the proposed greenhouse area.

The proposed developments are situated on gently to moderately sloping ground, with isolated areas of steep ground (>50%). The ridge itself is generally smooth with pockets of hummocky ground on the side slopes, examples of which are shown on Figure 3. The hummocky ground is interpreted to be associated with a few different conditions. In places, the variability of the ground surface appears to be an expression of the long-term landscape evolution of the slope caused by differential erosion. In other places the hummocky areas appear to be associated with slow downhill creep of shallow soils or a very slow moving earthflow. We did not observe any significant slope failures or other traditional landslide features. Soils undergoing down slope creep and/or associated with earthflows are considered the primary stability hazard to the proposed developments. Strategies for minimizing risk associated with these areas are discussed in Section 5 below. Provided our recommendations are adhered to, we conclude that the potential for slope instability to affect the development is low.

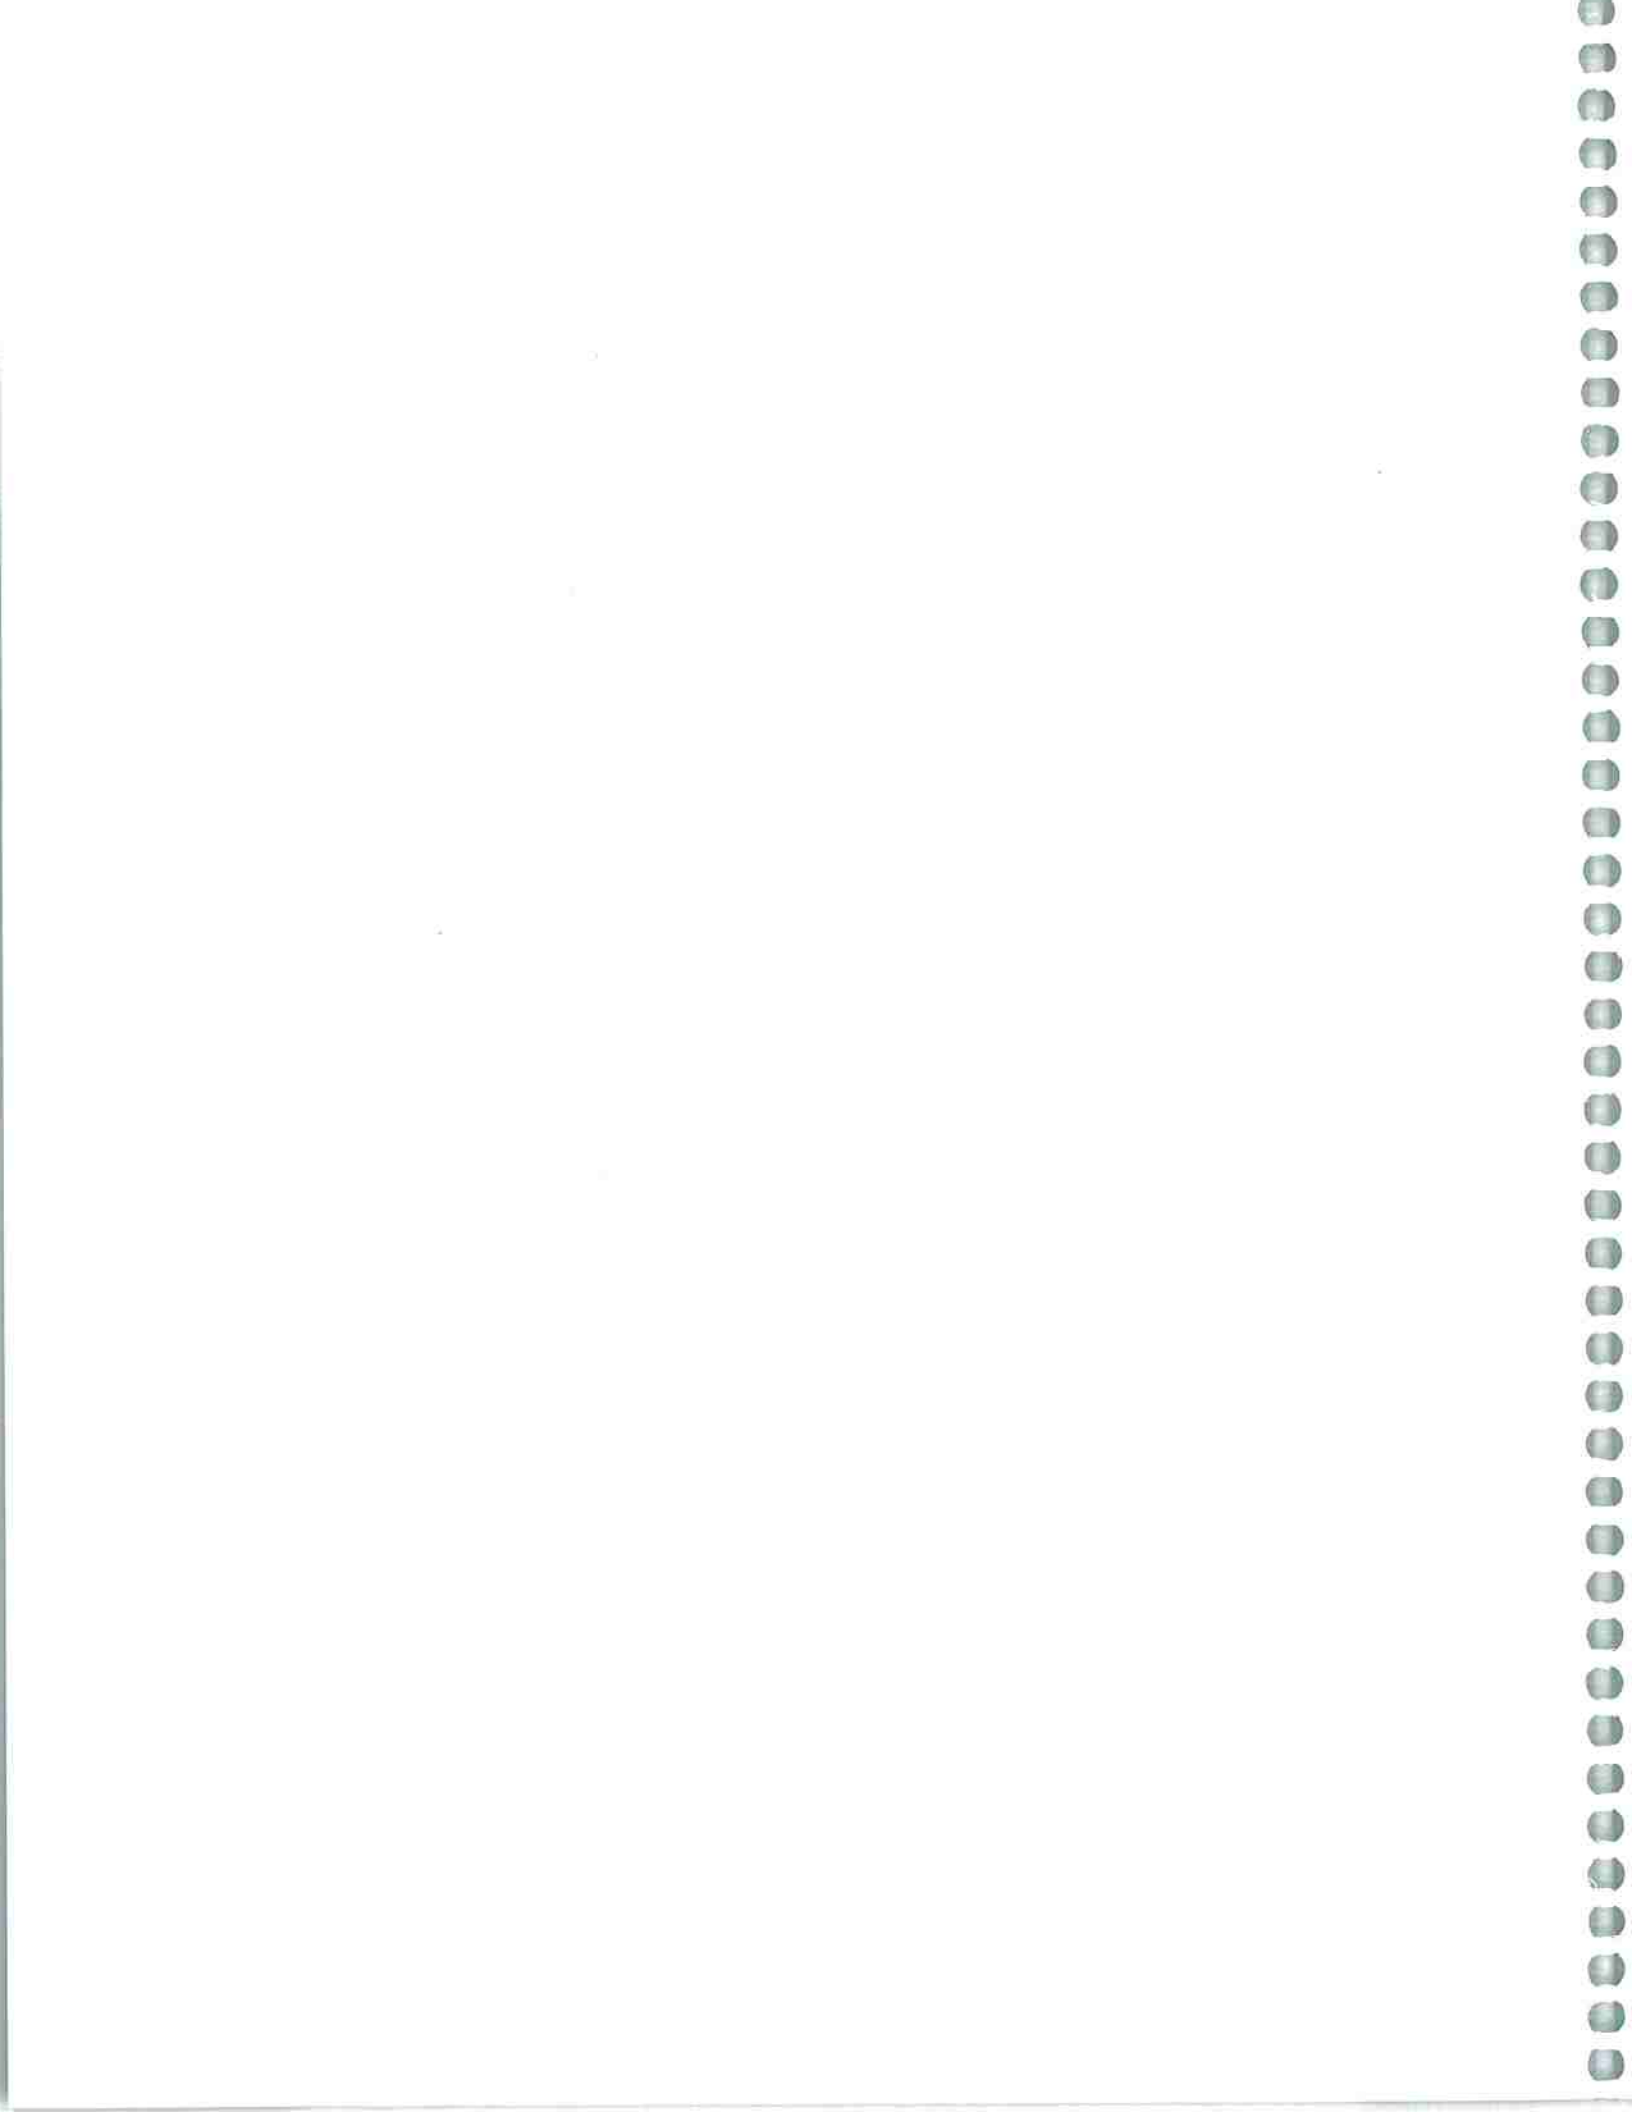
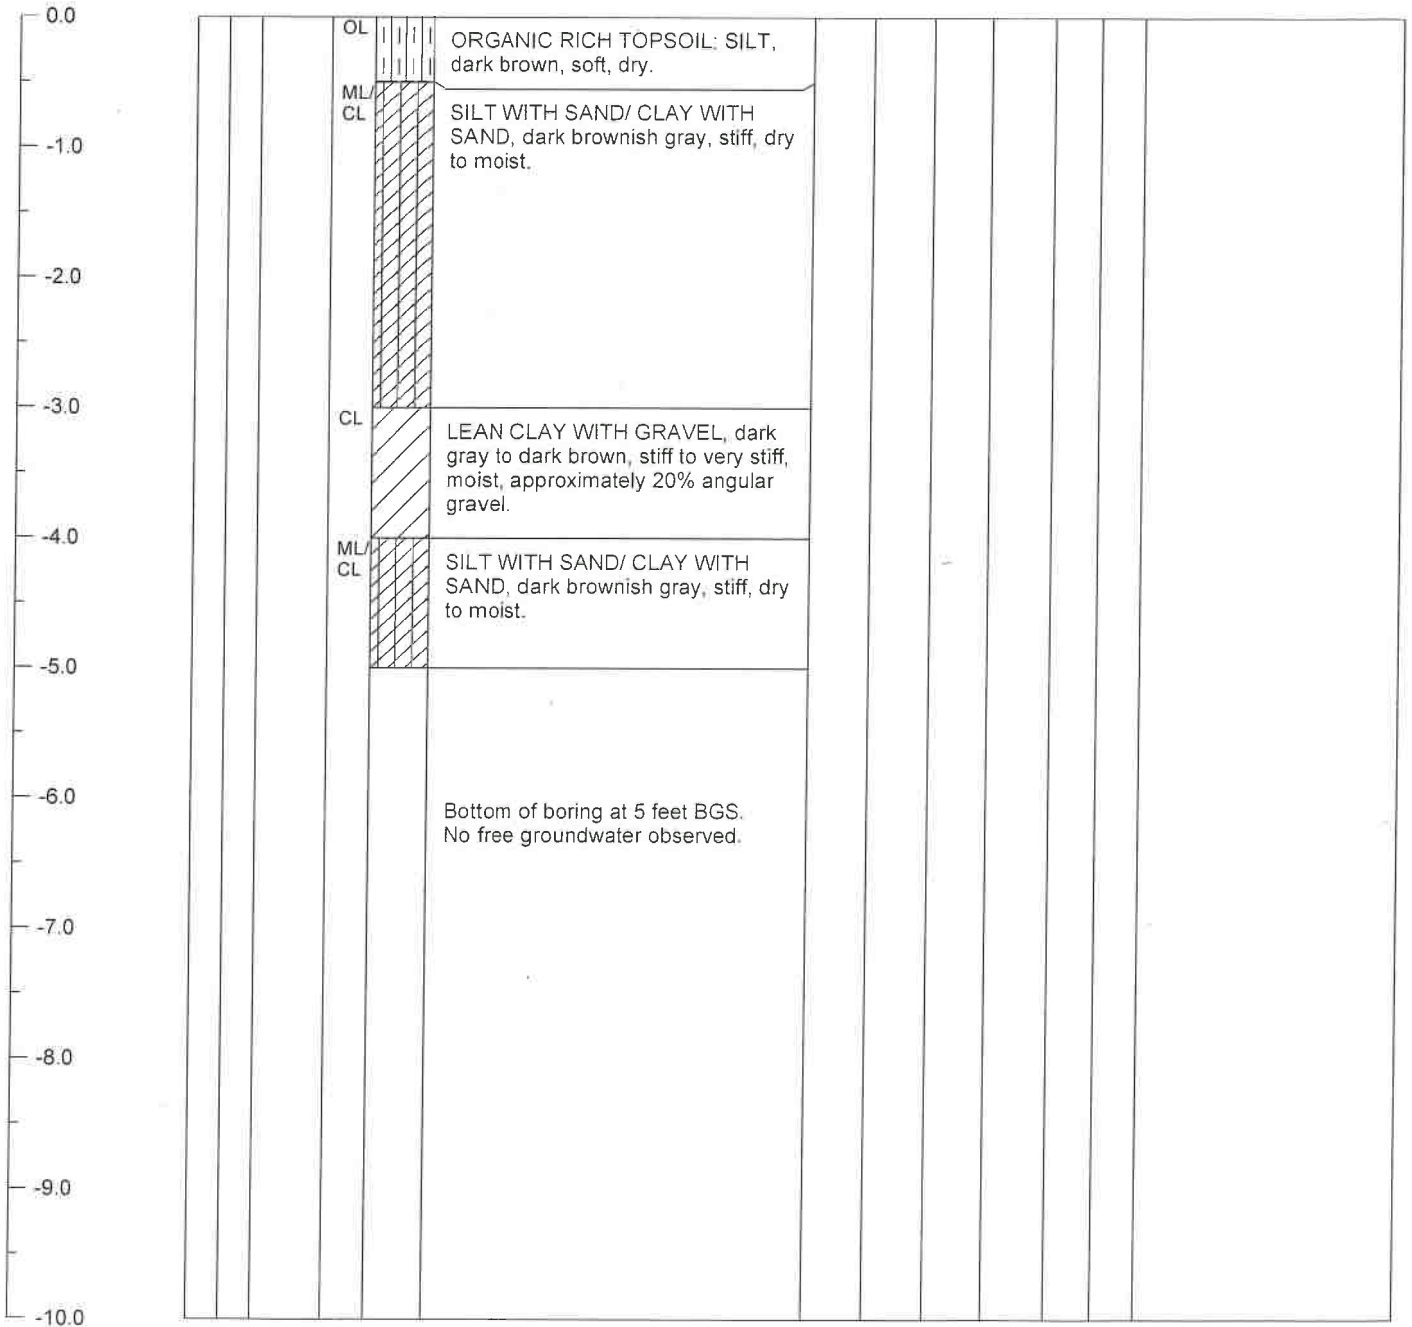
BORING
NUMBER
HA-1

The soils encountered in the boring were logged and field classified in general accordance with the Manual-Visual Classification Method (ASTM-International [ASTM] D 2488). During excavation, the project geologist evaluated the in situ soil consistency based on equipment performance and level of effort required to advance the boring. A final log of the soils encountered in the boring is presented in Appendix 1.
