Geotechnical Investigation

Fault-Rupture Hazard Evaluation
Mad River Fault Zone
Alquist-Priolo Special Study Zone
Portions of Section 6, T6N, R1E, H.M.
Arcata North 7.5 Quadrangle

McKinleyville School District Property

Job No. 3104

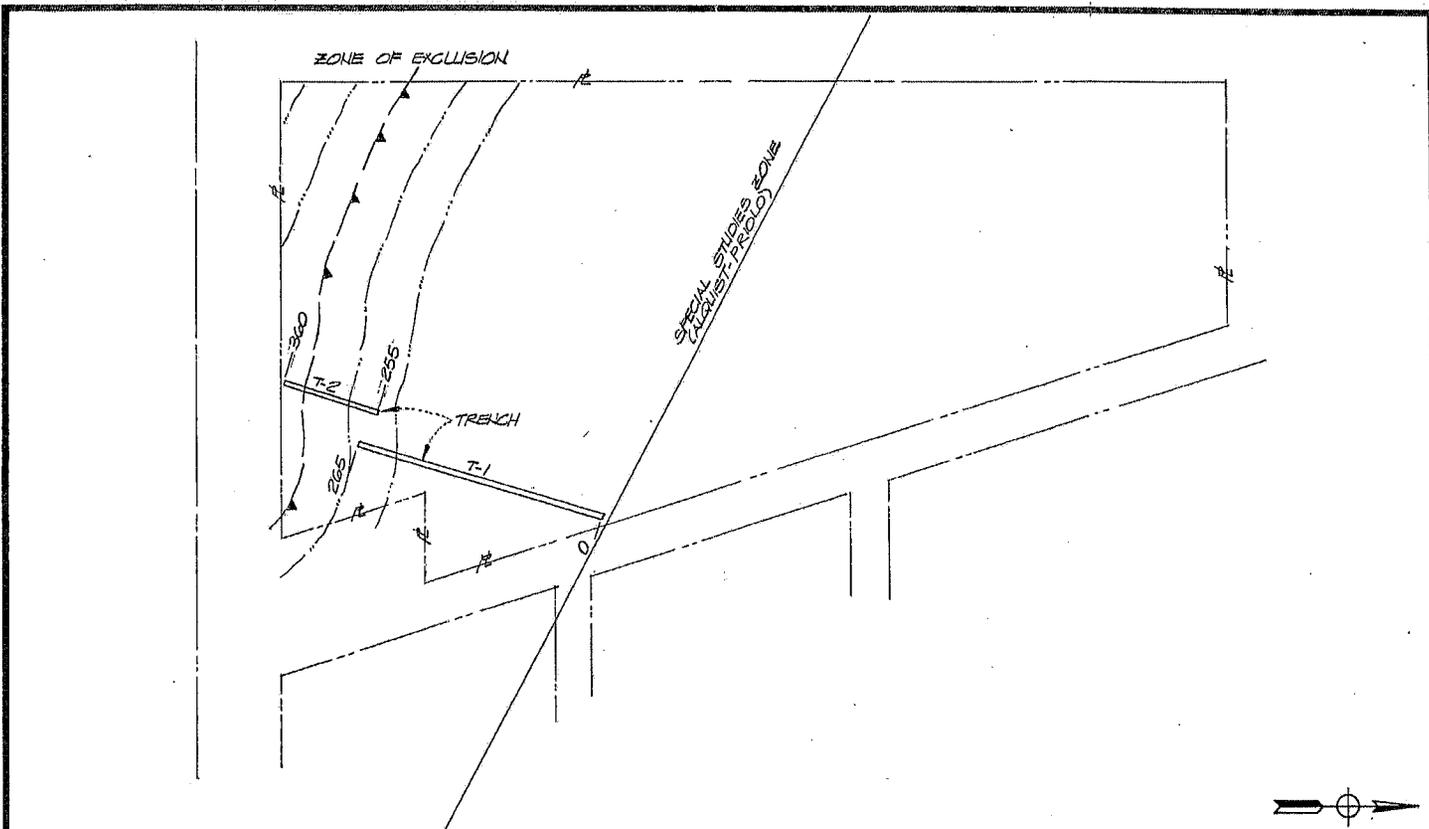
DRAWN BY: DRS	SCALE: 1" = 100'	SITE PLAN MCKINLEYVILLE, CA	JOB NO. 3104
CHECKED BY: FRB	DATE: 8-10-89	G. D. MATEON ARCHITECTS EUREKA, CA	SHEET FIGURE 2

6. The trace of the fault is about 40 feet beyond the base of the scarp. There is no direct expression of a surface trace of the fault where trenched or elsewhere on the School Road-Washington Avenue site.

8. The scarp is the only off-site to on-site photolineniment or ground observed match up.
9. The site was trenched from the south property boundary (School Road) across the fault to the Alquist-Priolo Special Studies Boundary to the north (Washington Avenue). Only one fault was exposed in the trenches (Figure 2 and trench logs, this report).

1. Do not build any structure for human occupancy in zone

of setback (exclusion) in Figure 2. This zone begins at south boundary line (fence line along School Road) and extends north past the fault to 50 feet north of the top of the scarp.

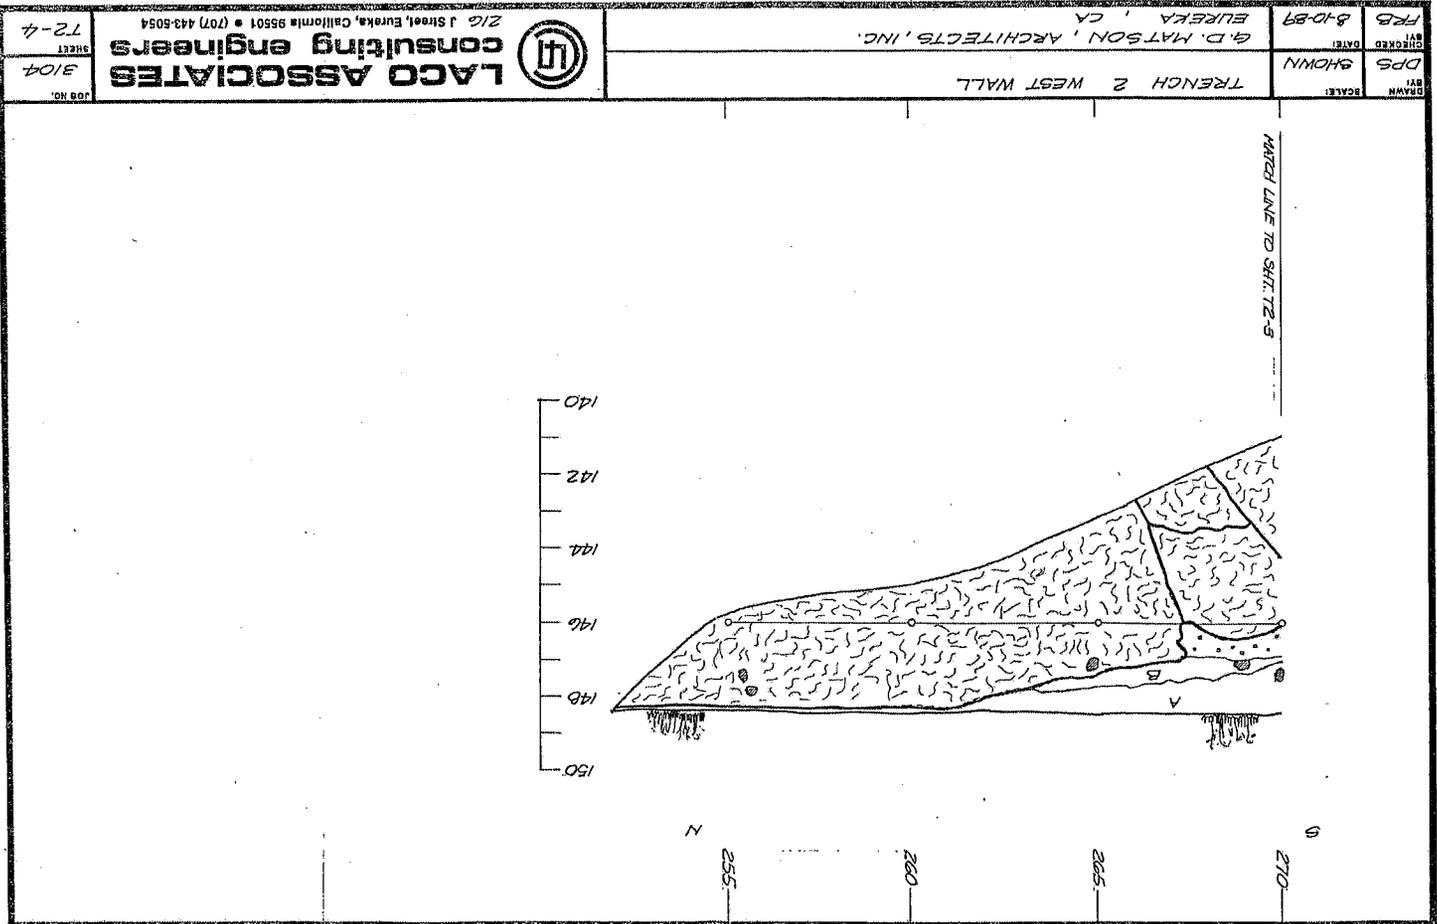
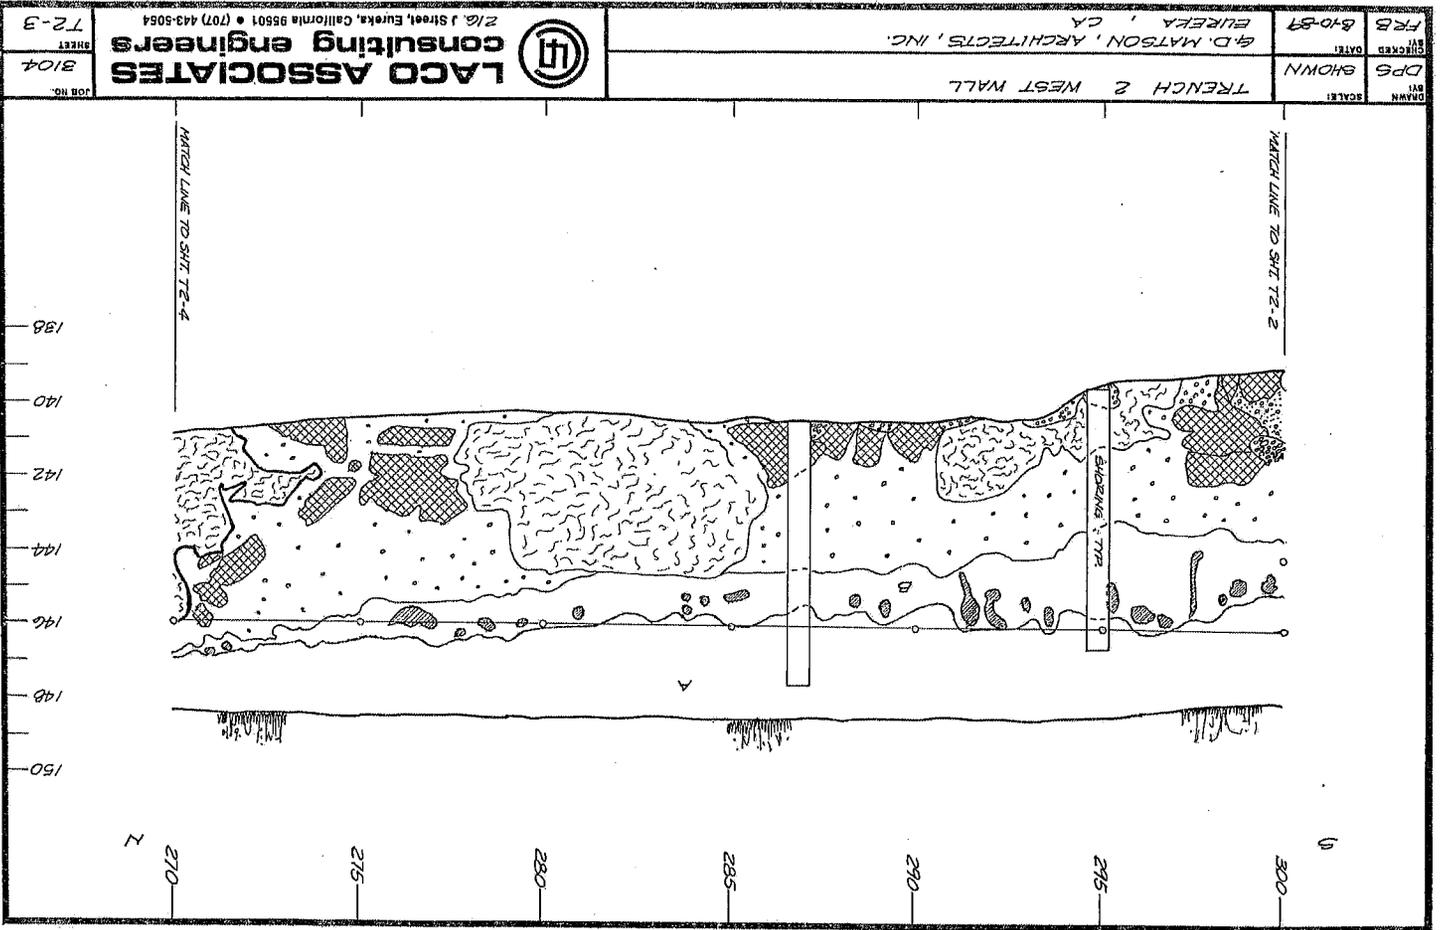
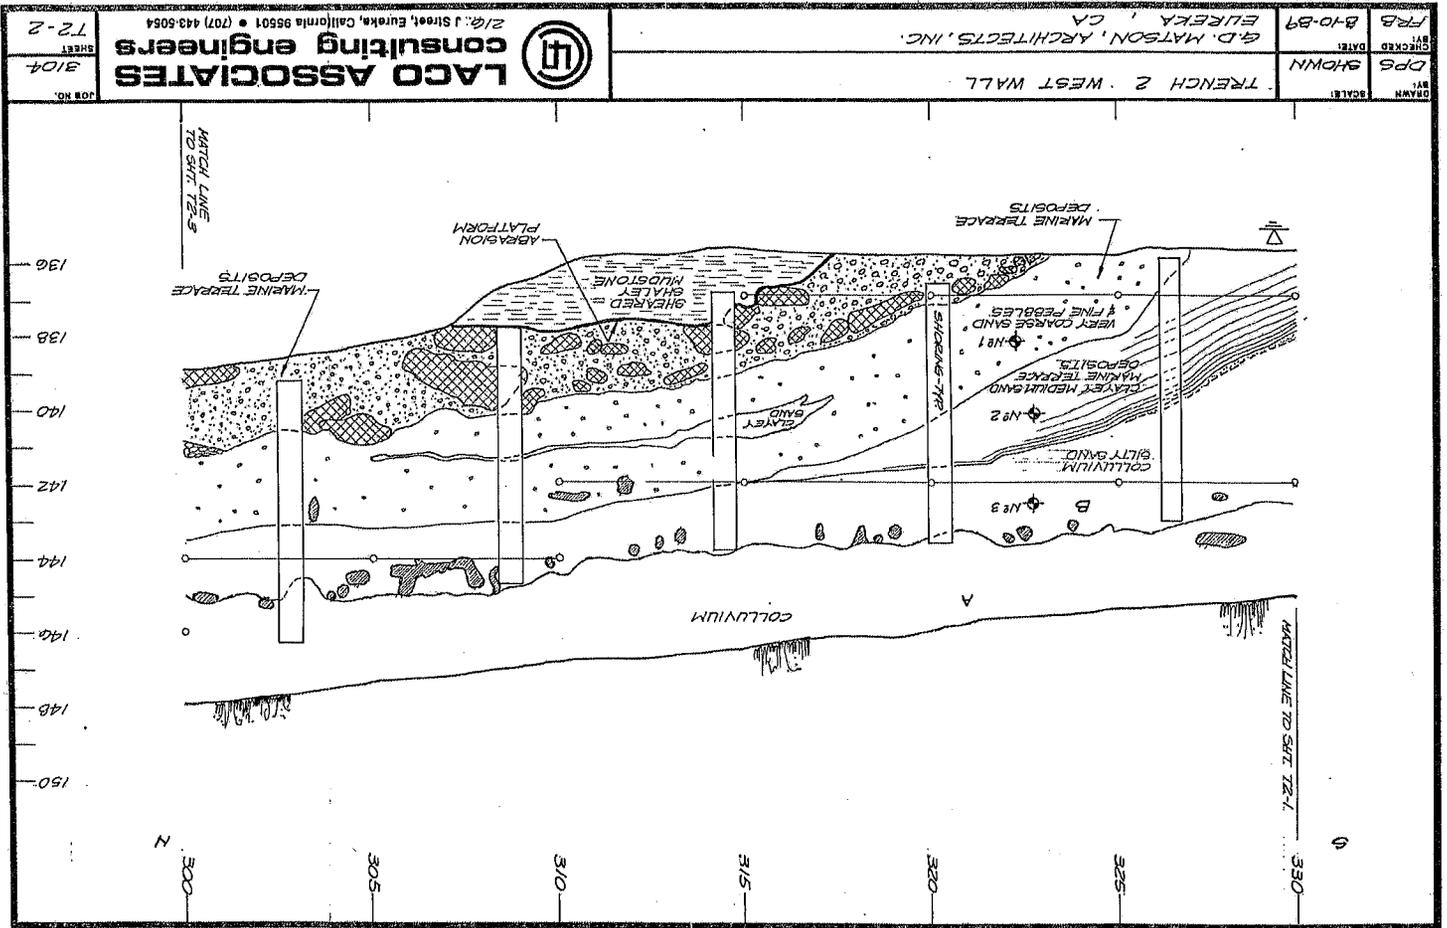
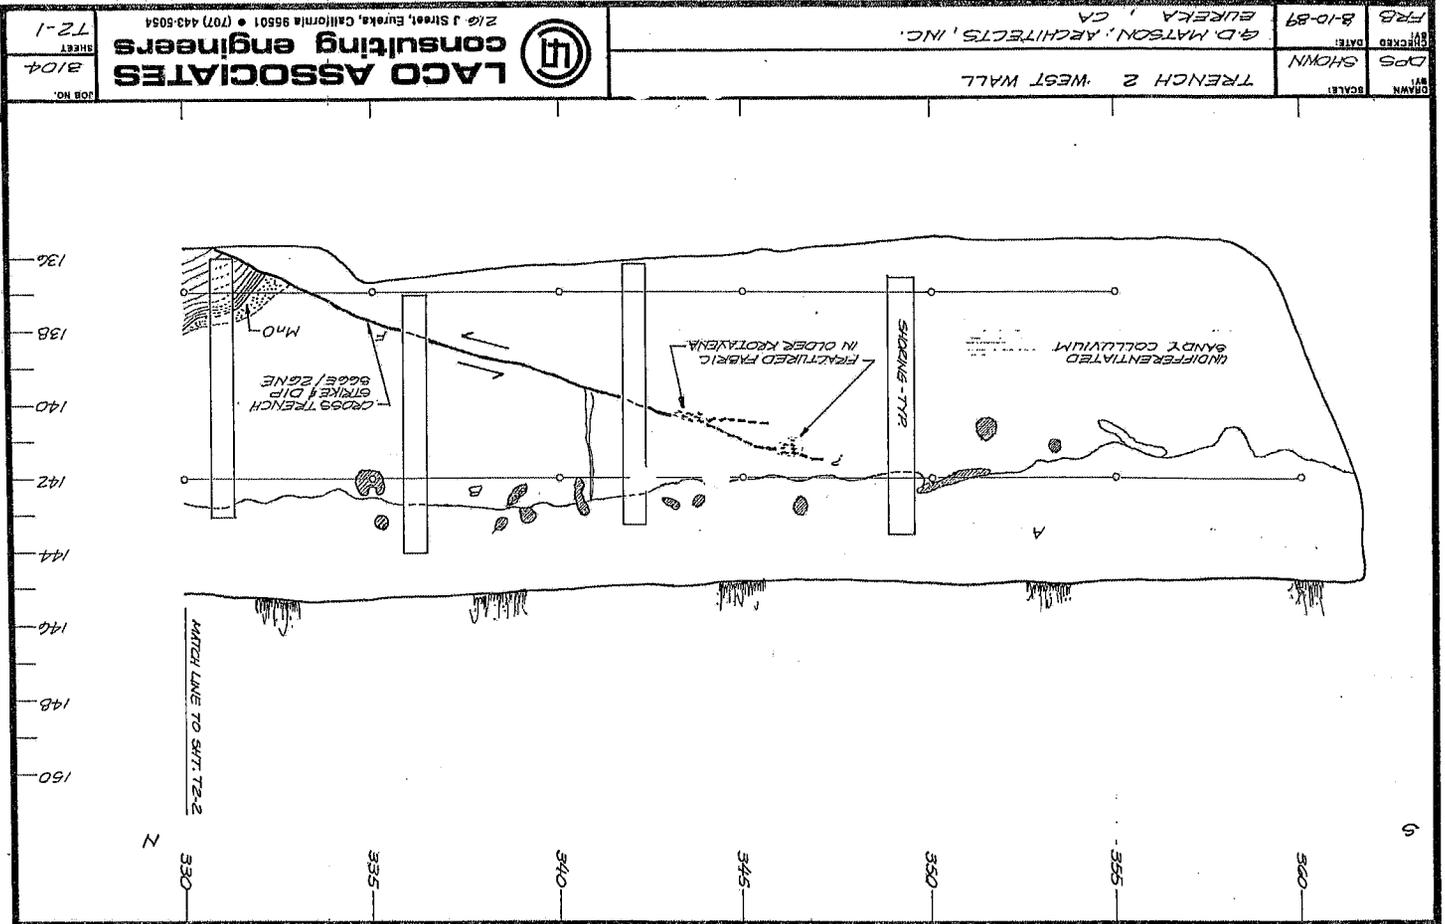
TRENCH 2 WEST WALL

5. The fault is a northwest-trending (N66W) low angle (26 degree NE dipping) thrust as exposed in trench 2. Where trenched on the School Road-Washington Avenue site, only one fault trace is apparent.

1. The fault is the north strand of the Mad River Fault as mapped by CDMG (1983) and zoned as potentially active (Figure 1).
2. On-site, the fault is a N66W striking, 26 degree NE dipping low angle thrust fault (see sheets T2, 1-4). Only one fault is apparent in the trenches (sheets T1, 1-8; T2, 1-4).
