# ENGINEERING GEOLOGIC SOILS REPORT

GEOLOGIC HAZARDS AND DEVELOPMENT CLASS R2

Matthew Culpepper  
APN: 111-121-007  
Block 112, Lot 001  
Shelter Cove, CA  
Humboldt County

November 21, 2023  
Job# 23-6056

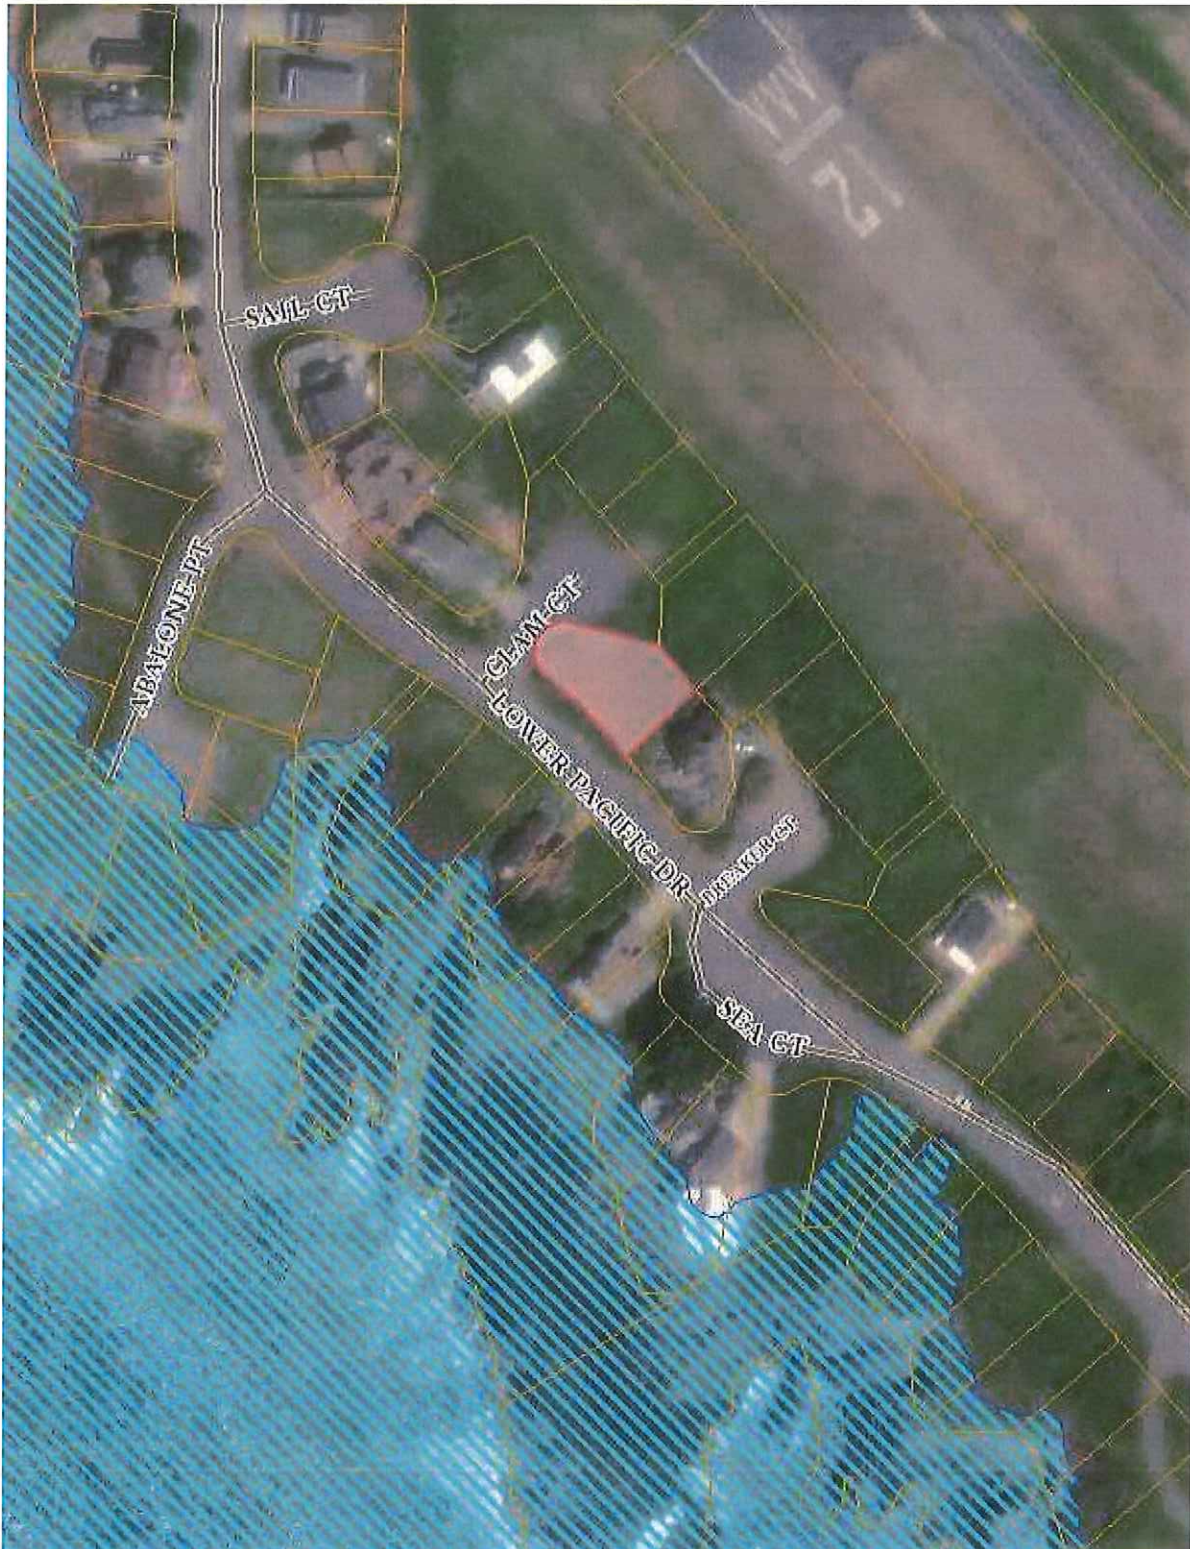
Flood Map, 100-yr

The site is not within the 100-yr flood zone (see Flood Map, 100-yr, attached).

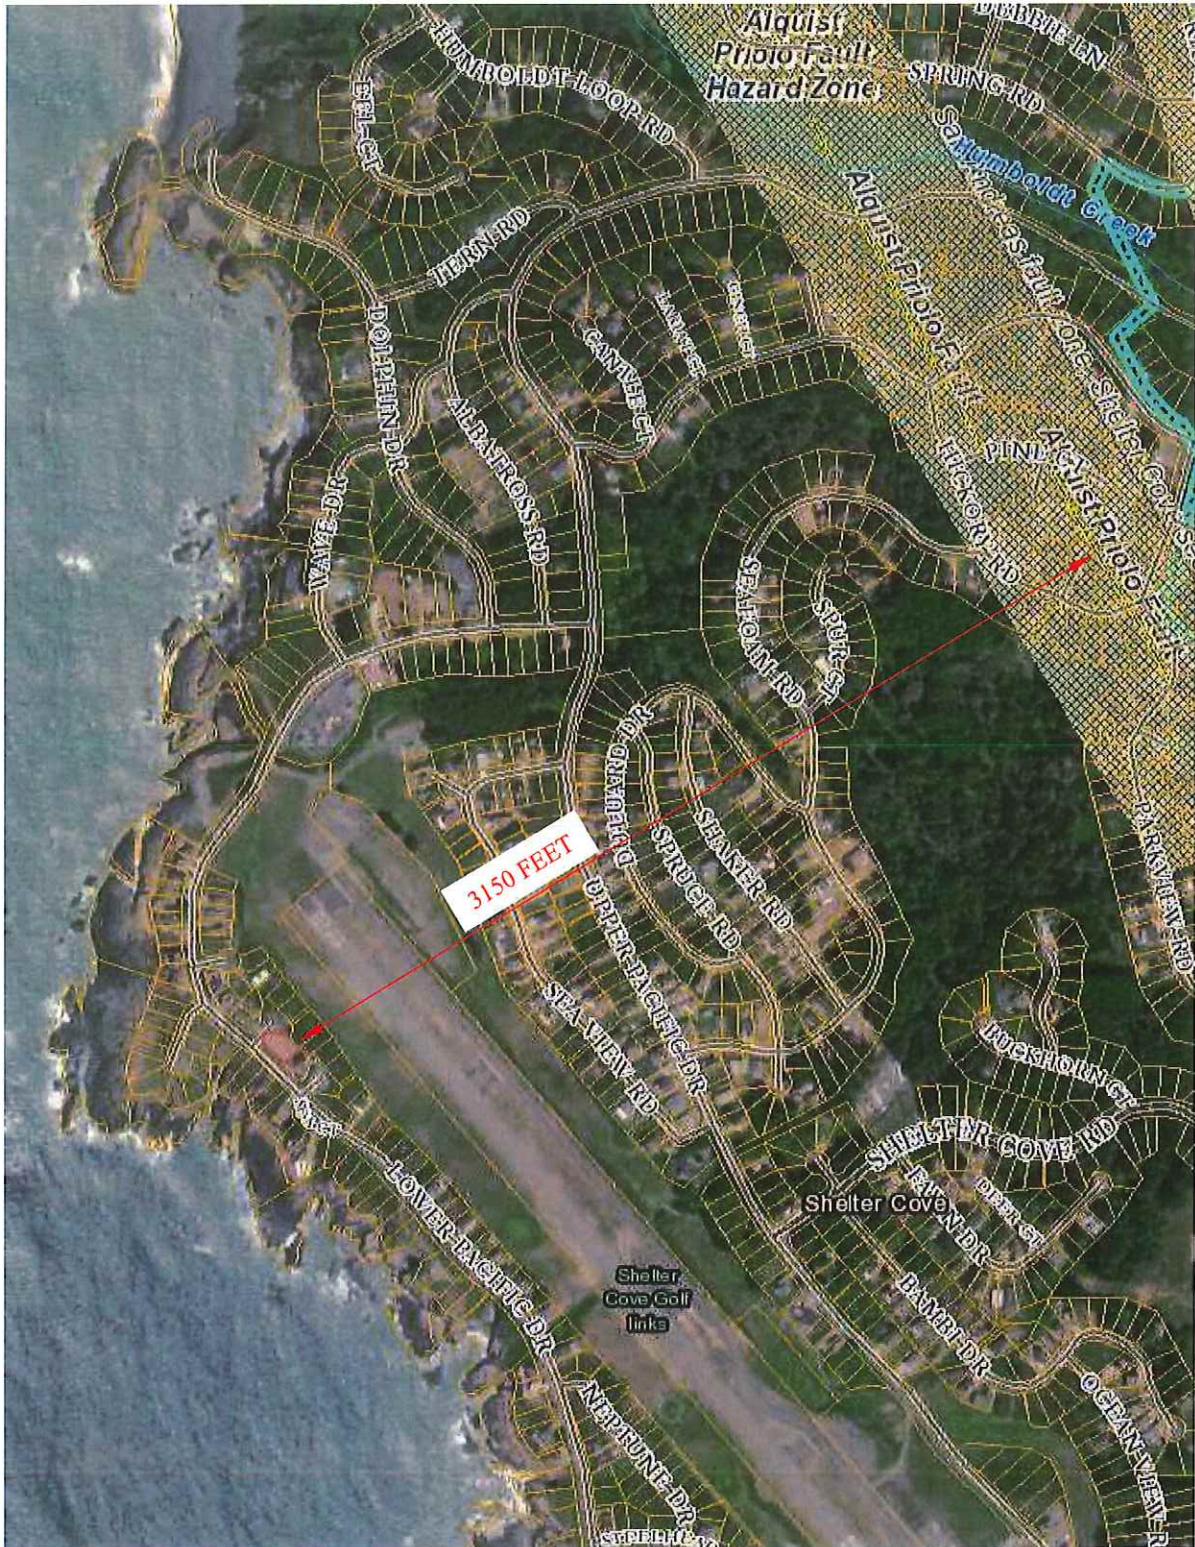
### Fault Activity Map

According to the California Department of Conservation and the Humboldt County General Plan, this parcel is located in a special studies earthquake zone within 2 kilometers of the active Class A San Andreas Fault (North Coast), and within 25 kilometers of the Type B Garberville Fault. Recent research conducted by the USGS has concluded that the San Andreas Fault is not exclusively located offshore of Shelter Cove but that "... a significant Quaternary fault is located onshore ...", actually running through the residential areas of Shelter Cove and extending past Kaluna Cliff (Prentice, et. al., 1999). The building site is located approximately 3,150 feet west from this fault trace indicated in the Geological Society of America article, which runs nearly adjacent to Shelter Cove Road and out to the ocean. A map of this trace showing the property location is enclosed for reference (Fault Activity Map).
