# Preliminary Engineering Geologic Report

Proposed Grading and Development Project

3852 Thomas Road

Miranda, California

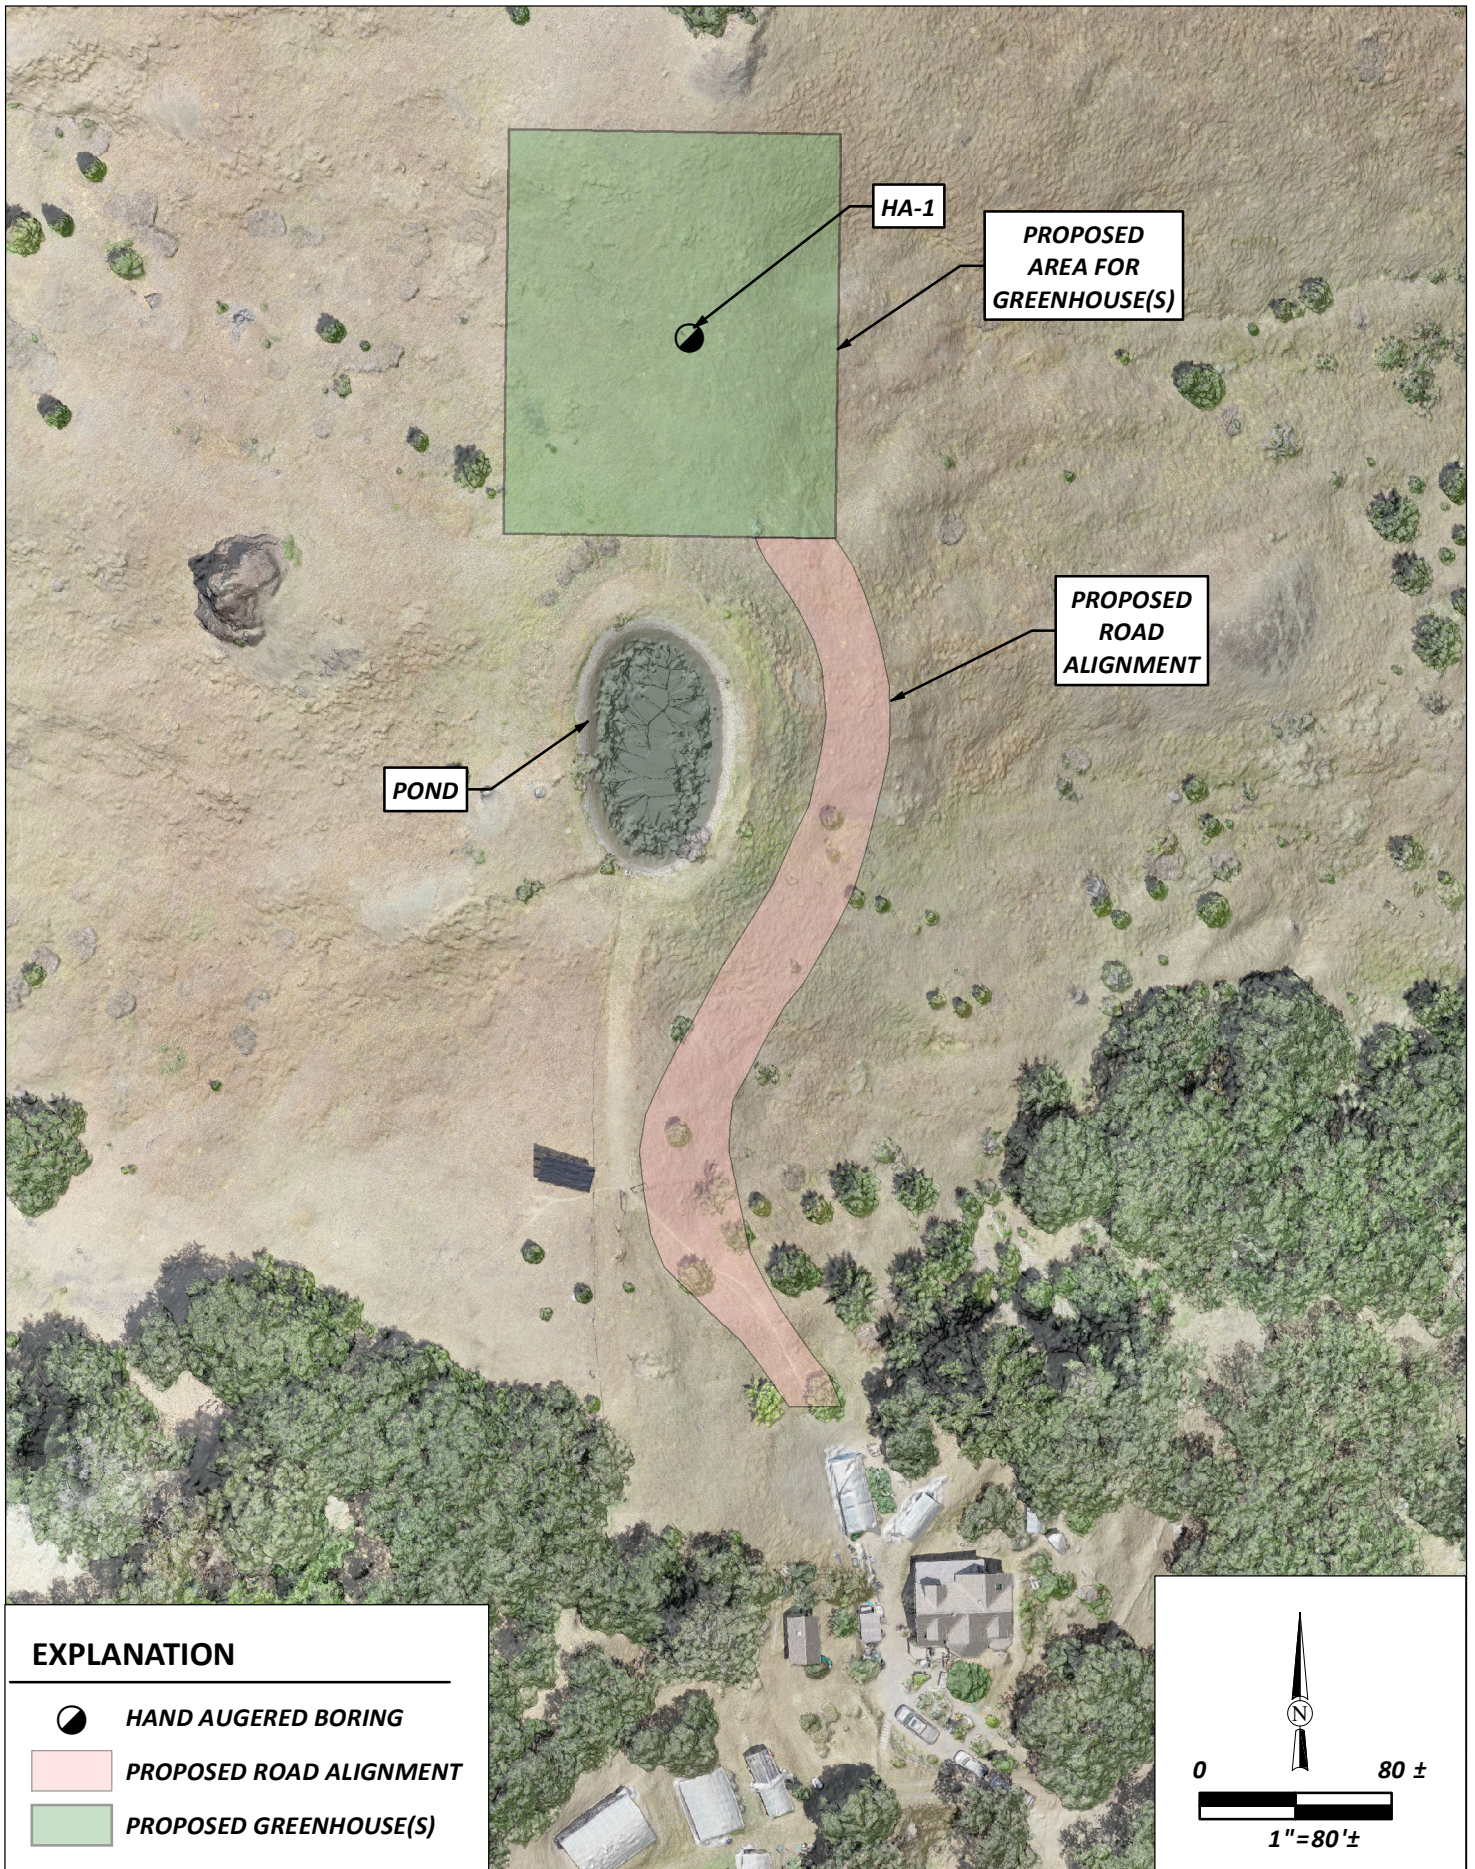
Figure 2

On July 12, 2019, a project geologist from SHN met with the owner at the project site and discussed the conceptual design of the proposed improvements. SHN conducted a reconnaissance inspection of the project site, evaluated the existing conditions of the surrounding slopes, and logged and sampled a shallow hand-augered boring at the project site. The boring was excavated to a depth of 5 feet below existing ground surface (BGS) in a location considered to be representative of the onsite soils. The boring was located within the proposed footprint of the graded pad that would support future greenhouses (Figure 2).

During our site reconnaissance, we reviewed exposed native soils in cut slopes and stream bank exposures. We also installed a hand-augered boring (HA-1; Figure 2) within the vicinity of the proposed new greenhouse pad. The results of our subsurface investigation and review of exposures indicate that the site is underlain by a mixture of weathered bedrock and a matrix material consisting of silty clay with variable amounts of gravel. Based on our field observations, we characterize the shallow subsurface materials that would support structures to be medium dense to medium stiff. The site soils are anticipated to vary laterally and with depth, with some areas primarily soil like, and others consisting of fractured rock. In some places, deep cracks in near surface soils were observed. These cracks are interpreted to be shrinkage cracks that may be indicative of expansive soils.

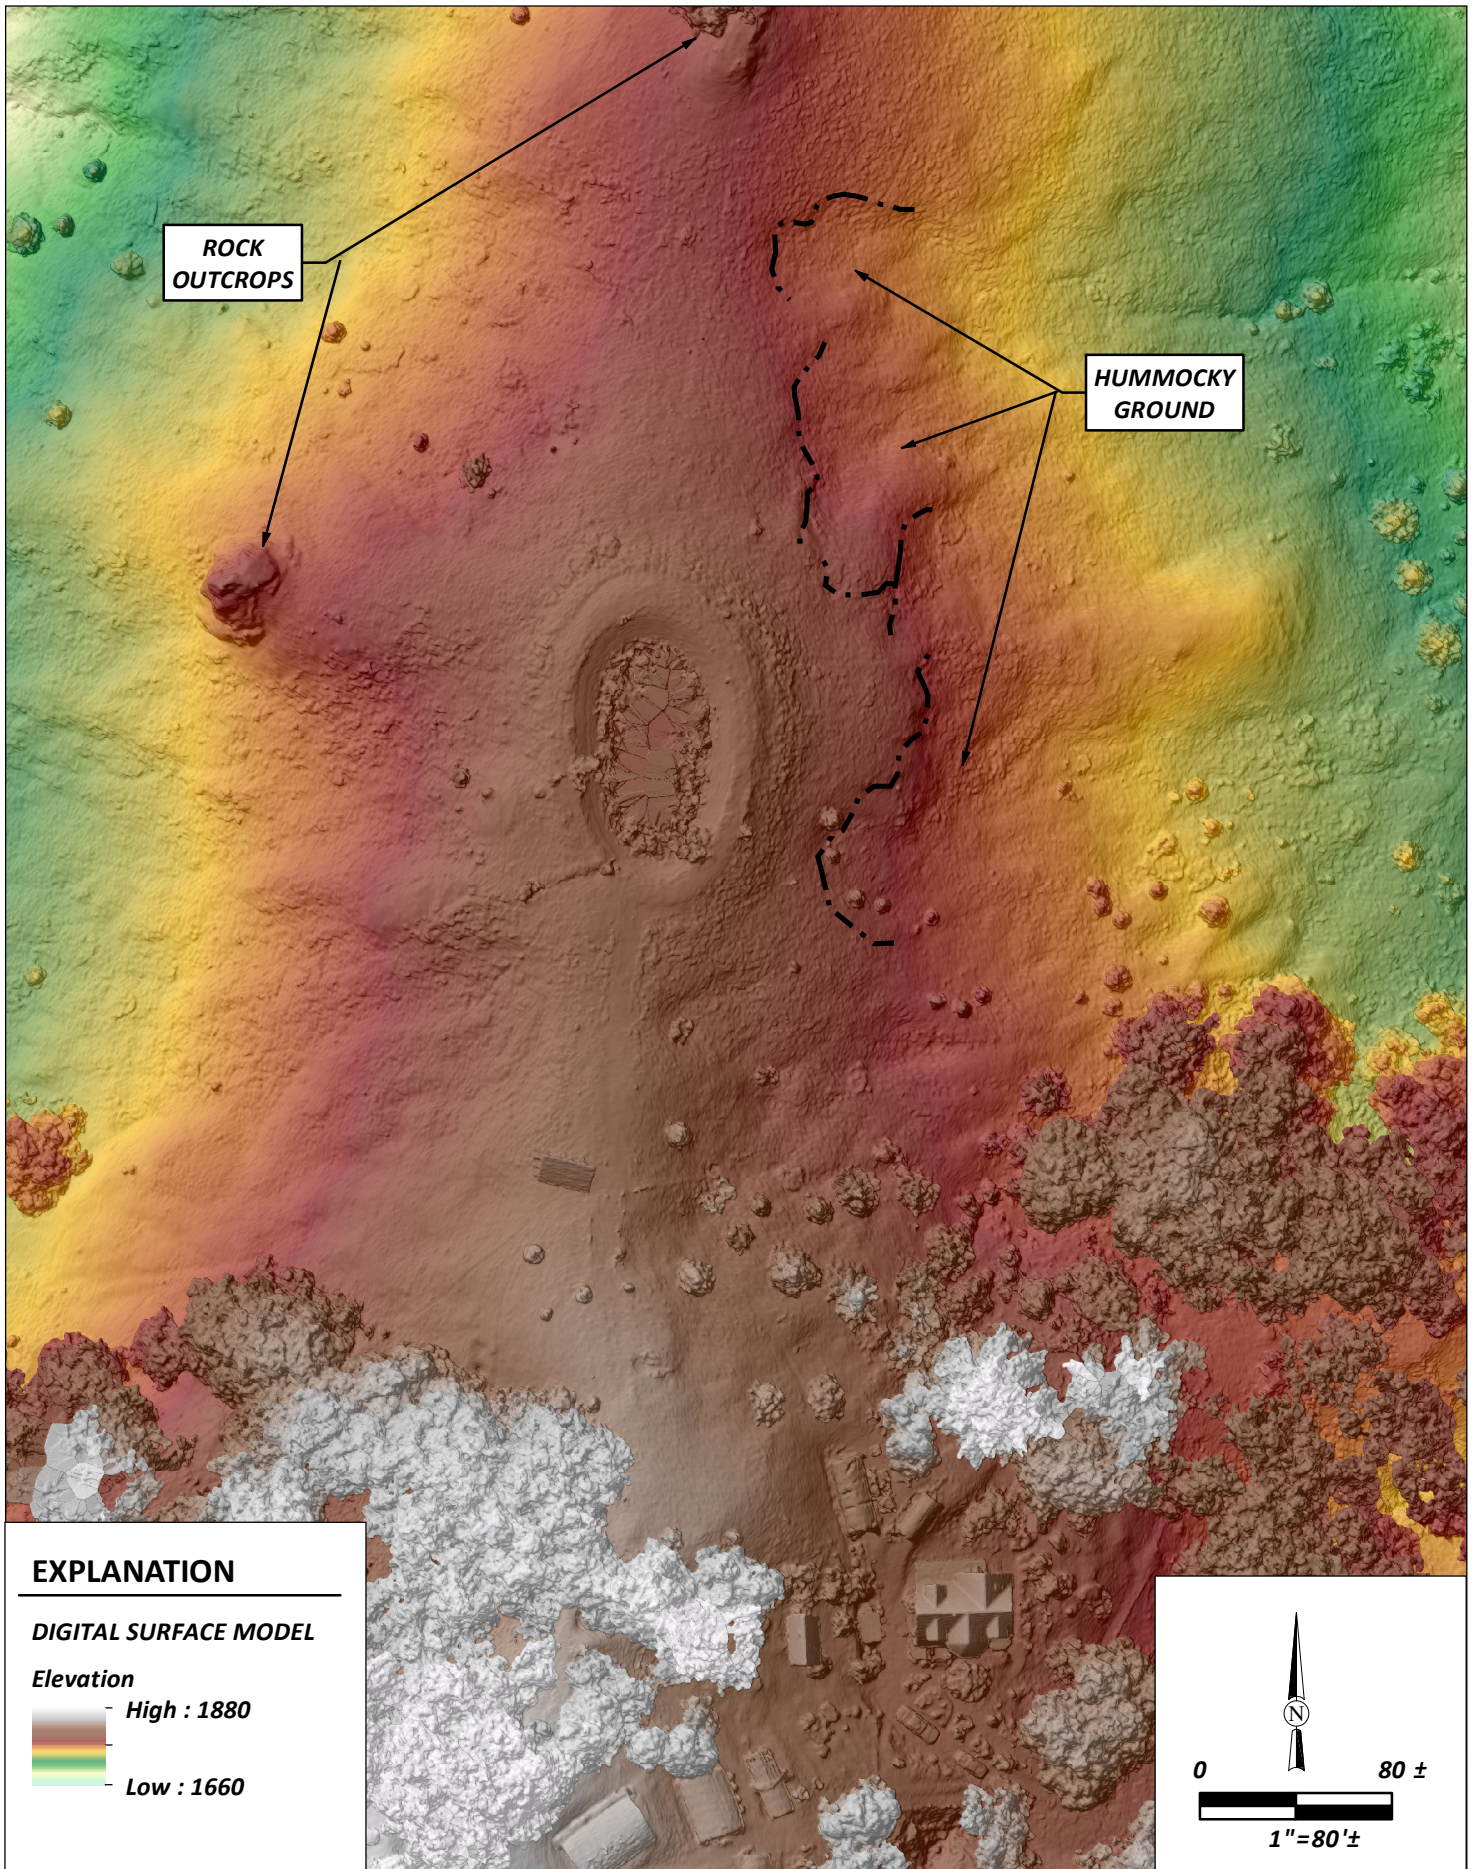
An unmanned aerial vehicle (UAV) was used to map the existing conditions of the project site and vicinity. The digital surface model derived from the processed UAV data is shown on Figure 3 and highlights the geomorphic features of the project site.

The proposed developments are situated on gently to moderately sloping ground, with isolated areas of steep ground (>50%). The ridge itself is generally smooth with pockets of hummocky ground on the side slopes, examples of which are shown on Figure 3. The hummocky ground is interpreted to be associated with a few different conditions. In places, the variability of the ground surface appears to be an expression of the long-term landscape evolution of the slope caused by differential erosion. In other places the hummocky areas appear to be associated with slow downhill creep of shallow soils or a very slow moving earthflow. We did not observe any significant slope failures or other traditional landslide features. Soils undergoing down slope creep and/or associated with earthflows are considered the primary stability hazard to the proposed developments. Strategies for minimizing risk associated with these areas are discussed in Section 5 below. Provided our recommendations are adhered to, we conclude that the potential for slope instability to affect the development is low.

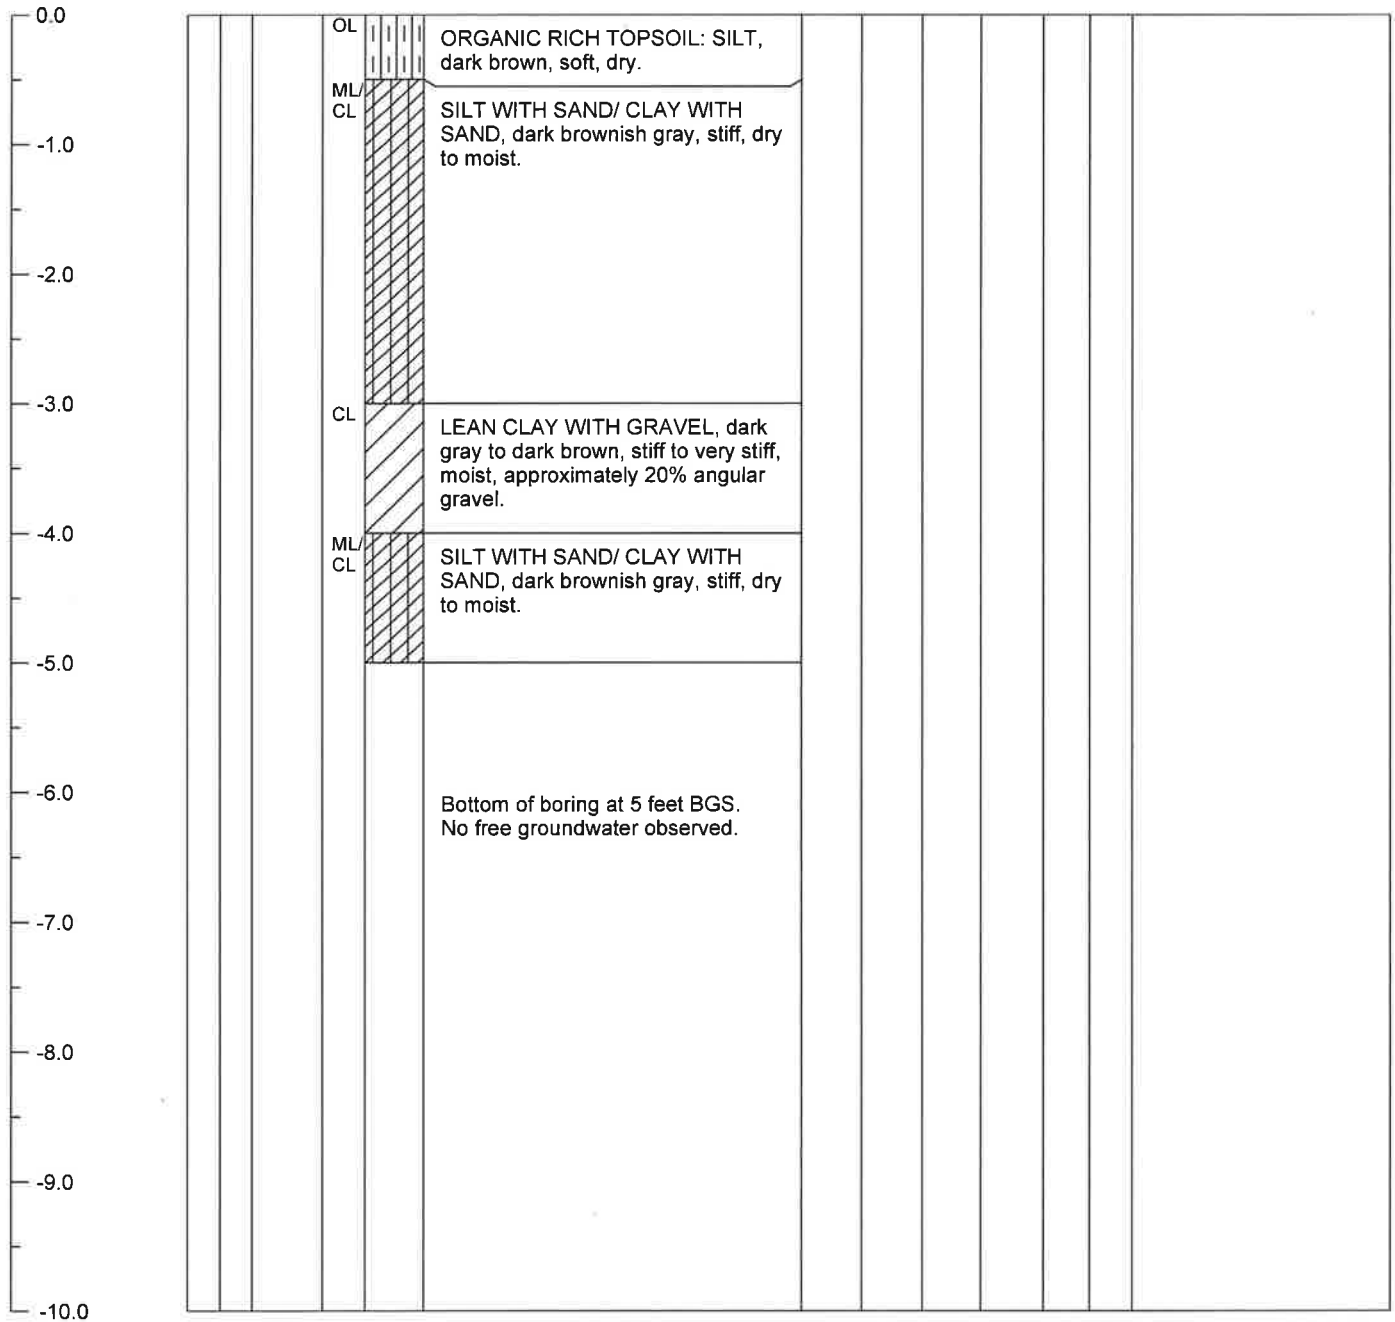
**BORING  
NUMBER  
HA-1**

The soils encountered in the boring were logged and field classified in general accordance with the Manual-Visual Classification Method (ASTM-International [ASTM] D 2488). During excavation, the project geologist evaluated the in situ soil consistency based on equipment performance and level of effort required to advance the boring. A final log of the soils encountered in the boring is presented in Appendix 1.
