March 14, 2022

**Subject: Oak Woodland Restoration Plan APN 216-082-006**

# APN 216-082-006 Oak Restoration Map

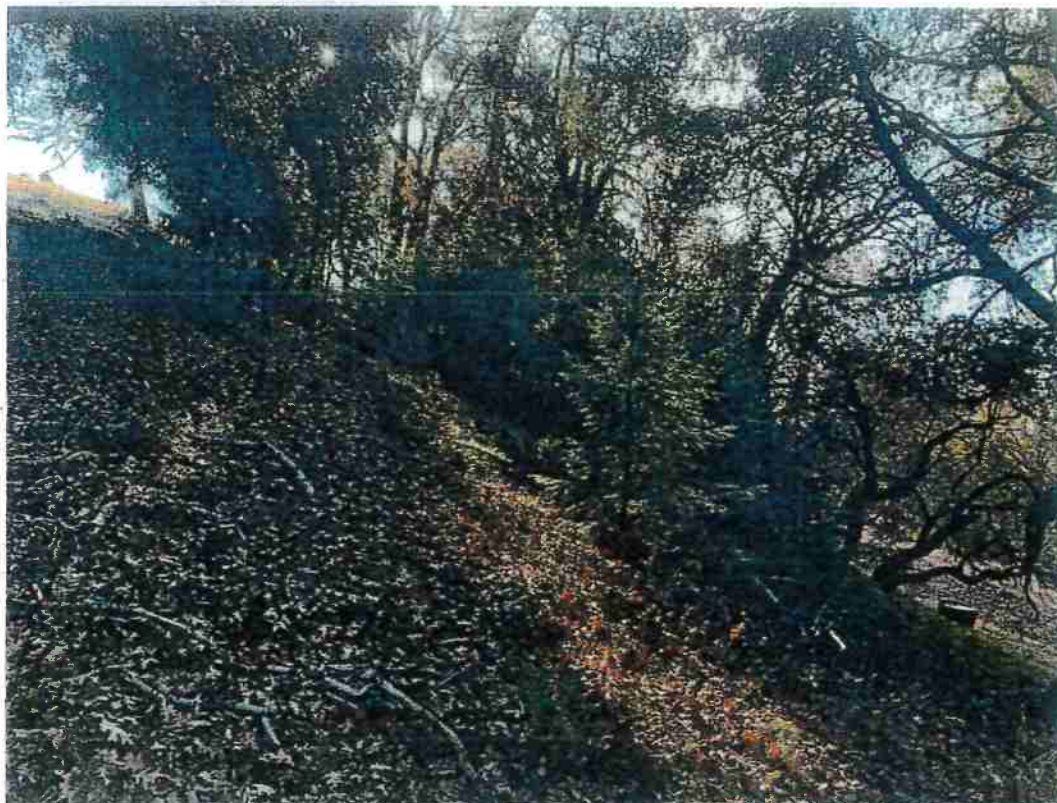
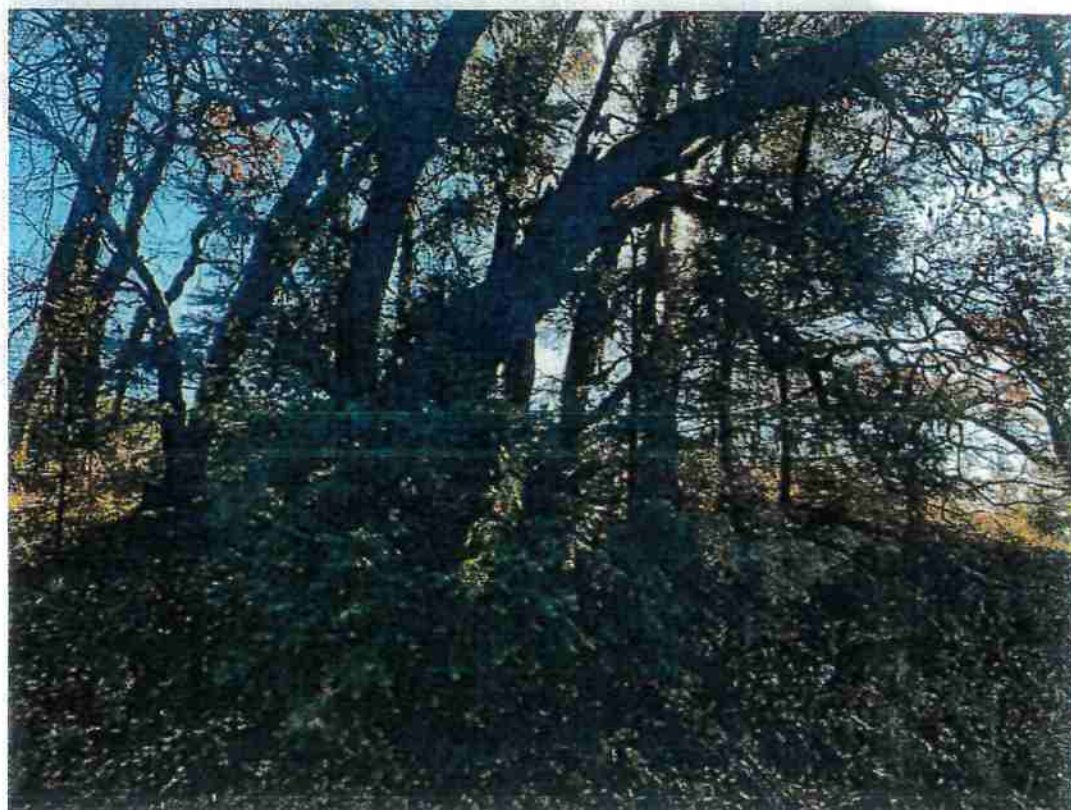
As stated previously, the degree to which these areas are being encroached varies greatly. Whereas some of the property contain only minimal amounts of encroachment in the form of seedlings and sapling-sized conifers, others contain mature Douglas-fir trees in the dominant and codominant canopy positions. Of the 11.22 acres of oak woodland proposed for restoration, three management types were qualitatively stratified as follows: Encroachment Stages 1, 2, and 3.

*Oregon white oak and California black oak woodland with encroaching Douglas-fir trees. Above & below*

- Remove Douglas-fir regeneration via hand crew (chain saws). Cut all Douglas-fir trees up to 12" DBH. Removal target is 80% or more of Douglas-fir stems. The cut needs to be made as low as possible on the stem, below the lowest live branch. Trees that are too difficult to fell safely can be girdled.

- Girdle (or cut) all Douglas-fir trees 12" DBH and greater if safety or damage to residual trees is a concern. Girdles must completely go around the tree and should consist of two parallel horizontal bands through the bark and cambium several inches apart. After the grooves have been made, the bark and cambium should be peeled away. Merchantable trees may be left for future commercial harvests.

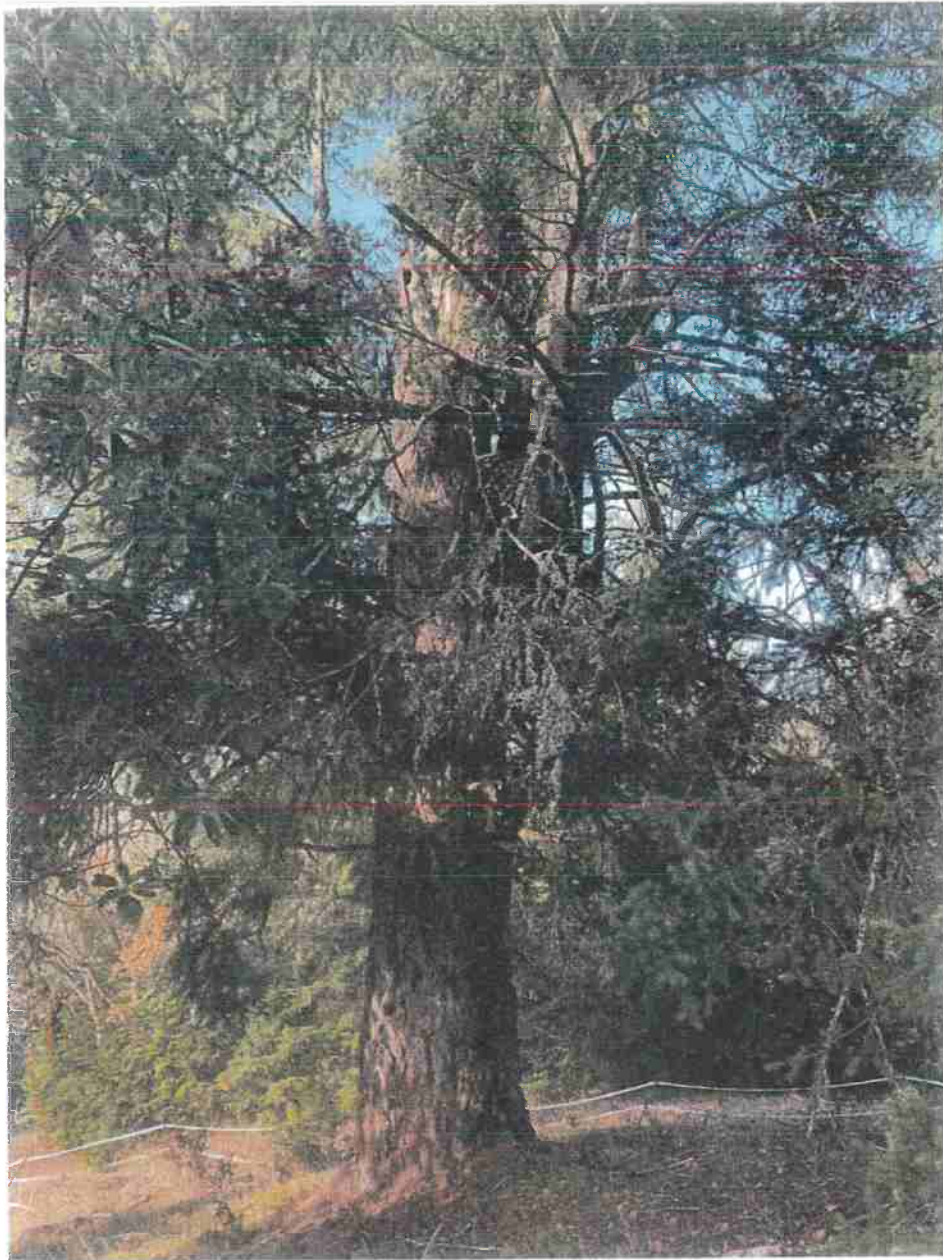
*Decadent and Deformed Trees with Value to Wildlife, which shall be retained.*

\*No large old trees (trees existing before 1800 AD and is greater than 48" in diameter at stump height) or Decadent and Deformed Trees with Value to Wildlife shall be cut.

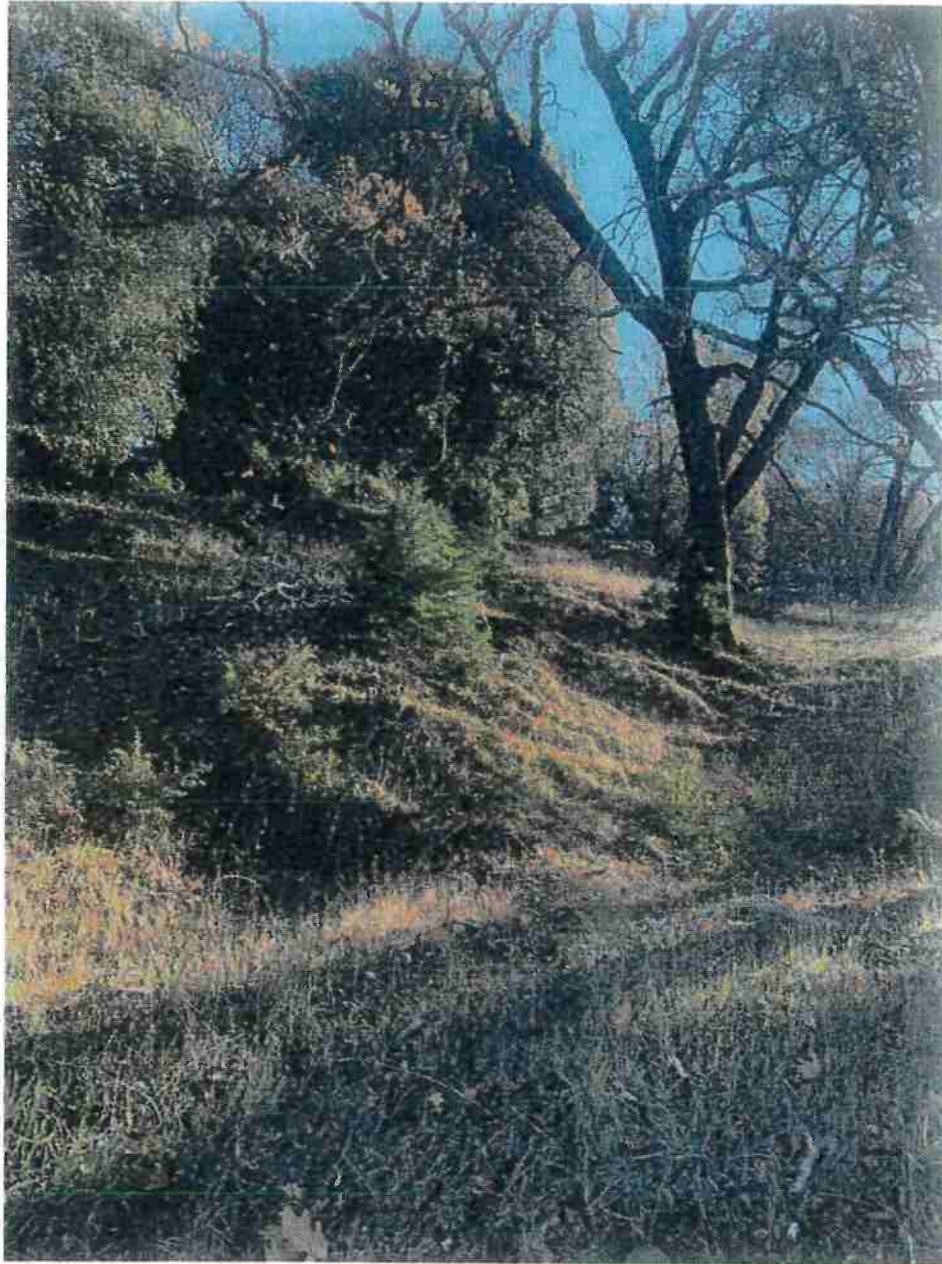
These areas consist of a dominant overstory of scattered Oregon white oak and California black oak and an understory of Douglas-fir regeneration, generally 0-15 feet tall. No overtopping is occurring and all of the Douglas-fir is sub-merchantable. This includes Douglas-fir encroachment located within the small natural grassland openings that are part of the oak woodland habitat type. If no action is taken, these stands will inevitably transition into conifer stands is approximately 20 years.

*Example of oak woodland Encroachment Stage 1.*

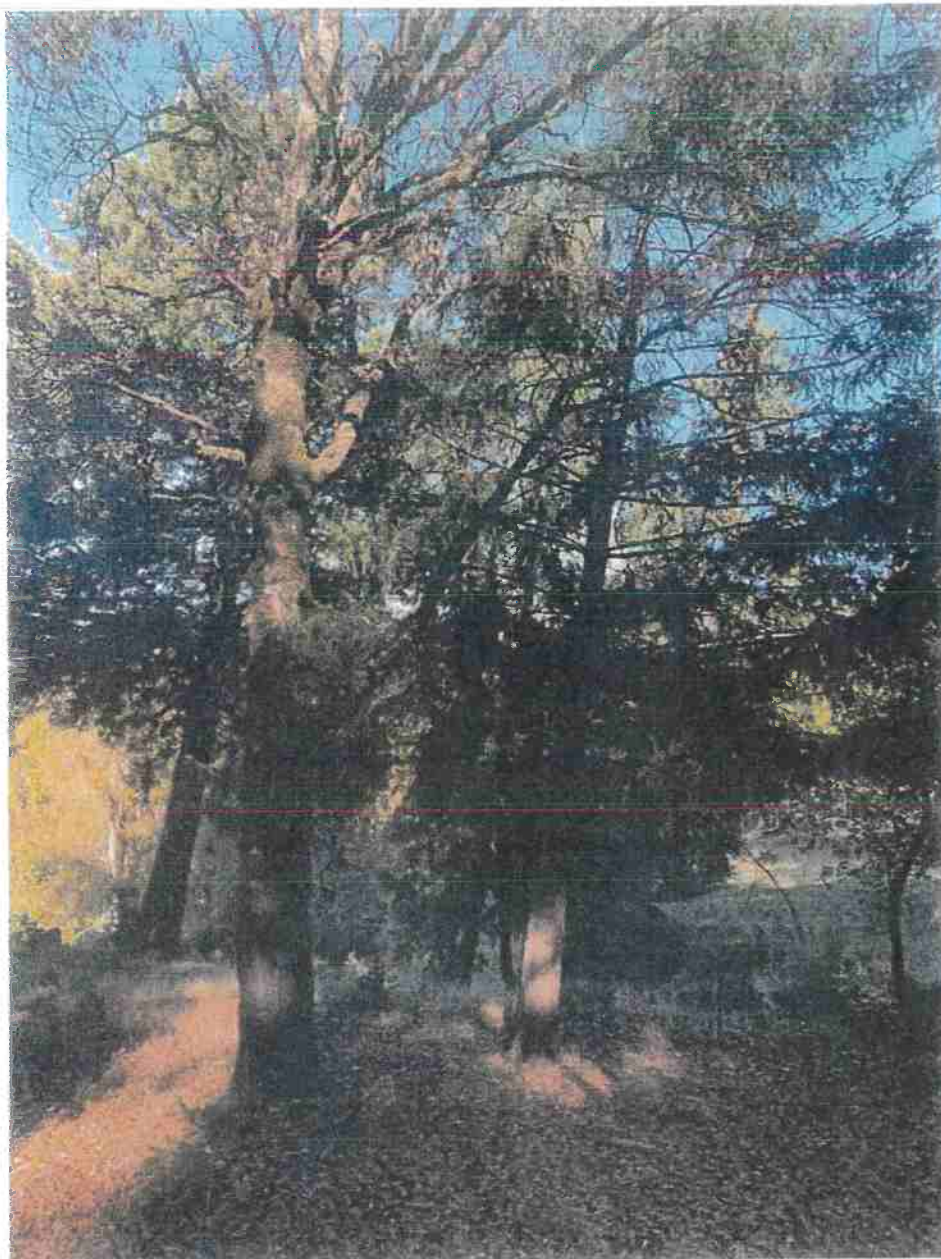
These areas consist of an overstory made up of pre-dominant oak trees and younger pole to small timber sized Douglas-fir trees in the dominant crown position. The average conifer diameter is approximately 15 inches at breast height, and basal area ranges from 75-250 ft<sup>2</sup> per acre. Sapling sized Douglas-fir trees occupy the intermediate crown positions, and the understory is generally sparse.

*Example of oak woodland Encroachment Stage 3*

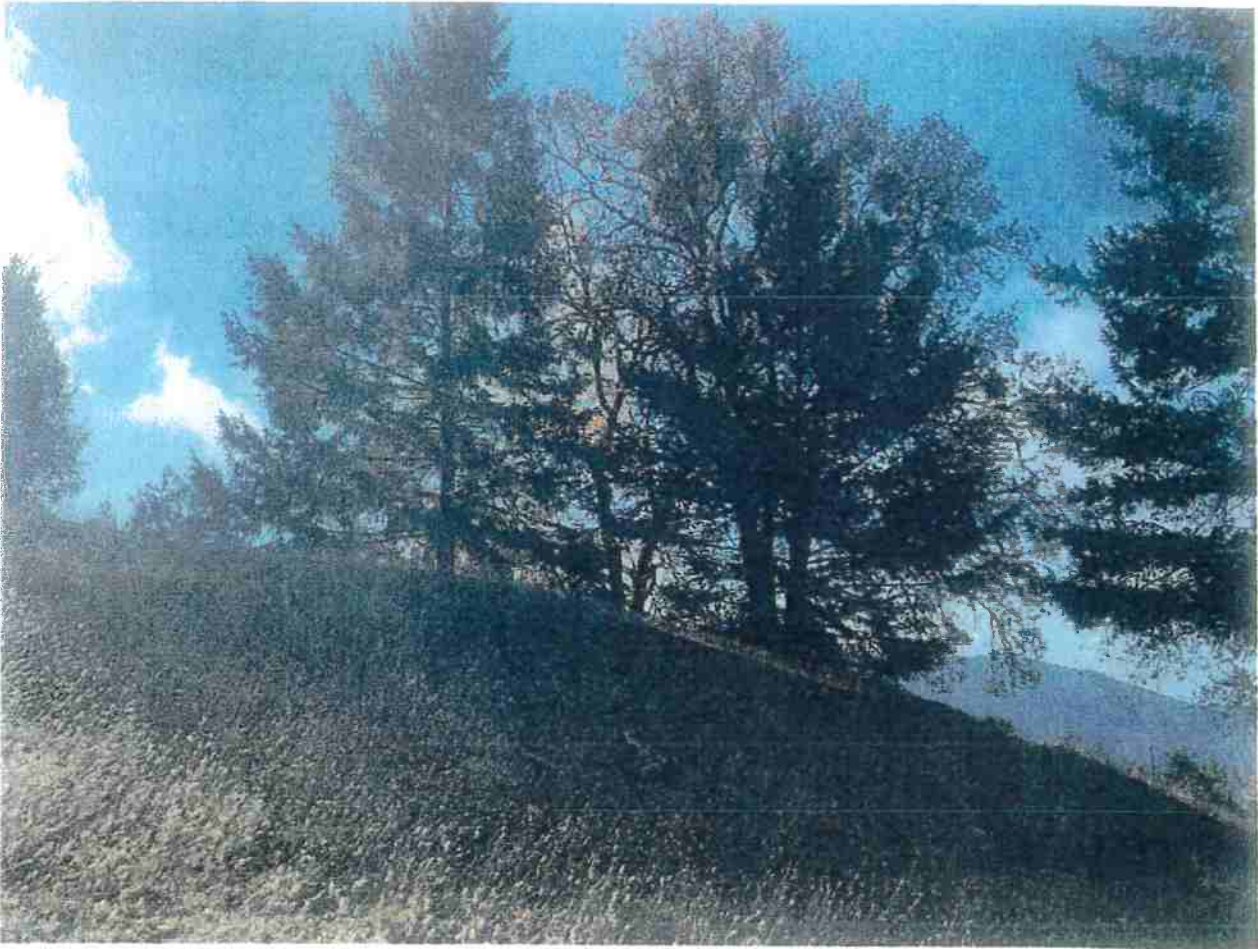
*Example of oak woodland Encroachment Stage 3*
