Lost Coast Elixirs LLC 569 Eubanks Rd, Garberville CA 95542 Permit Application 11247

Water Resource Protection Plan

Assessment of Standard Conditions for APN 220-081-016 – WDID #1B16459CHUM

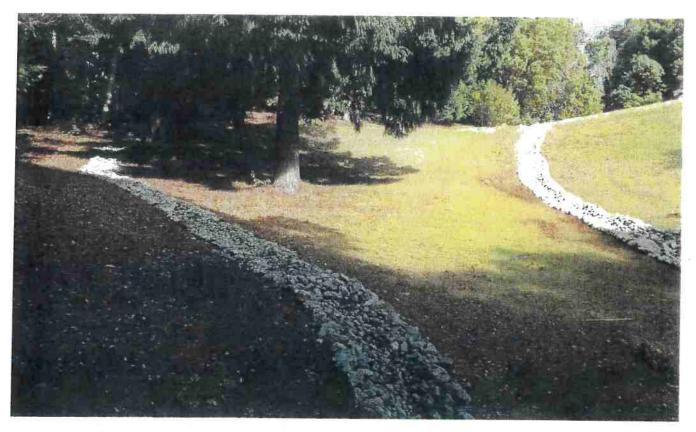
Picture 3: This is a picture of the newly rock lined drainage channels located upslope of Map Point 2. The channel on the left extends from the outlet of an existing ditch relief culvert. The channel on the right extends from the surface of the developed cultivation area. Photo date 12/2/2016

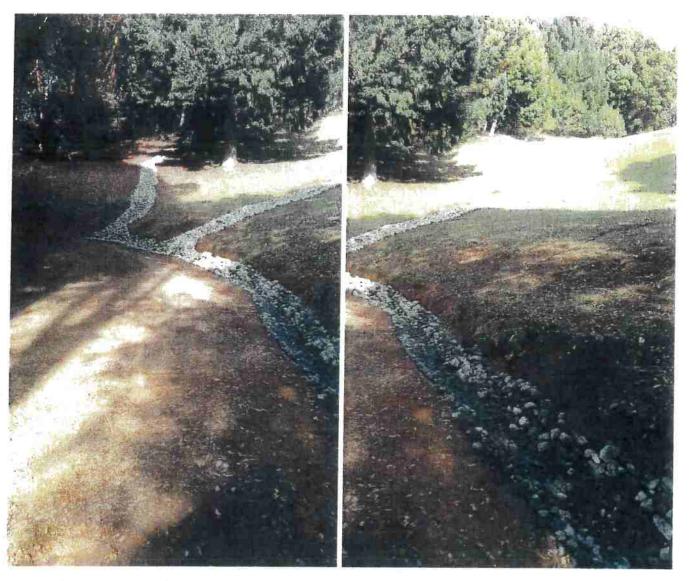
Pictures 4 and 5: These pictures show the bottom of the newly rock lined drainage channels and where they intersect with the newly rock lined inside ditch along Map Point 2. Photo date 12/2/2016

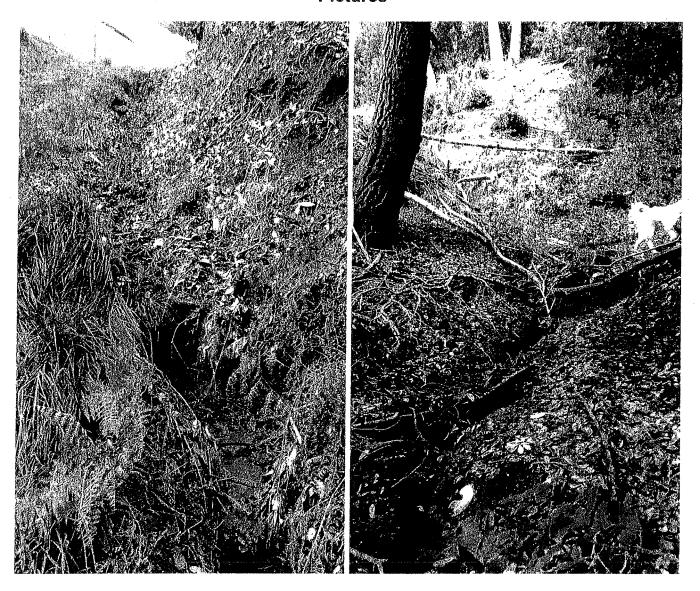
Pictures 13 and 14: These are pictures taken at the southeast of Map Point 6. It shows the eroded gully between the end of the road and the Class III watercourse. The dog in the picture on the right is pointing up the natural Class III watercourse. Photo date 12/2/2016

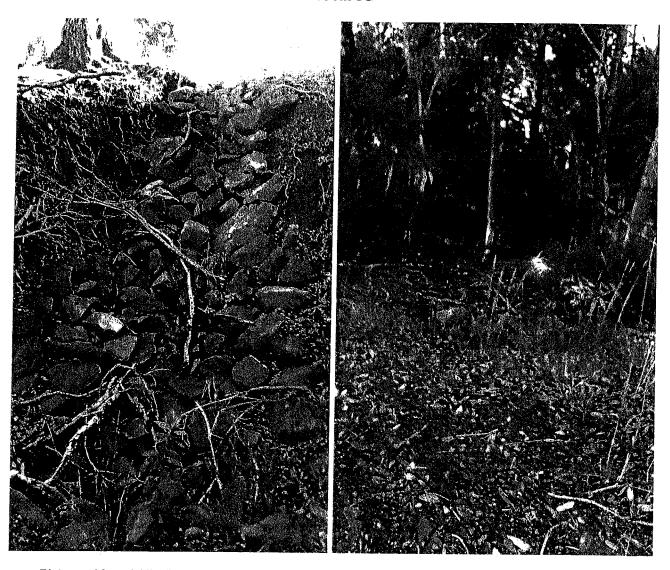
Pictures 16 and 17: The picture on the left shows the heavily rock armored inlet above the inlet at Map Point 7. The inlet is located at the lower left corner of the picture. The picture on the right shows the outlet of the culvert at Map Point 7 taken from the surface of the roads. Photo date 11/3/2016

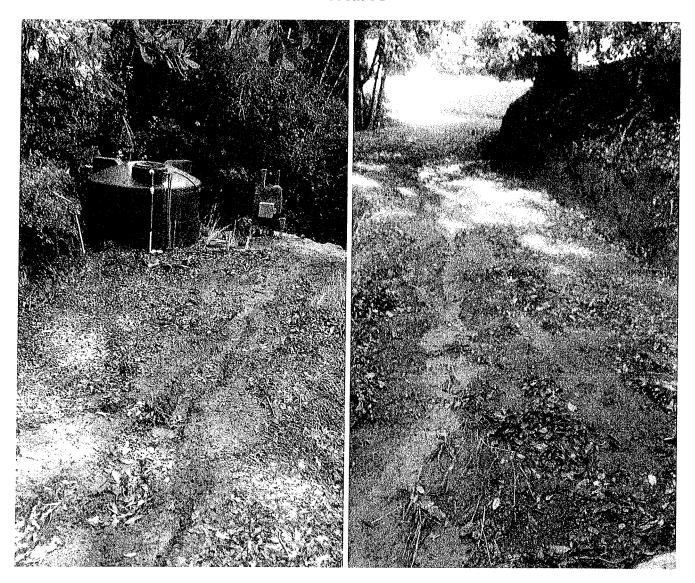
Pictures 1 and 2: These are the pictures taken along the segment of Map Point 2 prior to the recent rock lining of the inside ditch. The picture on the left shows the south end of the road segment identified as Map Point 2 on the WRPP Map. The picture on the right is taken from south end of this road segment and is looking up the road in a northerly direction. The recent October rainfall has caused the runoff to overflow the inside ditch and over the fill at the end of the road. The Discharger had recently installed erosion control "Jute" Netting on the face of the road fill. Photo date 11/3/2016

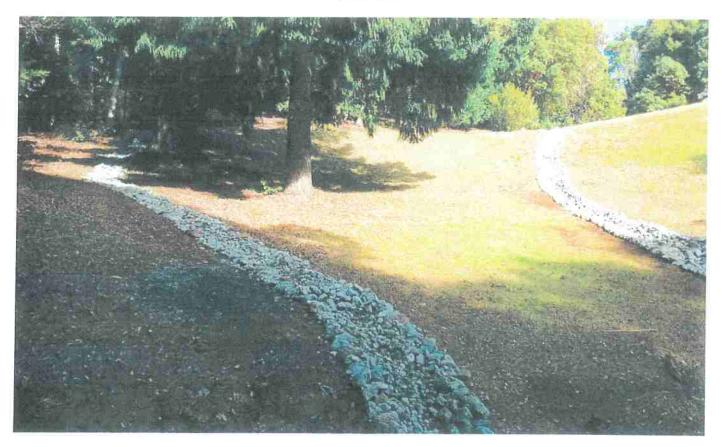
Picture 3: This is a picture of the newly rock lined drainage channels located upslope of Map Point 2. The channel on the left extends from the outlet of an existing ditch relief culvert. The channel on the right extends from the surface of the developed cultivation area. Photo date 12/2/2016

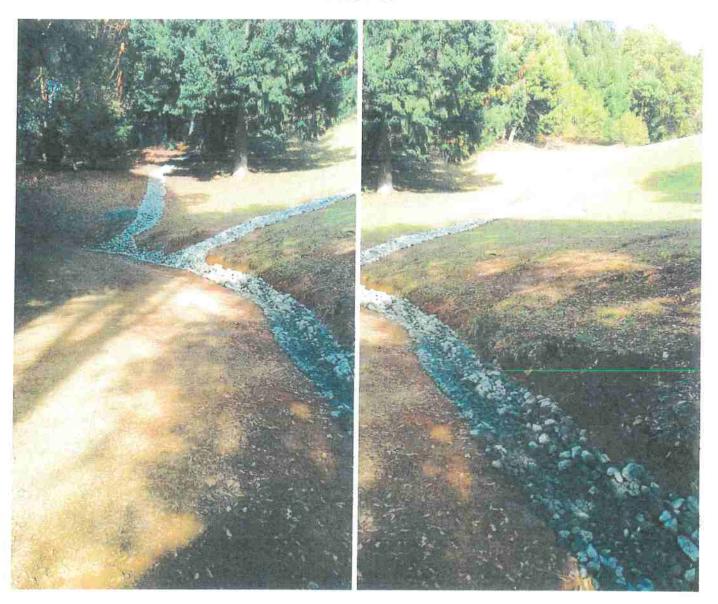
Pictures 4 and 5: These pictures show the bottom of the newly rock lined drainage channels and where they intersect with the newly rock lined inside ditch along Map Point 2. Photo date 12/2/2016

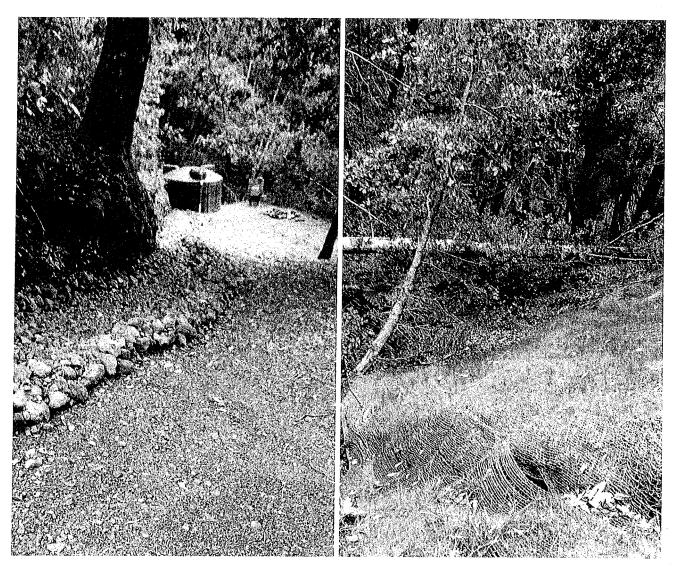
Pictures 8 and 9: The picture on the left shows recently widened and rock lined ditch. A rolling dip shall be installed just prior to the end of the road, to drain the road surface and the ditch towards the right so that it no longer can drain over the fill slope straight off of the end of the road. The picture on the right shows the grassed over jute netting placed on the fills beyond the end of the road. Photo date 2/13/2017

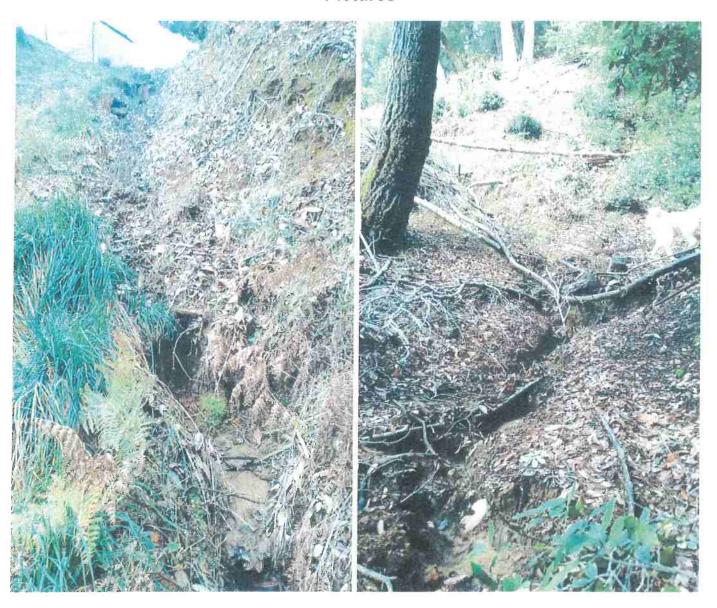
Pictures 12 and 13: These are pictures taken at the southeast of Map Point 6. It shows the eroded gully between the end of the road and the Class III watercourse. The dog in the picture on the right is pointing up the natural Class III watercourse. Photo date 12/2/2016
