# Site Management Plan

Miller Creek Farms  
WDID# 1\_12CC417788  
APN 220-271-008  
1600 Miller Creek Road  
Briceland, CA 95542

January 23, 2020

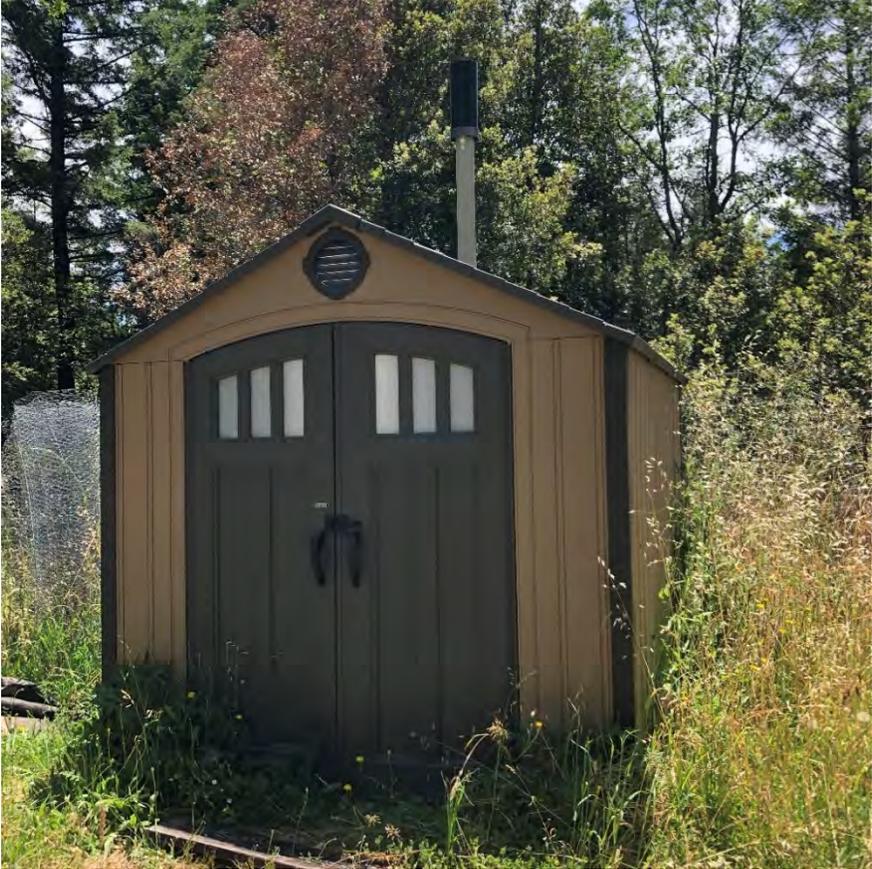
Photo 6. Nutrient Shed at Cultivation Area 2, Looking South.

An approximately 50 ft<sup>2</sup> (6 x 8 feet) hard-plastic, pre-fabricated (stand-alone) gardening shed with an impermeable floor (photo 6), located adjacent to Cultivation Area #2 (CA 2). It contains a Sun-Mar Composting Toilet. The shed is also used for nutrient storage. Shed4 resides on the same flat as CA 2 and is greater than 200 feet from any waterway; the nearest stream being Buck Gulch (Class I). New shelves will be installed for nutrient storage organization.

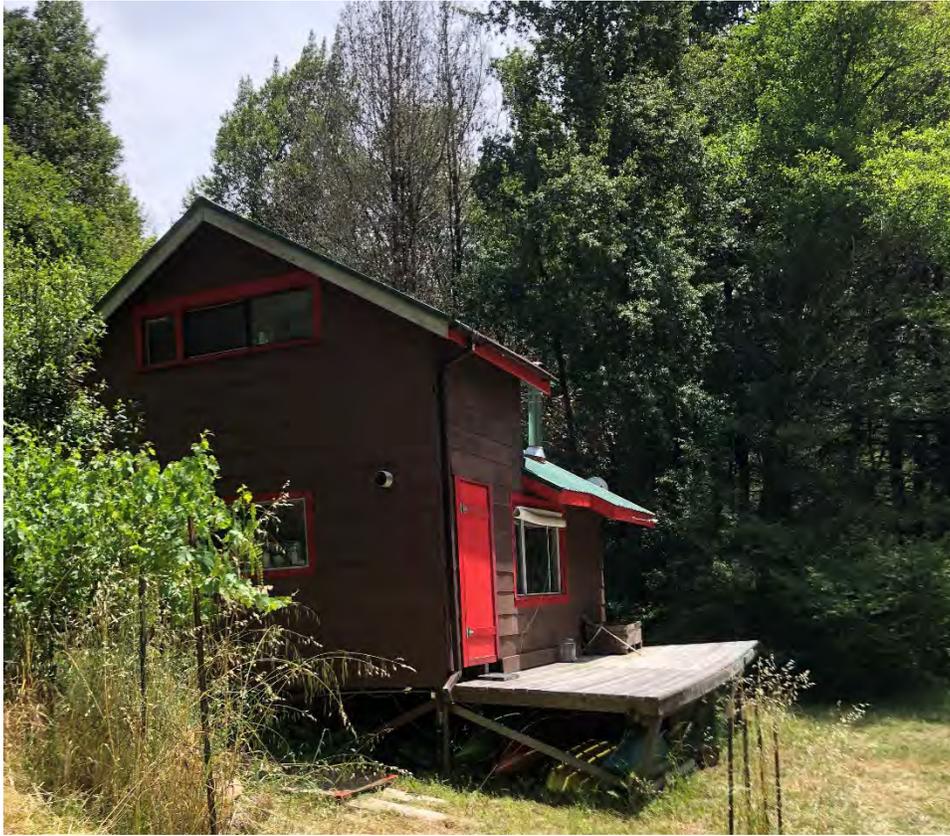
An approximately 450 ft<sup>2</sup> (30 x 15 feet) cabin on pier and post foundation, used for domestic storage. This historic cabin and the road to it are within the riparian setback of Buck Gulch. The building has no affiliation with the cannabis cultivation. There is no greywater or sewage discharge at this building. The road will be upgraded to meet the standards of the *Handbook for Forest and Ranch Roads*. This road is closed to vehicle access but serves as foot-traffic access to the water pump and transfer tanks. Fuel for the water diversion pump is carried in a 1-gallon can by hand, as needed. The road is used for access to the domestic storage cabin very rarely, and never sees any vehicle traffic.

Photo 7. Creekside Cabin, Looking Southeast.

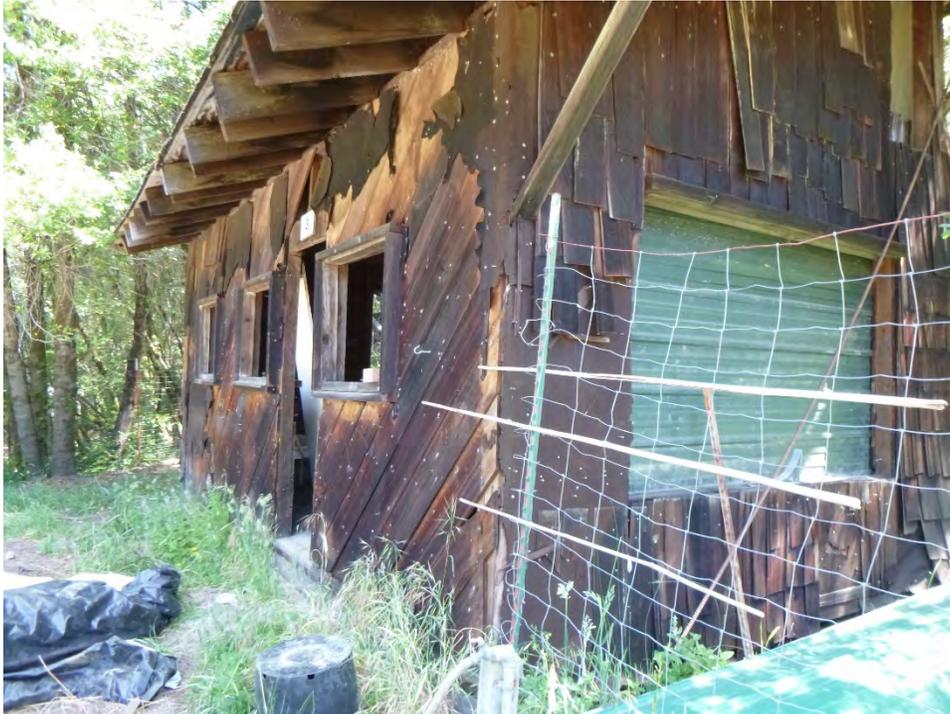
An 8-foot by 12-foot historic structure located adjacent to Cultivation Area #1 (CA 1). This building is not used for any cannabis related activity. Currently the building has some domestic items inside that are planned to be removed and stored elsewhere. Shed3 is greater than 100 feet from any waterway, the nearest being Buck Gulch (Class I).

Photo 8. Shed3. Unused legacy structure adjacent to Cultivation Area 1, Looking North.

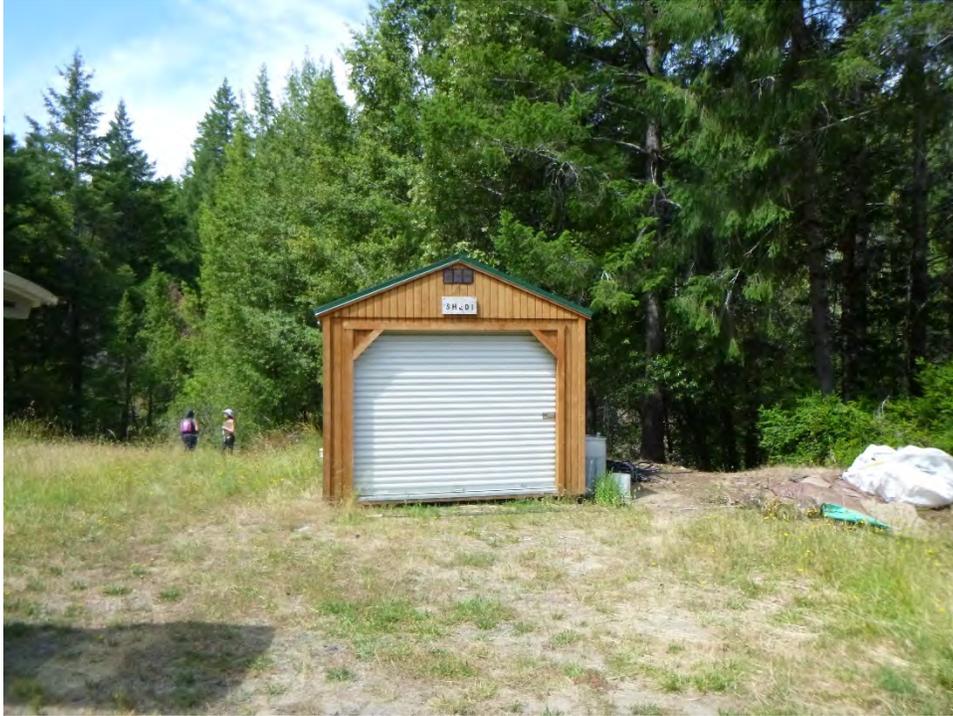
A 12-foot by 18-foot building on a pier-and-post foundation. The building is utilized for nutrient storage during the cultivation season, and then drying at harvest time. The structure has a plywood floor and a shop style roll-up door. Shed1 is greater than 150 feet from any waterway, the nearest being Miller Creek (Class I). No petroleum products will be stored in this building.

Photo 9. Shed1 is located near (south) Cultivation Area 1, Looking West.

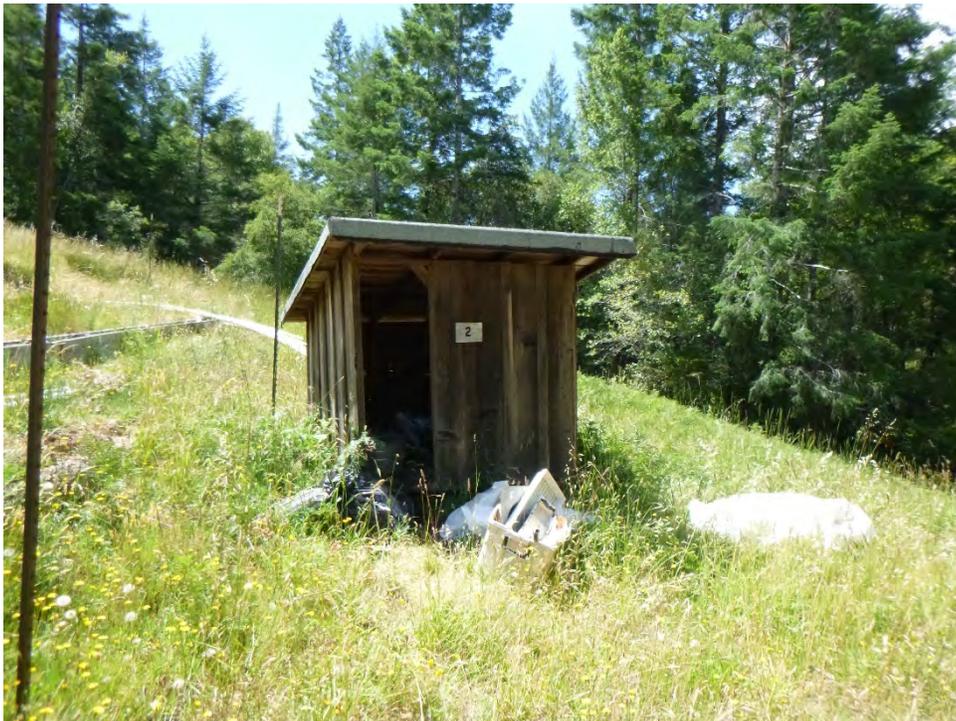
A 5-foot by 6-foot dilapidated historic structure adjacent to an abandoned cultivation area. This building is not used for any cannabis related activity. Currently the building has some metal

items stored inside that will be removed and recycled. Shed2 is greater than 150 feet from any waterway, the nearest being Miller Creek (Class I).

Photo 10. Shed2 is south of Shed1, adjacent top abandoned (legacy) cultivation, Looking South.

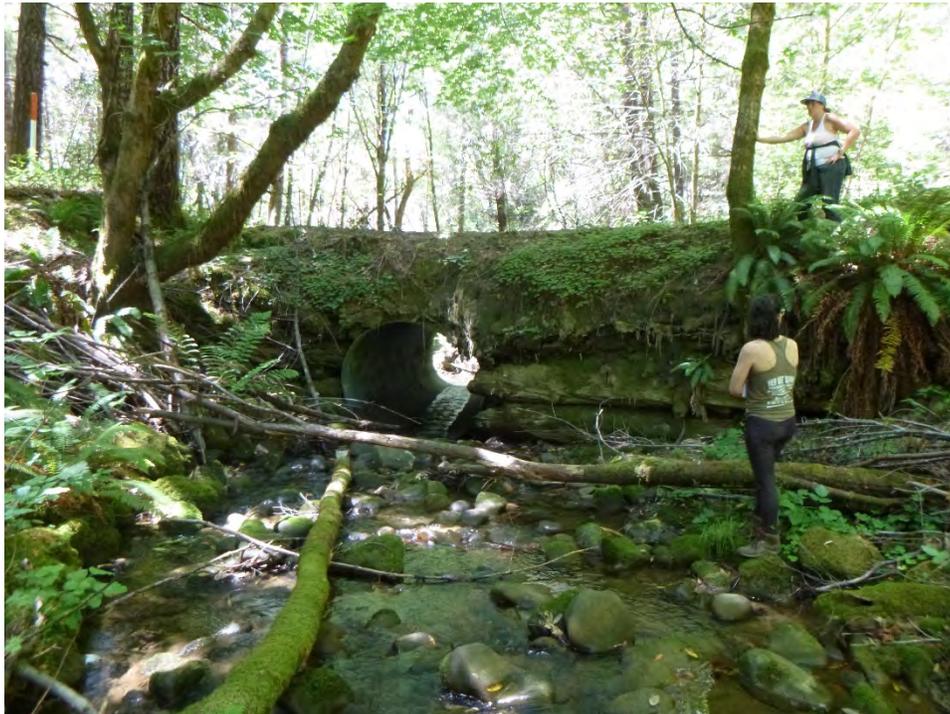
Per the Stillwater Sciences TECH Memo (Appendix C): Crossing 1 is proposed replacement of a fish-passage barrier culvert (6-foot diameter, shotgun outlet). The replacement stream crossing will be an 18-foot width by 11-foot 4-inch rise arch culvert, designed to accommodate the 100-year flood flow. Minor channel modification and large wood and armor placement in the upstream channel is also proposed to maintain grade that will allow fish passage and restore a natural sediment transport regime. An engineering Basis of Design was produced for Crossing 1 by Stillwater Sciences and is included in their Technical Memorandum to CDFW regarding stream crossing upgrades and water diversions on APN 220-271-008. The design described above however, has recently changed. Per Elena (Discharger), there is now (currently) a design for a bridge instead of the arch culvert design in the existing LSAA: Stillwater Sciences is pursuing grant funding for this shared road stream crossing.

Photo 12. Miller Creek Road crossing over Buck Gulch, Looking Downstream.

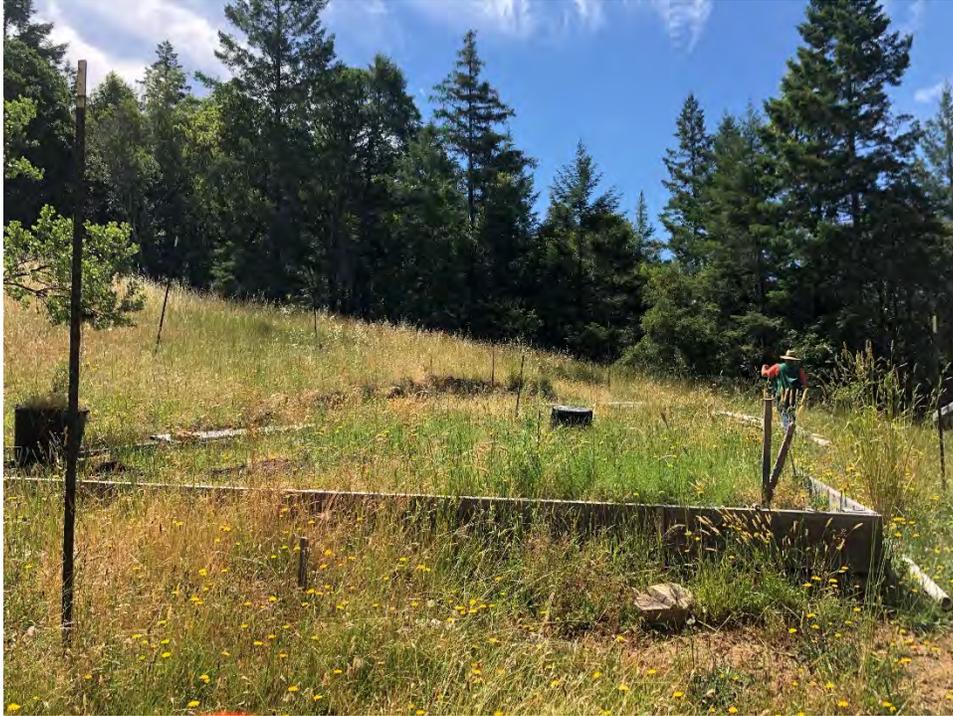
Photo 13. Legacy cultivation area, Looking South.

There is an abandoned cultivation bed (23 x 57-foot) in the grassland south of CA1 that has a disturbance area of 1,315 ft<sup>2</sup>. This legacy feature will be remediated by removing all lumber and other human contribution here. The natural grass has revegetated the area and there is no disrupted drainage, erosion or fill failure potential associated with this flat (Photo 13).

Recontouring here would provide no additional benefit vs. the short-term impacts and risk associated with heavy equipment use. Hand tools will be used to soften the vertical edges of the beds after the lumber is removed. Straw mulch will be applied to exposed soil and straw wattle will be installed at the downslope edge of the remediation area. Natural revegetation - as opposed to reseeding of the small bare surface area - is the preferred vegetation treatment after the removal work, eliminating the risk of introducing non-native species. The disturbance area will be a monitoring point (MP 24) and adaptive management will be prescribed as necessary.
