Wetland and Other Waters Delineation Report

Assessor's Parcel Numbers
015-111-006, 008, 012, and 013
Eureka, California

Prepared for:
Jim Paye

December 2021
021184

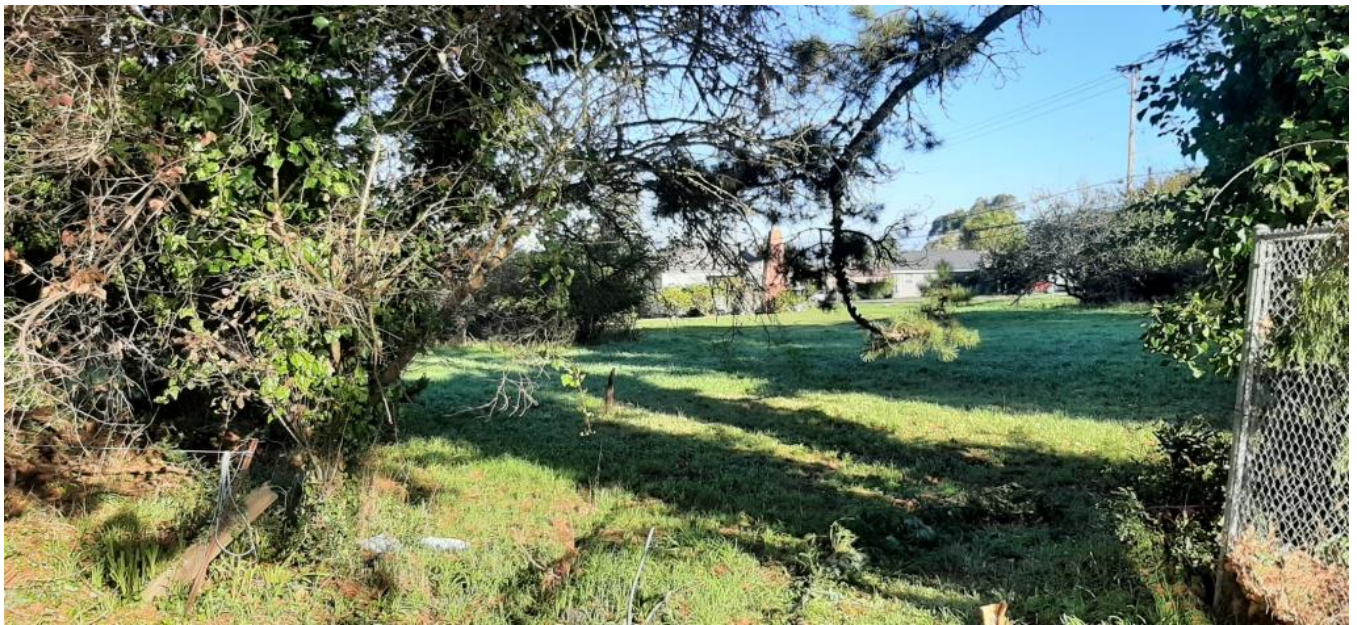
TP2 was excavated north of TP1 as an additional investigation of conditions within the flat upper terrace (Figure 2; Appendix 1, Photo 2). One wetland parameter (hydrophytic vegetation) was present at this TP, and therefore TP2 and the surrounding area do not meet State or USACE wetland definition.

Photo 2: Looking north across non-native lawn towards structures on APN 015-111-006. Photo taken November 11, 2021.

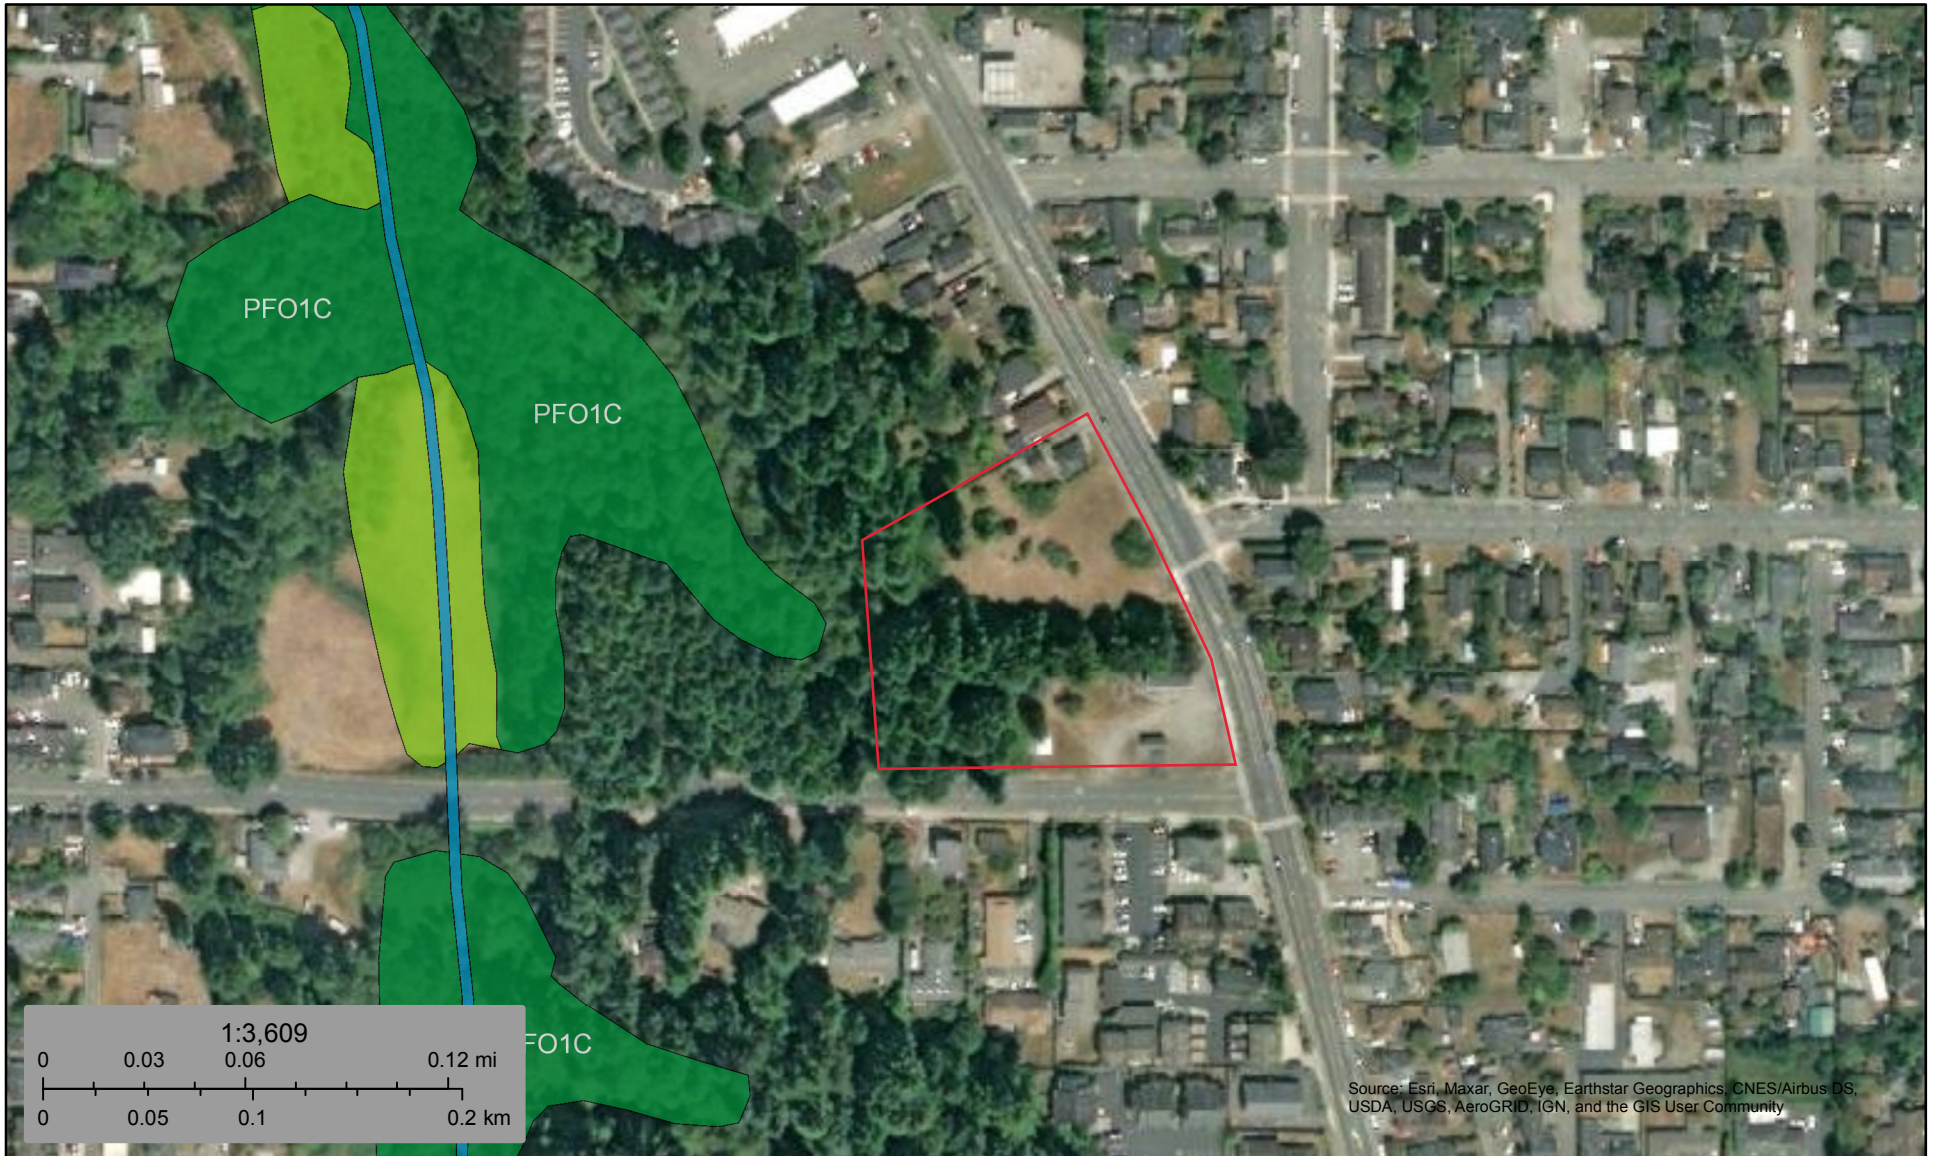
**National Wetlands
Inventory
Soil Map**

A freshwater forested/shrub wetland occurs west of the study area as shown on the NWI map (Appendix 2). The NWI mapping generally shows the wetland confined to the main northwest-southeast drainageway gulch. During this investigation, the wetland boundary was found to extend east from the main drainage up several side ravines carved out by seeps issuing from the west facing terrace slope. Paired plots were excavated to help delineate the extent of the wetland boundary within this region including: TP4 and 5, TP6 and 7, TP8 and 9, and TP10 and 11.
