MEMORANDUM

RE: **Revised Notification for 1600-2019-0011 – Description of informational items**

DATE: **February 25, 2021**

Notification 1600-2019-0011 - Revision
Site 1 Remediation Area: 1,293 sq. ft.
Site 2 Remediation Area: 2,741 sq. ft.

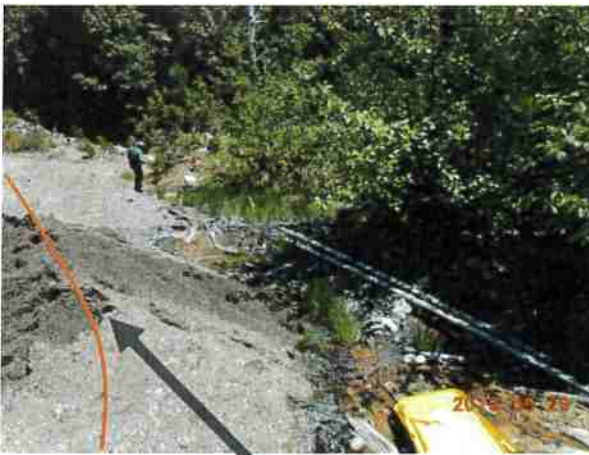
During the 2019 site visit, cultivation soils had been temporarily placed on the road next to the depression and some had entered the water due to lack of BMPs. The toe of the fillslope touches the west end of the depression as well.

Fig. 1. Soil on skid road next to wetted depression, looking east

1. All cultivation-related spoils will be removed from and adjacent to the depression
2. The fillslope will be pulled back and recontoured
3. Temporary and permanent BMPs will be established, which includes stabilizing the fillslope with fiber rolls, straw, and straw wattles, anchoring in a silt fence at the base of the fillslope, and staking in construction fencing between the skid road and depression as an avoidance measure.
4. Avoidance of riparian vegetation during and after construction

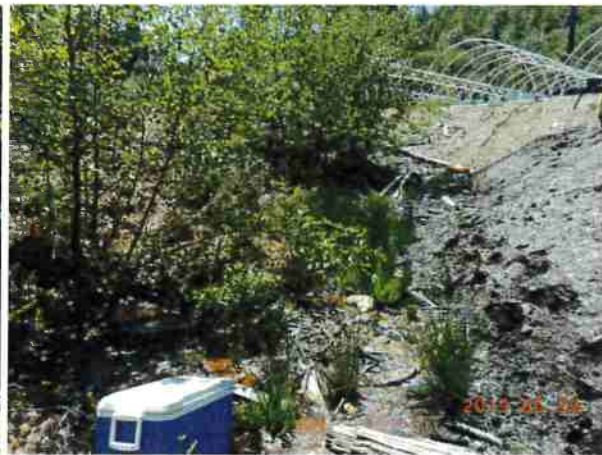
Fig. 2. Fillslope and soil encroaching on riparian vegetation

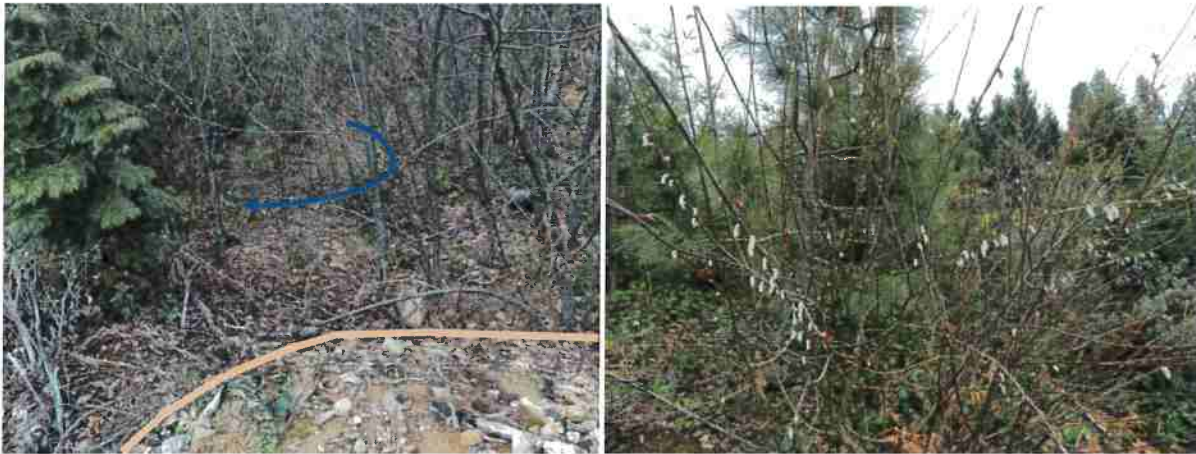
A class III ephemeral stream is near the southern edge of the cultivation flat. When this section of the original landing was expanded, it encroached upon the riparian habitat of the stream. The toe of the slope is just a few feet away from the top of bank and creek alders are growing along the fillslope (Figure 3). Erosion is not apparent on this southern fillslope, but it has not been stabilized with appropriate erosion and sediment control measures.

Approximately 6-10, 4-6" trees growing out of the fillslope will likely need to be cut down as part of the landing retreat. This includes Jeffrey pine, willow, and creek alder (Figure 4).

Fig. 3. Class III stream and toe of the fillslope

Fig. 4. Vegetation on top of the southern edge of the cultivation flat fillslope

1. Pull the fillslope back 50 ft from the top of bank and recontour to a 2:1 slope
2. Install erosion and sediment control BMPs before and after construction, similar to Site 1
3. Avoid riparian vegetation to the extent feasible

Once the fillslope is pulled back and stabilized, the thicket-forming alders are expected to regrow within the first year, widening and enhancing the riparian habitat.

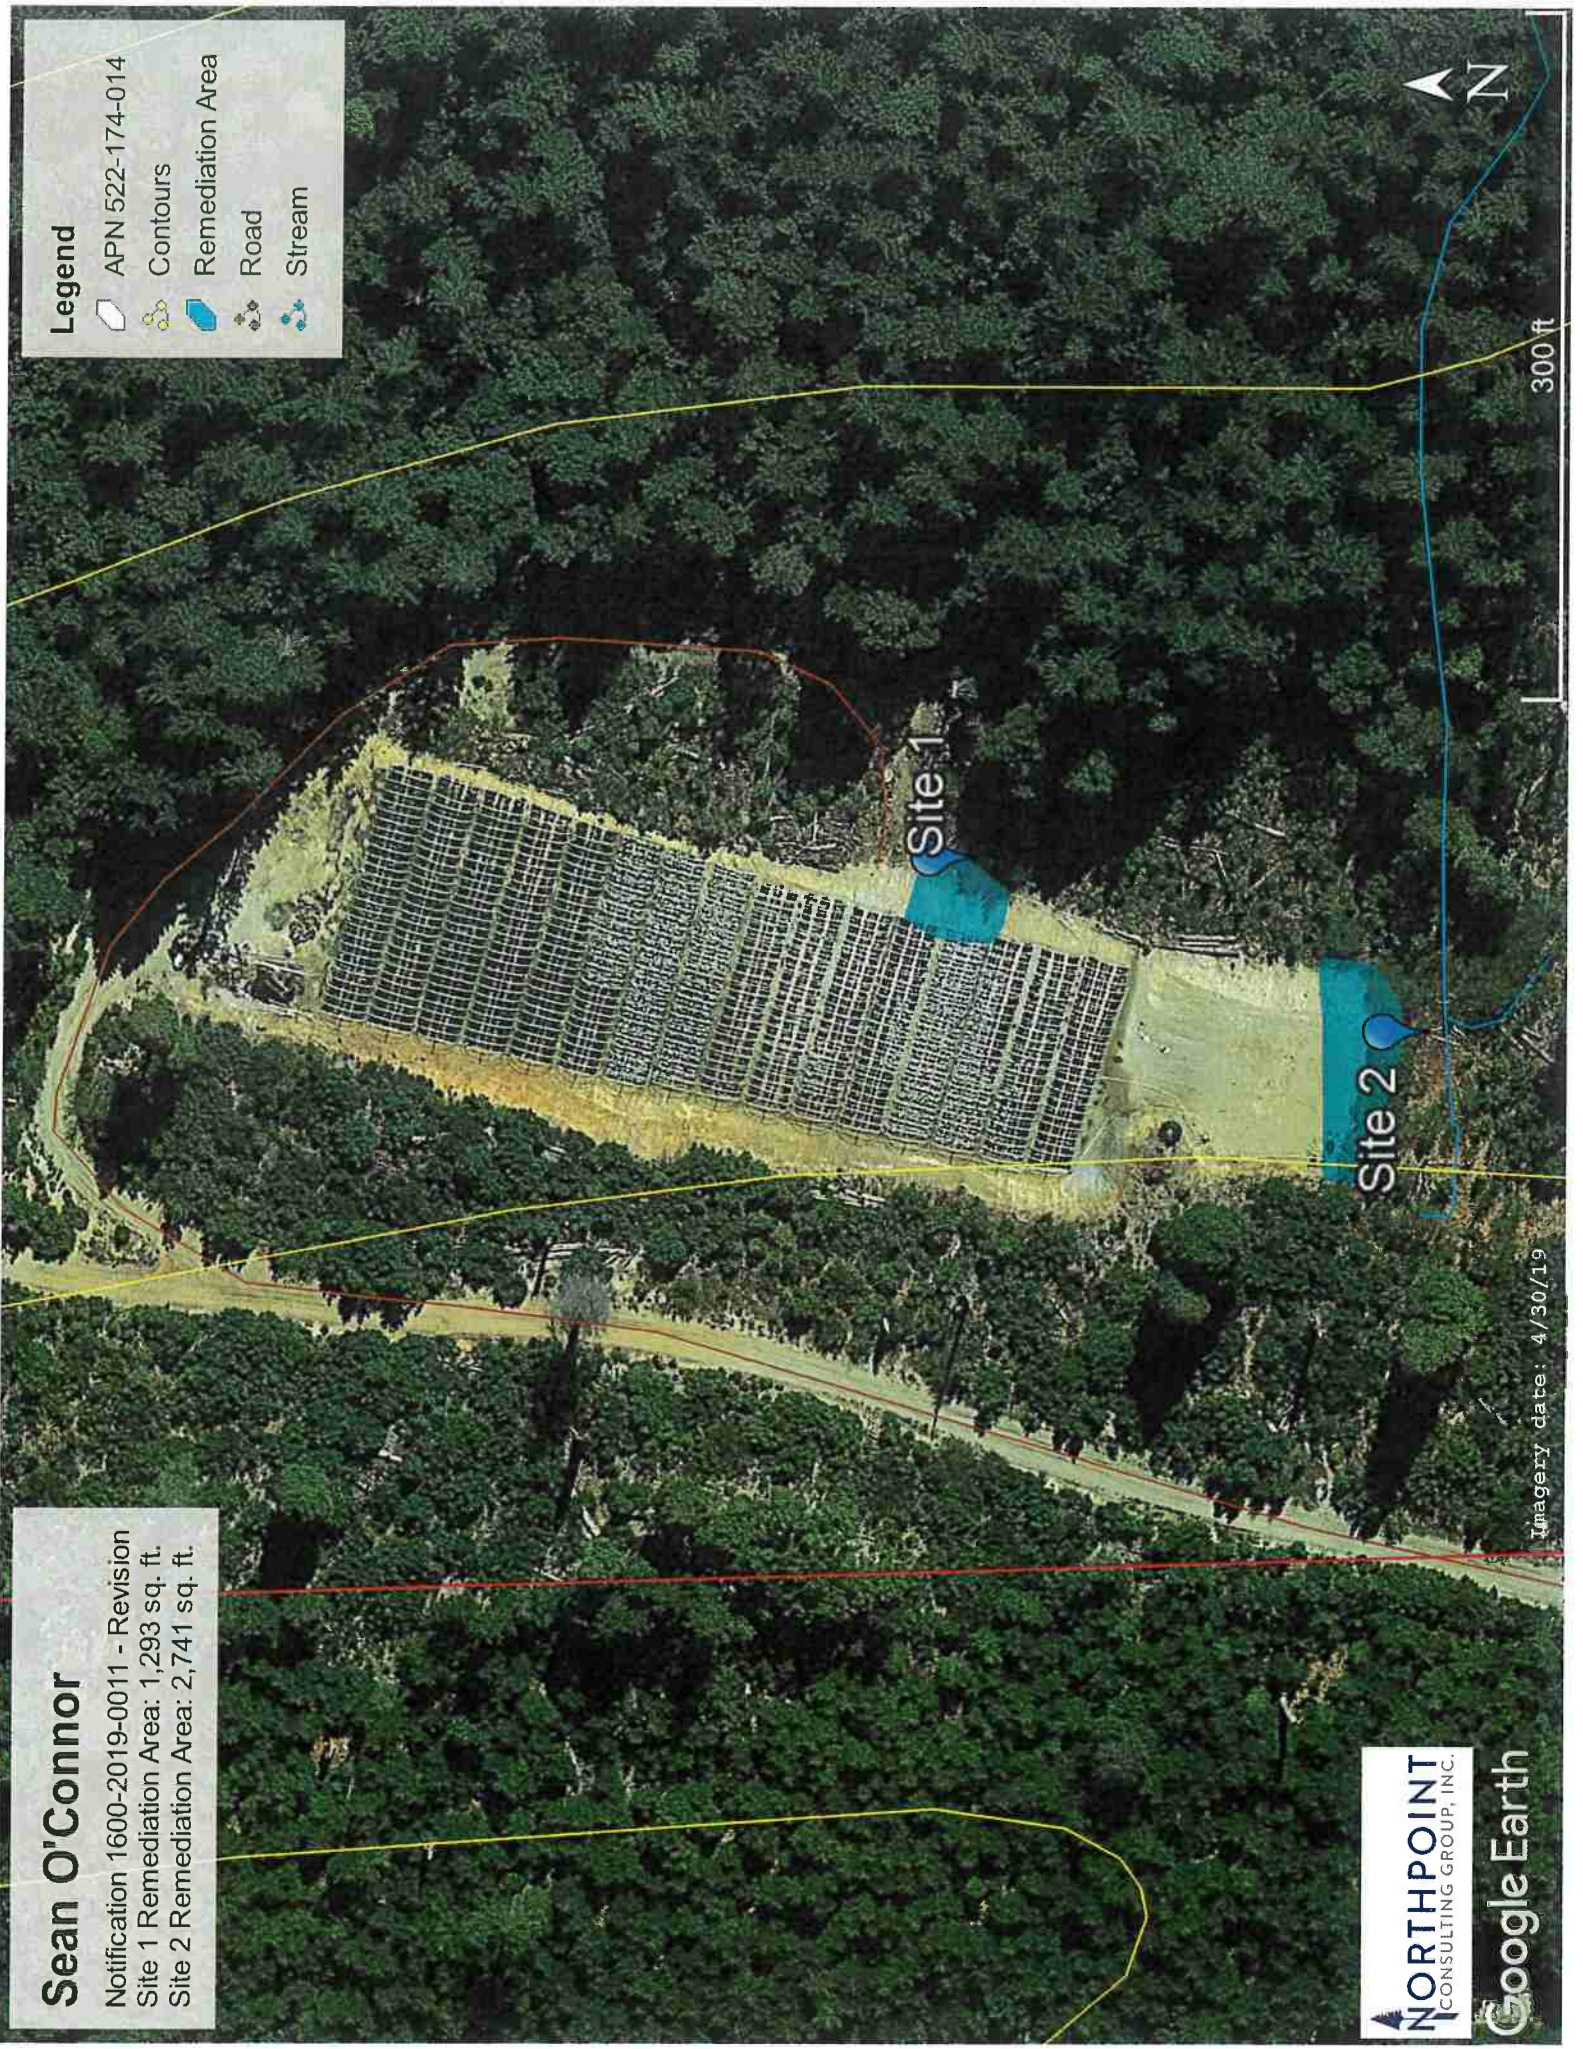
Encl. 1 – Site Map

Site 1

Site 2
