Buffer Enhancement & Vegetation Plan

Kernen Construction

APN: 516-151-916 1760 Glendale Drive, Glendale CA 95519

November 26, 2024

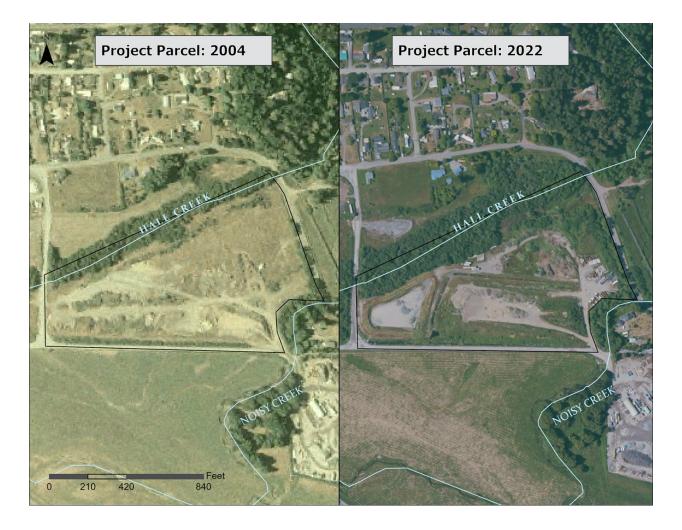
Figure 2. Comparison of historic (left) and recent (right) satellite imagery demonstrating the increase in shrub and tree cover over time in roadside ditch along Glendale Drive on the eastern side of the parcel.
