COUNTY OF HUMBOLDT
PLANNING AND BUILDING DEPARTMENT
CURRENT PLANNING DIVISION

Hearing Date: February 03, 2022

Subject: **H2 Equity, LLC, Conditional Use Permit**
Record Number: PLN-11248-CUP
Assessor's Parcel Number (APN): 221-021-008
Ettersburg area

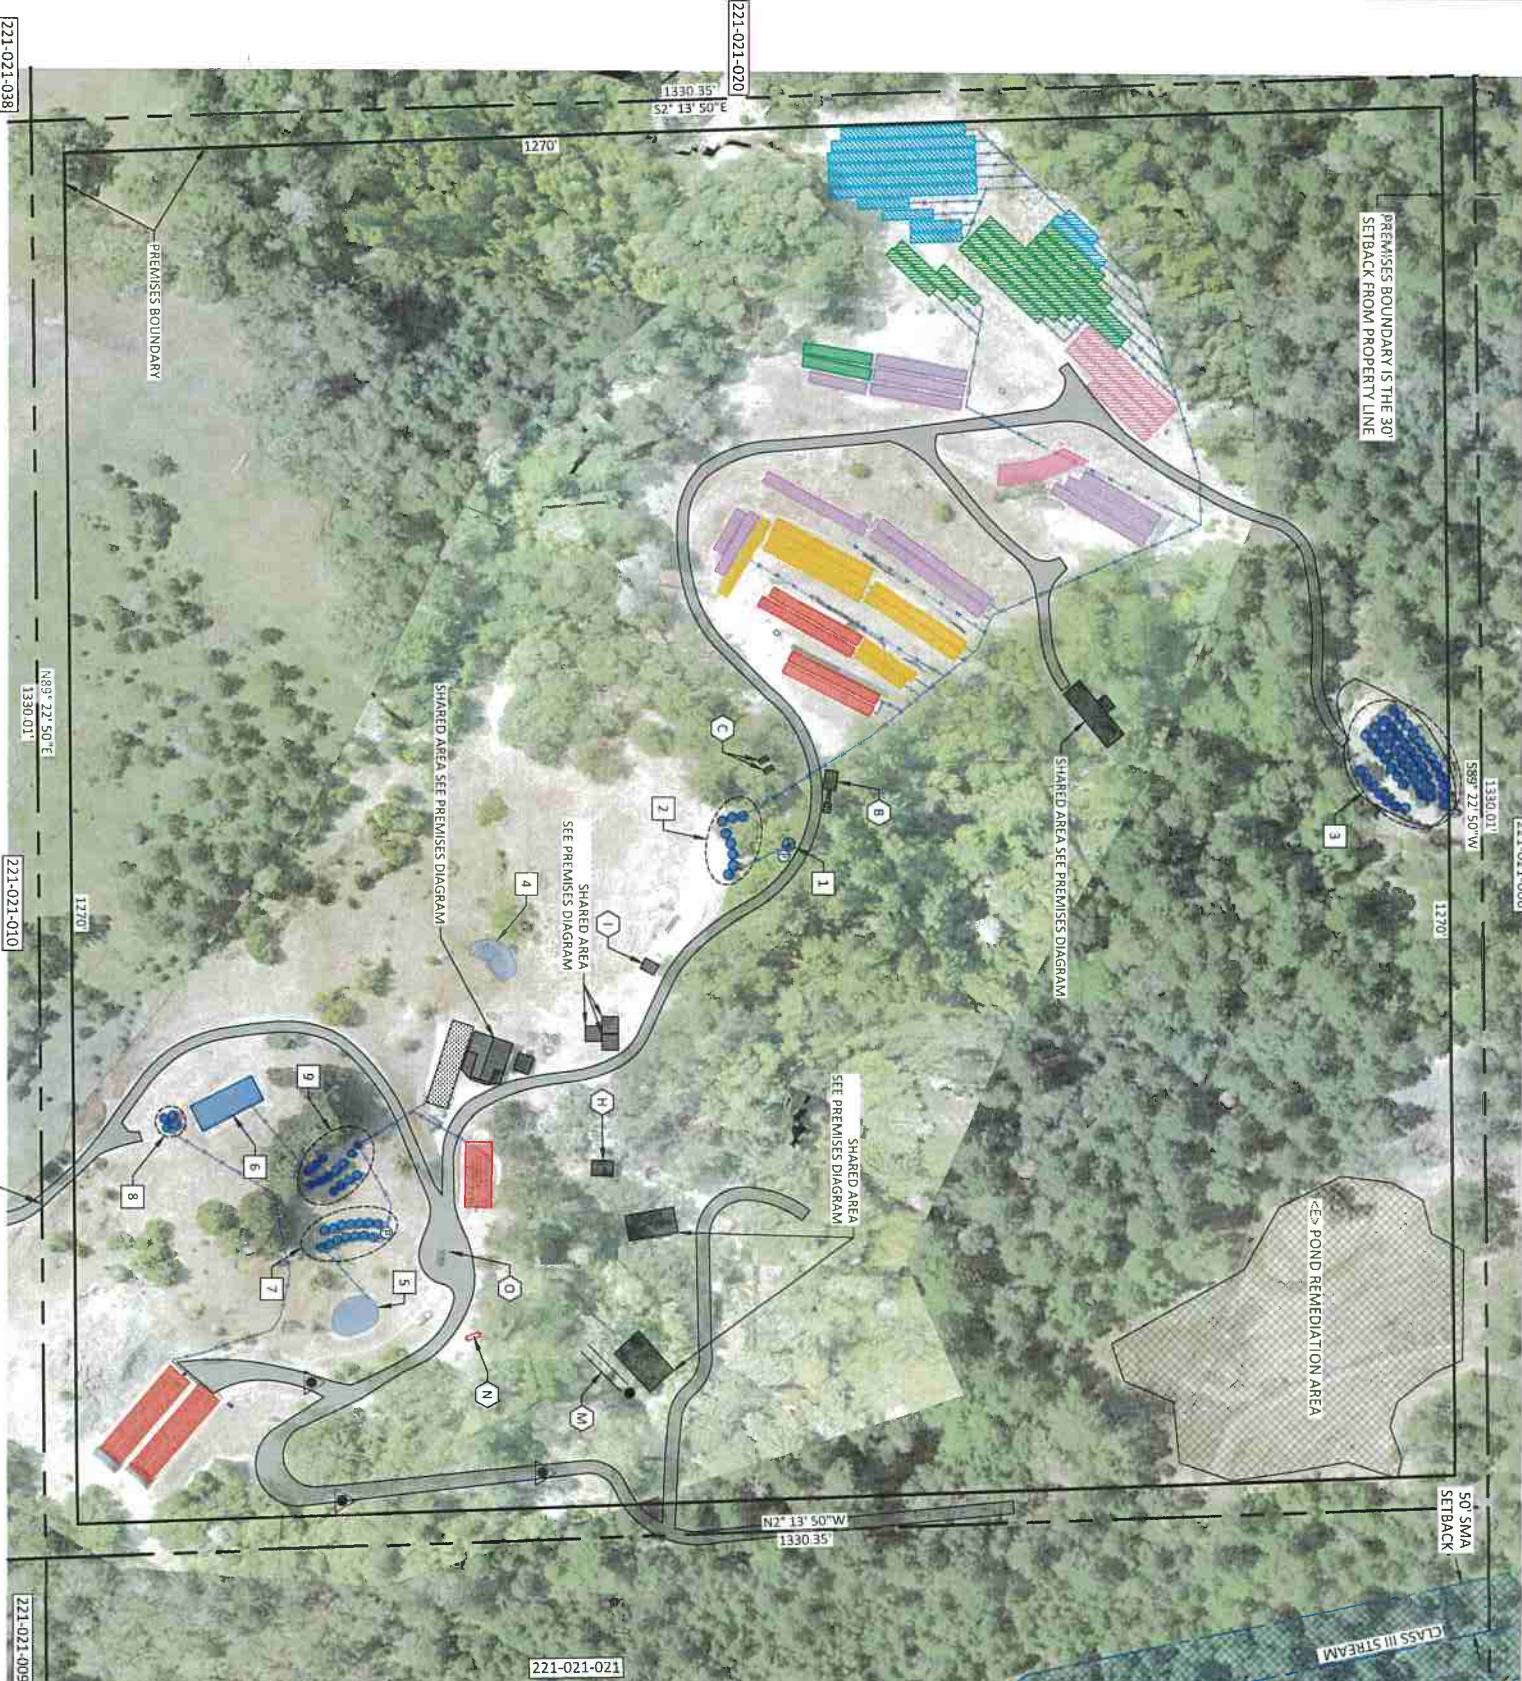
PROPERTY DIAGRAM
 APN: 221-021-008-000
 3845 THOMAS ROAD
 SALMON CREEK, CA 95553

PREMISES BOUNDARY IS THE 30' SETBACK FROM PROPERTY LINE

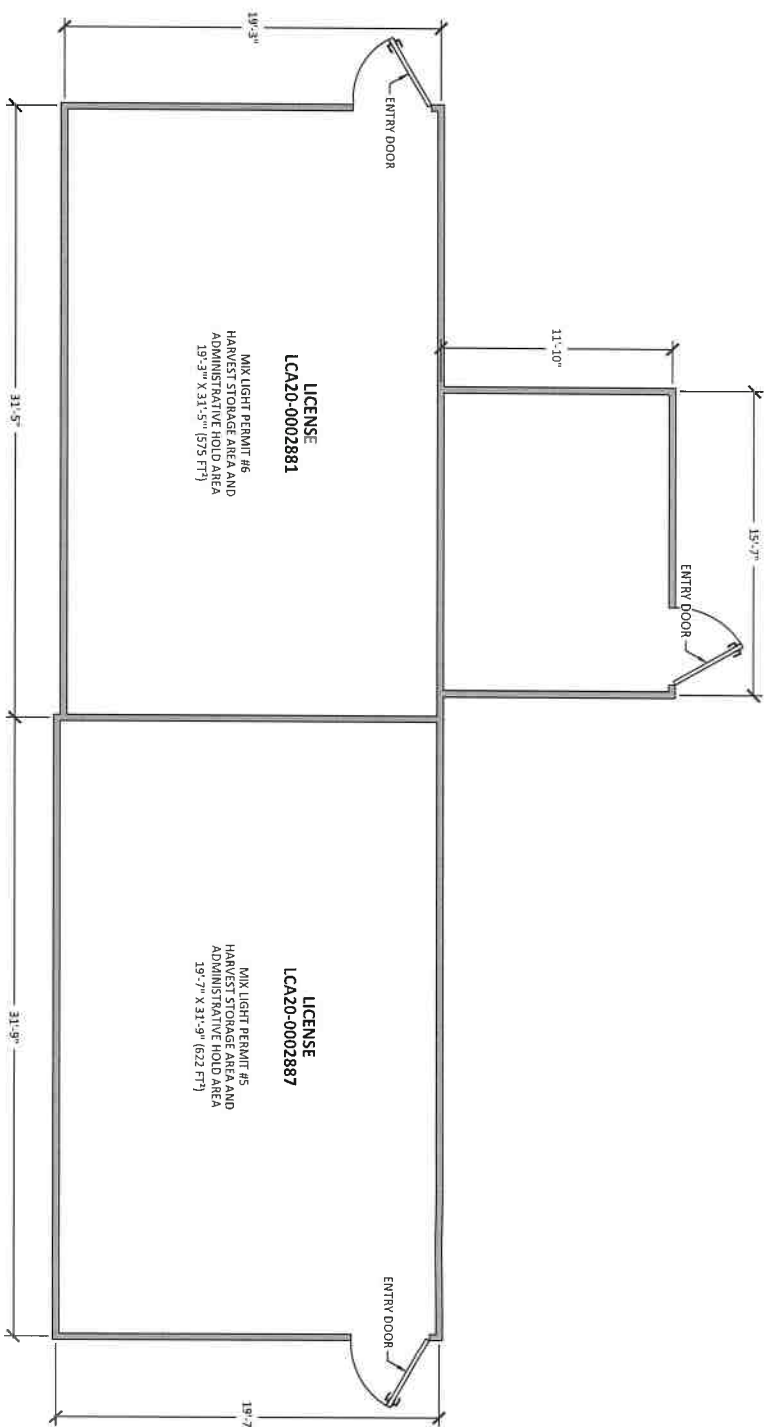
A STORAGE AREA DIAGRAM
 SCALE: 1/4" = 1' - 0"

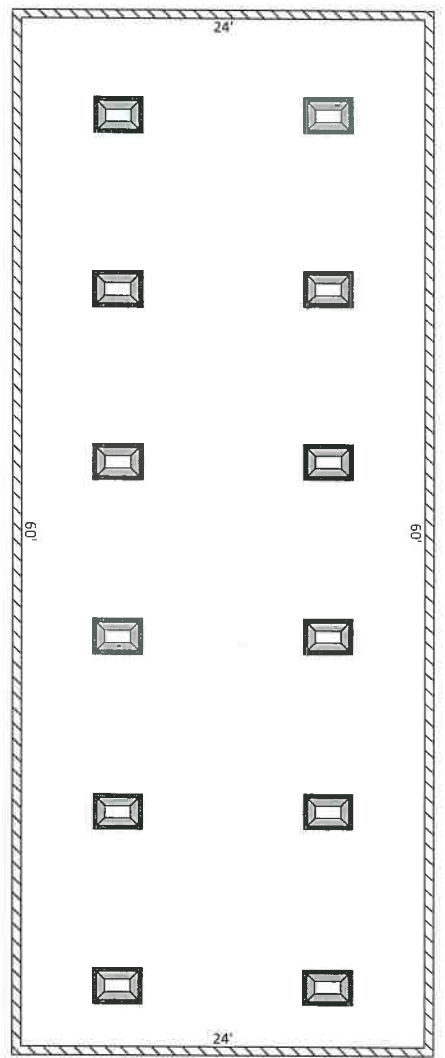
49 LIGHTING DIAGRAM - 24' X 60' GREENHOUSE
SCALE: 3/16"=1'-0"

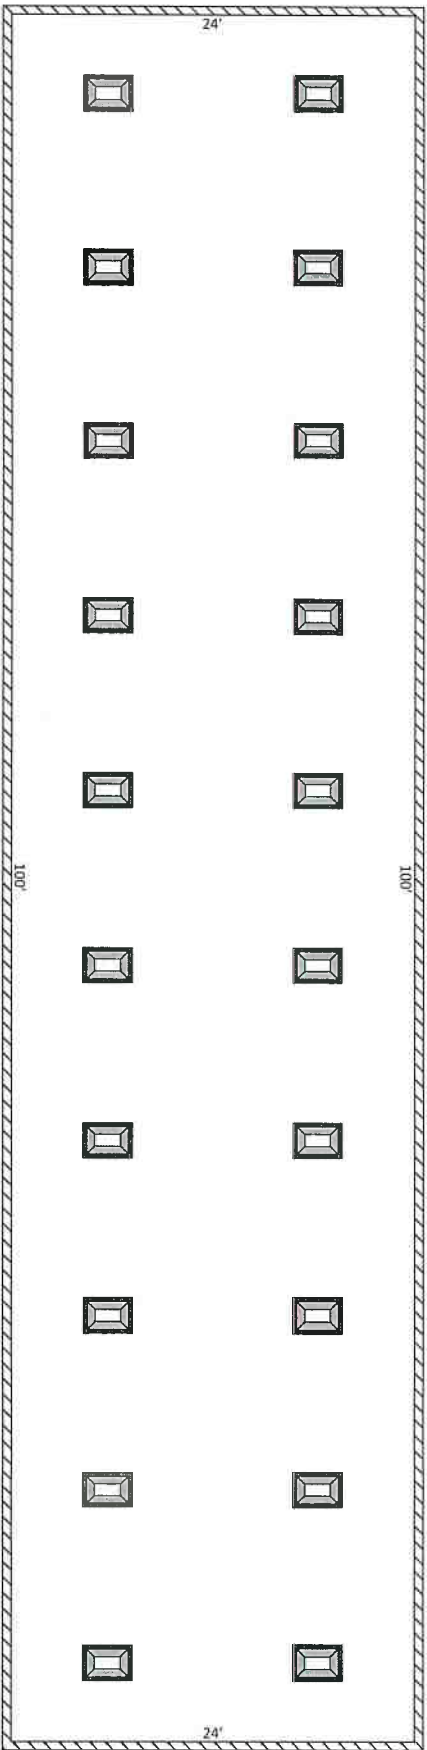
50 & 51 LIGHTING DIAGRAM - 24' X 100' GREENHOUSE
SCALE: 3/16"=1'-0"

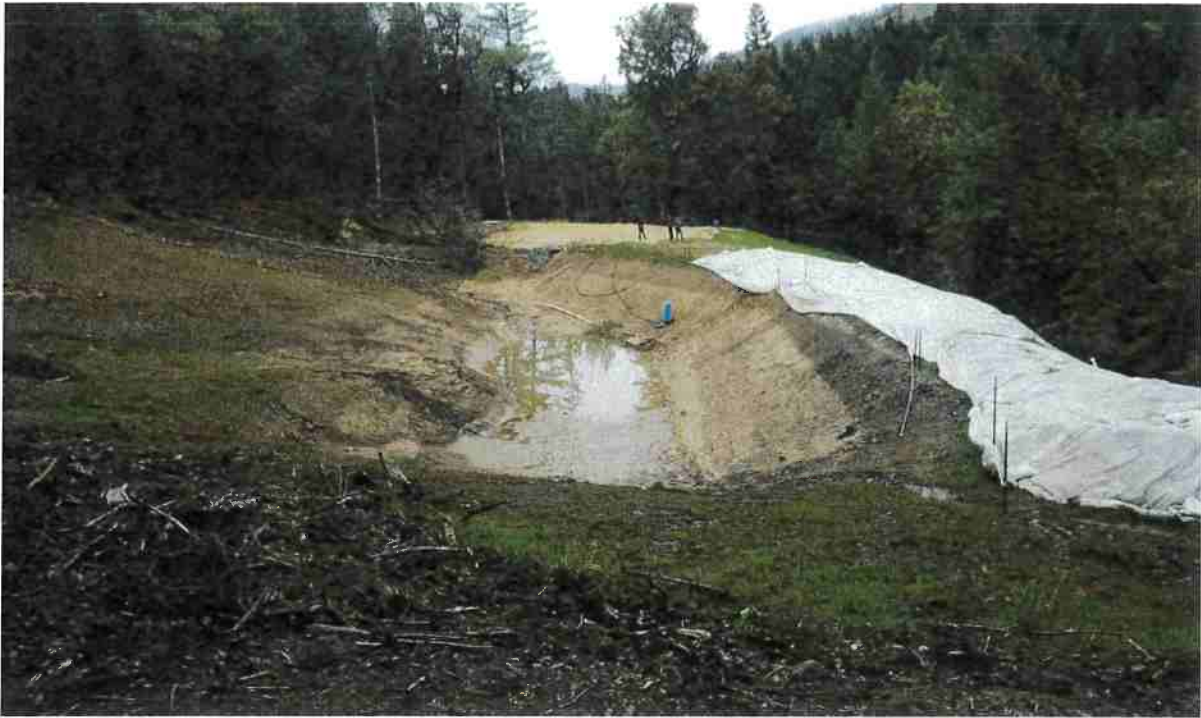
IMG 0826 1.3 acre illegal clearing with large pond in center

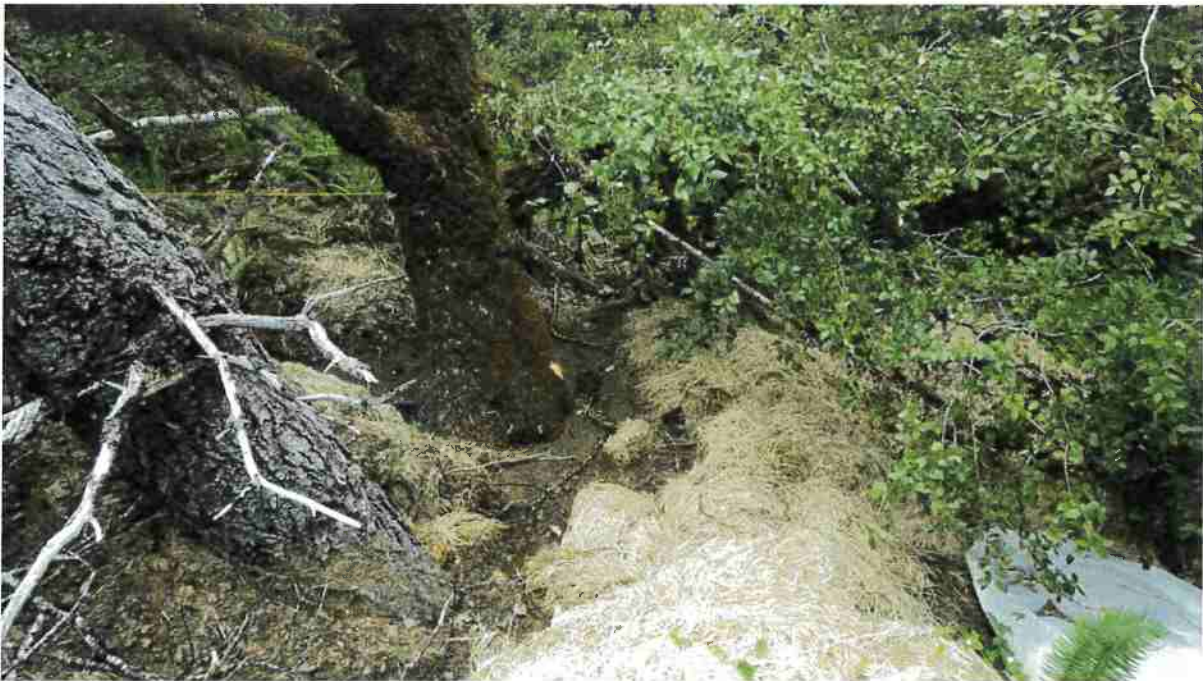
IMG0827 Sediment transport from the ponds dam above Class II watercourse

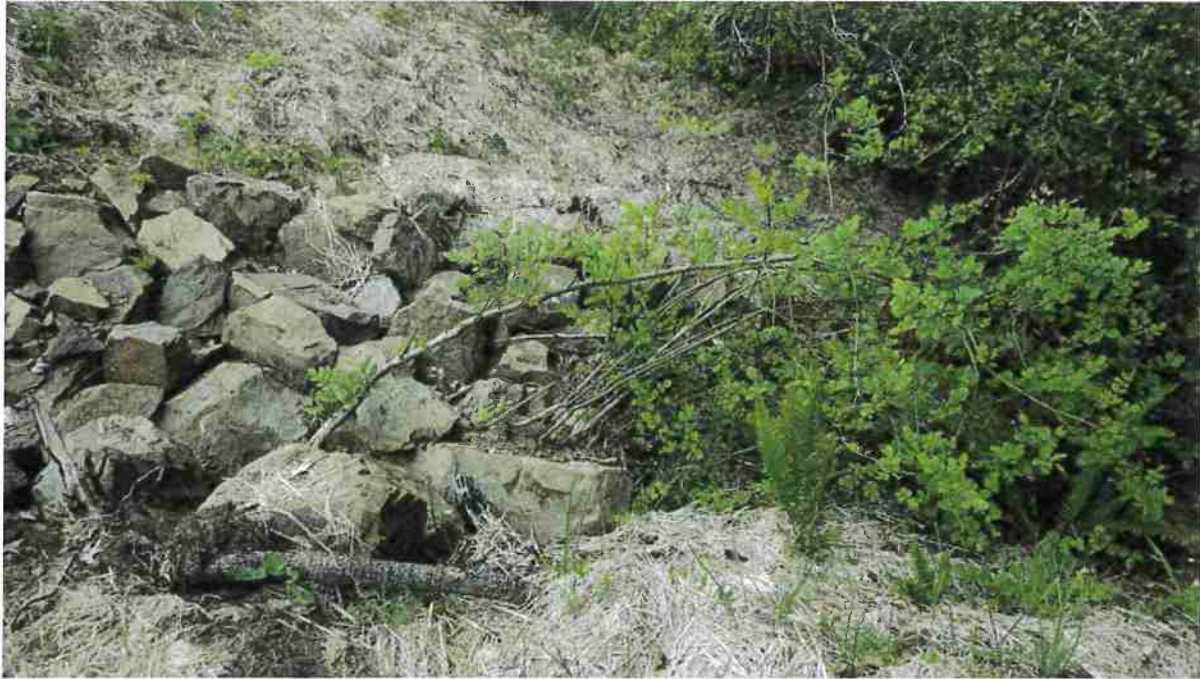
IMG0828 Sediment discharge into a Class III watercourse

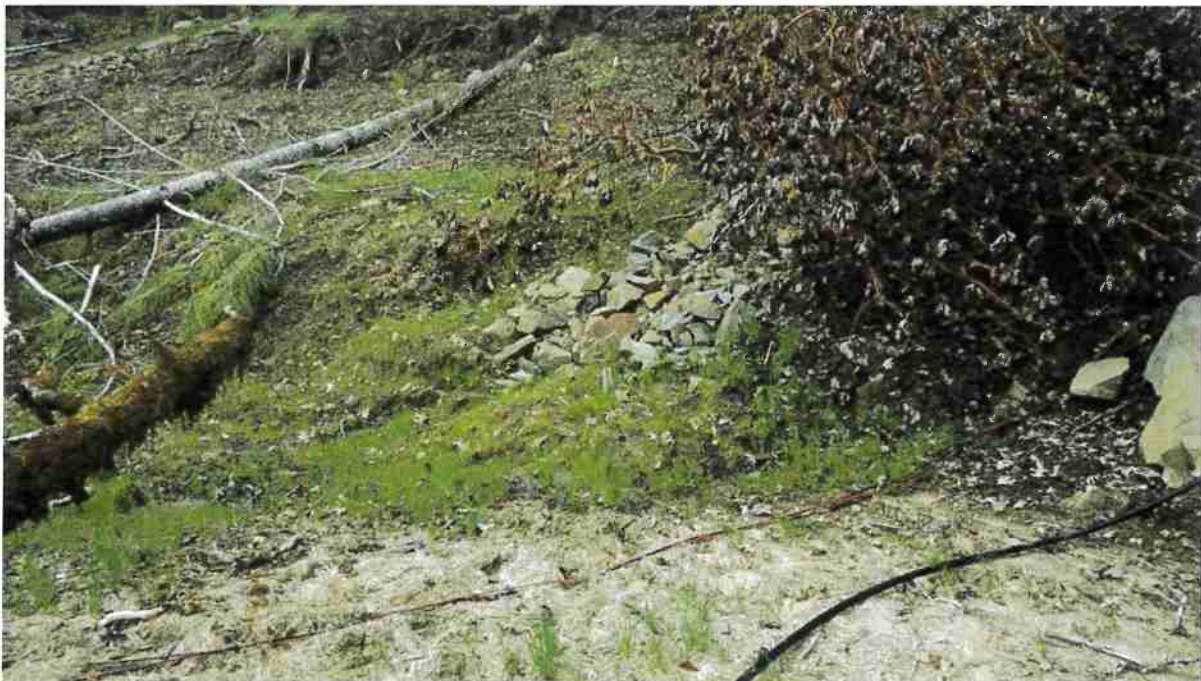
IMG0829 Illegal clearing across Class III watercourse on an unstable area

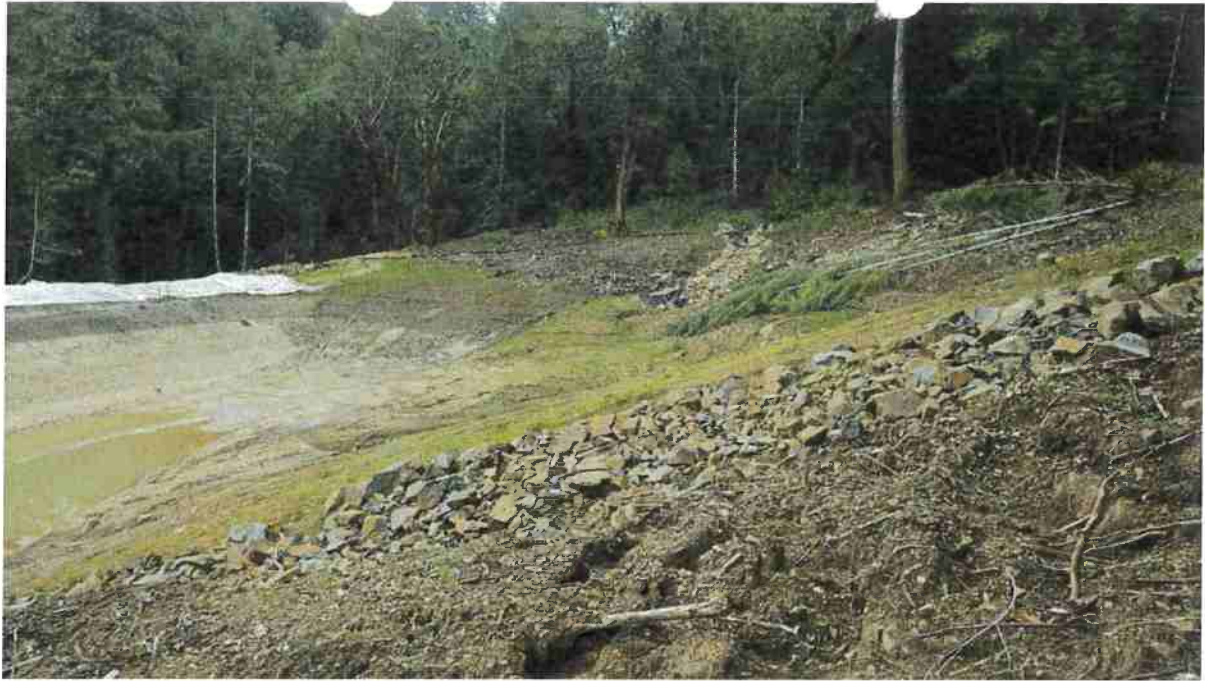
IMG0830 Large portion of cutbank failing into an illegally constructed pond in an unstable area

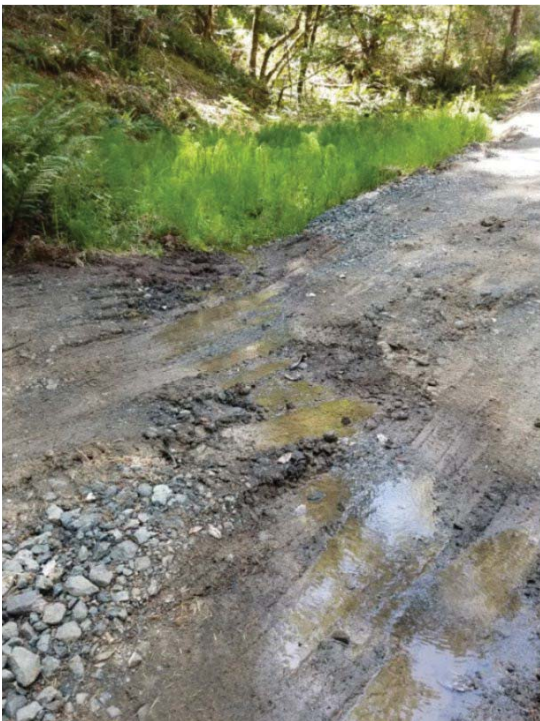
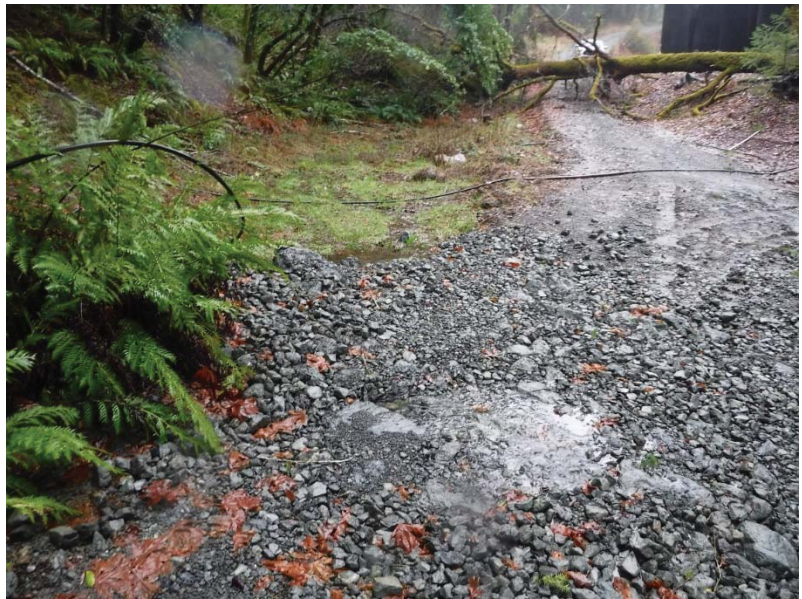
Figure 1: Before (4/25/18) and after (1/18/19) photos of the crossing at MP-1. An armored rock ford has been installed across the road temporarily to allow vehicle and equipment access to the site. Photos taken looking upstream (west).

MP-1 was diverted, not during the construction of the failed pond structure, but during the construction of a flat that was used for water tanks and bladders. The watercourse originates approximately 60 linear feet from where it intercepts the access road. During this project, the flat was removed and recontoured to match the existing topography, and the diverted reach was restored with woody debris. The crossing over the road is currently an armored ford to allow for access to the project site through the summer of 2019 (Figure 1 and Figure 2). The long-term plan for this point is the removal of the crossing and restoration of open stream, with the road to the project site being fully decommissioned and blocked from vehicular access. Minimal equipment work may be necessary during summer 2019, and planting operations will take place in the fall of 2019. The significance of rain events in fall of 2019, and/or the need for equipment access next year and beyond will inform the timing of the removal of this crossing and restoration to open stream.

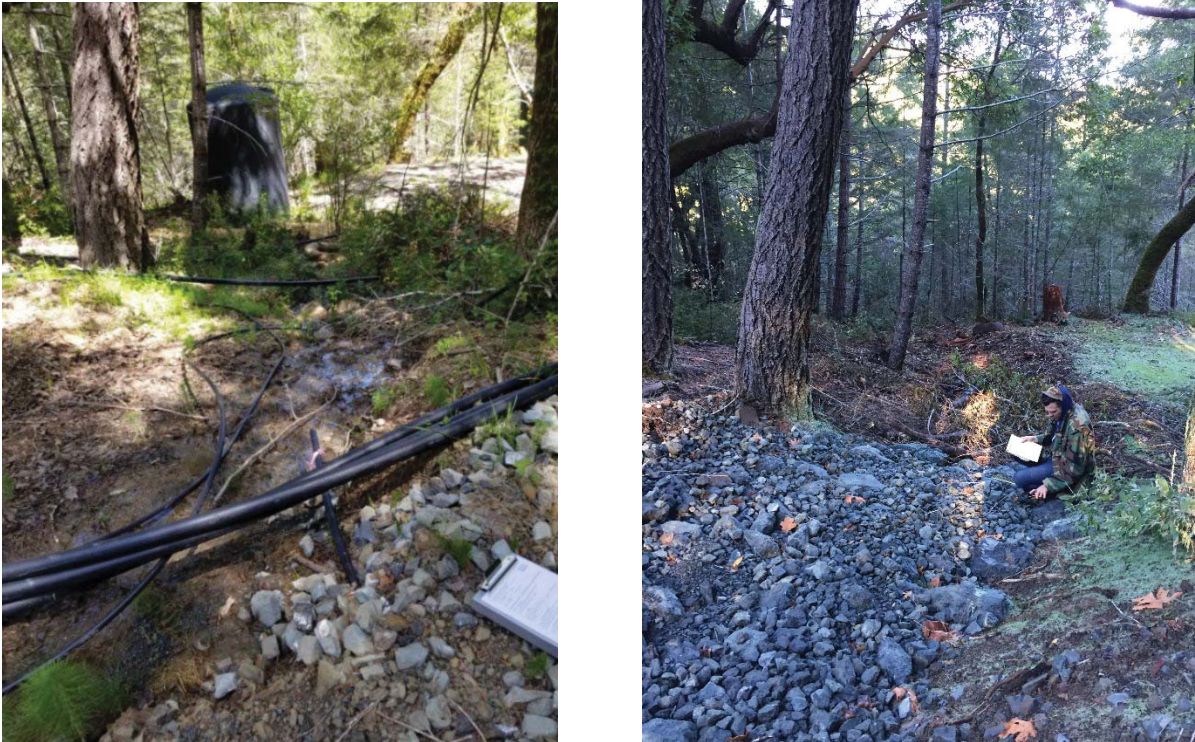
Figure 2: MP-1 before (4/25/18) and after (12/6/18) downstream (northeast) from access road. The rock armor extends from the road approximately 25 feet into the channel. The next 50 feet of the restored reach is armored with slash and woody debris. The recontoured flat with tank removed is seen in the background.

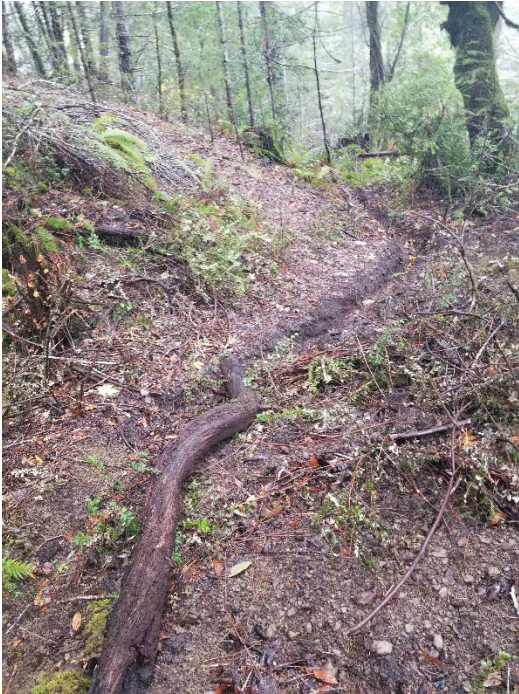
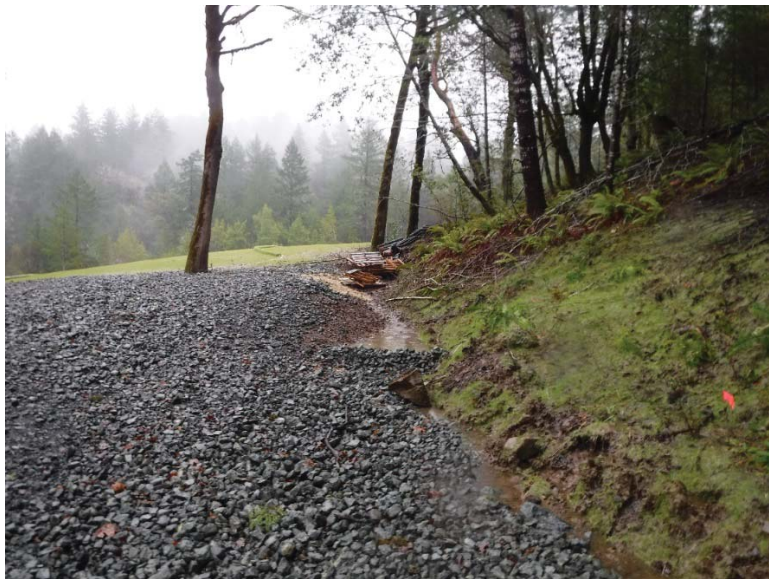
Figure 3: Rerouted reach of MP-3. A small ditch was hand-dug to keep the flow in this channel off the restored pond area (left). The right photo shows the outlet from the forest onto the rock ford, looking east. Photos taken on 11/23/18.

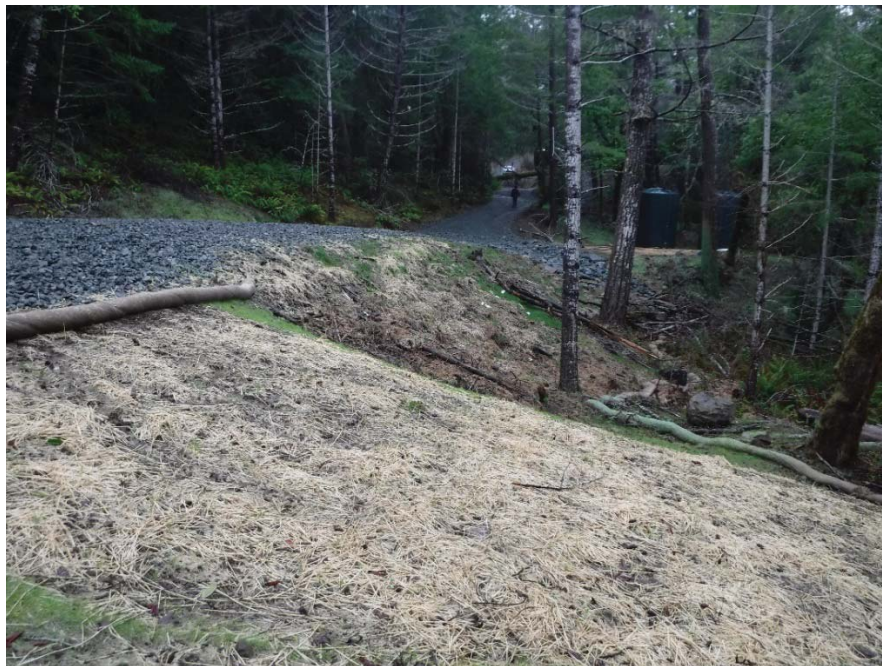
Figure 4: Rerouted reach of MP-3 where it meets the existing vegetated swale. Photo taken looking west on 1/8/19.

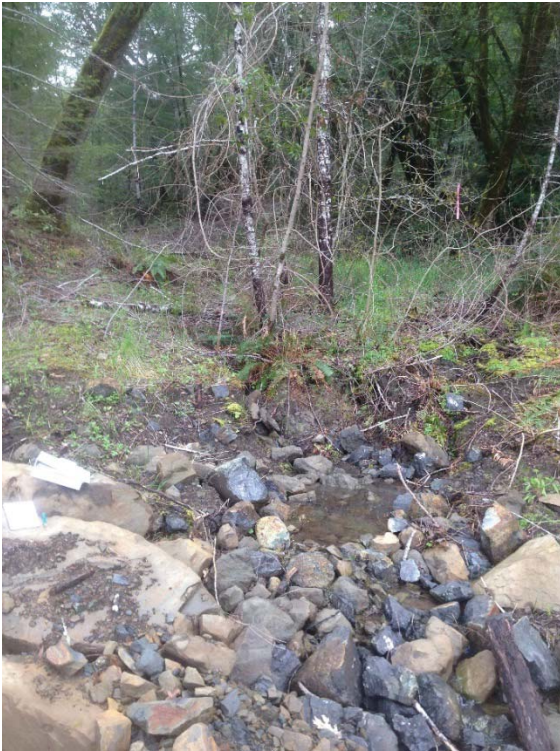
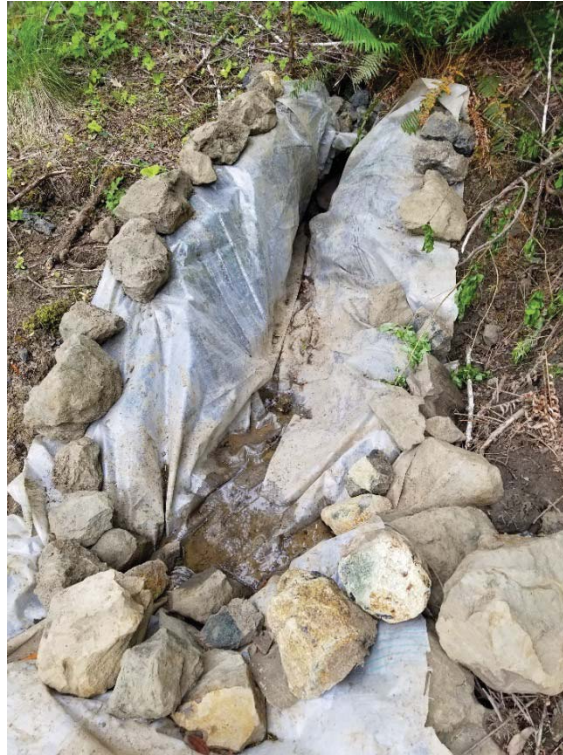
Figure 5: Before (4/25/18) and after (5/9/18) installation of the cofferdam diversion on MP-5. This temporary measure will be removed before October 2019. Photo taken looking southeast.

MP-5 historically flowed northwest into the project site and was observed to be the greatest input of water into the pond during the controlled draining operation. MP-5 continued to flow throughout the summer of 2018. MP-5 originates from a seep or series of seeps approximately 80 feet from the edge of disturbance of the pond. A cofferdam diversion was installed in May of 2018 to divert this watercourse away from the pond and into the Class II stream to the east, to facilitate better drying of the area in preparation for earthwork in late summer and fall of 2018 (Figure 5, Figure 6, Figure 7, Figure 8, Figure 9 and Figure 10). The cofferdam diversion will be removed and the area planted with riparian species in the fall of 2019 to uptake additional seep flows that were not intercepted by the rerouted stream structure installed for the reach at MP-5.

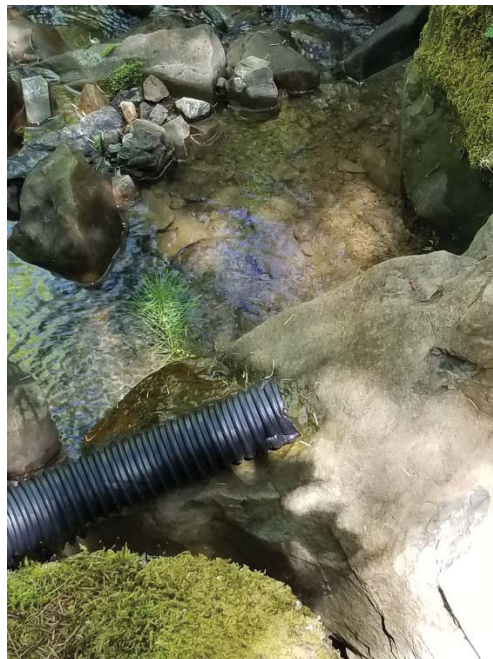
Figure 6: Outlet of cofferdam diversion (DP-3) into unnamed Class II watercourse. Photo taken looking northeast on 5/3/18.

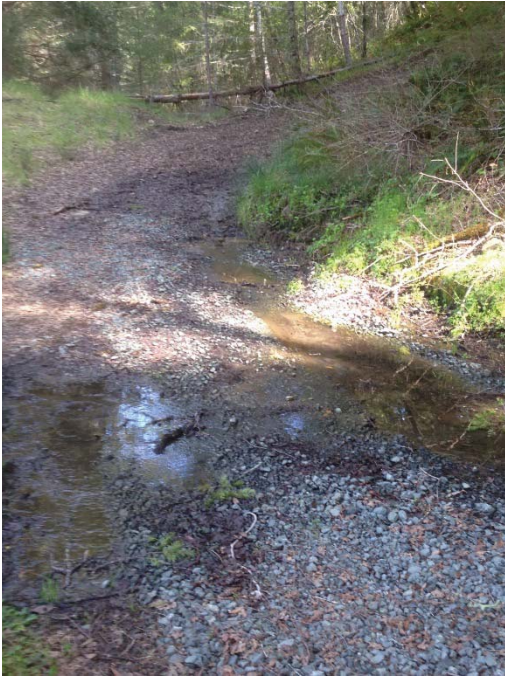
Figure 7: Before rerouting of reach of MP-5 flow over now decommissioned riparian road. This is upstream of the cofferdam diversion and approximately 60 feet from the headwaters of this stream. Photos taken looking south on 4/18/18 and 4/2/18.

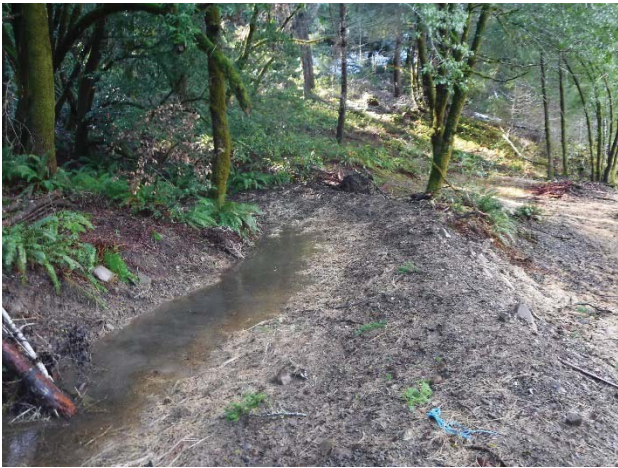
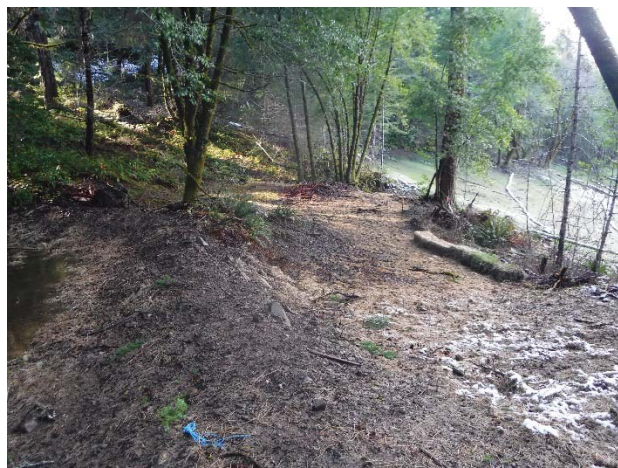
Figure 8: View of the rerouted reach of MP-5 looking upstream. This is approximately where the decommissioned road intercepted the watercourse. The reconstructed slope can be seen in the background. Photos taken looking west on 2/5/19.

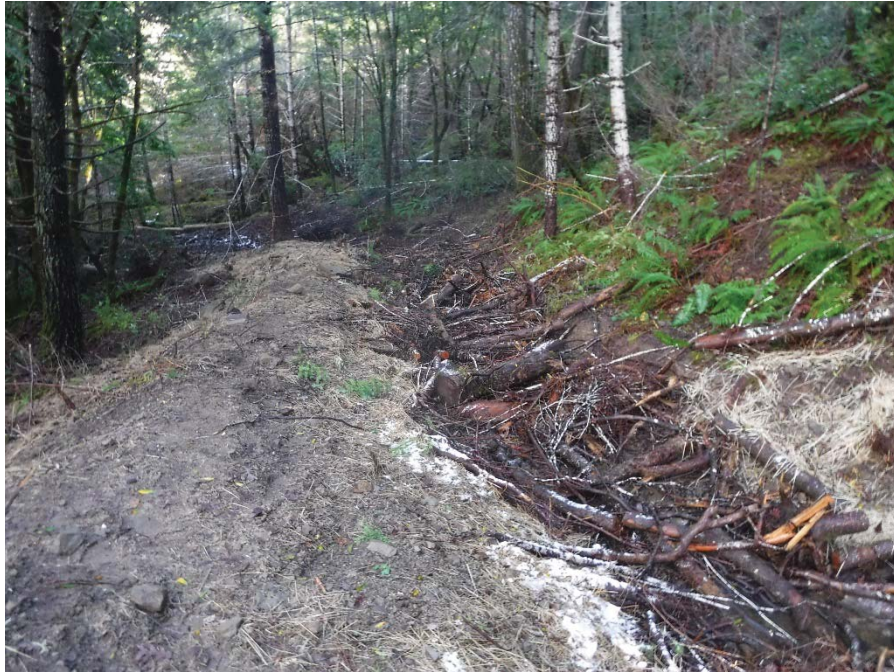
Figure 9: Rerouted reach of MP-5 looking downstream from point of interception with now decommissioned road. Photo taken looking east on 2/5/19.

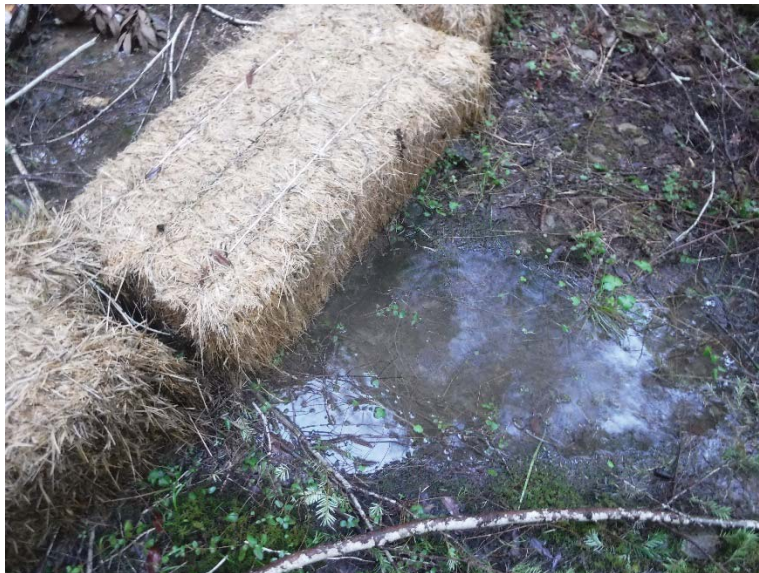
Figure 10: Outlet of rerouted reach of MP-5. Straw bales placed as a temporary checkdam/sediment trap will be replaced with an armored outfall into the unnamed Class II during summer of 2019. Photo taken 2/5/19.

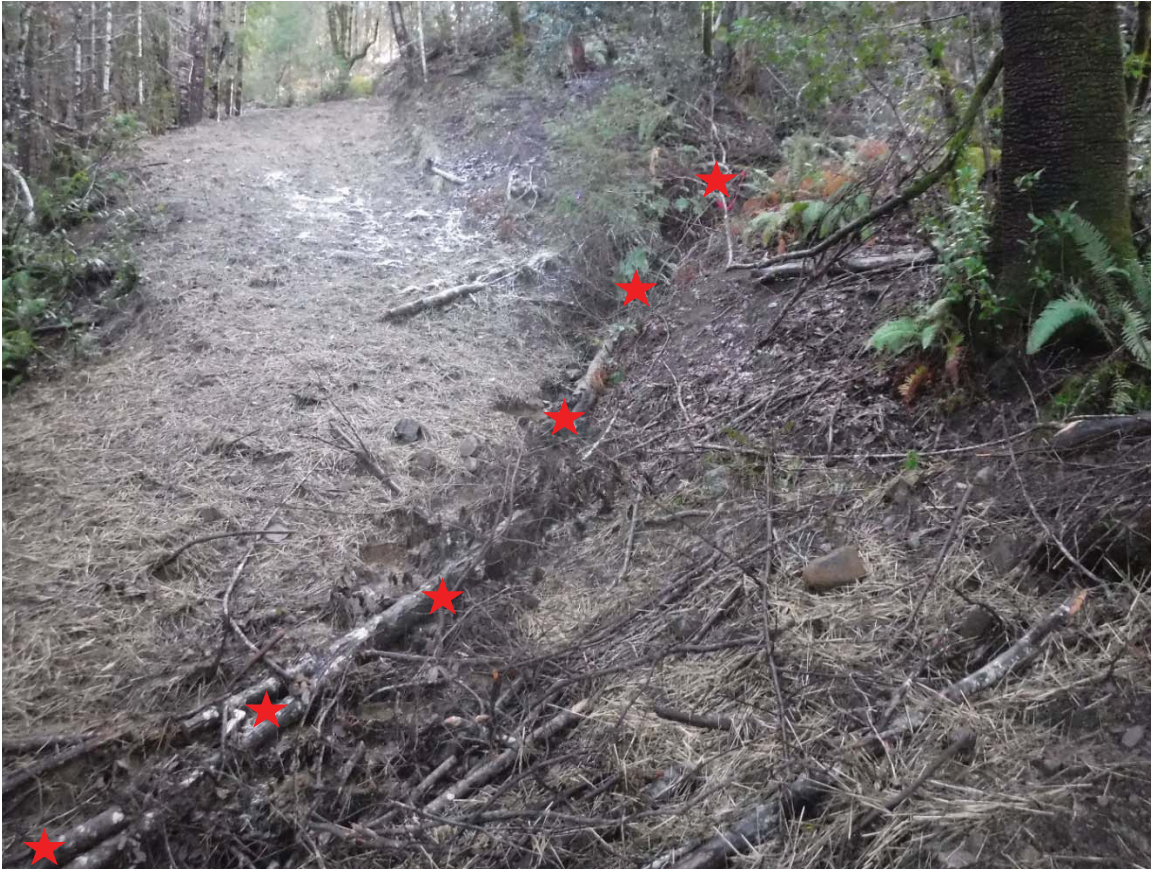
Figure 11: Path of MP-6 across decommissioned riparian road marked by red stars. Photo taken looking south on 2/5/19.

MP-6 is located on a Class III watercourse to the southeast of the pond site. This watercourse originates near a cabin uphill from the road crossing (Figure 11). This project included the decommissioning of the road and the restoration of this watercourse at the road crossing point.

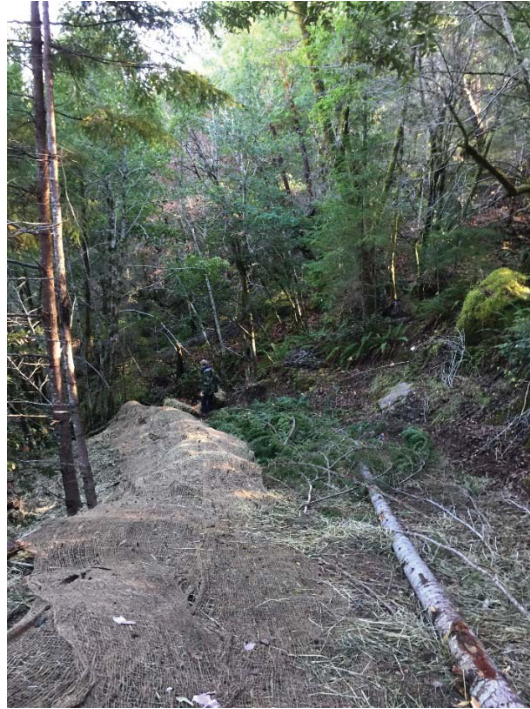
Figure 12: View of the decommissioned road south of MP-6. This is the point is the end of vehicle access from the flat with a cabin. An exaggerated water bar has been installed to make the roadway impassable for vehicles. Woody debris, jute netting and straw bale barrier have been installed to filter surface runoff and prevent erosion. Photo taken looking north on 12/6/18.

bars were installed intervals along the decommissioned length to prevent vehicular access (Figure 12, Figure 13 and Figure 14).

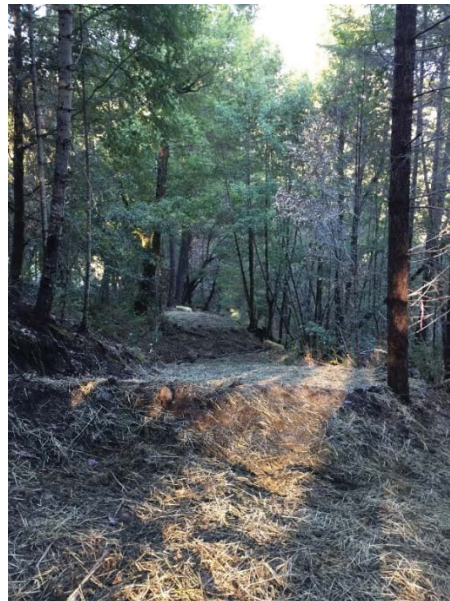
Figure 13: Water bar visible in the in the foreground. In the background the stream crossing at MP-6 is visible. Photo taken looking west on 12/06/18.

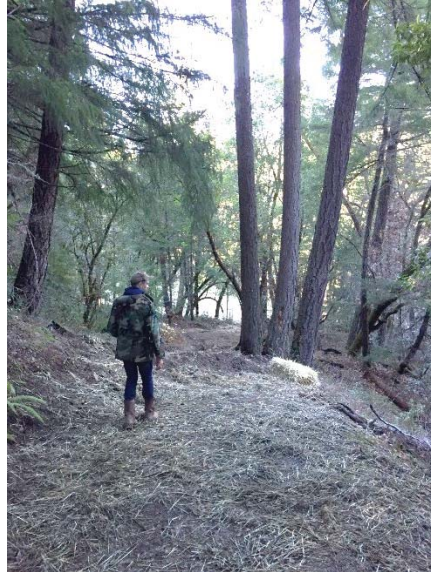
Figure 14: Water bar installed between MP-5 and MP-6. A straw bale was installed at the outlet of the bar and straw mulch placed for erosion control. Photo taken looking northwest on 12/6/18.

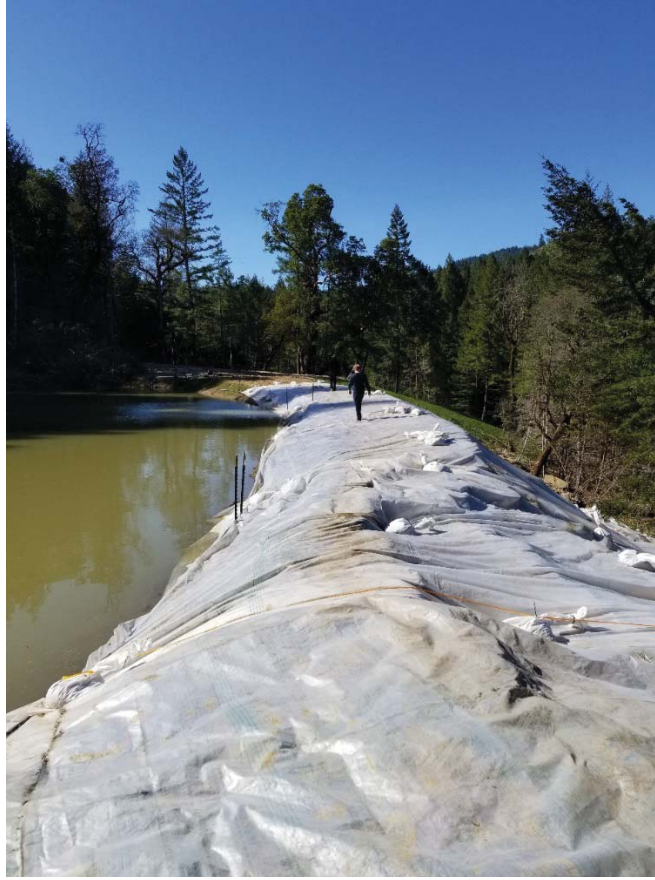
Figure 15: Pond before draining, with scarps on embankment shown in foreground. The owner tried to stabilize the embankment by covering with plastic sheeting to protect from rain. Photo taken looking northwest on 04/02/18.

The Pond was drained in April 2018 by conveying flow through a perforated PVC manifold into the forest to the northwest of the disturbed area. Views of the Pond prior to draining are illustrated in Figure 15, Figure 16, Figure 17 and Figure 18). After the pond was drained and the potential of catastrophic failure of the embankment was eliminated, the area was allowed dry throughout the summer of 2018 (Figure 19). Grading to restore the original slope and contours of the of the disturbed area commenced in late summer after all the required work permits were obtained. Completed slopes are all less than 2H:1V, in accordance with the Humboldt County Grading Ordinance and sound engineering practice. Compaction tests according to ASTM D6938 – 17a - Standard Test Methods for In-Place Density and Water Content of Soil and Soil-Aggregate by Nuclear Methods (Shallow Depth) were performed for four days during construction of the slope. Tests from the lower 2/3 of the slope returned relative compaction values of 90% or higher. The upper 1/3 of the slope was not constructed in the typical manner by placing 8-inch loose lifts, then compacting before placing the next. This was due to the logistics of earthmoving at the site and the necessity of preserving the upland forested area. This upper portion has experienced slight surface movement as expected, with small scarps forming across contours. This area will continue to be monitored, and any necessary equipment work conducted during summer 2019 (Figure 20).

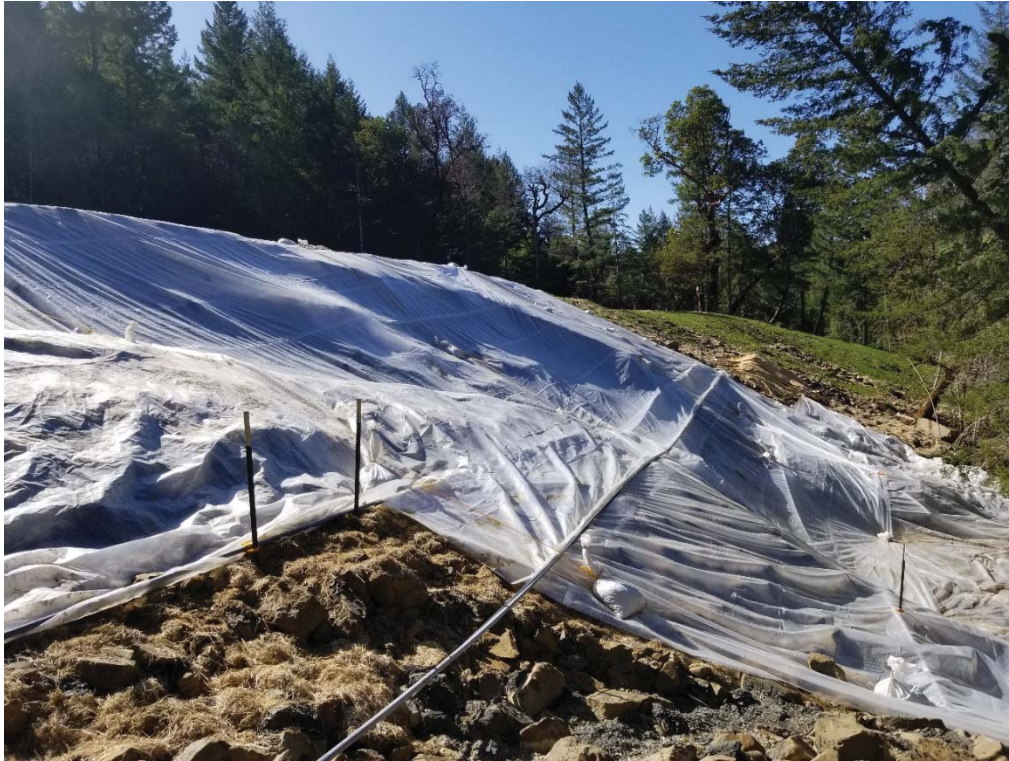
Figure 16: Exterior of embankment, showing the backtilted conifer and scarps under plastic sheeting. Photo taken looking west on 4/2/18.

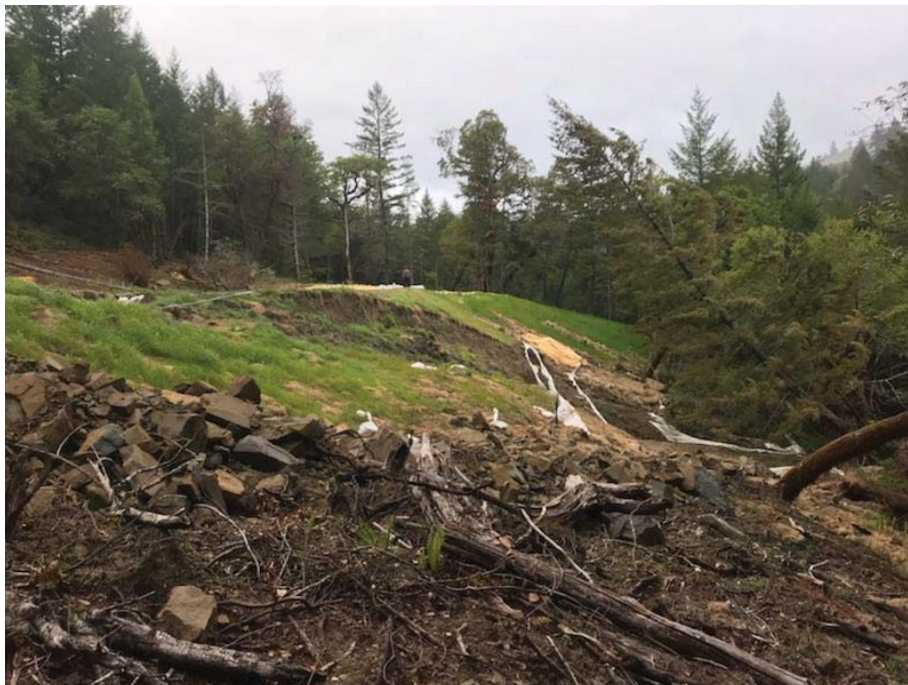
Figure 17: View of the exterior embankment after the plastic sheeting was removed. Photo taken looking west on 5/17/18.

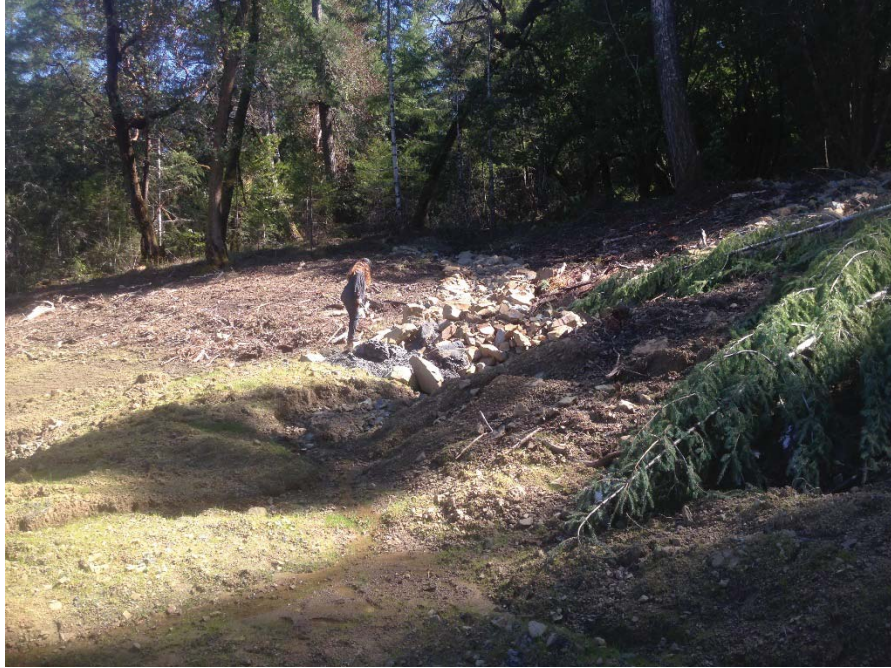
Figure 18: Cutslope above pond showing slope failure and fallen trees. Photo taken looking southeast on 4/4/18.

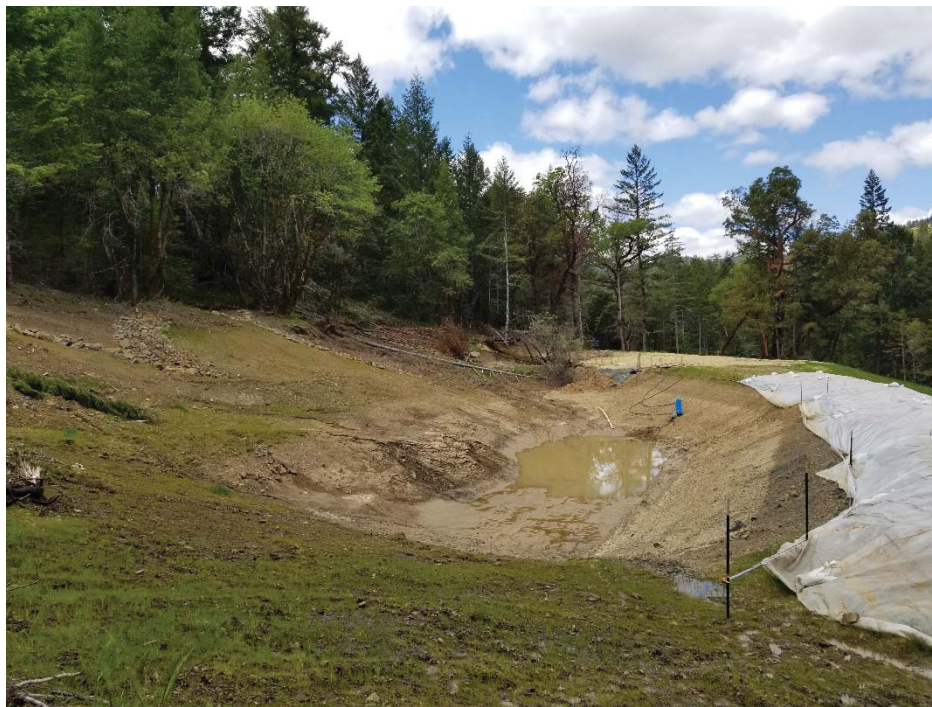
Figure 19: View of the pond basin during draining operations. Photo taken looking west on 5/9/18.
