COUNTY OF HUMBOLDT
PLANNING AND BUILDING DEPARTMENT
CURRENT PLANNING DIVISION

Hearing Date: February 03, 2022

Subject: **H2 Equity, LLC, Conditional Use Permit**
Record Number: PLN-11248-CUP
Assessor's Parcel Number (APN): 221-021-008
Ettersburg area

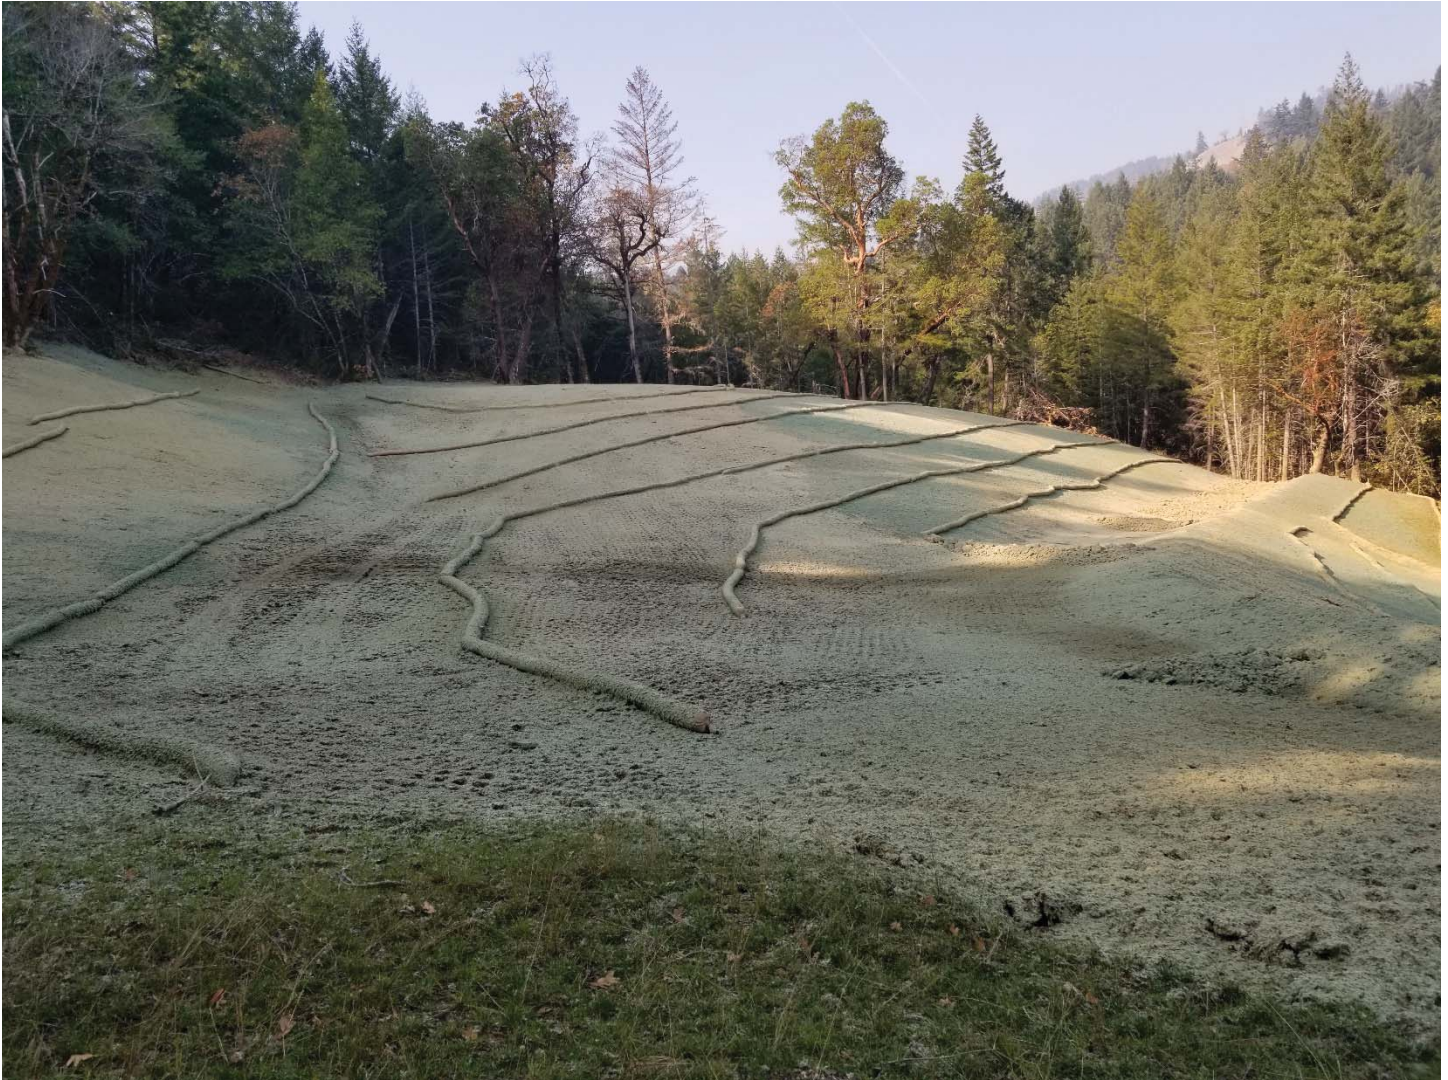
Figure 20: Reconstructed slopes showing hydroseed application and fiber rolls on contours. The former pond site is approximately in the center of this photo. All disturbed surfaces received surface treatment including hydroseed, straw mulch, and/or fiber rolls or jute netting to prevent erosion. Photo taken looking northwest on 11/14/2018.

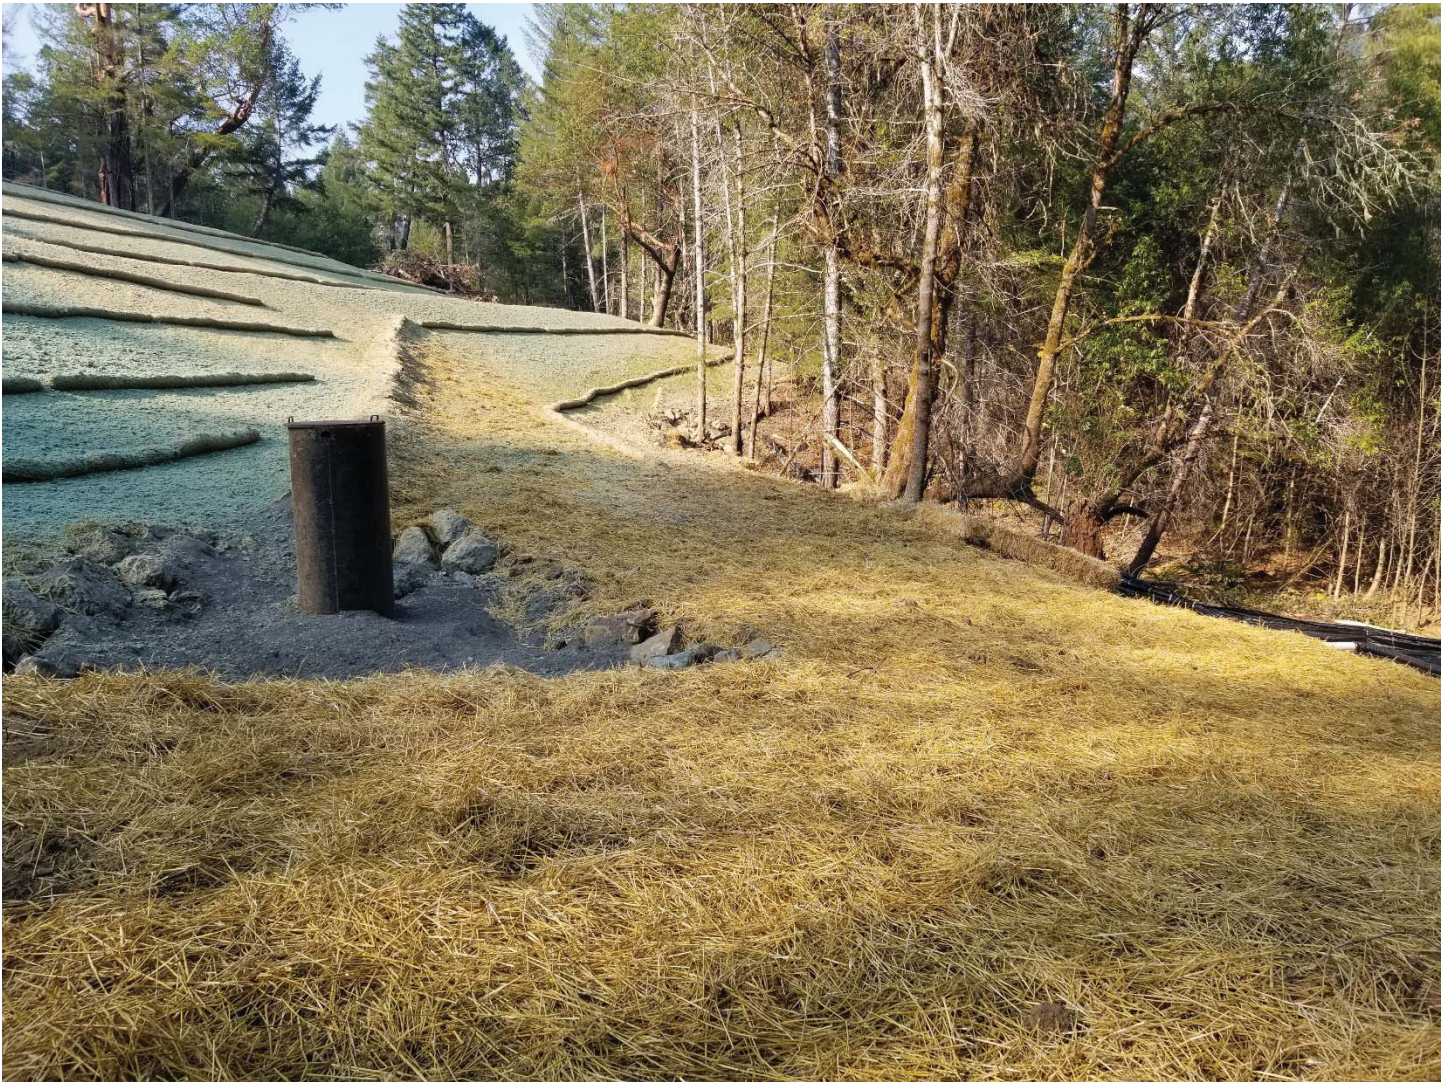
Figure 21: Groundwater seep interceptor at the base of the project area. The installation is located at the point of greatest embankment failure, an area of subsurface flow atop a bedrock shelf. Photo taken looking west on 11/14/18.

Monitoring throughout the winter and spring of 2018-2019 shows the GSI performing as intended, with no further sliding or wasting in the vicinity. The discharge point of the GSI has been visually monitored and sample tested for turbidity through the rainy season of 2018-2019 (Figure 23). See Monitoring and Reporting Plan for details and test results.

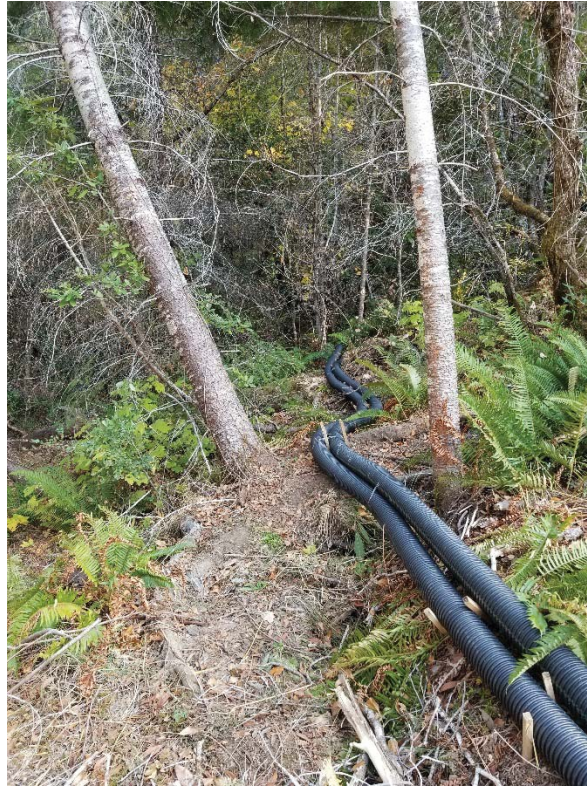
Figure 22: Discharge pipes from GSI directed across area of land instability below reconstructed slope. Photo taken looking northeast on 11/14/18.

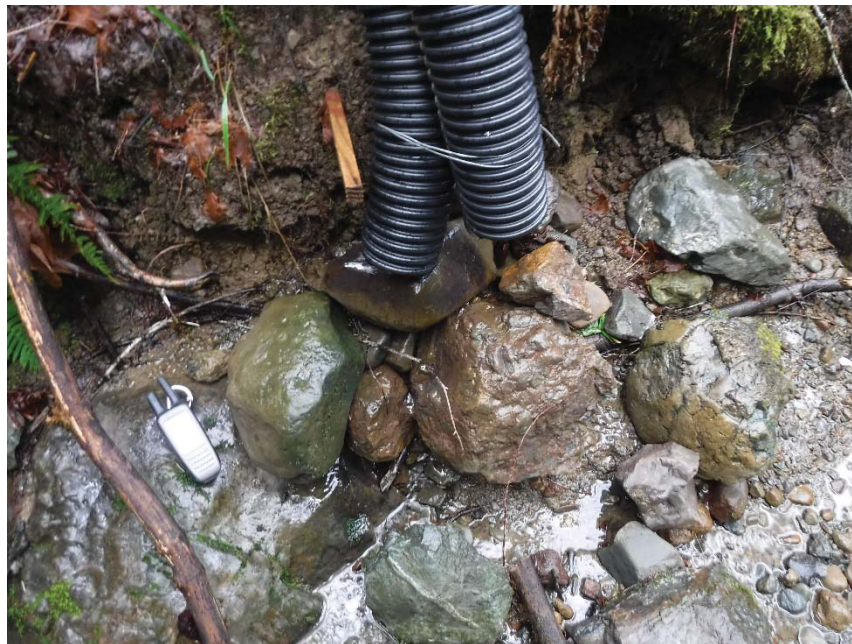
Figure 23: Outlet of the GSI, DP-4, where it drains onto the western bed of the unnamed Class II Salmon Creek tributary. Photo taken 02/28/19.

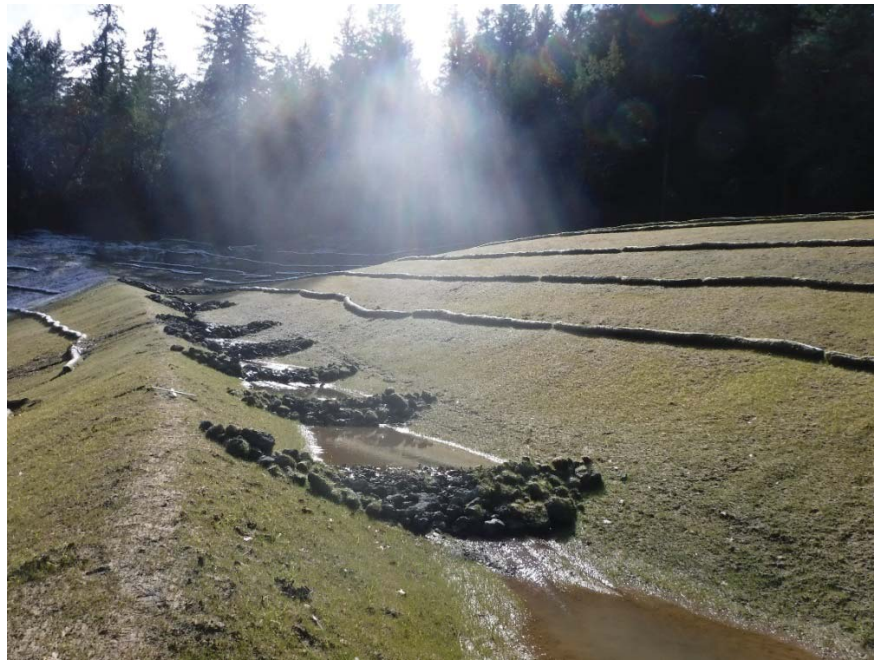
Figure 24: Constructed drainage swale installed to collect sheet flow from the upper reconstructed slope. Photo taken looking east on 02/05/19.

In the initial design of the remediation project, MP-5 was planned to be a reconstructed channel that ran through the former Pond area. The strategy shifted to one that kept as much water away from the project area as possible, so MP-5 was diverted to the east in the constructed swale filled with woody debris. This was accomplished with the installation of a constructed drainage swale for the purpose of collecting any surface sheet or seepage flow that may run over the former Pond area (Figure 24). This drainage swale was installed with check dams to minimize velocity and allow for sediment deposition (Figure 25). The constructed drainage swale continues to the limits of the project area (Figure 26) and then flows to join an existing watercourse, which drains into Salmon Creek [at DP-5] (Figure 27, Figure 28, Figure 29 and **Error! Reference source not found.**).

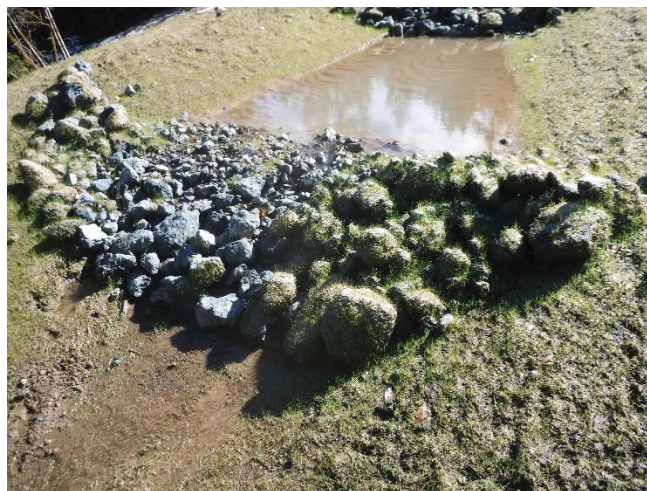
Figure 25: Typical checkdam installed in drainage swale. Photo taken looking upstream (east) on 2/5/19.

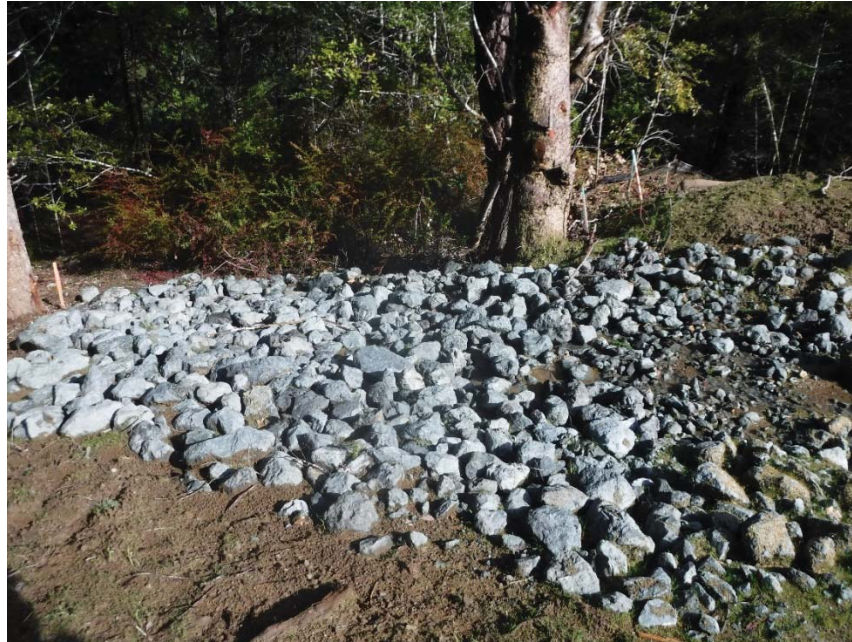
Figure 26: Interface between the project area and downslope, undisturbed area. The flow from the constructed drainage swale passes through a riprap apron into the vegetated area before joining an existing watercourse. Photo taken looking north on 02/05/19.

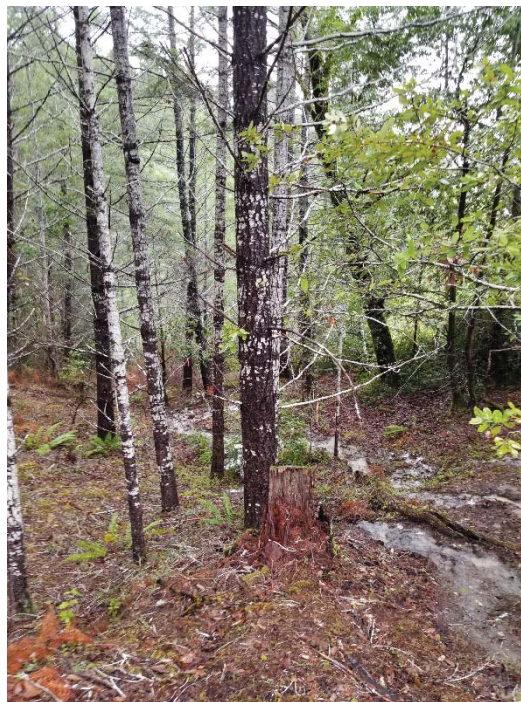
Figure 27: Path of flow from constructed drainage swale into forest just downstream of the armored interface shown in Figure 26. This flow joins an existing Class III watercourse approximately 200 linear feet from this point, which discharges ultimately into Salmon Creek. Photo taken looking northwest on 1/8/19.

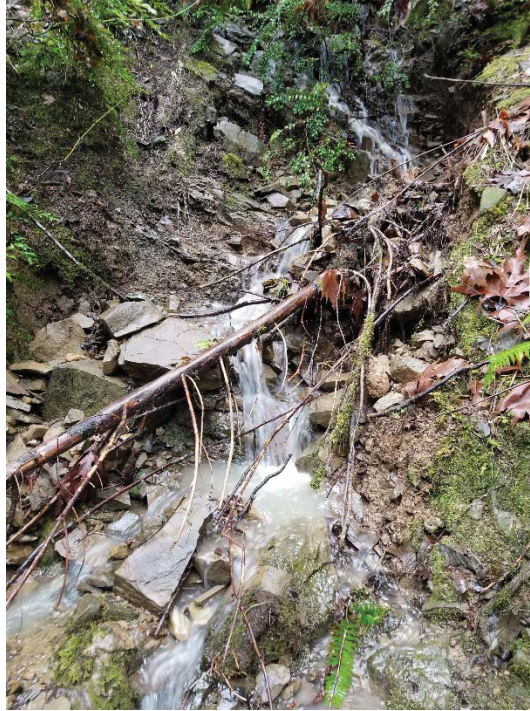
Figure 28: Existing watercourse downstream of the confluence with the flow from the constructed drainage swale, at the confluence of Salmon Creek, DP-5. Photo taken looking south on 1/8/19.

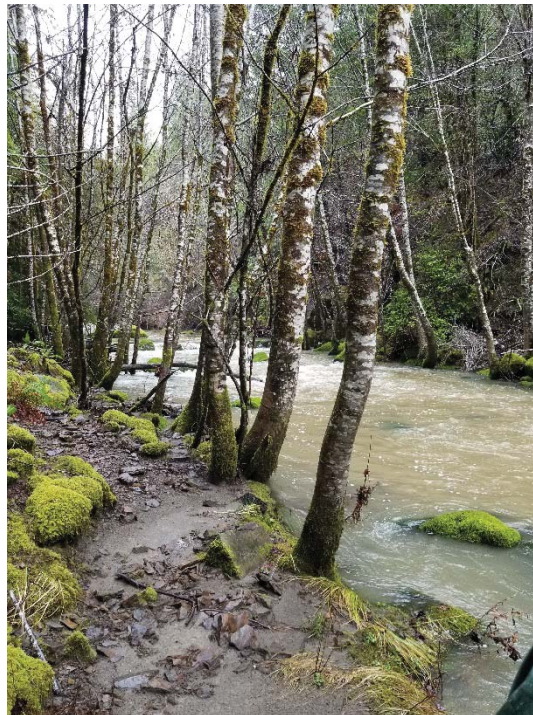
Figure 29: DP-5, at the confluence of Salmon Creek. Photo taken looking west on 02/05/19.

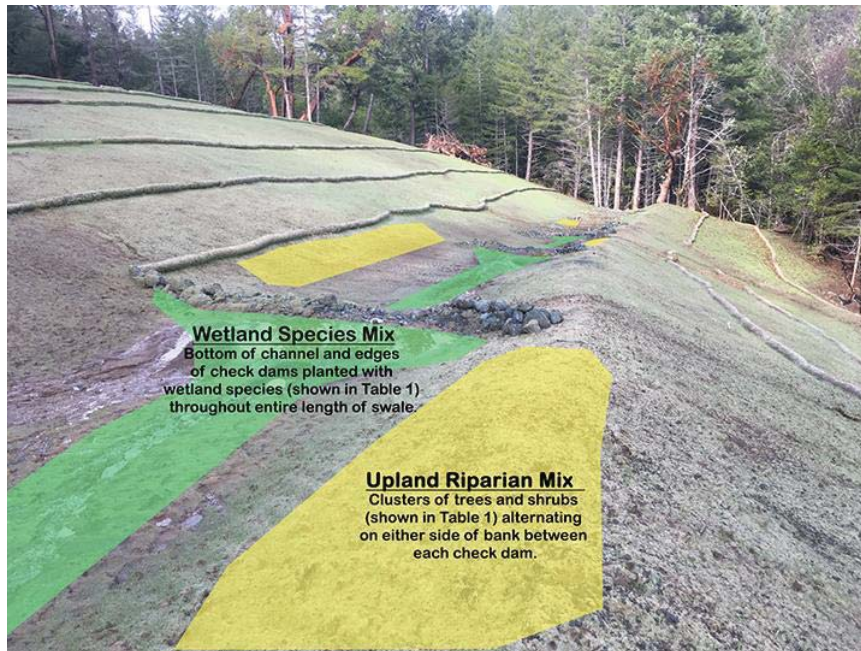
Above: Planting mix layout for the Drainage Swale and Check Dams.

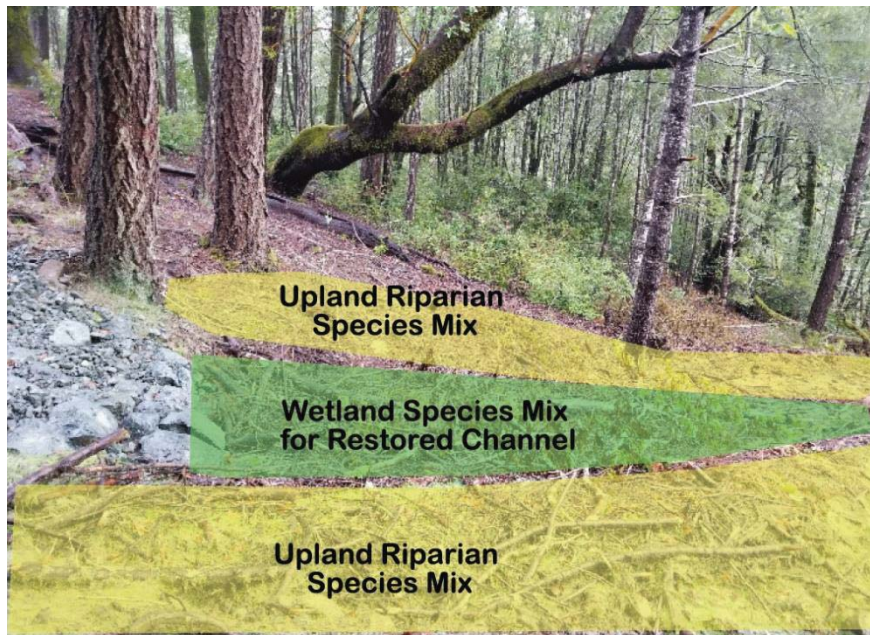
Above: Planting mix layout for site 2 restored channel

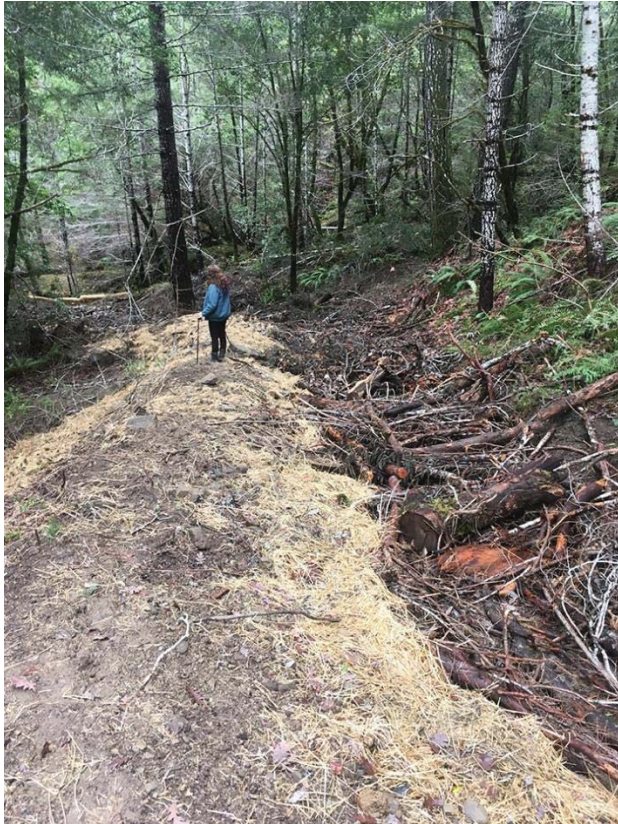
Above: Restored Channel berm to be planted with species mix in table 4.

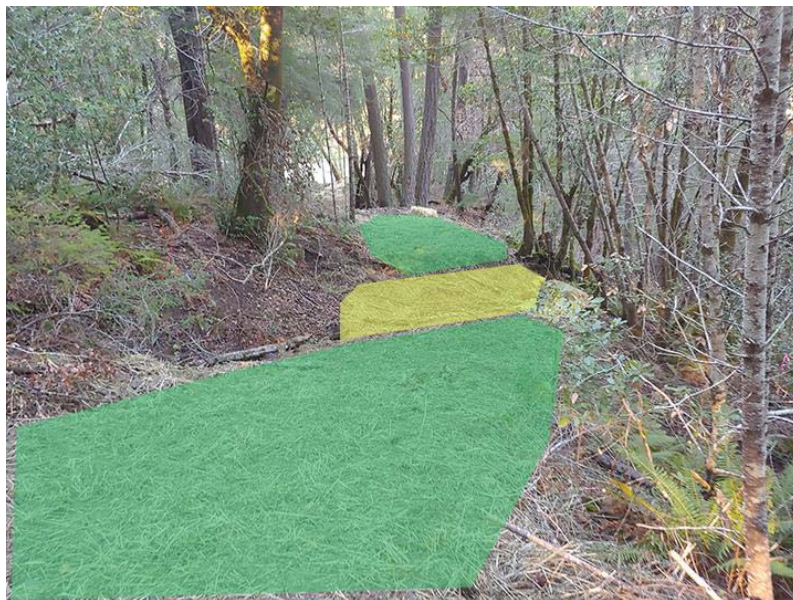
Above: Green represents the upland riparian species mix and the yellow represents the planting location for the wetland species mix for MP-6 shown in table 5.

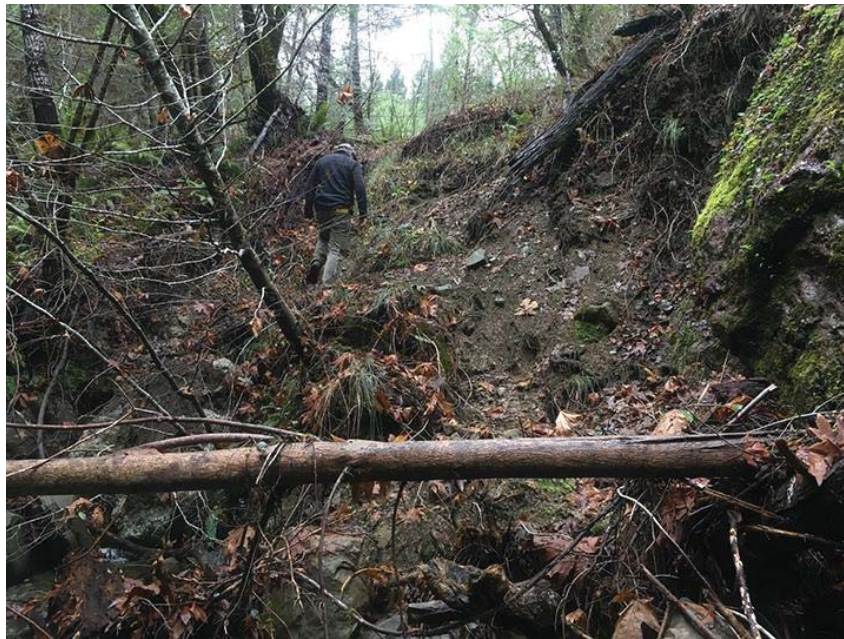
Above: Bare soil areas of the eroded bank to be planted with the species in Table 6.

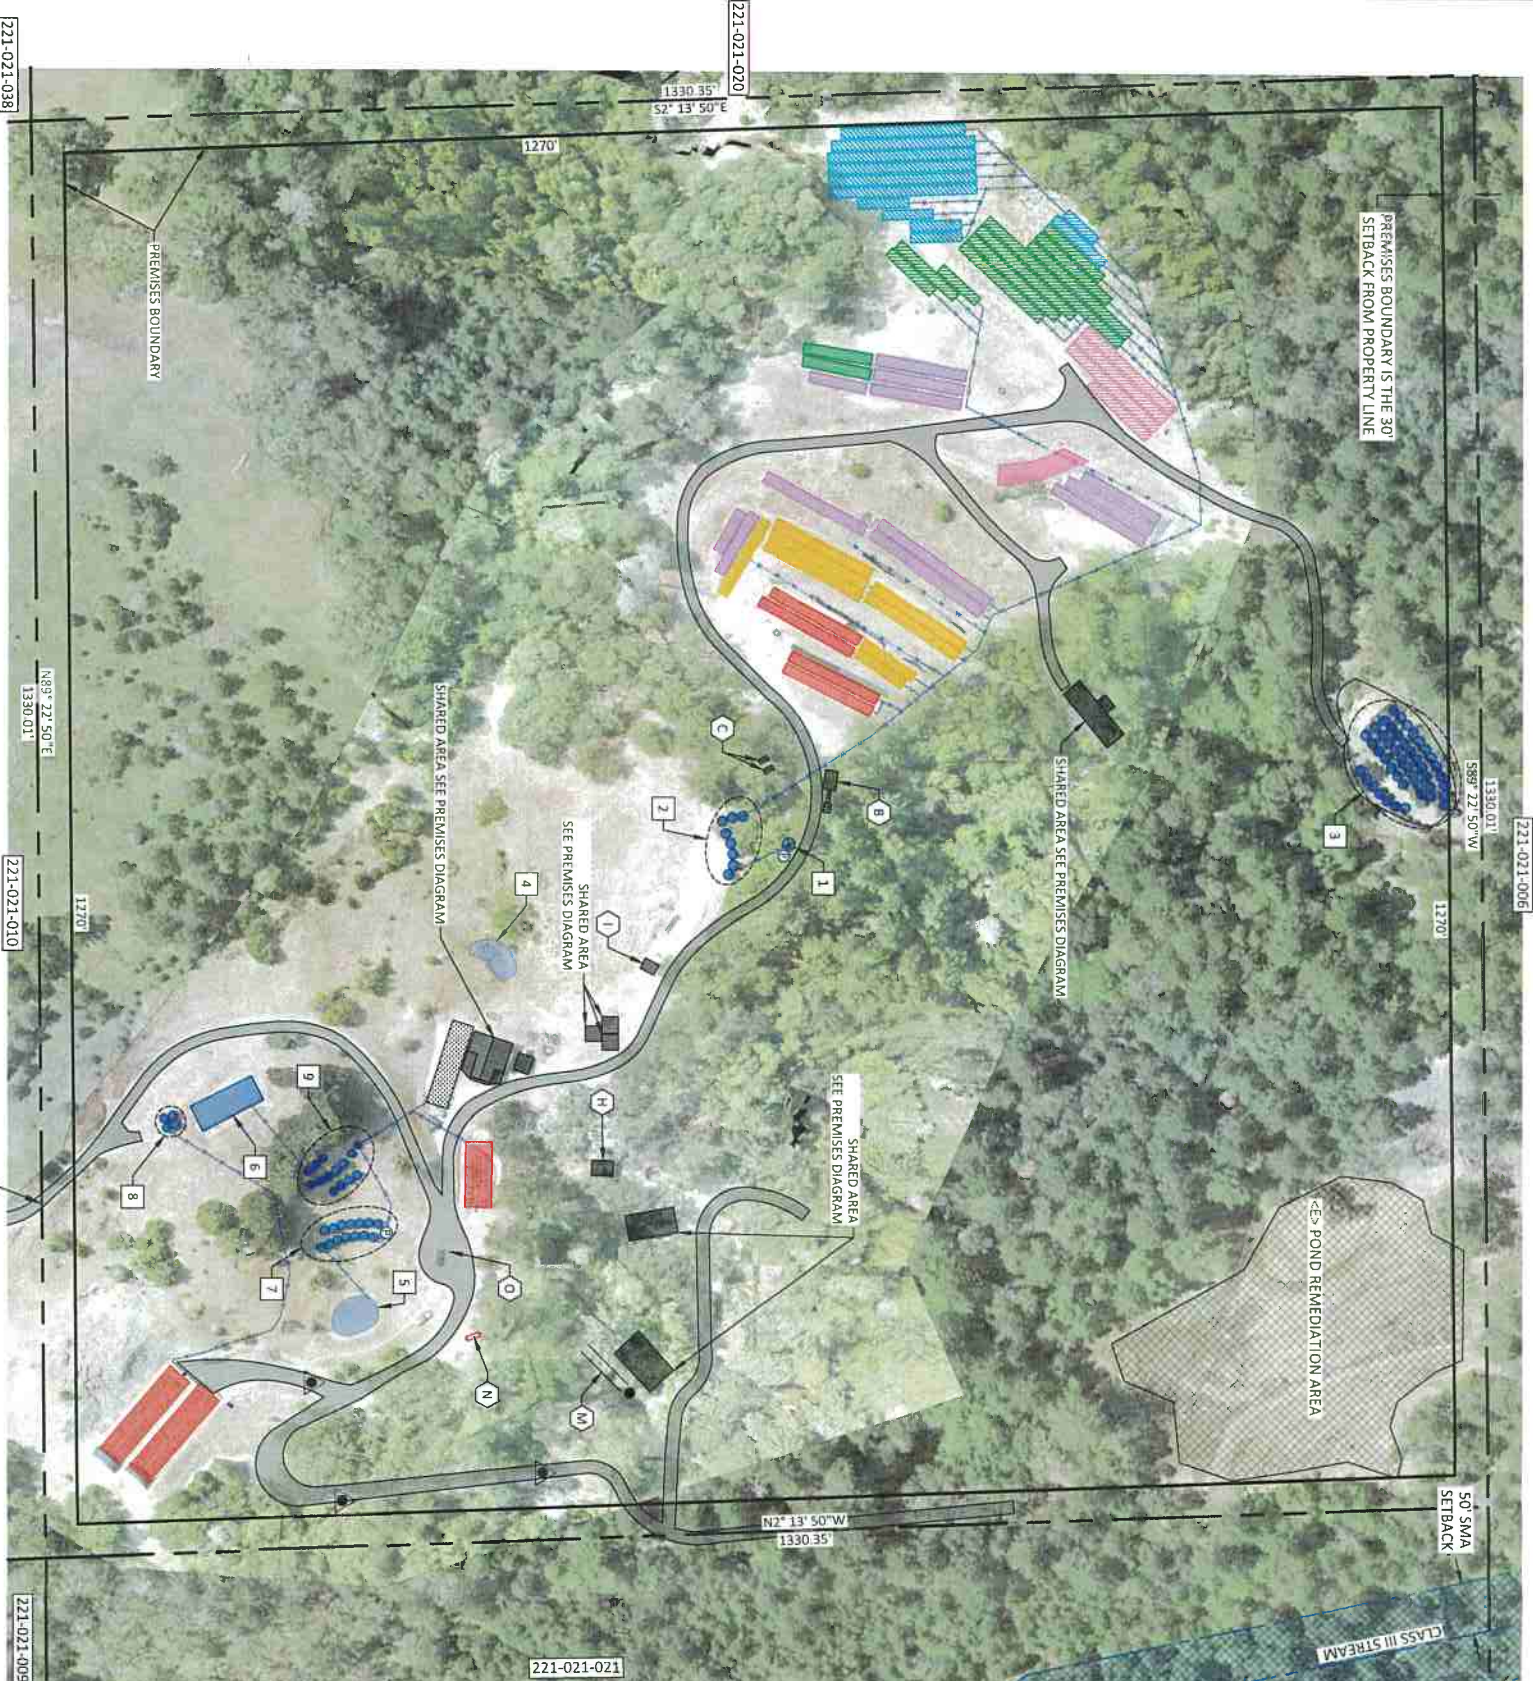
ITEM	DESCRIPTION	QTY	USAGE	TOTAL CAPACITY	LATITUDE	LONGITUDE
1	<E> WELL - WCR# WCR2019-006688 WITH PUMP	1	IRRIGATION	N/A	40.23293611°	-123.93861111°
2	<E> 5,000 GALLON PE TANK	5	IRRIGATION	25,000 GALLONS	40.23305278°	-123.93888889°
3	<E> 1,500 GALLON PE TANK	3	IRRIGATION	4,500 GALLONS		
RAIN CATCHMENT AREA - 9,700 FT FLAT						
3	<E> 5,000 GALLON PE TANK	1	IRRIGATION	5,000 GALLONS	40.23461389°	-123.93316667°
4	<E> 4,250 GALLON PE TANK	44	IRRIGATION	187,000 GALLONS		
4	<E> POND	1	NOT USED	8K	40.23238333°	-123.93861111°
5	<E> POND	1	IRRIGATION	± 50,000 GALLONS	40.23201667°	-123.93722222°
6	<E> WATER BLADDER	1	IRRIGATION	50,000 GALLONS	40.23172500°	-123.93805556°
7	<E> 5,000 GALLON PE TANK WITH PUMP	14	IRRIGATION	70,000 GALLONS	40.23202500°	-123.93750000°
8	<E> 5,000 GALLON PE TANK	4	IRRIGATION	20,000 GALLONS	40.23344444°	-123.93777778°
8	<E> 5,000 GALLON PE TANK	7	IRRIGATION	35,000 GALLONS		
8	<E> 5,000 GALLON PE TANK	5	IRRIGATION	15,000 GALLONS	40.23198889°	-123.93777778°

9	<E> 2,500 GALLON PE TANK	2	IRRIGATION	5,000 GALLONS

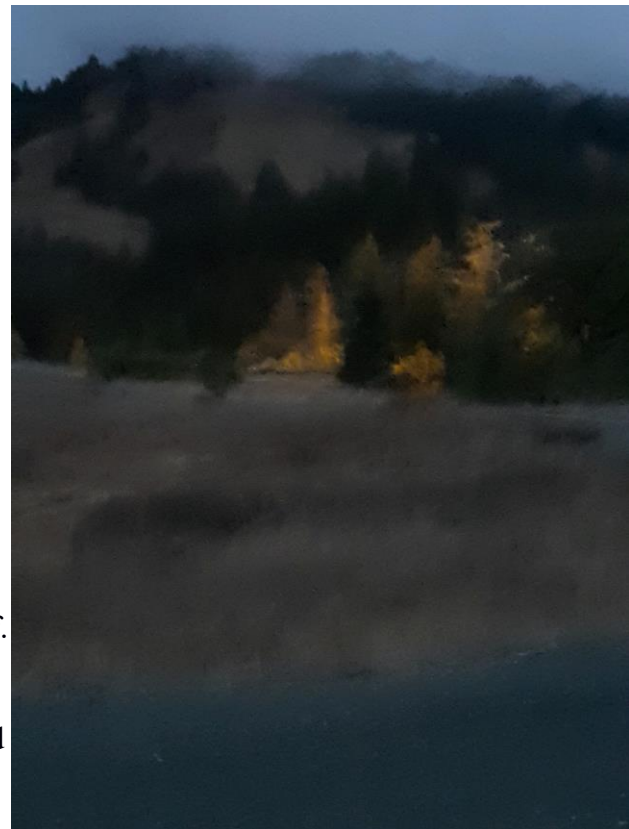
Illustration 2: Lights from greenhouse on September 18, 2021.

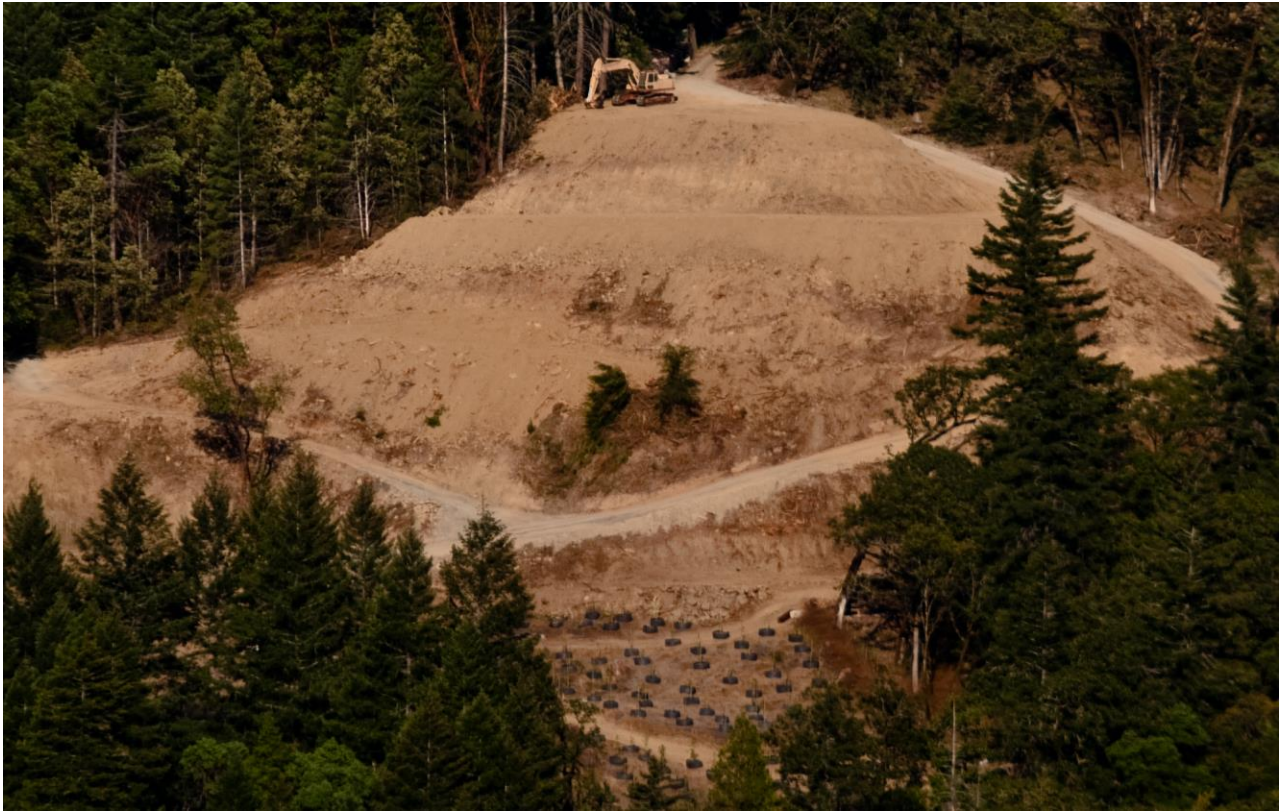
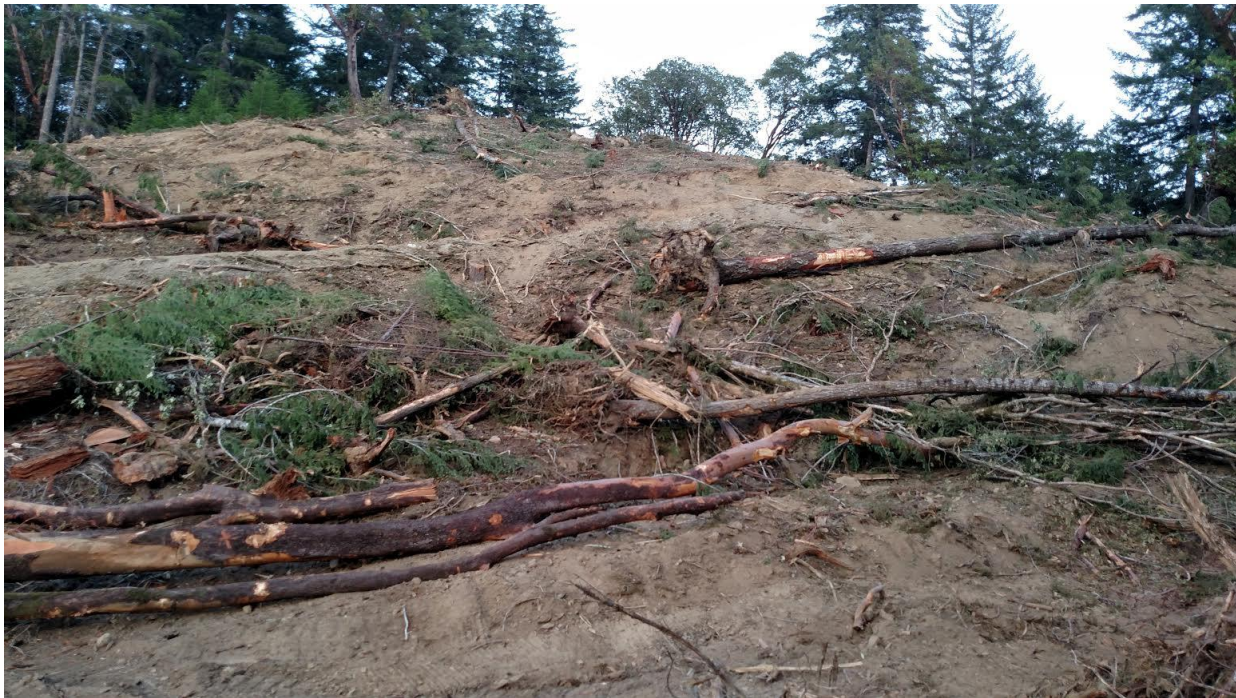
- Significant unconsolidated fill adjacent to drainages leading directly to Salmon Creek
- Grading and over steepened cut slopes that present significant erosion and sediment transport threats to local drainages and Salmon Creek
- Complete removal of nearly all stumpage and understory vegetation down to bare, and unconsolidated/un-compacted soil
- General excavation unnecessary for the purpose of timber harvest
- No erosion control efforts whatsoever
- Photos:
