LINDBERG GEOLOGIC CONSULTING
David N. Lindberg, Certified Engineering Geologist

**ENGINEERING GEOLOGIC R-1
SOILS EXPLORATION REPORT**

Proposed New Residence
141 Cove Point East
Shelter Cove, California

LGC Project No. 0518.00
(707) 442-6000

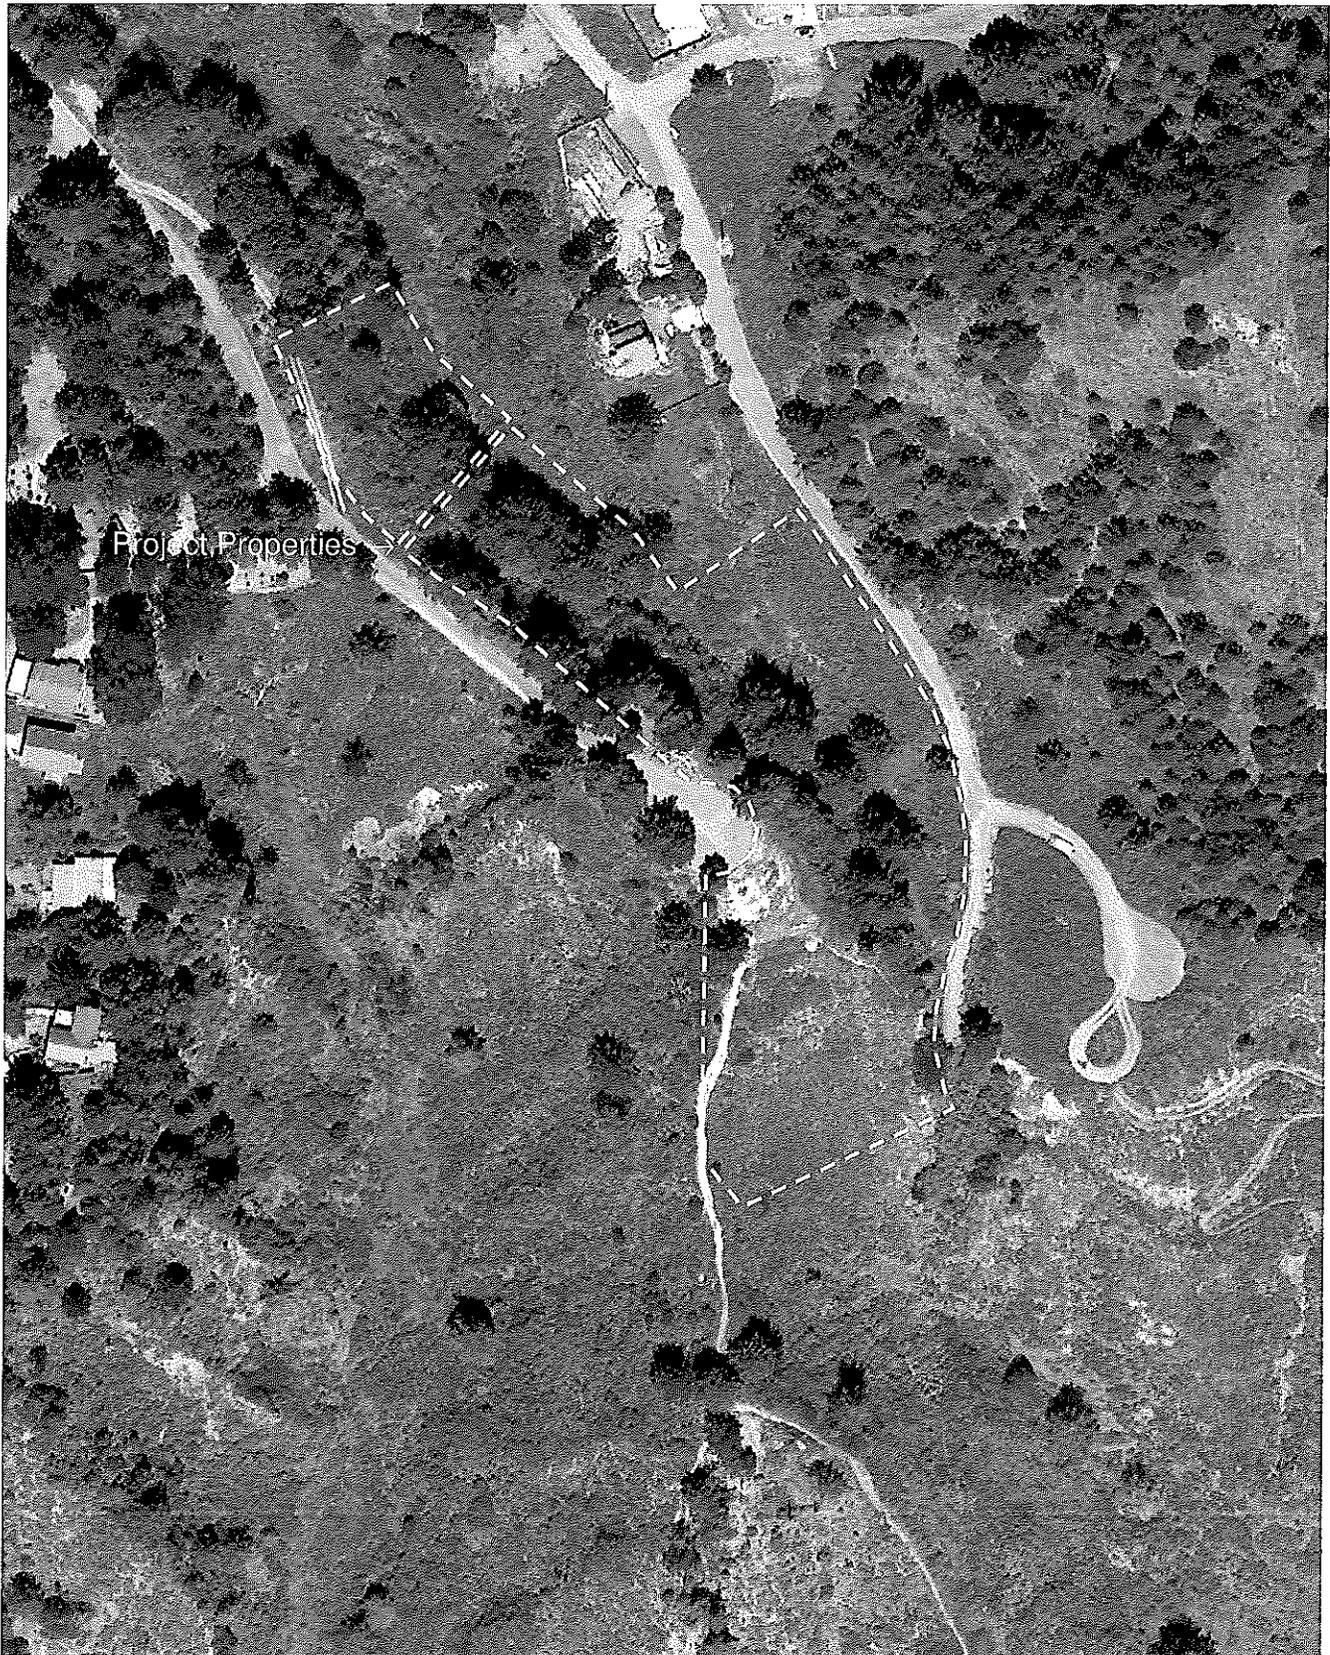
| (707) 442-6000 | Satellite Image of Project Location (all locations approximate) | 1" ≈ 150' |

Modified from: Google Earth Imagery of April 21, 2019. N ≈

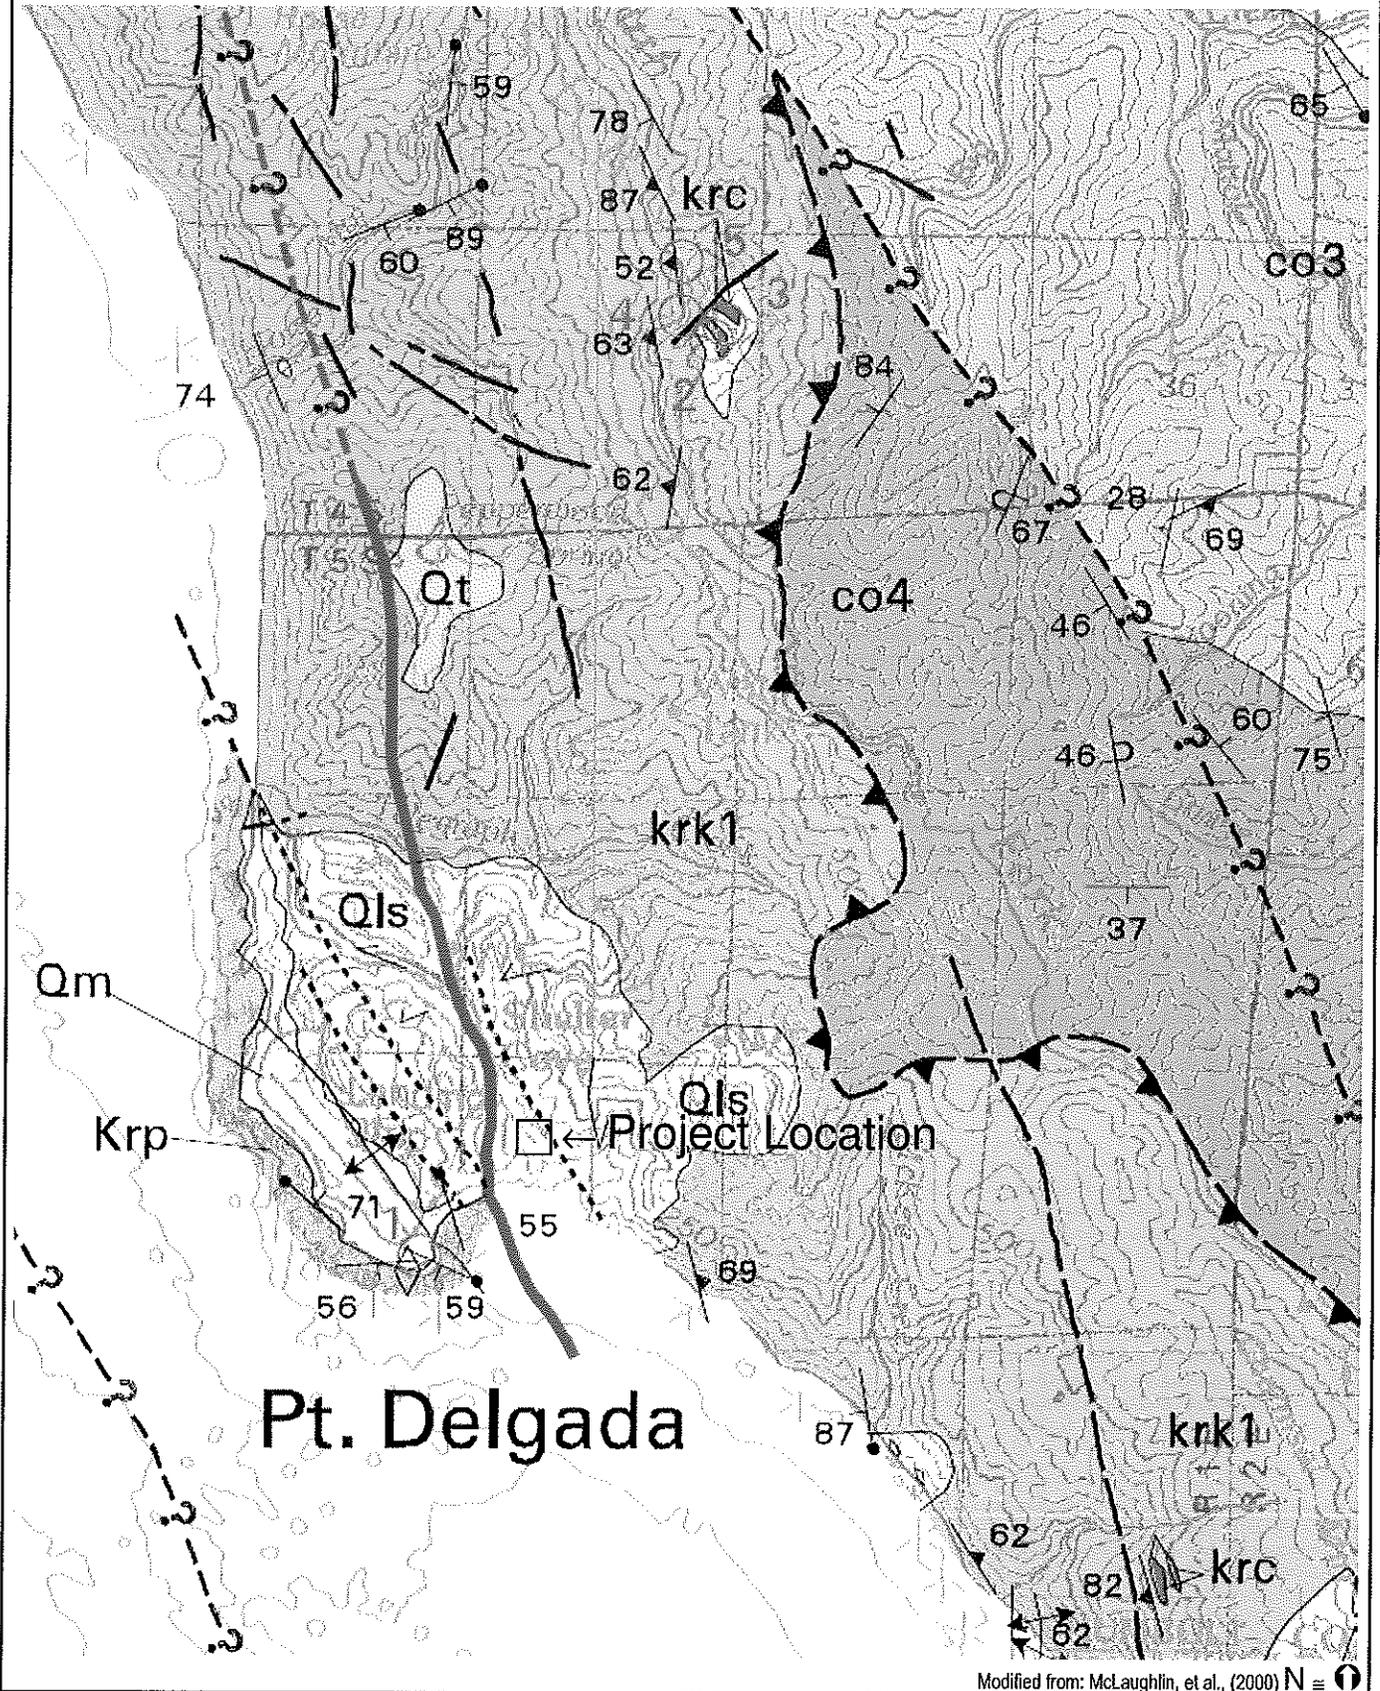
| Lindberg Geologic Consulting | Engineering-Geologic R-1 Soils Report | Figure 5a |

| (707) 442-6000 | Geologic Map (all locations approximate) | 1" ≈ 3,600' |

Modified from: McLaughlin, et al., (2000) N = [North Arrow]

This parcel is located within the Coast Ranges Geologic Province of California, a seismically active region in which large earthquakes are expected to occur during the economic life span (50 years) of any developments on the subject property. On the Geologic Map of California, Redding Sheet (CDMG, 1962), the project area is mapped as Jurassic - Cretaceous Franciscan Formation (KJf).

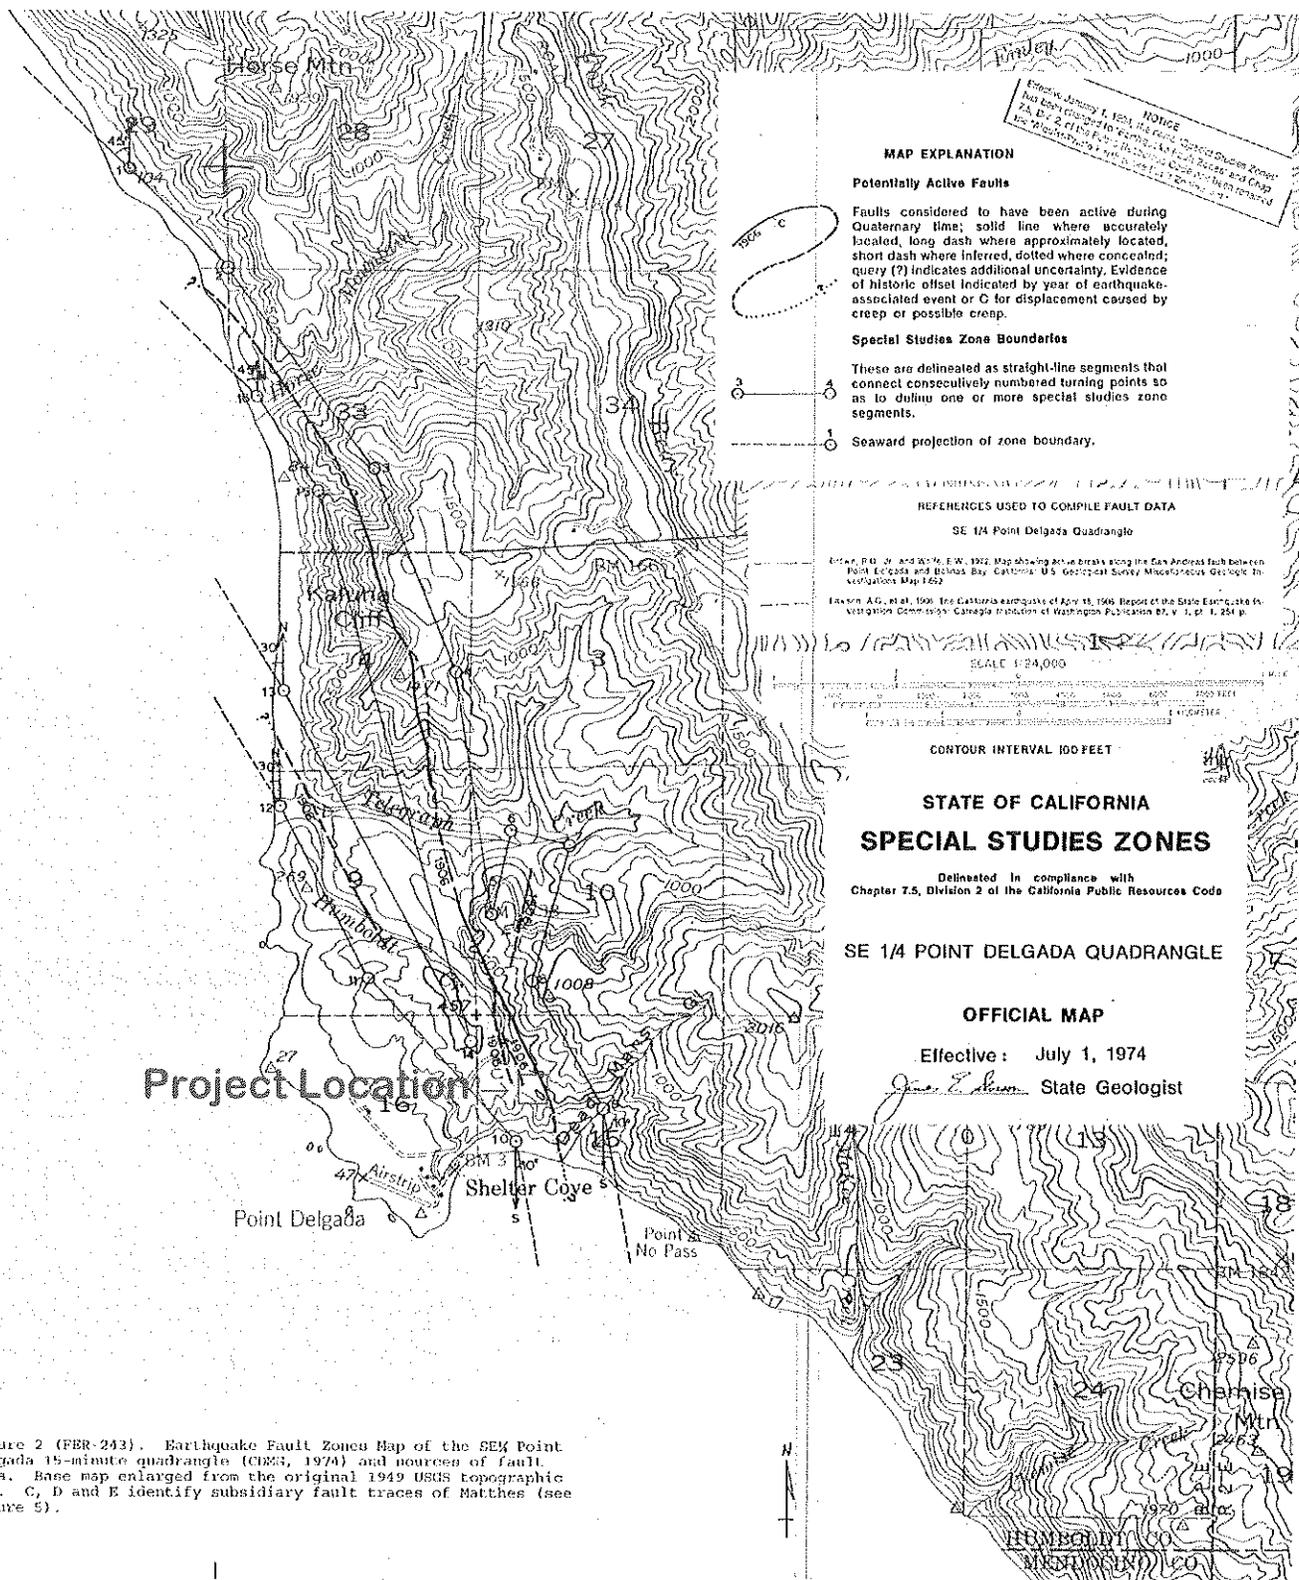
| (707) 442-6000 | Shelter Cove Fault Zone Map (all locations approximate) | 1" ≈ 3,900' |

Figure 2 (FER-243). Earthquake Fault Zones Map of the SE 1/4 Point Delgada 15-minute quadrangle (CE83, 1974) and sources of fault data. Base map enlarged from the original 1949 USGS topographic map. C, D and E identify subsidiary fault traces of Matthes (see Figure 5).

Modified from: Fault Evaluation Report FER-243 San Andreas Fault, Shelter Cove Area, Humboldt County, California Division of Mines and Geology, Earl W. Hart, December 3, 1996.

In response to the first area of concern, this site is located within the Fault Hazard (Special Studies) Zone associated with the northern San Andreas fault where surface rupture may be a hazard. The level of anticipated shaking at the site is a function of the magnitude of the postulated earthquake on a given fault system, and the shortest distance from the fault system to the site. A detailed discussion of this process has been presented by Seed and Idriss (1982).

It is believed that the north coast segment of the San Andreas fault moves in conjunction with events like the great San Francisco earthquake of 1906. Estimates of peak acceleration at this site are presented later in this report. The San Francisco earthquake of 1906 caused surface rupture nearby, on the north side of the subject property within the present-day Shelter Cove subdivision. The surface trace of the San Andreas fault is mapped northeast of the property between Cove Point East and Landis Road, as is the special studies zone designated by the State of California.

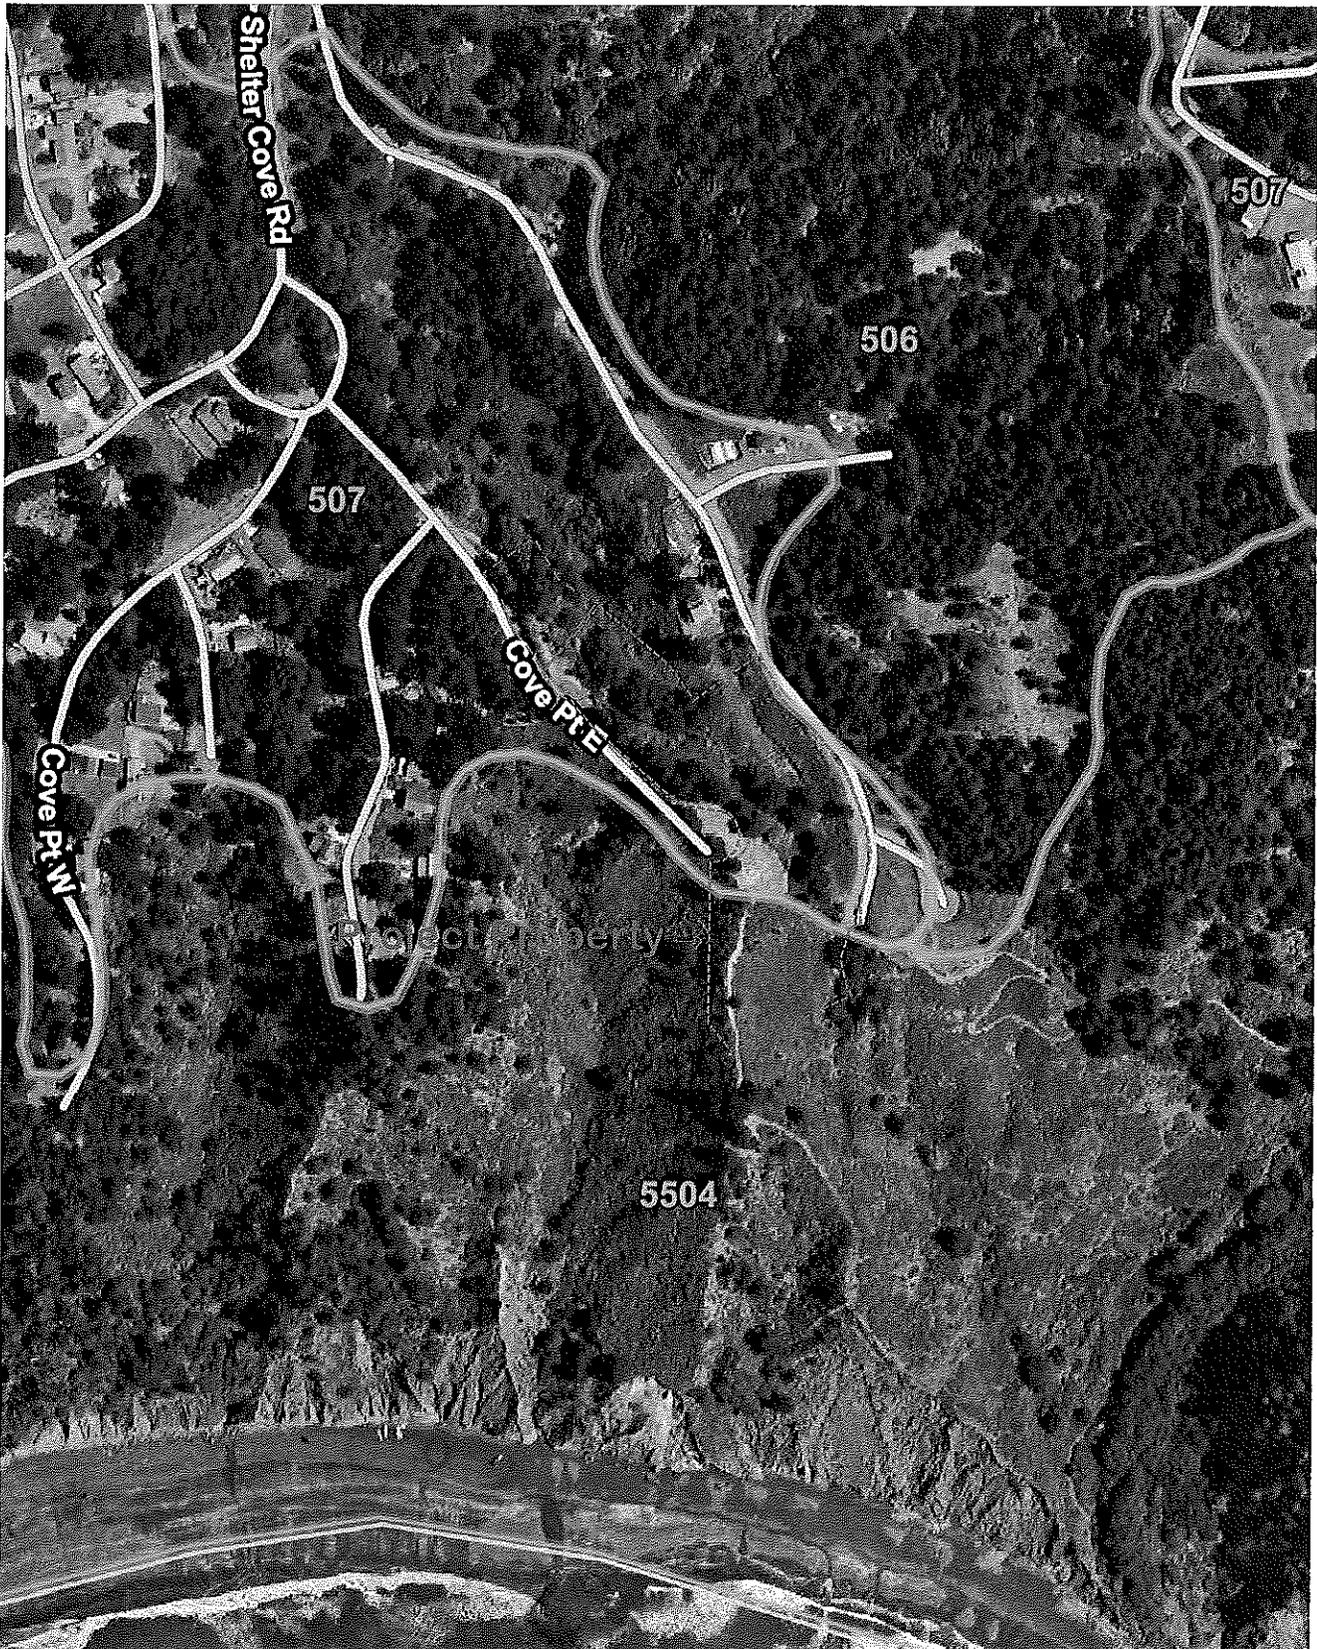
| (707) 442-6000 | USDA-NRCS Soil Map (all locations approximate) | Scale not Determined |

Humboldt County, South Part, California

507—Northbear-Caperidge-Capetown complex, 5 to 30 percent slopes

National map unit symbol: 2mhfz
Elevation: 20 to 2,800 feet
Mean annual precipitation: 45 to 90 inches
Mean annual air temperature: 50 to 54 degrees F
Frost-free period: 240 to 330 days
Farmland classification: Not prime farmland

This proposed residence is sited on a flat on the slope above Shelter Cove and the Pacific Ocean. As observed in road cut exposures near this site, this, and other nearby lots in the Shelter Cove subdivision, are underlain by native bearing soils consisting primarily of loam. For engineering purposes, these soils are characterized as sandy clay with fine gravel (CL) with less than 10 percent (estimated), sandstone rock fragments in a matrix of clay with silty fine sand. Topsoil was observed to be thin (>1 ft.) on these southwest facing slopes. A thin prism of side cast fill from subdivision development and historic road construction can be anticipated along the edges of the flat area. Soil distribution is shown in Figure 7, and the soil map unit description is attached.
