# Wetlands Habitat Mitigation & Monitoring Plan\_Rev1

**We Are Up Housing Project**

24 March 2025

# Aquatic Resources Delineation and Sensitive Habitat Report

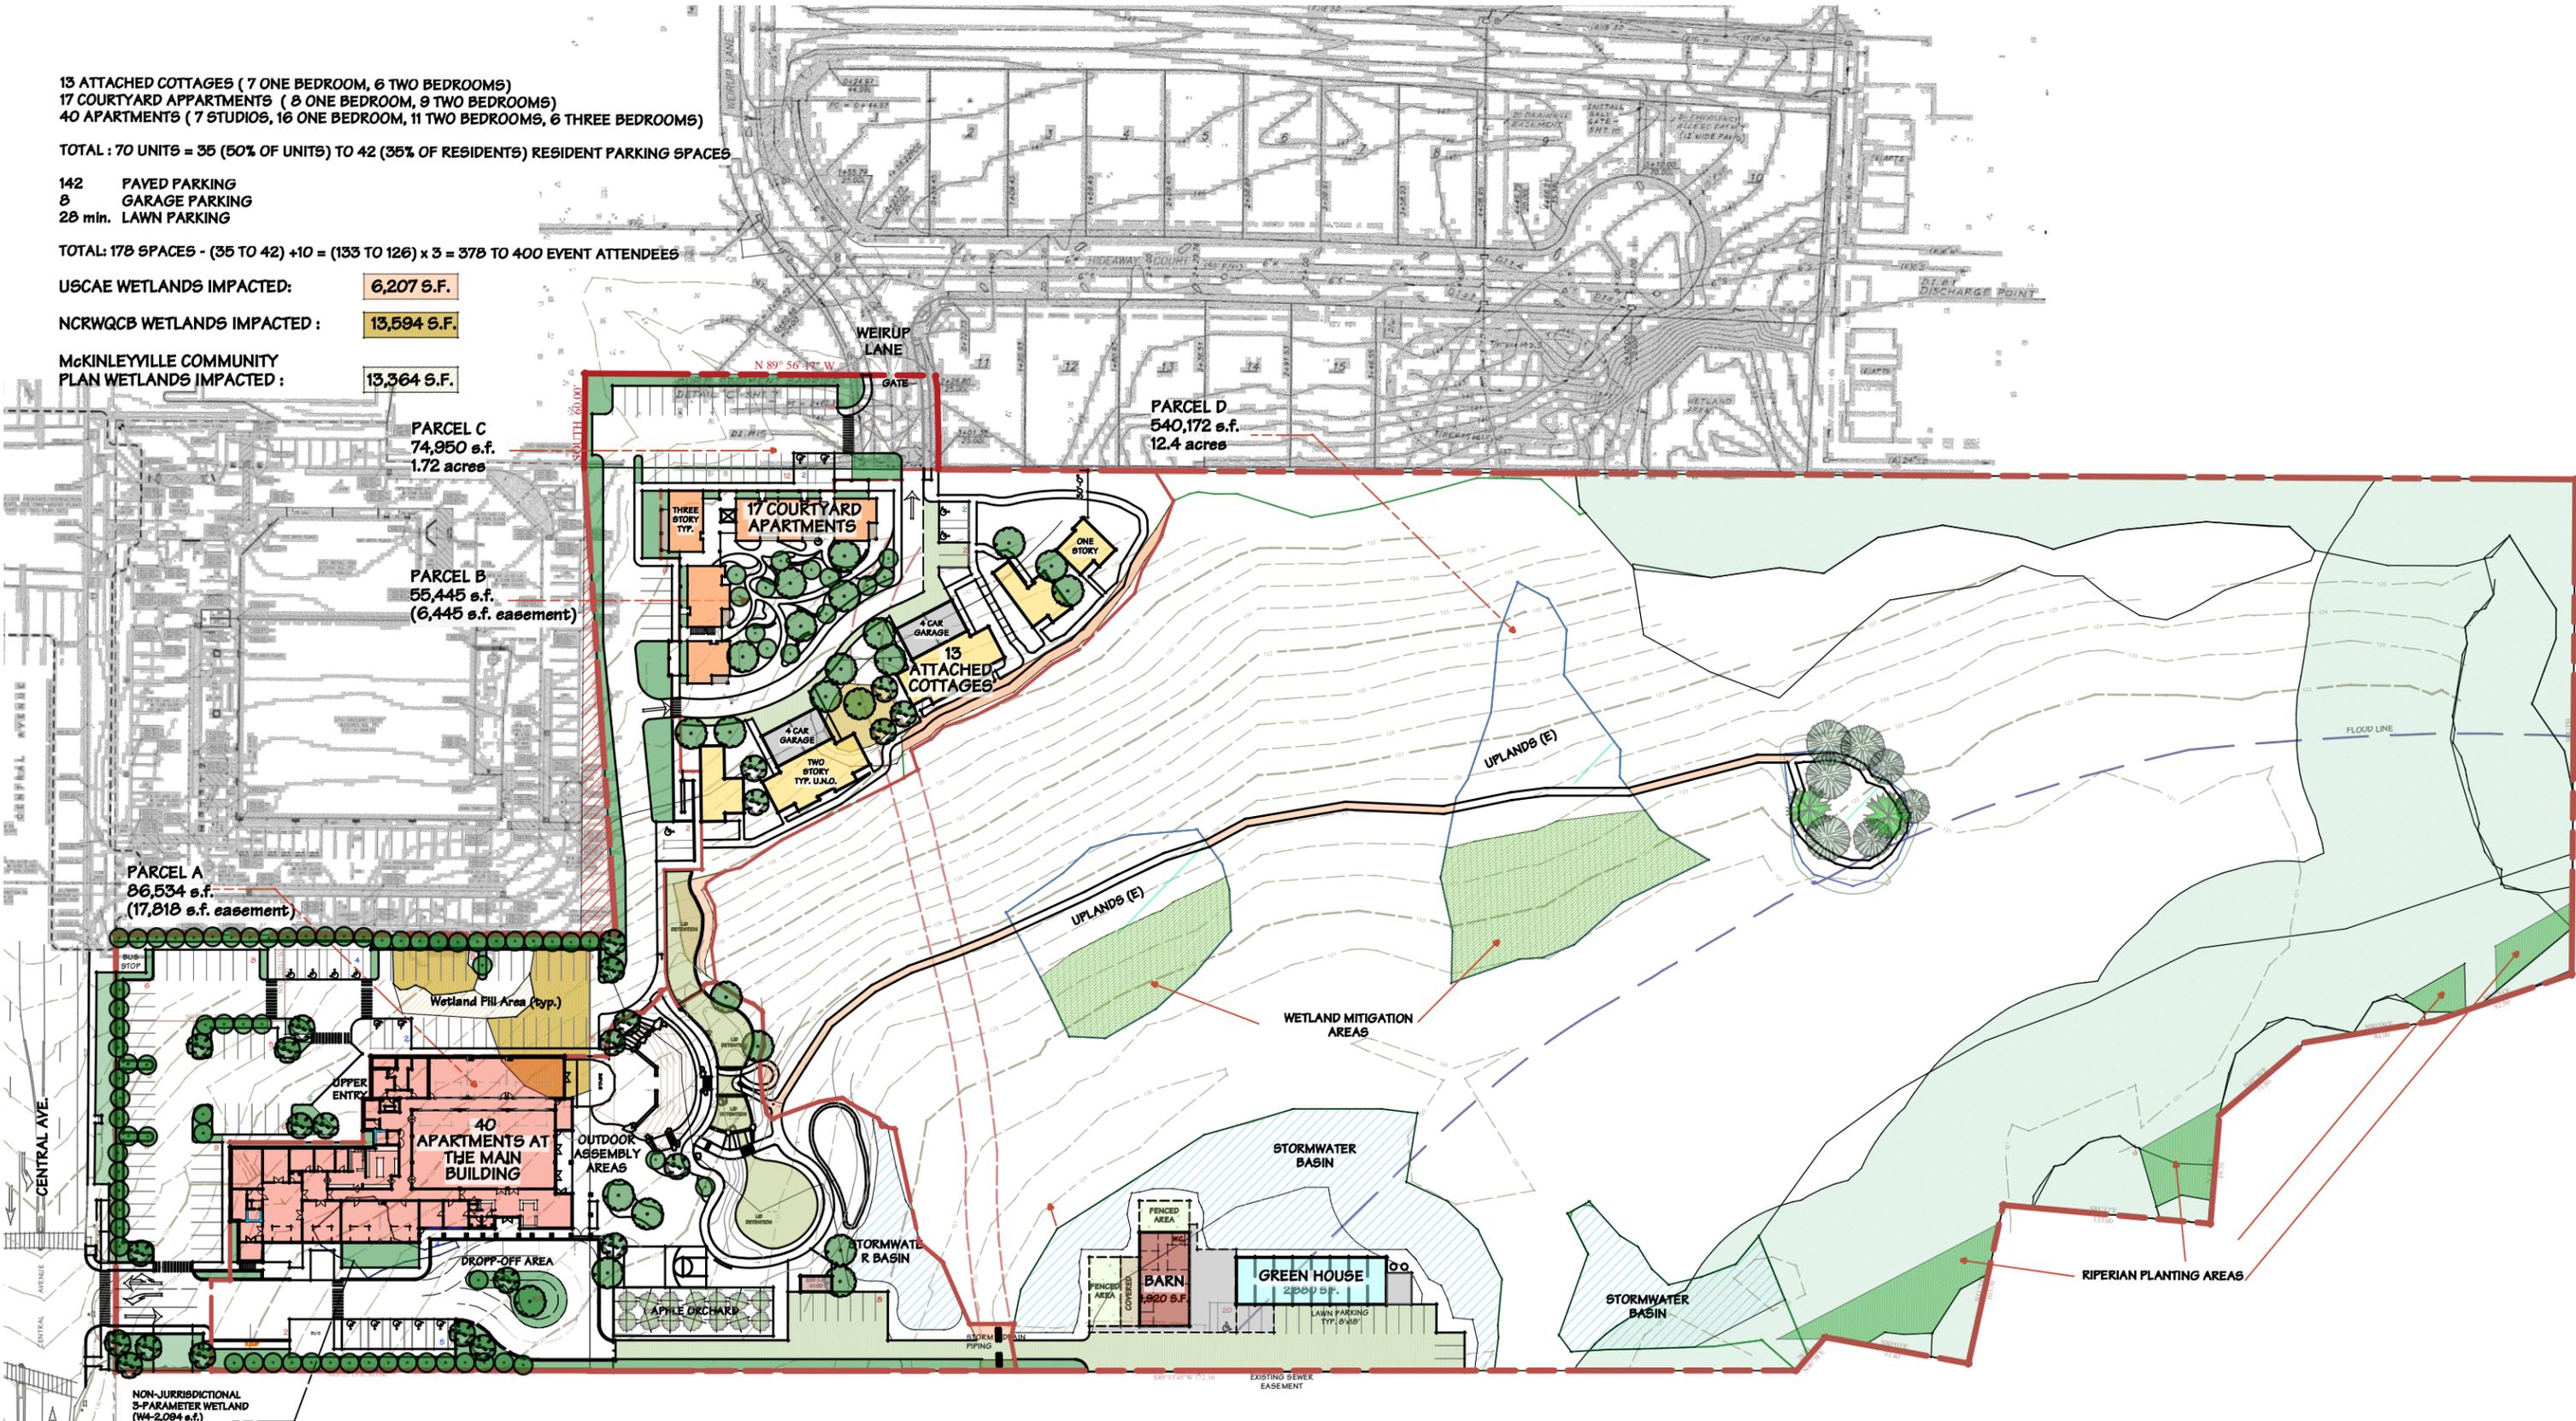
# OVERALL SITE PLAN

NCRWQCB WETLANDS IMPACTED : **13,594 S.F.**

McKINLEYVILLE COMMUNITY PLAN WETLANDS IMPACTED : **13,364 S.F.**

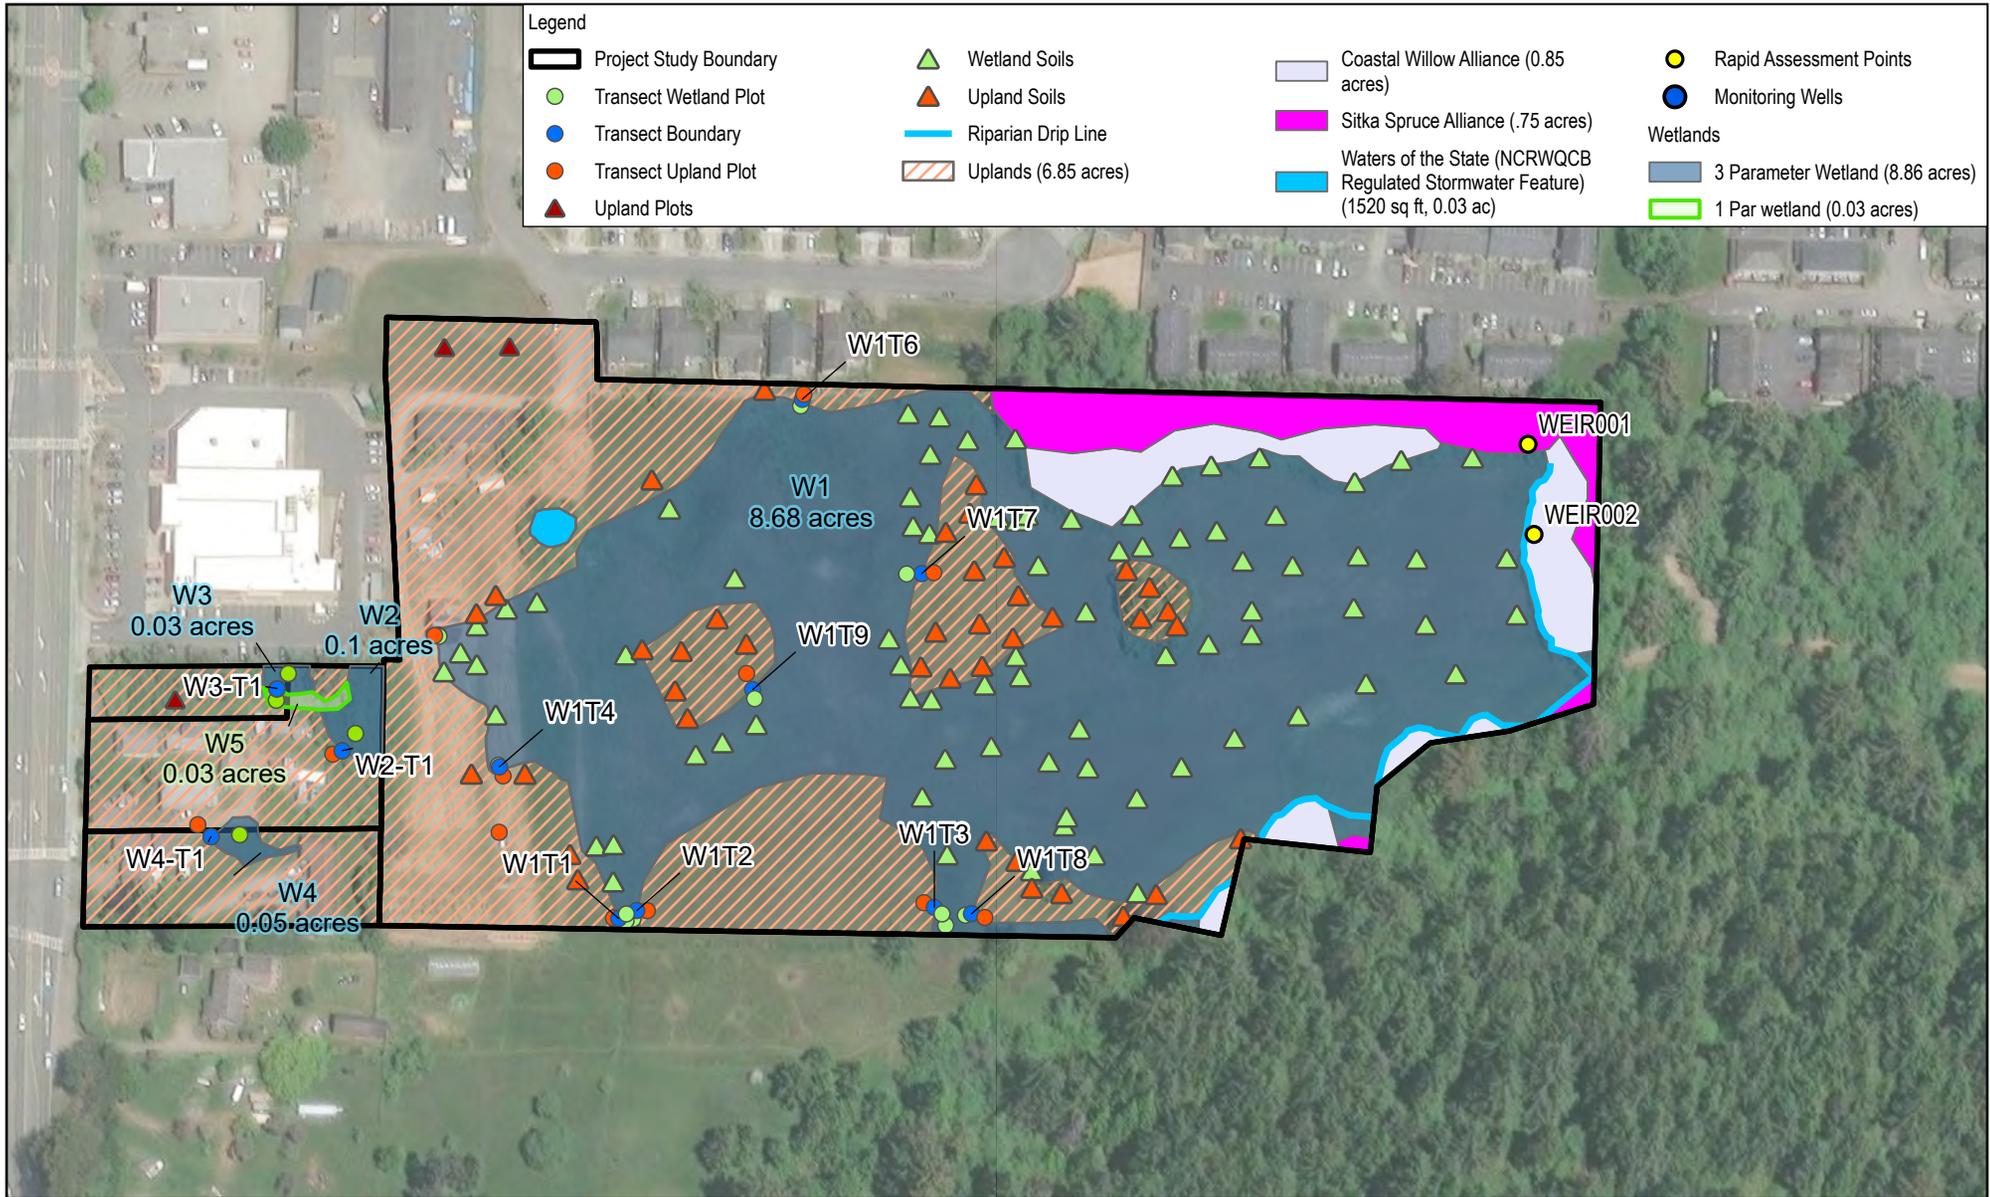
**FIGURE 3**

Four three-parameter wetlands and one one-parameter wetland were identified and mapped as shown in **Figure 3**. There were two Sensitive Natural Communities (SNCs) observed within the PSB. The total area of three-parameter wetlands mapped within the PSB is 8.86 acres, the total area of one-parameter wetlands mapped within the PSB is 0.03 acres, and the total area of SNCs mapped within the PSB is 1.6 acres (**Appendix A, Figure 3**).

Wetland Delineation and  
Sensitive Habitats

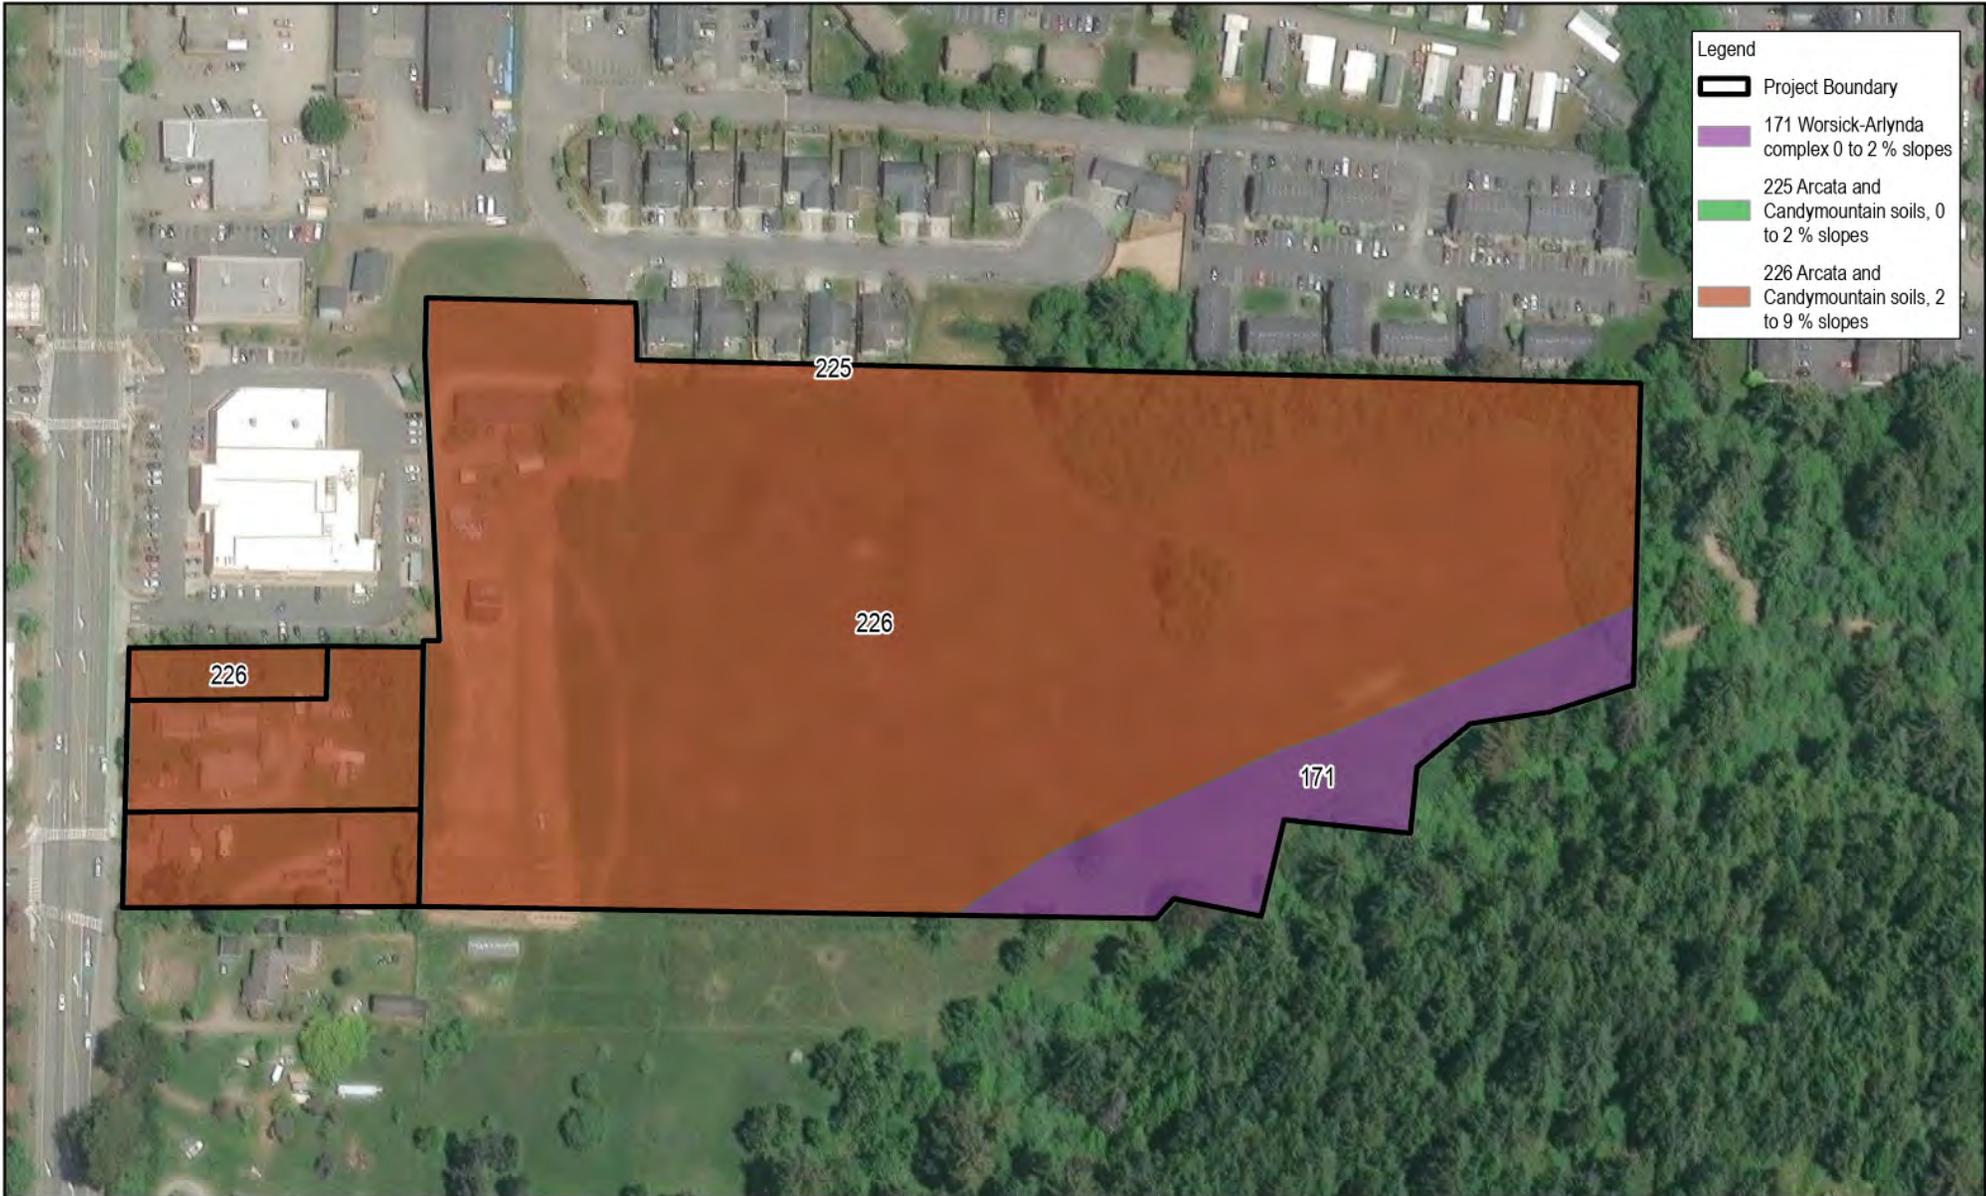
**FIGURE 4**

NRCS Soil Survey

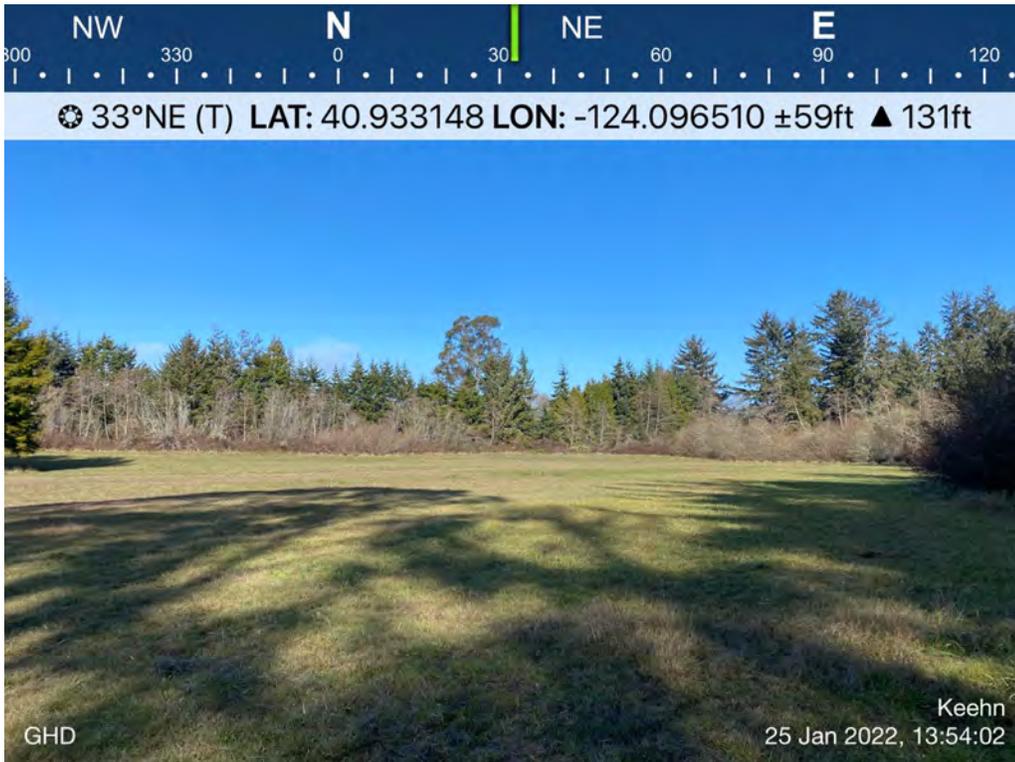
Photo 2. The northeastern edge of the PSB, showing the Coastal Willow Alliance backed by the Sitka Spruce Alliance behind it.

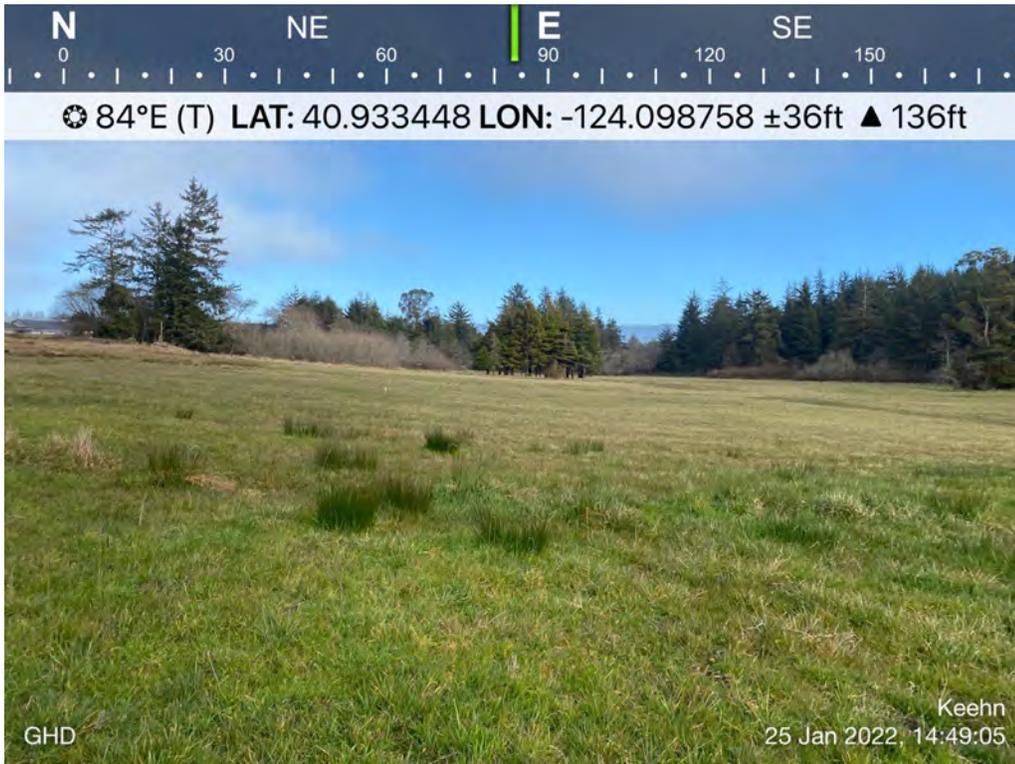
Photo 6. Viewing more hydrophytic vegetation within Wetland 1, present on the upper slope.

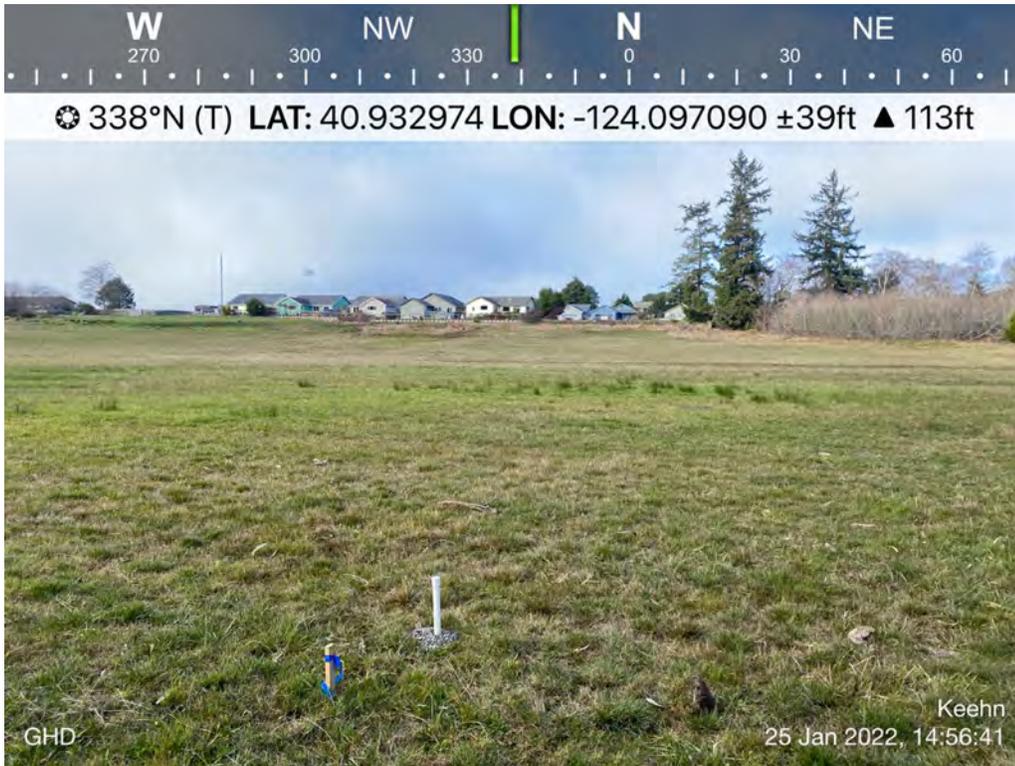
Photo 7. Viewing a swale at the base of the slope within Wetland 1.

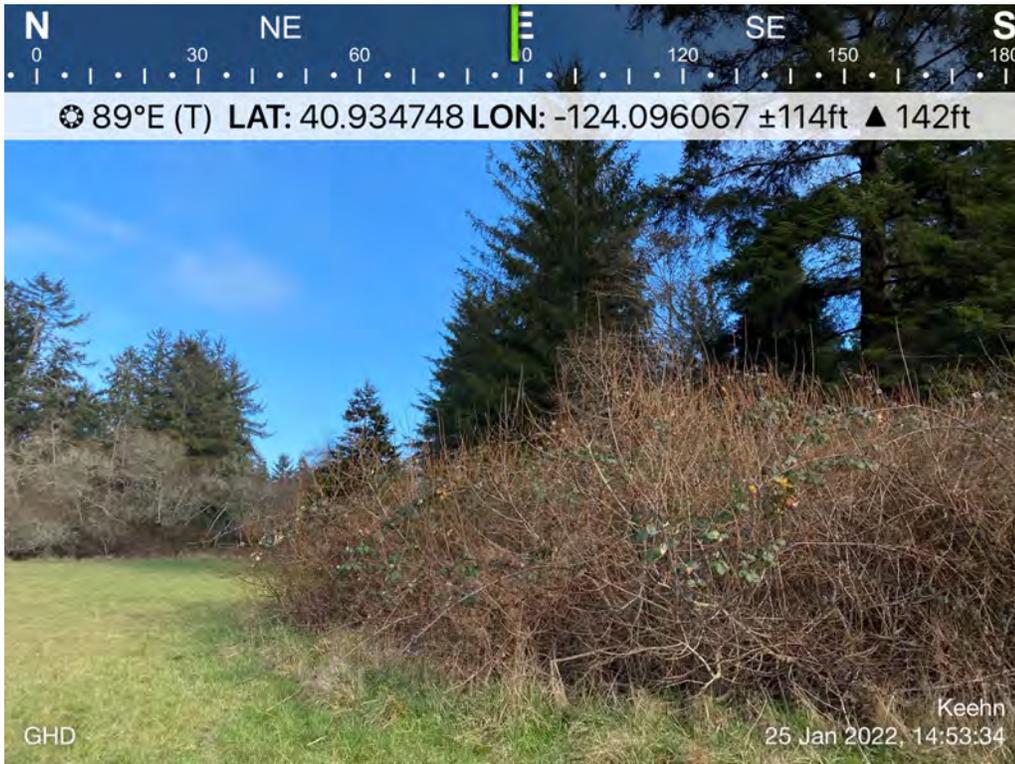
Photo 8. Dormant Coastal Willow Alliance SNC within the riparian corridor of Mill Creek.

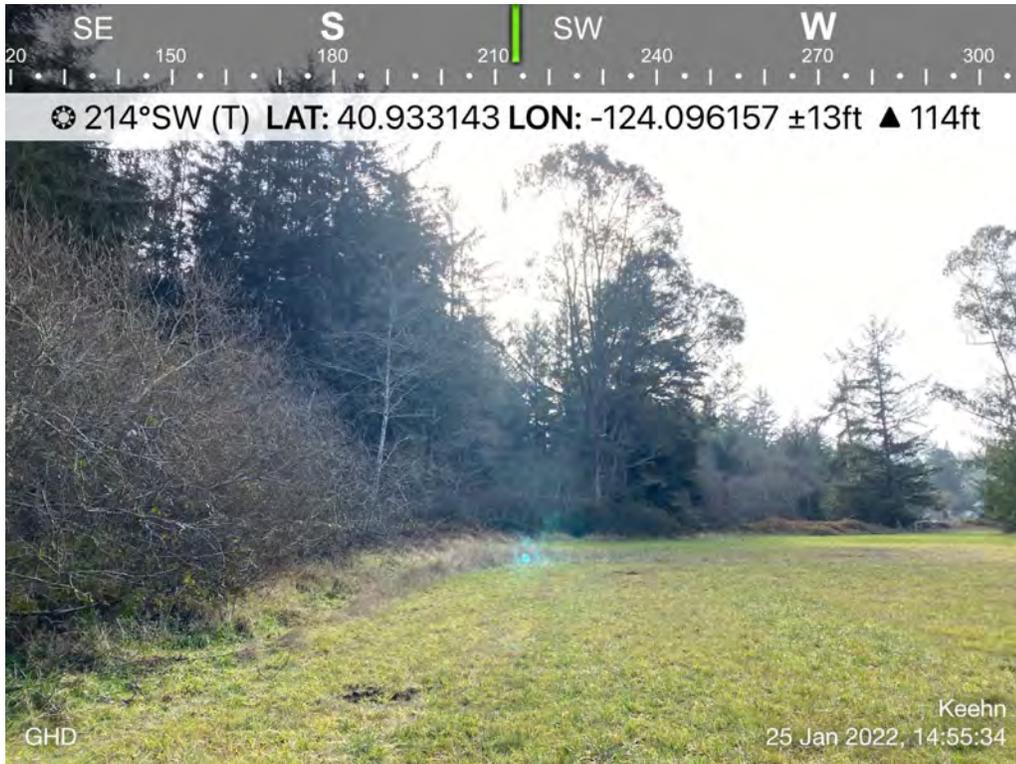
Photo 9. SNCs Coastal Willow Alliance backed by Sitka Spruce Alliance within the riparian corridor of Mill Creek.

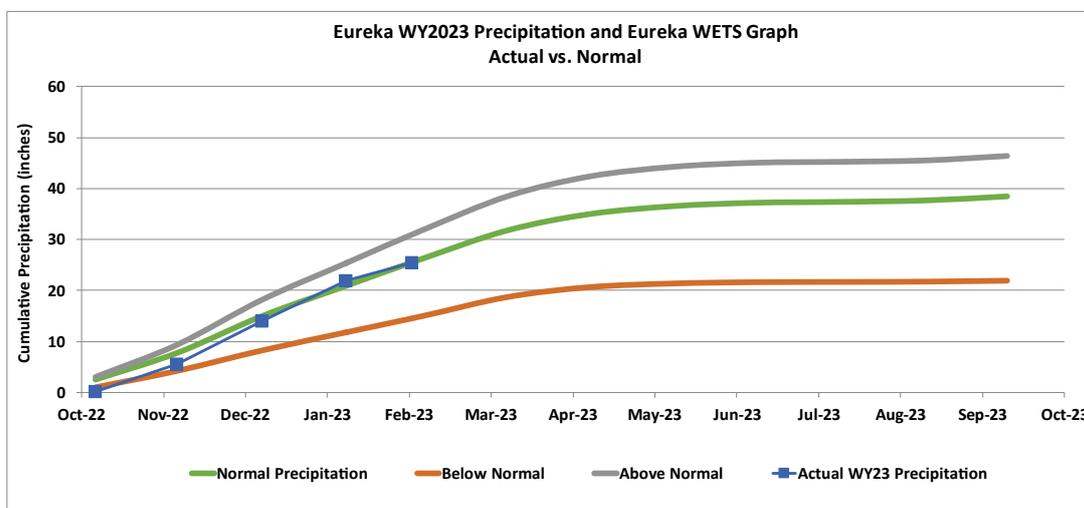
Rainfall data (as of February 24, 2023) for Eureka for the 2023 water year (October 1, 2022, to September 30, 2023) is shown in **Figure 1**. Below normal, normal, and above normal rainfall data from the WETS Table for Eureka are shown for comparison.

*Figure 1 Eureka, California WY 2023 Precipitation and WETS graph*
