# **Preliminary Jurisdictional Wetland and Other Waters Delineation**

**Emerald Family Farms, LLC  
Willow Creek, California**

September 2016  
016225.003

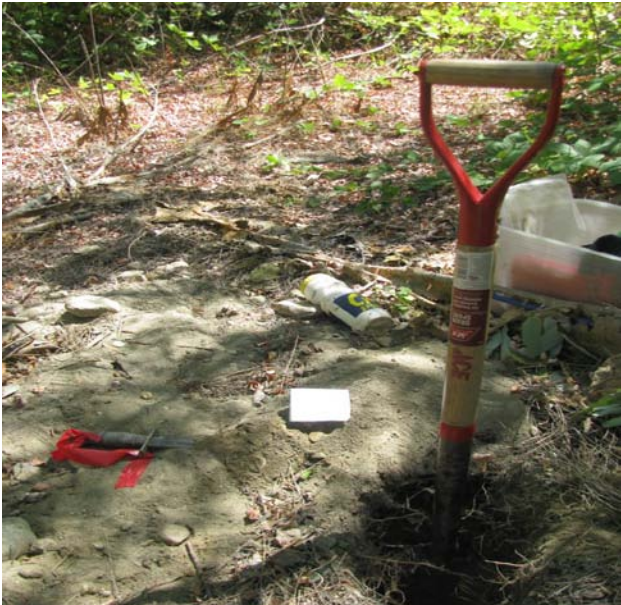
**Photo B-5 TP3 Site**

TP3U is 23 feet away from TP3W due to a broad transitional area where the algal mats stop and hydric soils end. Vegetation is the only parameter met, and it consists of the following: tree stratum-20 percent arroyo willow; sapling/shrub stratum-60 percent Himalayan blackberry and 5 percent arroyo willow; herb stratum-5 percent tall cyperus (*Cyperus eragrostis* [FACW]) and 5 percent bent grass (*Agrostis exarata* [FACW]).

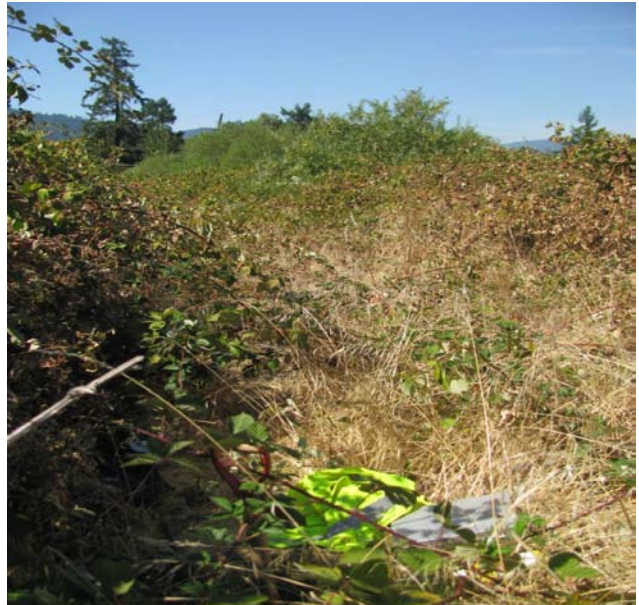
**Photo B-6 TP4 Site**

The onsite vegetation found is as follows: sapling/shrub stratum-60 percent Himalayan blackberry; herb stratum-80 percent wild oat (*Avena sativa* [UPL]), 10 percent blue wildrye (*Elymus glaucus* [FACU]), and 2 percent medusa head (*Elymus caput-medusae* [NL]).

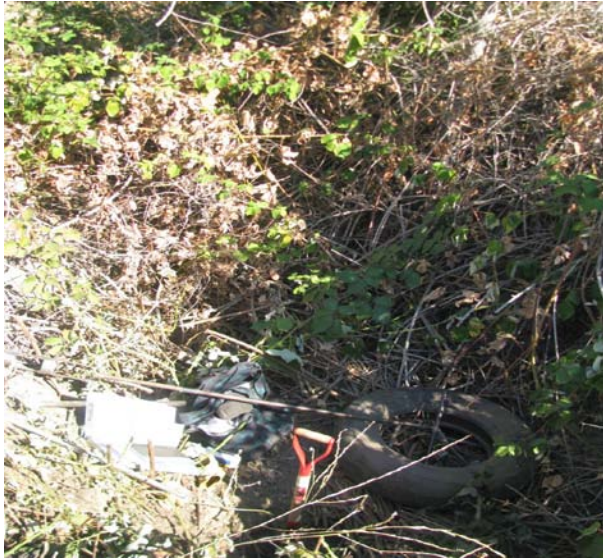
**Photo B-7 TP5 Site**

TP5 was excavated to see if this closed basin is a wetland site (Appendix B, Photo B-7). There is a berm between this basin and the TP1 site. It was difficult to find “normal circumstances” because of the loose soils spilling into the swale. One area was found to be representative of “normal circumstances” (a surface at least older than five years). None of the wetland parameters was present, and this basin is determined not to be a wetland site. A second, paired test pit was not performed due to the lack of three wetland parameters in the most likely location for wetlands to occur in this vicinity.

The onsite vegetation found is as follows: sapling/shrub stratum–70 percent Himalayan blackberry; herb stratum–30 percent wild oat and 5 percent black mustard (*Brassica nigra* [NL]).

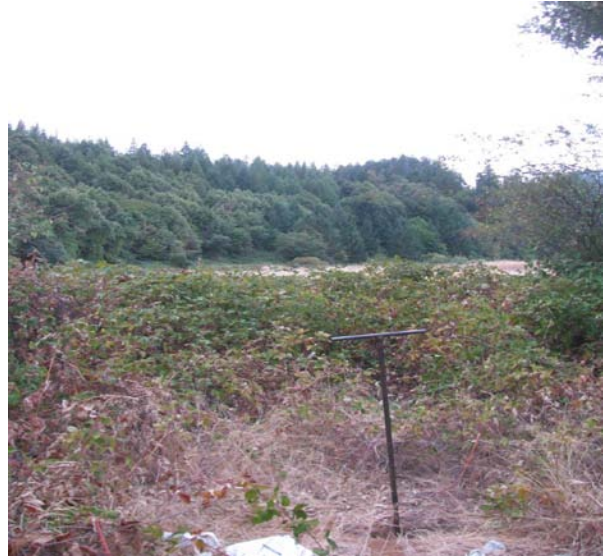
**Photo B-8 TP6 Site**

The onsite vegetation found is as follows: sapling/shrub stratum–70 percent Himalayan blackberry; herb stratum–50 percent Kentucky blue grass (*Poa pratensis* [FAC]), 10 percent blue wildrye, 2 percent Queen Anne's lace (*Daucus carota* [FACU]), and 2 percent orchard grass (*Dactylis glomerata* [FACU]).
