SUPPLEMENTAL INFORMATION #1

For Planning Commission Agenda of:
September 15, 2022

Project Title: **Lucas and Myrtle Mini-Storage Center**
Record Number: PLN-2020-16400
Assessor Parcel Numbers: 015-111-006, 015-111-012, 015-111-013
Location: Myrtle town Area

RE: **J & J FAMILY LLC; APN 015-111-006, APPS# PLN-2020-16400-CUP**

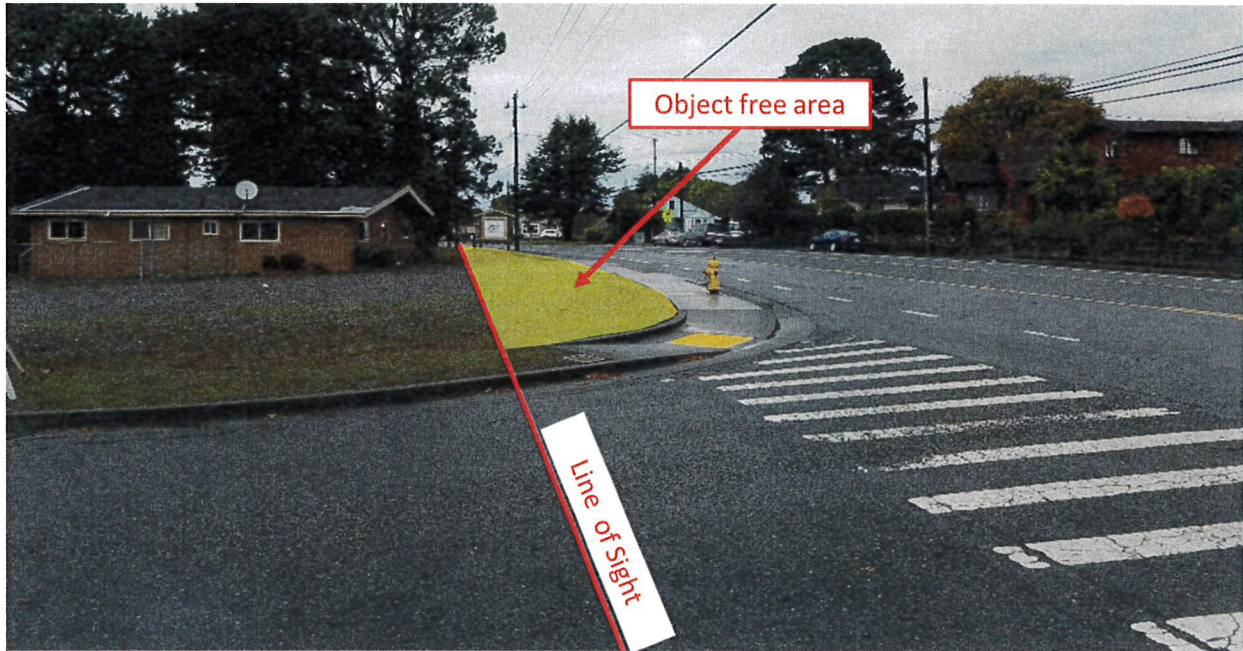
(1) Myrtle Avenue has a posted speed limit of 35 MPH. The subject property and Lucas Street are located on the inside of the curve of Myrtle Avenue. Line of sight is a common issue on the inside of a curve due to development blocking sight lines. Development within the front yard setback of Myrtle Avenue will negatively affect sight distance for Lucas Street traffic at the Myrtle Avenue intersection. Special conditions of visibility maintenance are required per County Code Section 341-1 and Humboldt County Road Design Manual Section 2-341 including a 350 foot line of sight. Prohibiting the development of all structures (including signs and fences) within an approximate 10 foot setback of the right of way line will help preserve the line of sight at this location. Even wrought iron or chain link fencing may be difficult to see through due to the line of sight running almost parallel to the potential placement of fencing at the right of way line. If the applicant is proposing

Above: Sight visibility line drawn on photo (approximate)

In addition, special conditions of visibility maintenance are required per County Code Section 341-1 and Humboldt County Road Design Manual Section 2-341 being a 350 foot line of sight. If the applicant is proposing fencing in this area, the applicant shall demonstrate to the satisfaction of the Department that visibility will not be obstructed by the fencing.

10. The applicant is responsible for maintaining County visibility requirements per the Division of Public Works memo dated November 17th, 2020. Development within the front yard setback of Myrtle Avenue will negatively affect sight distance for Lucas Street traffic at the Myrtle Avenue intersection. Special conditions of visibility maintenance are required per County Code Section 341-1 and Humboldt County Road Design Manual Section 2-341 including a 350-foot line of sight. Prohibiting the development of all structures (including signs and fences) within an approximate 10-foot setback of the right of way line will help preserve the line of sight at this location. Even wrought iron or chain link fencing may be difficult to see through due to the line of sight running almost parallel to the potential placement of fencing at the right of way line. If the applicant is proposing fencing in this area, the applicant must demonstrate to the satisfaction of the Department that visibility will not be obstructed by the fencing. The line of sight necessary for the intersection has been provided to the applicant as reference.

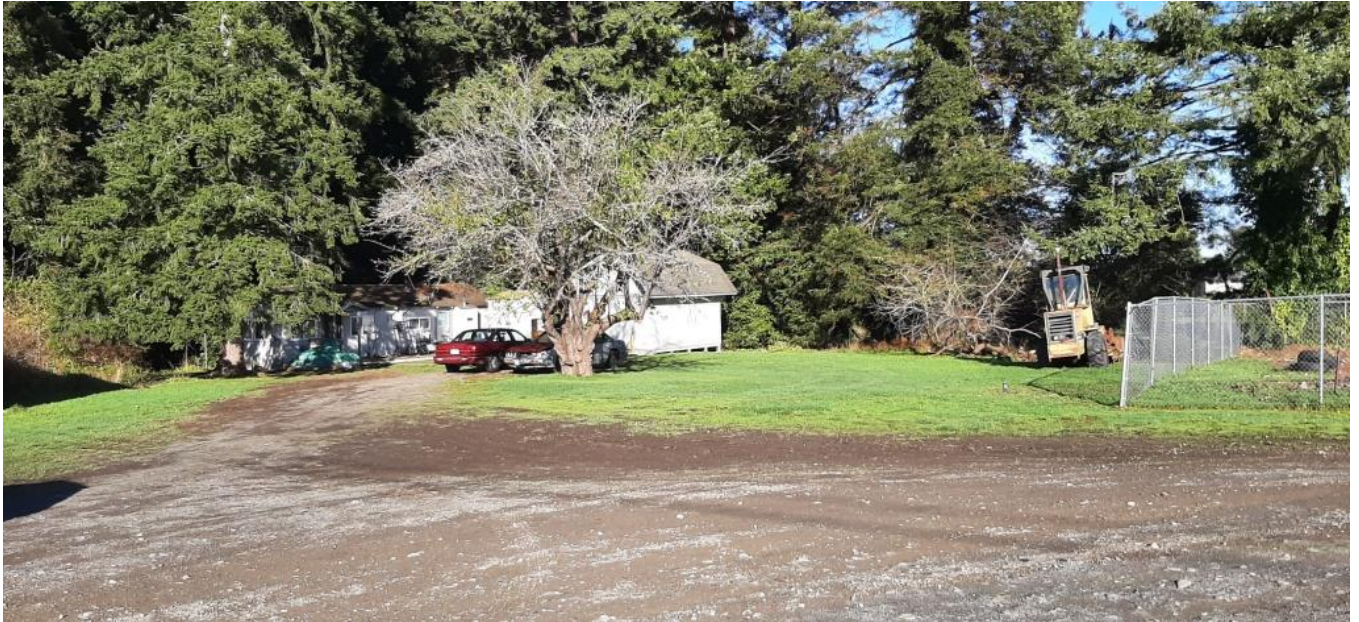
Photo 1: Existing residential structure and outbuildings on APN 015-111-012, looking west towards coast redwood forest on gulch hillslope. Photo taken November 11, 2021.

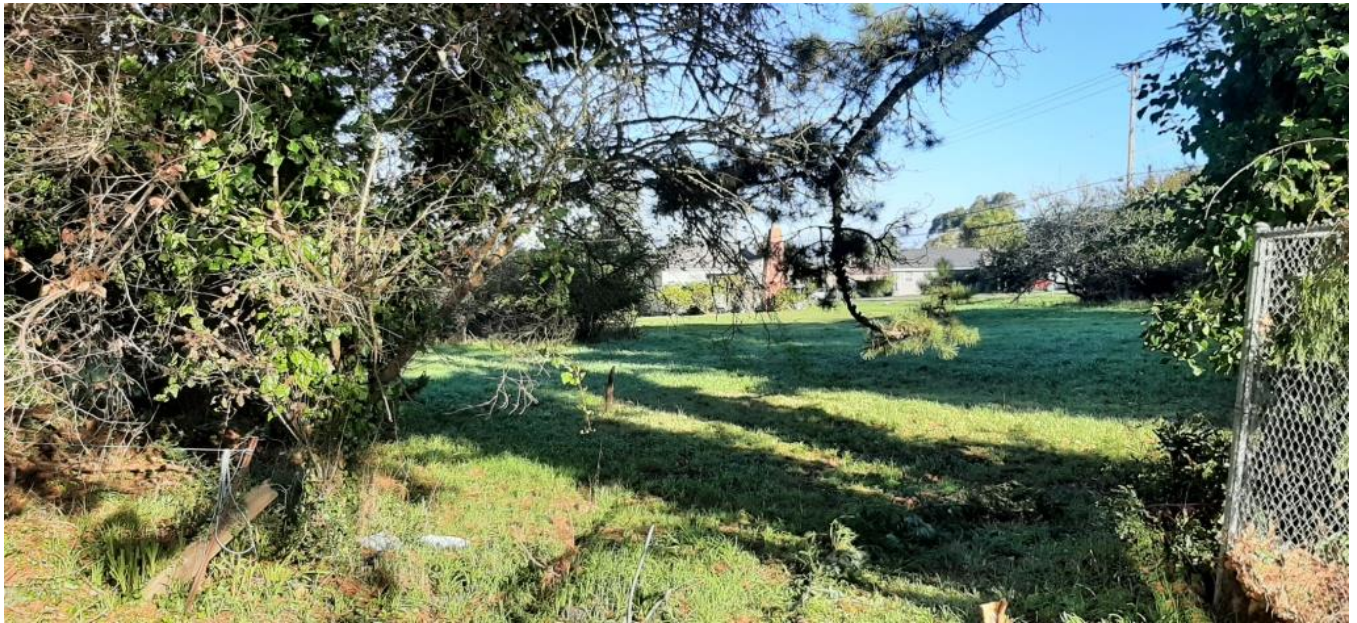
Photo 2: Looking north across non-native lawn towards structures on APN 015-111-006. Photo taken November 11, 2021.

TP2 was excavated north of TP1 as an additional investigation of conditions within the flat upper terrace (Figure 2; Appendix 1, Photo 2). One wetland parameter (hydrophytic vegetation) was present at this TP, and therefore TP2 and the surrounding area do not meet State or USACE wetland definition.

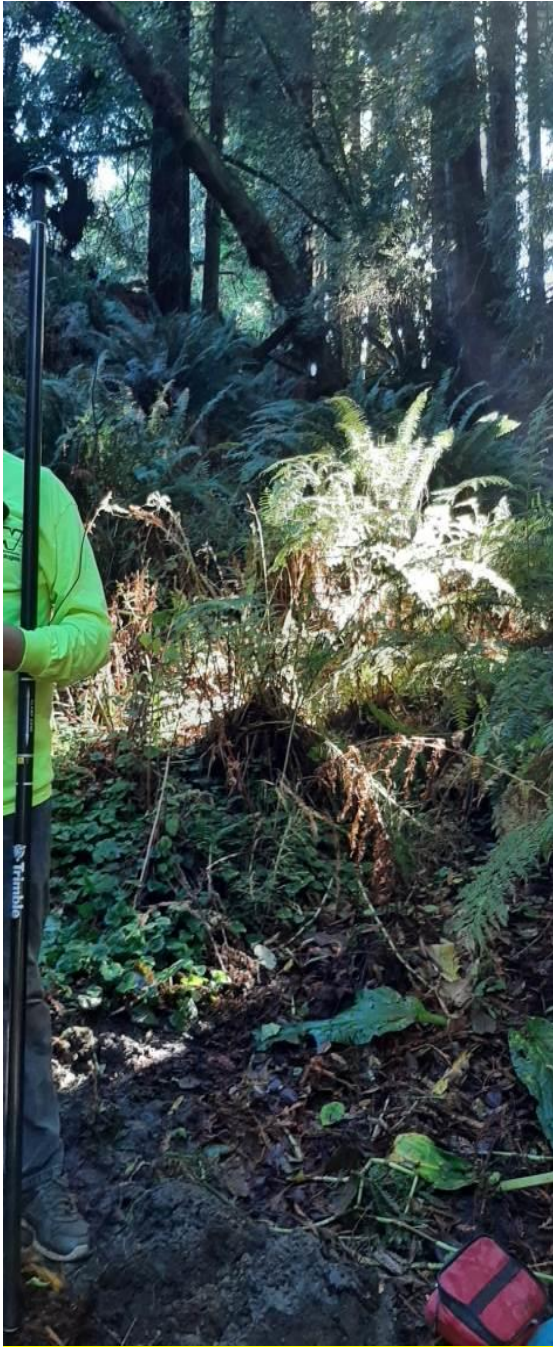
Photo 3: Typical vegetation in northwest-southeast drainage gulch. Photo taken November 11, 2011.

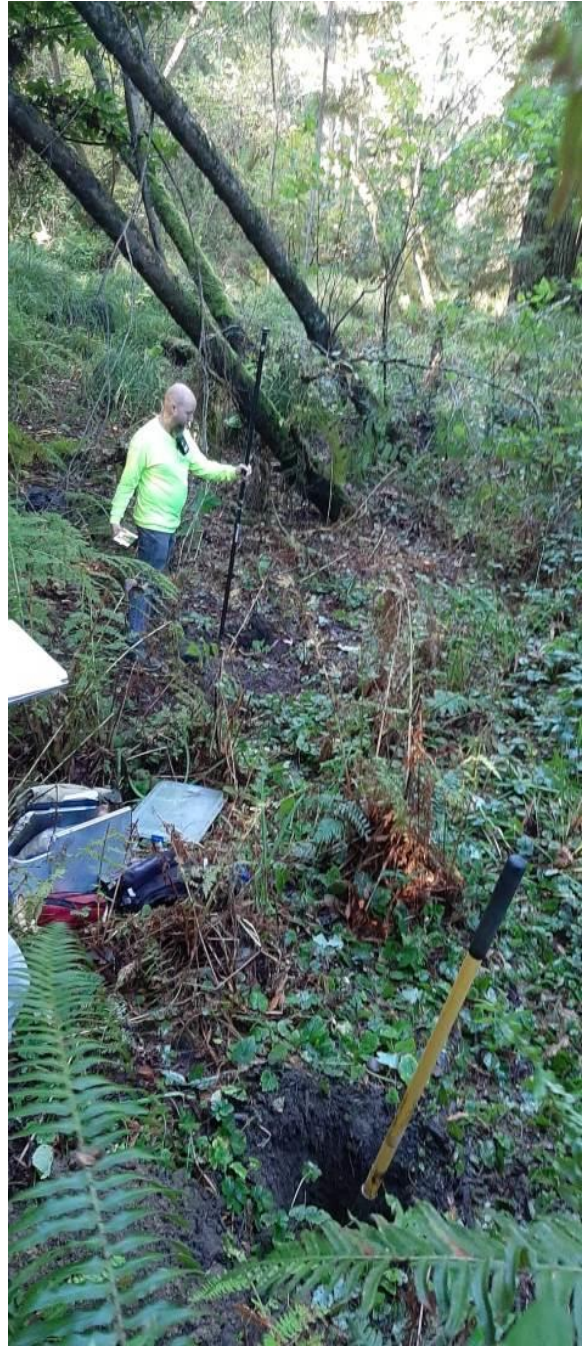
Photo 4: TPs 4 and 5 (TP5 with yellow shovel and TP4 with GPS antenna pole). Photo taken November 11, 2011.

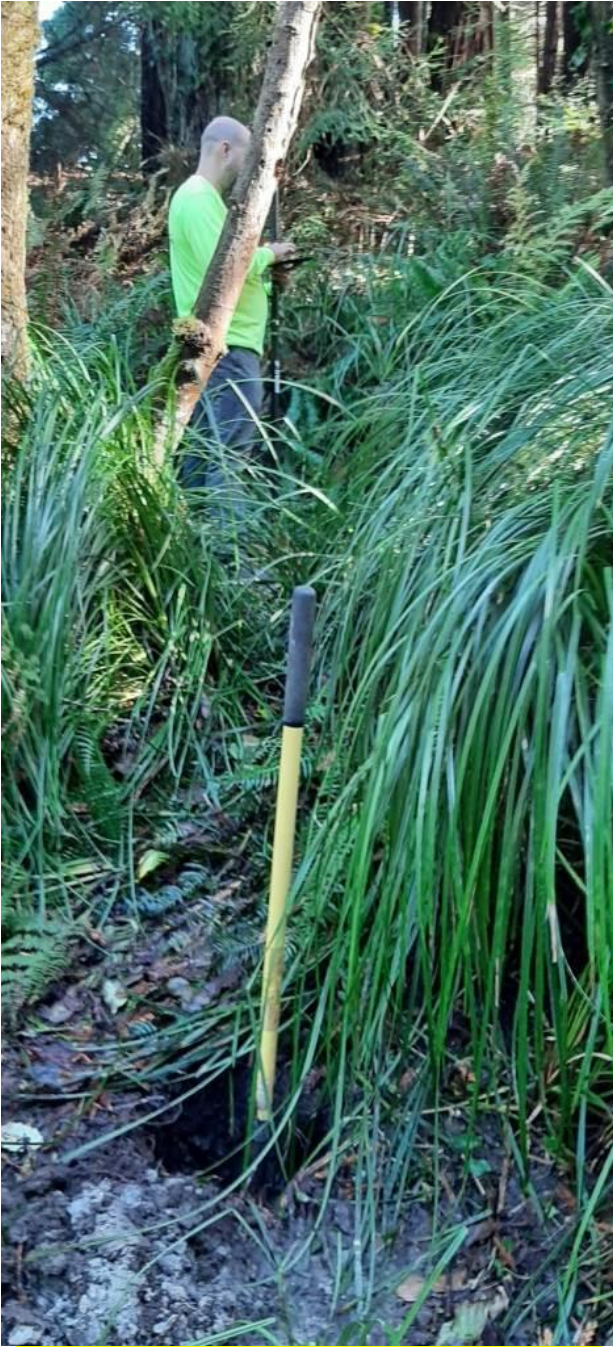
Photo 5: TP6 and TP7 (TP7 with yellow shovel and TP6 with GPS antenna pole). Looking east, upslope towards terrace. Photo taken November 11, 2021.

TP6 was excavated in the northwest-southeast drainage area and is the paired upland plot for TP7 (Figure 2; Appendix 1, Photo 5). Two wetland parameters were observed at this TP (hydrophytic vegetation and hydric soil) therefore, TP6 and the adjacent area do not meet the State or USACE wetland definition.

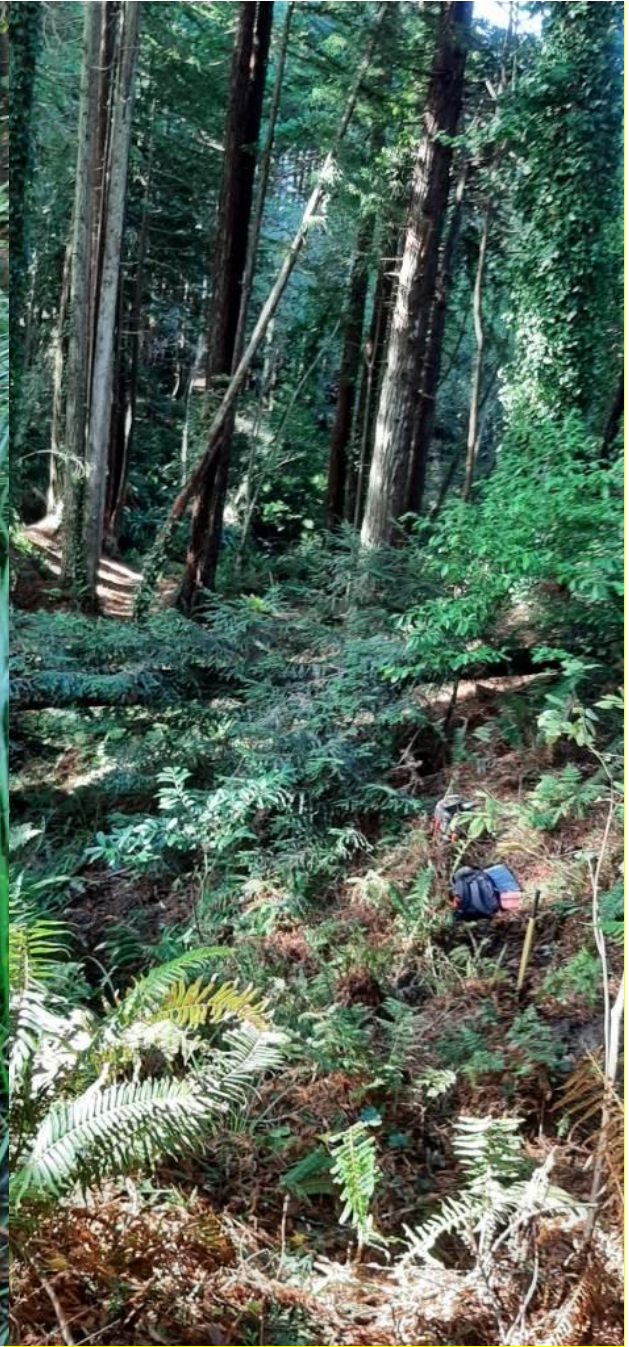
Photo 6: Location of TP8 and TP9 (looking west towards TP8 with yellow shovel). Eroded ravine with seep draining to the main gulch. Photo taken November 11, 2021.

TP8 was excavated to determine the eastern extent of the wetland edge within a small ravine containing a seep cutting into the eastern terrace. It is situated in the transitional zone between the upland and wetland boundary (Figure 2, Appendix 1, Photo 6). Two wetland parameters were observed at this TP (hydric soil and wetland hydrology) however hydrophytic vegetation dominance occurs within a very localized area around the seep but is obscured by upland vegetation occurring on the surrounding slopes. Because hydric soils and wetland hydrology are present with localized hydrophytic vegetation dominance, vegetation is determined to be problematic and the vegetation parameter has been met. All three wetland parameters were present at this TP; therefore, TP8 and the adjacent area associated with the seep meet both the State and USACE wetland definitions.

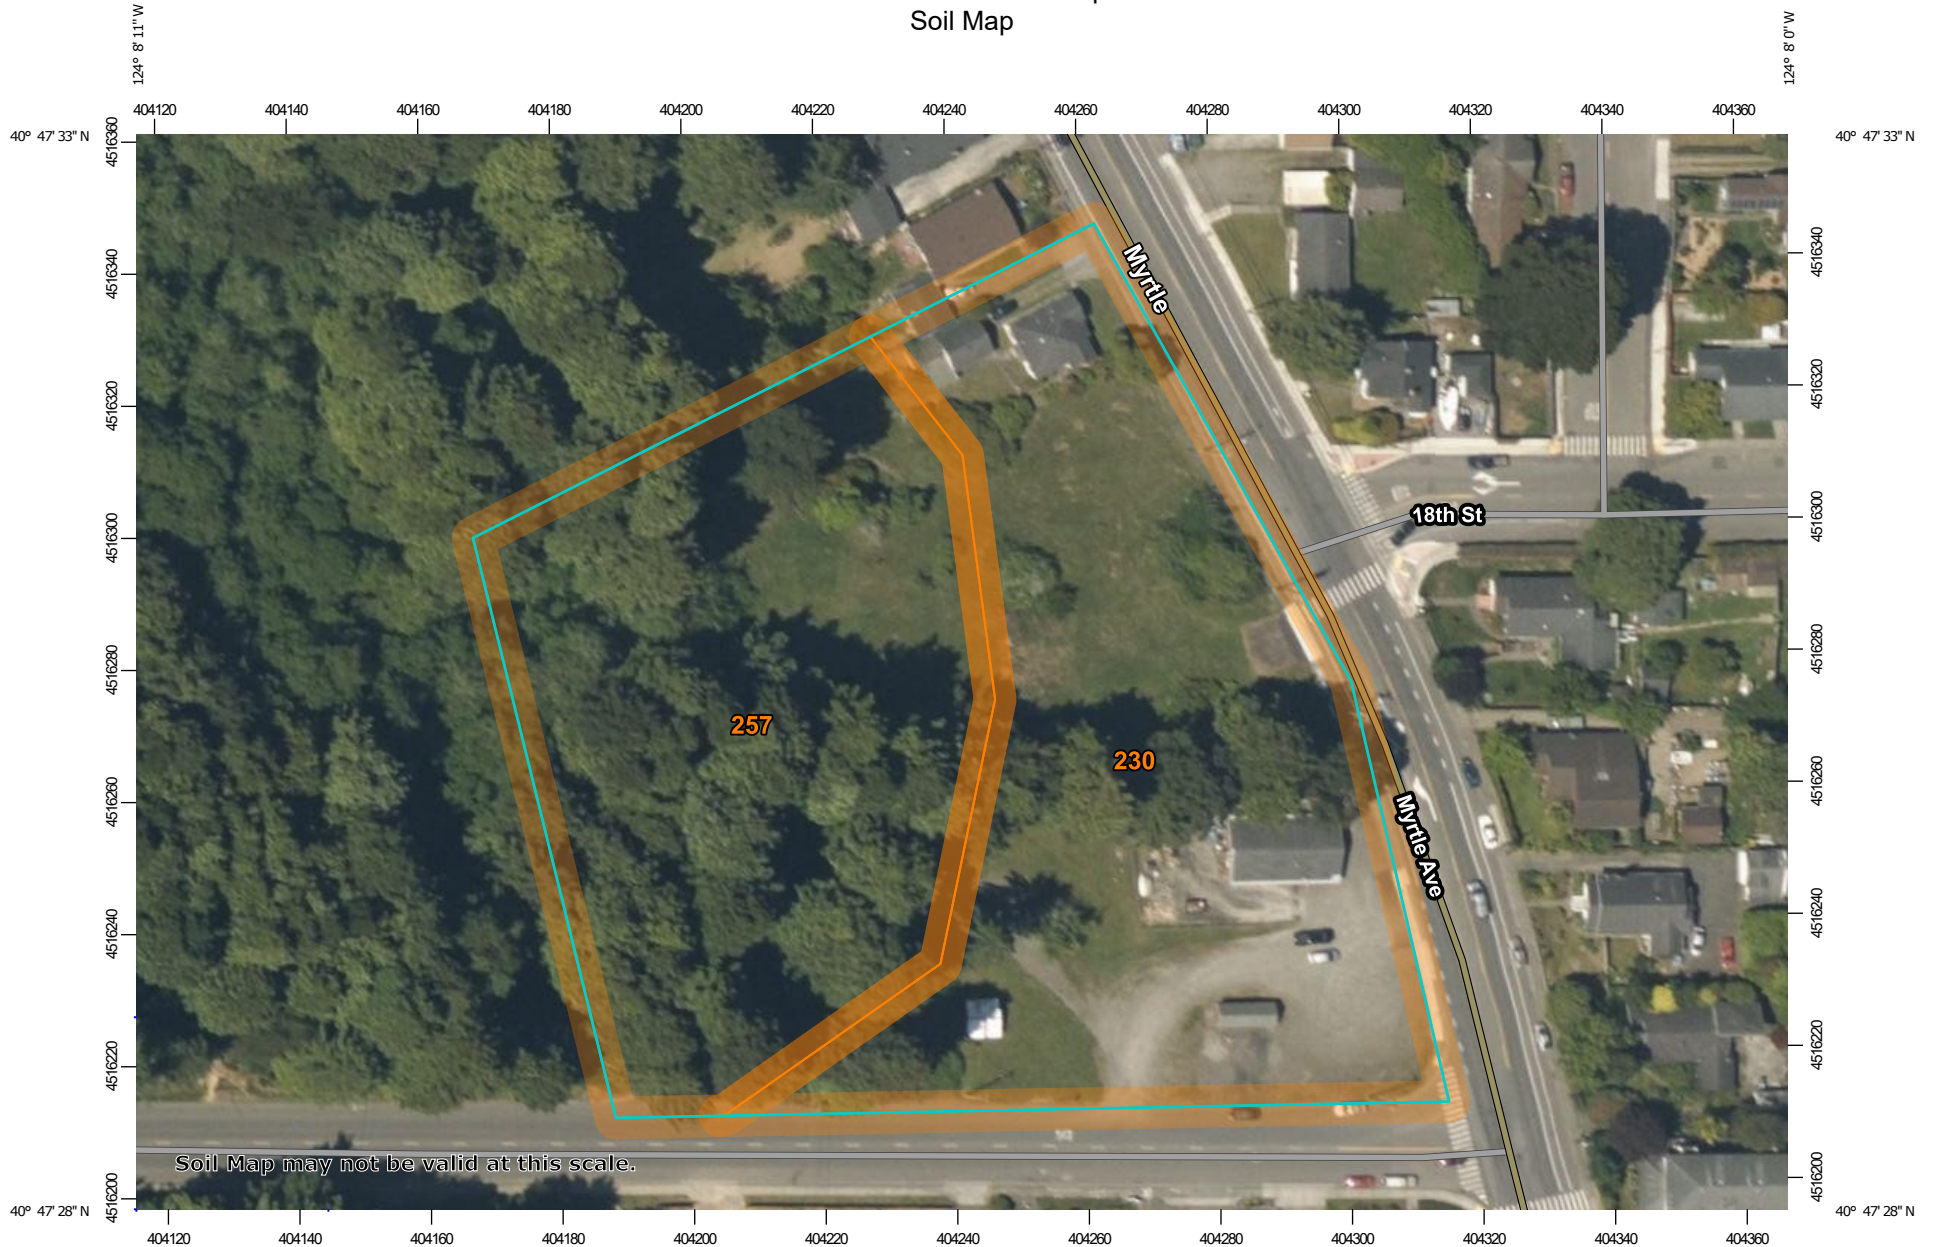
Custom Soil Resource Report Soil Map

The soil map section includes the soil map for the defined area of interest, a list of soil map units on the map and extent of each map unit, and cartographic symbols displayed on the map. Also presented are various metadata about data used to produce the map, and a description of each soil map unit.

The underlying soils in the study area have the USDA-NRCS soil map unit designation 230—Hookton-Tablebluff complex, 2 to 9 percent slopes and 257-Lepoil-Candymountain complex, 2 to 15 percent slopes, as described below (Appendix 2, Soil Map). The site-specific soil description at each exploratory soil TP is included in the wetland determination data forms found in Appendix 3, with photos in Appendix 1.
