HUMBOLDT COUNTY DEPARTMENT OF PUBLIC WORKS
ROAD EVALUATION REPORT

ROAD ASSESSMENT

This road assessment has been prepared on behalf of the Applicant, Jose Caballero, for a Humboldt County Cannabis Cultivation Project, on APN 223-022-002. This road assessment is required pursuant to Commercial Cannabis Land Use Ordinance (CCLUO), Section 55.4.12.1.8(c)(2) Performance Standard–Road Systems, which states:

The Roadshed accesses parcel APN 223-022-002, which is approximately 98 acres located approximately 2 miles southwest of the community of Harris, CA. It is located in Section 1, T5S-R4E, H.B.M.

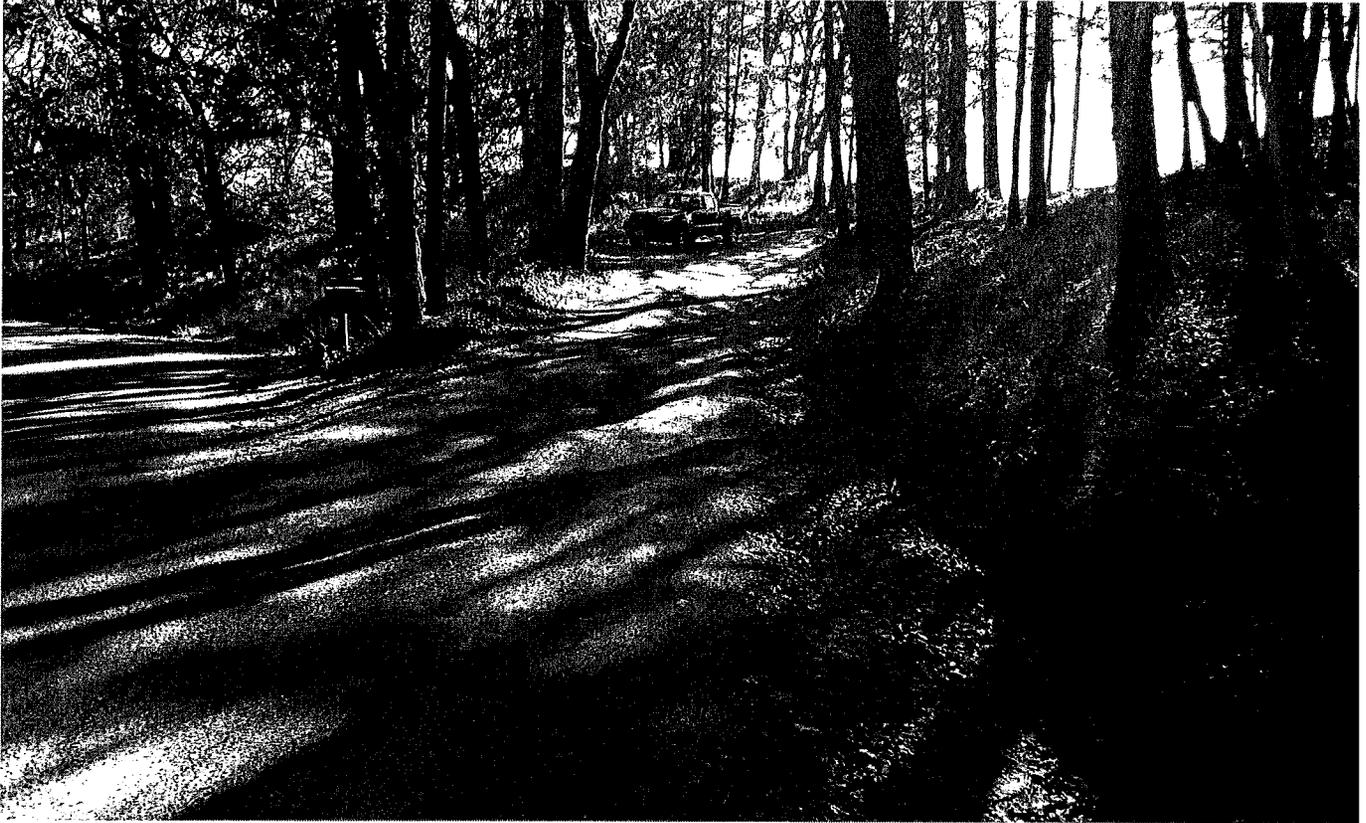
North Entrance to Bellus Road: The existing lead-out ditch at Map Point 5 is located near the vehicle pictured, and the inlet to the ditch relief culvert at Map Point 2 is located beyond the mailboxes in the left half of the frame. Photo date 11-21-2019.

Map Point 2: Existing 15-inch diameter ditch relief culvert located on Bell Springs Road, outside of the Roadshed. It is located above the head of a Class III watercourse. The area between the outlet at Map Point 2 and the head of the Class III watercourse is thick grass. Dry road sediment from the previous wet season could be seen filtering out in the grass for approximately 100 feet below the outlet. During heavy rainfall, runoff from the outlet likely connects with the head of the Class III watercourse. The ditch relief culvert receives drainage from the existing lead-out ditch at Map Point 5, and over 600 feet of the inside ditch along Bell Springs Road from the south. The area between Map Point 5 and the inlet at Map Point 2 is thick grass and no erosion was present. The lengthy inside ditch along the county road from the south picks up sediment from the south entrance to Bellus Road near Map Point 3. Installation of a new ditch relief culvert along Bell Springs Road, south of Map Point 2 would reduce the hydrologic connectivity to the Class III watercourse.

Map Point 5: Existing lead-out ditch that drains a short length of through-cut road surface and ditch. Maintain road surface and ditch to drain to this location and keep the lead-out ditch open. The north entrance to Bellus Road from Map Point 5 to Bell Springs Road is rocked with a slight inslope. Along this segment, keep the road graded to maintain its current drainage pattern, and eliminate berms that build up along the roadside edges. Apply clean, compacted rock as necessary to maintain a stable operating surface.

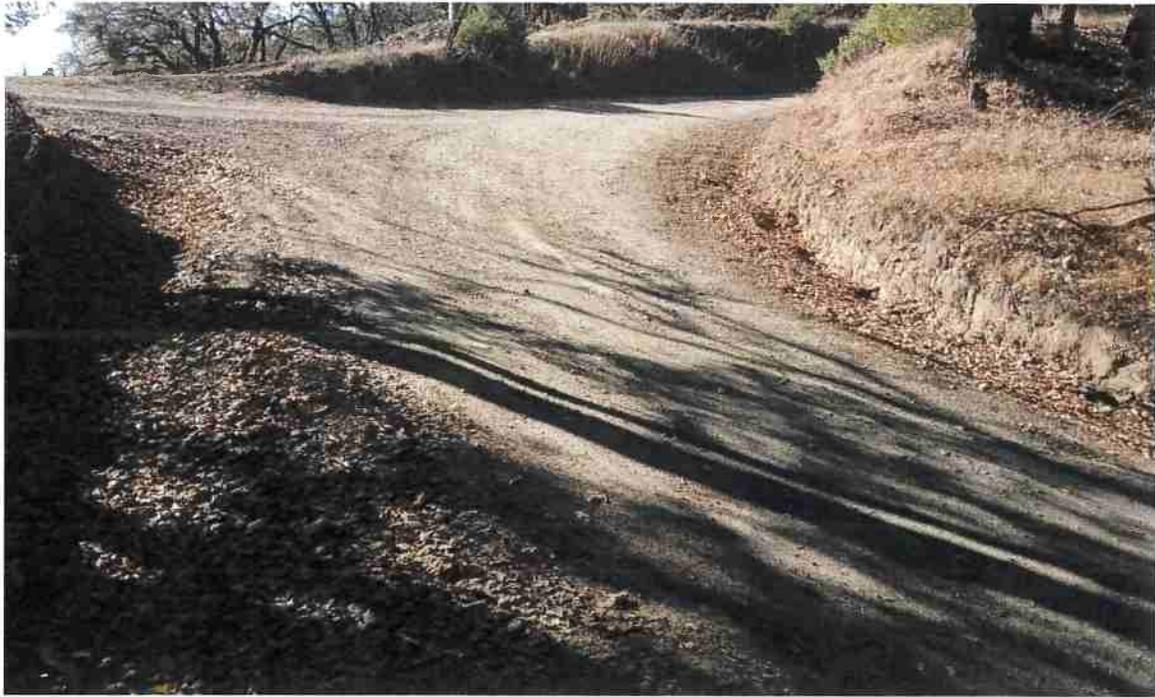
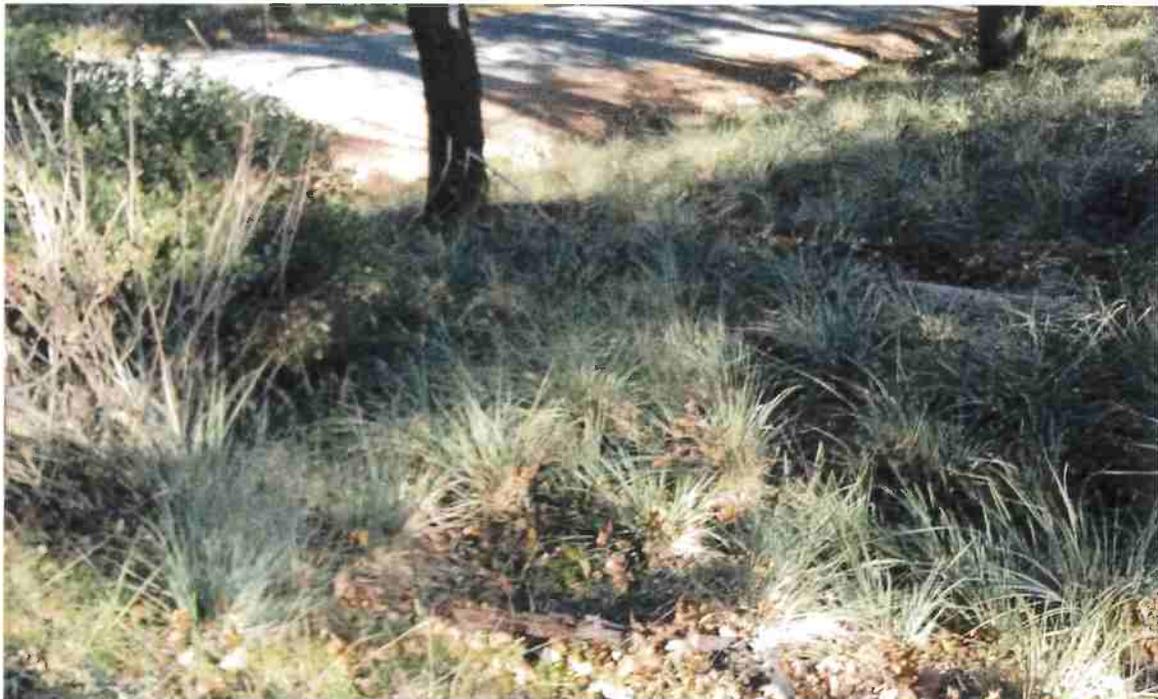
Map Point 5: The left edge of the picture on top shows the incoming ditch that drains to the existing lead-out at Map Point 5. The picture on the bottom shows the grass area between Map Point 5 and the inlet to the ditch relief culvert at Map Point 2. Photo date 11-21-2019.

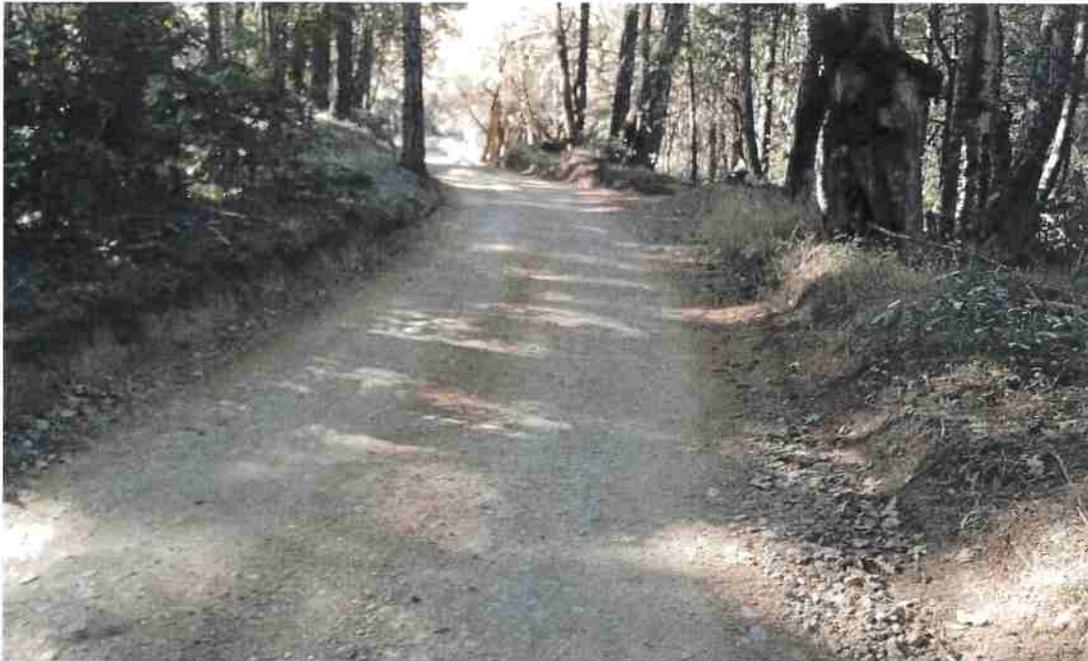
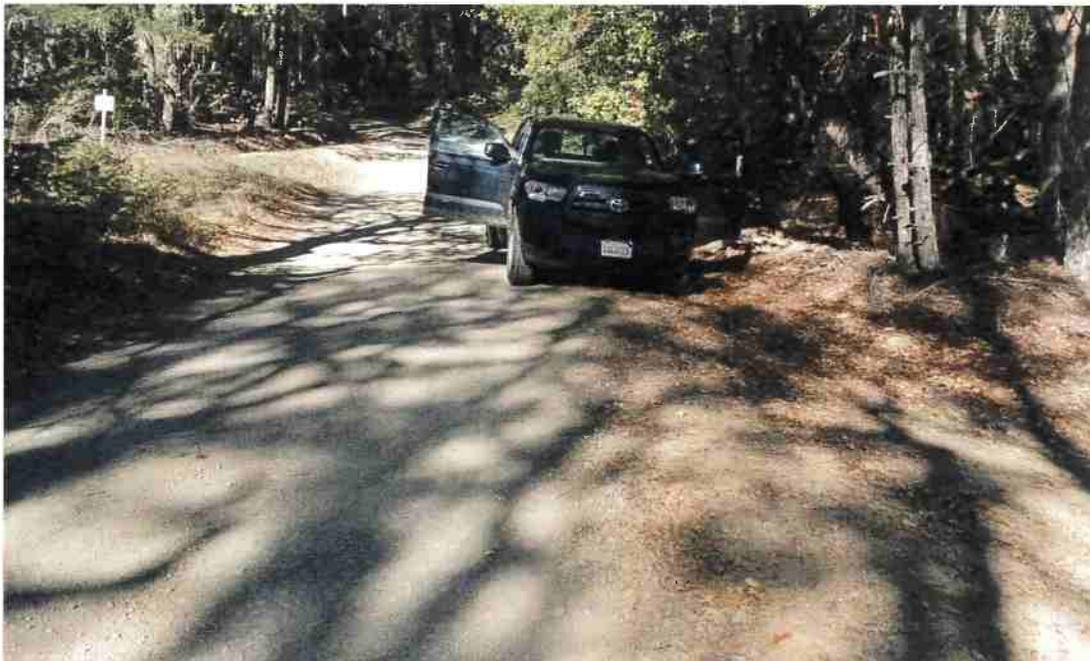
Map Point 7 and 10: The picture on top is looking westerly with the existing lead-out ditch at Map Point 7 in the distance. The picture on the bottom shows the two existing lead-out ditches that drain each side of the road at Map Point 10. One begins near the front of the pick-up and drains towards the right, the other can be seen in the distance, behind the pick-up and drains to the left. Photo date 11-21-2019.

Road Segment 5 to 11: Road Segment follows a broad ridgetop and is located in a shallow through-cut section. The road surface is rocked and graded to drain the road surface to ditches on both sides of the road with numerous lead-outs for ditch relief. The road appeared to be maintained and there were no signs of erosion along ditches. Near Map Point 11, the road surface drainage pattern begins to transition to out-sloped. Along Road Segment 5 to 11, keep the road graded to maintain its current drainage pattern and keep the ditches open. Maintain the existing drainage facilities at Map Point 6, 7, 8, 9, and 10. Apply clean, compacted rock as necessary to maintain a stable operating surface.

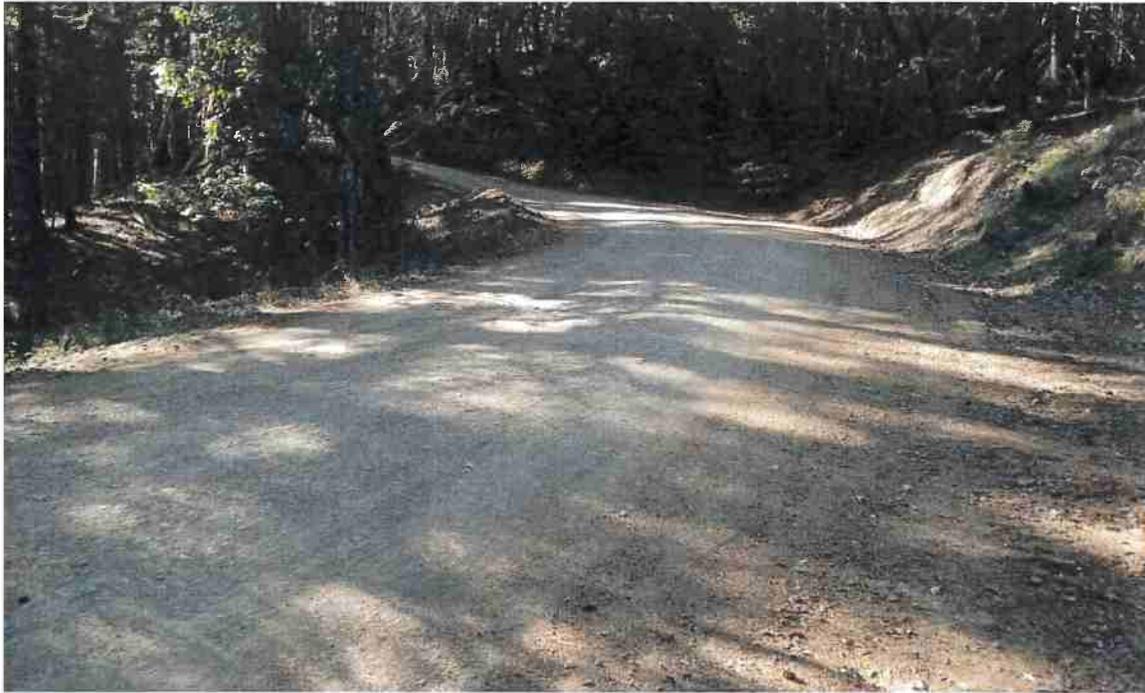
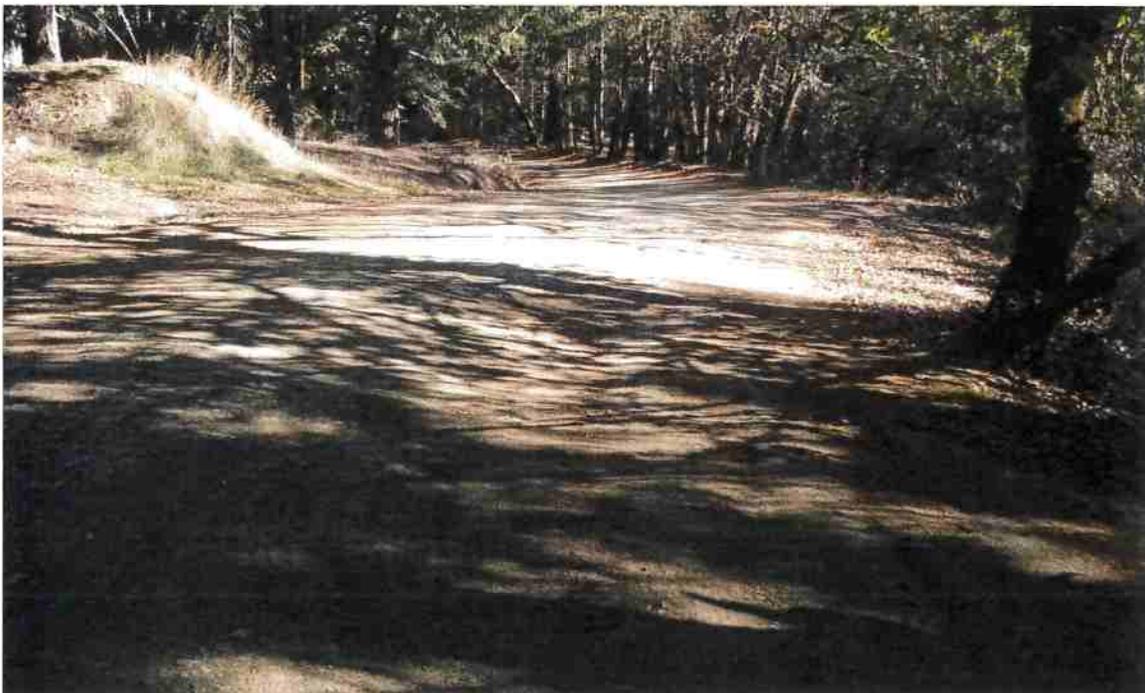
Map Point 12: The pictures show the condition of the road near the rock source at Map Point 12. The picture on top is looking upslope southwesterly, and the picture on the bottom is looking northeasterly. The road has a heavily rocked surface with no sign of erosion. Photo date 11-21-2019.

Road Segment 11 to 14: Road Segment located along a ridgetop in a shallow through-cut, and transitions to a sidehill with out-sloping drainage. The road surface is rocked and graded to drain the inner half of the road surface towards the inside ditch and to available lead-outs. The outer half of the road drains by way of out-sloping when possible. The road appeared to be maintained and there were no signs of erosion along ditches. Along Road Segment 11 to 14, keep the road graded to maintain its current drainage pattern and keep the ditches open. Maintain the existing drainage facilities at Map Point 11 and 13. Apply clean, compacted rock as necessary to maintain a stable operating surface. As a point of reference, Map Point 12 is a rock source located along the road.

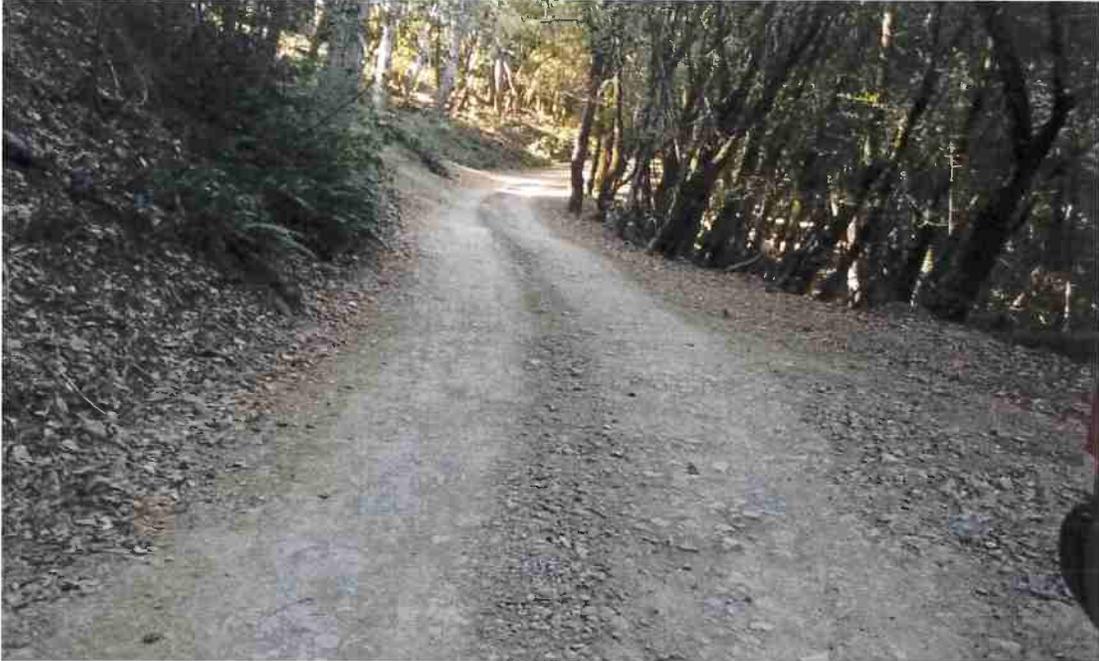
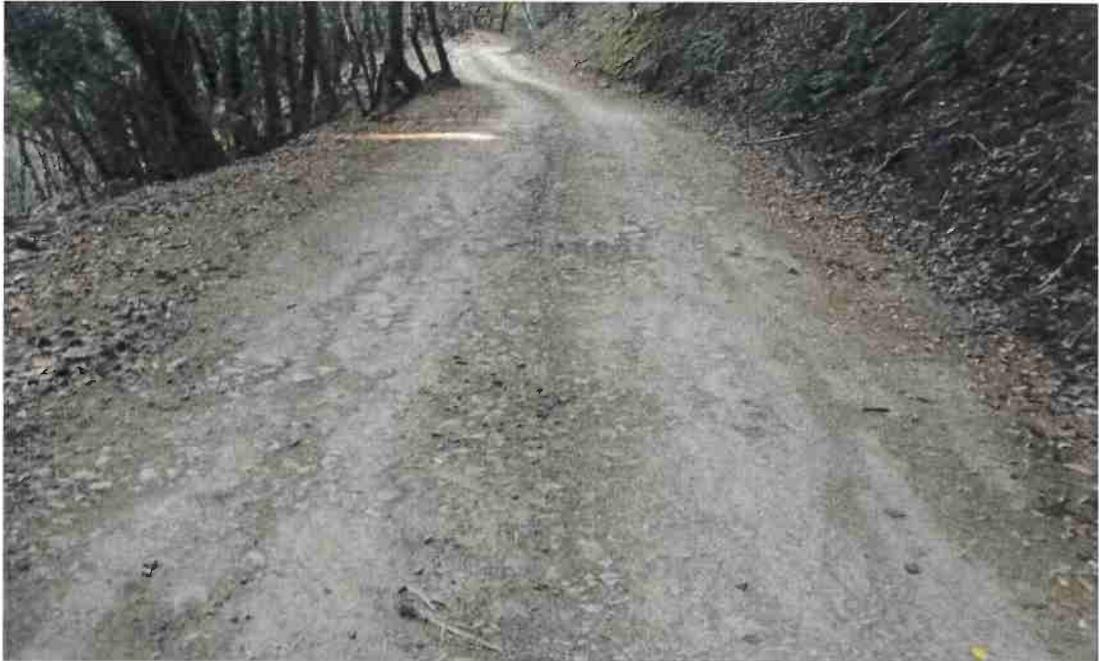
Road Segment 14 to 30: The pictures show the rocked, outsloped road near Map Point 20 and 21. An adequate number of existing rocked rolling dips are located along this segment. The road has a heavily rocked surface with no sign of erosion. Photo date 11-21-2019.

Road Segment 14 to 30: Road Segment located along a sidehill with an out-sloped surface drainage pattern. It is located just below the main ridgeline. The Road Segment has an adequate number of existing rocked rolling dips and lead-out ditches. The road surface is rocked and graded to drain the road surface towards the outboard edge, and to existing rocked rolling dips and lead-outs. The road and drainage features were maintained and there were no signs of erosion. Along Road Segment 14 to 30, keep the road graded to maintain its current out-sloped drainage pattern and eliminate berms and high spots that develop along the outboard edge. Keep the existing rocked rolling dips and lead-outs open. Apply clean, compacted rock as necessary to maintain a stable operating surface. Install an additional rocked rolling dip at Map Point 28.

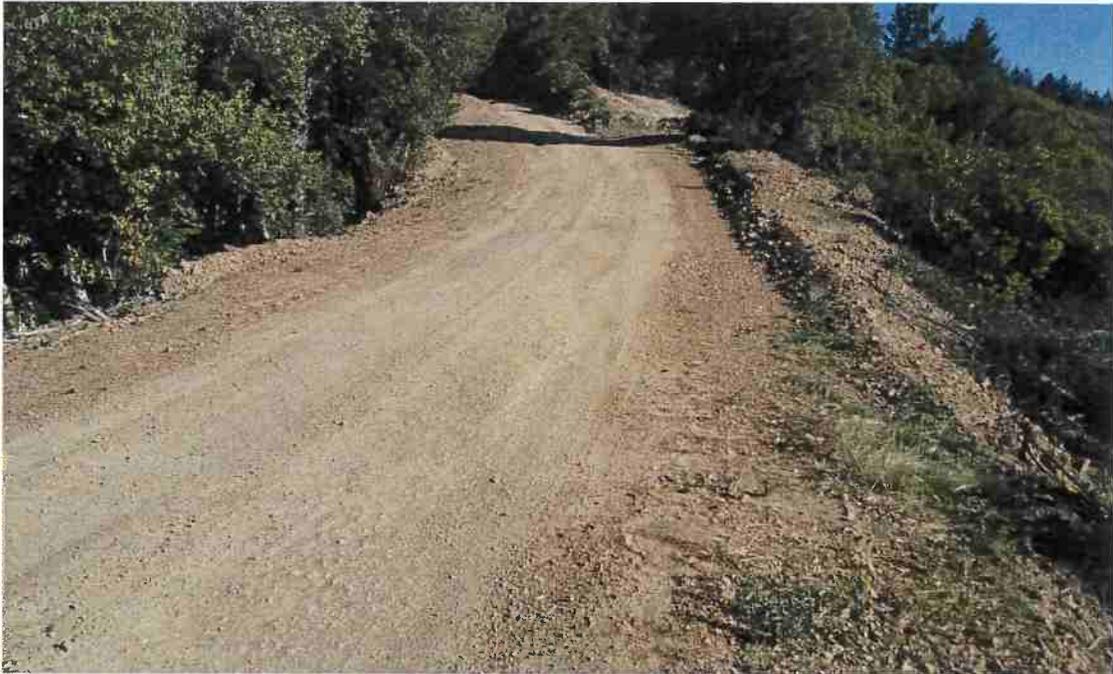
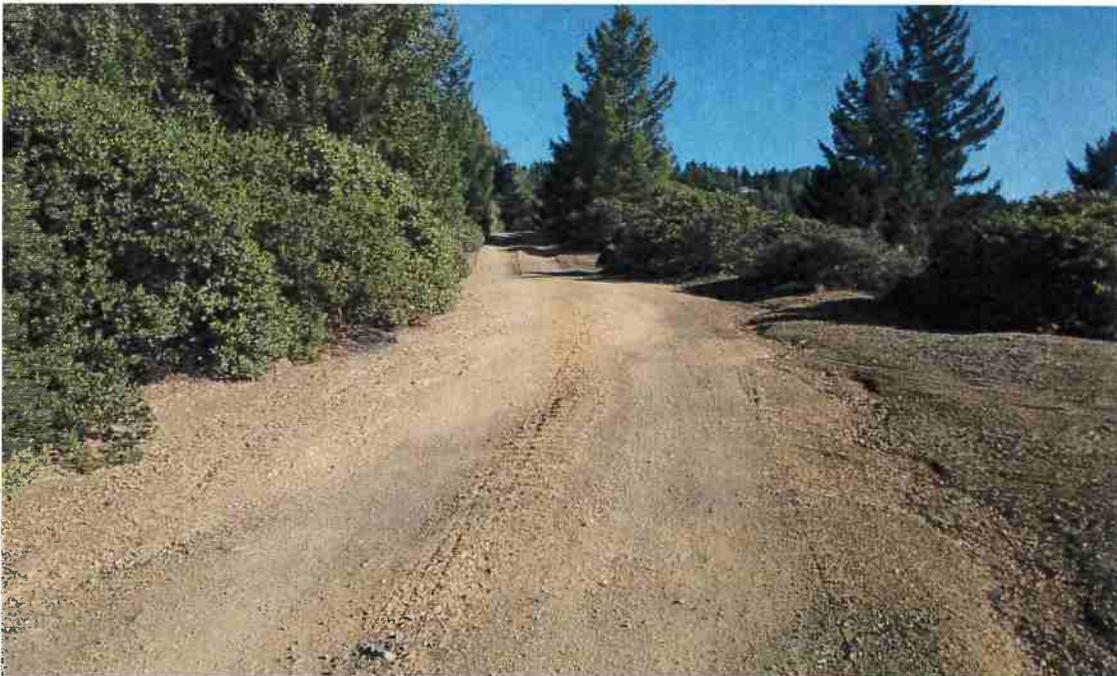
Road Segment 30 to 40: The picture on top is from near Map Point 33 looking northeast. The picture on the bottom is from near Map Point 38 looking northerly. Along this segment, maintain the existing lead-outs and install rocked rolling dips at the locations shown on the attached map. In most cases dips can be shallow with lead-outs excavated through berms to allow runoff to exit. Photo date 11-21-2019.

Road Segment 30 to 40: Road Segment transitions back to a ridgetop location within some short sections of shallow through-cuts. The drainage pattern is best described as crowned and the surface appeared rocked and maintained. Runoff collects along berms on one or both sides of the road and sometimes down a tire depression for a short distance until it is drained by way of a lead-out. This causes minor gulying on the roadside edge or surface, but there are no watercourses nearby. Along Road Segment 30 to 40, maintain the existing lead-outs and install rocked rolling dips at the locations shown on the attached map. In most cases dips can be shallow with lead-outs excavated through berms to allow runoff to exit. See the attached BMPs for rolling dip and lead-out design. Apply clean, compacted rock as necessary to maintain a stable operating surface.

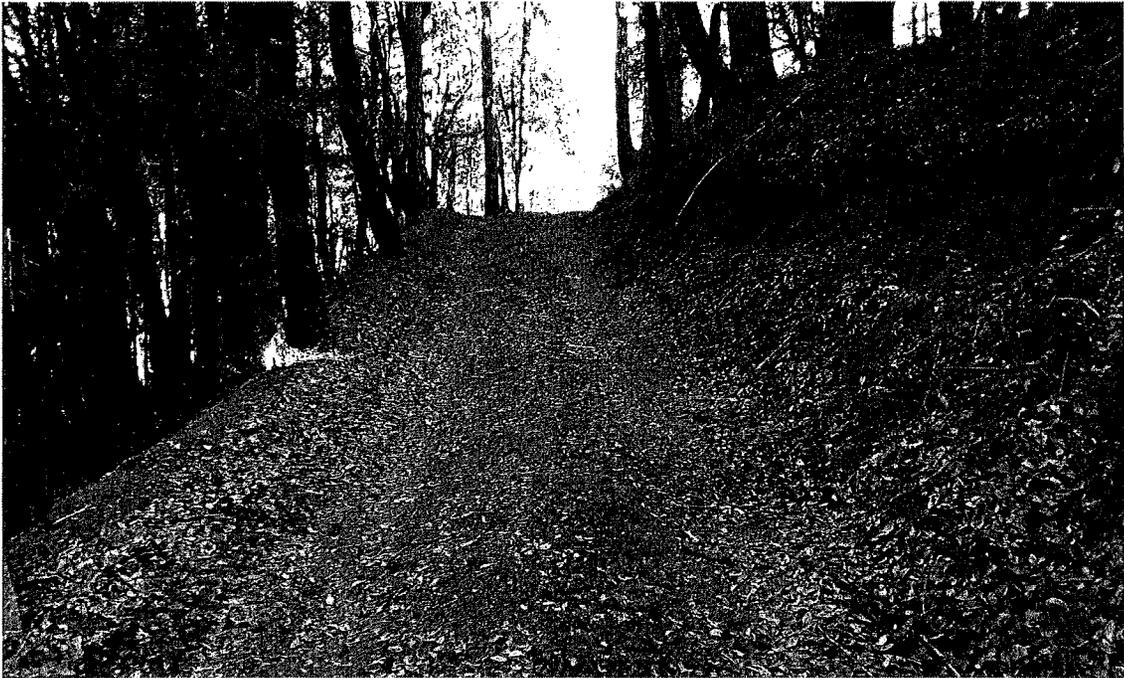
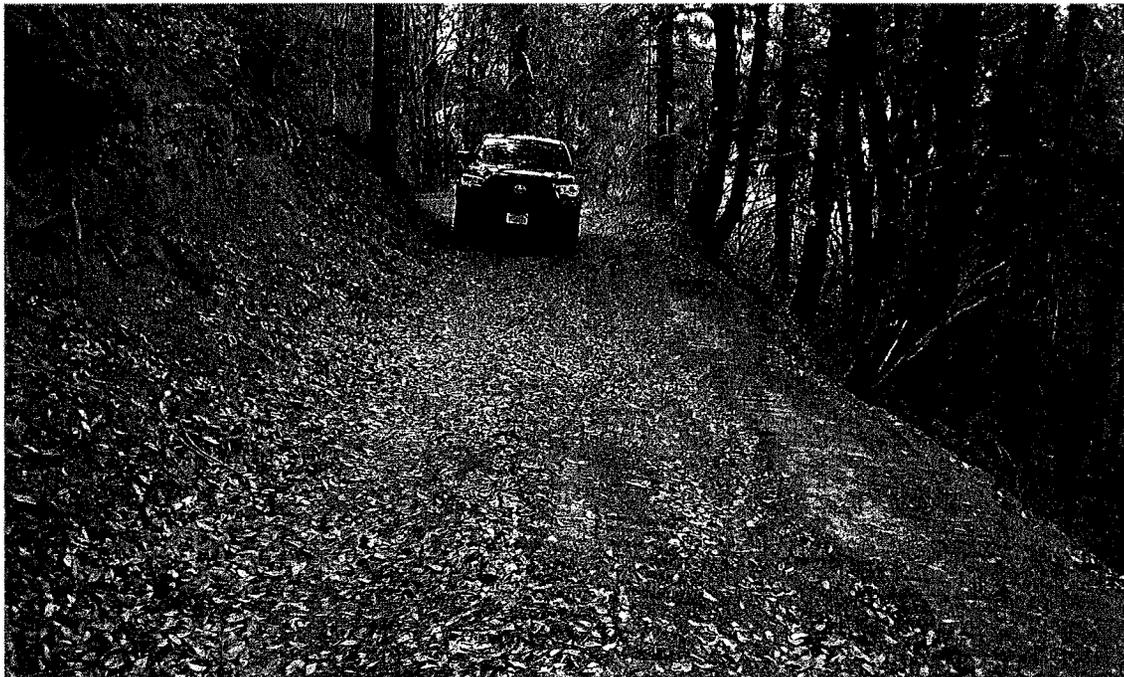
Road Segment 40 to 43: The picture on top is from near Map Point 41 looking northerly, and the picture on the bottom is looking southerly. Along Road Segment 40 to 43, grade the road shoulder and surface per the attached Road Outsloping BMPs. Maintain the existing lead-outs and install a rocked rolling dip at Map Point 43. Photo date 11-21-2019.

Road Segment 40 to 43: Road Segment leaves the ridgetop and becomes an outsloped road. From the forks in the road south of Map Point 40 to the property boundary, the road is less traveled and the surface has accumulated slough, leaves, and duff. The road has a very hard native rock surface that is resistant to erosion. Although this road was constructed as an outsope, there is a build-up of duff and material along the shoulder, and runoff flows down tire depressions. The landowner had recently bladed a short section of built up material from the shoulder. Along Road Segment 40 to 43, grade the road shoulder and surface per the attached Road Outsloping BMPs so the road surface drains. Maintain the existing lead-outs and install a rocked rolling dip at Map Point 43.

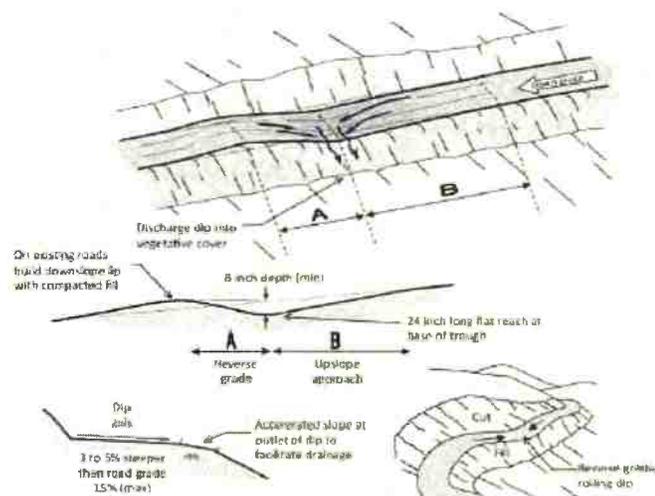
FIGURE 34. A classic Type 1 rolling dip, where the excavated up-road approach (B) to the rolling dip is several percent steeper than the approaching road and extends for 60 to 80 feet to the dip axis. The lower side of the structure reverses grade (A) over approximately 15 feet or more, and then falls down to rejoin the original road grade. The dip must be deep enough that it is not obliterated by normal grading, but not so deep that it is difficult to negotiate or a hazard to normal traffic. The outward cross-slope of the dip axis should be 3% to 5% greater than the up-road grade (B) so it will drain properly. The dip axis should be out-sloped sufficiently to be self-cleaning, without triggering excessive downcutting or sediment deposition in the dip axis (Modified from: Best, 2013).

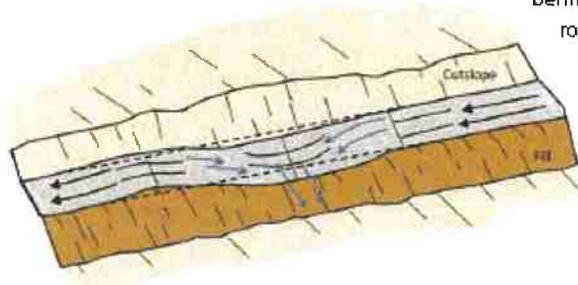
Type 1 Rolling Dip
(Standard)

Type 1 rolling dips are used where road grades are less than about 12-14% and road runoff is not confined by a large through cut or berm. The axis of the dip should be perpendicular to the road alignment and sloped at 3-4% across the road tread. Steep roads will have longer and more abrupt dip dimensions to develop reverse grade through the dip axis. The road tread and/or the dip outlet can be rocked to protect against erosion, if needed.

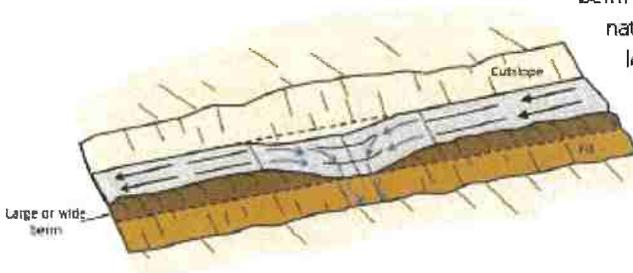
Type 2 Rolling Dip
(Through-cut or thick berm road reaches)

Type 2 rolling dips are constructed on roads up to 12-14% grade where there is a through cut up to 3 feet tall, or a wide or tall berm that otherwise blocks road drainage. The berm or native through cut material should be removed for the length of the dip, or at least through the axis of the dip, to the extent needed to provide for uninterrupted drainage onto the adjacent slope. The berm and slope material can be excavated and endhauled, or the material can be sidecast onto native slopes up to 45%, provided it will not enter a stream.

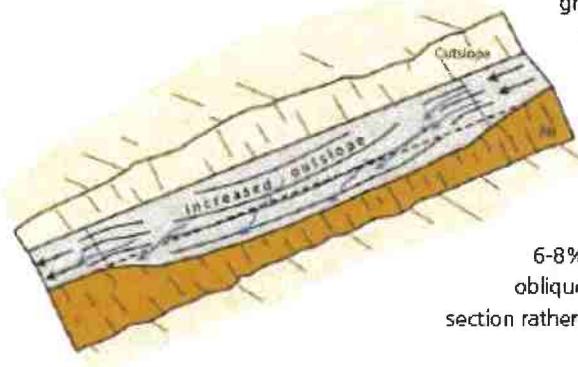
Type 3 Rolling Dip
(Steep road grade)

Type 3 rolling dips are utilized where road grades are steeper than about 12% and it is not feasible to develop a reverse grade that will also allow passage of the design vehicle (steep road grades require more abrupt grade reversals that some vehicles may not be able to traverse without bottoming out).

Instead of relying on the dip's grade reversal to turn runoff off the roadbed, the road is built with an exaggerated outside of 6-8% across the dip axis. Road runoff is deflected obliquely across the dip axis and is shed off the outsloped section rather than continuing down the steep road grade.

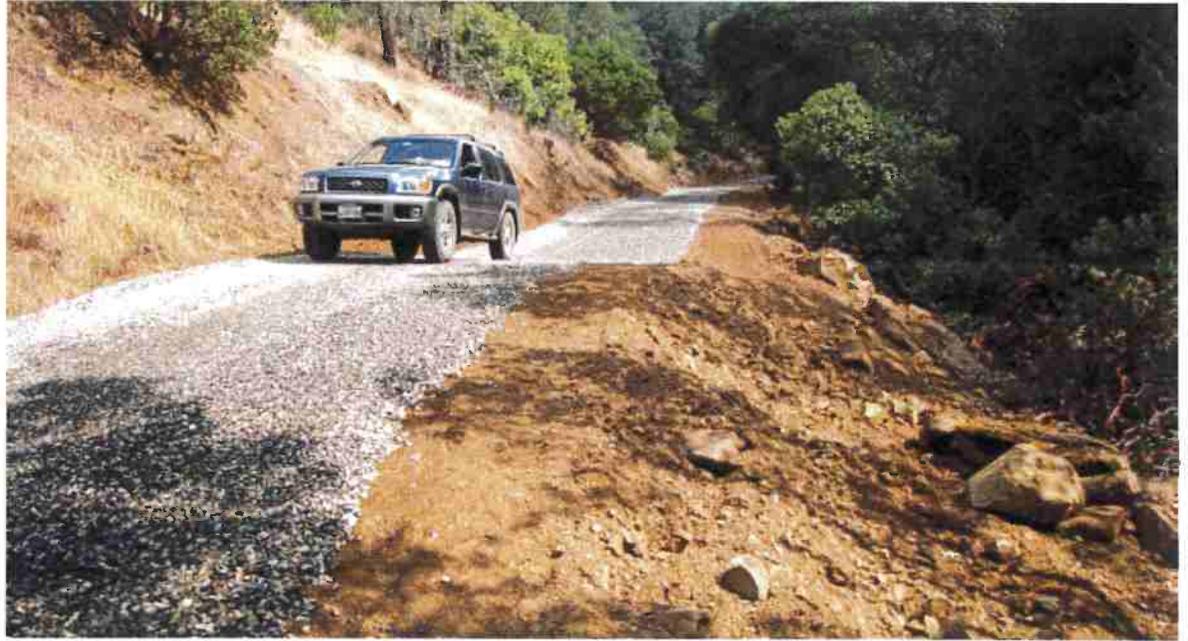
FIGURE 33A.

Rolling dip constructed on a rock surfaced rural road. The rolling dip represents a change-in-grade along the road alignment and acts to discharge water that has collected on, or is flowing down, the road surface. This road was recently converted from a high maintenance, insloped, ditched road to a low maintenance, outsloped road with rolling dips.

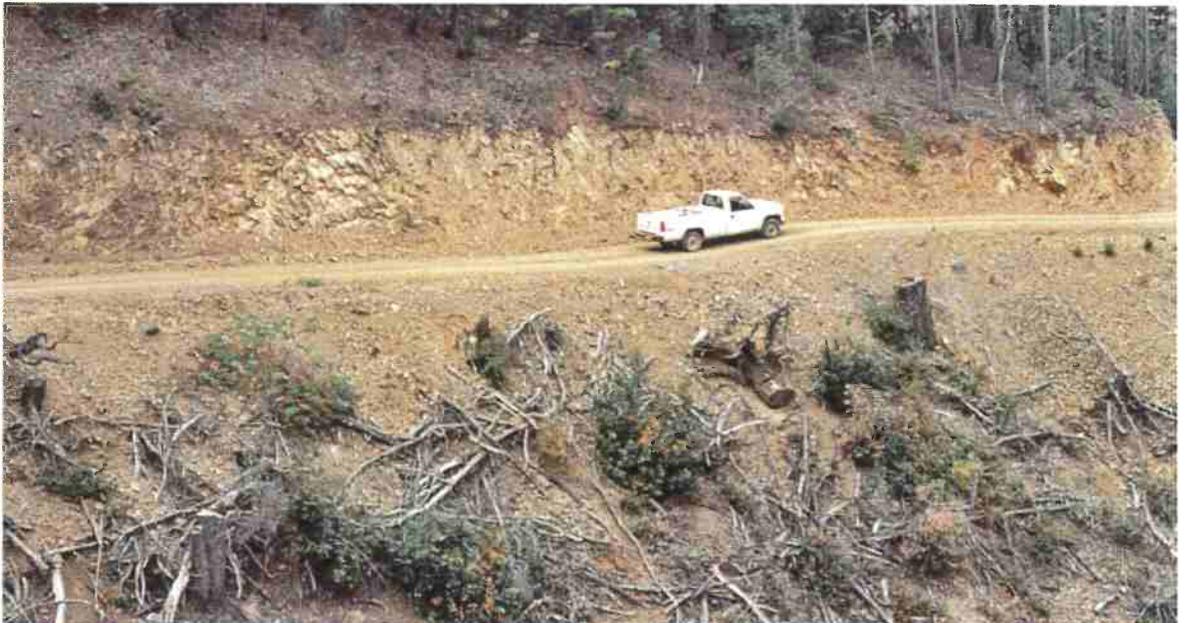
FIGURE 33B.

This side view of an outsloped road shows that the rolling dip does not have to be deep or abrupt to reverse road grade and effectively drain the road surface. This outsloped forest road has rolling dips that allow all traffic types to travel the route without changing speed.

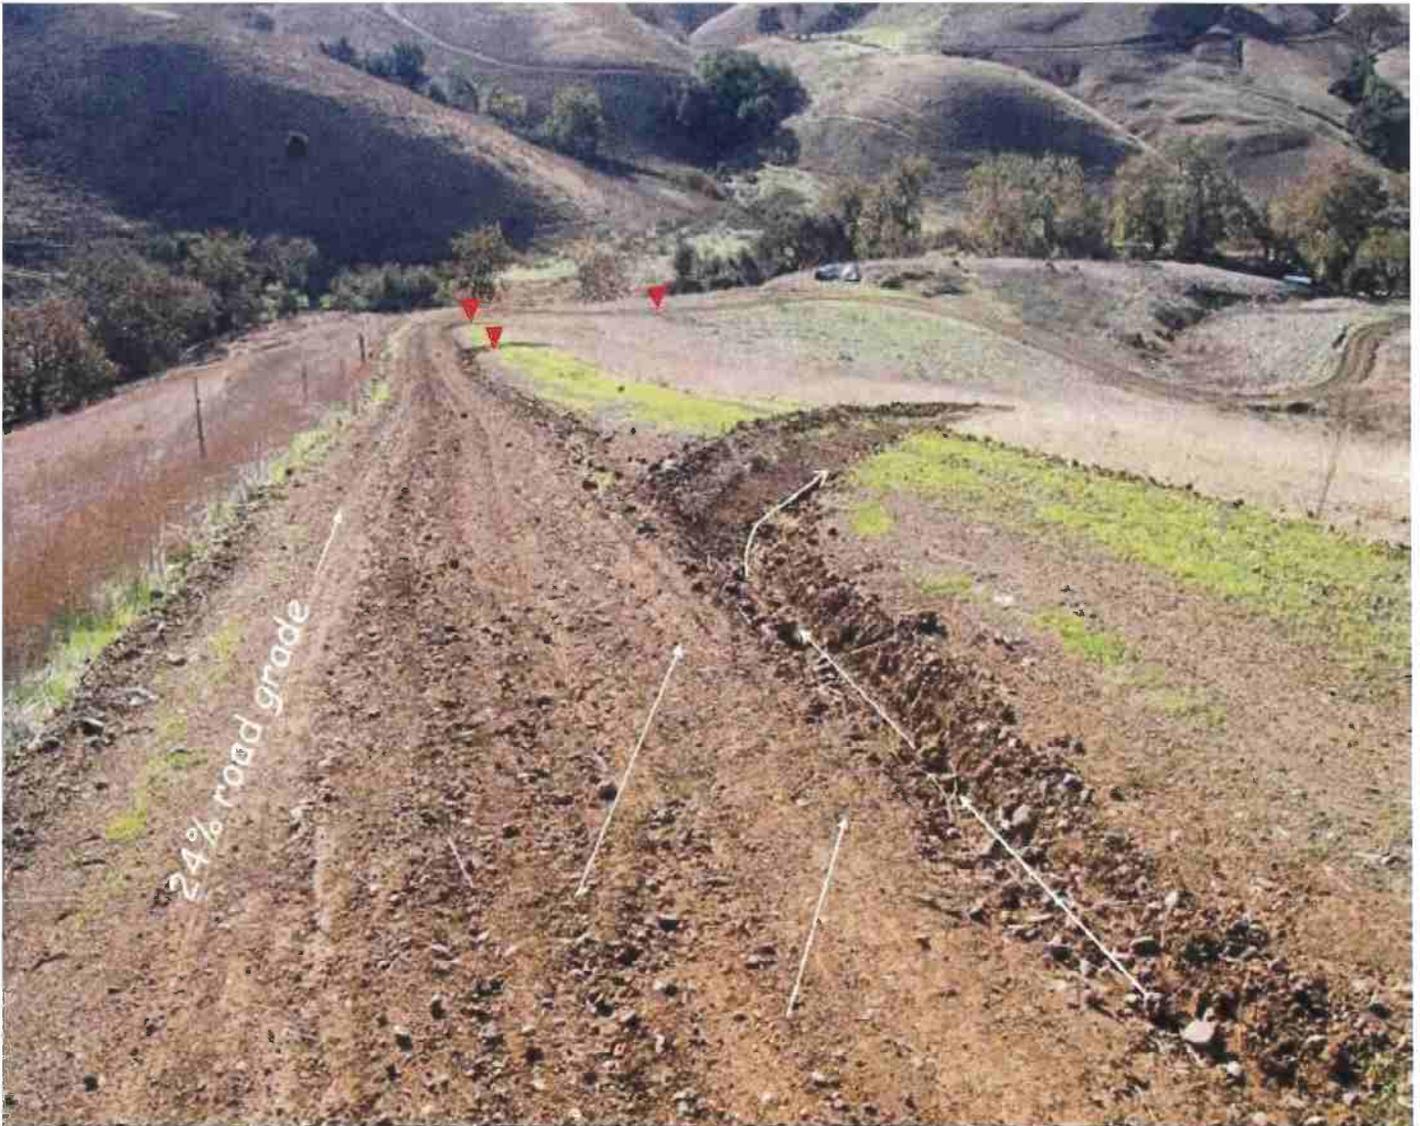
FIGURE 55. Steep roads that go straight up or down a hillside are very difficult to drain. This steep, fall line road developed a through cut cross section that was drained using lead out ditches to direct runoff off the road and onto the adjacent, vegetated hillside. The road was "outsloped" to drain runoff to the right side, and the lead out ditch was built slightly steeper than the road grade, to be self-cleaning. Four lead out ditches have been constructed at 100-foot intervals to the bottom of the hillside.

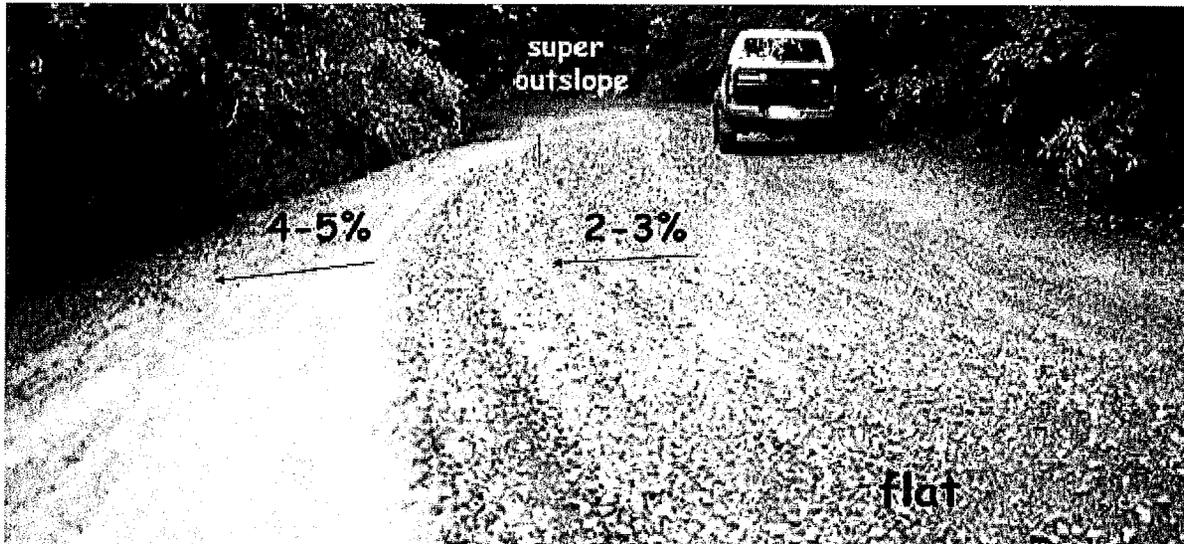
FIGURE 29. Road shape changes as the road travels through the landscape. For example, an out-sloped road will have a steep or “banked” outslope through inside curves, a consistent outslope through straight reaches and a flat or slightly insloped shape as it goes through an outside curve. The road may have an outslope of 2-3% across the travel surface while the shoulder is more steeply outsloped to ensure runoff and sediment will leave the roadbed.
