ATTACHMENT 3C
Wetland Delineation Report

Aquatic Resources Delineation

High Point Honeydew Farms
(APN: 107-054-036)

June 2021

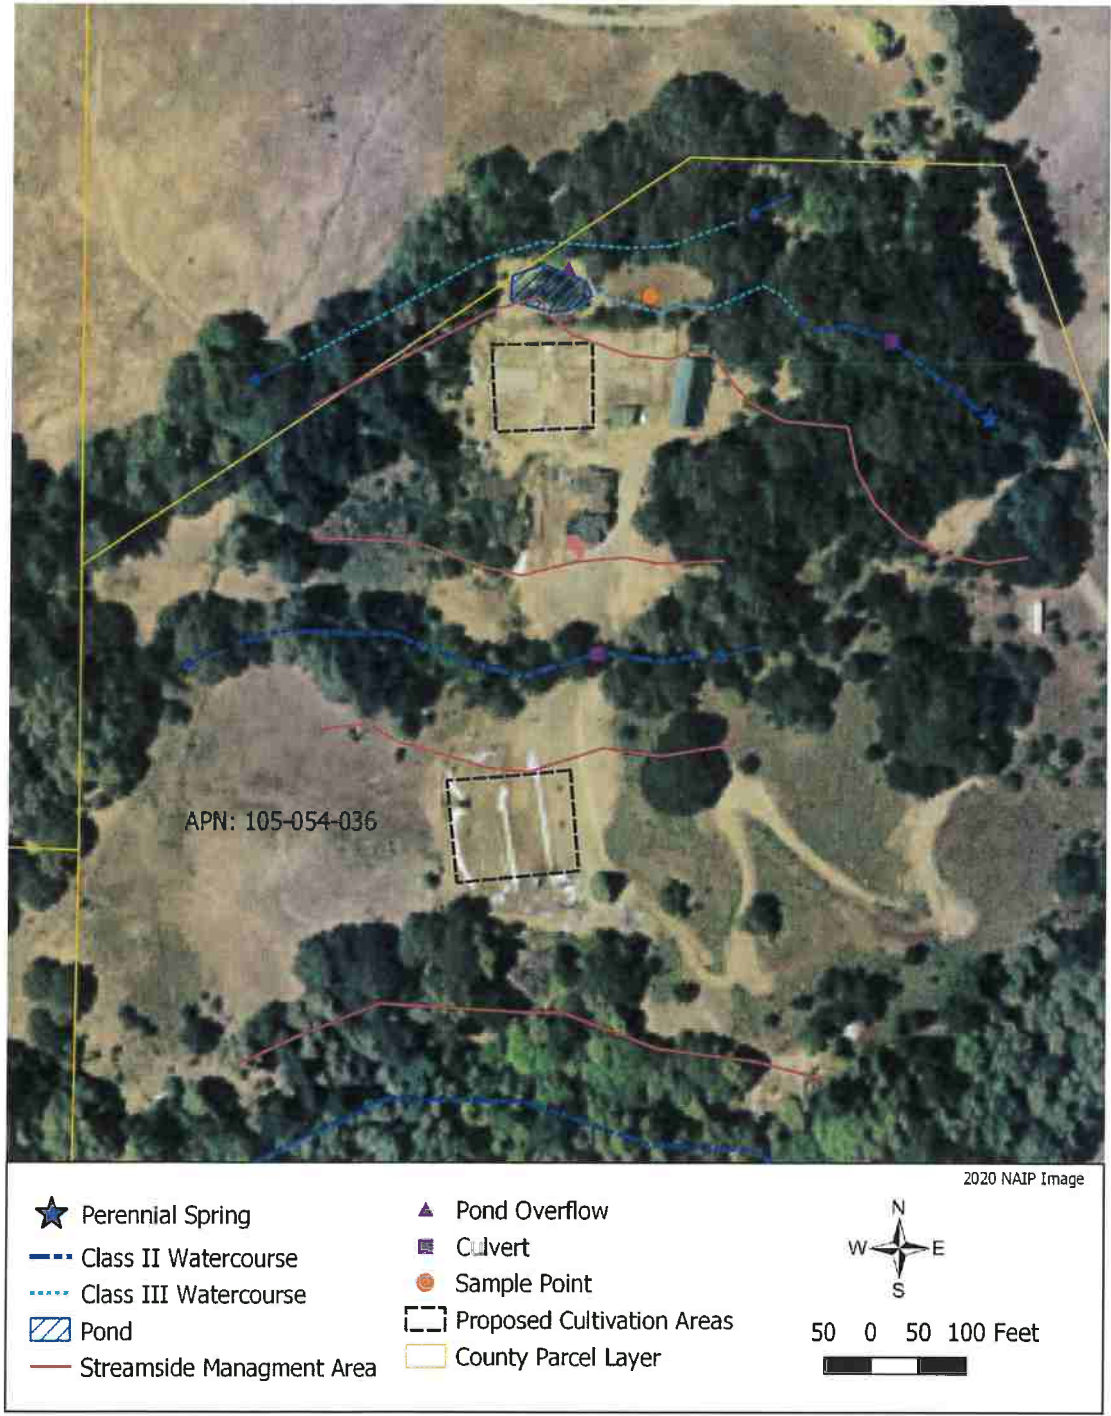
Figure 2. Aquatic Resources Map.

The aquatic features in the vicinity of the NWI polygon include a perennial spring that flows into a watercourse that currently connects to a pond (Figure 2). There are three other main watercourses on the parcel.

The water from the spring was flowing on September 2, 2021, and down a portion of the stream channel, but became subsurface in the lower section of the channel toward the cultivation area. Plants associated with the spring include lady fern (*Athyrium filix-femina* [FAC]) and sword fern (*Polystichum munitum* [FACU]).

There are no wetlands associated with the stream channel below the spring. The upper portion of the stream flows through upland forest dominated by (*Pseudotsuga menziesii* [FACU]), canyon live oak (*Quercus chrysolepis* [UPL]), and California bay (*Umbellularia californica* [FAC]).

The lower portion of the stream just above the pond flows through upland grassland that is dominated by wild oat (*Avena barbata* [UPL]), rattlesnake grass (*Briza maxima* [UPL]), six weeks grass (*Festuca myuros* [FACU]), blue wildrye (*Elymus glaucus* ssp. *glaucus* [UPL]), and ox-eye daisy (*Lecantherum vulgare* [FACU]) (Appendix D). There were no indicators of hydric soil and no indicators of wetland hydrology outside the channel in the lower (Class III) part of the stream near the cultivation area. There are also apple and other fruit trees in the lower part of the NWI polygon along the cultivation area.

The pond includes stands of non-native wetland plants including horticultural iris (*Iris pseudocorus* [OBL]) and umbrella plant (*Cyperus involuctraus* [FACU]) that were likely planted in the pond.

The SMAs for the aquatic features include a 150-foot setback around the perennial spring, a 100-foot setback along the Class II watercourses, and a 50-foot setback along Class III watercourses. There is no riparian vegetation along the streams, thus the stream setbacks are measured from the top of the bank.

The lower portion of the stream channel adjacent to the northern cultivation area is proposed to be re-aligned and reconnected directly to the stream just to the north to bypass the pond. This will make it an off-stream, non-jurisdictional pond, and not subject to setbacks. A portion of the SMA along the stream will move north farther from the project area when the stream is re-aligned. The map (Figure 2) is based on GPS and hand mapping on aerial imagery and is considered approximate. Setbacks directly adjacent to the cultivation areas should be established by physically measuring from the top of the stream bank on the ground.

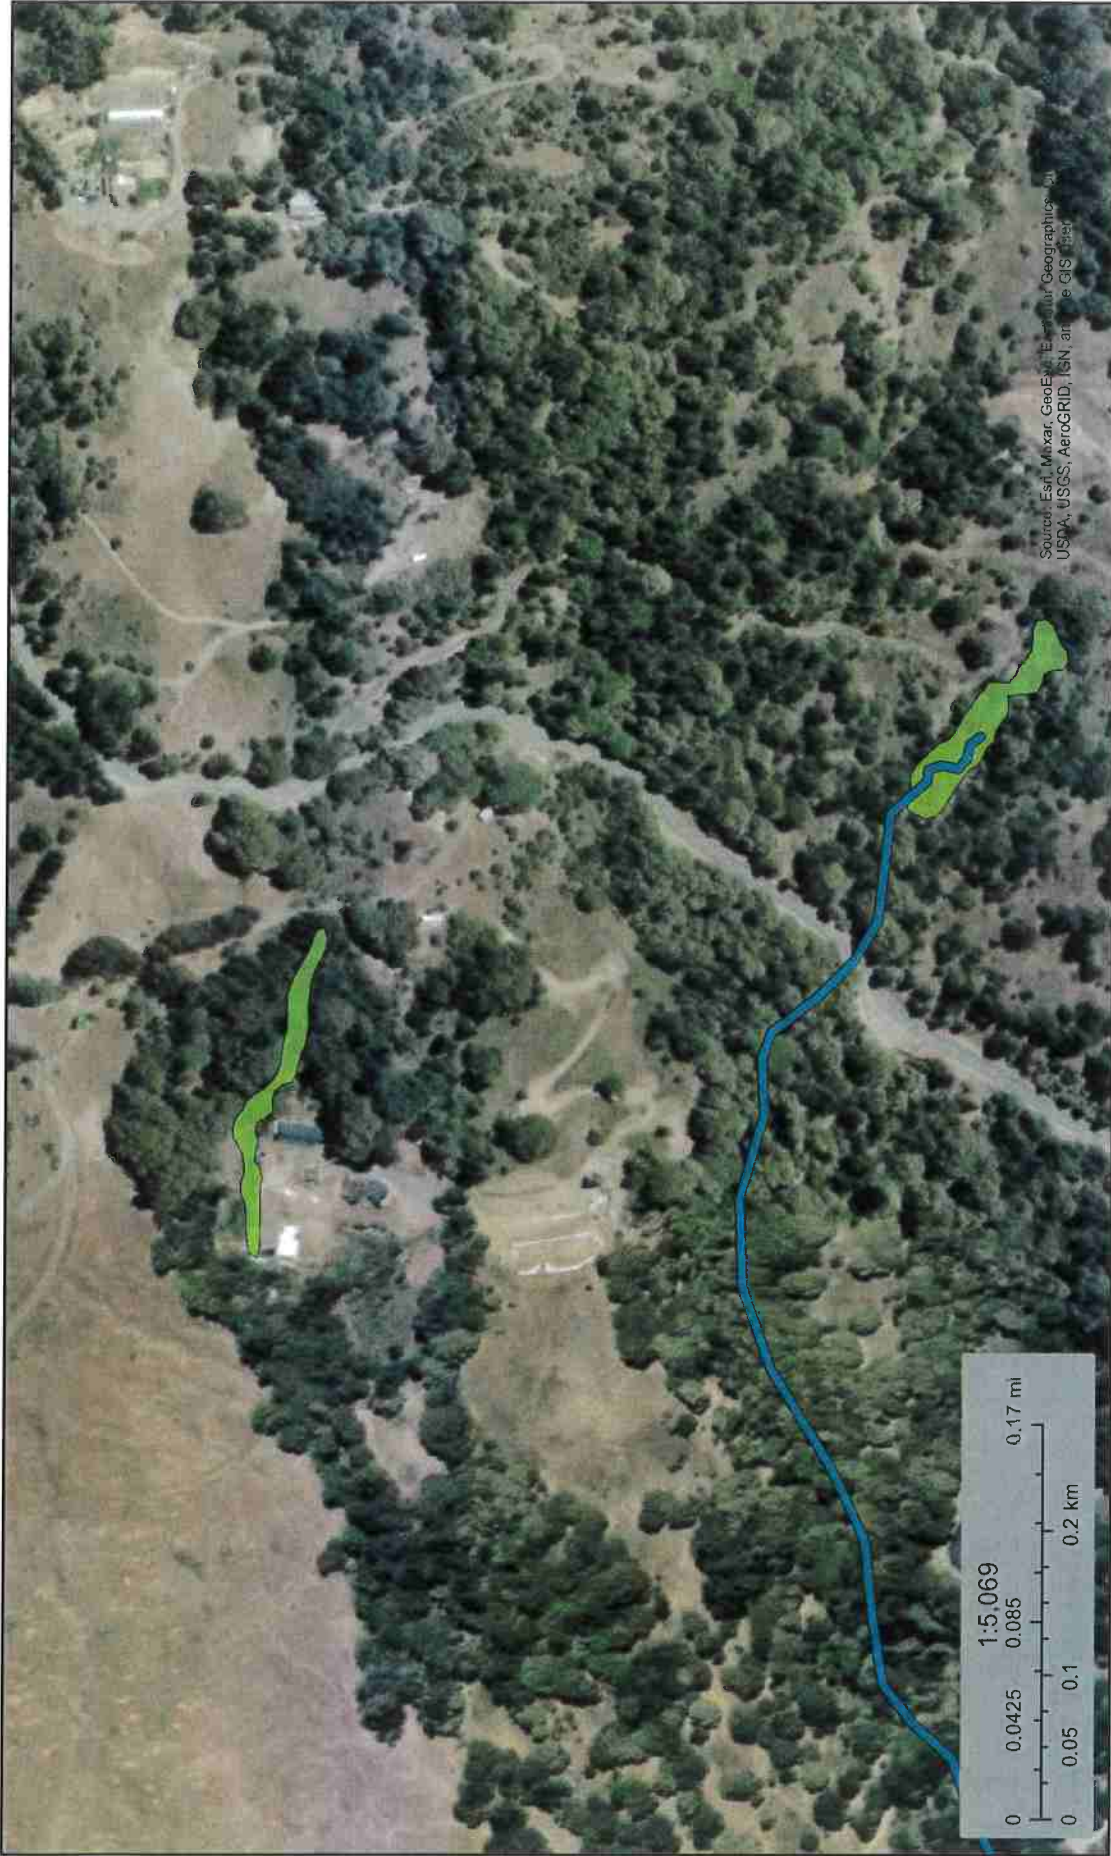
APPENDIX B. National Wetlands Inventory Map

The purpose of this report is to identify wetlands and other sensitive aquatic resources that could be impacted by commercial cannabis cultivation on APN: 107-054-036 near Honeydew (Appendix A). The Humboldt County Planning and Building Department has specifically raised concern (email to Austin Theriault, ETA Humboldt, on August 12, 2021) about an area mapped as wetland in the *National Wetlands Inventory* (NWI) (USFWS 2021) near the project area (Appendix B). The same polygon is shown on the Humboldt County *Web GIS* application.

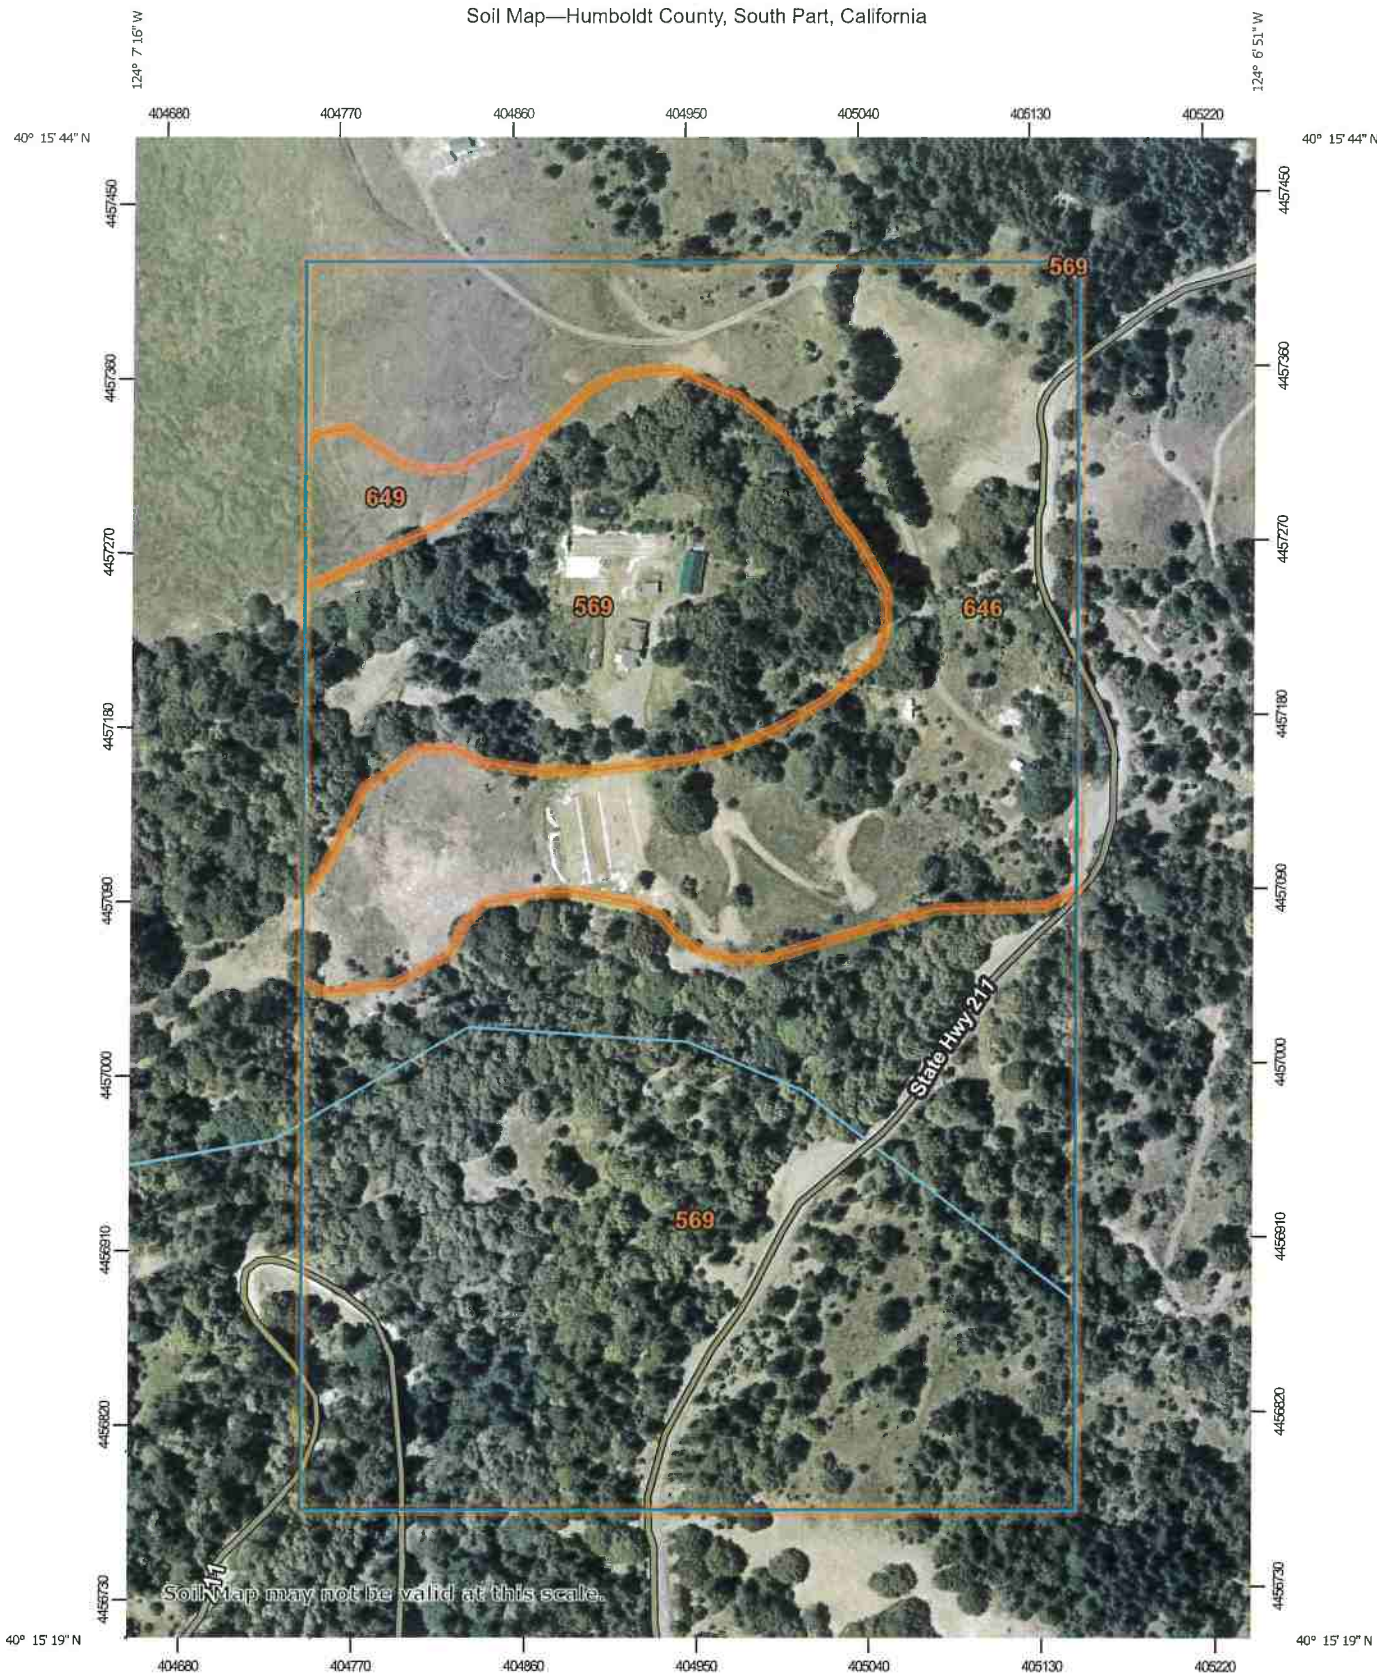
APPENDIX C. NRCS Soil Map

The soil types mapped on the parcel include Crazycoyote-Windynip-Caperidge complex, 15 to 50 percent slopes and Wirefence-Windynip-Devilshole complex, 5 to 30 percent slopes (United States Department of Agriculture, Natural Resource Conservation Service 2021) (Appendix C). These soil types are derived from sandstone and mudstone parent material. The major and minor soil components have non-hydric soil ratings.

Map Unit Symbol	Map Unit Name	Acres in AOI	Percent of AOI
569	Crazycoyote-Windynip-Caperidge complex, 15 to 50 percent slopes	41.2	63.8%
646	Wirefence-Windynip-Devilshole complex, 5 to 30 percent slopes	22.1	34.3%
649	Windynip-Wirefence-Devilshole complex, 30 to 50 percent slopes	1.2	1.9%
Totals for Area of Interest		64.5	100.0%
