**Integrated Horticulture Systems LLC Less Than Three Acre Conversion Mitigation Plan**

This document has been prepared pursuant to Section 55.4.10(j) of the Humboldt County Commercial Medical Marijuana Land Use Ordinance, applications for Commercial Cannabis Activity occupying sites created through prior unauthorized conversion of timberland. The document evaluates site conditions and conversion history for the parcel and contains a Registered Professional Foresters (RPF’s) recommendation as to remedial actions necessary to bring the conversion area into compliance with provisions of the Forest Practice Act.

a. Site Address: 8200 Salmon Creek Road Miranda, CA

c. Assessor’s Parcel No(s): 221-011-021

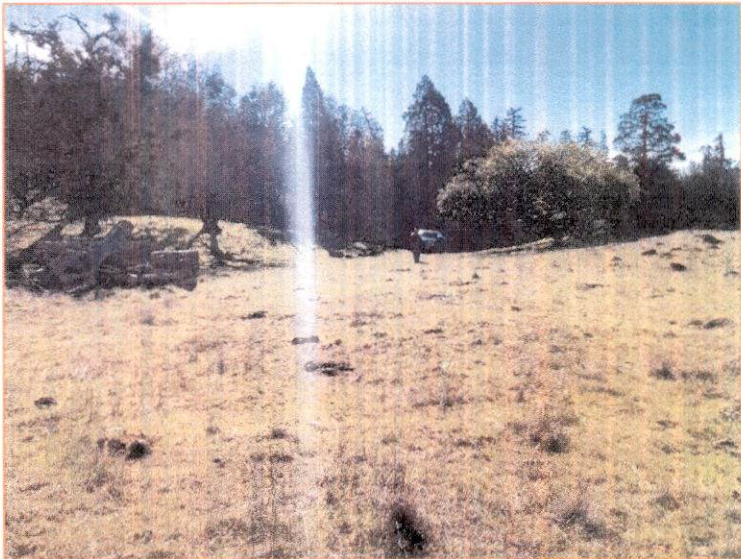
3A) West facing east, note flagging of 50' ELZ buffer.

History: The site appears as an open grassland in all available imagery back to 1993. No cannabis cultivation has occurred on this site to date. No trees have been or need to be cleared to convert the area to a cultivation site. No timber harvesting has occurred in or around this site in the last ten years. The proposed site will be converted for cannabis cultivation outside of all WLPZ and ELZs. No rare threatened or endangered animals or plants present within 1000' as per 2021 CNDDDB search. A hazard reduction issue is present at this site. Woody debris has been piled in the center of this site from the tree removed at Site 2. The site is zoned Agriculture Exclusive (AE). Ownership at the present time is Integrated Horticulture Systems LLC.

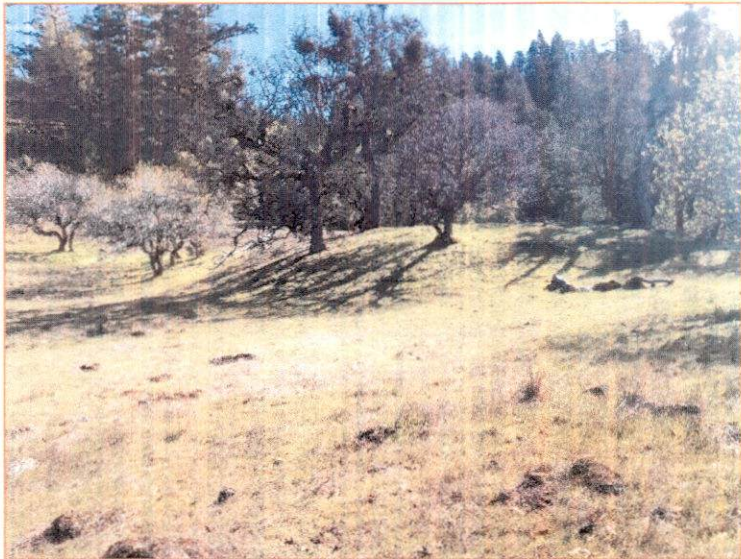
3B) South facing north.
