**Disturbed Area Stabilization Plan
Technical Report
Order WQ 2019-0001-DWQ**

For
APN 208-221-013 and 208-221-014

Located at
**Parcels 51 and 52, Timberline Ranch Estates RS, BK 26
Mad River, California**

October 2021

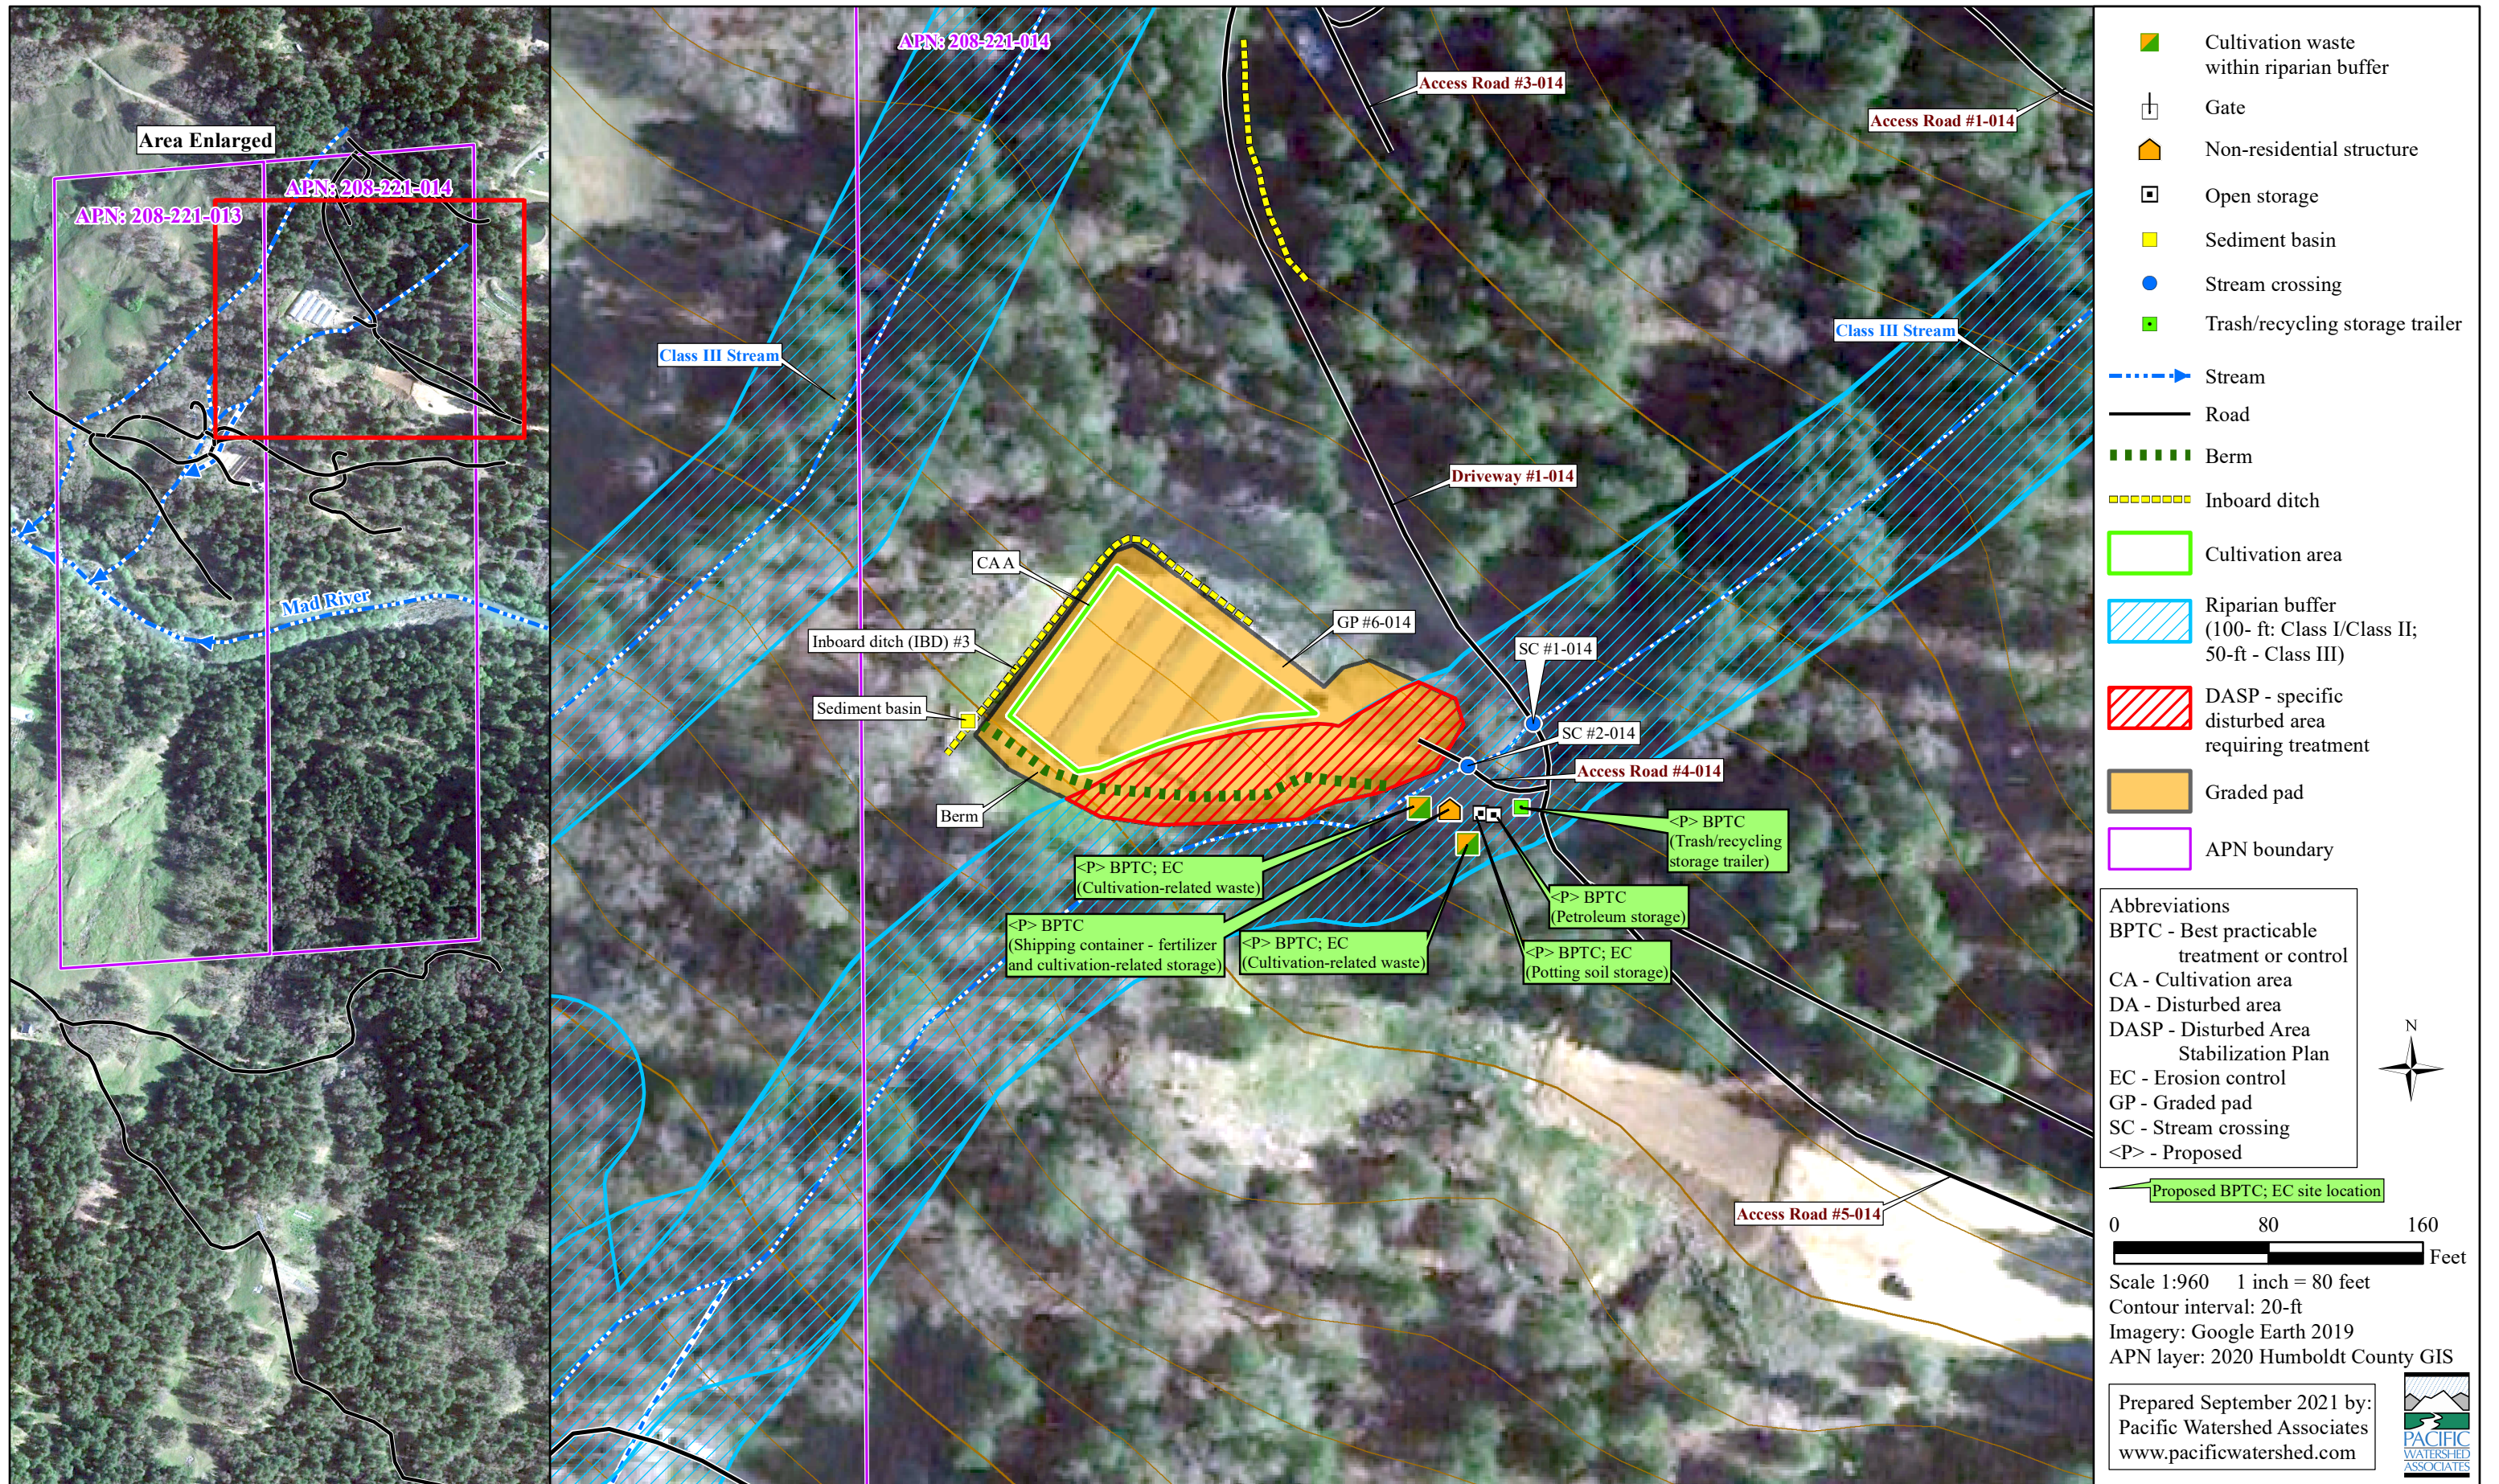
Figure 2B. Site Map for Drosihn Disturbed Area Stabilization Plan, APN 208-221-013 and 208-221-014, located at Parcel 51 and 52, Timberline Ridge Estates RS BK 26, Mad River, Humboldt County, California.

Based on a cursory assessment of available Google Earth aerial imagery it appears development of the Project Site first occurred between 2005 and 2009 for cannabis cultivation, which included the construction of multiple graded pads and likely reoccupation and use of an existing ranch or timber harvest road network. There are three locations on the Project Site where cultivation-related disturbances have occurred within the riparian setback from streams. These locations include the downstream portion of SC #5-013, which also consists of the northeast portion of the graded pad at Cultivation Area #1 (CA #1; Figure 2A), the southwest portion of the graded pad at Cultivation Area #3 (CA #3; Figure 2A), and the south-southeast portion of CA A located downstream of SC #2-014 (Figure 2B).

- Remove all invasive species from the excavated stream channel banks at SC #5-013/CA #1 (Figure 2A) and the riparian area surrounding the graded pad at CA A (Figure 2B), and as otherwise found within designated restoration areas during removal activities.

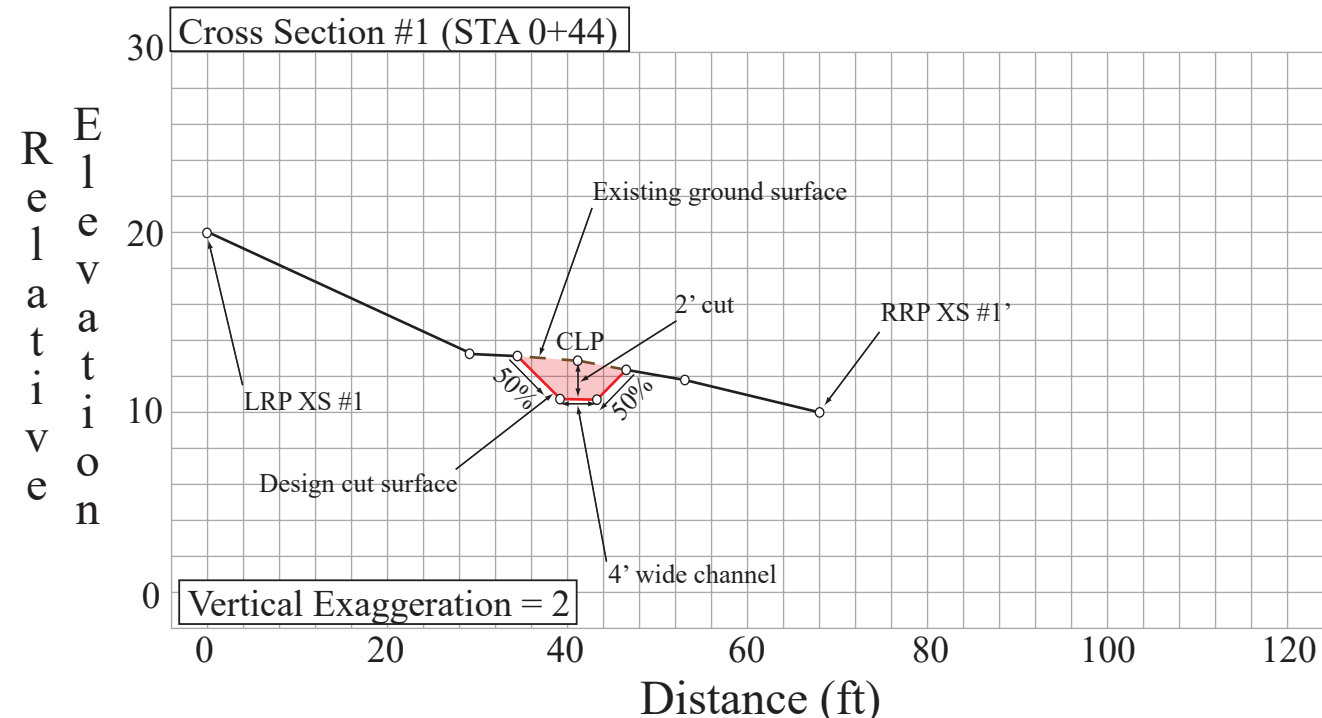
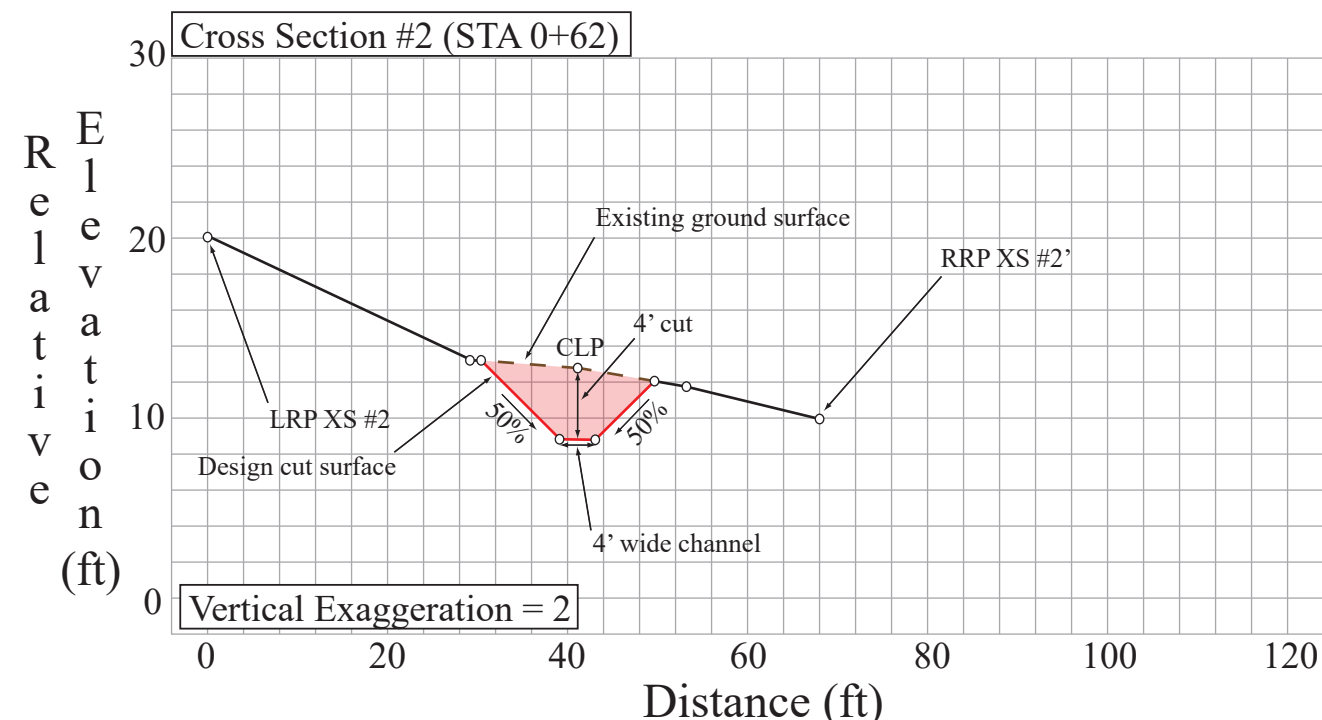
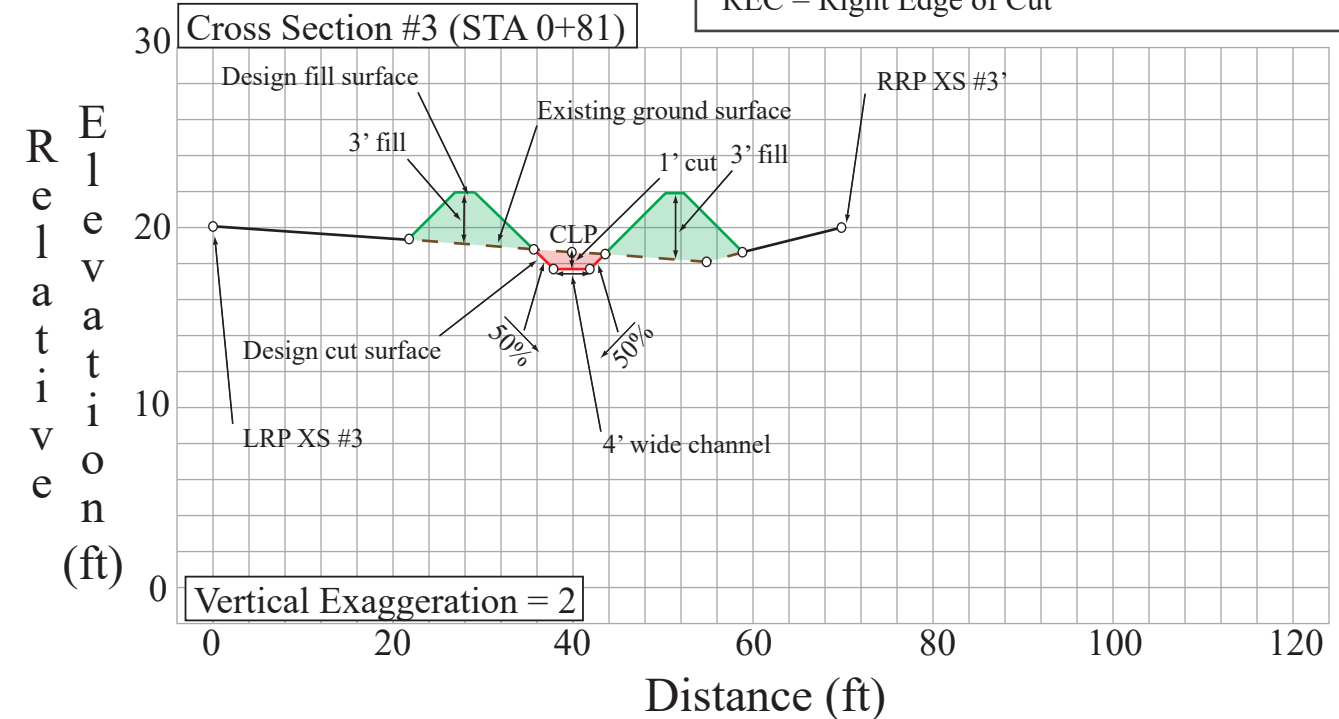
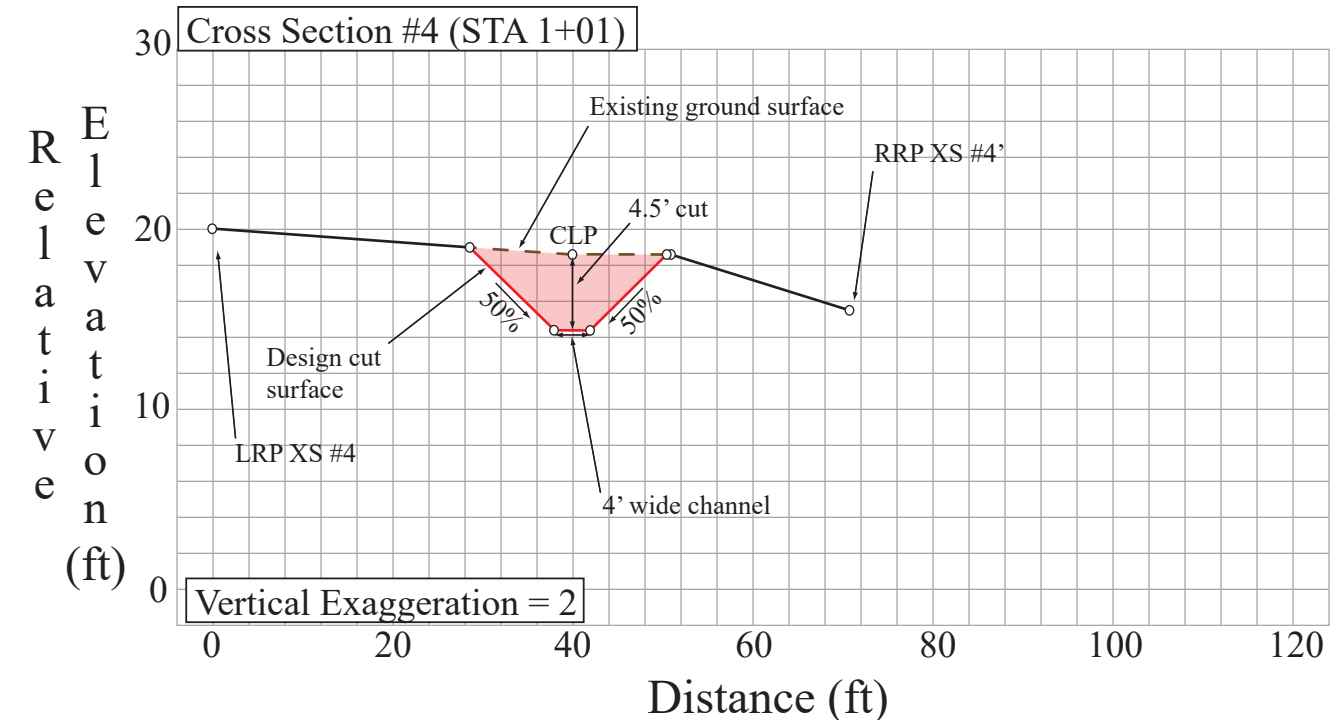
Balanced Cut/Fill Volume: 300 cu yds

PROJECT PLAN DESCRIPTION:
Proposed Stream Crossing #5
Cross Sections #1 - #4
Drosihn Project Site
APN # 208-221-013
