RE: Revocation of Kernens Construction Conditional Use Permit – Public Hearing, December 3, 2024

**Attachment 1: Site Maps**

**Photos:**

Subject: **Notice of Violation of Water Code Section 13267** Investigative Order R1-2022-0025 (13267 Order or Order) and Industrial General Permit Order No. 2014-0057-DWQ (IGP) for Kernen Construction and **Directive to Apply for Water Quality Certification/Waste Discharge Requirements** for Activities in Waters of the State pursuant to Water Code section 13260.

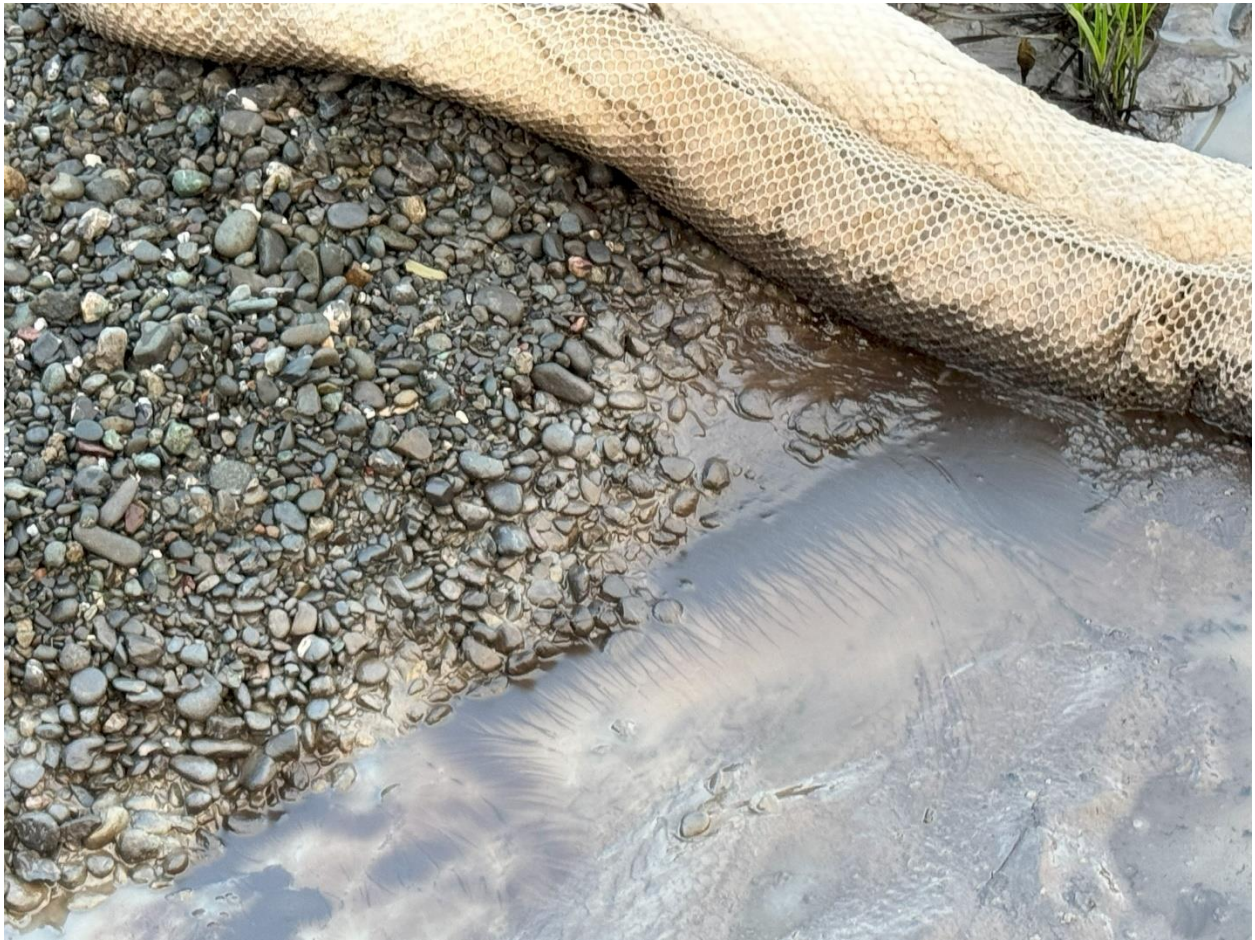
A sheen was observed on the water surface and a black oily residue was observed on the gravel and the absorbent sock within the sediment trap within the upper yard (See picture 7). The IGP requires the Discharger to evaluate the Facility for areas where spills and leaks can likely occur and control these sources of pollutants. The preventative maintenance and spill prevention and response sections of the IGP must be implemented.

Picture 7 - View of an absorbent sock in the sediment trap. A sheen was observed on the water surface and a black oily residue was observed on the gravel and the absorbent sock within the sediment trap. Picture taken by Walt Dragaloski.

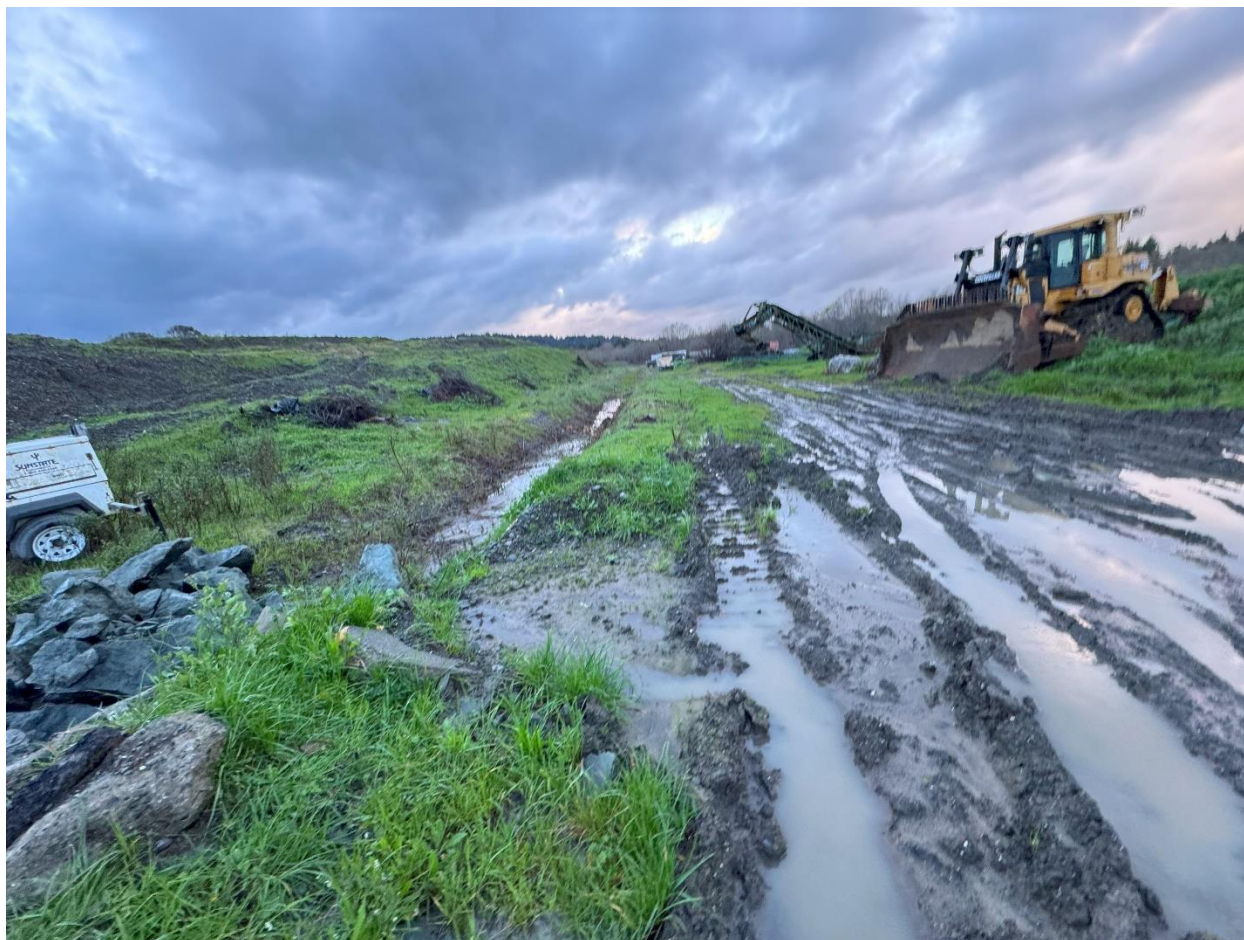
Picture 9 - View of unpaved access road adjacent to an on-site drainage ditch in the lower yard. No sediment and/or erosion control BMPs were observed. Overflow from this ditch discharges into Waters of the State into Noisy Creek or into Waters of the State at an unnamed tributary to Hall Creek. Picture taken by Walt Dragaloski.
