# Wetland and Other Waters Delineation Report

Assessor's Parcel Number  
512-072-002  
5364 Fieldbrook Road  
Fieldbrook, California

**022203**

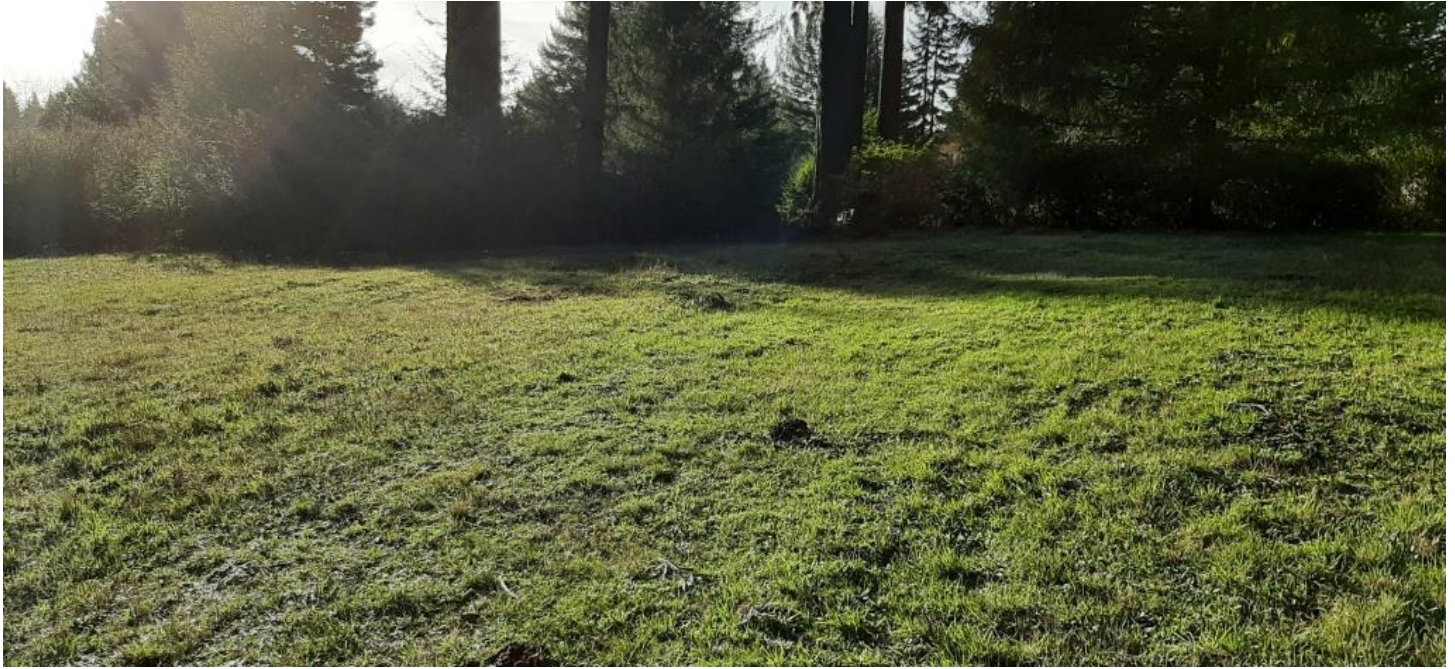
**1**

**Photo 1: North view of project site. Photo taken January 19, 2023.**

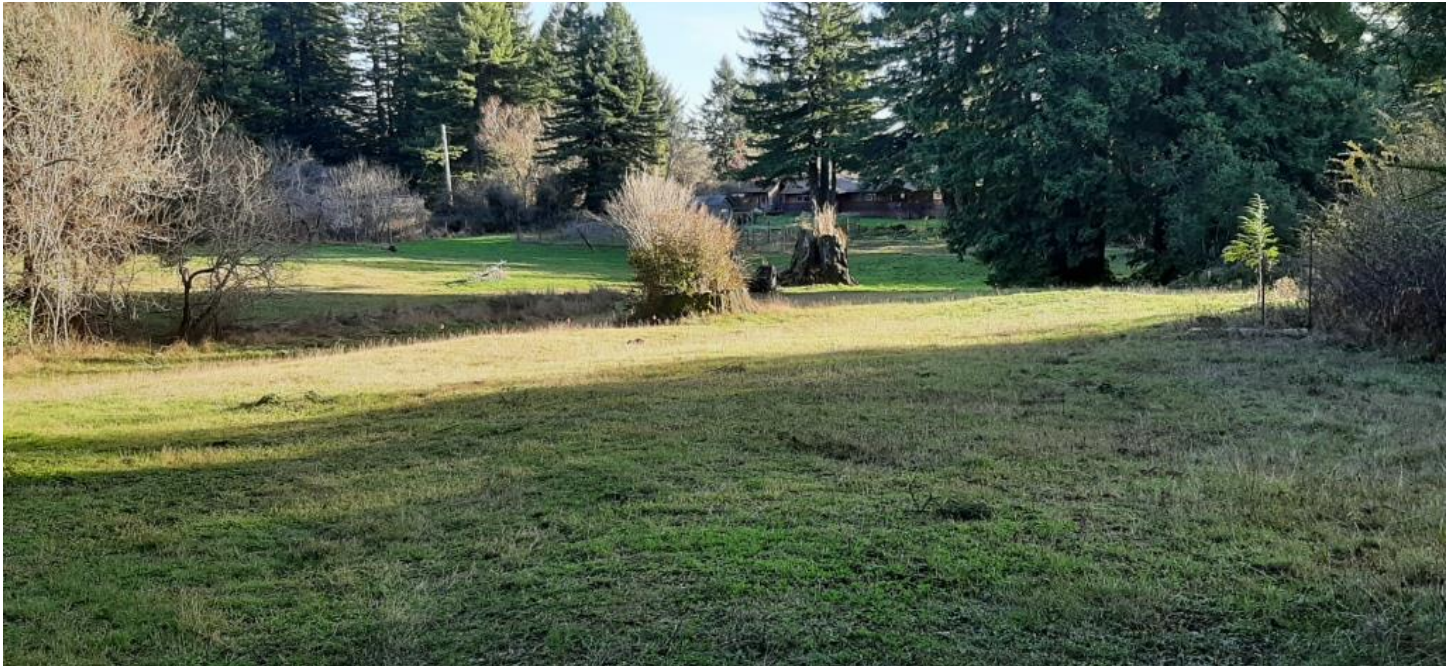
**Photo 2: South view looking towards existing residential home with wetland and stream in swale. Photo taken January 19, 2023.**

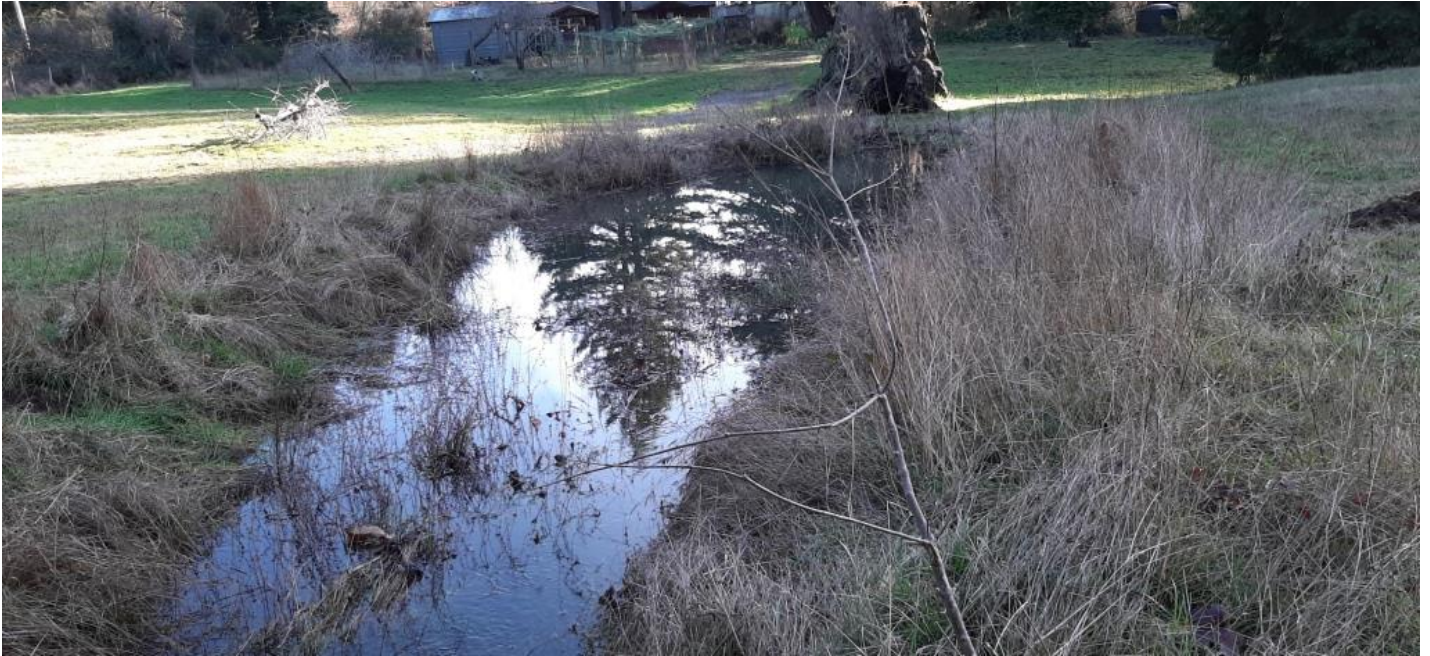
**Photo 3: Looking south, towards the existing residence. The constructed wetland is in the foreground in the stream that flows southwest. Photo taken January 19, 2023.**

TP1 was excavated within the wetland that is in the study area (Figure 2; Appendix 1, Photos 3 and 4). The wetland was created by adding a dam in an intermittent stream that drains the forested hillslope north of the parcel. The owner indicated this occurred several years ago; therefore, normal circumstances were assumed. The test site was chosen to determine if the pond has enough hydrology during the year to support wetland conditions. All three parameters were present (hydrophytic vegetation, hydrology, and hydric soils); therefore, it is considered a USACE wetland.

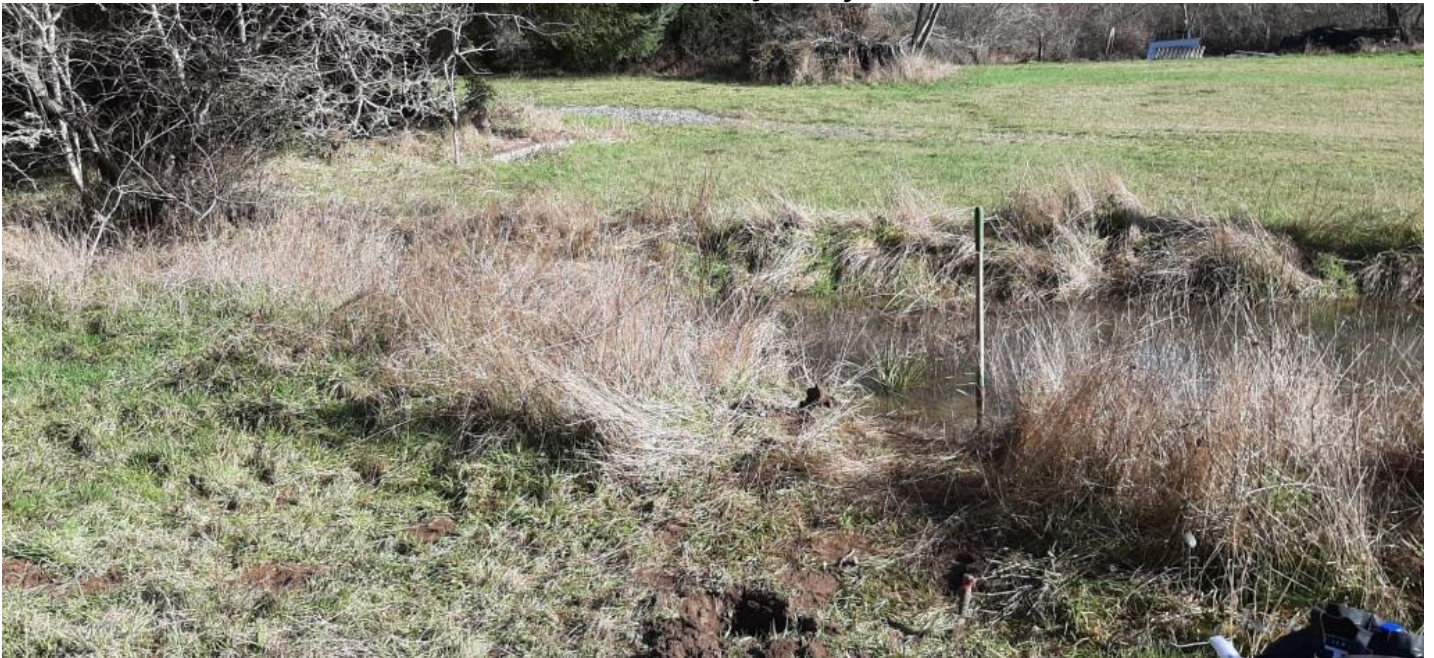
**Photo 4: Looking east at TP1 (located at shovel). TP2 is in foreground at excavated pit in the upland mowed field. Photo taken January 19, 2023.**

TP2 was excavated 10 feet above TP1 in the mowed field above the wetland and is the paired plot to TP1. It is at the base of a well-drained 20-percent sloped hillslope. None of the three parameters were observed; and therefore, is not considered a USACE wetland (Figure 2; Appendix 1, Photo 4).
