M e m o r a n d u m

Subject: Violations of Fish and Game Code Sections 1602, 5650, and 5652 in Conjunction with Cannabis Cultivation

On October 15, 2024, and October 24, 2024, California Department of Fish and Wildlife (CDFW) staff inspected the property at Assessor's Parcel Number (APN) 208-111-028 (Property), owned by CTCC LLC, managed by Michael McEnry.

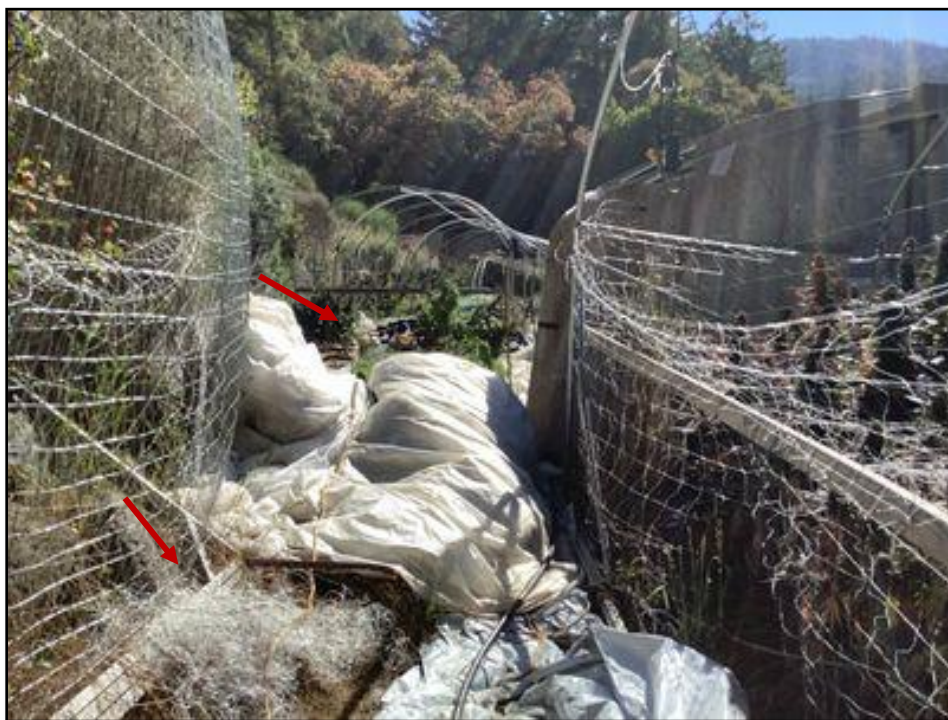
Figure 4. Looking east at a portion of the cannabis cultivation observed on the Property. Note a small portion of the uncontained plastic trellis netting observed onsite (red arrows).

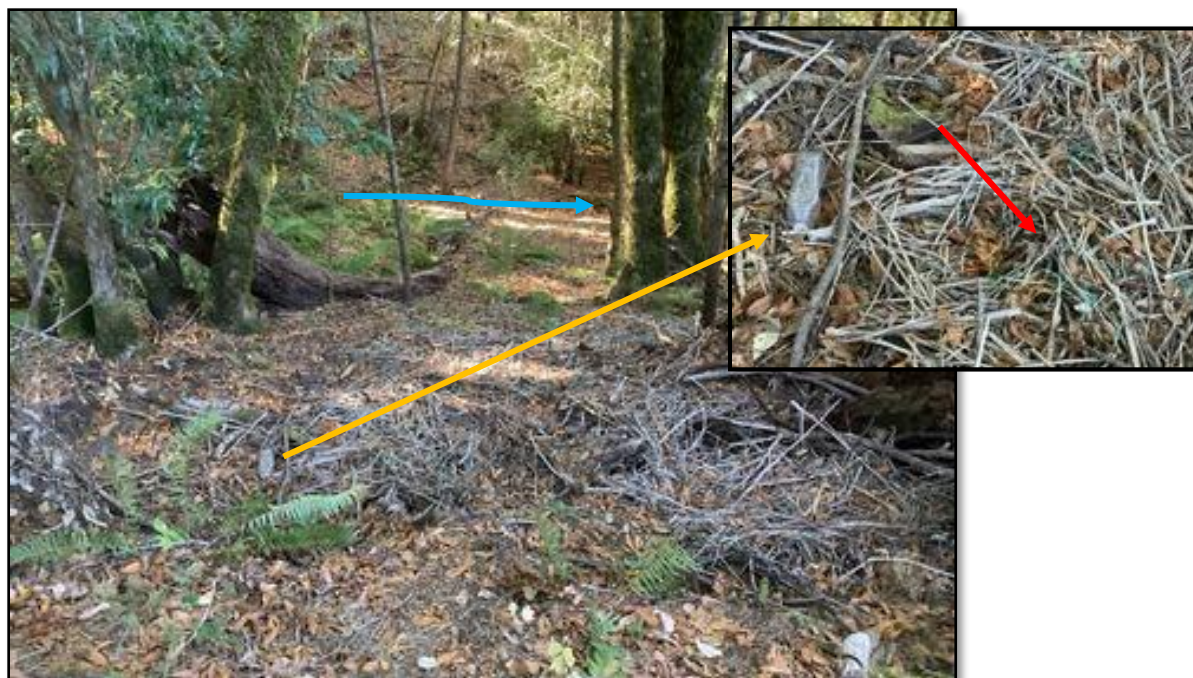
Figure 5. Violation No. 1 (Map ID PP-1). Looking southwest at cannabis cultivation waste containing plastic bottles, trellis netting, and other plastic materials (red arrow) deposited upslope (approx. 24 feet) from a stream (blue arrow).

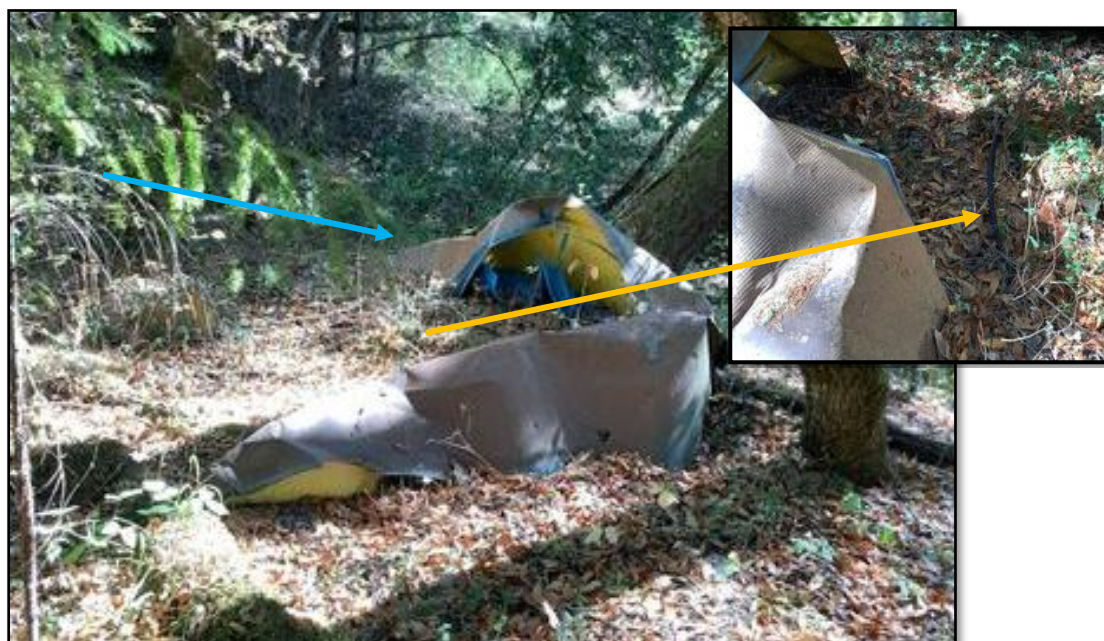
Figure 6. Violation No. 2 (Map ID PP-2). Looking east at abandoned waste (above ground pool, plastic irrigation pipe, etc.), associated with cannabis cultivation, deposited upslope (approximately 20 feet) from a stream (blue arrow).

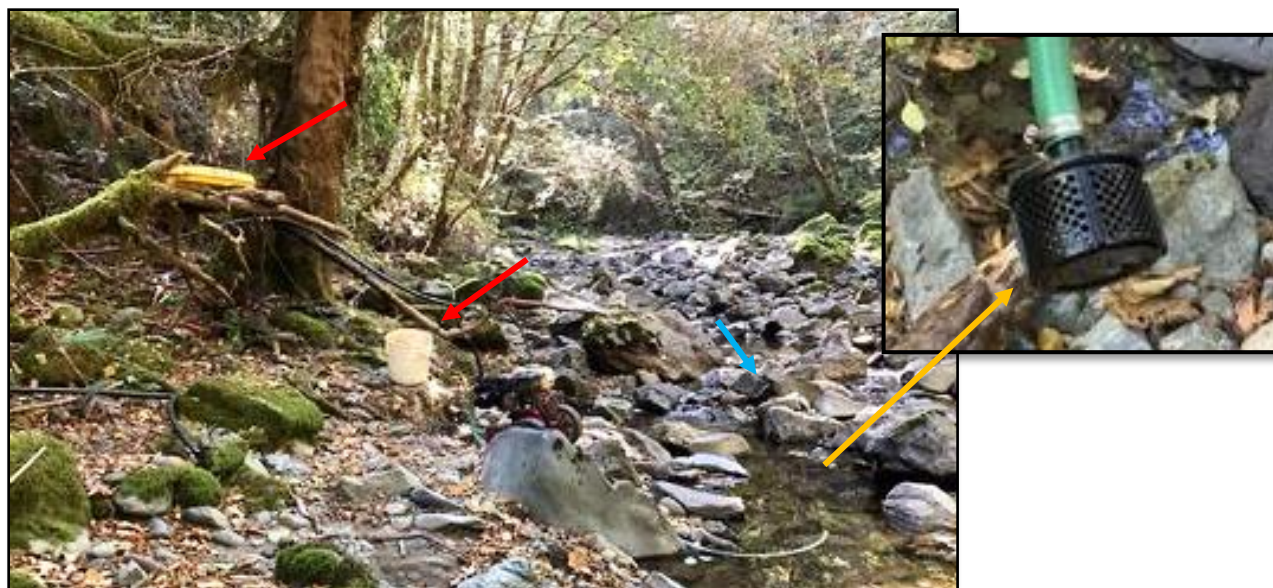
Figure 7. Violation Nos. 3-5 (Map ID WS-1). Looking southeast (upstream) at a gas-pump water diversion located on Little Larabee Creek, a Class I fish bearing stream, during the October 15, 2024, site visit. The intake screen is insufficient to prevent harm to aquatic life. Diverted water was stored on the Property and used for cannabis irrigation. Note the placement of the bucket and gas tank (red arrows). Blue arrow indicates direction of streamflow.

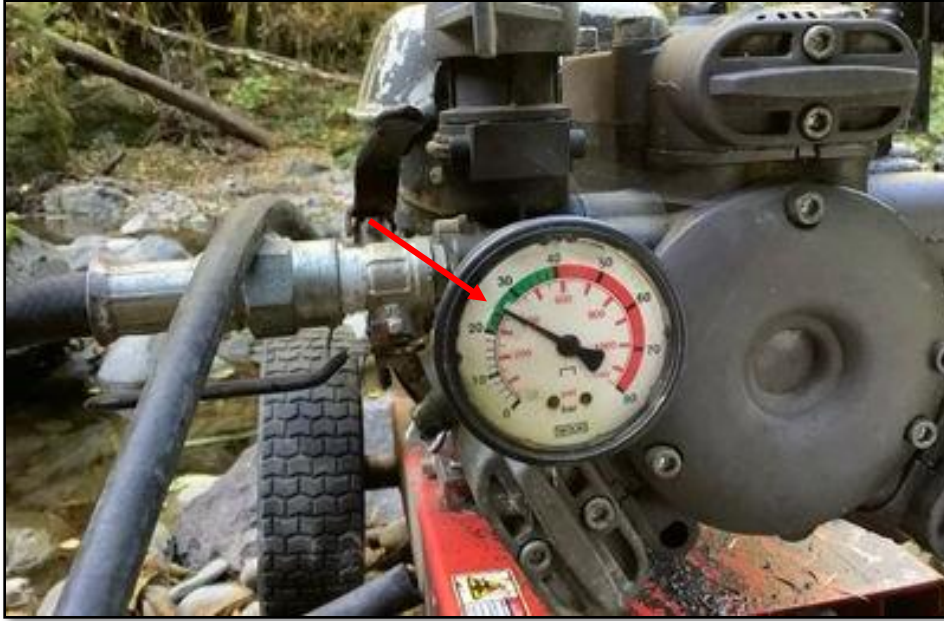
Figure 9. Violation Nos. 3-5 (Map ID WS-1). Looking west at the gauge on the gas-pump, used to divert water for cannabis irrigation on the Property. The guage shows approximately 25 pounds of pressure indicating its recent use.

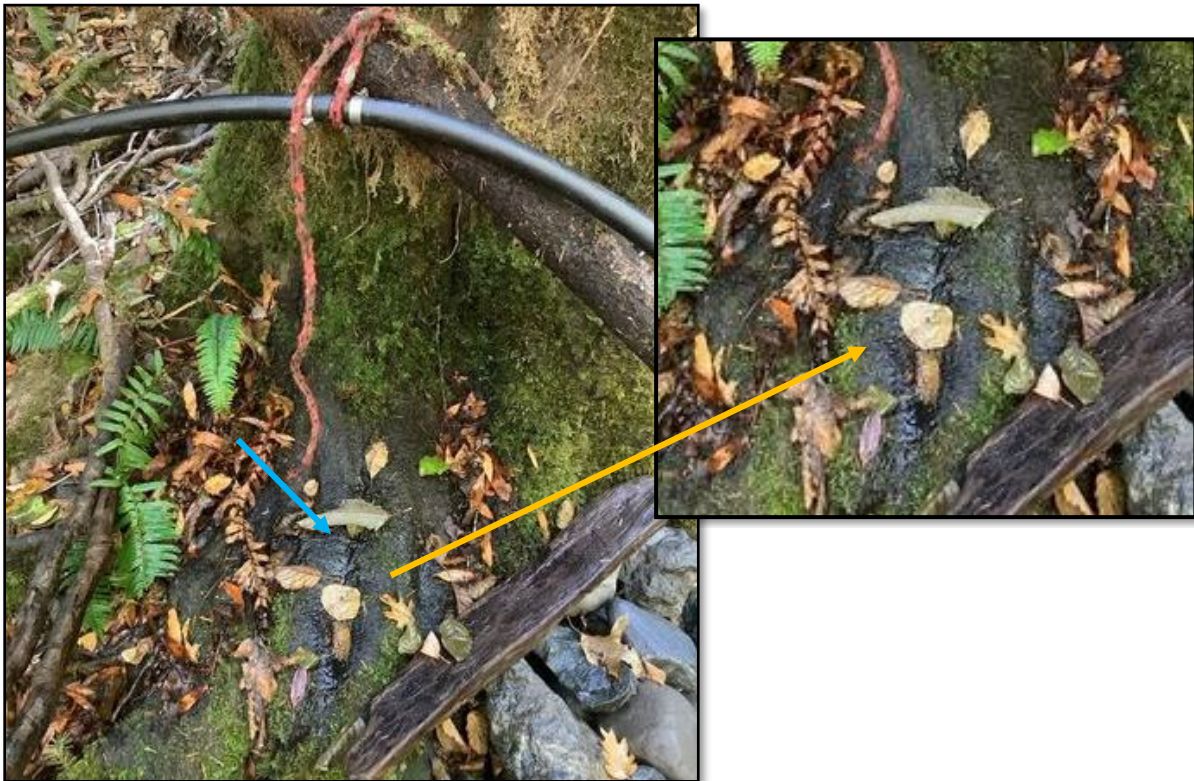
Figure 10. Violation No. 3 and 4 (Map ID WS-1). Looking east at the plastic water diversion pipe actively dripping water onto the ground (blue arrow) at the time of the October 15, 2024, inspection.

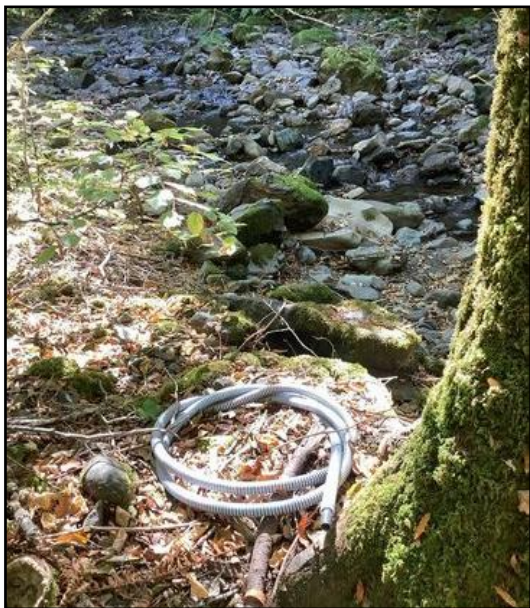
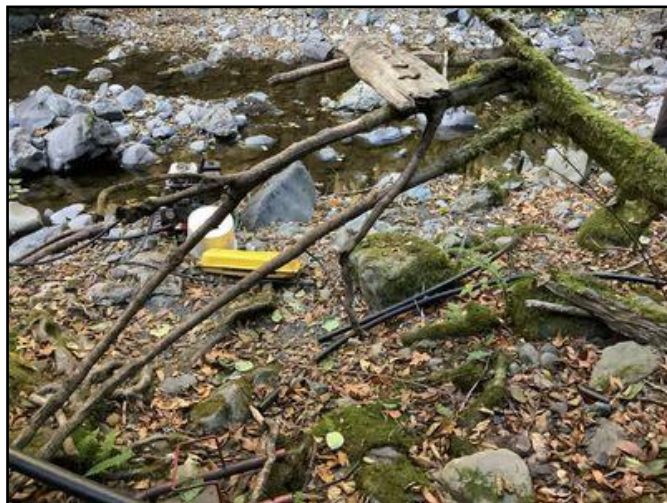
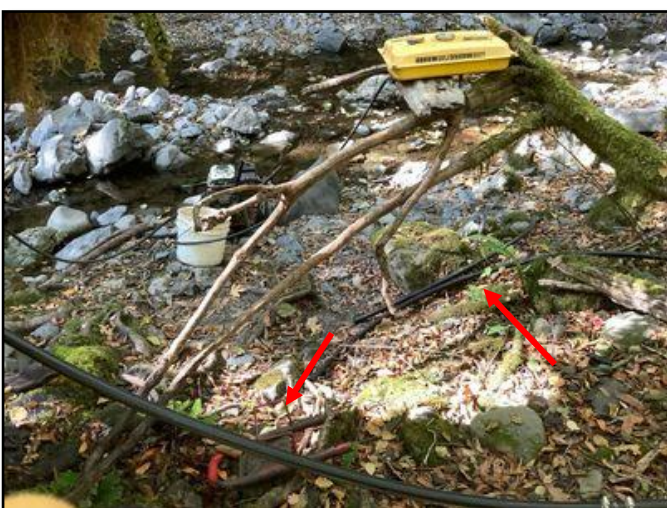
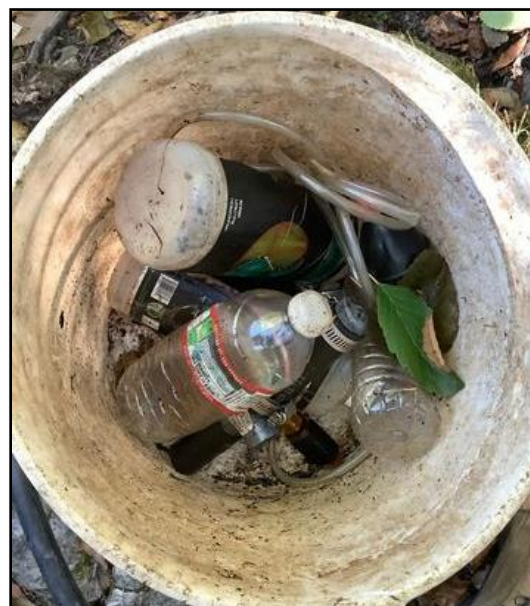
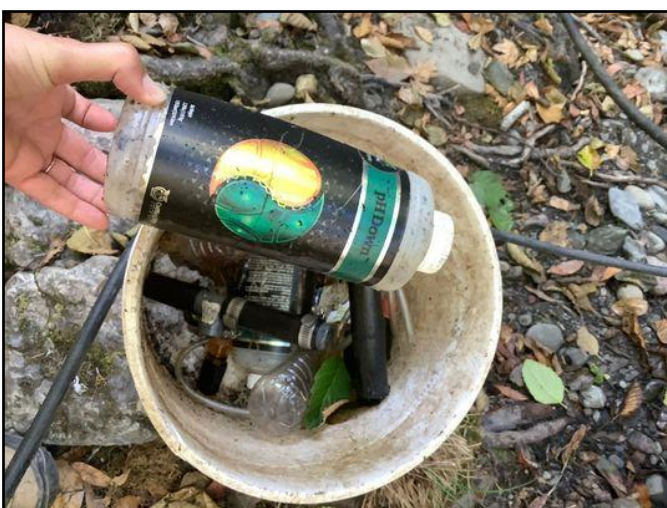
Figure 11. Violation No. 3-5 (Map ID WS-1). Photos showing the refuse associated with WS-1 placed into and where it can pass into State waters. Red arrows indicate a portion of the trash partially obscured by leaf litter, and includes pieces of plastic pipe, a metal dolly handle, plastic bottles, and other plastic and non-plastic trash.

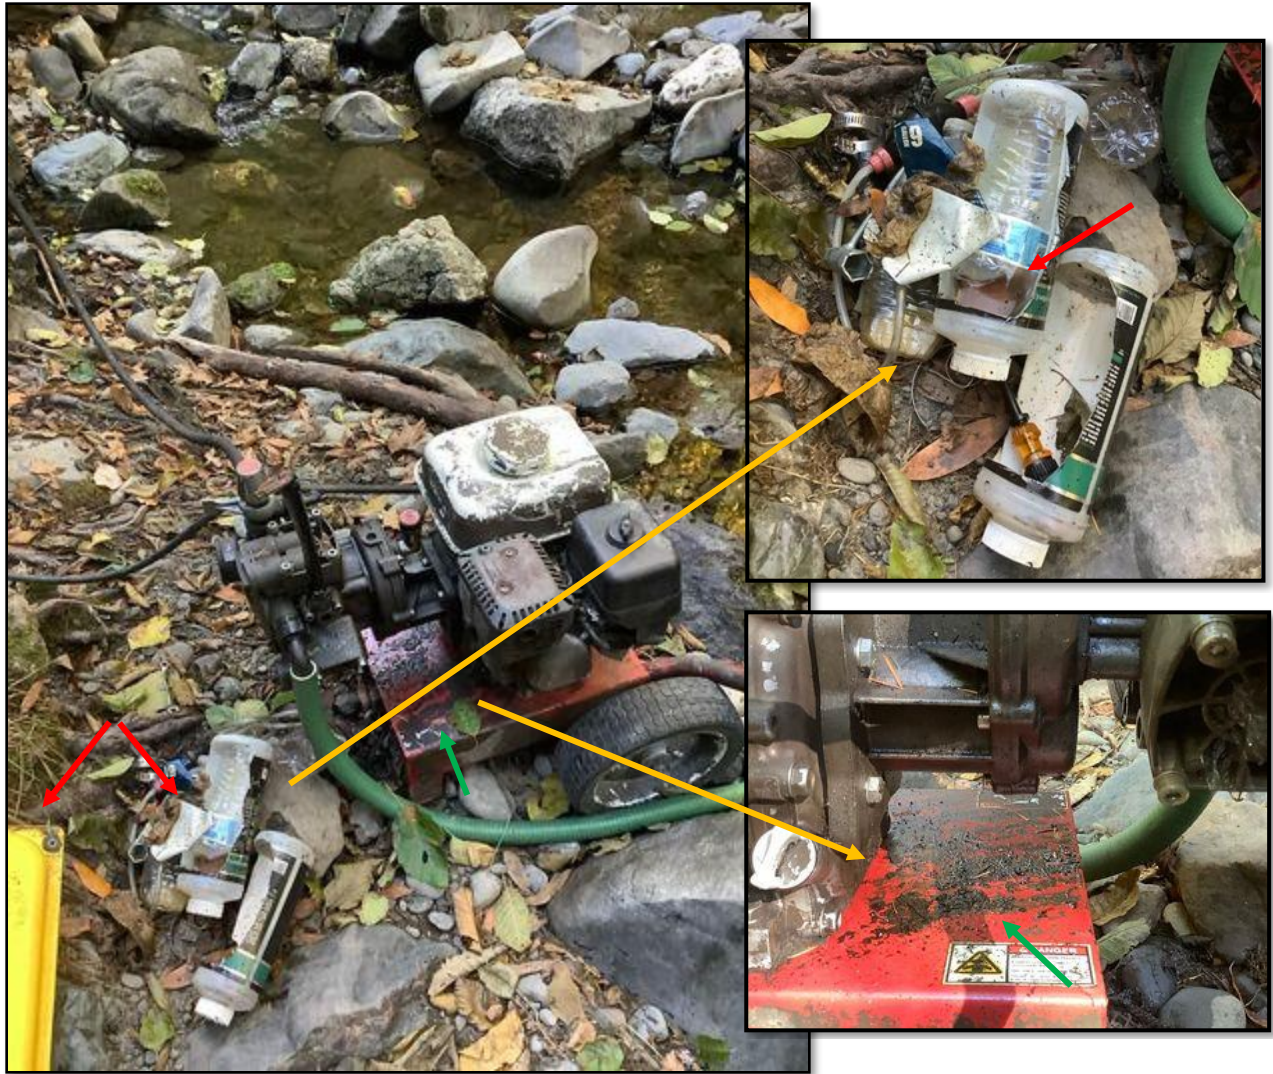
Figure 12. Violation Nos. 3-5 (Map ID WS-1). A close up image of the gas-powered pump and associated fuel and oil containers, used to divert water for cannabis cultivation on the Property. The leaky pump (green arrows) and petroleum products (red arrows) lack proper storage or secondary containment resulting in delivery of petroleum to State waters. Plastic irrigation line, plastic bottles, and other plastic and non-plastic refuse were placed into, and where they could pass into, State waters, resulting in water pollution and potential for future delivery.

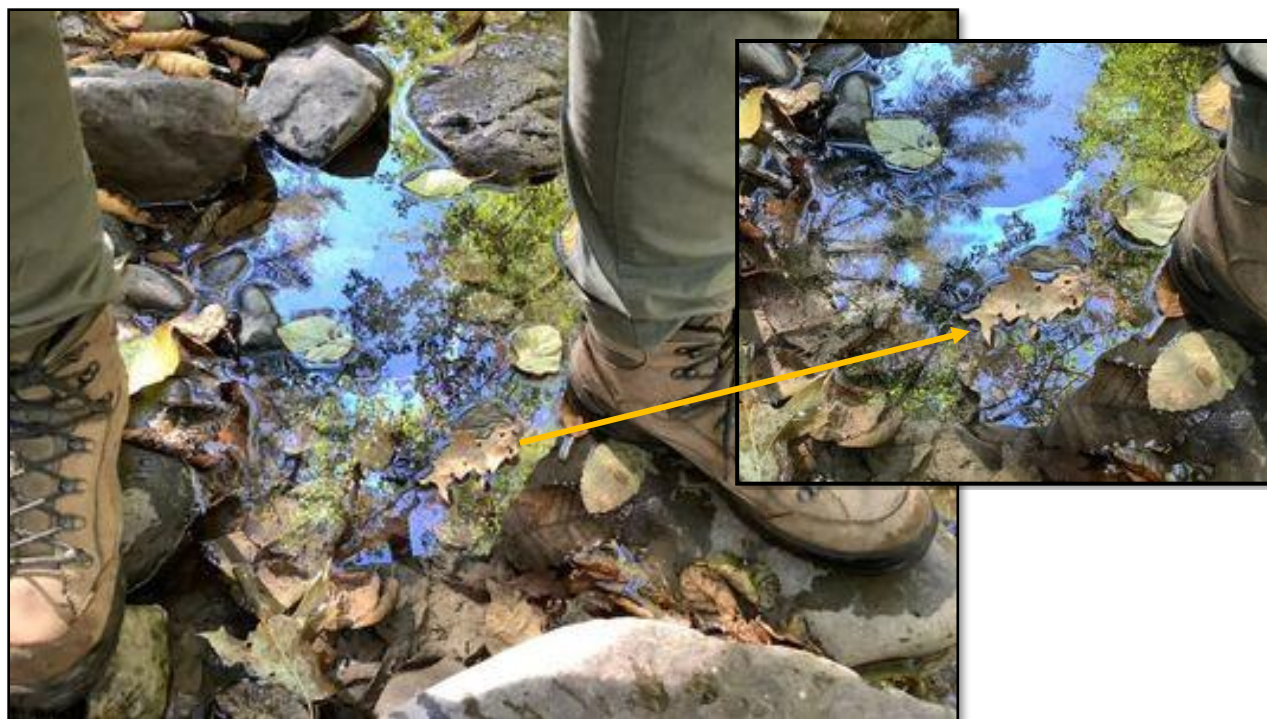
Figure 13. Violation No. 5 (Map ID WS-1). Showing the sheen of petroleum on the water surface of Little Larabee Creek adjacent to the gas-powered pump. Juvenile salmonids (fish) were observed in the stream at this location.

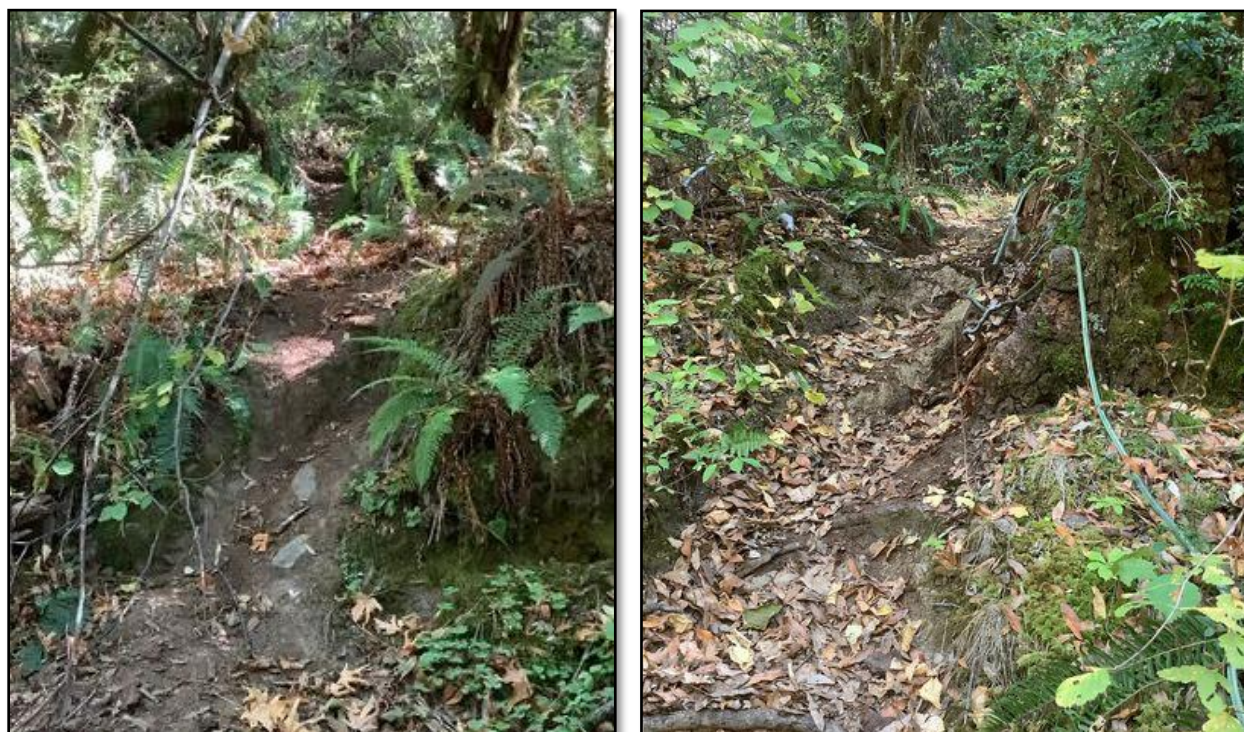
Figure 14. Map ID WS-1. Sections of the well-worn footpath leading from the cannabis cultivation sites to the water diversion (WS-1) on Little Larabee Creek.

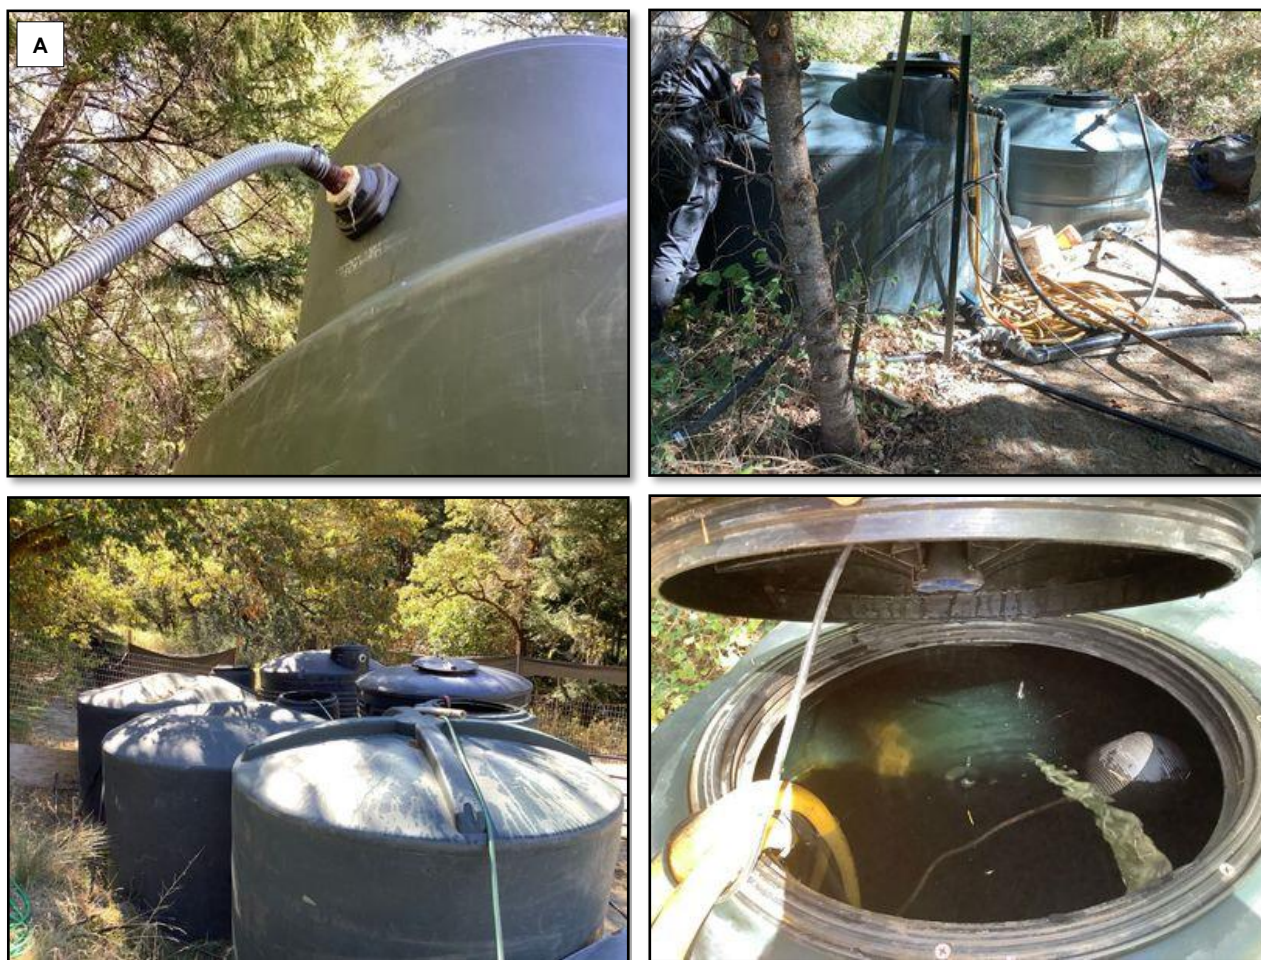
Figure 15. Showing a portion of the water storage tanks on the Property receiving diverted water from Little Larabee Creek. Photo (A) shows the water tank directly connected to water diversion WS-1. Note the gray hose, which was also found near the site of water diversion WS-1 (see Figure 14).

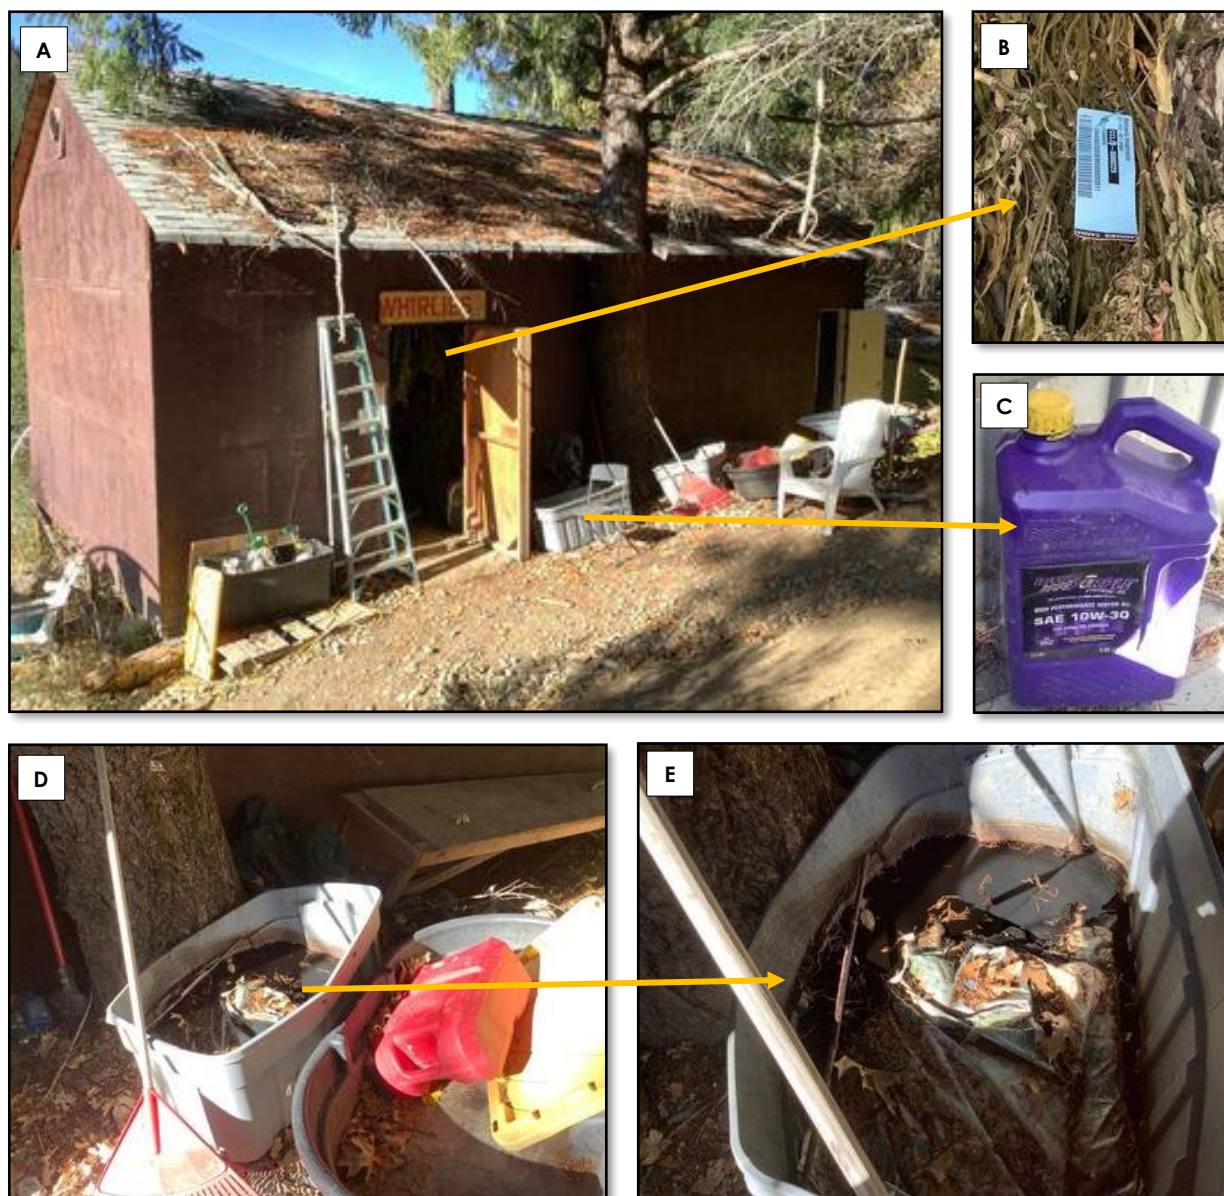
Figure 17. Cannabis drying shed on the Property (A) containing recently harvested cannabis drying in the shed (B). Outside the building, containers of oil were present (C) along with an open air plastic storage container filled approximately 2/3rds full with a mixture of used oil and rainwater (D and E).

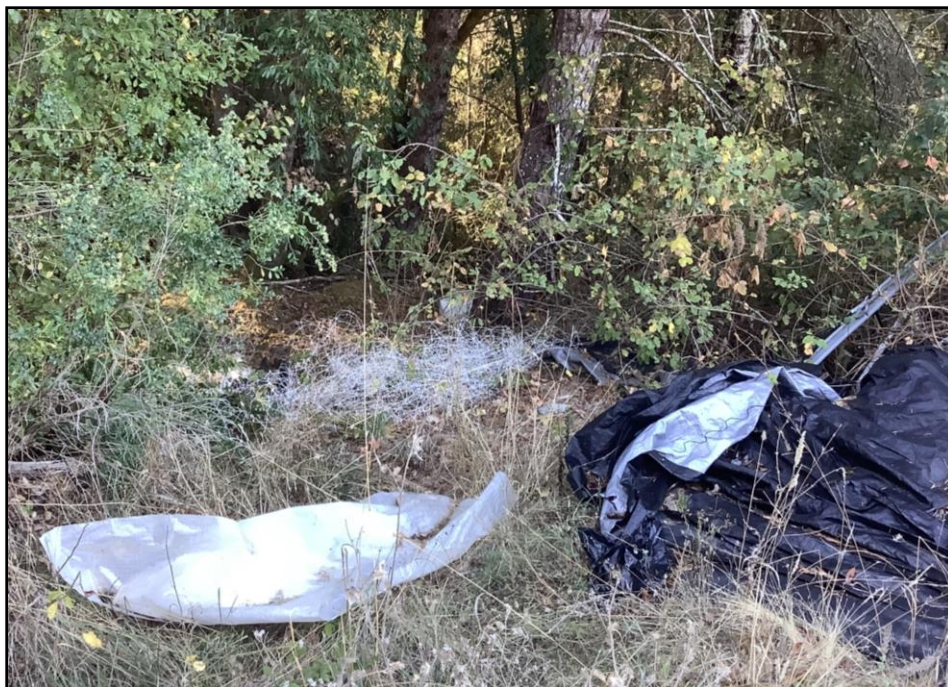
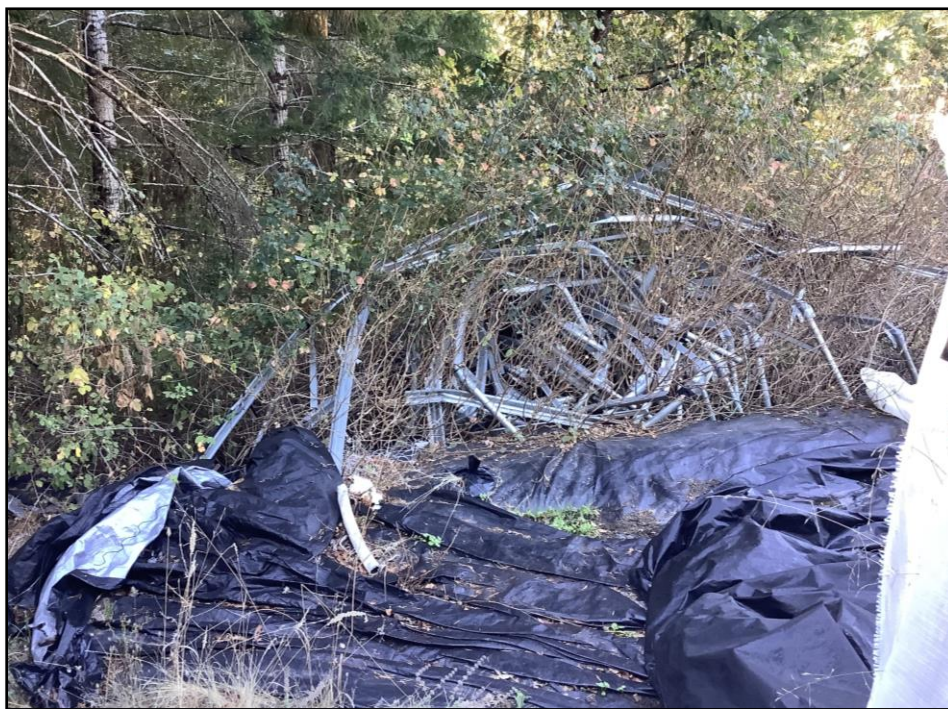
Figure 18. Example of unkempt cannabis cultivation waste including plastic tarping, plastic trellis netting, and metal greenhouse infrastructure placed/abandoned in the forest and underlying vegetation.

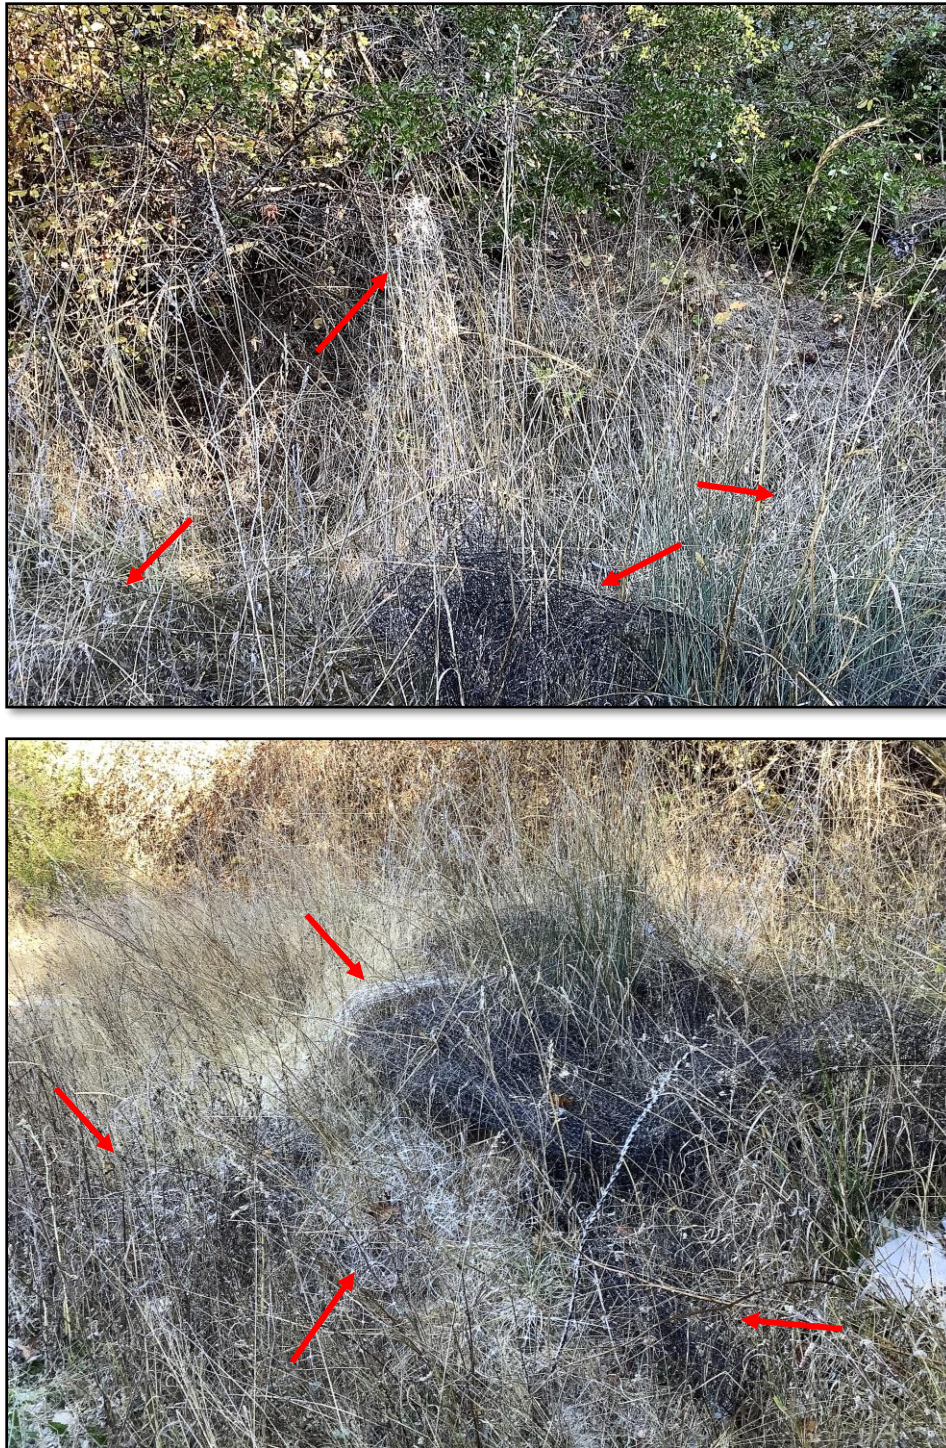
Figure 19. Example of a portion of the monofilament (plastic) trellis netting and plastic deer fencing improperly discarded into nearby vegetation on the Property.

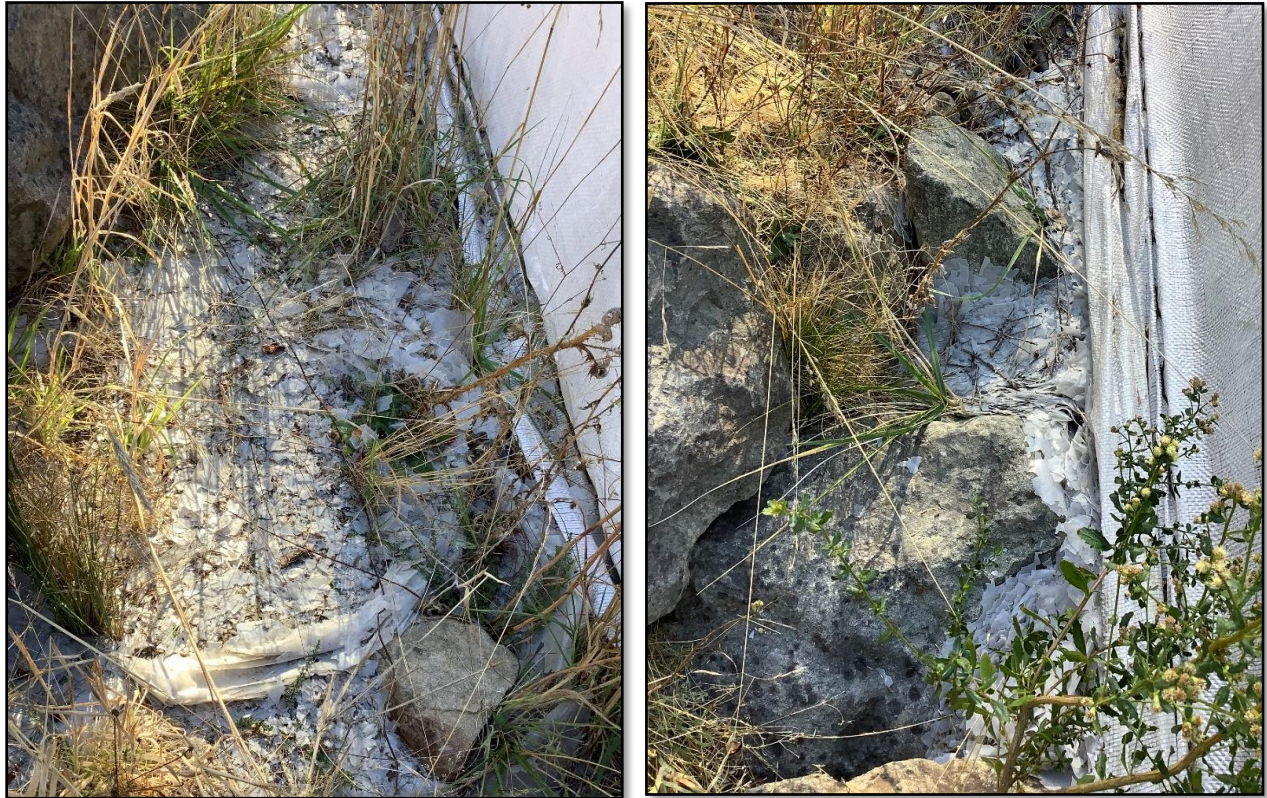
Figure 20. Example of a portion of the photo-degraded plastic greenhouse tarp found on the Property. Millions of micro-plastic pieces have been left to further degrade and disperse into the surrounding environment.
