NorthPoint Consulting Group, Inc.
1117 Samoa Blvd.
Arcata, CA 95521
(707) 798-6438

RE: Lucy Gulch, LLC - Road Evaluation Report
APNs: 221-091-015
Apps# 13016

Exhibit 1: Primary Access Road Evaluation and Road Evaluation Map

Exhibit 2: Secondary Emergency Access Road Evaluation Summary

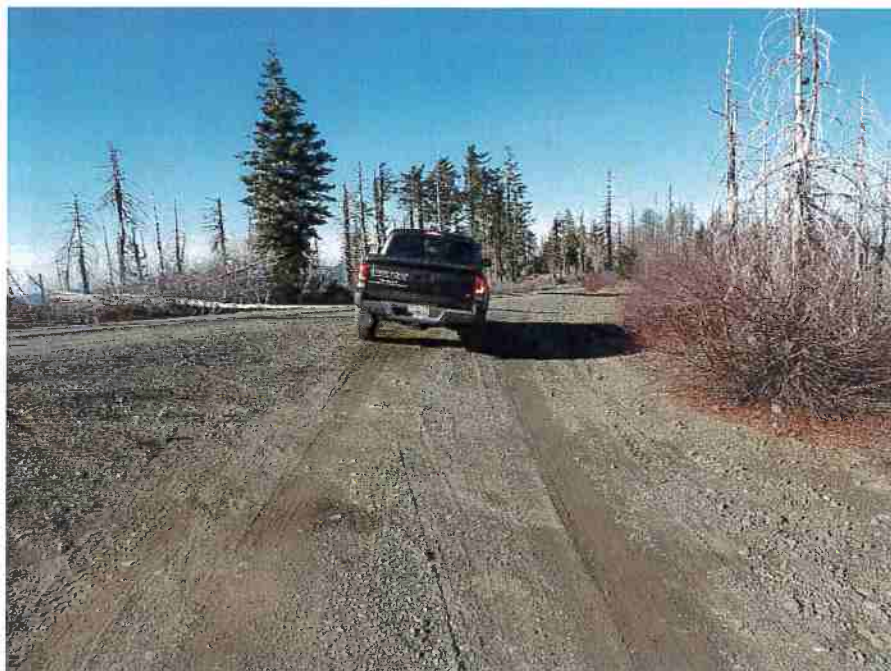
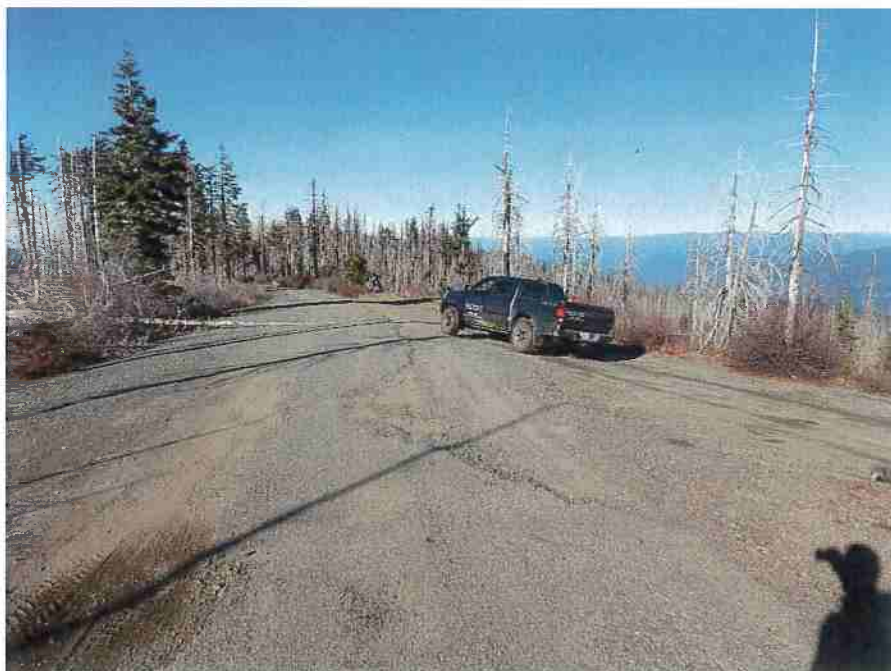
RP	Photo # in Exhibit 3	Lat. Long	Description of Current Condition	Measured Road Width (ft.)	Turnout provided?	Recommendation
1	1-2	40.6290, -123.5717	Intersection of Subject Access Road and US Forest Route 1 (6N01). No sight distance restrictions.	25+	Yes	Maintain existing roadway width and turnout.
2	3-4	40.6288, -123.5714	Gate measures 12 feet in width. No vertical clearance restrictions. No sight distance restrictions.	14	Yes	Maintain existing roadway width, gate width and turnout.
3	5-6	40.6291, -123.5703	Large Turn Around area.	18	N/A	Maintain turn around area and roadway width.
4	7-8	40.6342, -123.5703	Typical section of the Primary Access Road.	18	N/A	Maintain existing roadway width.
5	9-10	40.6395, -123.5719	Gate measures 12 feet in width. No vertical clearance restrictions. No sight distance restrictions.	14	Yes	Maintain existing roadway width, gate width and turnout.
6	11-12	40.6364, -123.5684	Pinch point. Bench cut roadway around large rock outcropping. Minimal visibility restrictions.	14	Yes	Maintain existing roadway width and turnout.

Photo 1: RP 1. Vehicle traveling north, photo taken facing north.

Photo 2: RP 1. Vehicle traveling north, photo taken facing north.

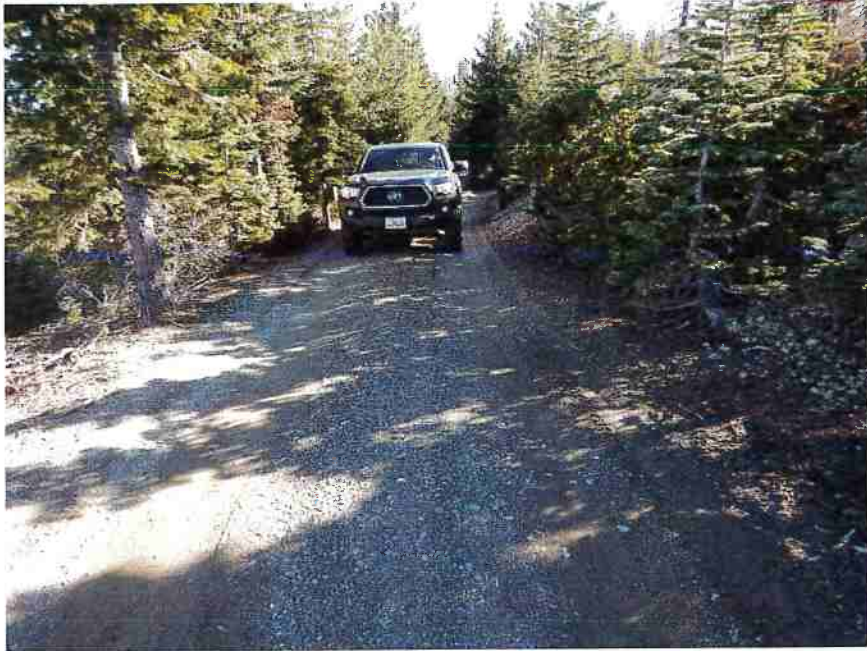
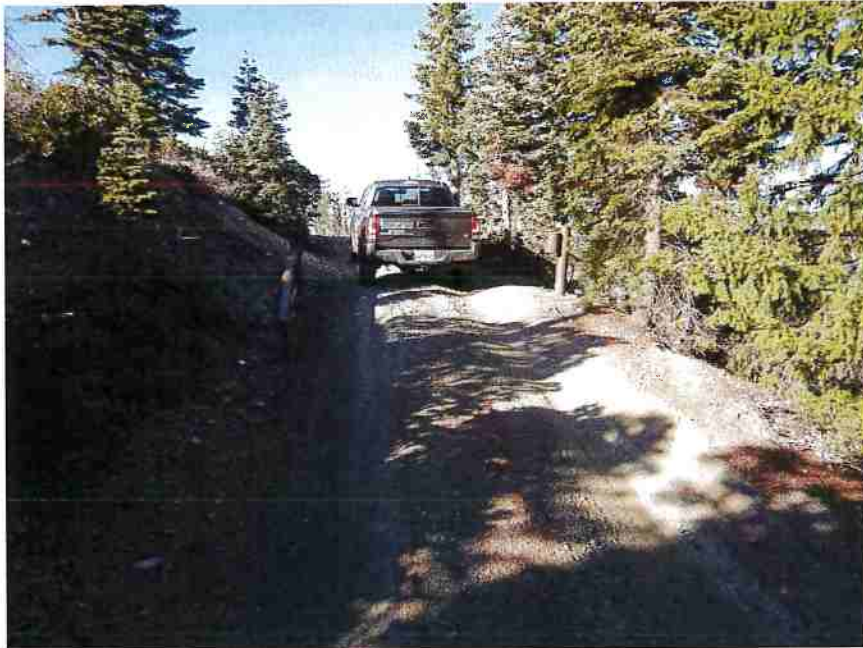
Photo 3: RP 2. Vehicle traveling north, photo taken facing south.

Photo 4: RP 2. Vehicle traveling north, photo taken facing north.

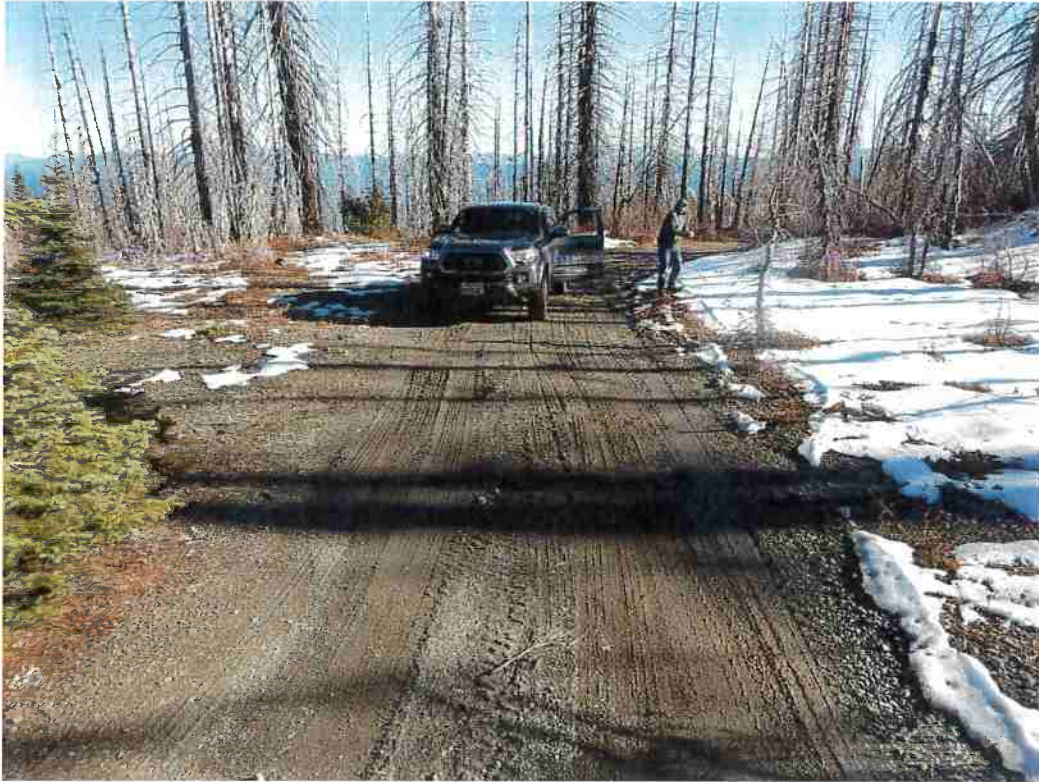
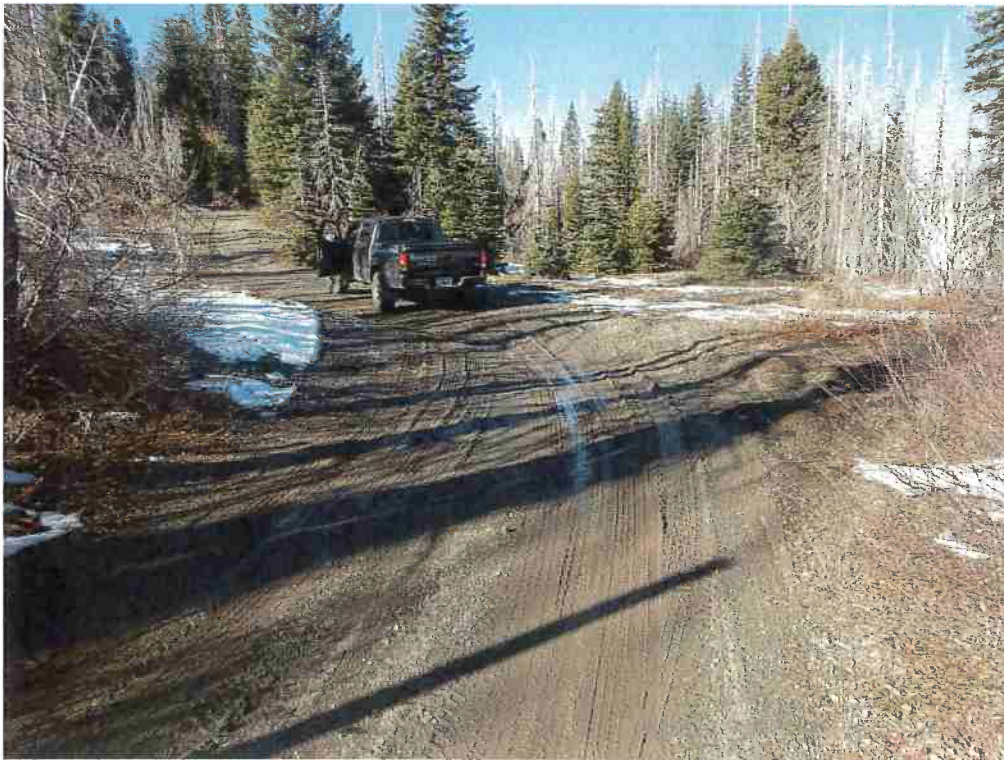
7	13-14	40.6349, -123.5679	Typical section of the Primary Access Road.	18	N/A	Maintain existing roadway width.
8	15-16	40.6336, -123.5640	Large Turn Around area.		N/A	Maintain existing turnout area and roadway width.
9	17-18	40.6331, -123.5617	Bench cut roadway around large rock outcropping. Minimal visibility restrictions.	16	Yes	Maintain existing roadway width and turnout.
10	19-20	40.6339, -123.5610	Turnout at top of moderately steep section of roadway.	20	N/a	Maintain existing turnout area and roadway width.
11	21-22	40.6340, -123.5615	Top of moderately steep section of roadway. Roadway is ±18% in grade for approximately 450' in length.	18	Yes	Maintain existing turnout area and roadway width.
12	23-24	40.6350, -123.5600	Bottom of moderately steep section of roadway. Roadway is ±18% in grade for approximately 450' in length.	16	No	Clear and level for turnout area. Maintain existing roadway width.

Photo 13: RP 7. Vehicle traveling north-west, photo taken facing south-east.

Photo 14: RP 7. Vehicle traveling north-west, photo taken facing north-west.

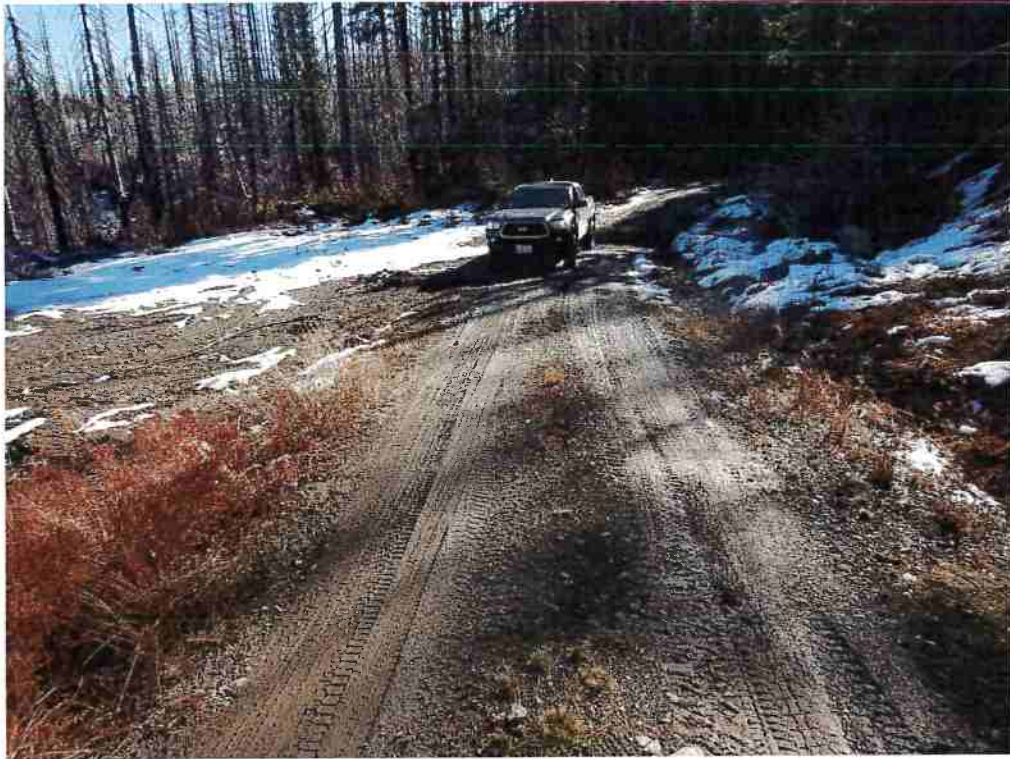
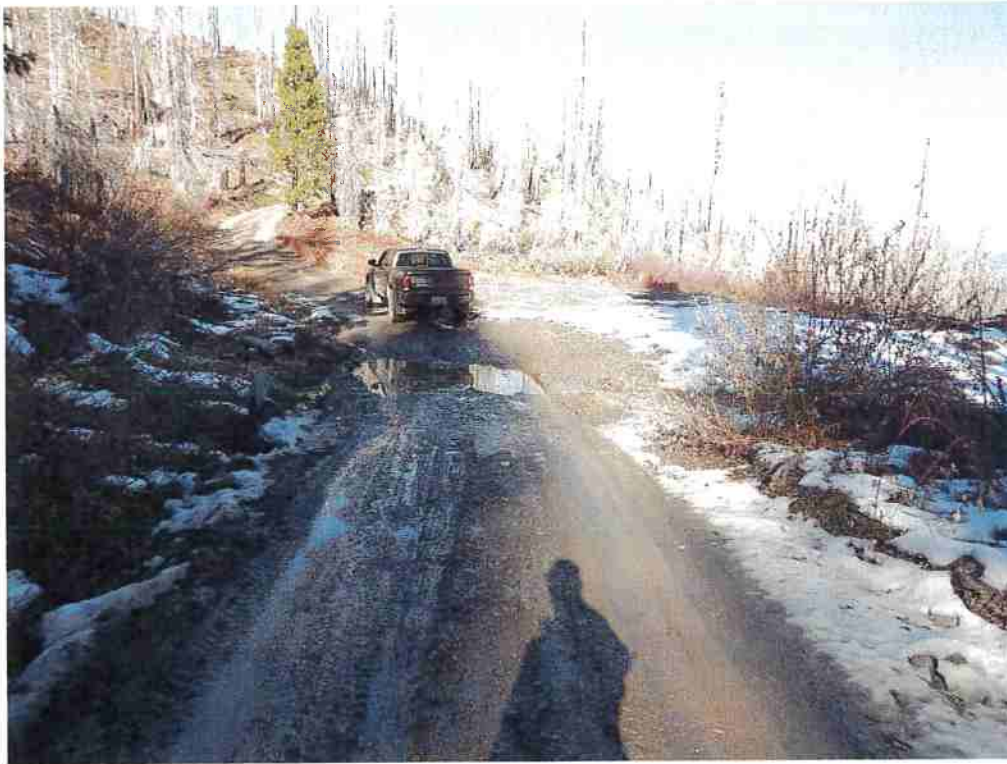
Photo 15: RP 8. Vehicle traveling north, photo taken facing south.

Photo 16: RP 8. Vehicle traveling north, photo taken facing north.

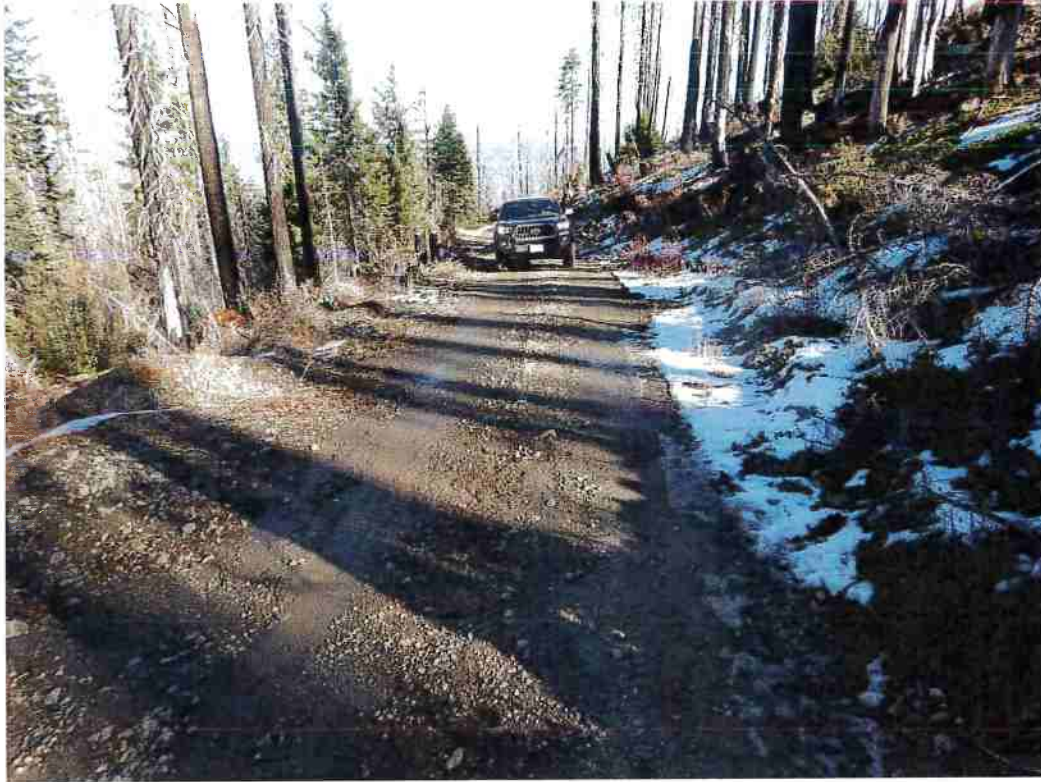
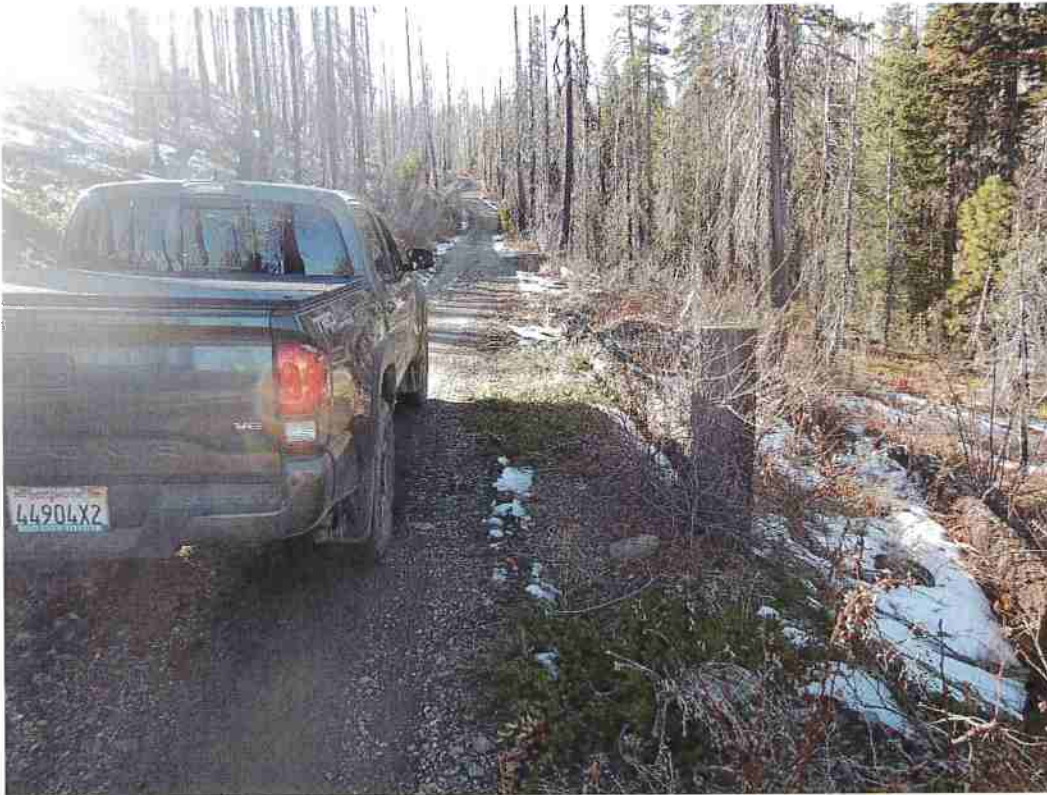
Photo 23: RP 12. Vehicle traveling south-west, photo taken facing north-east.

Photo 24: RP 12. Vehicle traveling south-west, photo taken facing south-west.

In conclusion, the subject roads leading to the subject parcels need only minor modification to accommodate the increased traffic due to Lucy Gulch, LLC's proposed project. Minor modifications include the installation of a turnout at RP 12, the widening of the existing roadway at RP 13 and the clearing of vegetation and timber waste from the turnout area at RP 20. It is also recommended to maintain all existing turnouts and roadway widths.

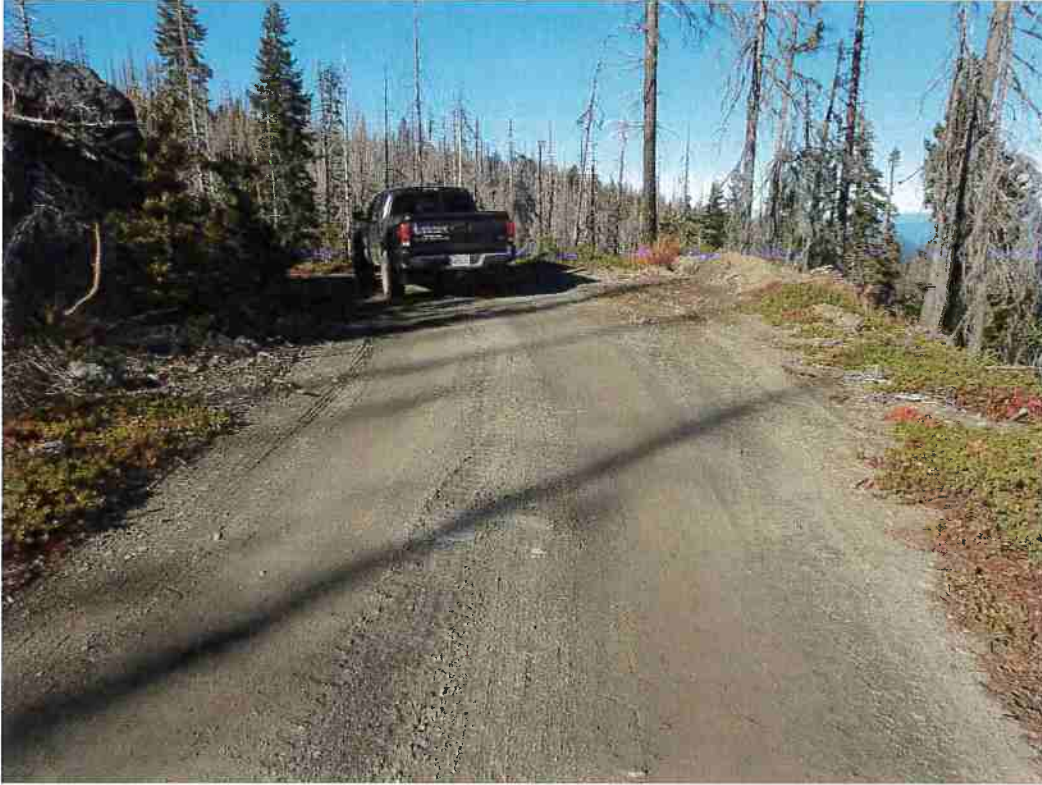
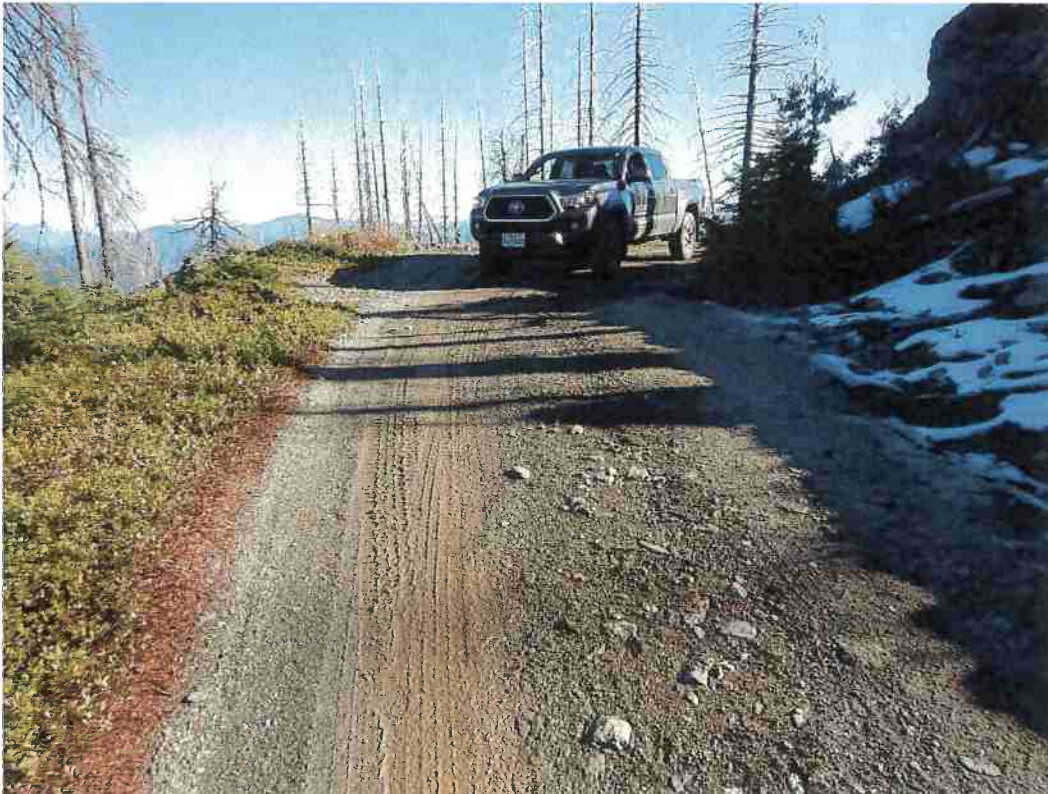
13	25-26	40.6352, -123.5591	Pinch point. Curve around large rock outcropping. Outside of turn needs minor earthwork to increase roadway width. Minimal visibility restrictions.	14	No	Clear and level outside of turn to widen existing roadway.
14	27-28	40.6335, -123.5597	Pinch point. Rock cropping reduces roadway width. No visibility restrictions.	12	Yes	Maintain existing turnout area and roadway width.
15	29-30	40.6333, -123.5590	Gate measures 12 feet in width. No vertical clearance restrictions. No sight distance restrictions.	14	Yes	Maintain existing turnout area and roadway width.
16	31-32	40.6323, -123.5581	Entrance gate to subject parcel. Gate measures 12 feet in width. No vertical clearance restrictions. Gate has been damaged by fire. No sight distance restrictions.	14	Yes	Maintain existing turnout area and roadway width.

Photo 25: RP 13. Vehicle traveling north-west, photo taken facing north-west.

Photo 26: RP 13. Vehicle traveling north-west, photo taken facing south-east.

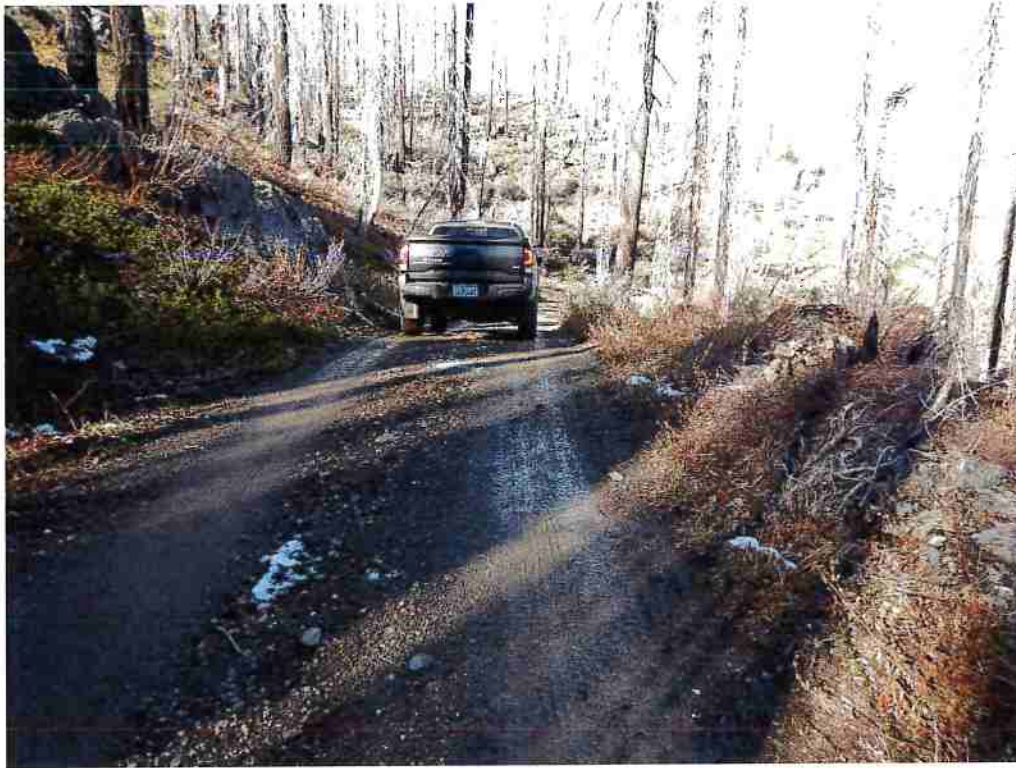
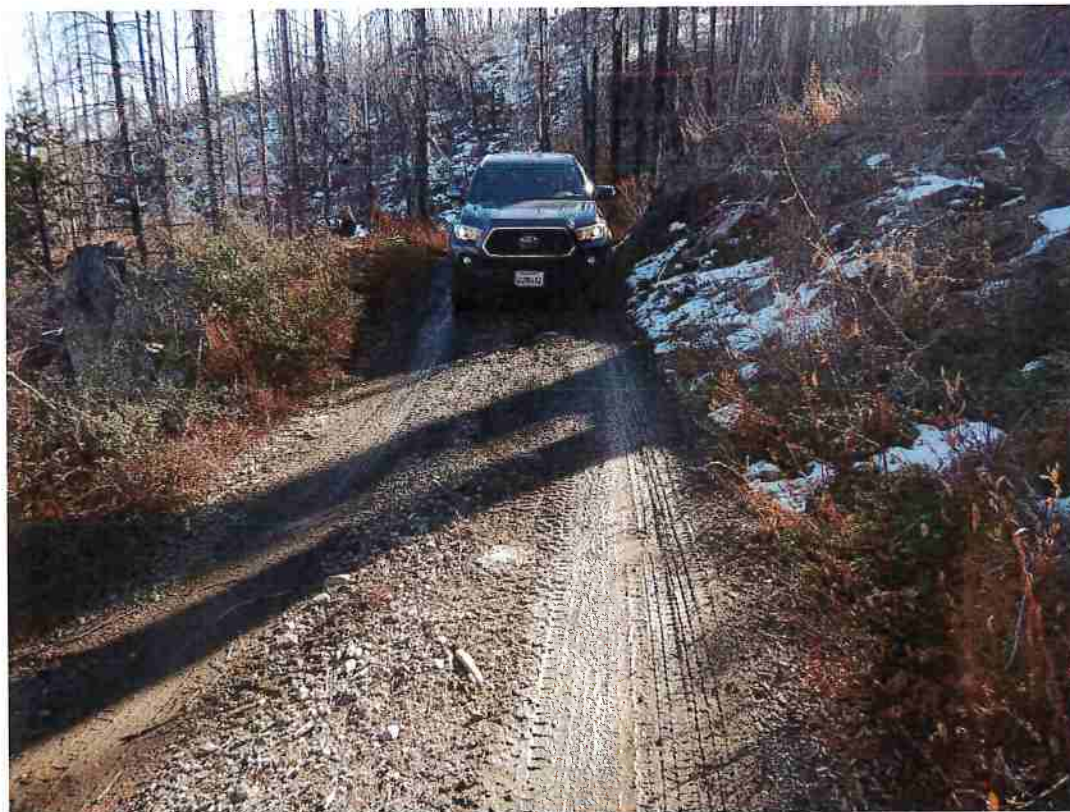
Photo 27: RP 14. Vehicle traveling north, photo taken facing north.

Photo 28: RP 14. Vehicle traveling north, photo taken facing south.

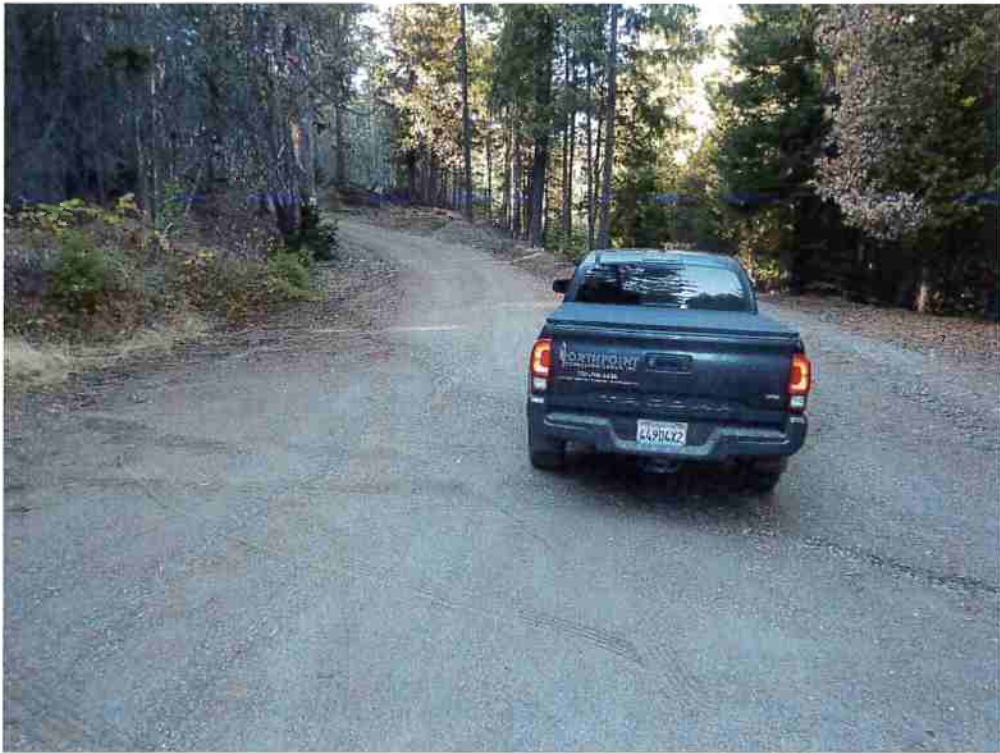
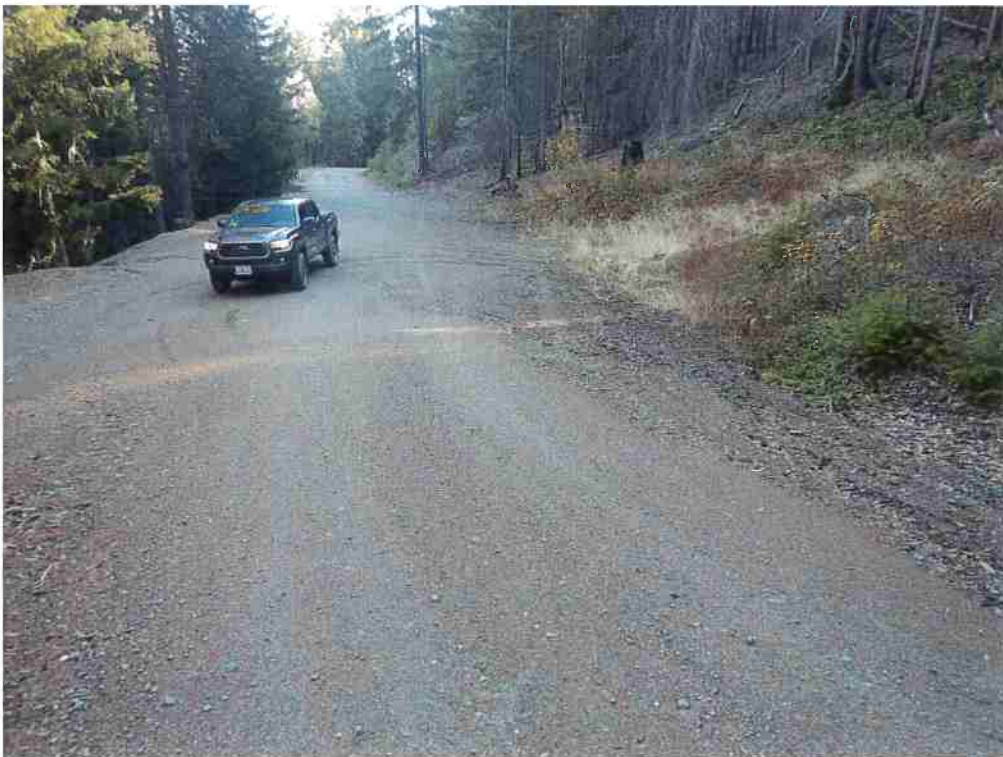
RP	Photo # in Exhibit 3	Lat. Long	Description of Current Condition	Measured Road Width (ft.)	Turnout provided?	Recommendation
17	33-34	40.6361, -123.5402	Intersection of 3N14 and Secondary Access Road. No sight distance restrictions.	25+	N/A	Maintain existing roadway width.
18	35-36	40.6355, -123.5393	Gate measures 19 feet in width. No vertical clearance restrictions. No sight distance restrictions.	18	N/A	Maintain existing gate width and roadway width.
19	37-38	40.6336, -123.5390	Sharp curve and moderate grade. Minor sight distance restrictions due to roadway geometry.	16	Yes	Maintain existing turnout area and roadway width.
20	39-40	40.6342, -123.5407	Existing turnout. Vegetation and timber waste present in turnout area.	18	N/A	Clear vegetation and timber waste from turnout area. Maintain existing roadway width.
21	41-42	40.6339, -123.5449	Pinch point. Bench cut roadway along rock cropping and moderate incline. No sight distance restrictions.	16	Yes	Maintain existing turnout area and roadway width.

Photo 33: RP 17. Vehicle traveling west, photo taken facing west.

Photo 34: RP 17. Vehicle traveling west, photo taken facing east.

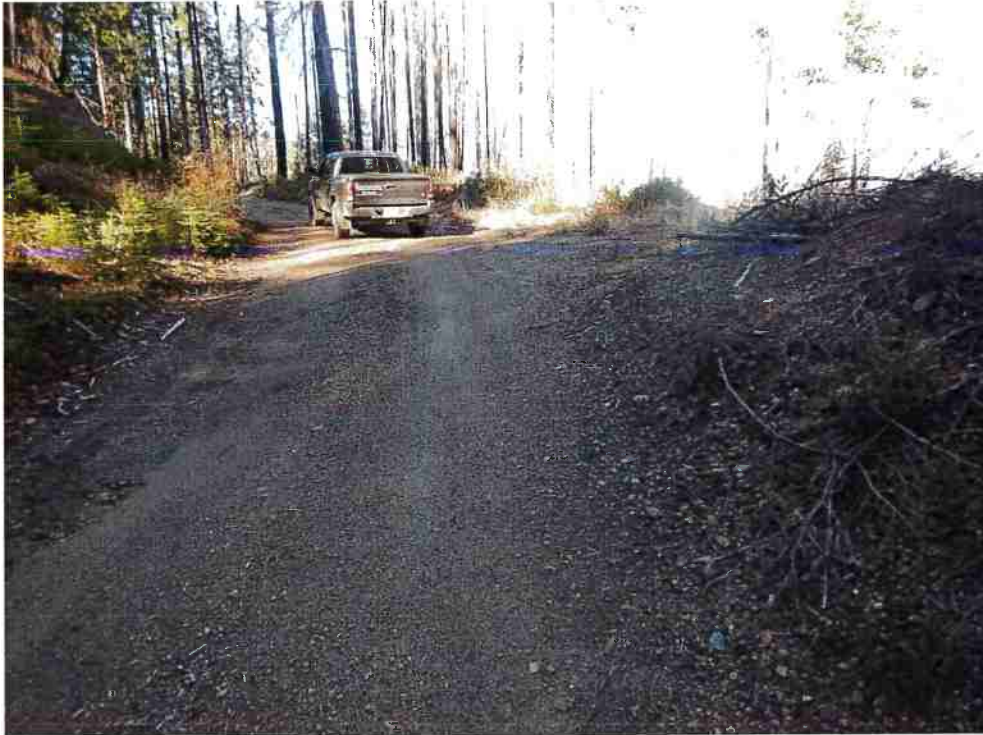
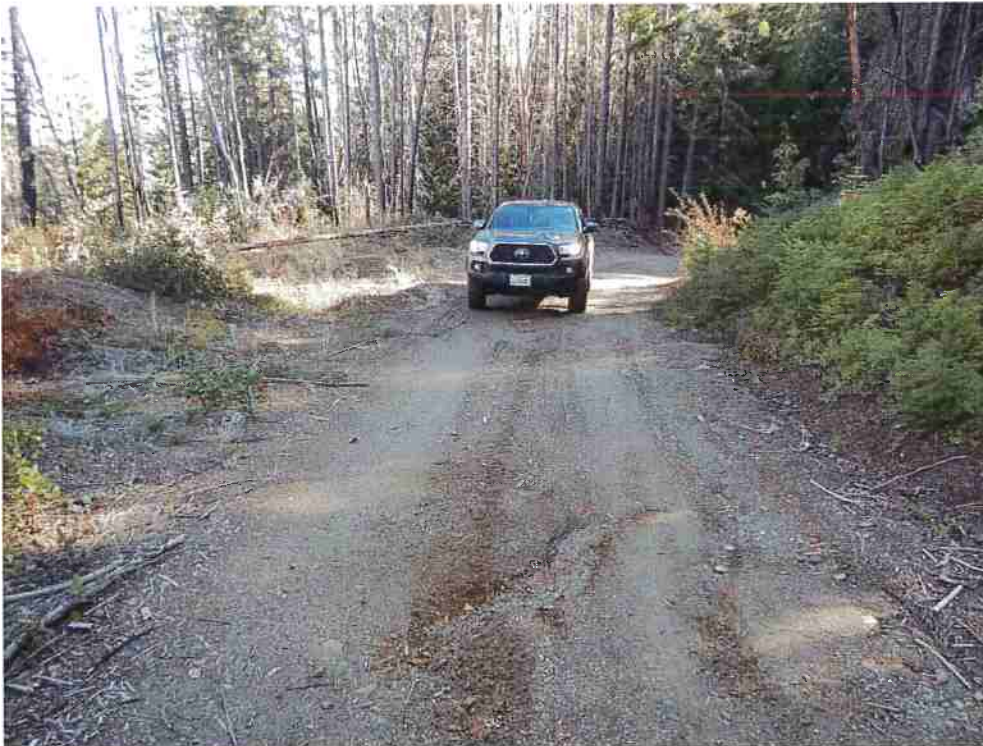
Photo 39: RP 20. Vehicle traveling west, photo taken facing west.

Photo 40: RP 20. Vehicle traveling west, photo taken facing east.

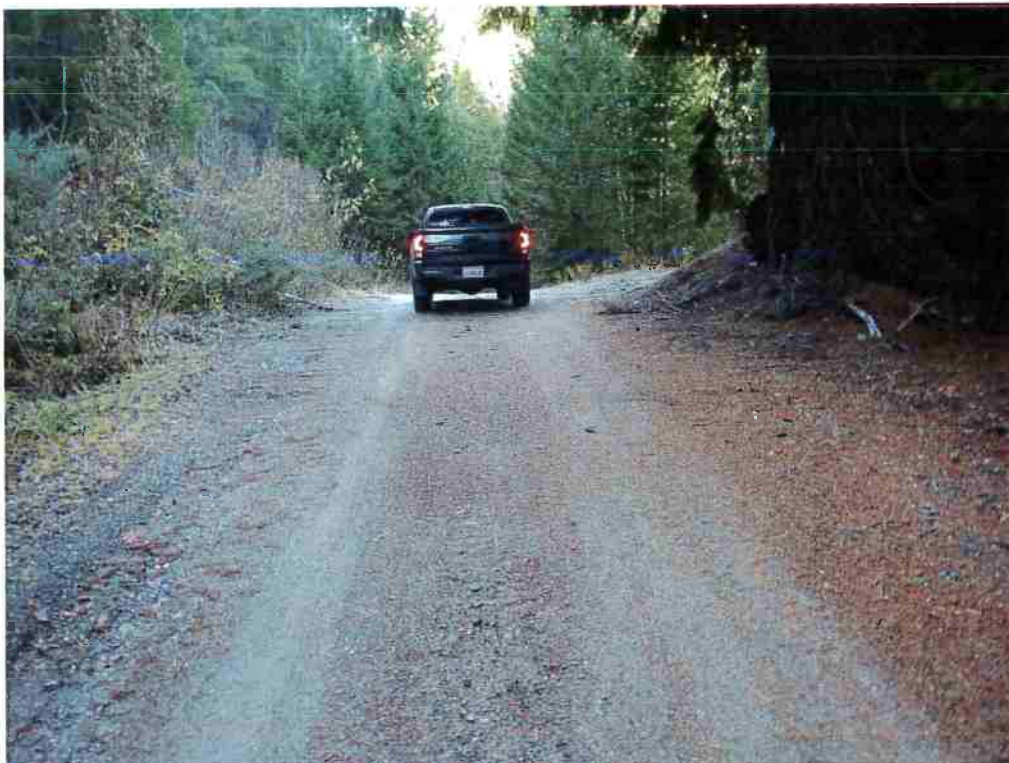
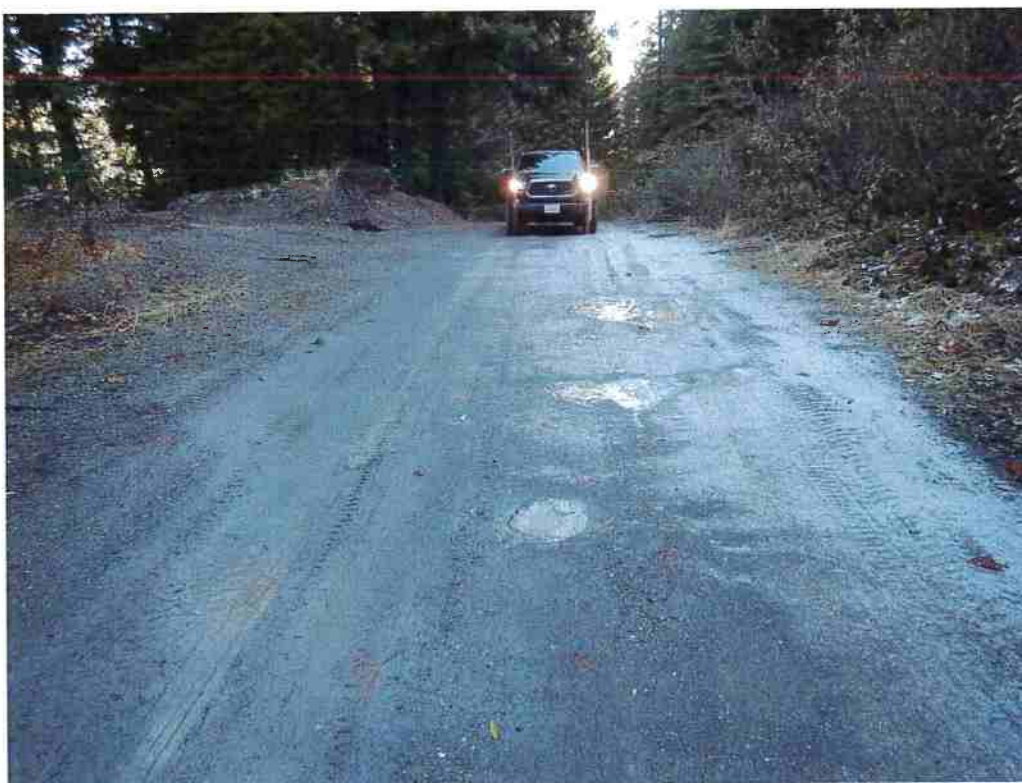
22	43-44	40.6327, -123.5486	Property line of subject parcel. No sight distance restrictions.	18	N/A	Maintain existing roadway width.

Photo 43: RP 22. Vehicle traveling west, photo taken facing west.

Photo 44: RP 22. Vehicle traveling west, photo taken facing east.
