Dyerville Farms, LLC

APN 216-144-17

Cultivation and Operations Plan

November 2018
Revision 0

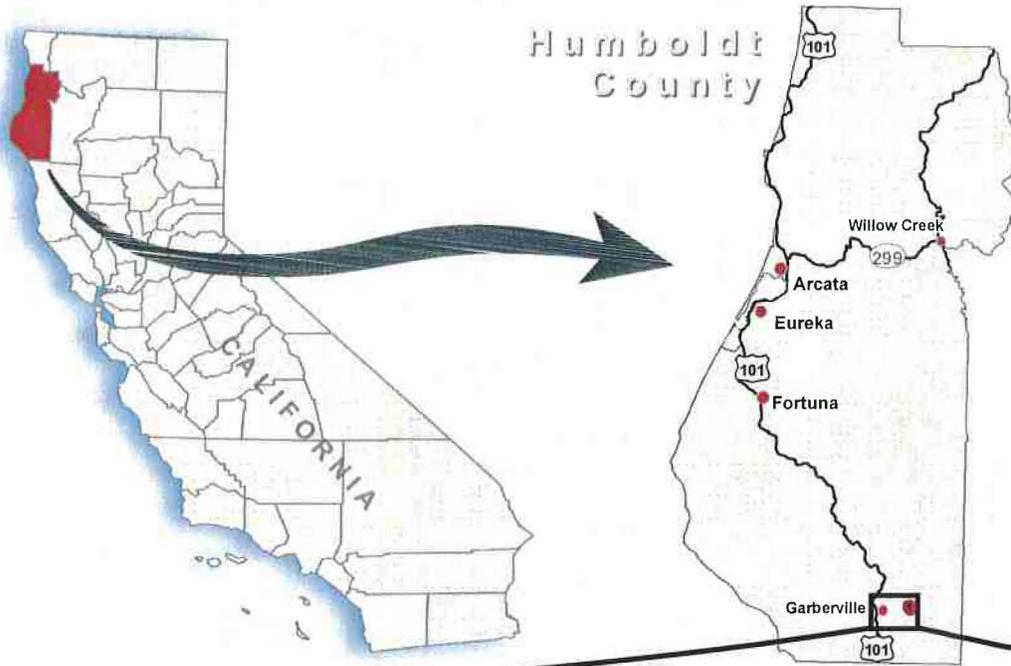
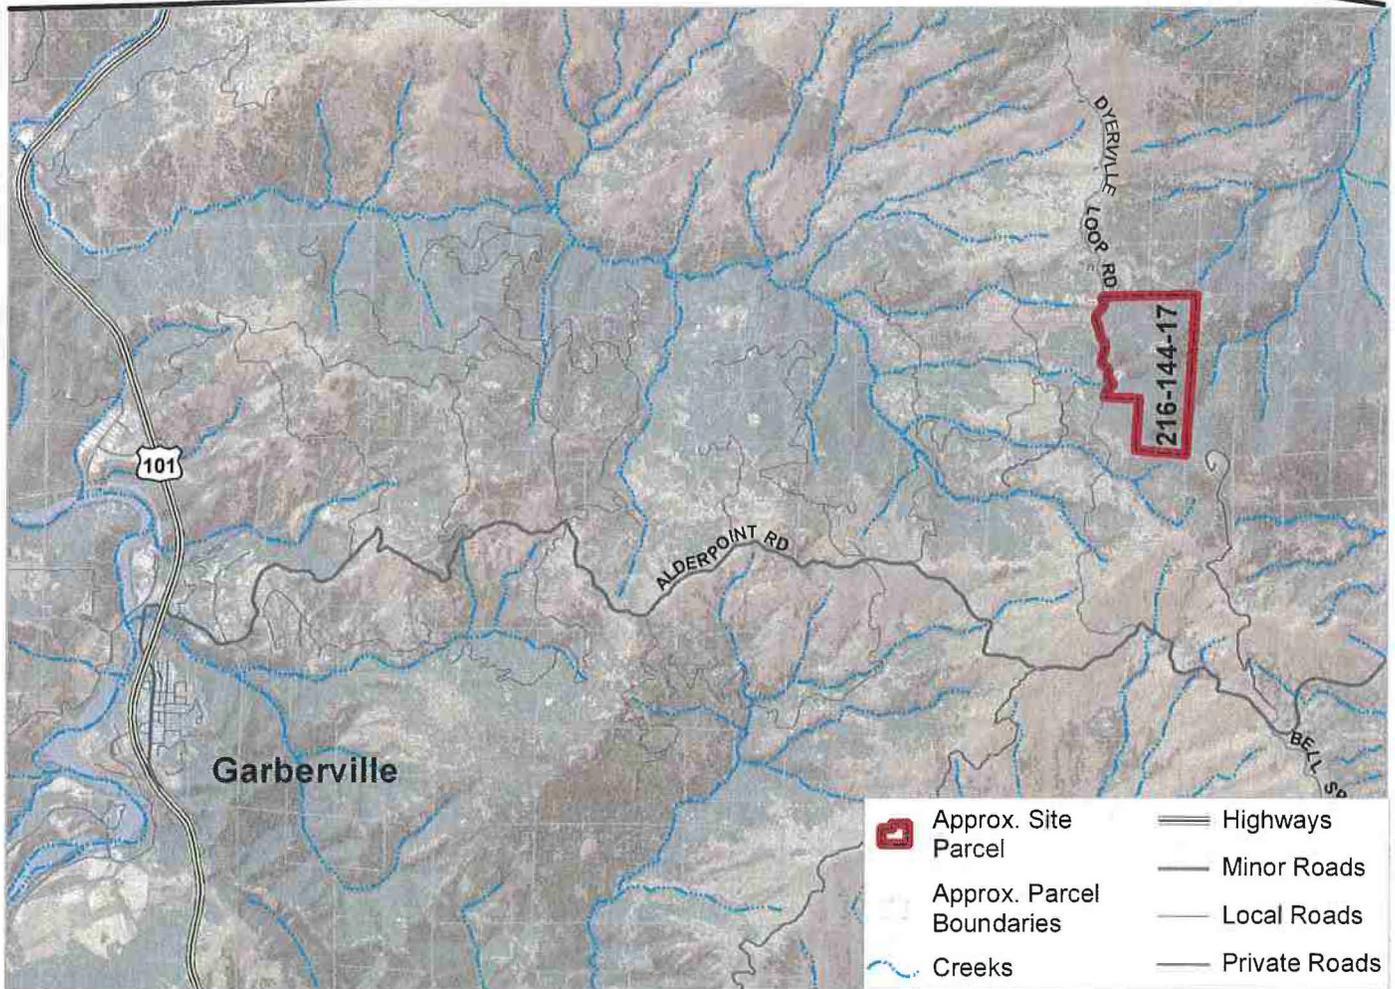
FIGURE 1

Vicinity Map
APN 216-144-17

This Plan has been completed in association with the Owner's property identified as Assessor's Parcel Number (APN) 216-144-17 (project site). The project site is located in an unincorporated area of Humboldt County, California, east of the town of Garberville. The project site is located approximately four miles north of the Dyerville Road intersection with Alderpoint Road. The project site and vicinity (aerial plan view) is depicted on Figure 1 Vicinity (Figure 1) located in Appendix A.

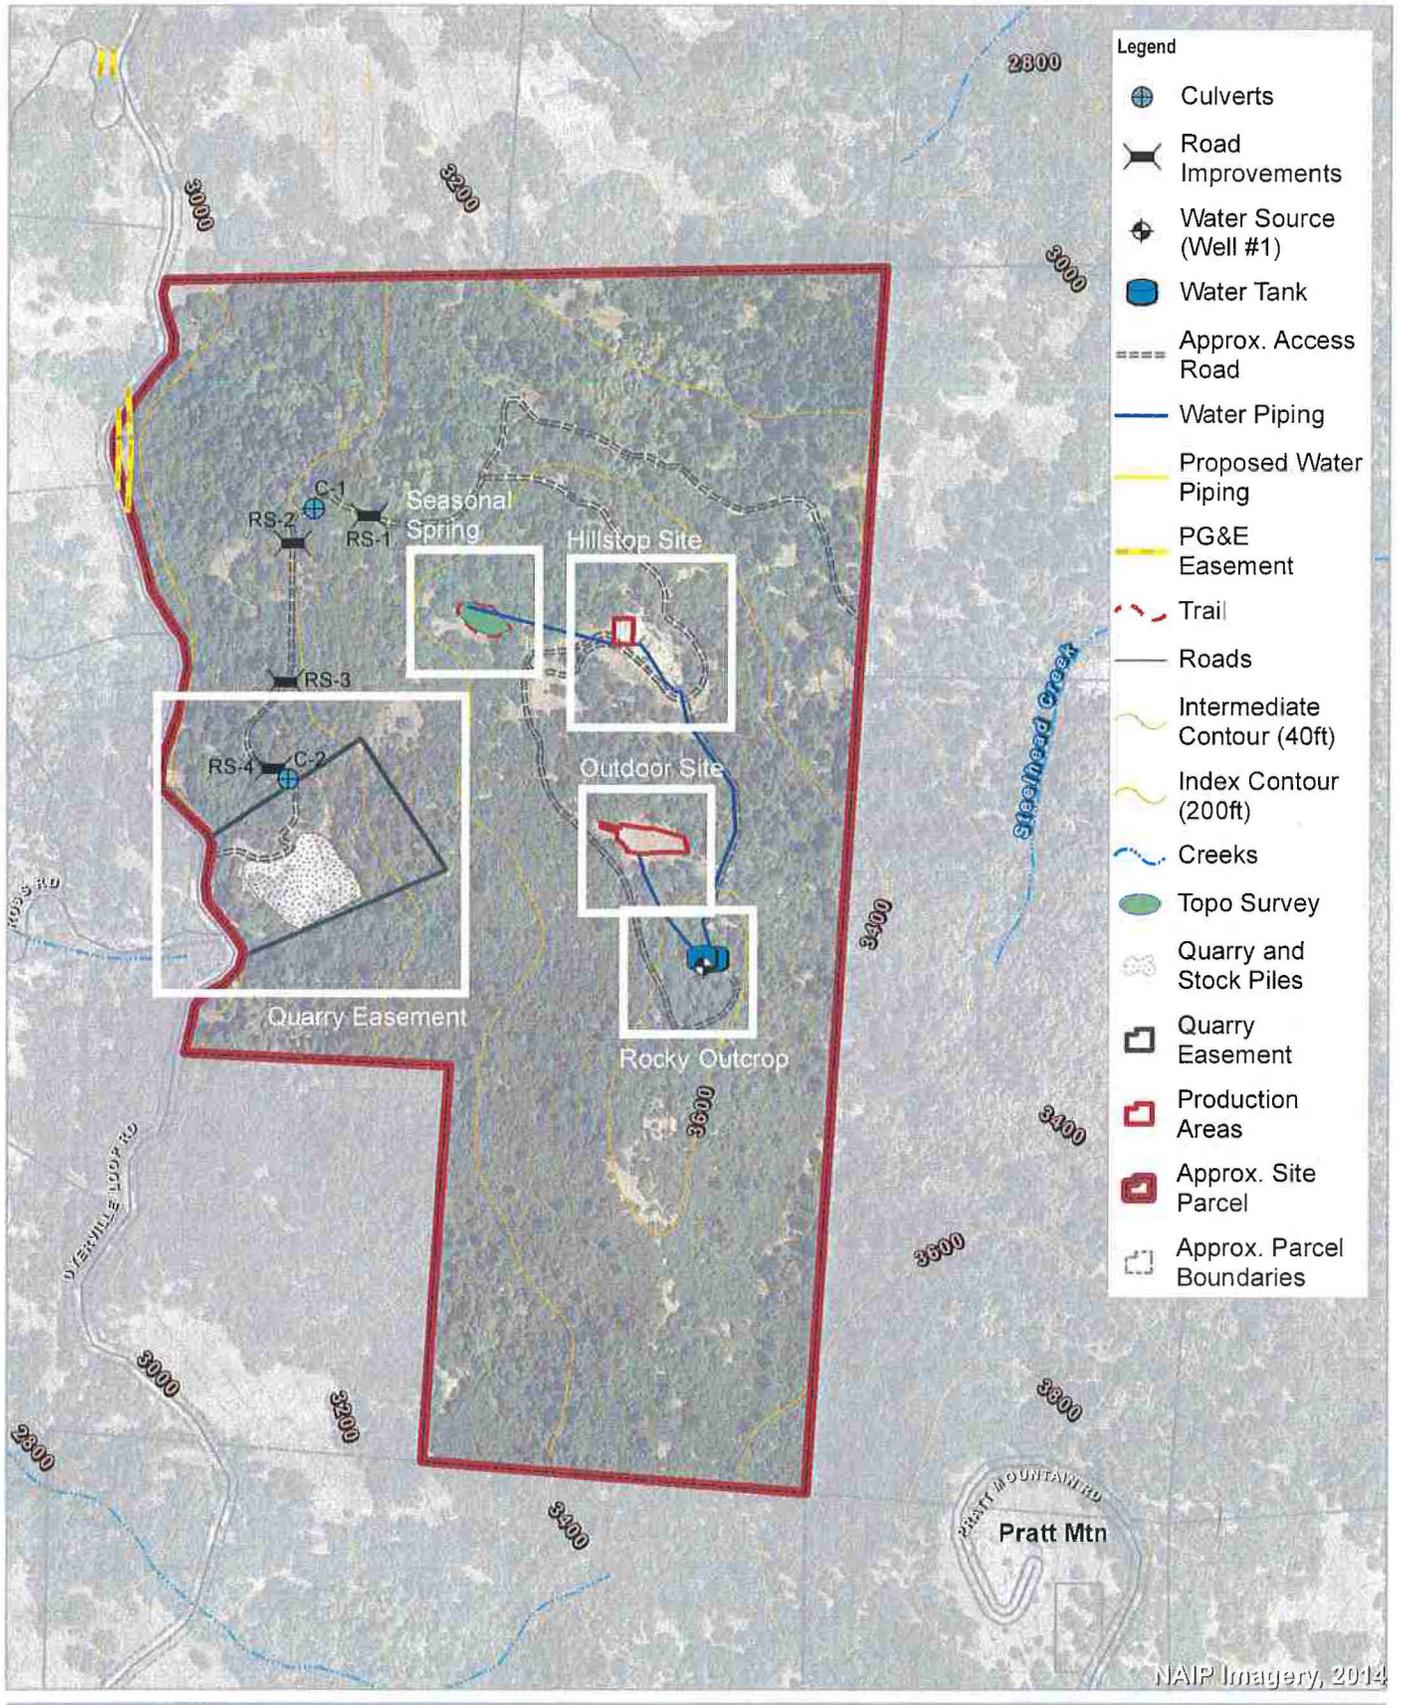
FIGURE 2

Overview Map
APN 216-144-17

Soil used for cultivation is prepared and stockpiled at the quarry site shown on the site plans on Figure 2 Overview and Figure 4 Insets B in Appendix A. Approximately 100 cubic yards of mushroom compost is delivered annually and mixed with onsite recycled soil, which is covered with a tarp and stockpiled within the quarry pit. Soil is reused annually and there is no waste material produced per the owner from the cultivation areas. The quarry site is concave and sediment runoff from this area is unlikely. Per Owner information, depending on the year, sometimes the soil and mushroom compost is tarped and stockpiled at the Outdoor Site, in a 16 by 32 foot fenced enclosure, however it is typically not overwintered at this location as it is used up during the growing season. Leaf waste from the garden is composted in this location as well.

The Hilltop Site shown on Figure 2 Overview and Figure 3 Insets, contains three greenhouses and a drying barn. Greenhouse #1 is approximately 600 sf and is predominantly used to house the mother plants, conduct clone propagation, seed starting and plant sexing. Greenhouse #1 contains radiant floor heating and is utilized throughout the year. Greenhouses #2 and #3 are both hoop houses and are each approximately 1,150 sf. Work within Greenhouses #2 and #3 consists of mixed light cultivation consisting of two cycles per year from April to October. The total area of the three greenhouses amounts to 2,900 sf. The cultivation areas are flat with an average 0-2 percent slope with overall site slope in the immediate vicinity ranging from 0-10 percent. The drying barn is approximately 1,160 square feet and contains a 10 by 8 by 8 foot cargo container with security locks and a camera. The site was previously cleared when the current Owner purchased the site, and the house foundation was in place. This site is over 1,000 linear feet from the perennial tributary to Steelhead Creek on the adjacent APN and approximately 200 linear feet to the seasonal isolated spring.

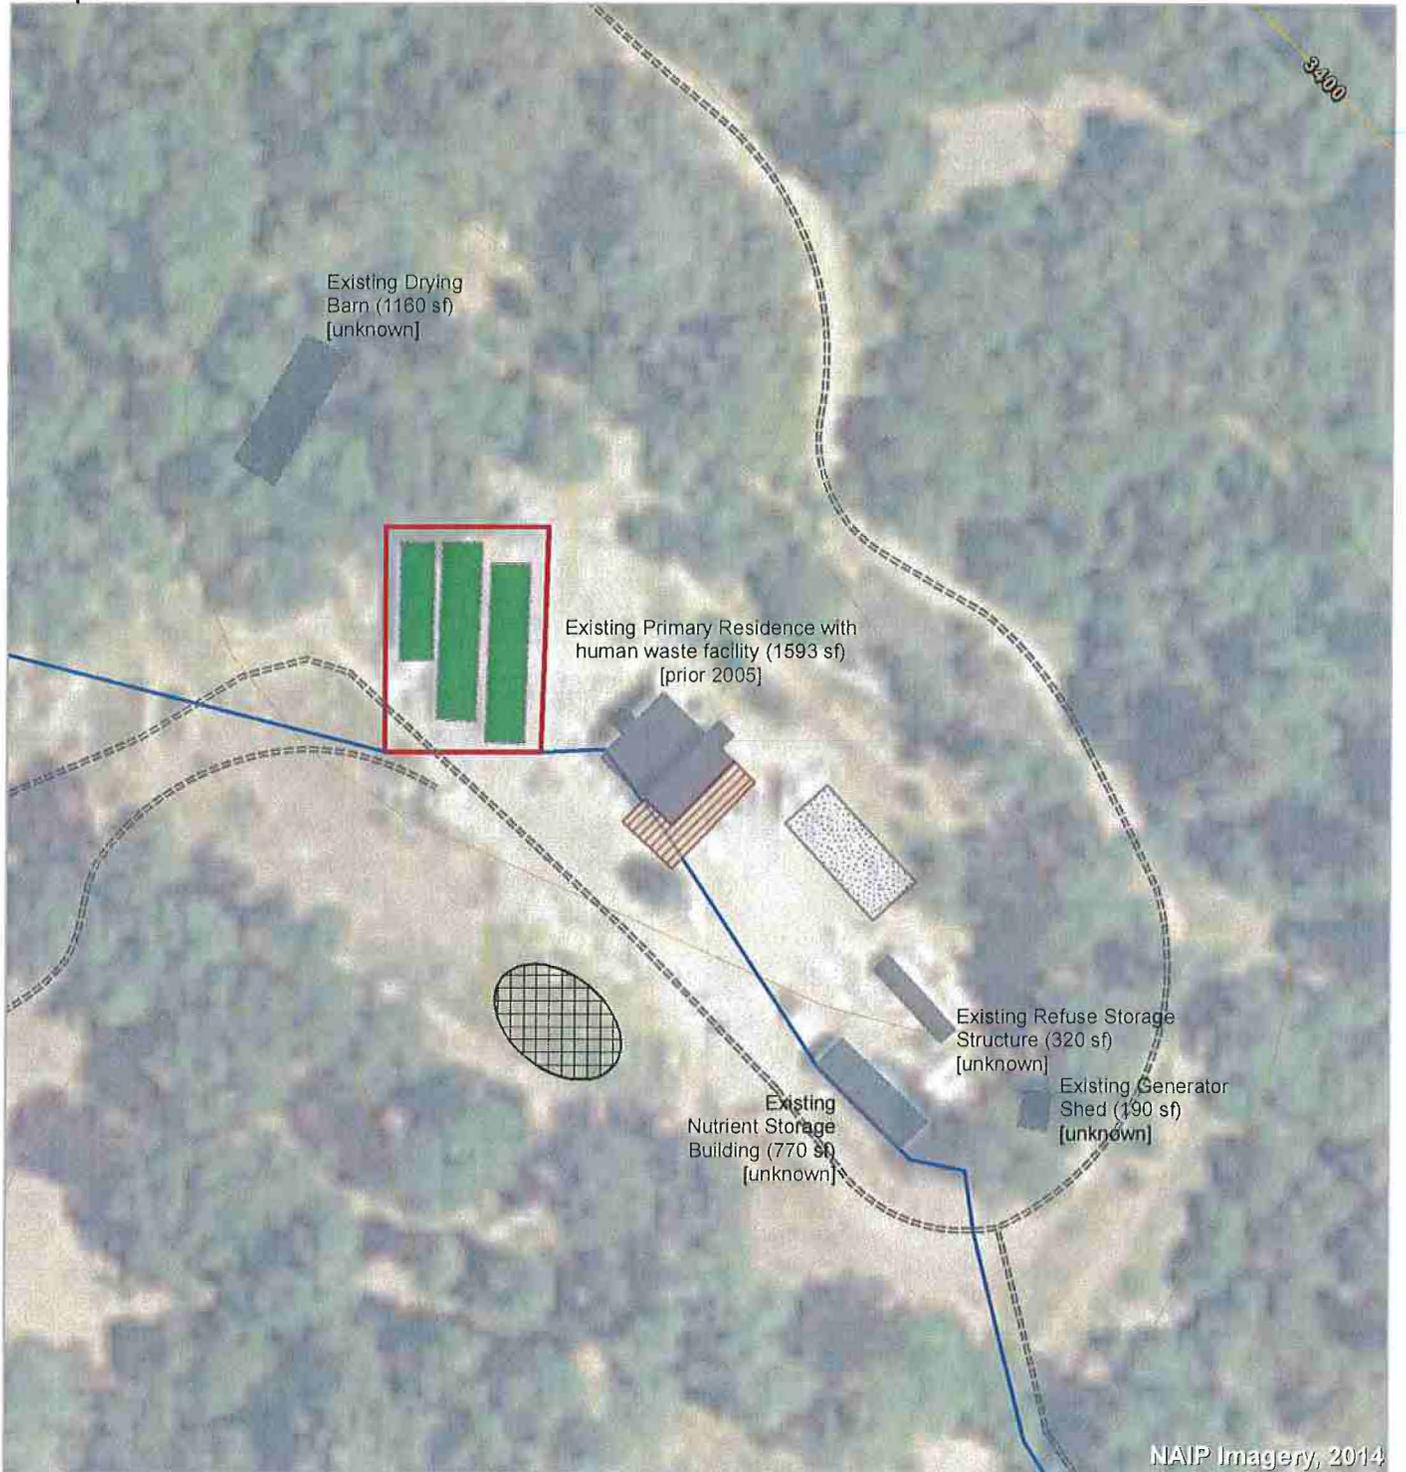
FIGURE 3

Hilltop Site

Insets A
APN 216-144-17

Perennial surface waters or wetlands were not identified within the project site in 2016, with the exception of one natural seasonal spring (see Seasonal Spring - Figure 4). The seasonal spring is on the Hilltop Inset on Figure 3 Insets A and has been used for agricultural purposes on a seasonal basis until approximately May 15th when the seasonal spring becomes dry depending on the hydrologic year. The spring becomes visible above ground and is typically operable from fall to winter, once enough rain has accumulated to initiate groundwater flow and spring discharge. In 2016 GHD observed that the spring appears isolated and does not connect surficially hydrologically downgradient to apparent water course or water body.

Refuse from agricultural and residential uses is recycled, green waste is fed to the pigs/livestock at the Hilltop site, and the remaining waste is stored in a container north of the Nutrient Storage Building and east of the residence designated as Existing Refuse Storage Structure located on Figure 3 Inset in Appendix A.

As mentioned above in Section 4 (General Project Site Description), there are two production areas at the project site that were being used for agricultural cultivation at the time of the 2016 site visits (see Figures 3 and 4 for Production Area locations). The Owner confirmed on November 14, 2018 that the location, area, configuration of the existing production areas has not been modified since the GHD site visit conducted in 2016, except as described below. The site observations made by GHD in 2016 are understood to represent current conditions, as confirmed by the Owner, with the exception of the reduction cultivation area as defined herein. As of the writing of this PLAN, GHD has not independently verified the CMMLUO permit and related Owner-supplied information.

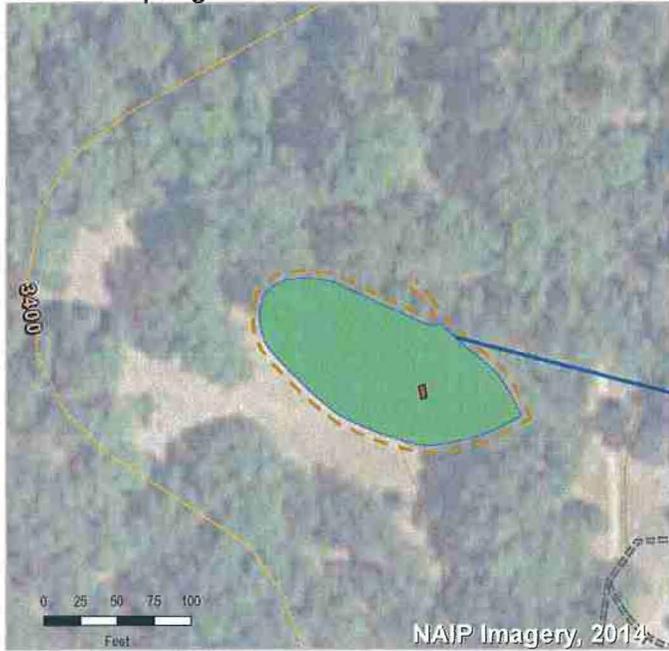
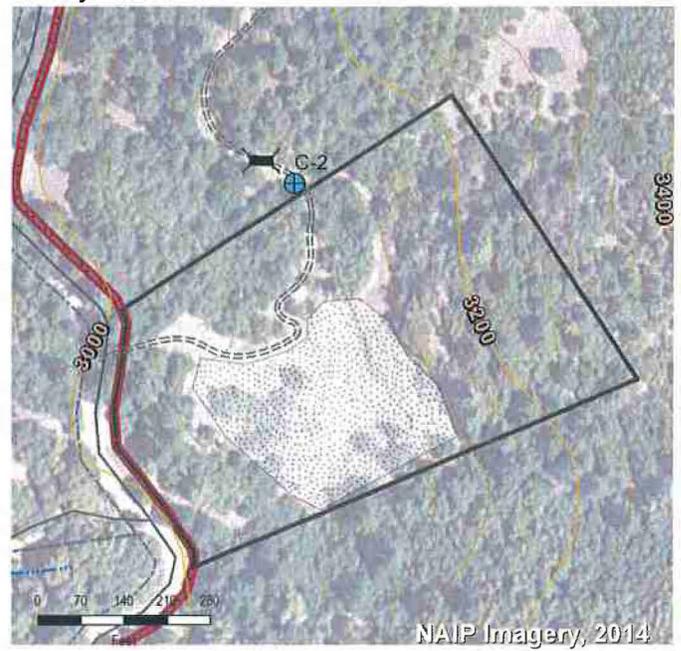
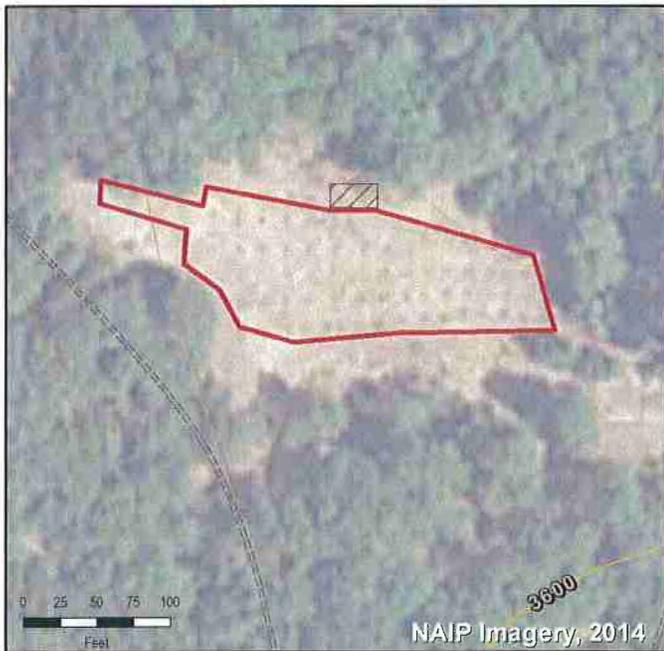
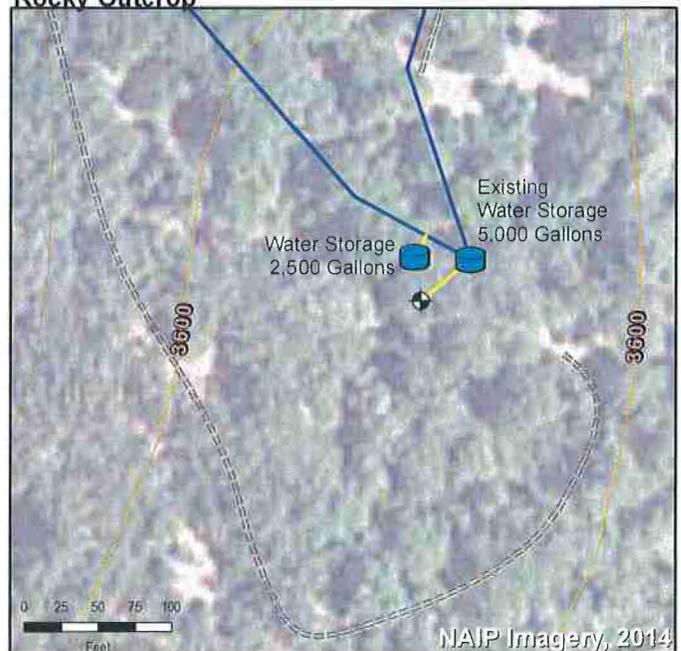
FIGURE 4

Road improvement areas considered to be controllable sediment discharge sites as listed in the WRPP under SWRCB Order No. R1-2015-0023

**Insets B
APN 216-144-17**

Water for cultivation, livestock, fire suppression and residential use onsite is sourced from a single groundwater well located on the project site. The location of the well, noted as Well #1, is shown on Figure 4 (see Rocky Outcrop – Figure 4 located in Appendix A). Well #1 was installed in November 2018 and accesses groundwater beneath the project site.

In the past, surface water from the spring was diverted seasonally and stored in a 2,500-gallon water storage tank and utilized for agricultural uses including cultivation. However, as of approximately May 2018 it is no longer being used as a water source for the property and the Owner is in the process of relocating the 2,500 gallon tank to be located adjacent to Well #1 (See Rocky Outcrop - Figure 4). Well #1 is the sole source of water for the property.

There are no fish bearing streams or perennial streams within the property. The property is located at the top of a hill and contains two culverts (C-1 and C-2) as shown in Figure 2 – Overview in Appendix A. C-1 drains spring water produced seasonally (typically November through April) in addition to stormwater flow and C-2 drains stormwater flow. Due to the upland nature of the property and its location on a ridgeline, cumulative flow is not a significant issue as culverts are predominantly draining stormwater flow sourced onsite. Continued maintenance and additional rock armouring is proposed at C-1 and C-2 outlets in order to limit potential erosion through dissipation of stormwater flow at the outlet of the culverts, per the project's Water Resource Protection Plan (prepared for the State Water Resources Control Board under Order No. 2015-0023, Tier 2 requirements). According to photographic evidence, including the lack of erosion at C-1 and minimal erosion at C-2, in addition to the proposed rock armouring and maintenance, the current culverts onsite appear to be sized adequately to manage stormwater flow.

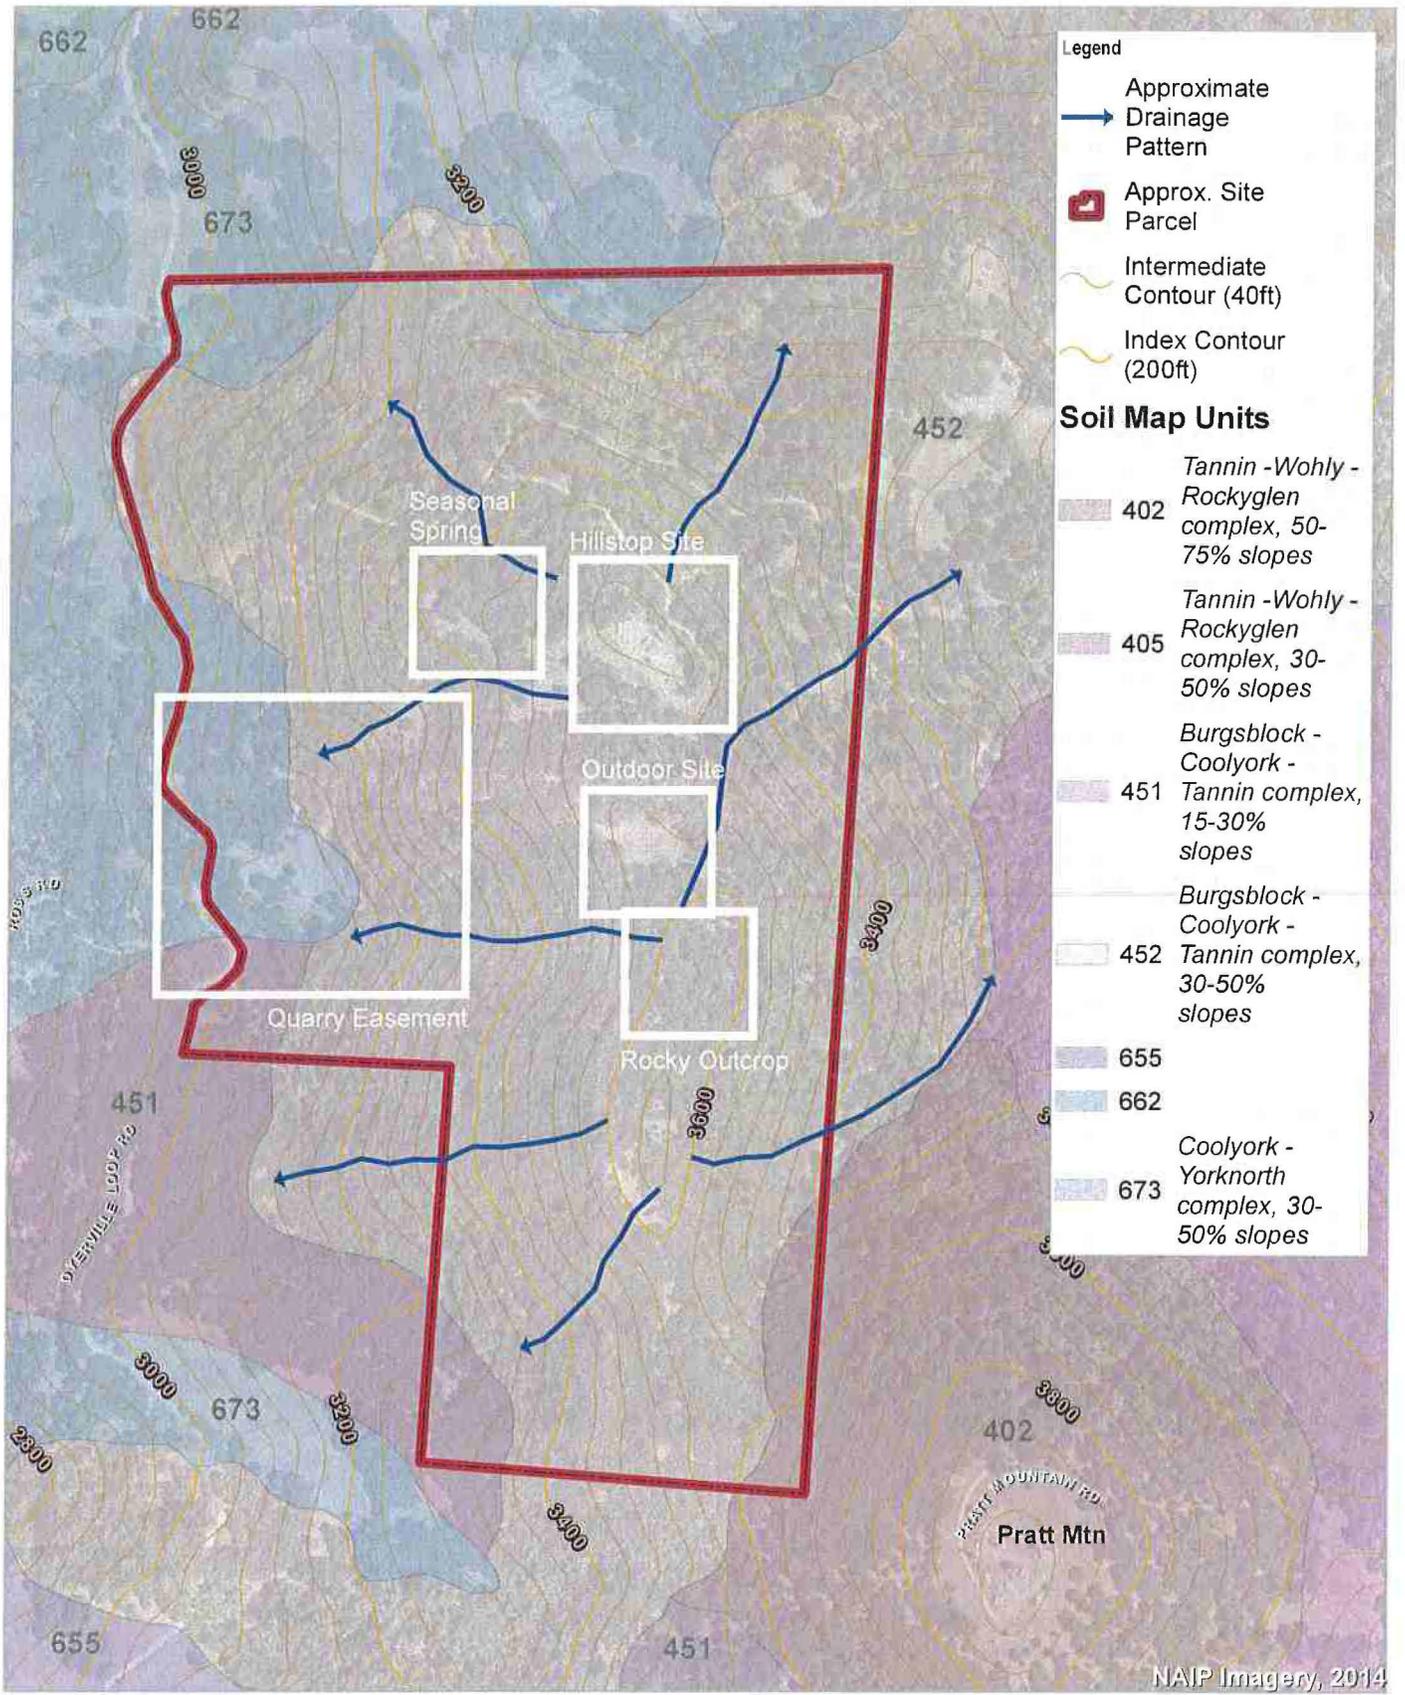
FIGURE 5

Drainage Patterns
APN 216-144-17

The project site is typified by forested woodland (mostly oak with fir sapling encroachment in some areas), sloping hillside, ridgetop oak woodland, some flat plateaus, and sparse open grasslands. Due to its location along a terraced ridgeline, drainage within the project site generally radiates outwards towards the steepest contours. See Figure 5 – Drainage Patterns for an approximate depiction of site drainage.

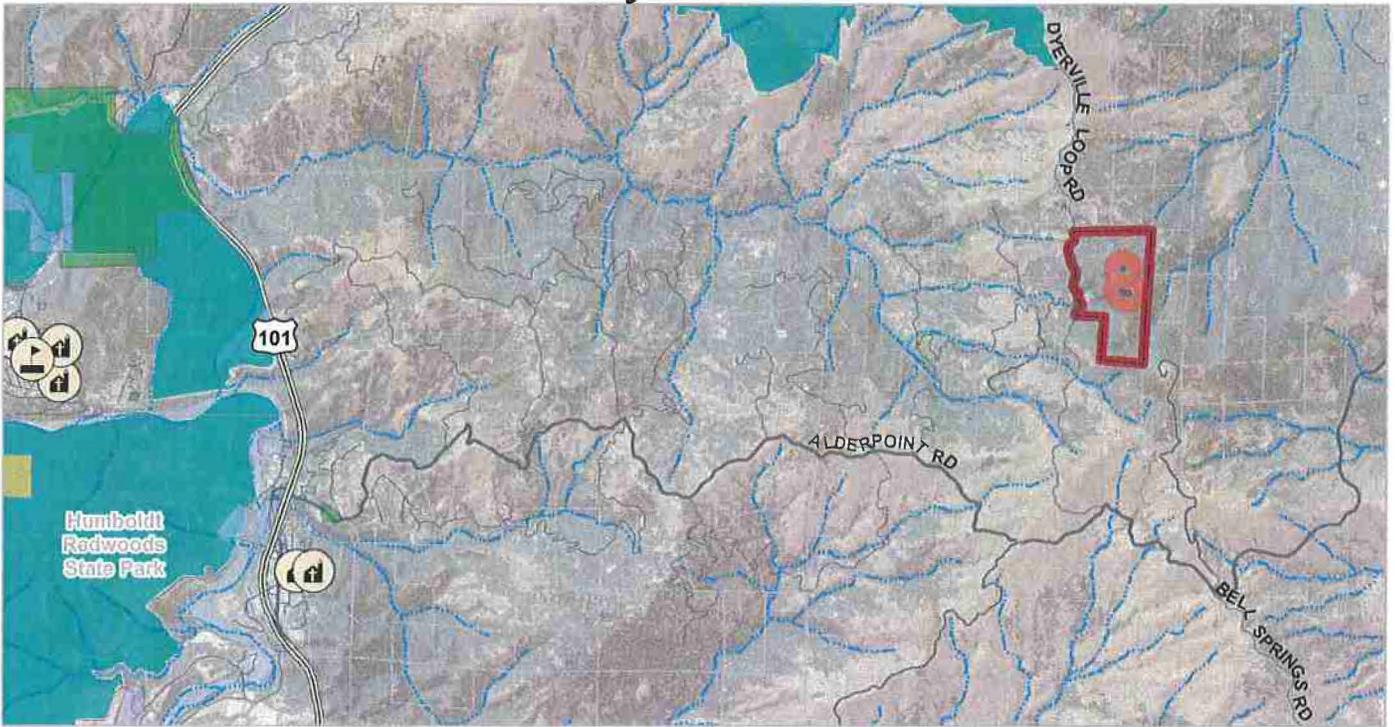
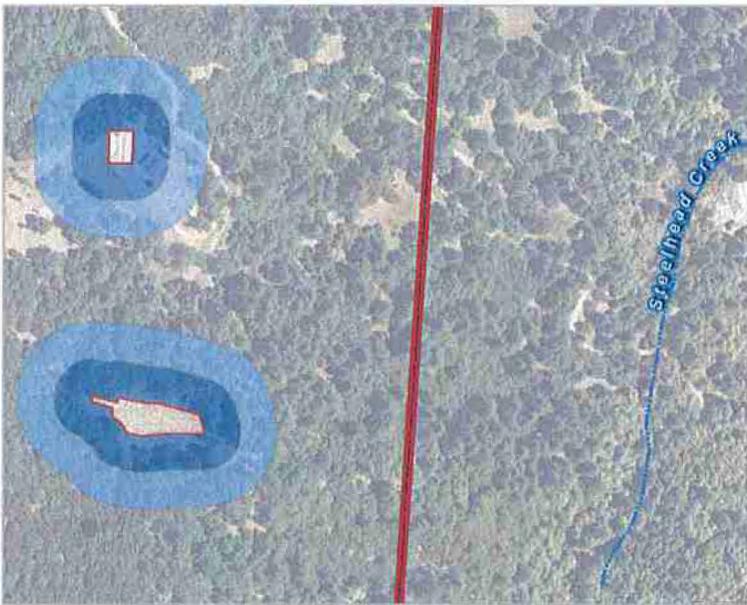
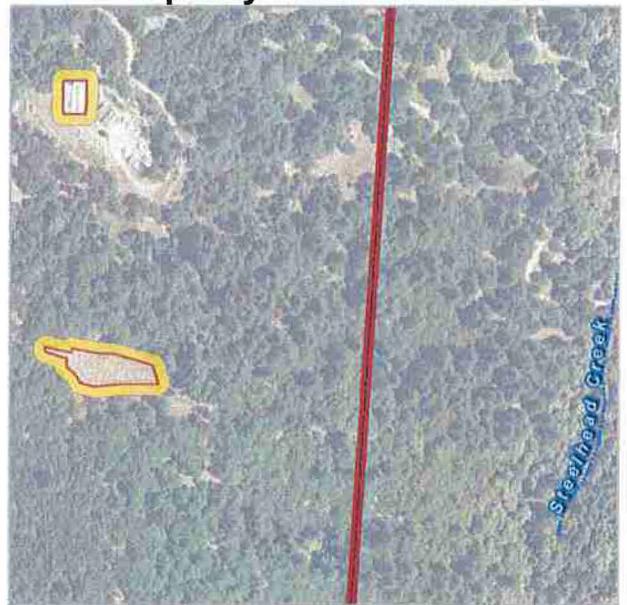
FIGURE 6

Vicinity Setbacks

Creek Setbacks

Property Line Setbacks

Setbacks
APN 216-144-17
