**Update to  
Aquatic Resources Delineation  
Northcoast Highway Solar Project  
Fortuna, Humboldt County, California**

**Hydesville, California, USGS 7.5-minute Topographic Quadrangle Map  
Township 2 North, Range 1 East, Section 19 NW**

**Phoenix Biological Consulting**

July 02, 2023

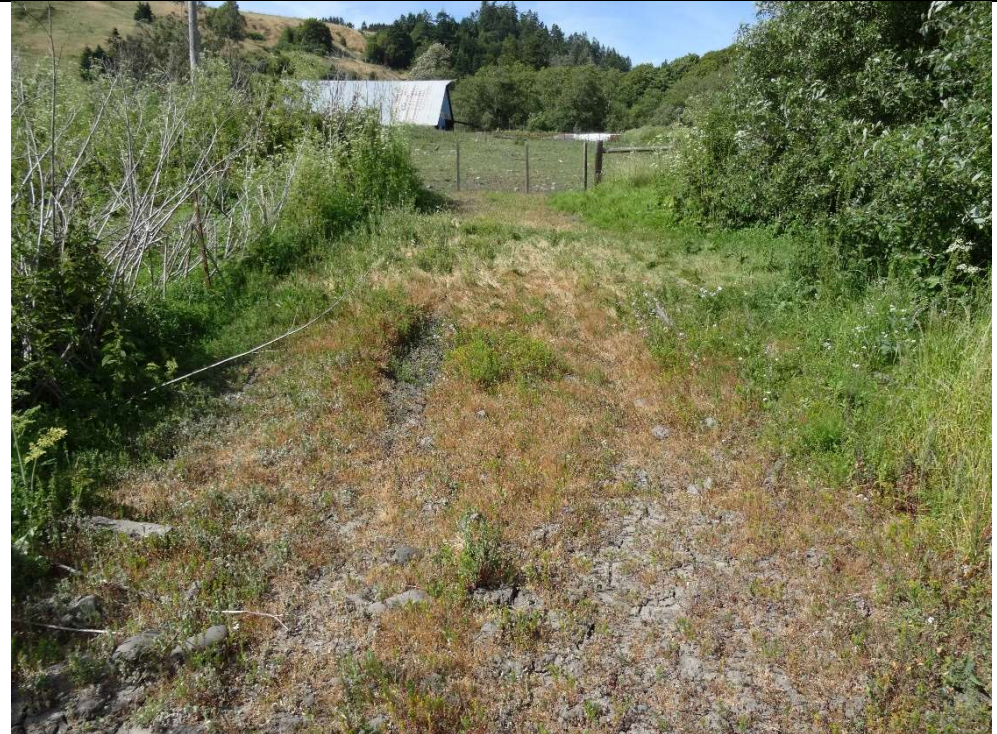
| | <p><b>June 17, 2023.</b><br/><b>Access road /</b><br/><b>seasonal wet area.</b><br/><b>(40.544146, -</b><br/><b>124.115401)</b></p> |

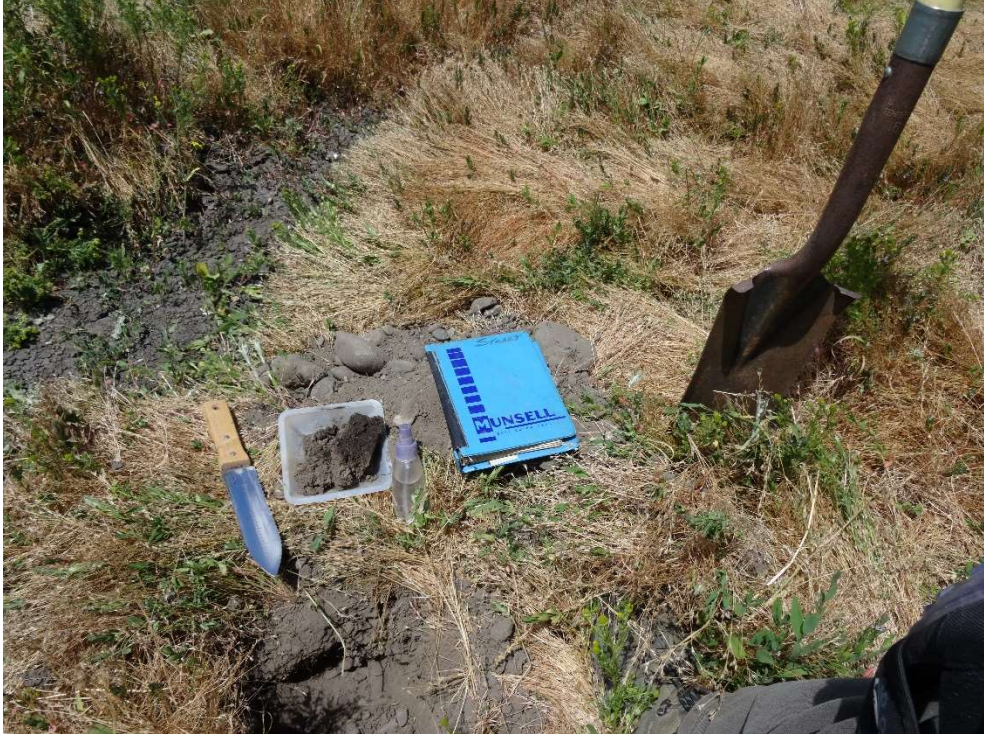
| | <p>June 18, 2023.<br/>Wetland<br/>investigation site<br/>001. Wetland<br/>sample point.<br/>Excavated pit.<br/>(40.544146, -<br/>124.115401)</p> |

Remarks: Well drained fine sandy loam above coarse gravel lens. Soil stays wet long enough for FROW plants but no evidence of anoxic conditions

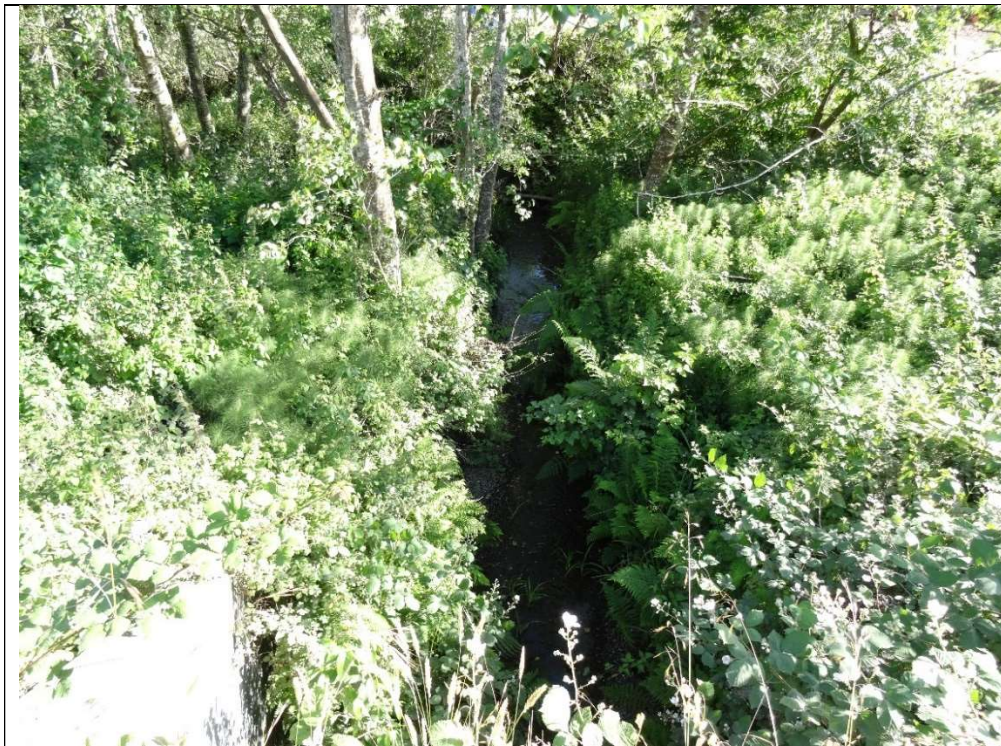
**June 18, 2023.**  
**Wolverton Gulch**  
**at concrete box**  
**culvert and Hwy**  
**36, looking south.**  
**(40.546012, -**  
**124.115143).**

The upper Wolverton Gulch (northeastern, Exhibit 9) stream channel was not accessible by foot and was estimated from the concrete box culvert, at Highway 36, width between wing-walls. An OWHM field data form was prepared based on the observable site conditions.

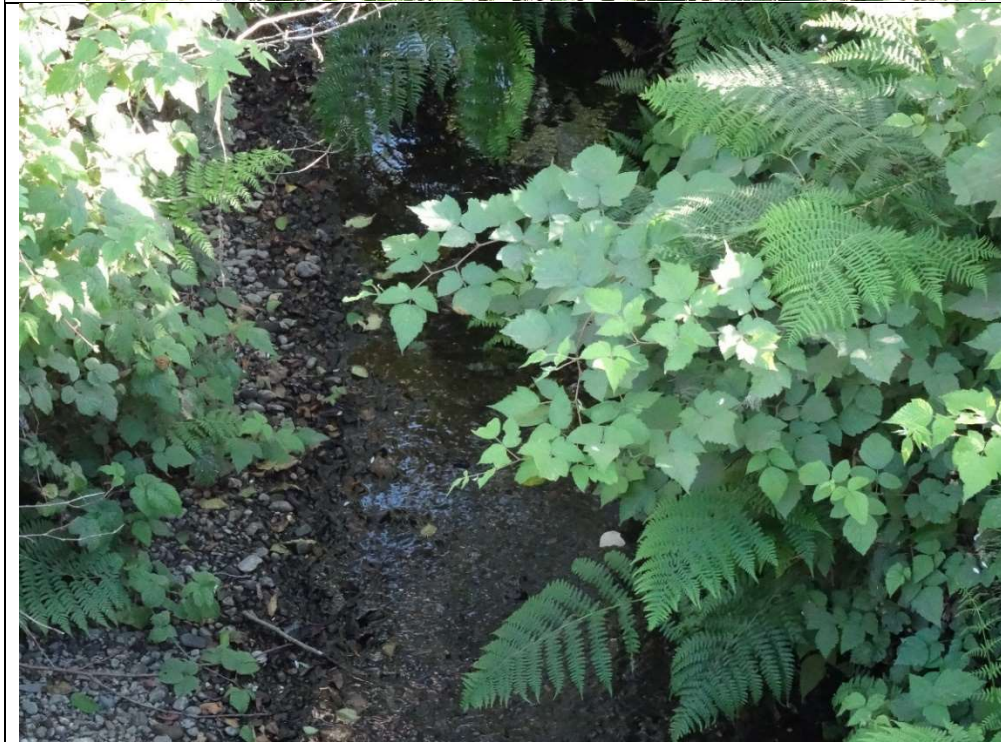
**June 18, 2023.**  
**Wolverton Gulch**  
**streambed looking**  
**south. (40.545951,**  
**-124.115156).**

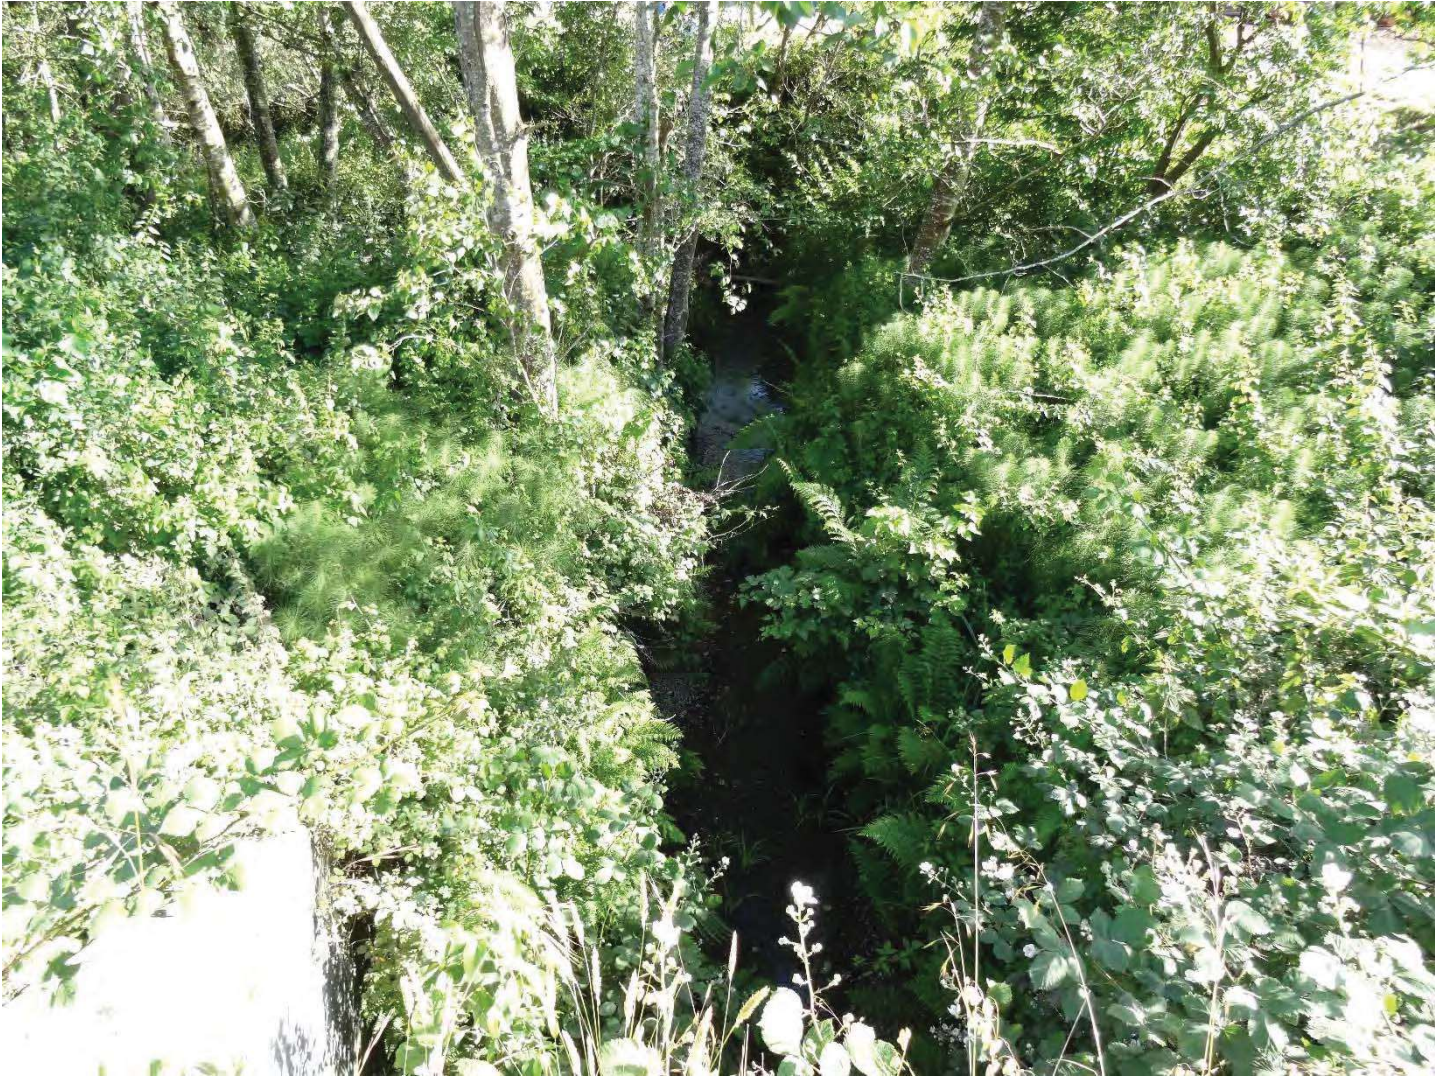
Aerial image of Wolverton Gulch at northernmost extent of study area.
