# AQUATIC RESOURCES DELINEATION REPORT

141 Cove Point East, Shelter Cove, 95589, Humboldt County, CA

111-221-012 & 111-161-068

July 27<sup>th</sup>, 2025

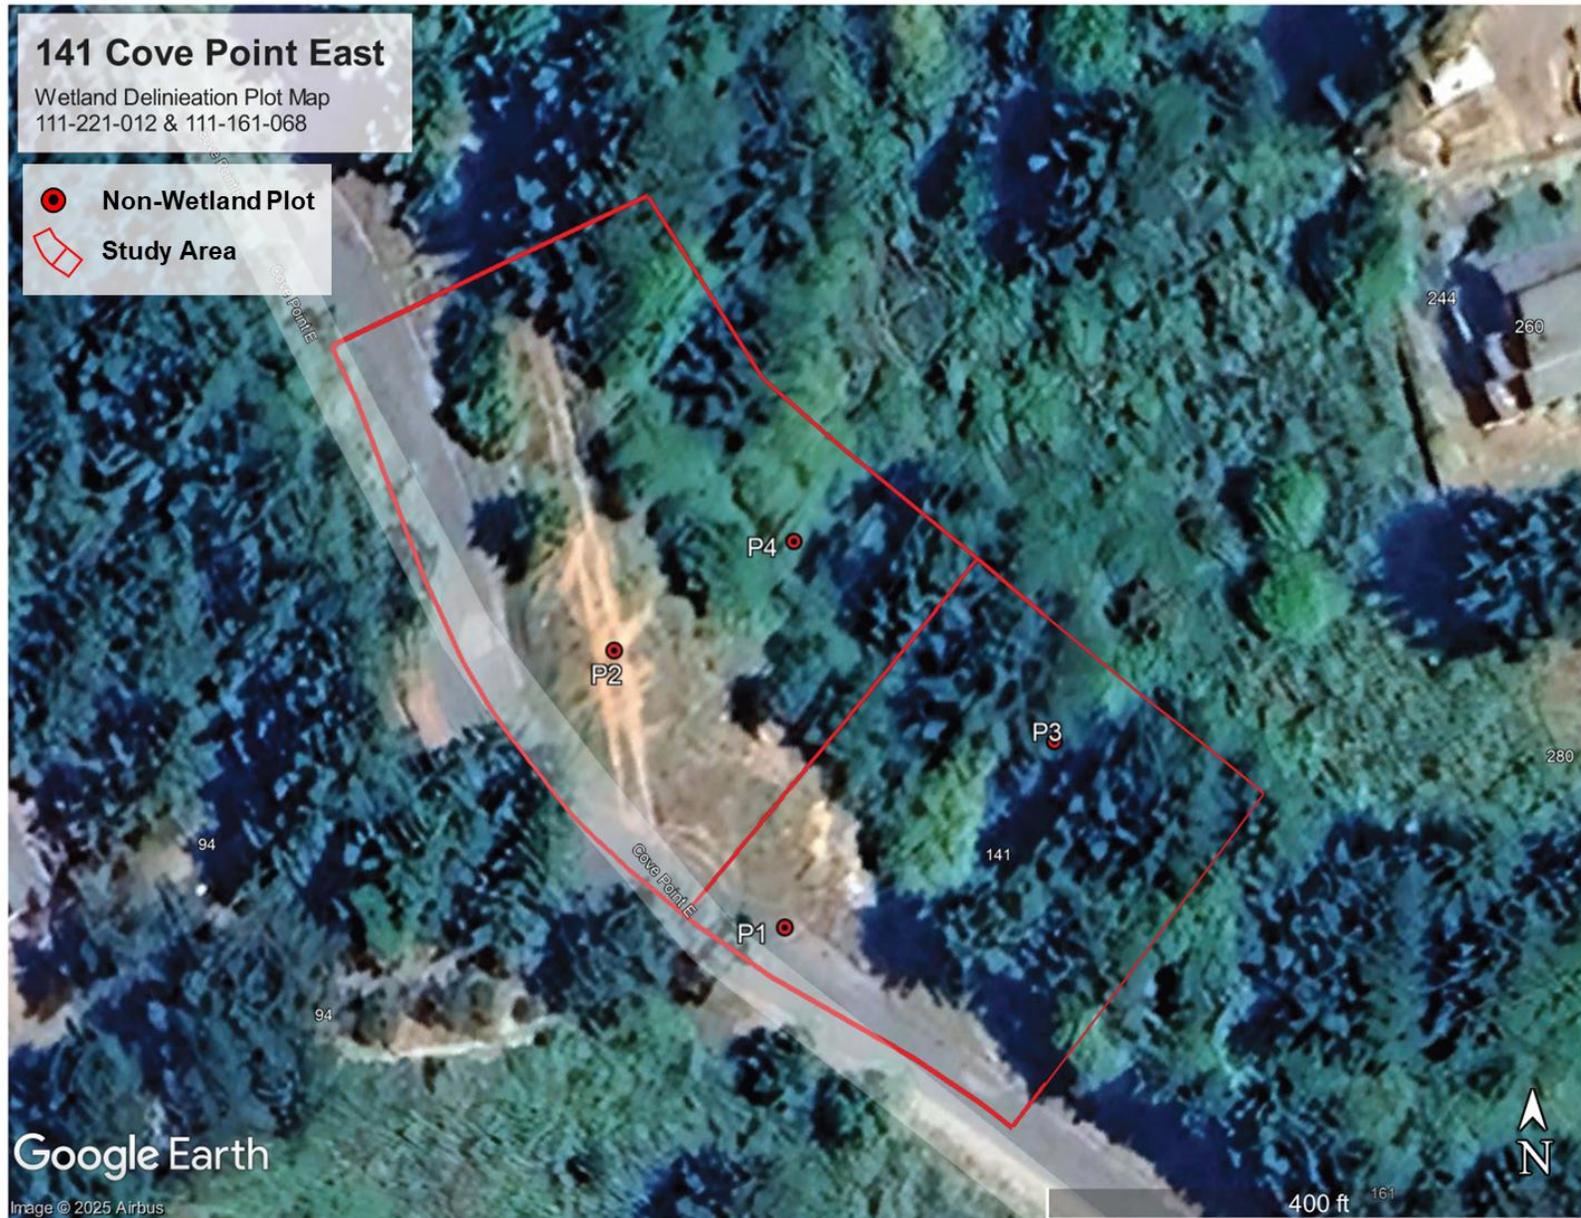
**Figure 5.** Map showing the locations of delineation plots within the Study Area. Study Area boundaries were obtained from Humboldt County's Web GIS. Any discrepancies in boundary alignment reflect the source data provided by the County.

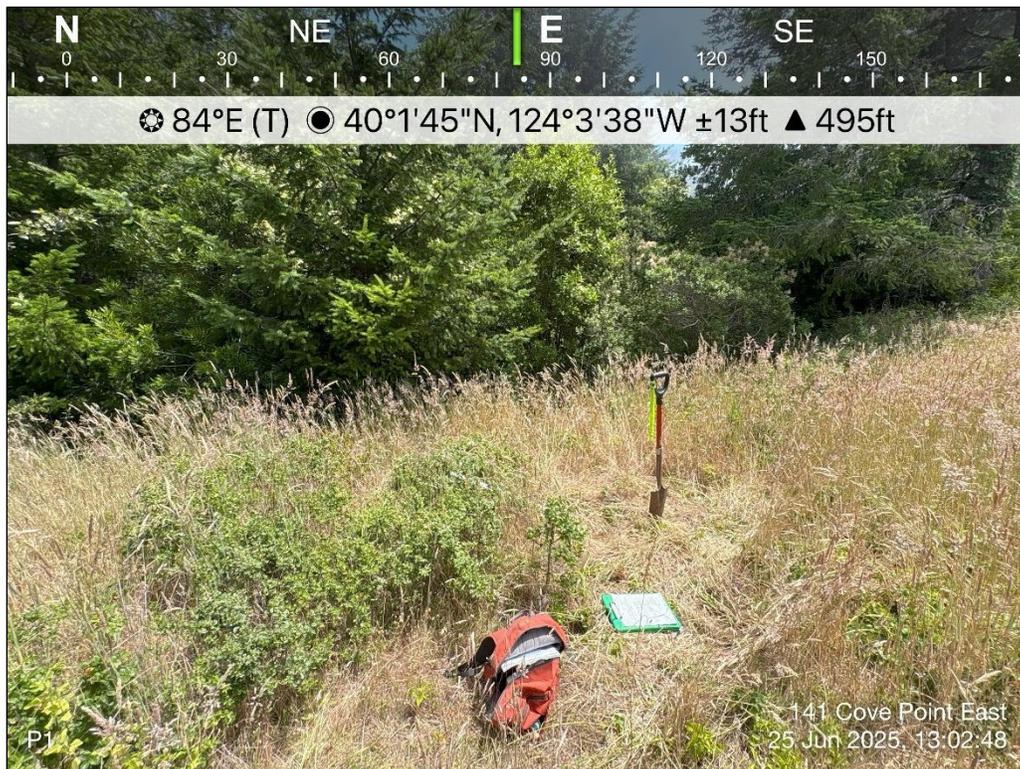
**Photo 2.** P1 location in the southwestern portion of the Study Area within the proposed project footprint and adjacent to the county road.

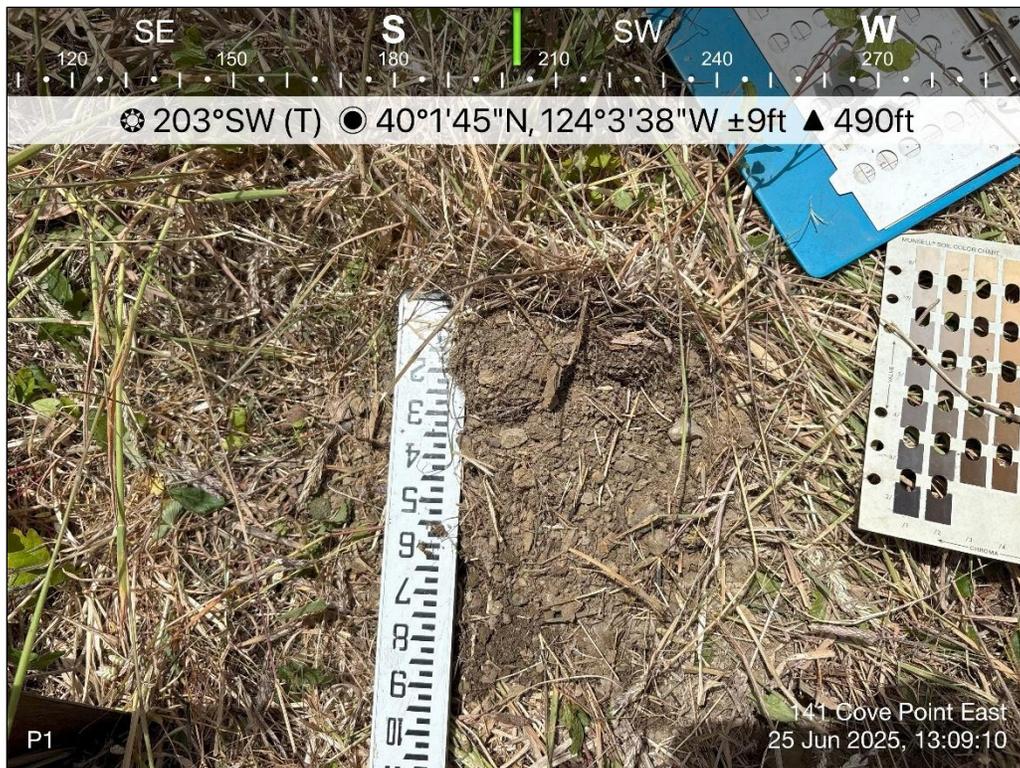
**Photo 1.** P1 soil profile, with restrictive gravel/rock layer at approximately 4 inches.

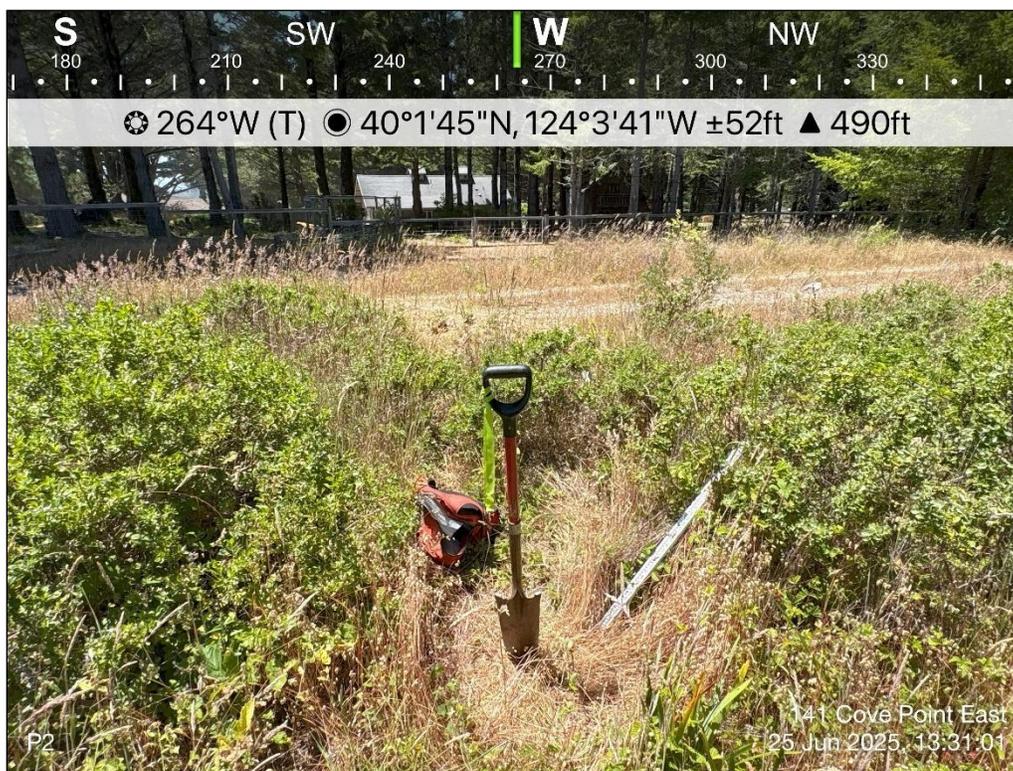
**Photo 3.** P2 location in the central western portion of the Study Area within the proposed project footprint and adjacent to the county road.

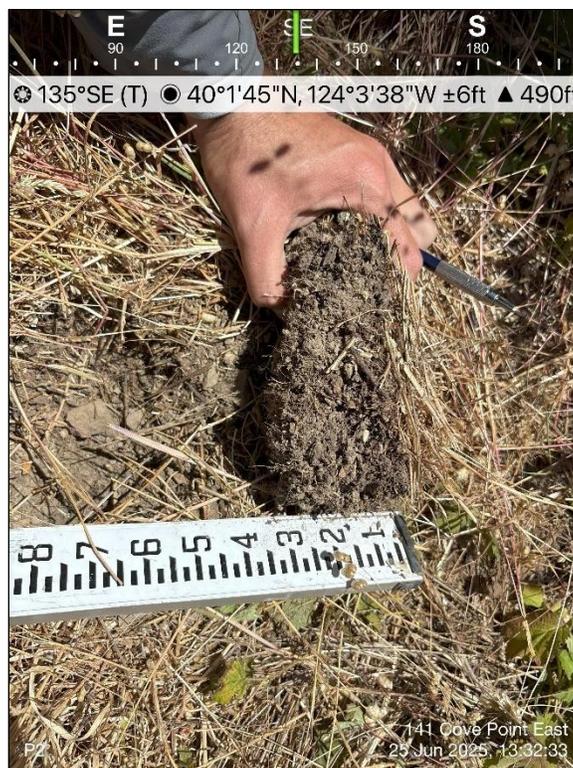
**Photo 4.** P2 soil profile, with restrictive gravel/rock layer at approximately 3 inches.

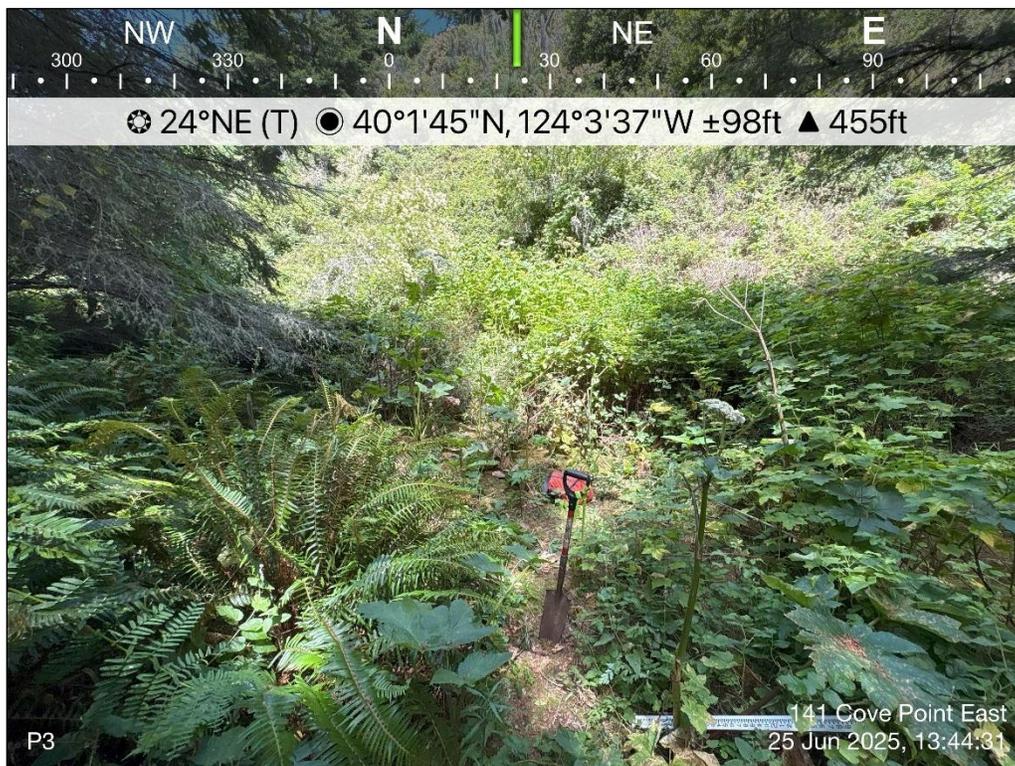
Plot P3, located within the topographic depression identified as a “swale” in the Timberland Resource Consultants *Coastal Biological Resources Evaluation* (2025), was specifically established to evaluate potential hydrologic expression within that feature. However, no evidence of surface water, ponding, saturation, runoff, or any other indicators of wetland hydrology was observed during the site visit, nor was there any indication that such conditions had occurred recently.

**Photo 5.** P3 location within the previously mapped "swale" feature located in the southeastern portion of the Study Area.

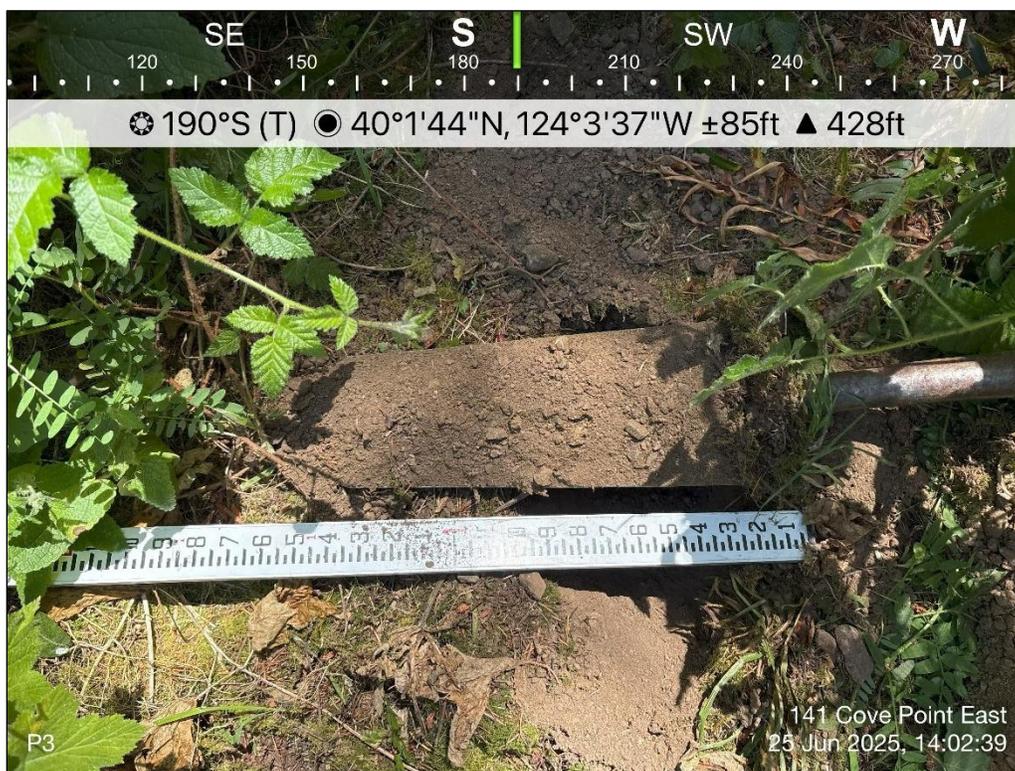
- **P3**, placed in the valley floor “swale”, was excavated to a full depth of 18 inches and exhibited a uniform 10YR 4/3 loam throughout the profile, with gravels appearing around 8 inches. No gleying, depleted matrices, redoximorphic features, or saturation lines were observed. Additionally, no surface ponding, or evidence thereof, or wetland vegetation was present at this location during the survey. While this site occupies a lower topographic position, the absence of hydric soil indicators suggests that any hydrologic expression is likely brief and insufficient to support wetland soil development.

**Photo 6.** P3 non-restricted soil profile displaying well-draining soils and no hydric indicators.

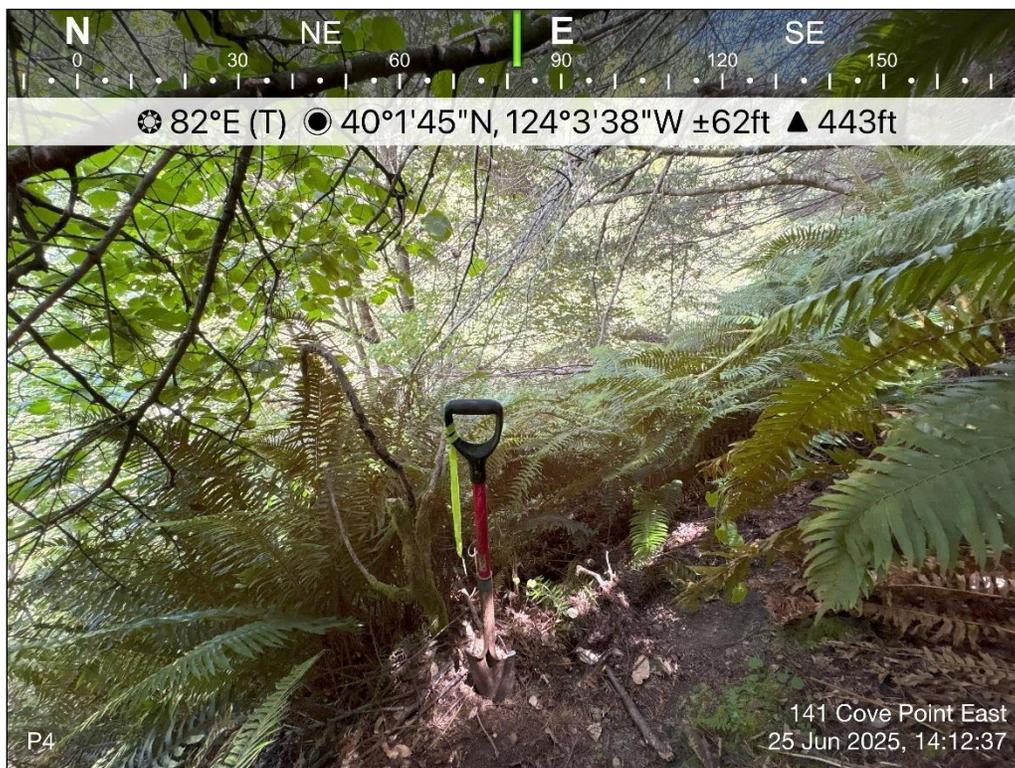
Photo 7. P4 location along the steep hillslope within the eastern central portion of the Study Area.

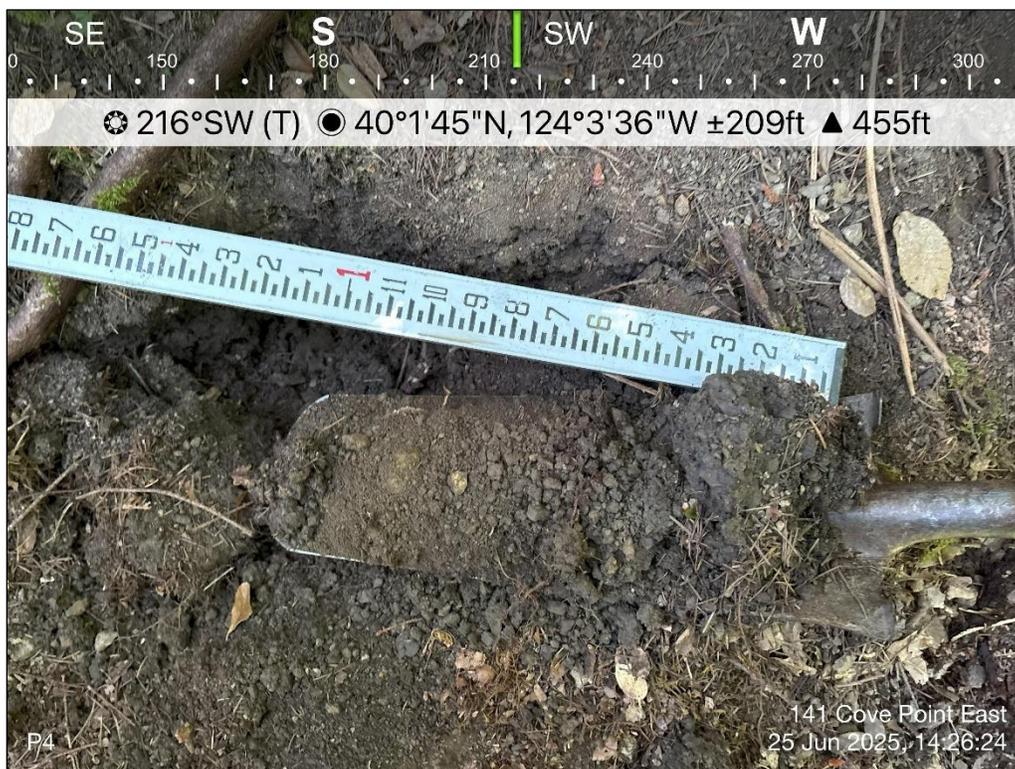
- **P4**, located on a steep east-facing hillslope, consisted of a dark loam surface layer with a Munsell color of 10YR 2/2. While this color falls within the acceptable range for the F7 (Depleted Dark Surface) indicator, no redoximorphic features were present within the upper 6 inches of the profile. As a result, the F7 indicator was not met, and no other hydric soil indicators were observed. The steep slope and rapid drainage likely prevent saturation from persisting for the minimum 14-day

Photo 8. P4 non-restricted soil profile displaying no hydric indicators.

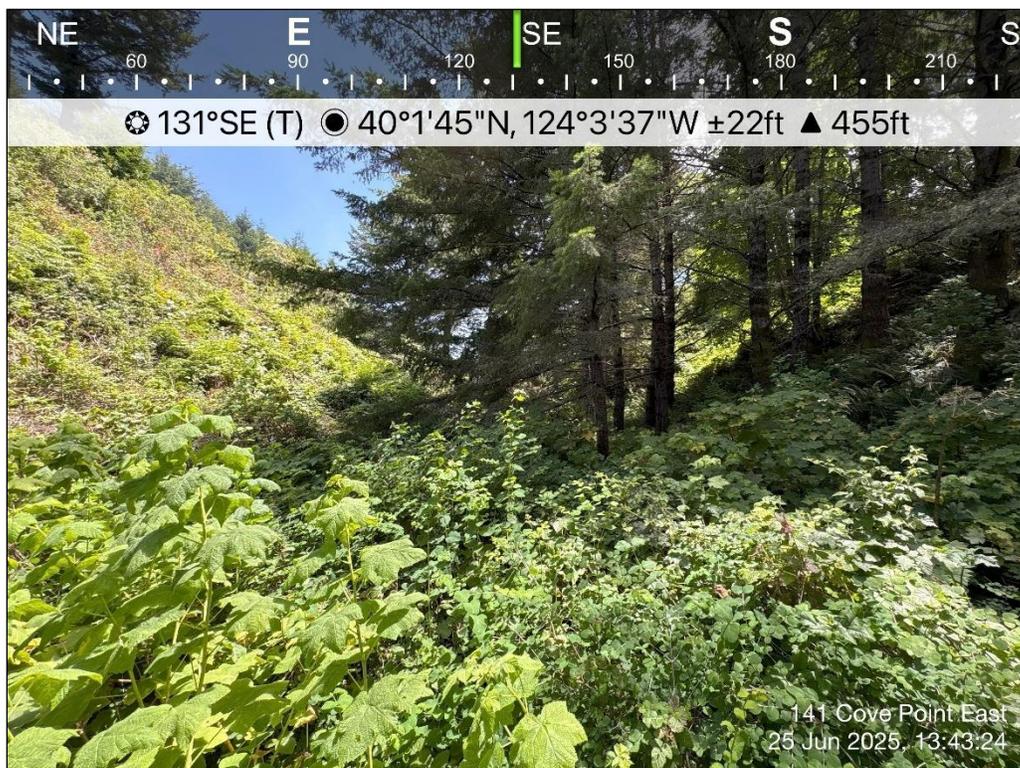
No watercourses, seeps, springs, or other surface hydrology features were observed within the Study Area during the June 25, 2025 site visit. A topographic depression referred to as a “swale” in the *Coastal Biological Resources Evaluation* was evaluated in detail. This feature originates approximately 400 feet southeast of the property and trends northwest but showed no signs of channel morphology, such as defined bed and banks, sediment deposition, or flow paths. Vegetation within this feature was undisturbed, and no indicators of episodic flow or scour were observed (Photo 9 & Figure ).

**Photo 9.** View of the topographic depression mapped as a "swale" in the southeastern portion of the Study Area. No evidence of seasonal water flow or surface hydrology was observed at this location.

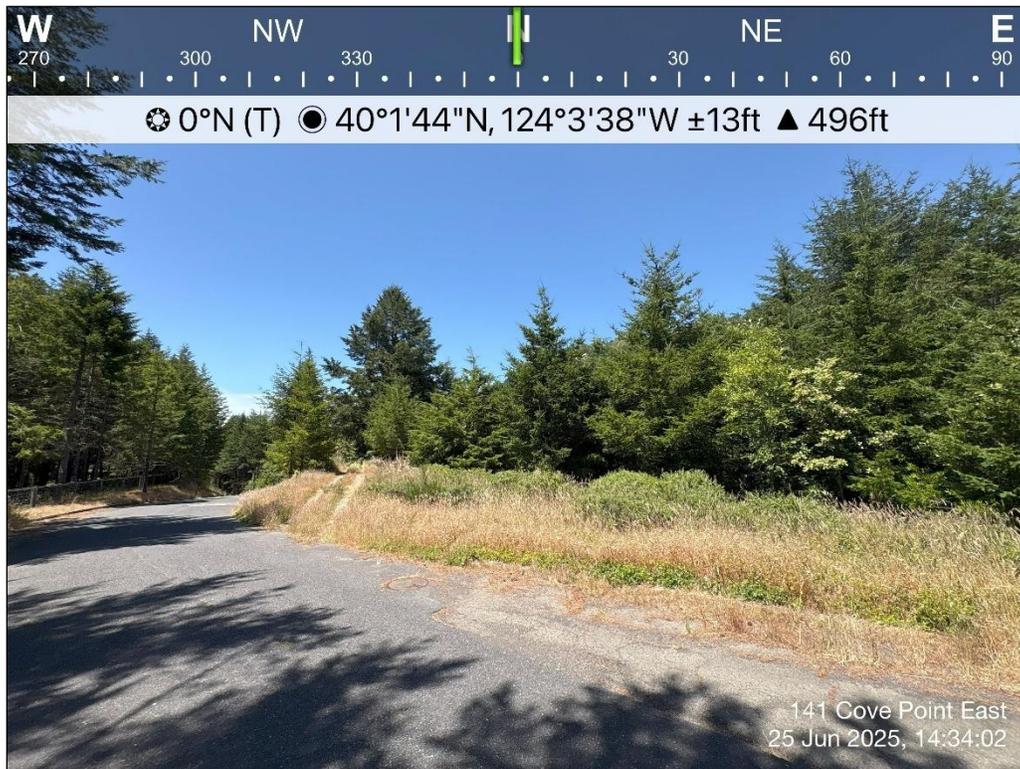
**Photo 11.** The upper western portion of the study area where P1 and P2 occur, and where the proposed development will occur.

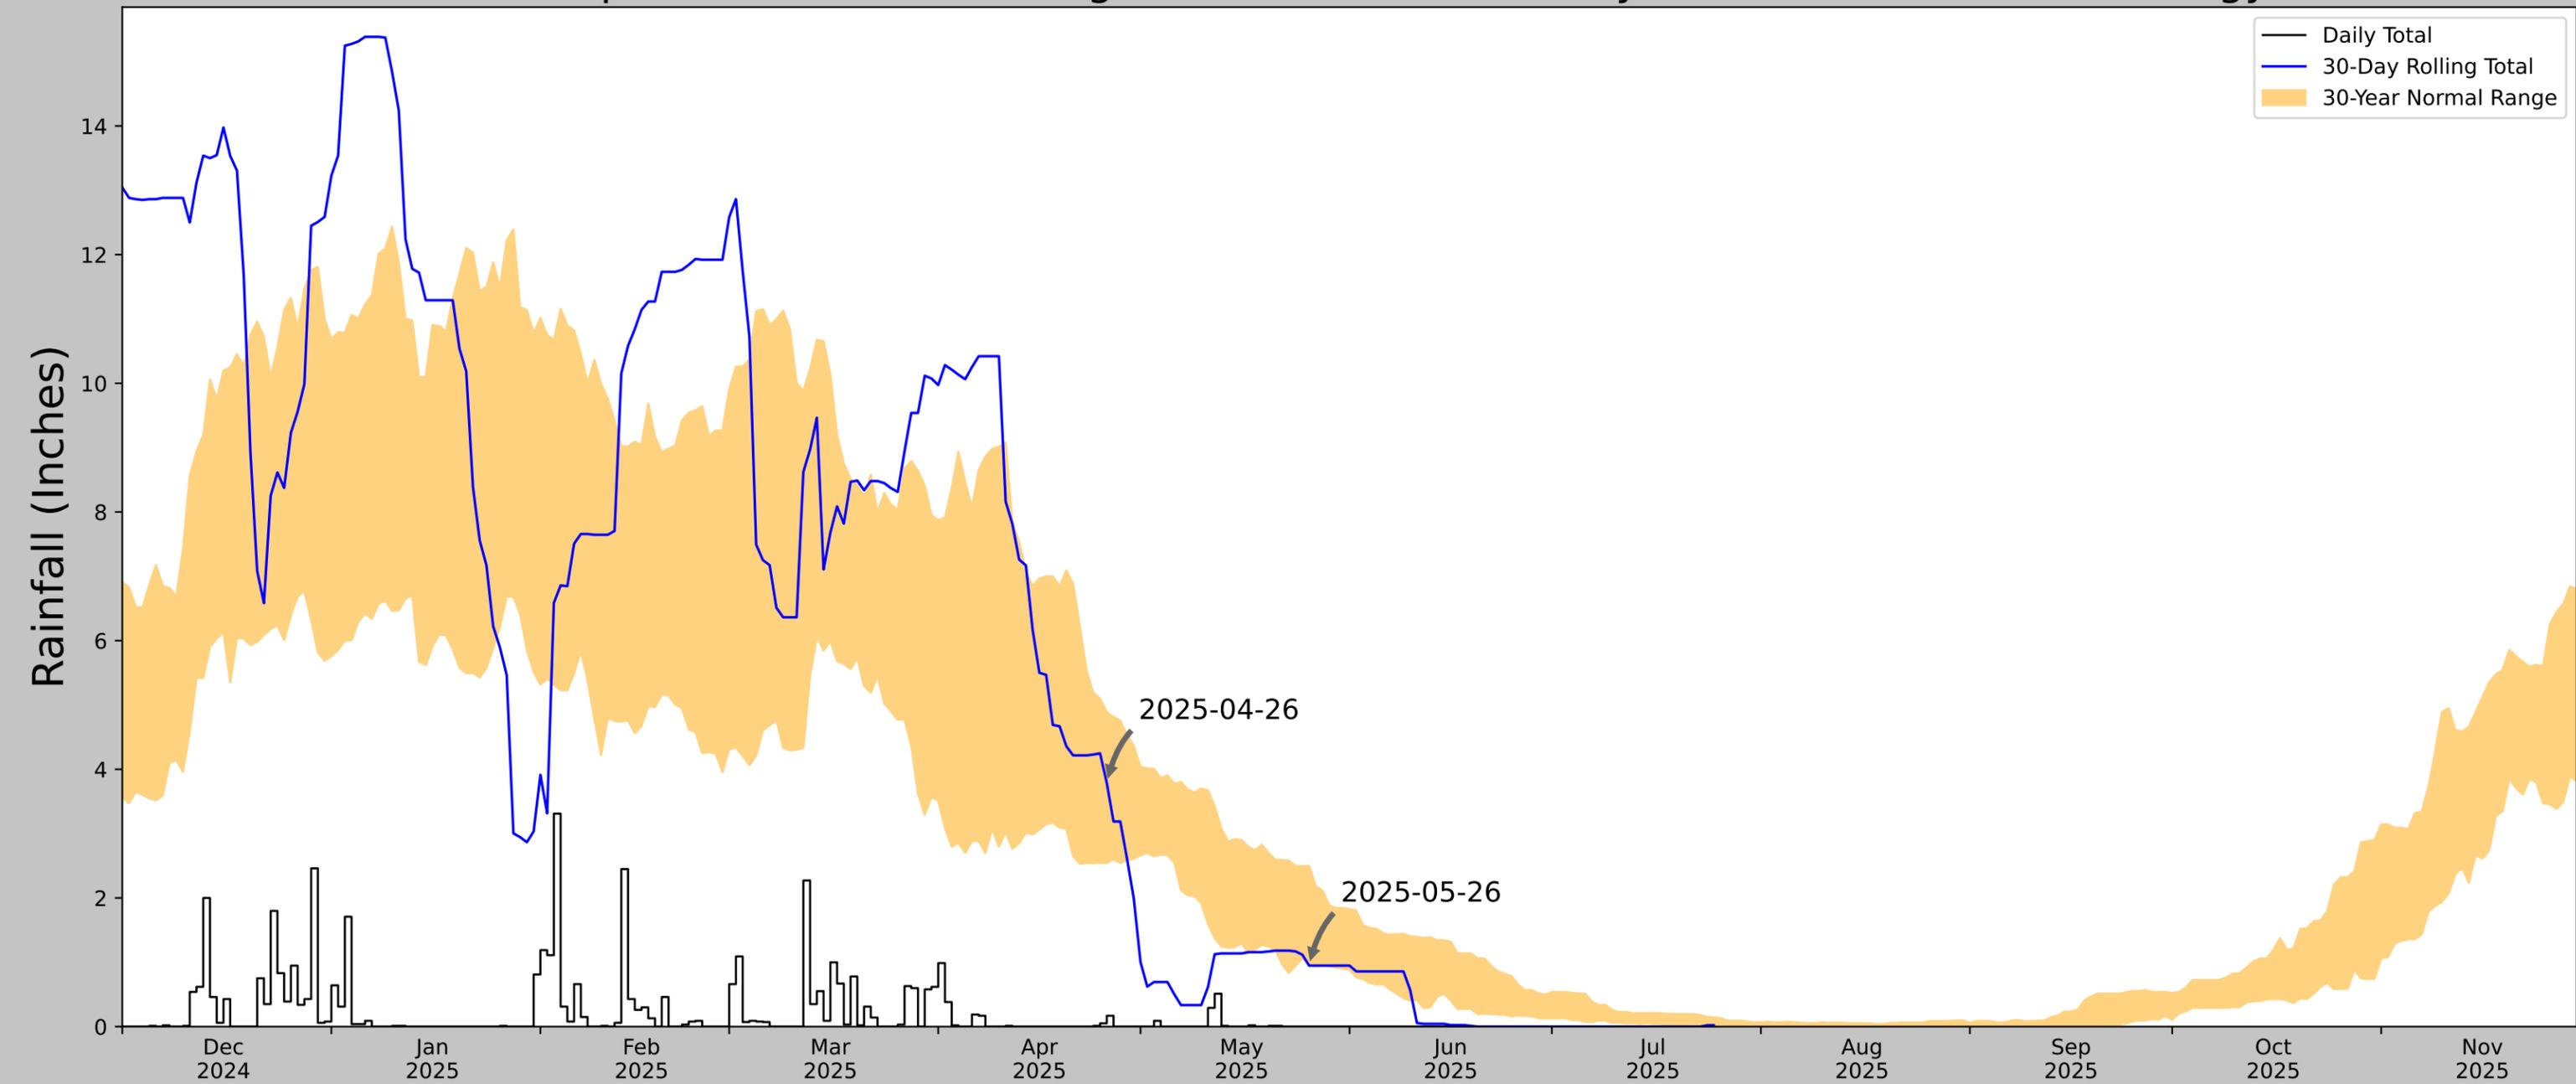
Coordinates	40.02946, -124.0606
Observation Date	2025-06-25
Elevation (ft)	452.202
Drought Index (PDSI)	Mild drought
WebWIMP H <sub>2</sub> O Balance	Dry Season

30 Days Ending	30 <sup>th</sup> %ile (in)	70 <sup>th</sup> %ile (in)	Observed (in)	Wetness Condition	Condition Value	Month Weight	Product
2025-06-25	0.159055	0.78622	0.0	Dry	1	3	3
2025-05-26	1.000394	2.497244	0.948819	Dry	1	2	2
2025-04-26	2.539764	4.888189	3.787402	Normal	2	1	2
Result							Drier than Normal - 7
