**Timber Conversion Mitigation Plan**

**Integrated Horticulture Systems LLC Less Than Three Acre Conversion Mitigation Plan**

a. Site Address: 8200 Salmon Creek Road Miranda, CA

c. Assessor’s Parcel No(s): 221-011-021

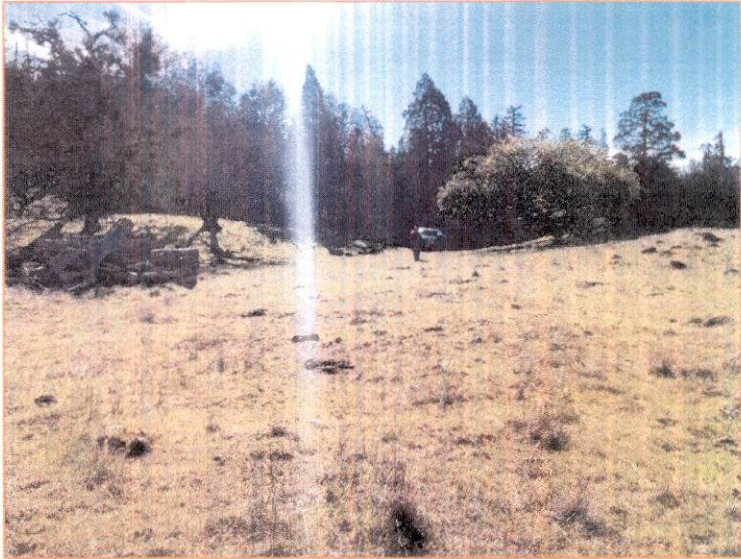
3A) West facing east, note flagging of 50' ELZ buffer.

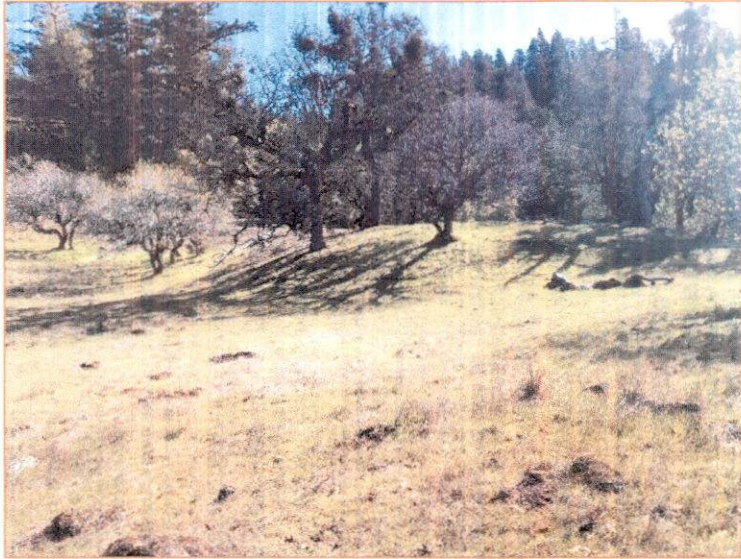
3B) South facing north.

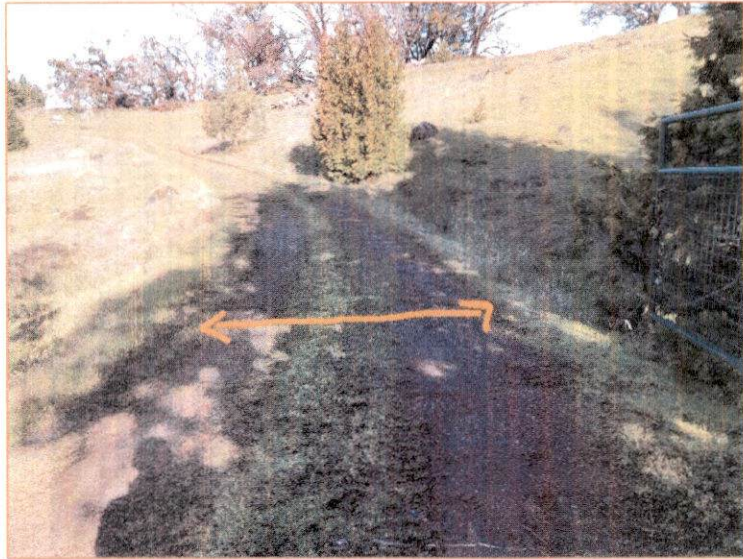
RP1) Install a critical dip.

RP1) View of inlet on a Class II stream.

**RP1** Existing and functional 36" diameter culvert on a Class II watercourse. Install a critical dip northwest of the crossing centerline. Rock the dip with 4" - 6" diameter sharp angular rock.

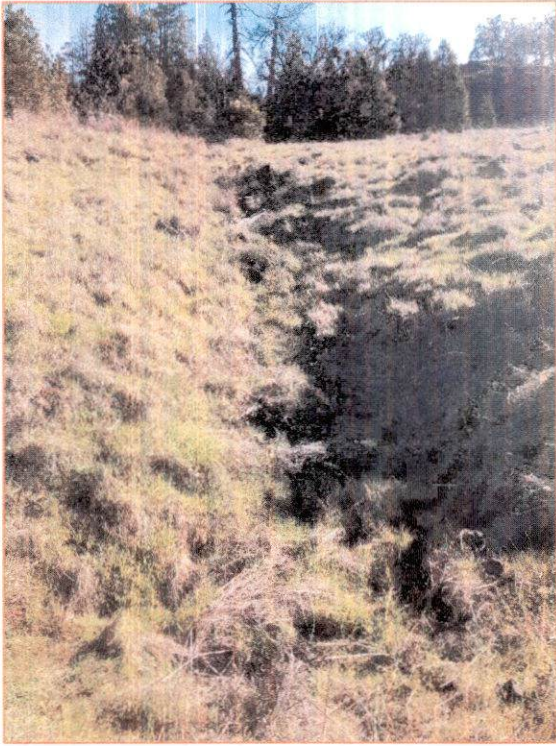
RP5) Viewing upstream at the inlet, headwaters of a class III stream.

RP5) View of outlet, replace undersized culvert on a class III stream.

**RP5** Existing undersized 8" diameter culvert on the headwaters of a Class III watercourse. Install an oversized 18" diameter culvert to stream grade. Rock the culvert inlet and outlet with 1' to 2' diameter sharp angular rock. Install a critical dip on the centerline. Rock the dip with 4" to 6" diameter sharp angular rock. **1600 required.**

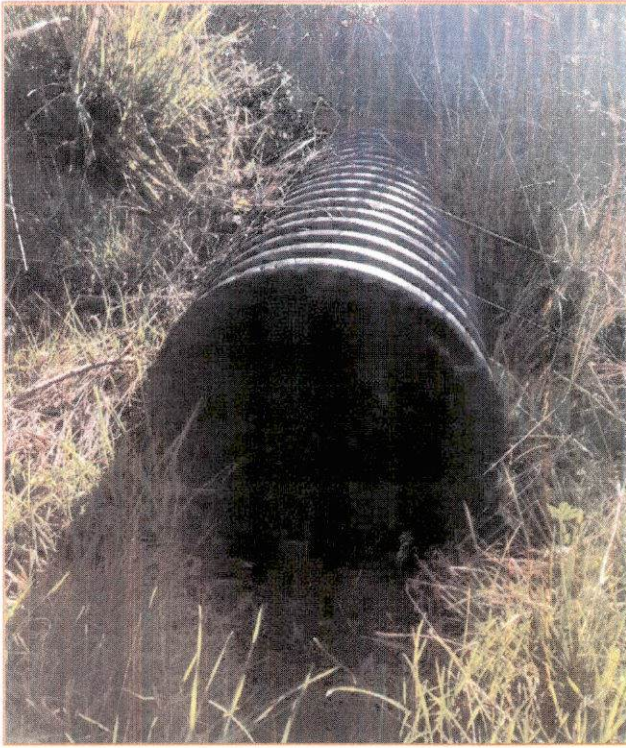
RP6) View of outlet, existing and functional DRC.

**RP6** Existing and functional 18" diameter ditch relief culvert (DRC). Clean and maintain the inlet and outlet. If DRC fails, install oversized 24" diameter DRC.

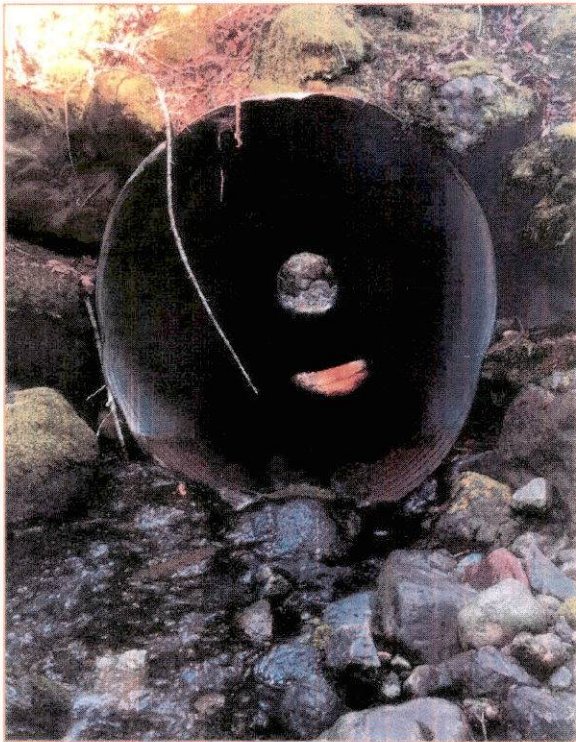
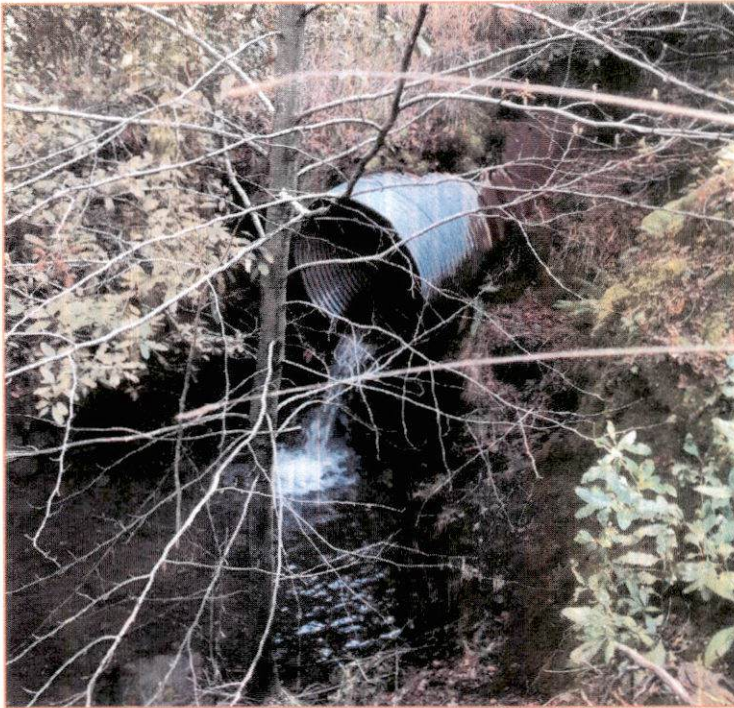
RP7) View of inlet on a class II stream.

RP7) View of shotgunned outlet on a class II stream.

**RP7** Existing and functional, but undersized, 54" diameter culvert with shot gunned outlet on a Class II watercourse. Install a 66" diameter culvert to stream grade. Rock the culvert inlet and outlet with 2' to 4' diameter sharp angular rock. Install additional 2' to 4' diameter sharp angular rock at base of the outlet. Rock the inside ditch for 30' north of the hingeline with 2" to 4" diameter crush rock. **1600 required.**

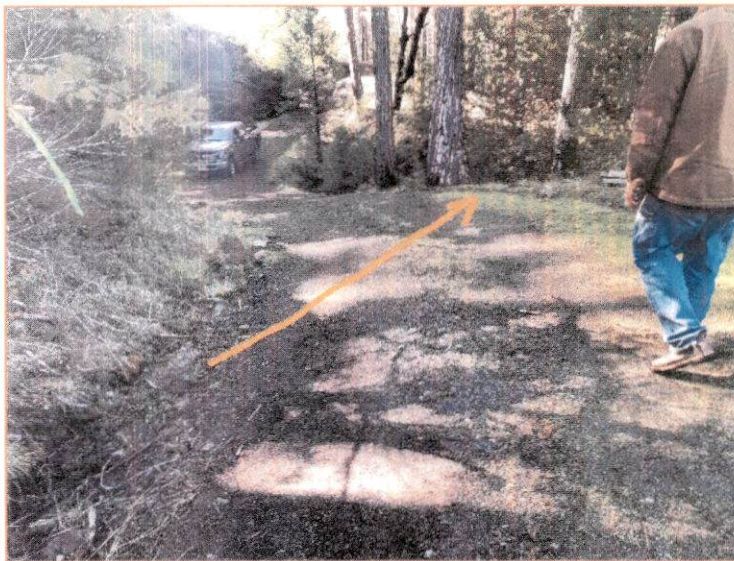
RP8) Install rocked rolling dip or replace failing DRC.

**RP8** Existing and failing 18" diameter DRC. Remove 18" DRC, install a rocked rolling dip or a 24" diameter DRC draining towards the Class II watercourse. For installing a rocked rolling dip, line/cap the dip with 2" to 4" diameter crush rock to reduce sediment transport from road prism. For installing a 24" diameter DRC, rock the inlet and outlet with 2' to 4' diameter sharp angular rock.

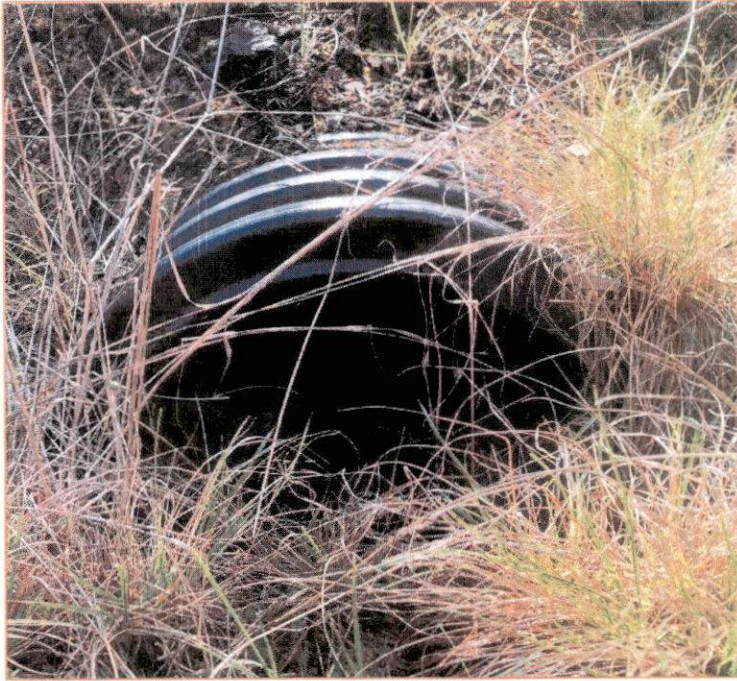
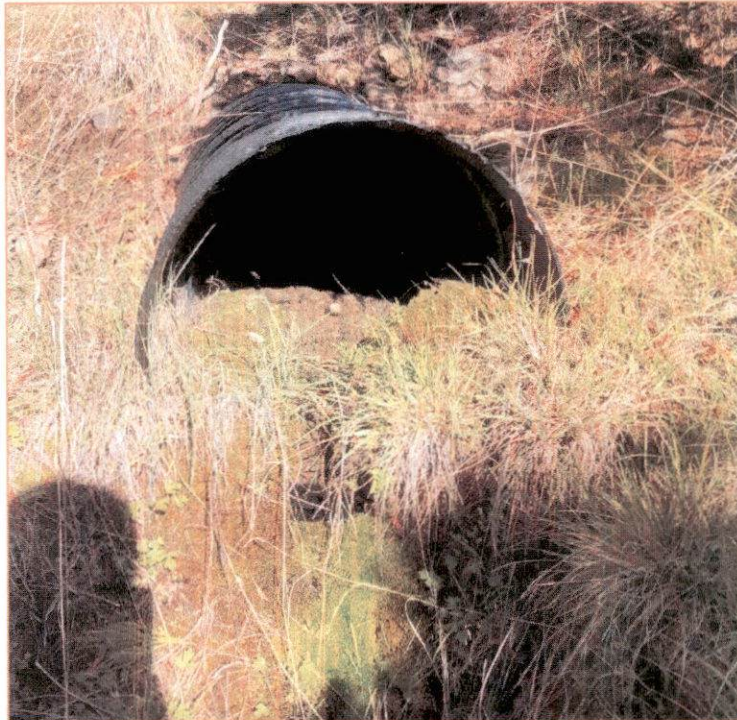
RP9) Clean and maintain DRC inlet.

RP9) Clean and maintain DRC outlet.

**RP9** Existing and functional 18" diameter DRC. Clean and maintain the inlet and outlet.

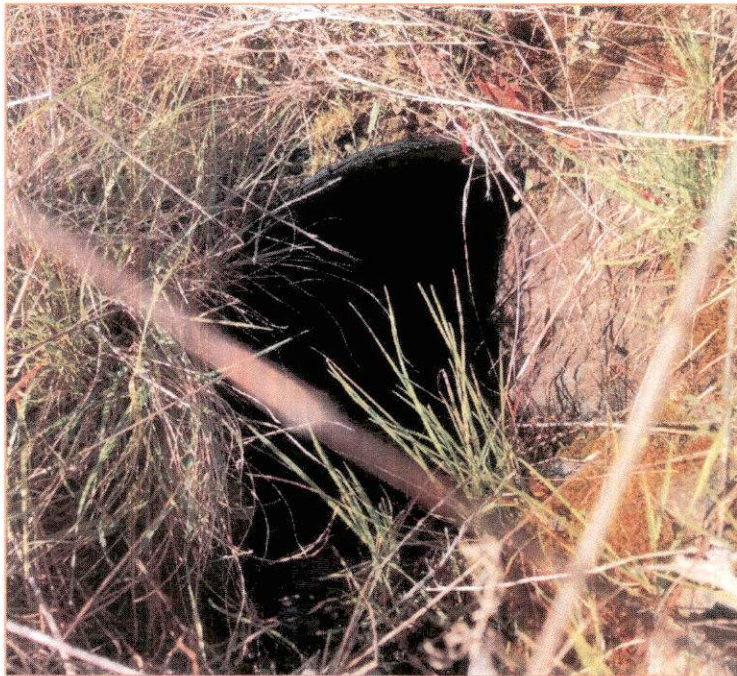
RP13) Clean and maintain DRC inlet.

**RP13** Existing and functional 12" diameter DRC. Clean and maintain the inlet and outlet.

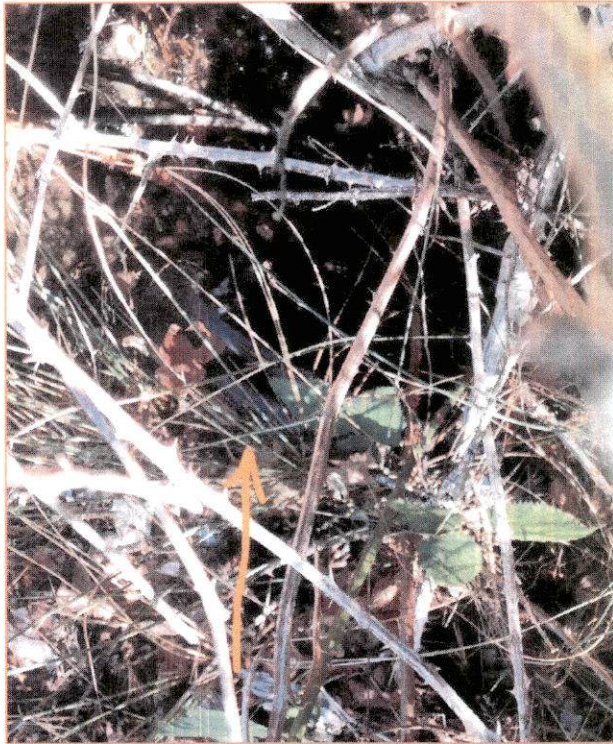
RP14) Clean and maintain the inlet.

RP14) View of outlet, install additional rock at base of outlet.

**RP14** Existing and functional oversized 24" diameter culvert on a Class III watercourse. Clean and maintain the inlet and outlet. Install additional 2' to 4' diameter sharp angular rock at base of the outlet. **1600 required.**
