# ATTACHMENT 5

## SLOPES, STABILITY, SEISMIC SAFETY, AND HOUSING INVENTORY FIGURES

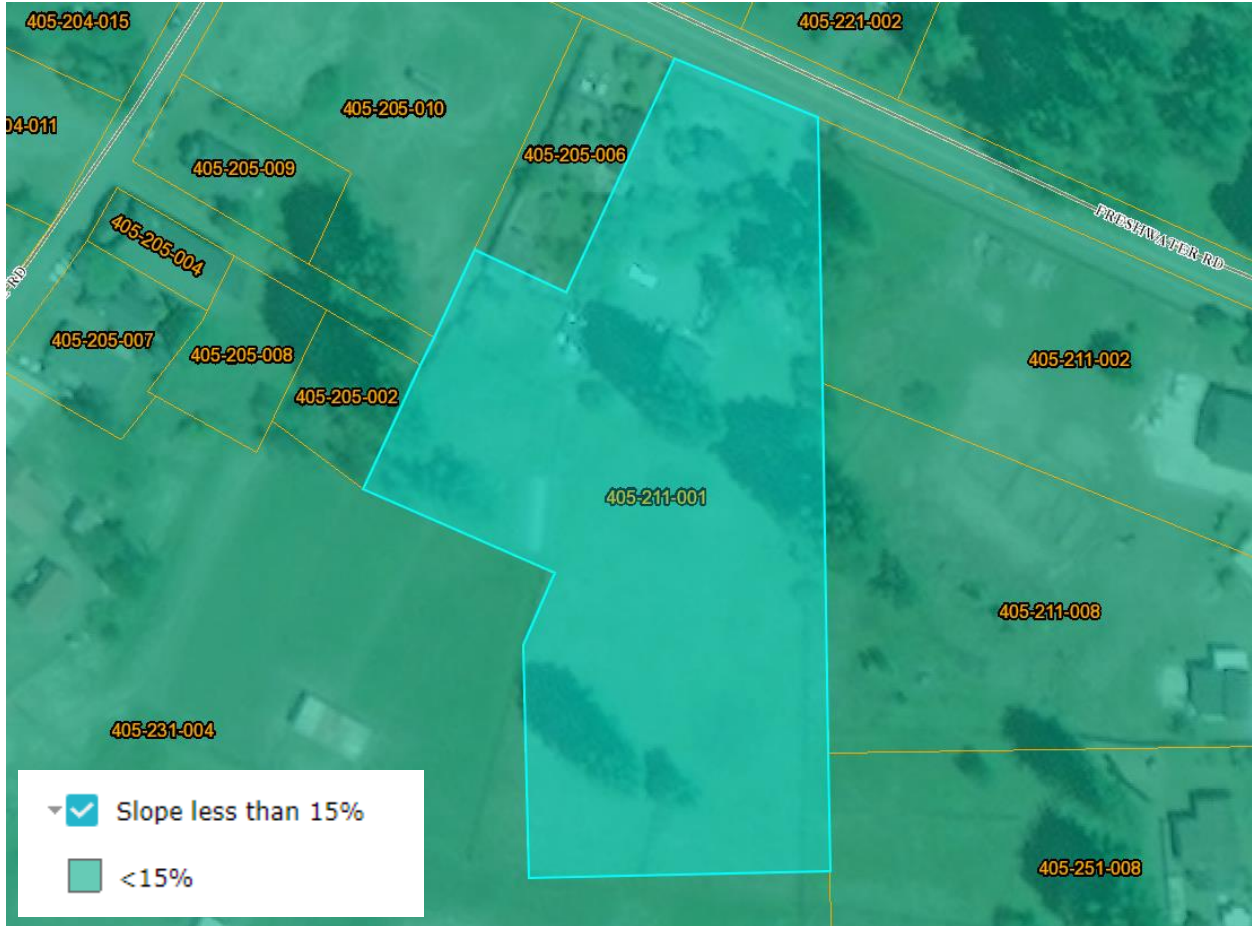
FIGURE 1 -SLOPE MAP

Note: The entire 2.30 acres of the Project Area contain slopes under 15%

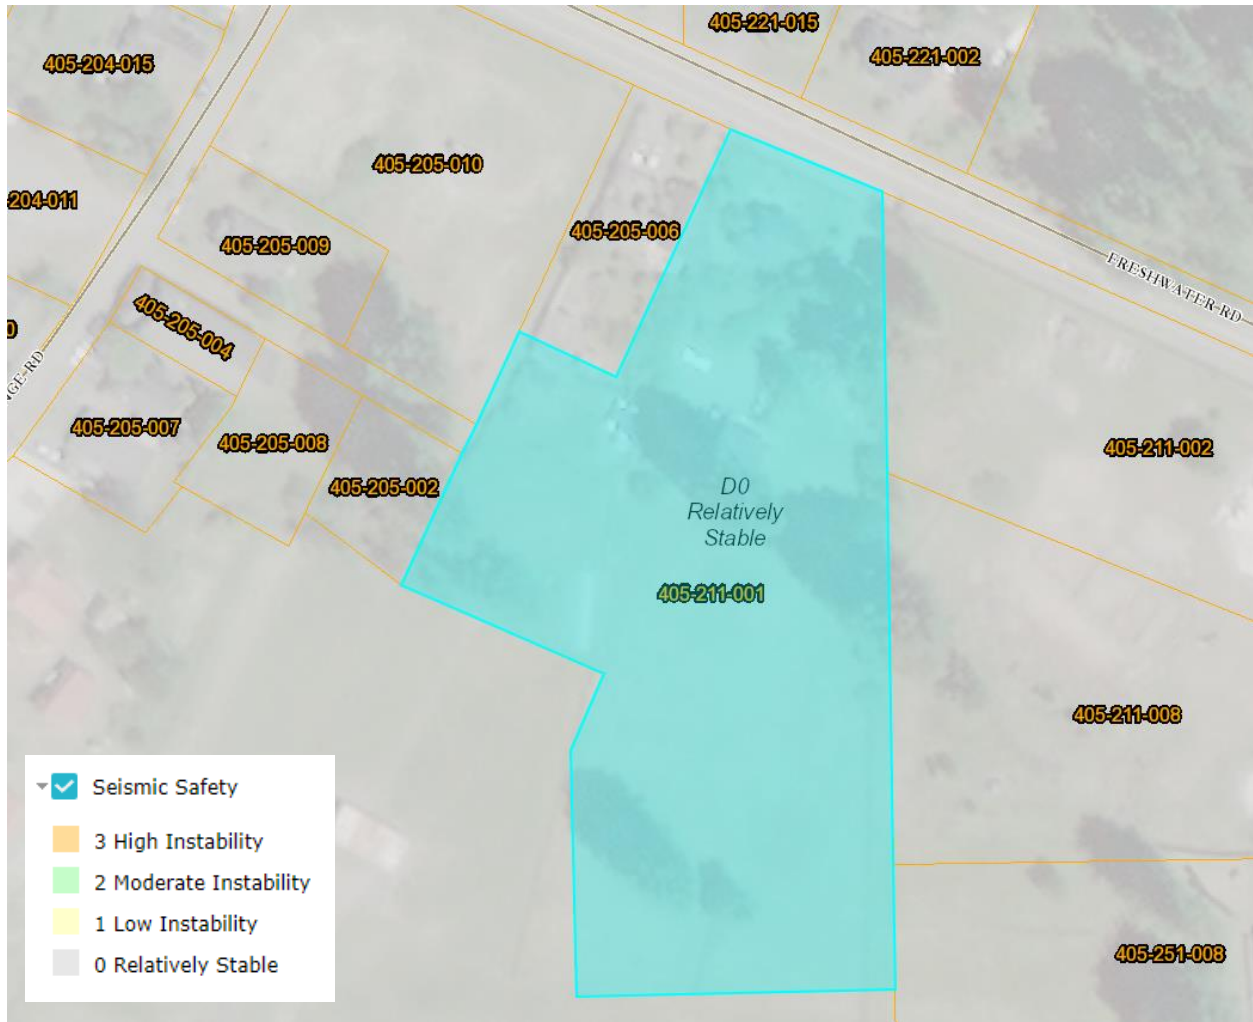
FIGURE 2 - SLOPE INSTABILITY

Note: Project area rating is entirely Relatively Stable (0).

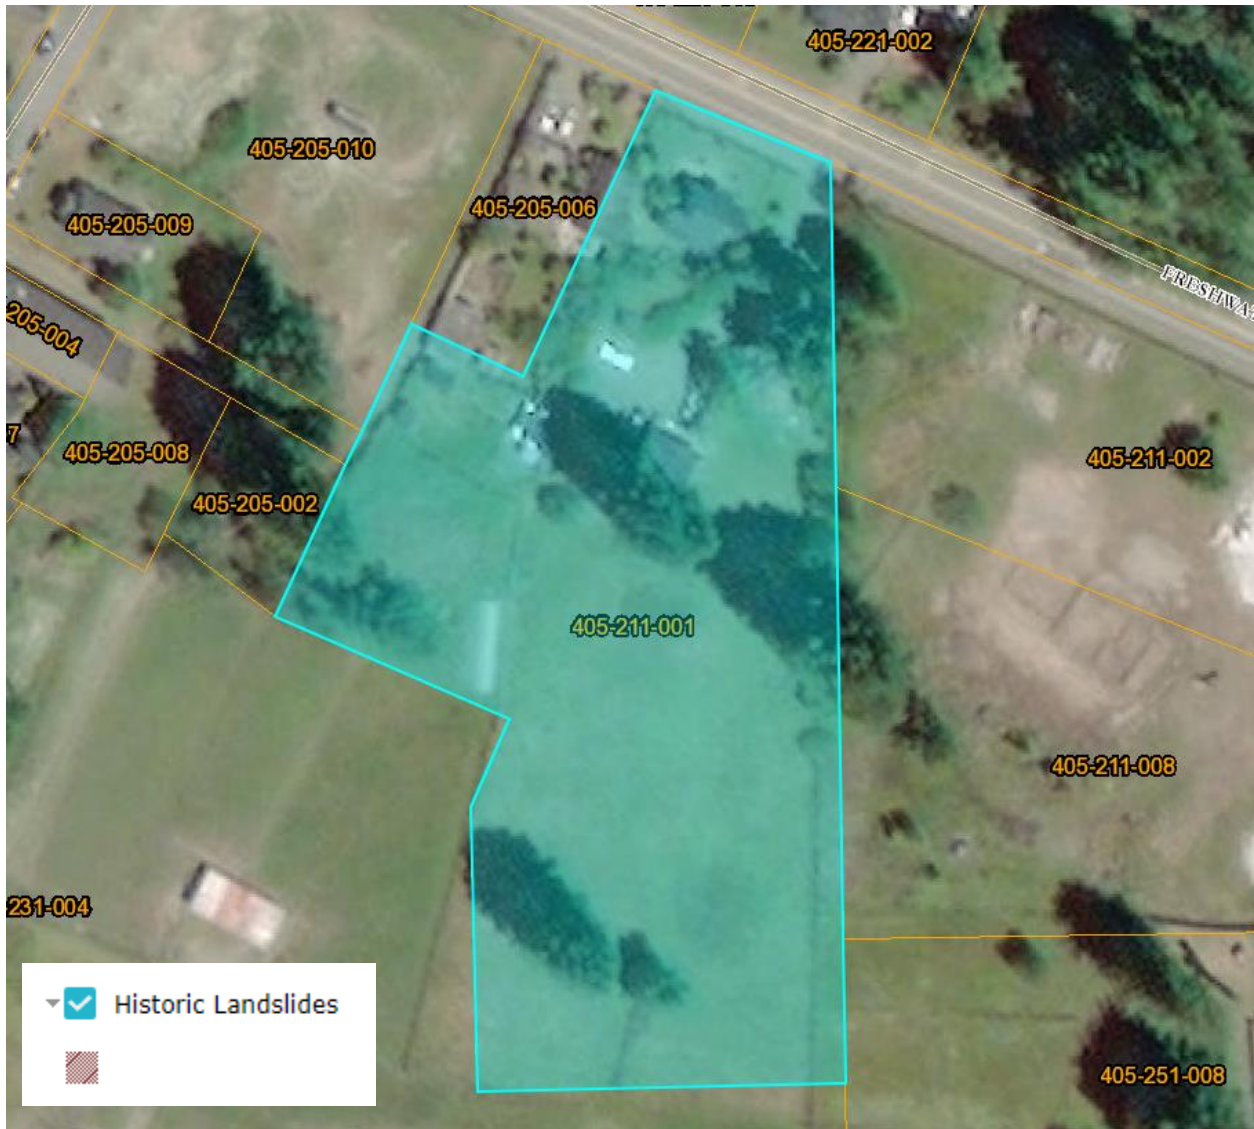
FIGURE 3 - HISTORIC LANDSLIDES

Note: The Project Area does not contain historic landslides
