Trent Sanders Less Than Three Acre Conversion Mitigation Plan

This document has been prepared pursuant to Section 55.4.10(j) of the Humboldt County Commercial Medical Marijuana Land Use Ordinance, applications for Commercial Cannabis Activity occupying sites created through prior unauthorized conversion of timberland. The document evaluates site conditions and conversion history for the parcel and contains a Registered Professional Foresters (RPF's) recommendation as to remedial actions necessary to bring the conversion area into compliance with provisions of the Forest Practice Act.

There are 3 sites that were assessed in the site visit. Site B is the only site that qualifies as a conversion totaling 1.75 acres of converted land on the property (see table below).

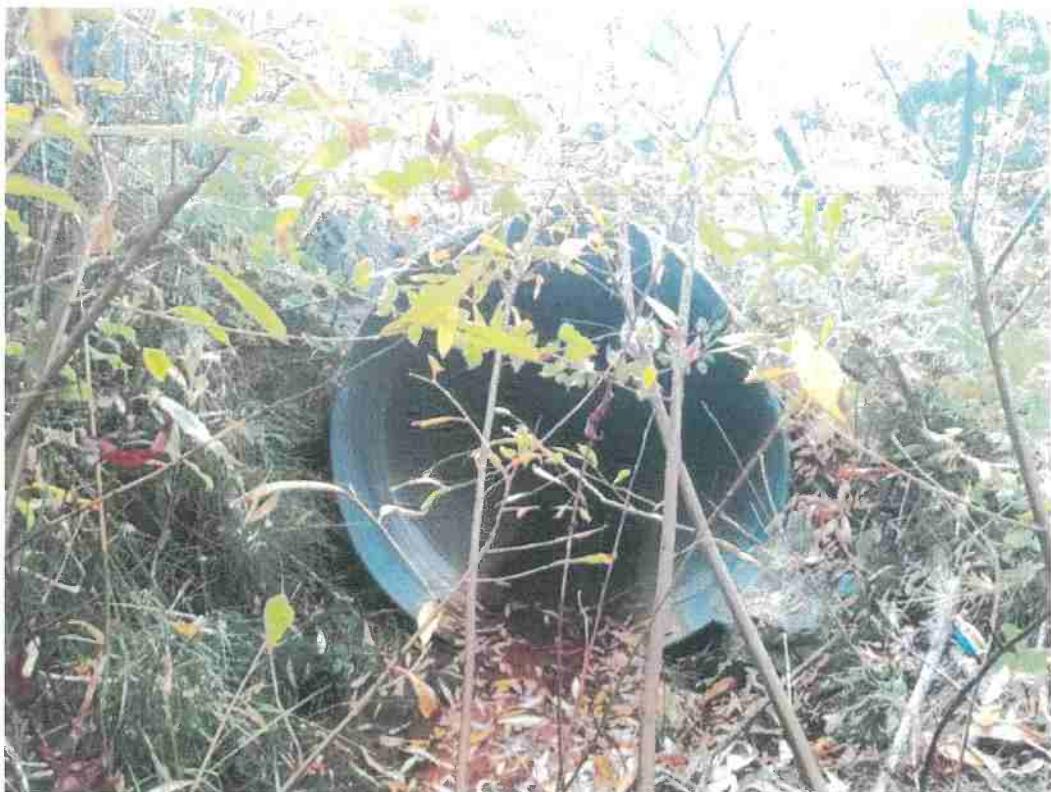
RP-1 (Main Access Road) Existing Functioning Class II Stream crossing with a 56" galvanized culvert. Frequency Magnitude calculations found that the culvert is adequately sized for 100 year flood flow. Install a rocked critical dip center of hinge line with 3"-6" diameter sharp angular rock. Disconnect the surface drainage by installing a rocked rolling dip 50' left of the crossing rock dip with 3- 6" crushed rock. Rock for 50' left and right of crossing hinge line with 1"+/- crushed rock.

RP-1 Main Access Road: Class II Stream Crossing 54" Culvert.

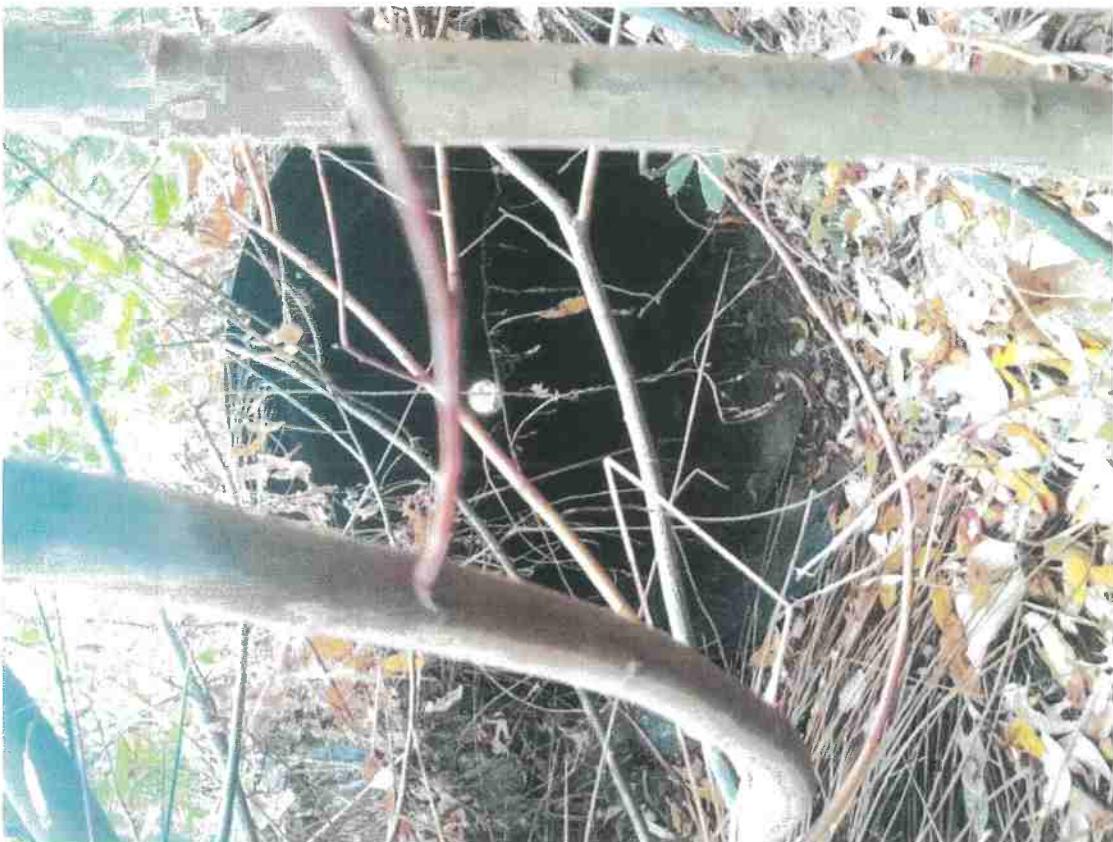
RP-2 (Main Access Road) Existing Functioning Class II stream crossing with a 30" plastic culvert installed to grade. Magnitude and Frequency equations call for a 32" culvert however the culvert appears to be adequately sized for the channel based on field observations and the disturbance required to replace it seems unwarranted. Install a rocked critical dip center of hinge line with 3"-6" diameter sharp angular rock. Disconnect the surface drainage by installing a 18" ditch relief culvert 50' left of the crossing and a rocked rolling dip 50' right of the crossing rock dip with 3- 6" crushed rock. Add additional surface rock for 50' left and right of crossing hinge line with 1"+/- crushed rock. Maintain and monitor inlet and outlet and keep clear of brush and debris.

RP-2 Main Access Road: Class II Stream Crossing 30" Culvert.

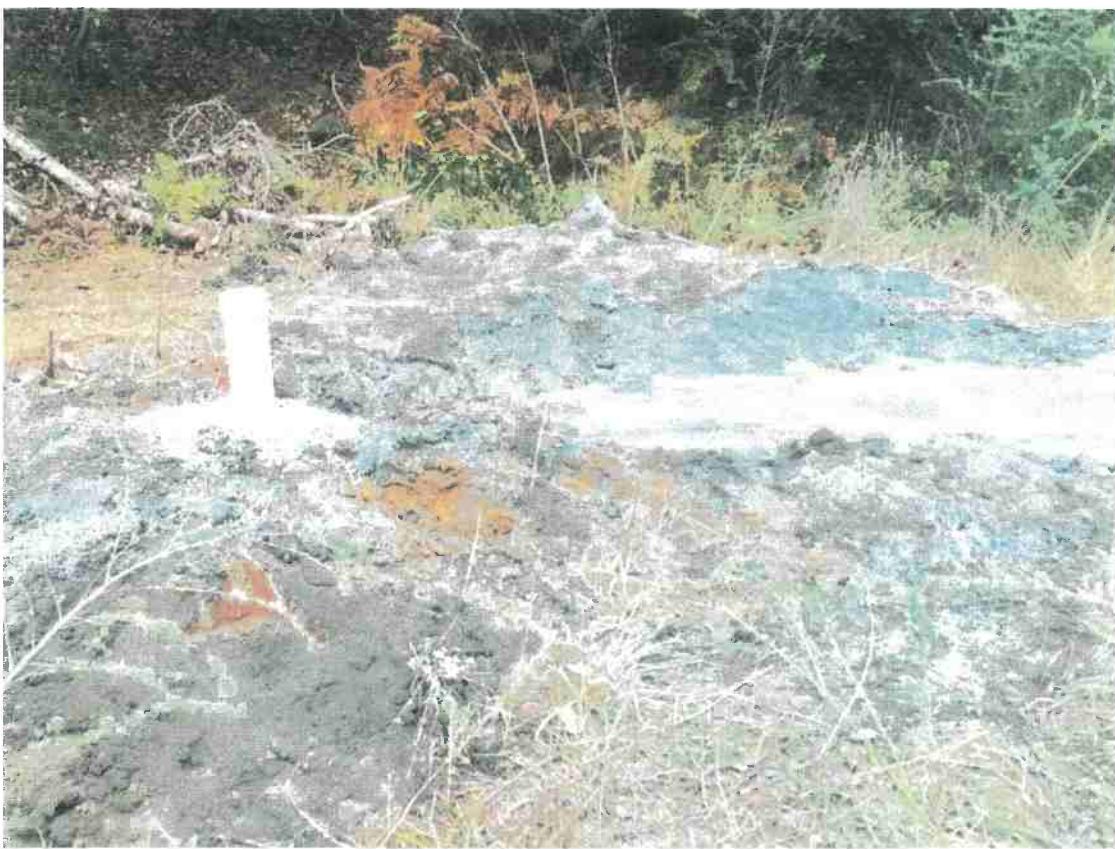
RP-4 (Main Access Road) New domestic well was installed at this location the well tailings could be carried by storm flow to the class III stream below the site remove and stabilize tailings and install straw mulch on any bare soil to prevent surface erosion.

RP-4 Newly Drilled Well

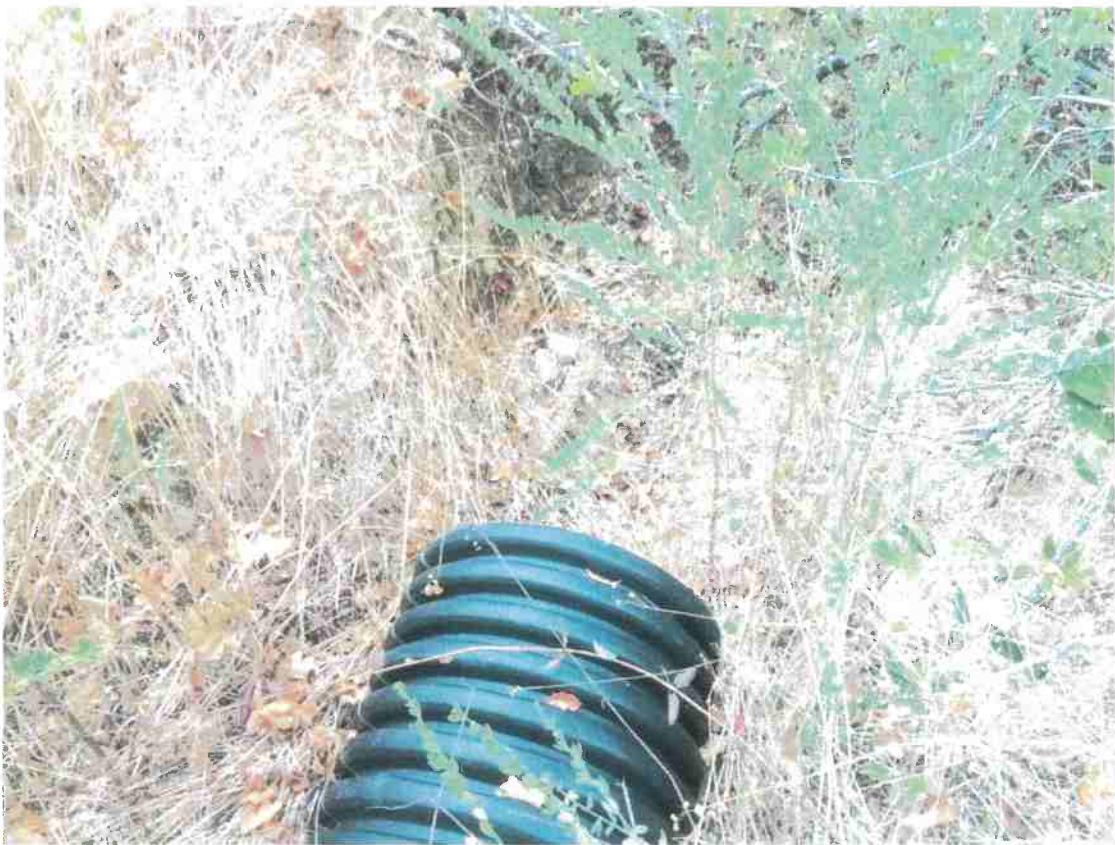
RP-5 (Main Access Road) Existing 18" DRC maintain and monitor inlet to keep clear of debris. Add 6-8" rock armor to the outlet to reduce erosion.

RP-5 Existing 18" DRC

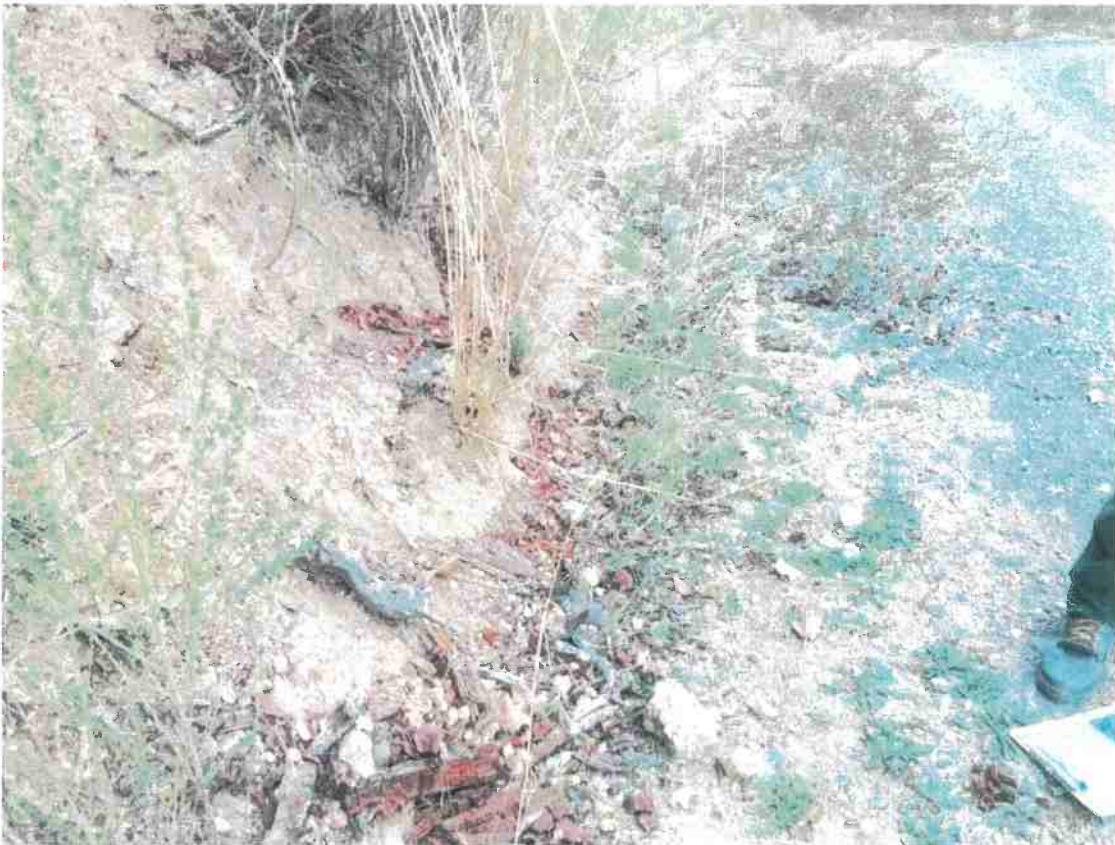
RP-6 (Main Access Road) inside ditch has filled with dirt and debris clean ditch for 50' above RP-6 to ensure proper surface drainage.

RP-6 Inside Ditch in Needs to be Cleaned

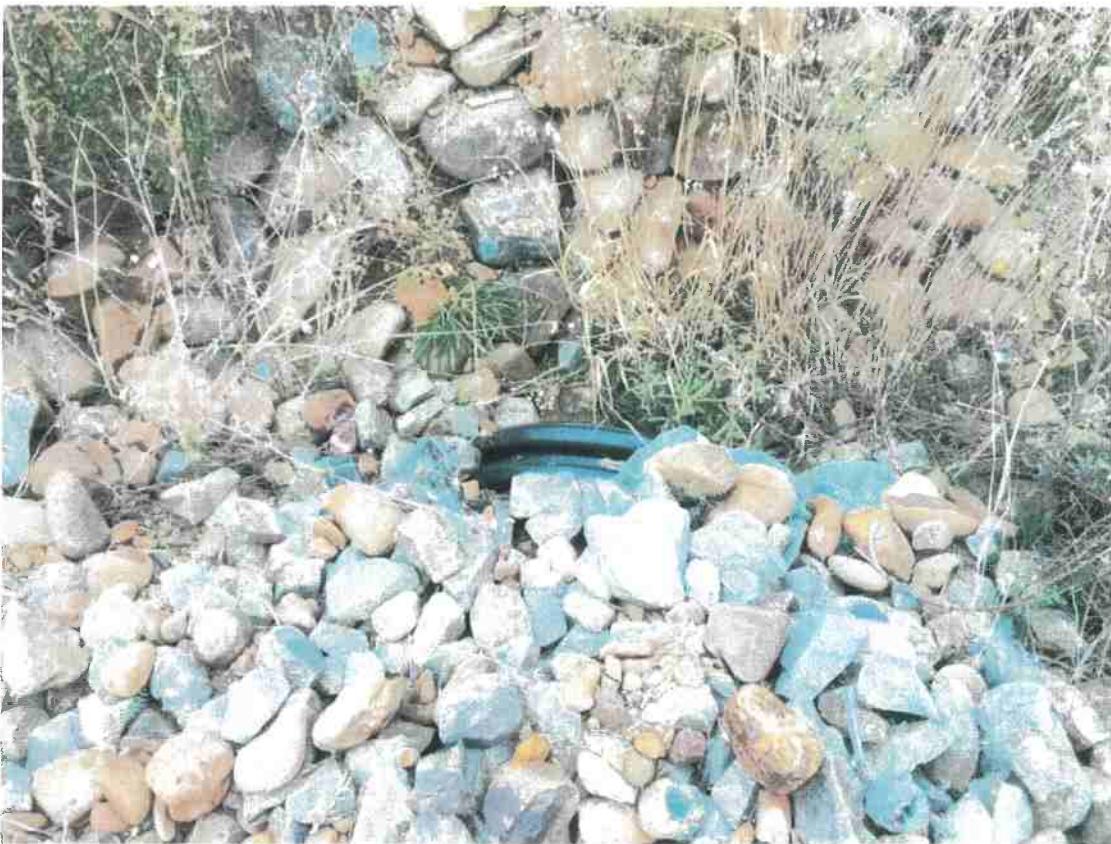
RP-7 (Main Access Road) Existing 18" DRC cut bank above the DRC has eroded filling the inside ditch above RP-7 and partially covering the inlet. Clear inlet and inside ditch of soil and debris for 100' above RP-7 and install 4-8" rock armoring to the inlet and outlet. Monitor and maintain as necessary to prevent blockage.

RP-7 Existing DRC Maintain Inlet to keep Clear of Debris.

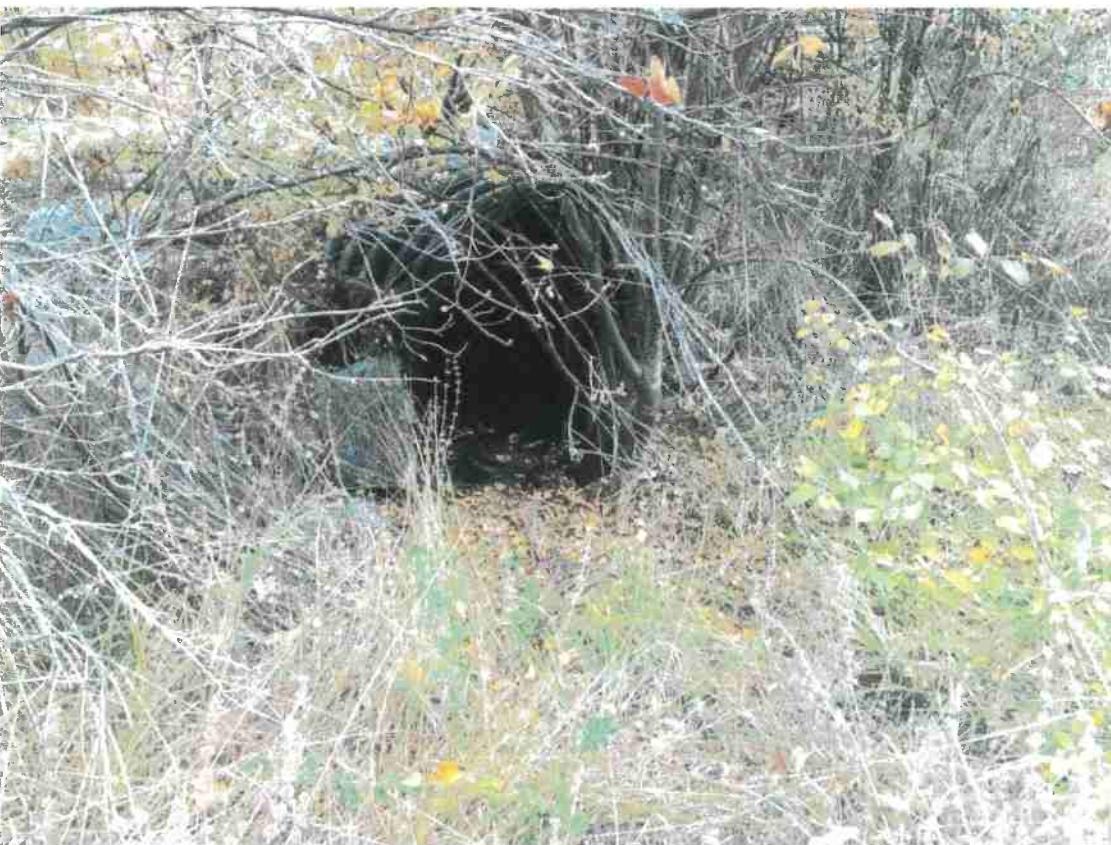
RP-8 (Main Access Road) Existing functioning crossing on a class III stream with a 36" plastic culvert. Frequency Magnitude calculations found that the culvert is adequately sized for 100 year flood flow. Install a rocked critical dip center of hinge line with 3"-6" diameter sharp angular rock. Disconnect the surface drainage by installing a rocked rolling dip 75' left of the crossing rock dip with 3- 6" crushed rock. Ensure that the RRD catches the inside ditch as well or install a 18" DRC with a shallow RRD. Rock road surface for 50' left and right of crossing hinge line with 1"+/- crushed rock.

RP-8 Main Access Road: Class III Stream Crossing 36" Culvert

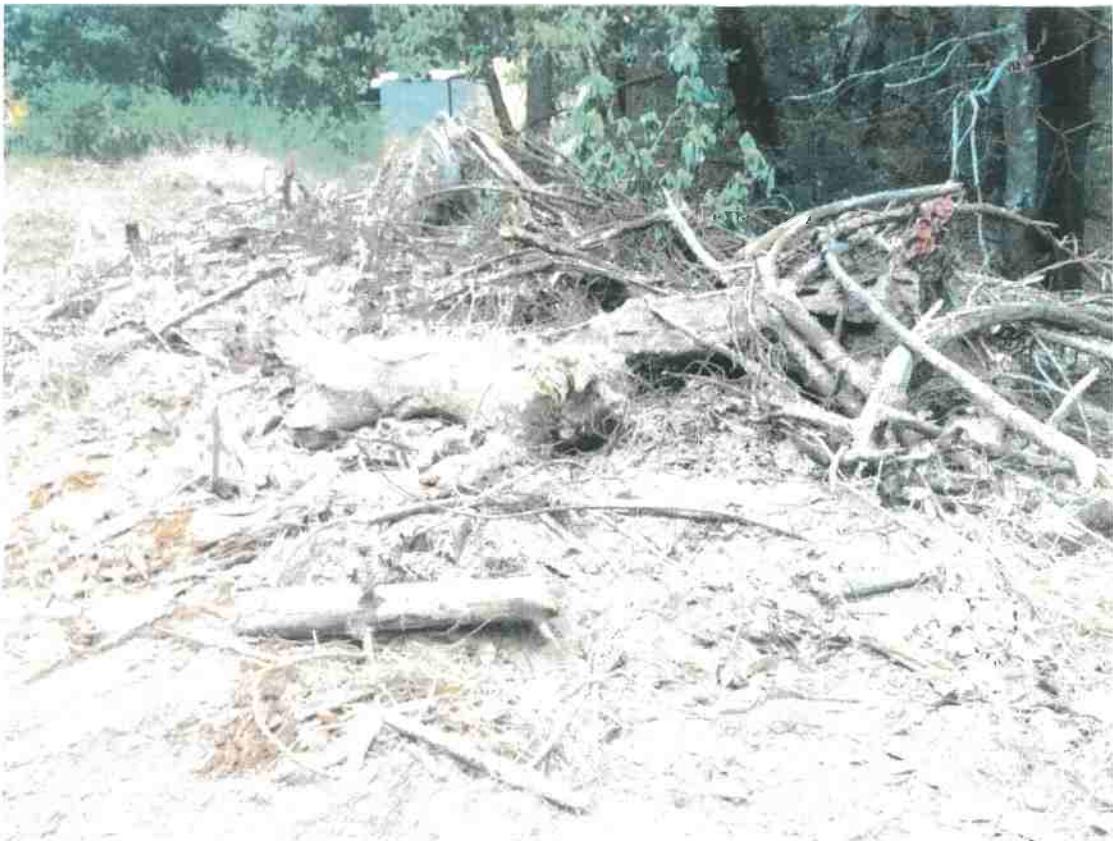
RP-9 (Site A) Bulldozed dirt and logs from road edge. Clean up slash and brush/logs, remove slash from loose dirt and compact dirt in 6" lifts to stabilize fill.

RP-9: Loose Fill Mixed with Slash

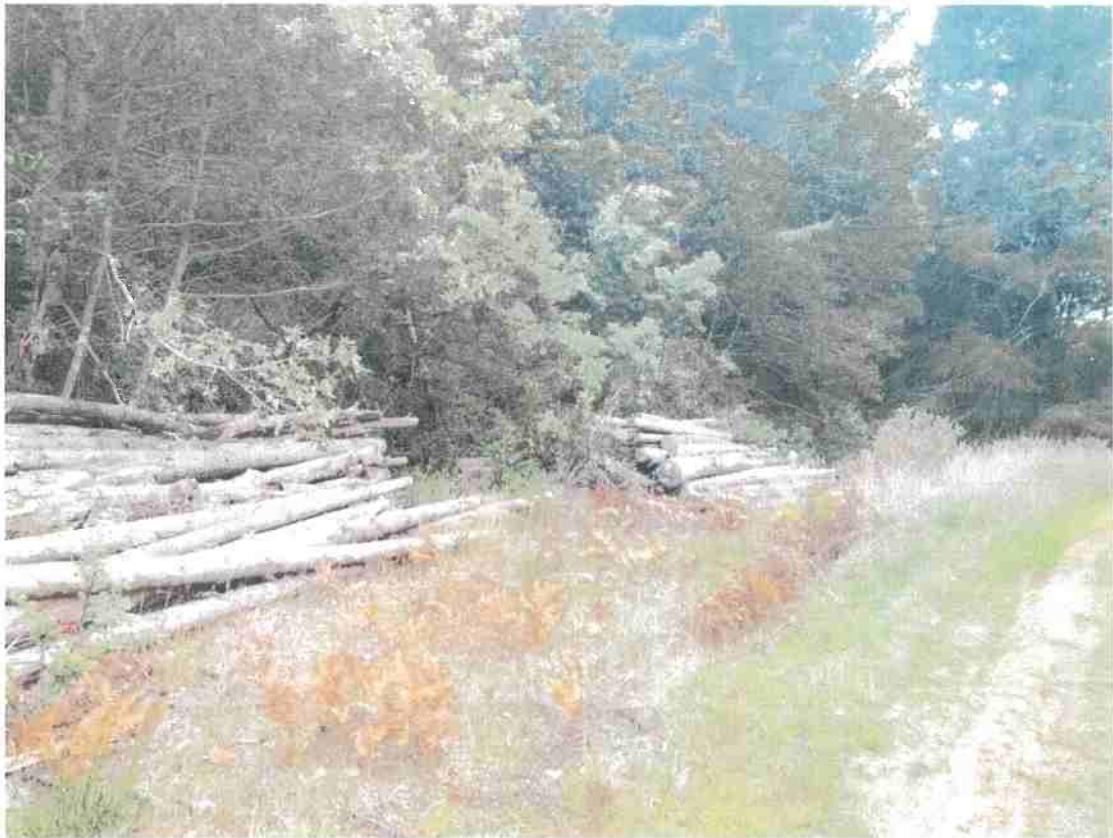
RP-10 (Site A) Old log pile, clear/remove logs or cut them up into 16" lengths.

RP-10: Logs/Slash Pile

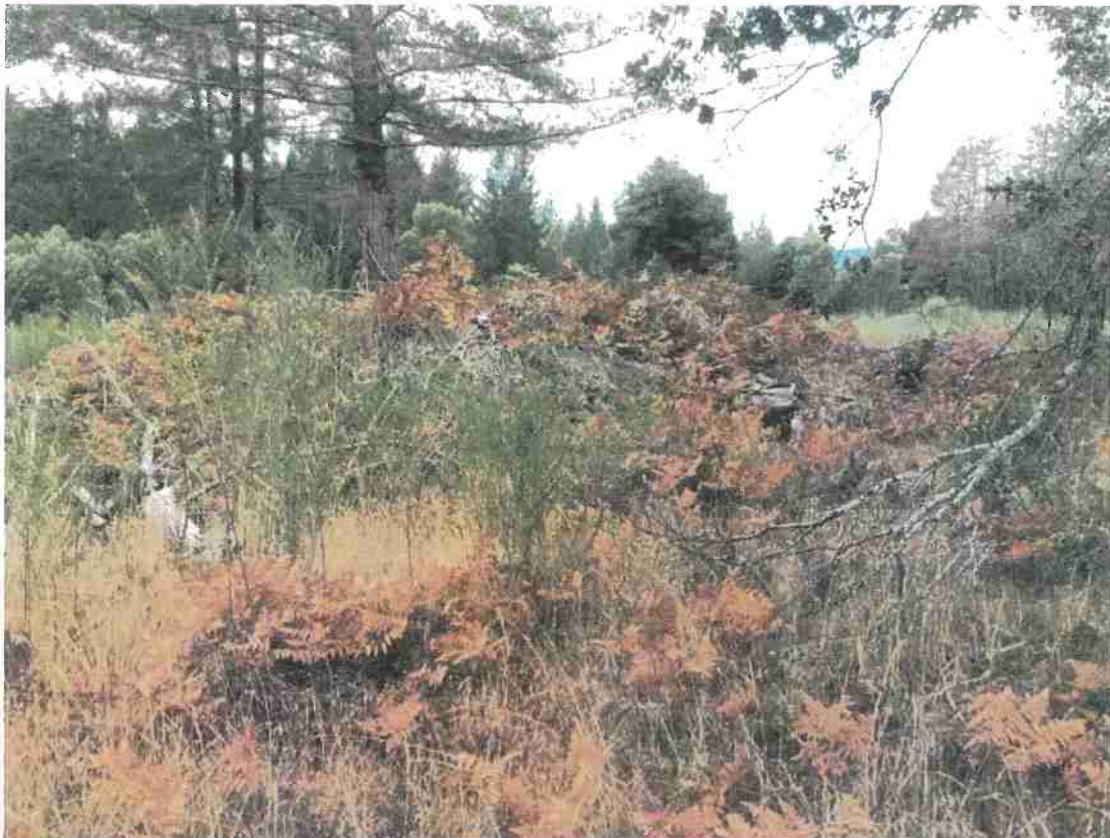
RP-11 (Site A) A series of pile of brush and slash exist around the site clear/remove slash and brush pile within 200' of the site.

RP-11: One of several Slash Piles Around Site A

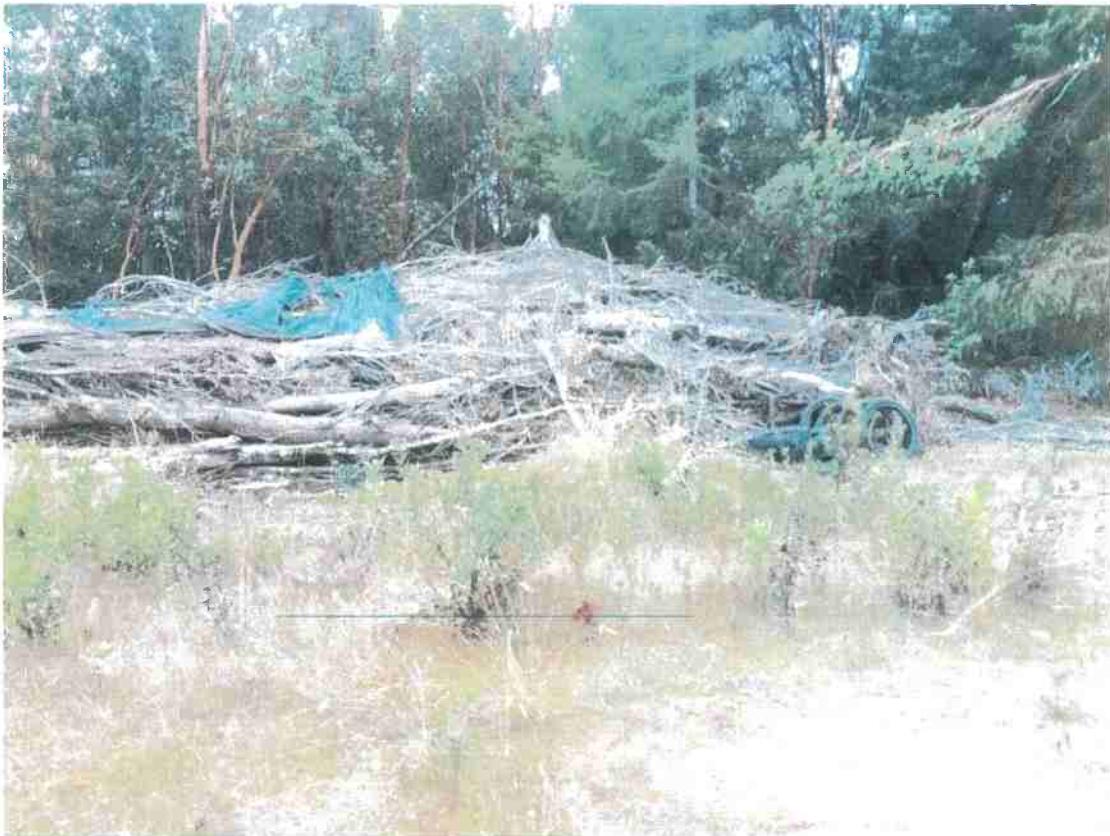
RP-12 (Site B) large pile of logs and slash from the conversion were left on the site. clear/remove the logs and slash from site or cut up in to 16" or less lengths. Also remove and recycle/properly dispose of used tires present on site.

RP-12: Large Pile of Logs and Slash

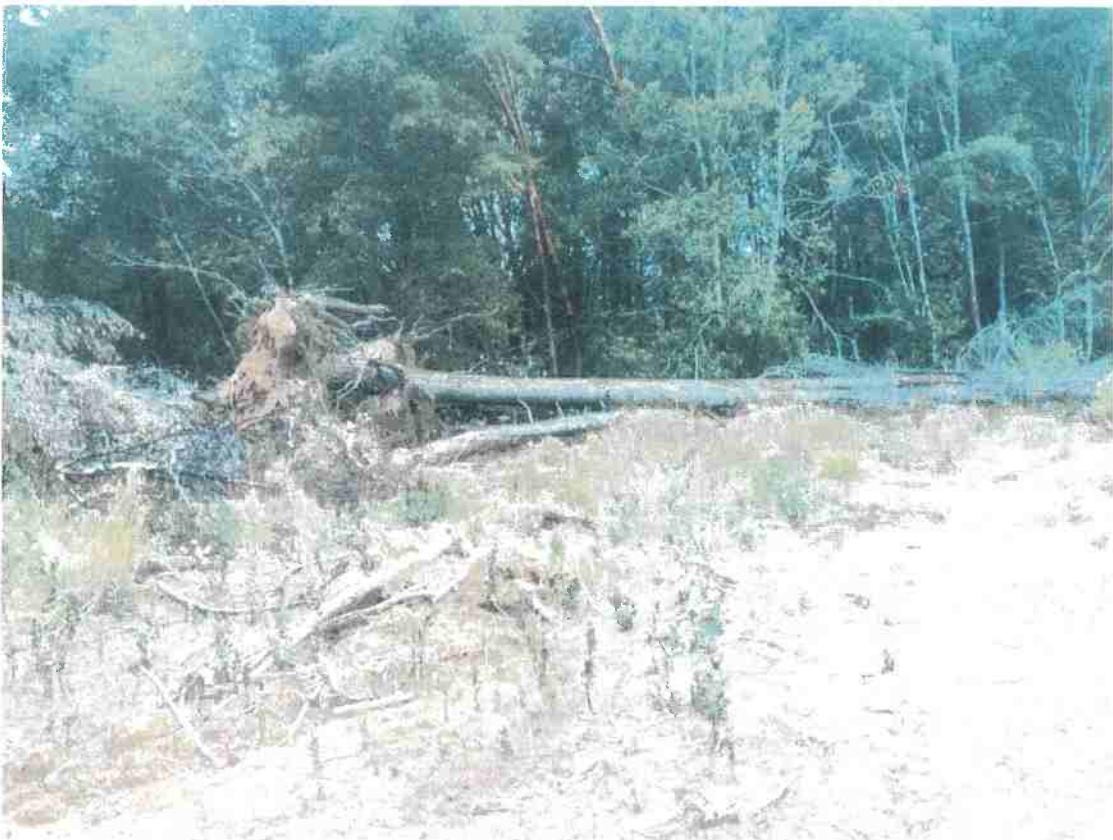
RP-13 (Site B) Log pile on edge of site clear/remove the logs and slash from site or cut up in to 16" or less lengths.

RP-13: Logs/Slash Pile

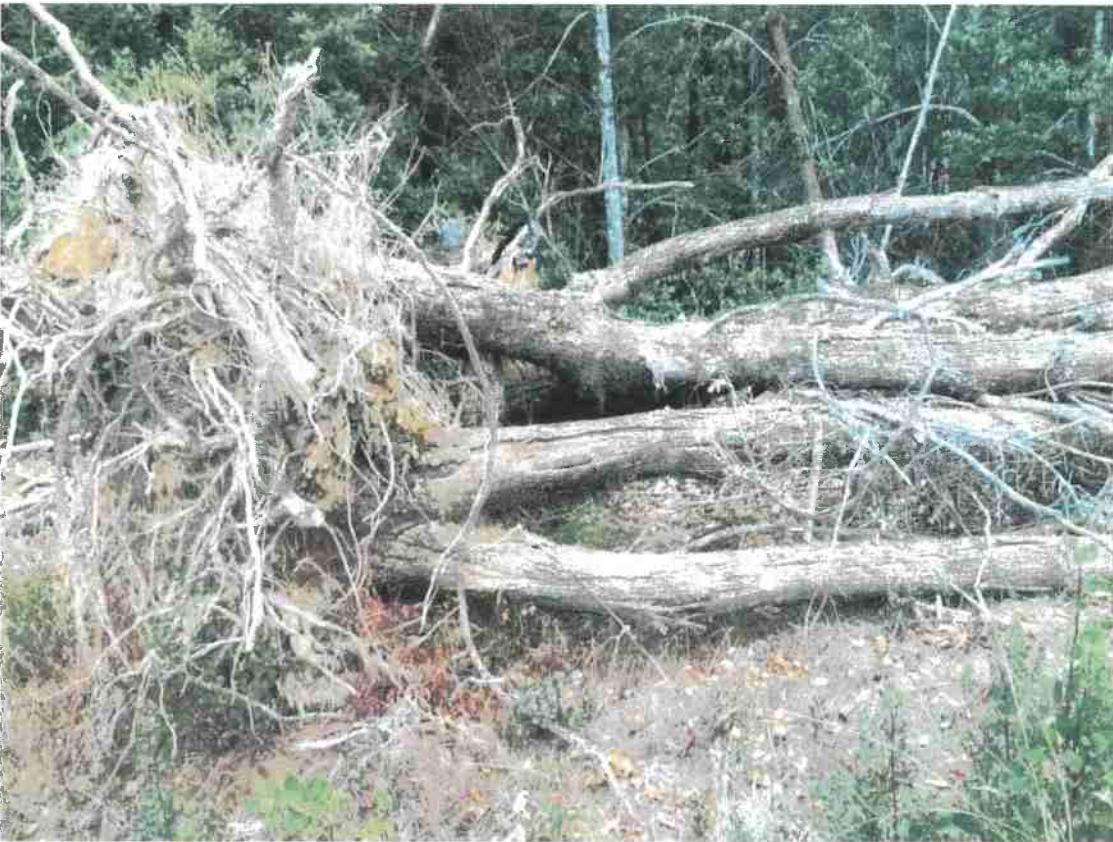
RP-14 (Site B) Logs and slash pile clear/remove the logs and slash from site or cut up in to 16" or less lengths.

RP-14: Logs/Slash Pile

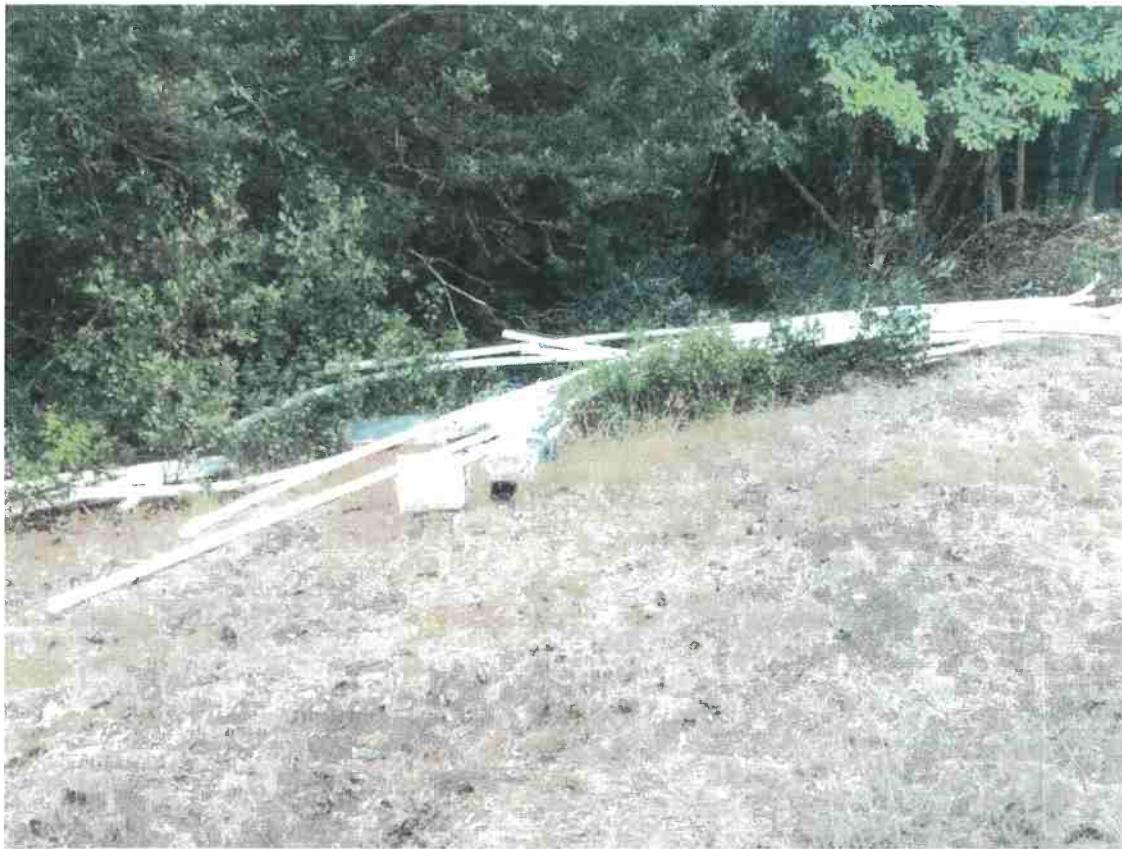
RP-15 (Site B) PVC Pipe plastic pots and various other growing supplies left on site. Clean up pipe and other grow items and dispose of properly or store in a suitable storage location if use of items is desired.

RP-15: PVC Pipe and Other Cultivation Materials

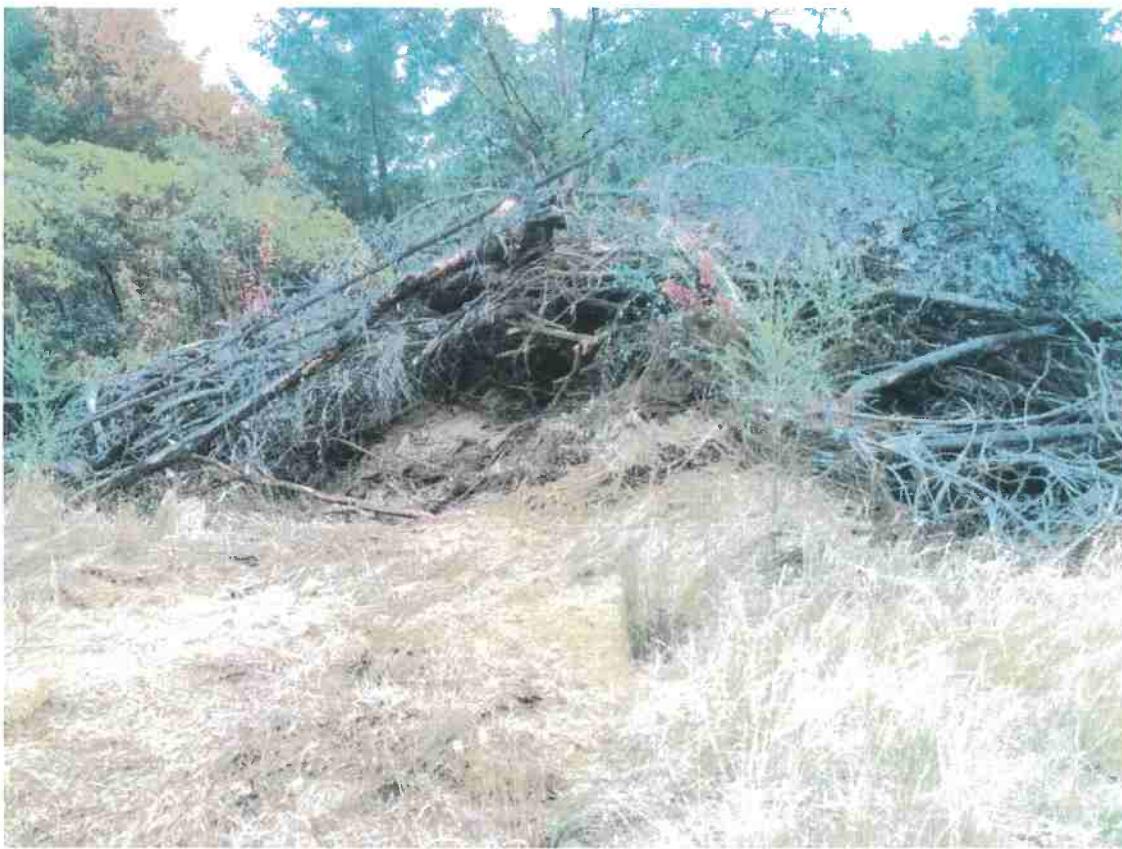
RP-16 (Main Access Road) Install a rocked rolling dip to disconnect surface drainage rock dip with 3-6" crushed rock. Additionally clear slash/brush from road side.

RP-16: Install Rocked Rolling Dip & Clear Slash

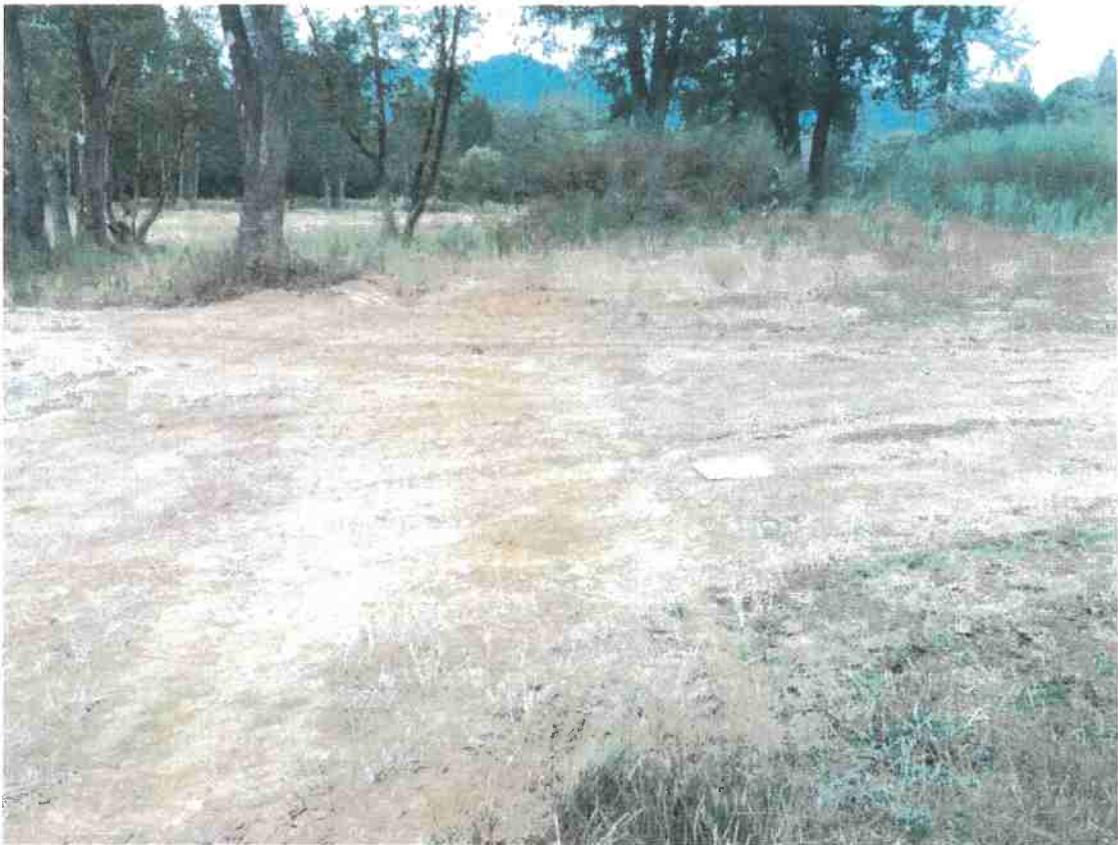
RP-17 (Main Access Road) Install a rocked rolling dip to disconnect surface drainage rock dip with 3-6" crushed rock.

RP-17: Install Rocked Rolling Dip

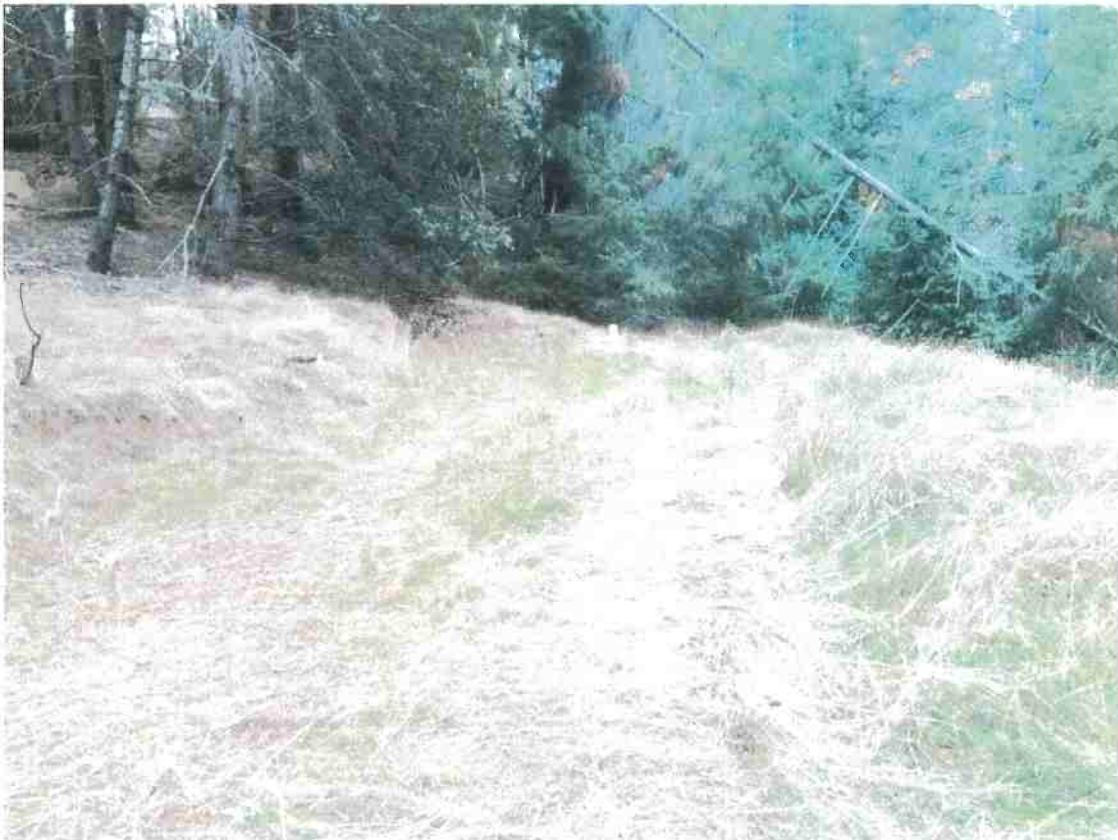
RP-19 (Site C) Domestic well with no issues

RP-19: Domestic Well with no Issues

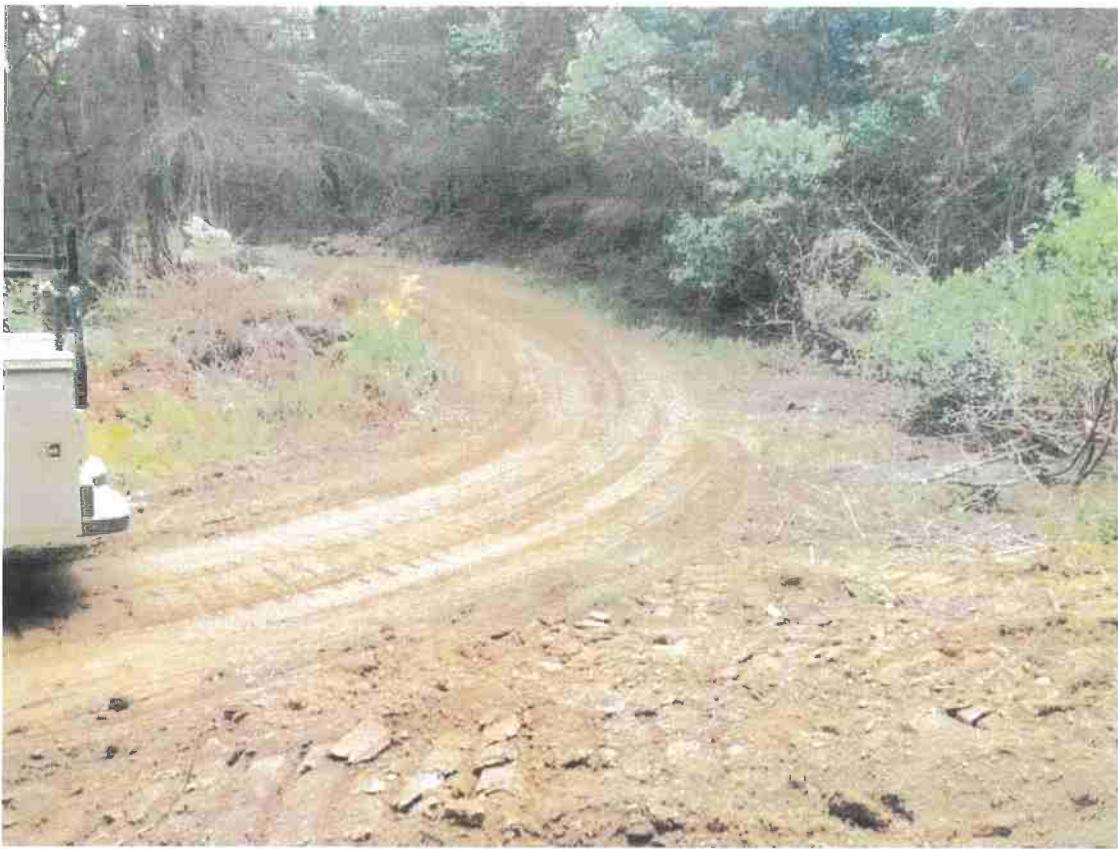
RP-24 (Site C Access Road) Road crosses a swell 60' above the top of a class III stream. Install a rocked rolling dip with 3-6" crushed rock. Rock the approaches to the dip with 1"+/- crushed rock for 50'.

RP-24: Install Rocked Rolling Dip and Rock Approaches Where Road Crosses Above Class III Stream

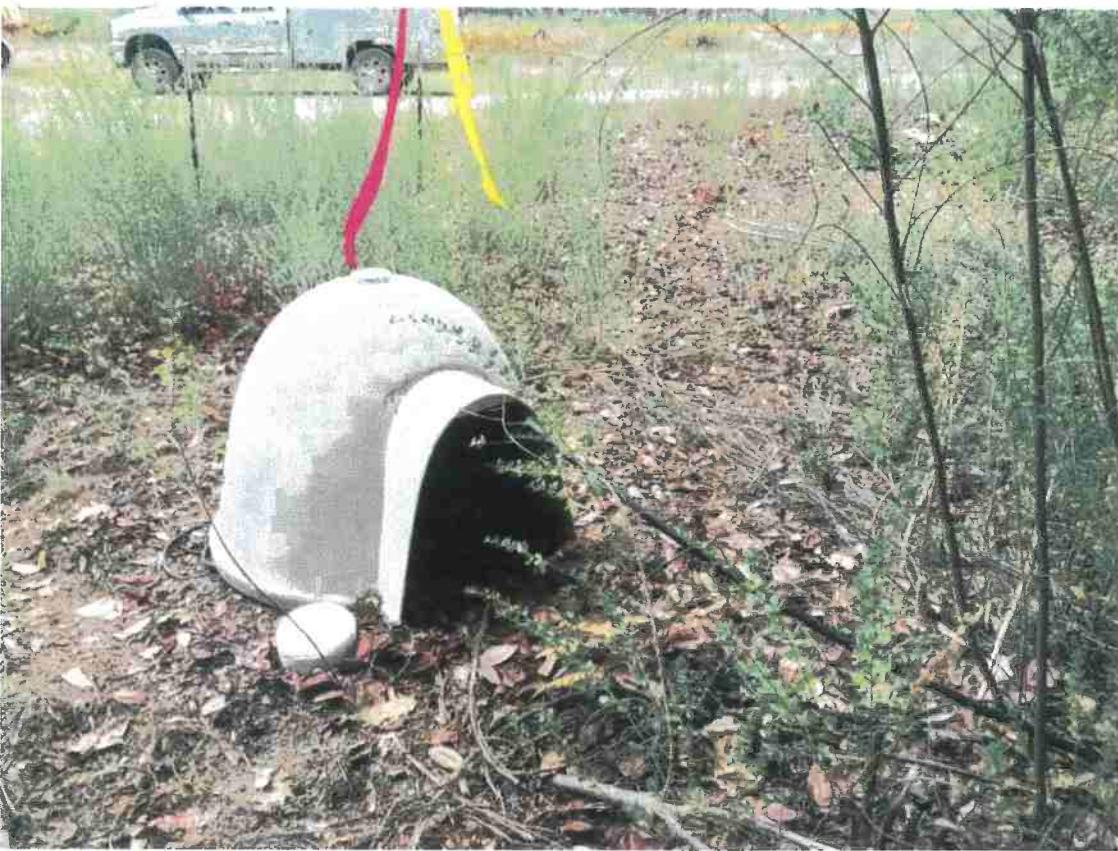
RP-27 (Site A) Domestic well with no issues.

RP-27: Domestic Well no Issues

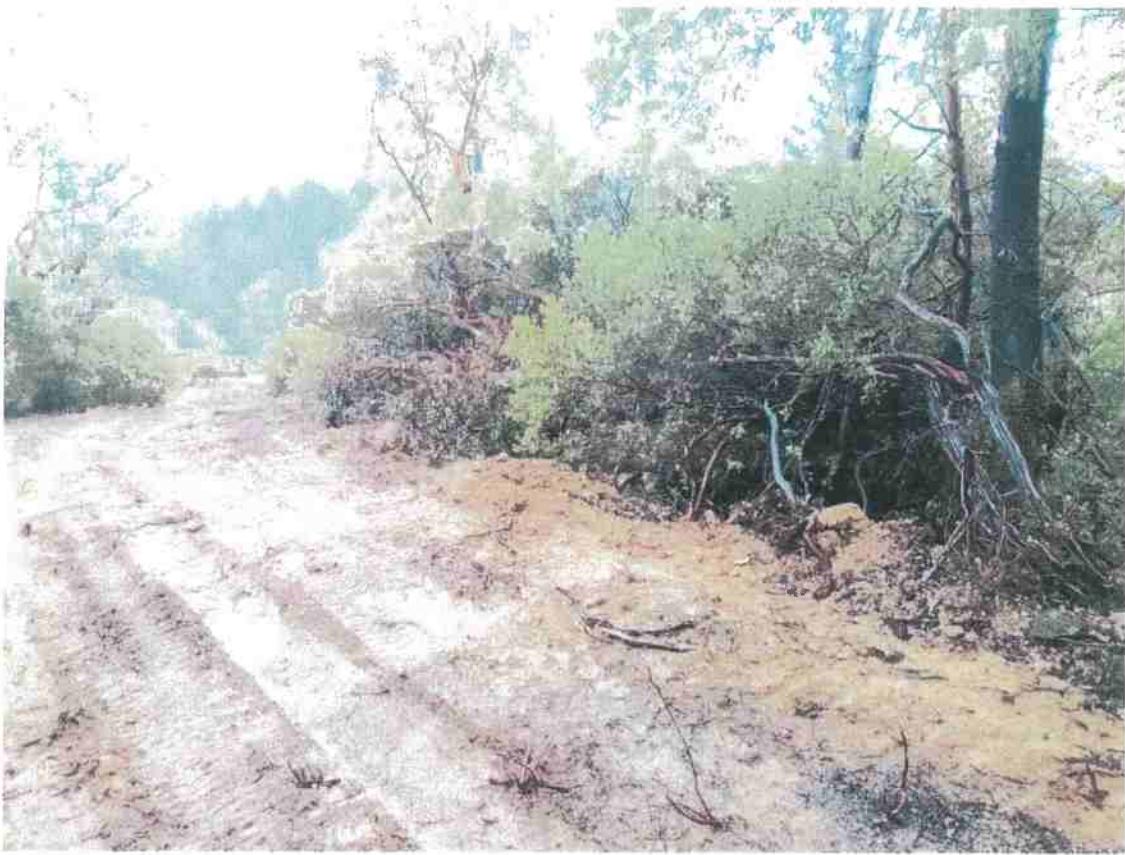
RP-28a (Site D) Newly re-dozed seasonal road. Clear dozed brush and slash from road edge and pull back all overhang perched fill. Additionally install water breaks or rolling dips every 100' to break up surface drainage. For the extent of the road from RP-28a to RP-28b.

RP-28: Re Bladed Seasonal Road

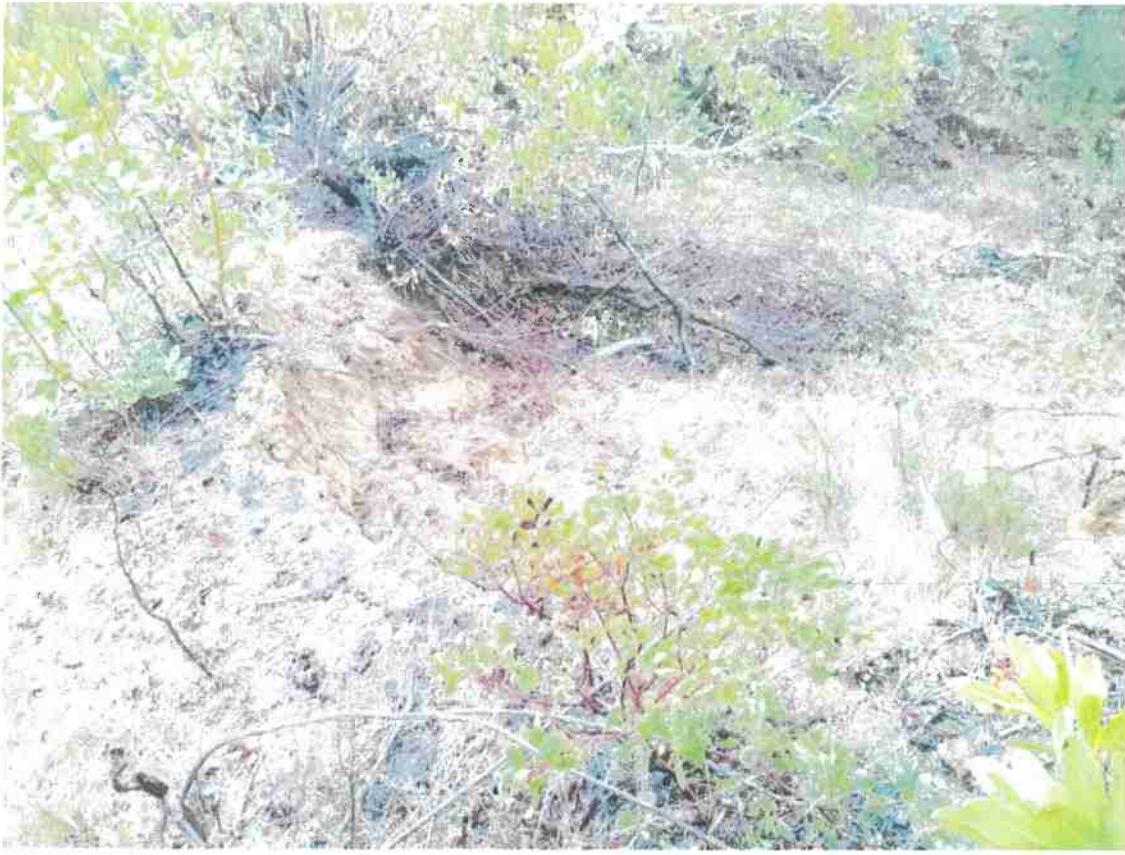
RP-29 (Site D) Fill failed on a tractor road leading off from the newly bladed truck road turnaround. Pull back the perched fill from the failure and stabilize with straw mulch or packed slash.

RP-29: Fill Failure on Tractor Road next to Newly Bladed Road Associated with RP-28

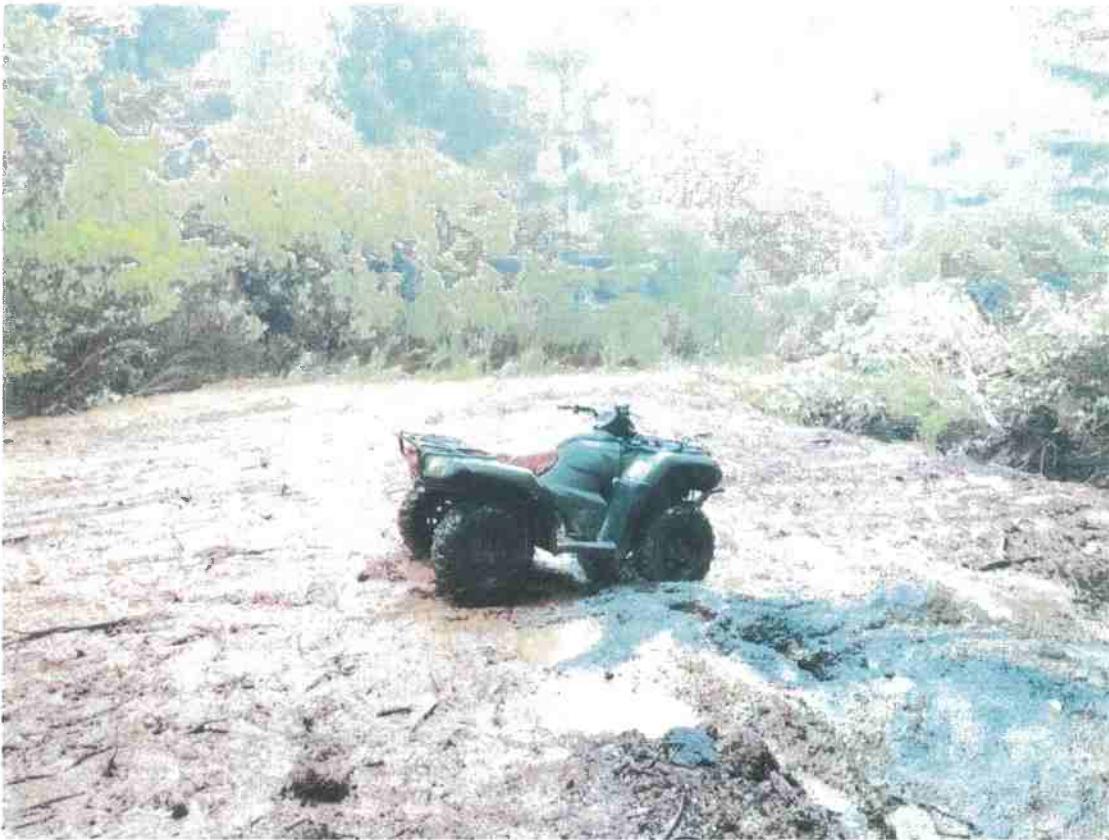
RP-30 (Site D) Newly drilled open well with no casing in old landing spur. Fill the well with dirt or case and cap appropriately to prevent wildlife from falling in the well. Stabilize graded soil and well tailing with straw mulch to prevent surface erosion.

RP-30: Unfilled Well and Newly Graded Landing
