Trent Sanders Less Than Three Acre Conversion Mitigation Plan

This document has been prepared pursuant to Section 55.4.10(j) of the Humboldt County Commercial Medical Marijuana Land Use Ordinance, applications for Commercial Cannabis Activity occupying sites created through prior unauthorized conversion of timberland. The document evaluates site conditions and conversion history for the parcel and contains a Registered Professional Foresters (RPF's) recommendation as to remedial actions necessary to bring the conversion area into compliance with provisions of the Forest Practice Act.

There are 3 sites that were assessed in the site visit. Site B is the only site that qualifies as a conversion totaling 1.75 acres of converted land on the property (see table below).

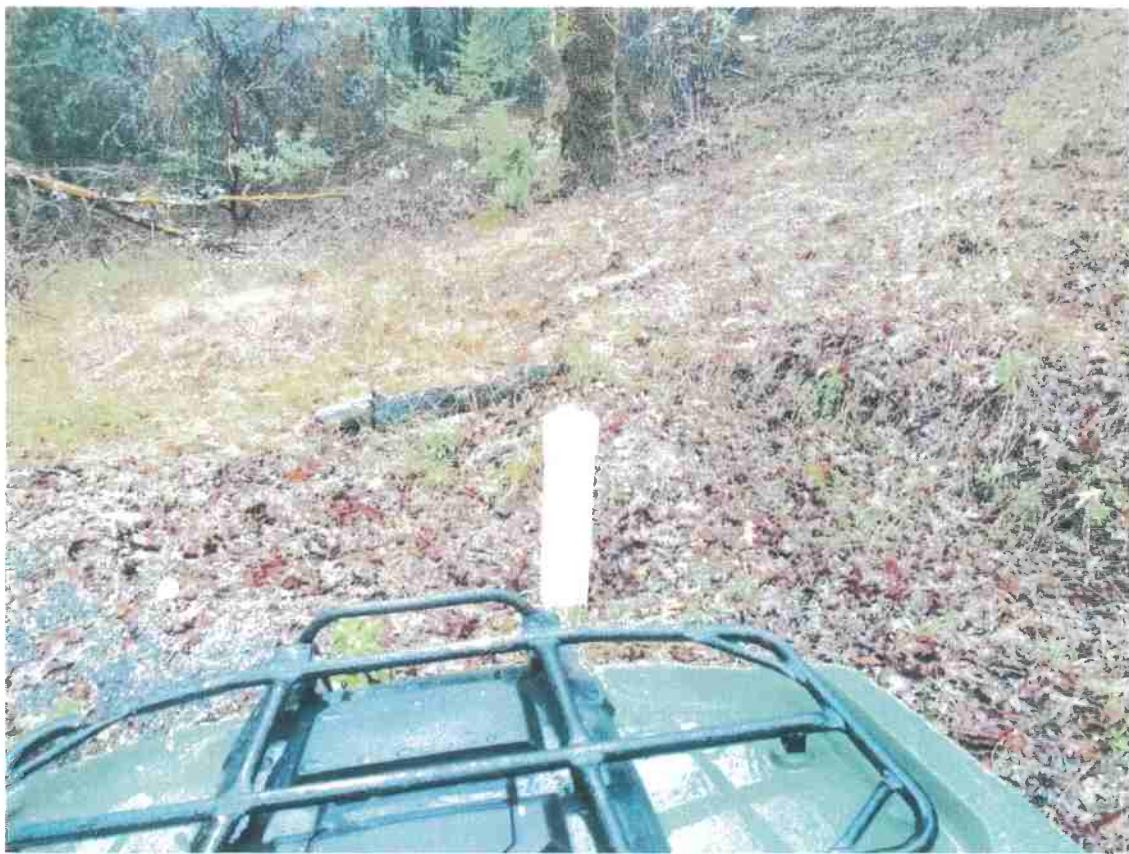
RP-31 (Site D) Cased well with no issues.

RP-31: Well with no Issues.

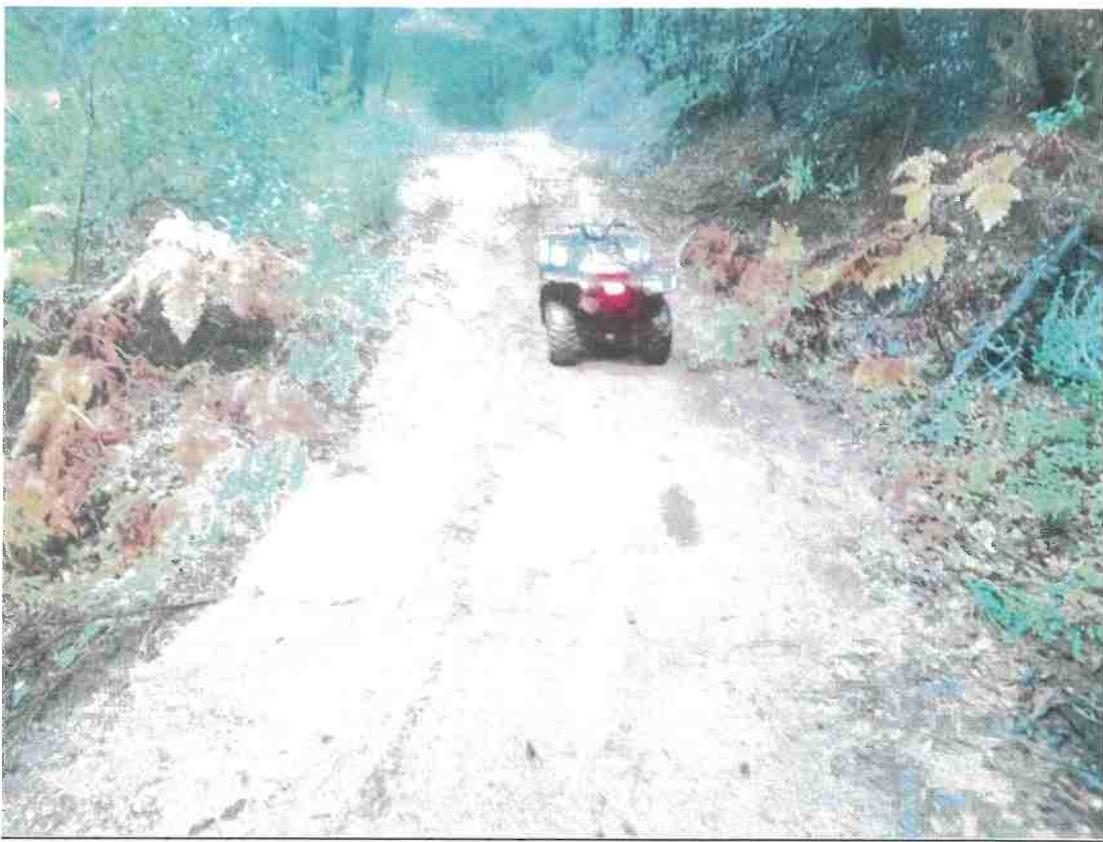
RP-32 (Site D) Rolling dip in a natural swale. The dip shall be rock dip with 3-6" crushed rock to reduce erosion.

RP-32: Rock Existing Rolling Dip

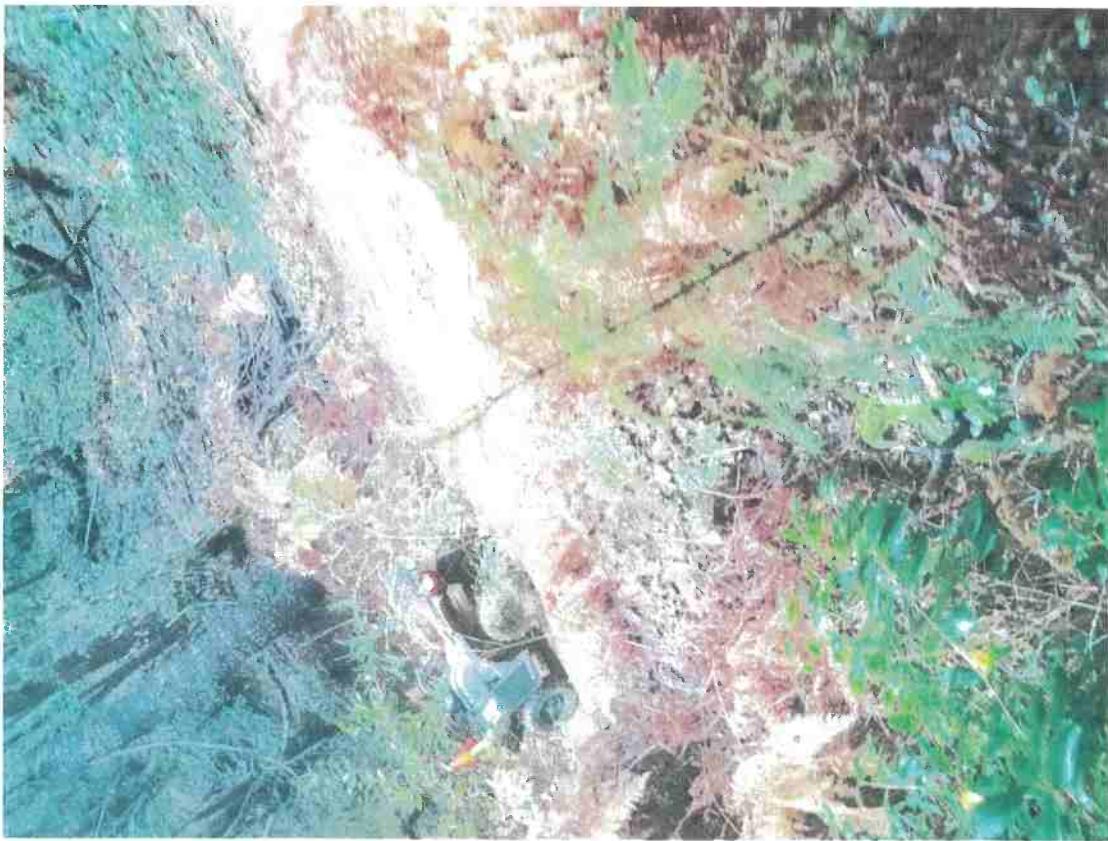
RP-33 (Site D) Class III stream crossing with no installed drainage structure. Install a rocked ford with 8"- 20" mixed diameter sharp angular rock 8' left and right of crossing. Install 3" – 6" " mixed diameter sharp angular rock from 8' to 25' out from either side of the crossing. Install rocked rolling dip 50' left and right of crossing to drain prism prior to crossing. Cover dip with 4"-6" diameter sharp angular rock and rock the approaches for 50' either side of the crossing with ± 1 " crushed rock. 1600 and ECP point with 5cy potential sediment delivery.

RP-33: Class III Crossing with no Drainage Structure, Install Rocked Ford.

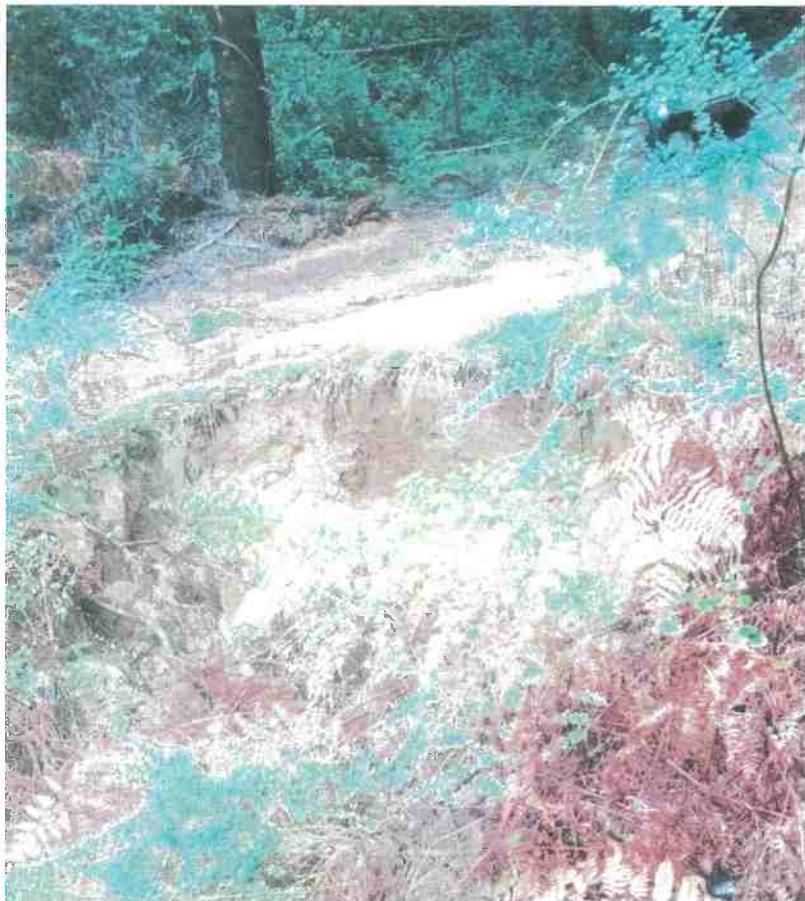
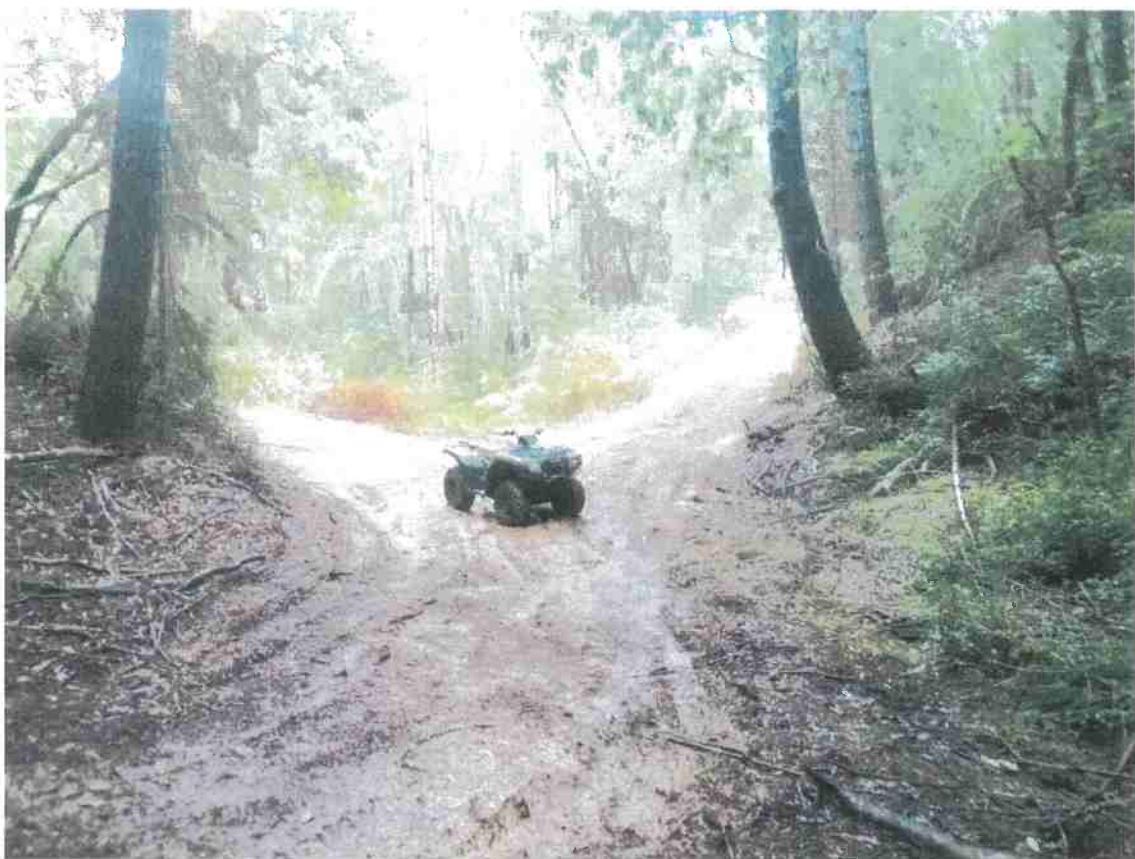
RP-34 (Site D) Class III stream crossing with no installed drainage structure. The old skid trail next to the class III stream was also bladed open to create a turnaround. The outboard edge of the crossing has eroded and is failing with potential of further failure in the future. Install a 24" x 40' long culvert to grade. Left of centerline install a critical dip line the dip with 3"-6" diameter sharp angular rock. Install rocked rolling dip 50' left and right of crossing to drain prism prior to crossing. Cover dip with 4"-6" diameter sharp angular rock and rock the approaches for 50' either side of the crossing with ± 1 " crushed rock. Rock the bladed skid trail with 3-6" crushed rock to 6" depth to stabilize; alternatively cover exposed soil with straw mulch and revegetate area using native plants. 1600 and ECP point with 25cy potential sediment delivery.

RP-34: Class III Stream Crossing with no Drainage Structure Install Culvert.

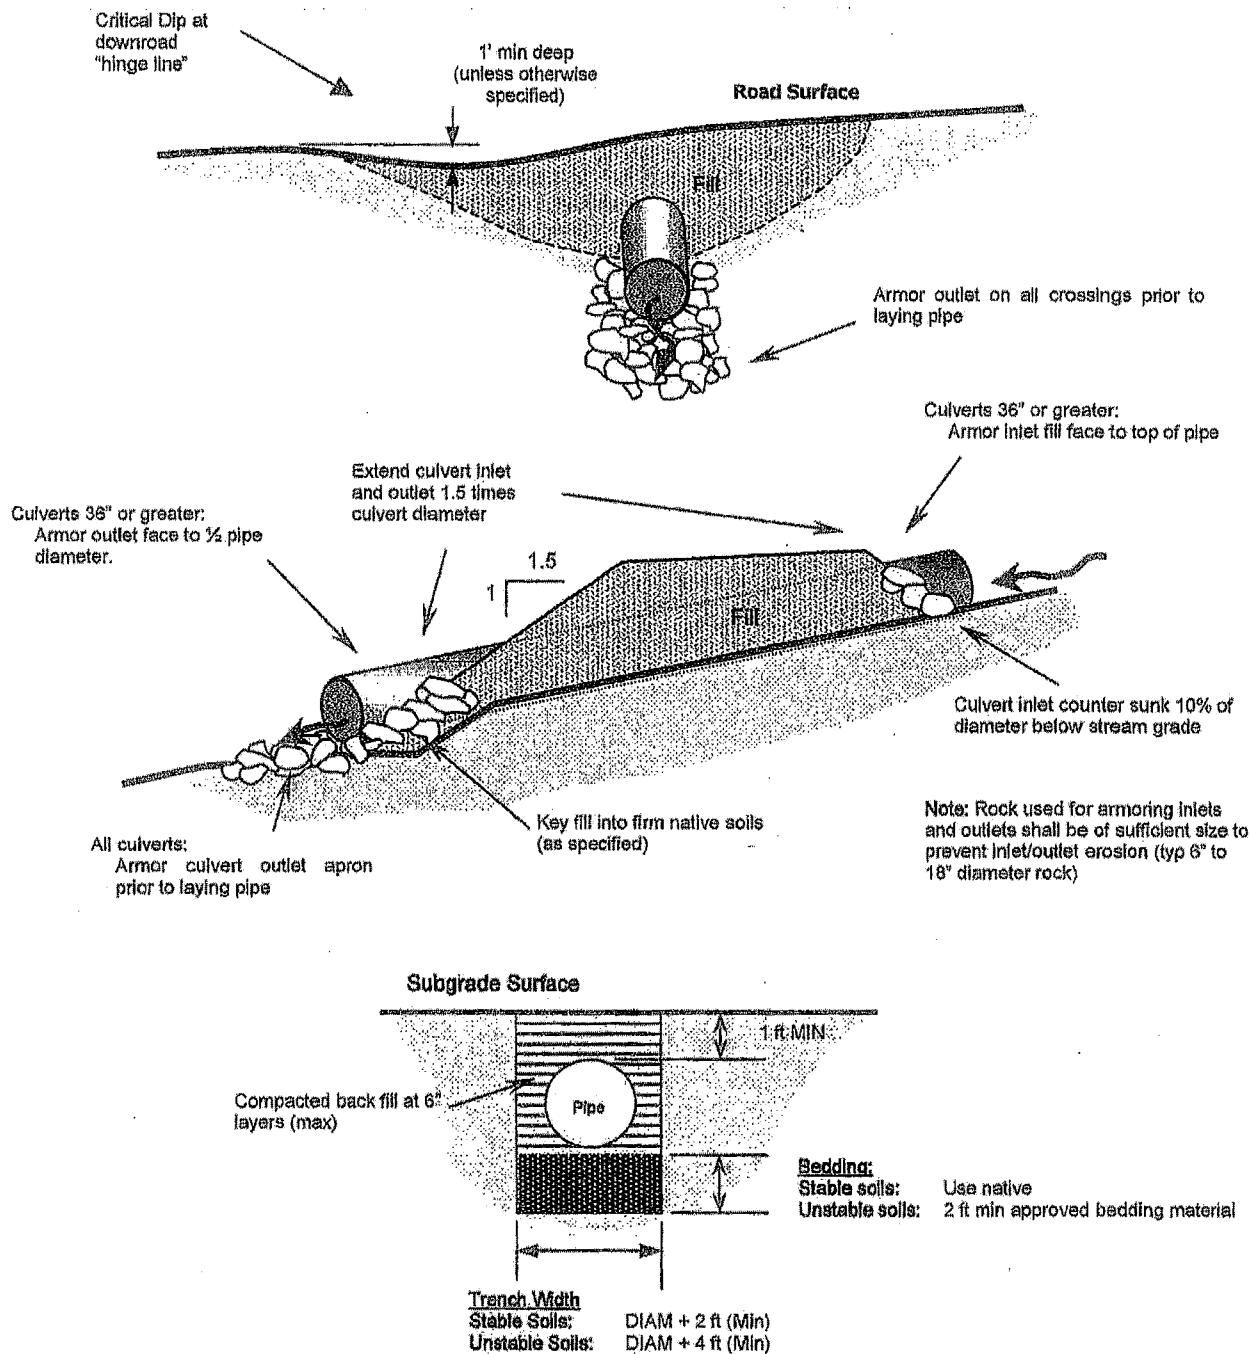
PERMANENT WATERCOURSE CROSSING STANDARD PLAN	Standard Detail
--	---	-----------------

- The culvert bed shall be clean and free of large woody debris and large rocks.
- Unsuitable foundation material (highly plastic material – "blue goo") shall be excavated below the invert elevation of the culvert to an approximate depth of 2 feet and a width of at least the culvert diameter plus 4 feet.
- Unsuitable material shall be replaced with selected granular foundation material and compacted to obtain a uniform foundation.
- Select mineral soil shall be used for culvert backfill. The back fill shall be free of lumps, chunks, highly plastic material, and organic material.
- No rocks greater than 3" in any dimension placed closer than 1 foot to the culvert.
- Back fill shall be compacted to a degree greater than the surrounding soils. Soil moisture shall be adequate to achieve suitable compaction.
- See Text for more detail.

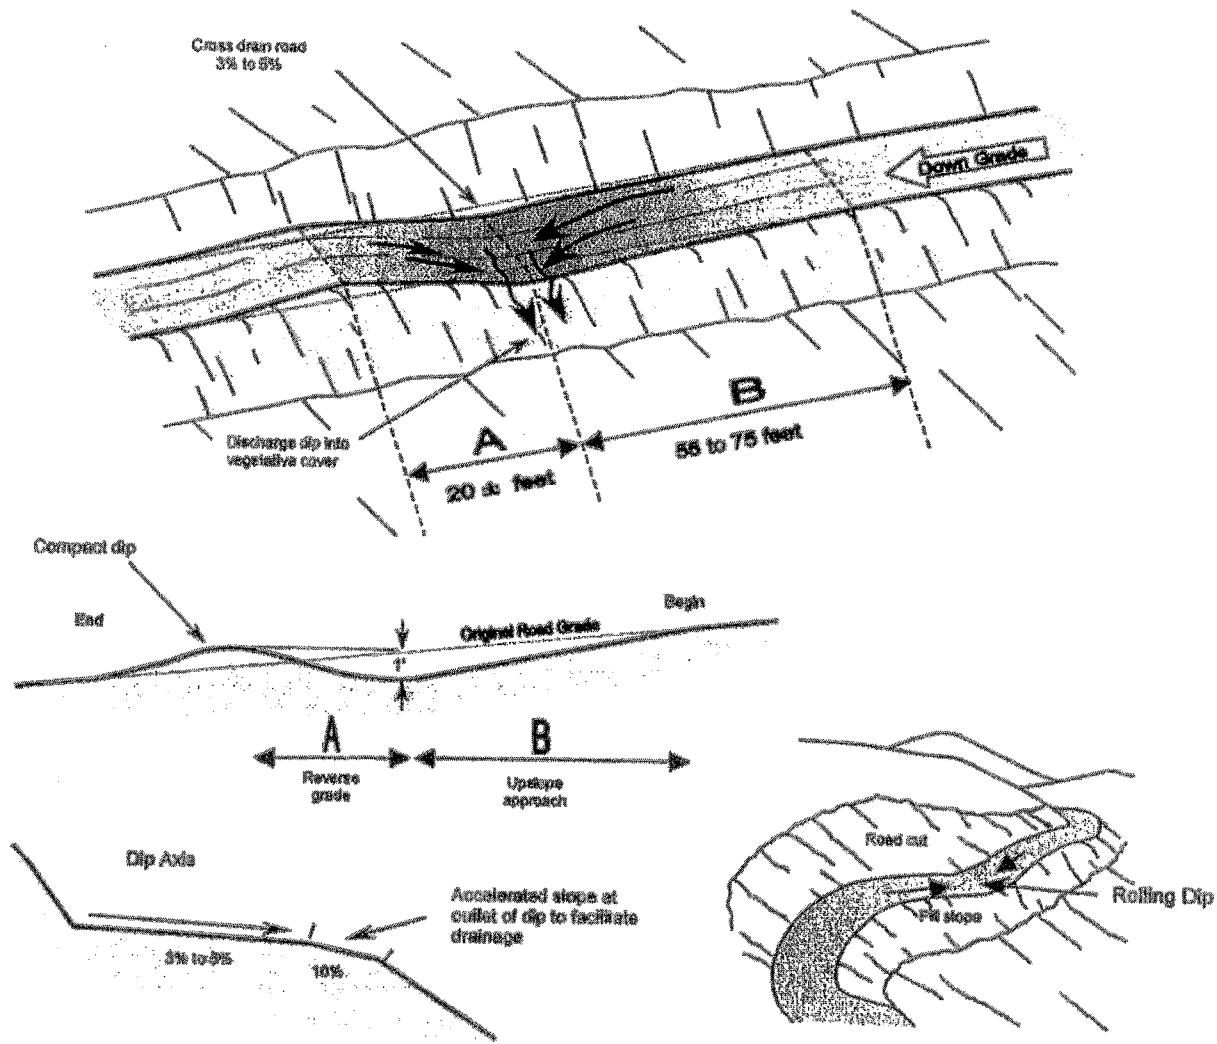
ROLLING DIP STANDARD PLAN

ROLLING DIP DIMENSIONS

- A rolling dip is a broad long permanent dip constructed into native soils. It is intended to drain the road while not significantly impeding traffic.
- The cross drain road (outslope) at 3% to 5%
- Dip outlets should be located to drain into areas with adequate sediment filter quality and non-erodible material such as rock, slash, brush, etc. Where specified, the bottom of the outfall of the dip will be surface rocked.
- Where natural slopes exceed 50%, fill shall not be pushed over the dip outlet. A backhoe or excavator may be required to pull back fill at outlet of existing dips.

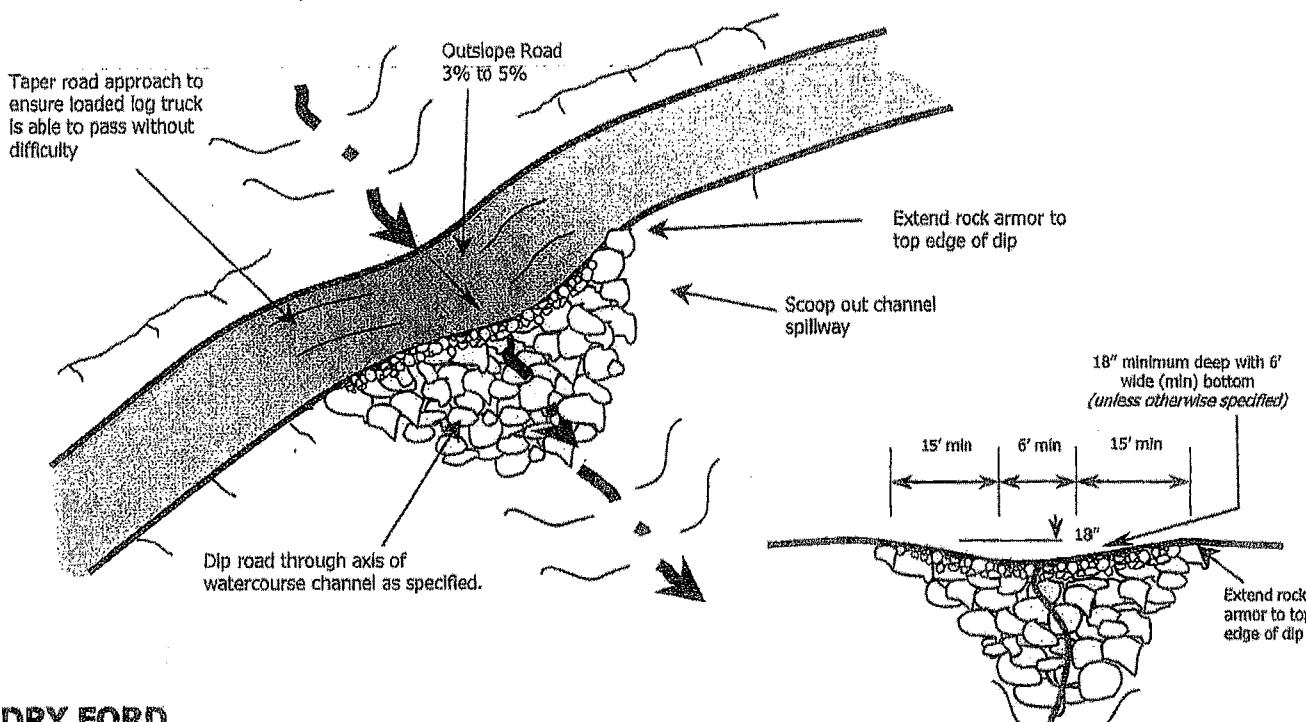
DRY FORD

Generally used where truck traffic is not expected when crossing is flowing.

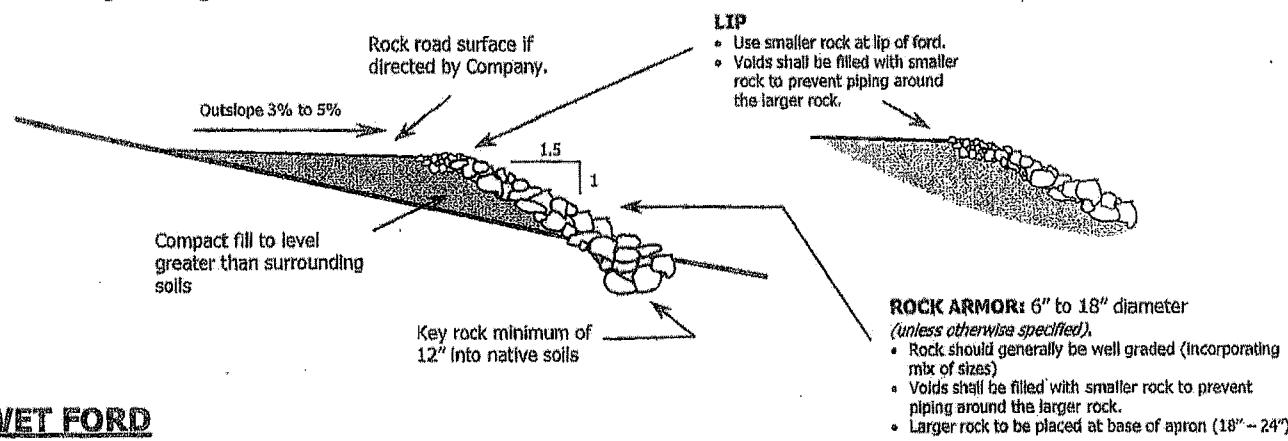
WET FORD

Generally used where 4x4 pickup traffic is anticipated in the winter months and/or where water is flowing

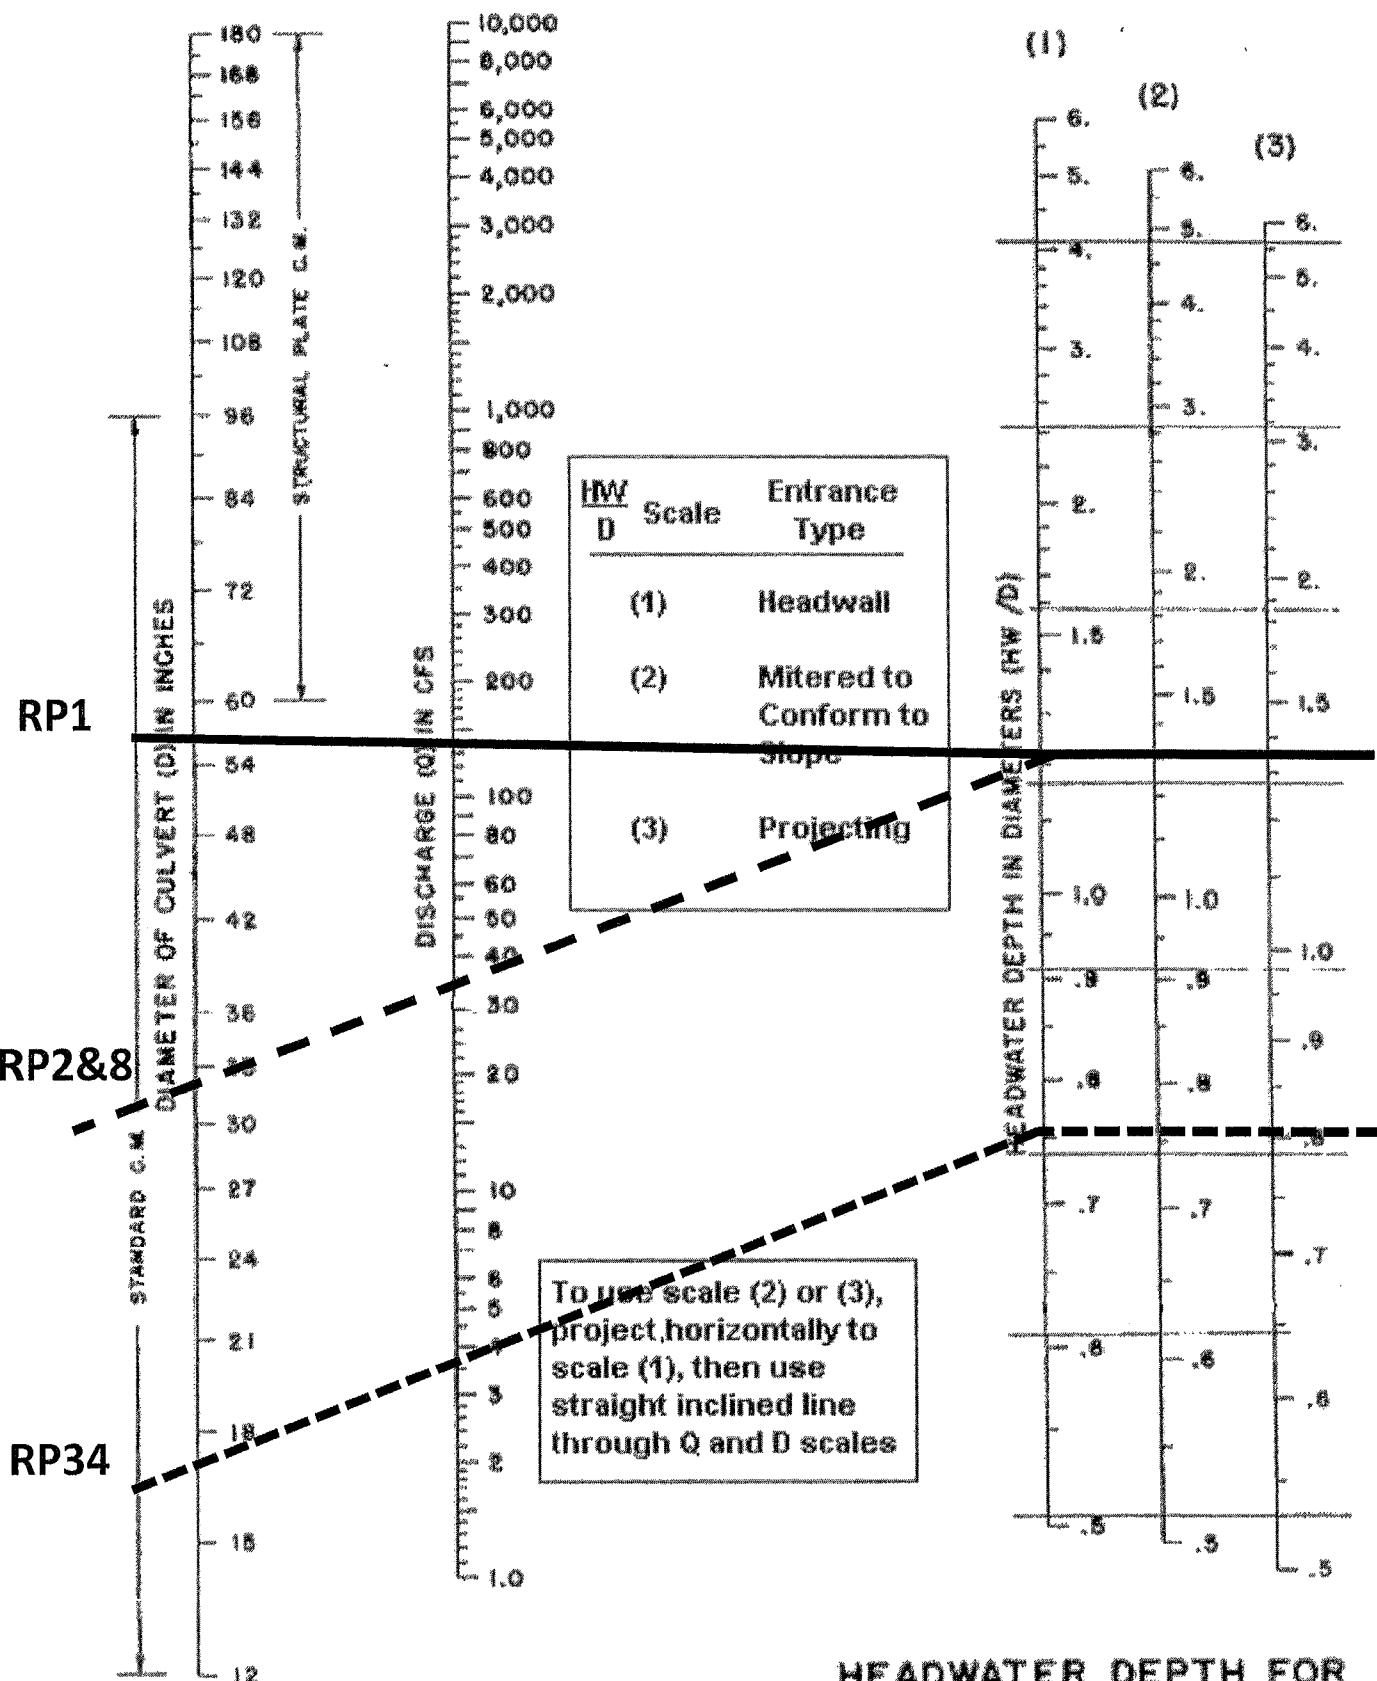
HEADWATER DEPTH FOR
C. M. PIPE CULVERTS
WITH INLET CONTROL
