Onsite Relocation: Environmental Superiority Analysis and Remediation Plan

APN: 317-033-008

December 2020

Prepared for: Macras Land Co., Inc. Permit App No. 11099 (305) 490-7890 Macraslandcoinc14@gmail.com Prepared by: Trillian Schroeder Senior Project Manager trill@mothereathengineering.com MEE Project #20007

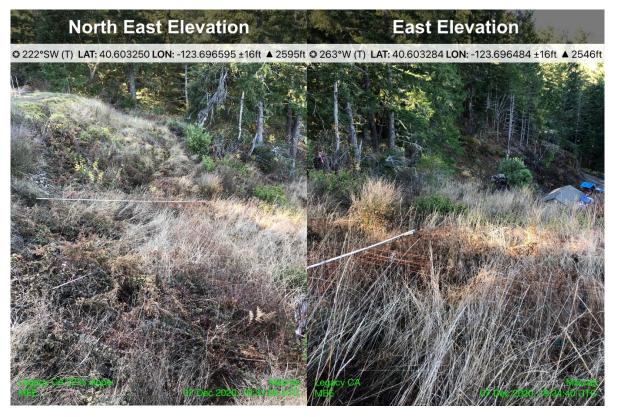
Pictures 1-2: View of the existing conditions at the former cultivation site with 22% slopes. Site is well revegetated with growing cages observed.

Currently, the former sites are well vegetated with a mix of native and nonnative species. However, growing cages were observed during the 12/7/20 site visit. Therefore, remediation efforts are to continue the clearance of former debris, including growing cages, from these sites.

Based on the 12/7/20 site visit, the former cultivation sites were well vegetated with a mix of native and nonnative species (Pictures 1-2). There are no recently disturbed areas that require revegetation. Therefore, revegetation efforts at these sites are not required.

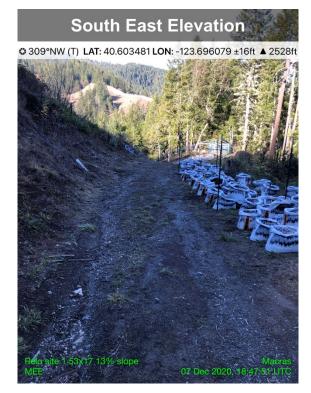
Picture 3: View of the relocations site, Relo 1. This site is a previously disturbed flat with 13% slopes.

Relo 1 is a previously developed legacy road feature between sites L and K. This site is approximately 901 square feet with 13% slopes. Relo 2 is also a previously developed road feature south and adjacent to Site L. This site is approximately 401 square feet with 3% slopes. The reduced slopes at these sites will reduce erosion risk, reduce potential sediment and nutrient runoff, and allow for stormwater runoff to attenuate and dissipate much more quickly and completely than areas with steeper slopes. Therefore, the relocation sites were found to be environmentally superior to cultivating at the existing sites L and K to the fullest extent.

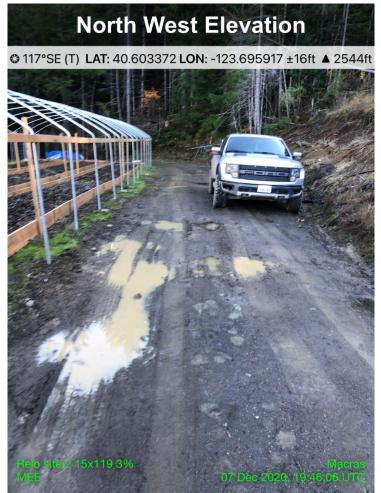
Picture 4: View the relocation site, Relo 2. This site is also a previously disturbed flat with 3% slopes.
