**4 Wheel Properties LLC**  
**Invasive Plant Management, Restoration**  
**and Monitoring Plan**

APNs #210-071-001, #210-054-008, and #210-062-007

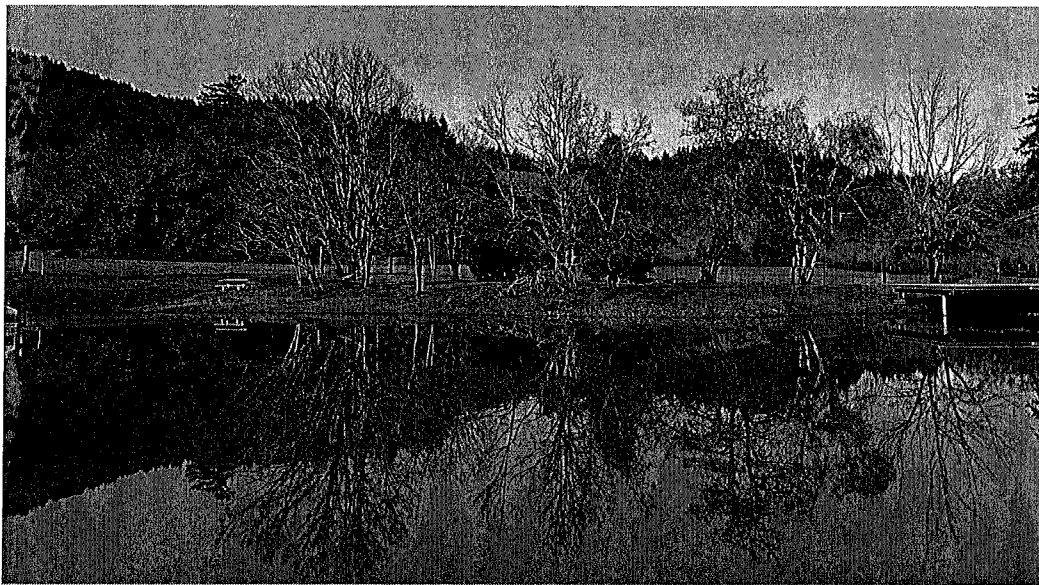
The on-stream pond near the residence is located in open grassland on an altered stream course. Cultivated Port Orford cedar and invasive black locust trees are planted around the pond. Some native willows are naturally recruiting to the edge of the pond, which was mostly bare, with patches of pasture grasses and pennyroyal. The culverts at the inlet and outlets on a class II watercourse are failing and must be replaced (Road Points 5 and 6). The culverts should be replaced according to specifications in the LSAA. The inlet and outlet should be rocked with 12" – 18" diameter rock. The pond shall not be stocked with fish. The pond was evaluated on 1/30/2020. The water clarity was low, but high numbers of invertebrates that indicate high water quality (caddisflies, water boatmen) were present along the edge of the pond. The pond is likely high quality habitat and potential breeding habitat for the western pond turtle and northern red legged frogs. The foothill yellow legged frog also has the potential to use this site. When surveyed under winter conditions, the pond maintained relatively low temperatures. At 11am on 1/30/20, the stream running into the pond was 49 degrees F, the pond was 50 degrees F, and the shallow water coming out of the pond outlet was elevated to 51 degrees F. With low vegetation cover, the pond has the potential to increase water temperatures substantially during the summer, which may negatively impact habitat quality for native amphibians and sensitive aquatic invertebrates found in the area.

Photo 3. The pond at Site K is on-stream, and native habitat enhancement is recommended.

At least 20 native riparian shade trees such as white alder, California buckeye, big leaf maple, Oregon ash, or black cottonwood should be planted around the pond edge where they may provide shaded native habitat. Invasive black locust trees on the northern pond edge are in poor health. Black locust trees have the potential to spread to the natural environment and alter native vegetation communities. The nine black locust trees should be removed and replaced with native trees such as the riparian trees listed above or Oregon white oak or Douglas fir in upland areas. Native willows (such as arroyo willow, Sitka willow, or shining Pacific willow) should also be planted in saturated soil approximately every ~6-10 feet around the edge of the pond. Some willows appeared to be naturally recruiting to the pond edge, and these should be supplemented by planting where bare areas remain. Willow cuttings may be sourced onsite or from a local nursery. Areas for recreational access to the pond may be left clear of vegetation. Willows are expected to improve water quality and habitat quality for native amphibians, western pond turtles, songbirds, and waterfowl. Willows should also be planted between the outlet culvert and road along channel leading the away from the pond to improve the quality of water flowing back into the stream channel (Photo 7). Herbaceous native wetland plants such as small-fruited bulrush or spreading rush may also be planted as desired in lieu of willows. The area should be surveyed for invasive American bullfrogs annually according to CDFW guidelines. Amphibian surveys targeting the CESA Candidate foothill yellow-legged frog and other sensitive species are recommended prior to work on the inlet and outlet.

- a) Cut down invasive black locust trees on the northern edge of the pond and replace them with at least 9 native trees (potential species listed in Table 1).
- b) Complete all recommended culvert replacements, earthwork, etc.
- c) Plant native willows along the saturated edge of the pond every ~6-10 feet.

- d) Plant 20 native riparian trees approximately 5-20 feet back from the saturated edge of the pond.

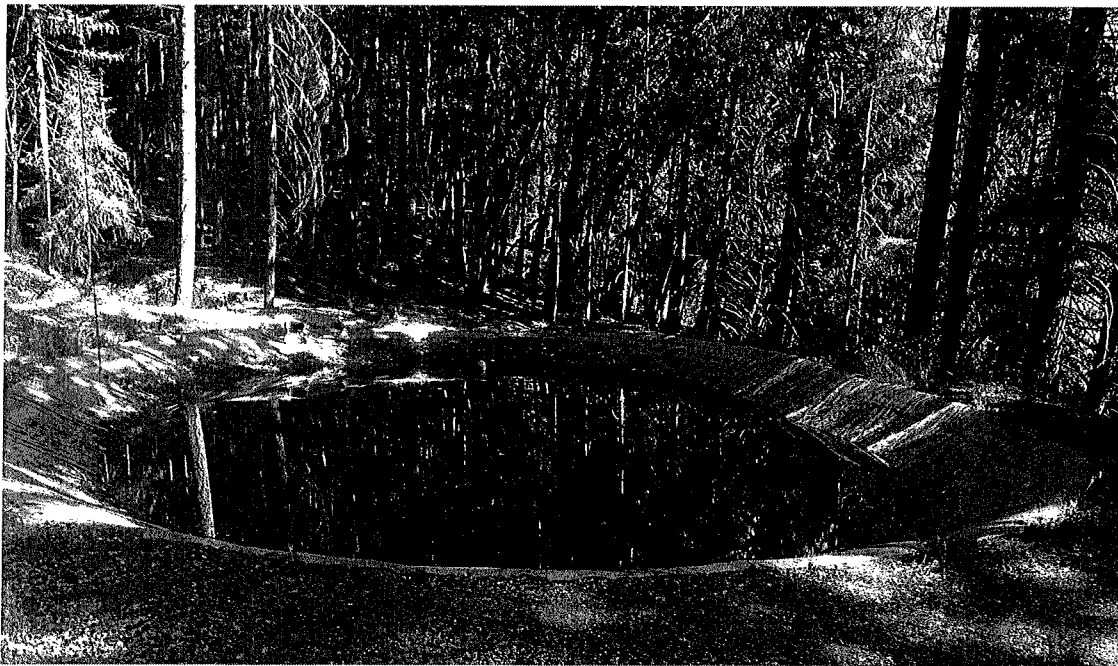
Conversion Site B2 is an on-stream pond within the forested slope. The site was first converted for a recreational pond (90' by 62') between 2014 and 2016. Surrounding vegetation includes Douglas-fir and black oak, with a minor amount of other hardwoods. The pond and fill material to create the earthen dam expands the site to 95' x 116'. The pond is failing with the flex pipe eroding the earthen fill. The pond has been recommended to be removed, contoured and planted with trees. Work should take place during dry conditions in the summer to early fall.

Photo 8. The onstream pond in the forested area.

- a) Remove existing pond outlet, the earthen dam and relief culvert structures.
- b) Excavate and align the 90' channel to grade. Spoils from excavation shall be placed within the southern section of the pond and feathered into to the slope.
- c) Slope the watercourse banks back to a 1: 1.5 ratio and compact.
- d) Straw mulch all bare soil within 100 feet of the watercourse.
- e) Slash piles from past logging may be lopped and scattered across the site to reduce rill erosion.
- f) Restoration work shall occur on dry rainless periods between June 1st and October 15<sup>th</sup>

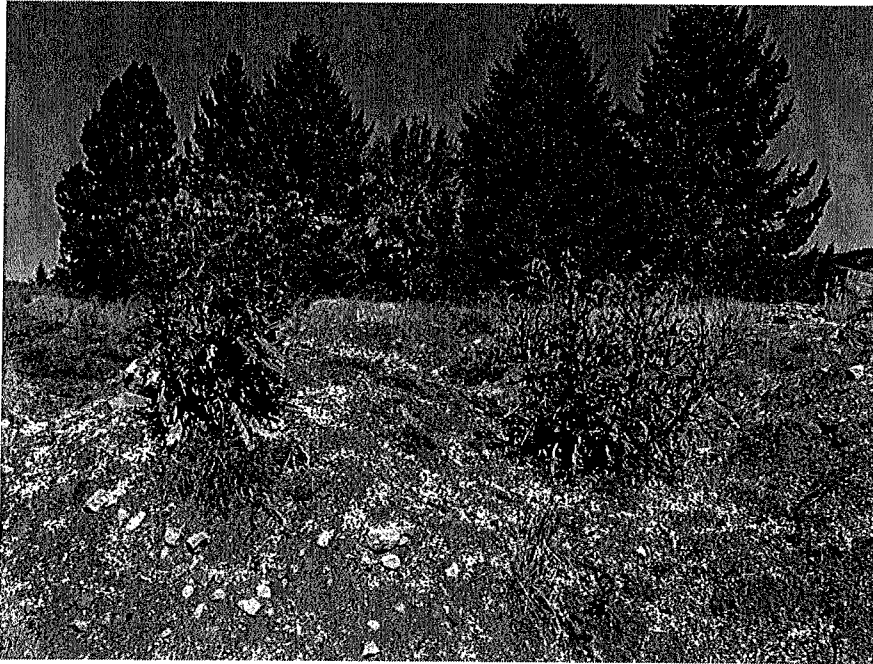
Photo 9. Invasive bull thistle thriving in an uncovered compost pile near Proposed Site A1.

At the end of each growing season, potting soil and other organic materials should be composted in a designated covered compost pile surrounded by a barrier to prevent erosion. During site visits, a large compost pile was observed to be supporting many weedy and invasive plants, most notably bull thistle. Nutrient-rich, disturbed bare soil can become hotspots for invasive plants and other weedy species to thrive and disperse to other areas of the property where they may degrade native habitat quality. Bull thistles should be pulled in the spring before they go to seed. The compost pile should be kept covered at all times to suppress any other invasive species and prevent nutrient-rich runoff and erosion to the surrounding area.

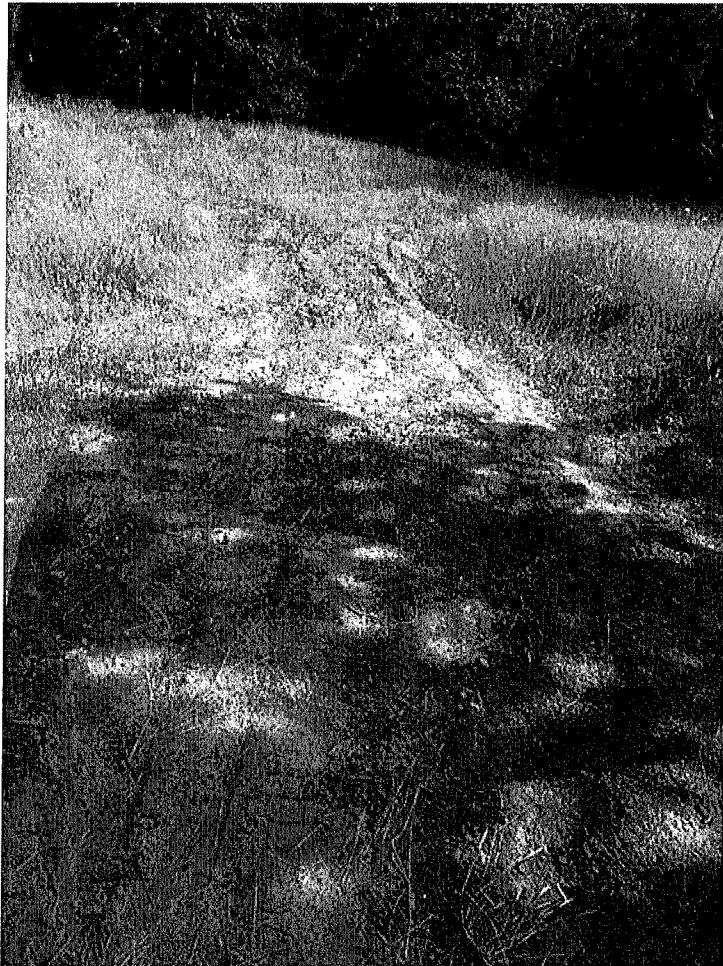
This upper site contains >30% slopes. The area should be abandoned, and the graded area should be restored to the natural contour. The water storage bladder and all cultivation materials should be removed. This 40' x 80' site was first graded for a log landing prior to 2004. The site has been graded several times since 2004. The site was converted for cannabis cultivation in 2014 and is currently abandoned. The site is located in a partially oak woodland grassy meadow.

Surrounding vegetation includes Douglas fir and black oak and tan oak, with a minor amount of other hardwoods. Fill failure is present and it is recommended that the failing material be pulled and the site planted. The road system is a dirt road and can only be used seasonally.

Photo 10. Site H was located along a seasonal road.

- a) Failing perched fill material (25' by 50'). Pull back fill material to 1.5:1 ratio slope to prevent further failure.
- b) Douglas-fir trees or other upland native tree species shall be planted in the disturbed area.
- c) Trees shall be planted the first winter following completion of the earth work.
- d) Remove all cultivation related materials and all other garbage.

- e) Any remaining disturbed fill should be seeded with a native grass mix such as Pacific Coast Seed Erosion Control Mix prior to the Nov. 15 winterization deadline.

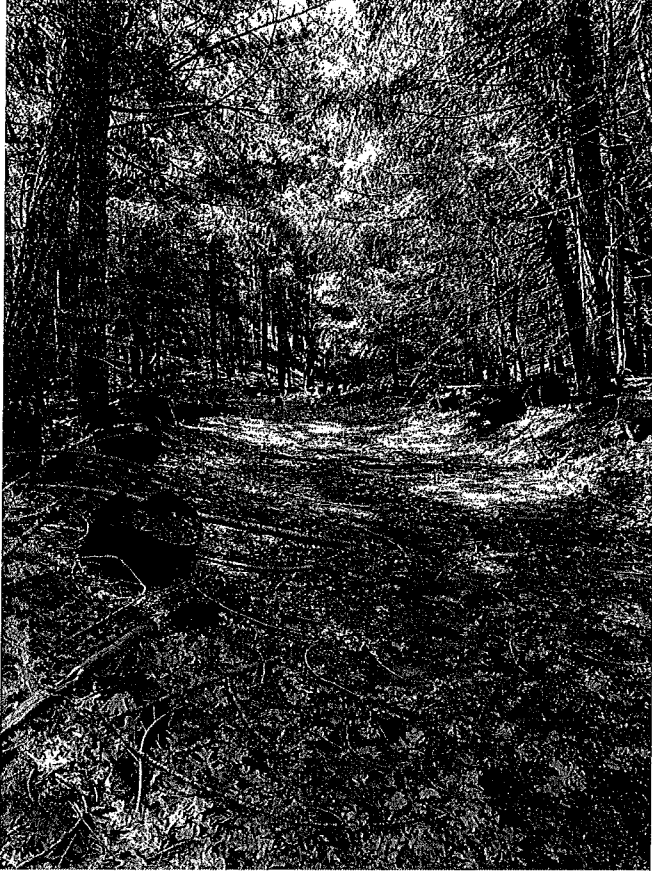
Former cultivation materials scattered along the mid-slope road should be removed. All pots, potting soil, and other cultivation materials and debris must be removed from the road and properly stored or taken to the dump. Potting soil and other materials should not be left in areas not designated for cultivation.

Photo 11. Cultivation materials need to be removed from the spur road. Potting soil should be composted in a designated covered compost pile, and other materials should be stored in sheds or taken to the dump.
