COUNTY OF HUMBOLDT
PLANNING AND BUILDING DEPARTMENT
CURRENT PLANNING DIVISION

Subject: **Seaside Ranch LLC Coastal Development Permit, Conditional Use Permit, Special Permit**
Record Number 9633 CDP
Assessor's Parcel Numbers (APNs) 111-221-034, 111-221-035, and 108-104-004
390, 394, and 398 Landis Road, Shelter Cove Area

Seaside Ranch LLC Coastal Development Permit, Conditional Use Permit, Special Permit
Record Number: CDP-9633
Assessor's Parcel Numbers: 111-221-034, 111-221-035, 108-104-004

Certifying compliance with the California Environmental Quality Act and conditionally approving Seaside Ranch, LLC Coastal Development Permit, Conditional Use Permit, and Special Permit

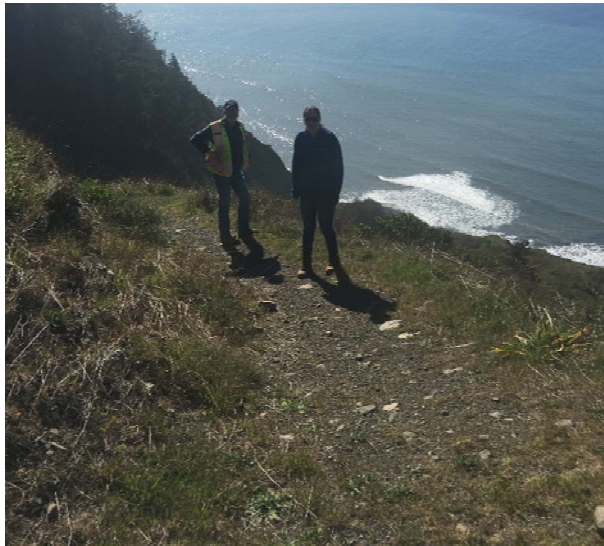
Figure 2. Upper Trail 3/12/2020

During the March 2020 inspection, it was observed that substantial reversion of the trail has occurred. Significant revegetation has occurred within the disturbed areas, primarily coyote brush (*Baccharis pilularis*) and poison oak (*Toxicodendron diversilobum*). The average trail width is approximately 2 to 3 feet. Remnant BMPs were observed on-site and appear to have operated as intended. These include remnant jute netting and fiber rolls, as well as cross trail water bars. No significant erosion was observed on the Upper Trail apart from a single area where runoff originating upslope and off-site intercepts the trail. This drainage is approximately 6 to 12 inches wide and appears to be ephemeral in nature. The trail does not show significant erosion and only minimal rilling is visible along the trail.

Based on observations made during our site visit, we do not recommend any further actions be taken within the Upper Trail and no further minimization measures are necessary.

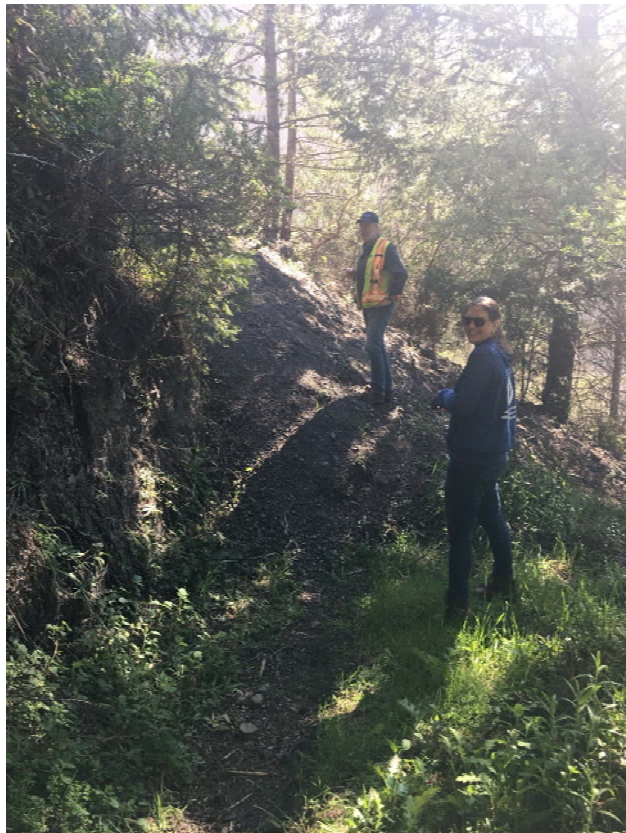
Figure 4. Mid Trail and Slide 3/12/2020

During the March 2020 inspection, it was observed that substantial reversion of the trail has occurred. Significant revegetation has occurred within the disturbed areas. The average trail width is approximately 2 to 3 feet. Remnant BMPs were observed on-site and appear to have operated as intended. These include remnant jute netting and fiber rolls, as well as cross trail water bars. Just south of the culvert present within this reach, a portion of the slope above the trail slid, depositing approximately 50 cubic yards of material within the footprint of the trail. No other significant erosion was observed on the Mid Trail.

Based on observations made during our site visit, we do not recommend any further actions be taken within the Mid Trail and no further minimization measures are necessary.

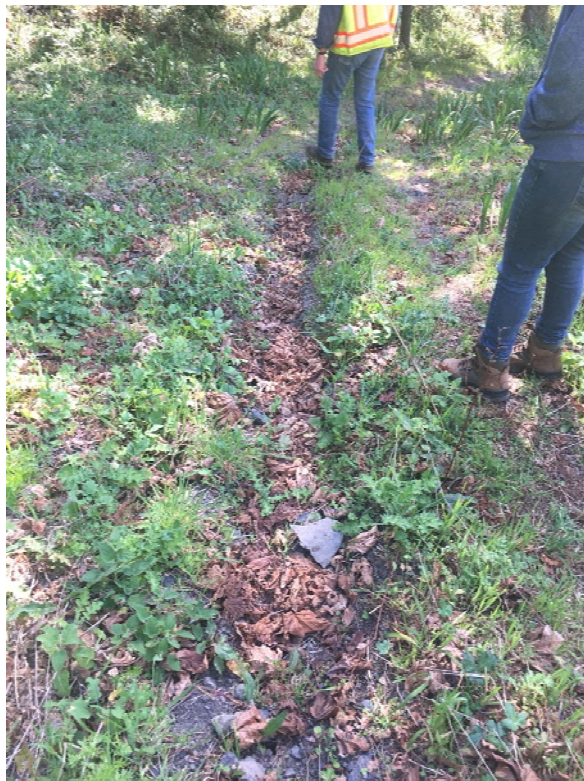
Figure 6. Lower Trail 3/12/2020

During the March 2020 inspection, it was observed that substantial reversion of the trail has occurred. Significant revegetation has occurred within the areas cleared of vegetation. Most dominant of the species observed is poison oak. The trail has an average width of 1 to 3 feet. Minor rilling is present, similar to the Upper Trail, and no significant erosion was observed.

Based on observations made during our site visit, we do not recommend any further actions be taken within the Lower Trail and no further minimization measures are necessary.

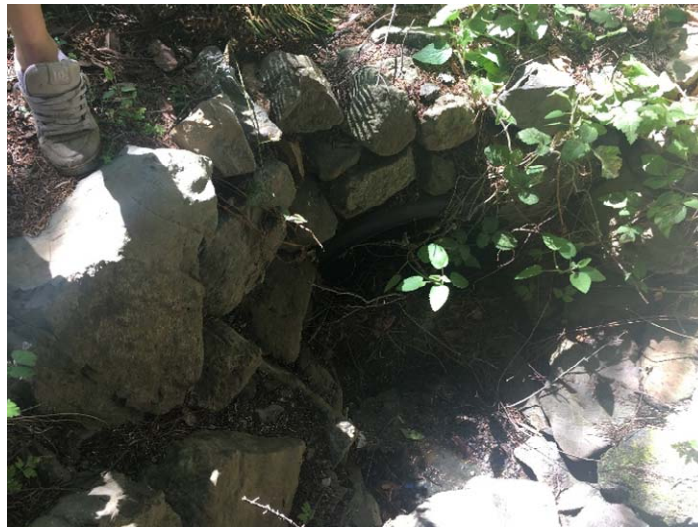
Figure 8. Culvert Inlet 3/12/2020

During the inspection, it was observed that the rock armoring was still in place and functioning as intended. Revegetation has occurred within the culvert footprint and the area appears stable. The culvert inlet was partially blocked with debris but appeared functional. Flows present at the time of inspection are estimated to be less than 1 cubic foot per second (cfs). The slide, which occurred directly south of the culvert, has essentially removed any unlikely diversion potential, as the culvert footprint is effectively bounded by areas

Based on observations made during our site visit, LACO recommended the culvert be annually maintained to prevent material from reducing inlet performance.

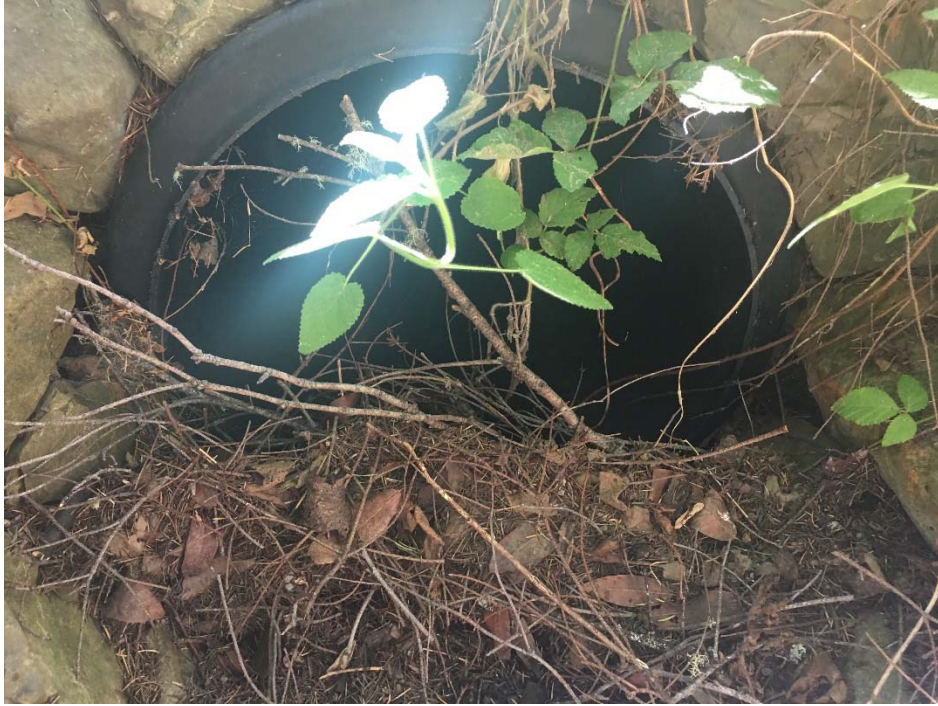
Figure 11. Culvert Inlet Debris 3/12/2020

of higher elevation and the slope of the trail no longer offers a potential relief path for water during instances of culvert overtopping. It is recommended that the debris at the inlet of the culvert, although not currently hindering performance, should be removed on a regular basis as preventative maintenance.

We recommend that the culvert be annually maintained for debris accumulation at the inlet. No other actions are recommended at this time and no further minimization measures are necessary.

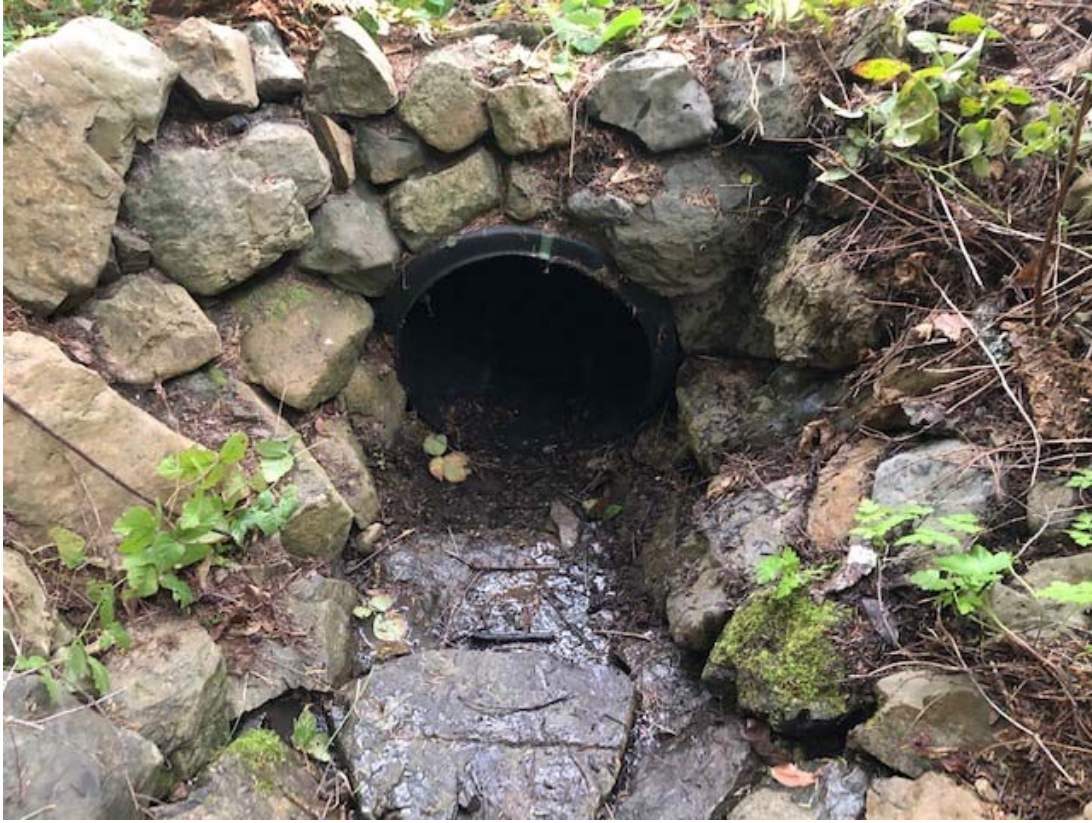
Figure 12. Culvert Post Maintenance 4/17/2020

Upon recommendation, the Applicant performed annual maintenance for the 2020 season and provided photographs to document the culvert's current condition. As shown in Figure 12 in Appendix 2, the culvert appears free of all debris and fully functional.
