We Are Up Project

Initial Study & Proposed Mitigated Negative Declaration

County of Humboldt
PLN-2022-18047 CUP/SP
APN 509-181-057

March 01, 2023

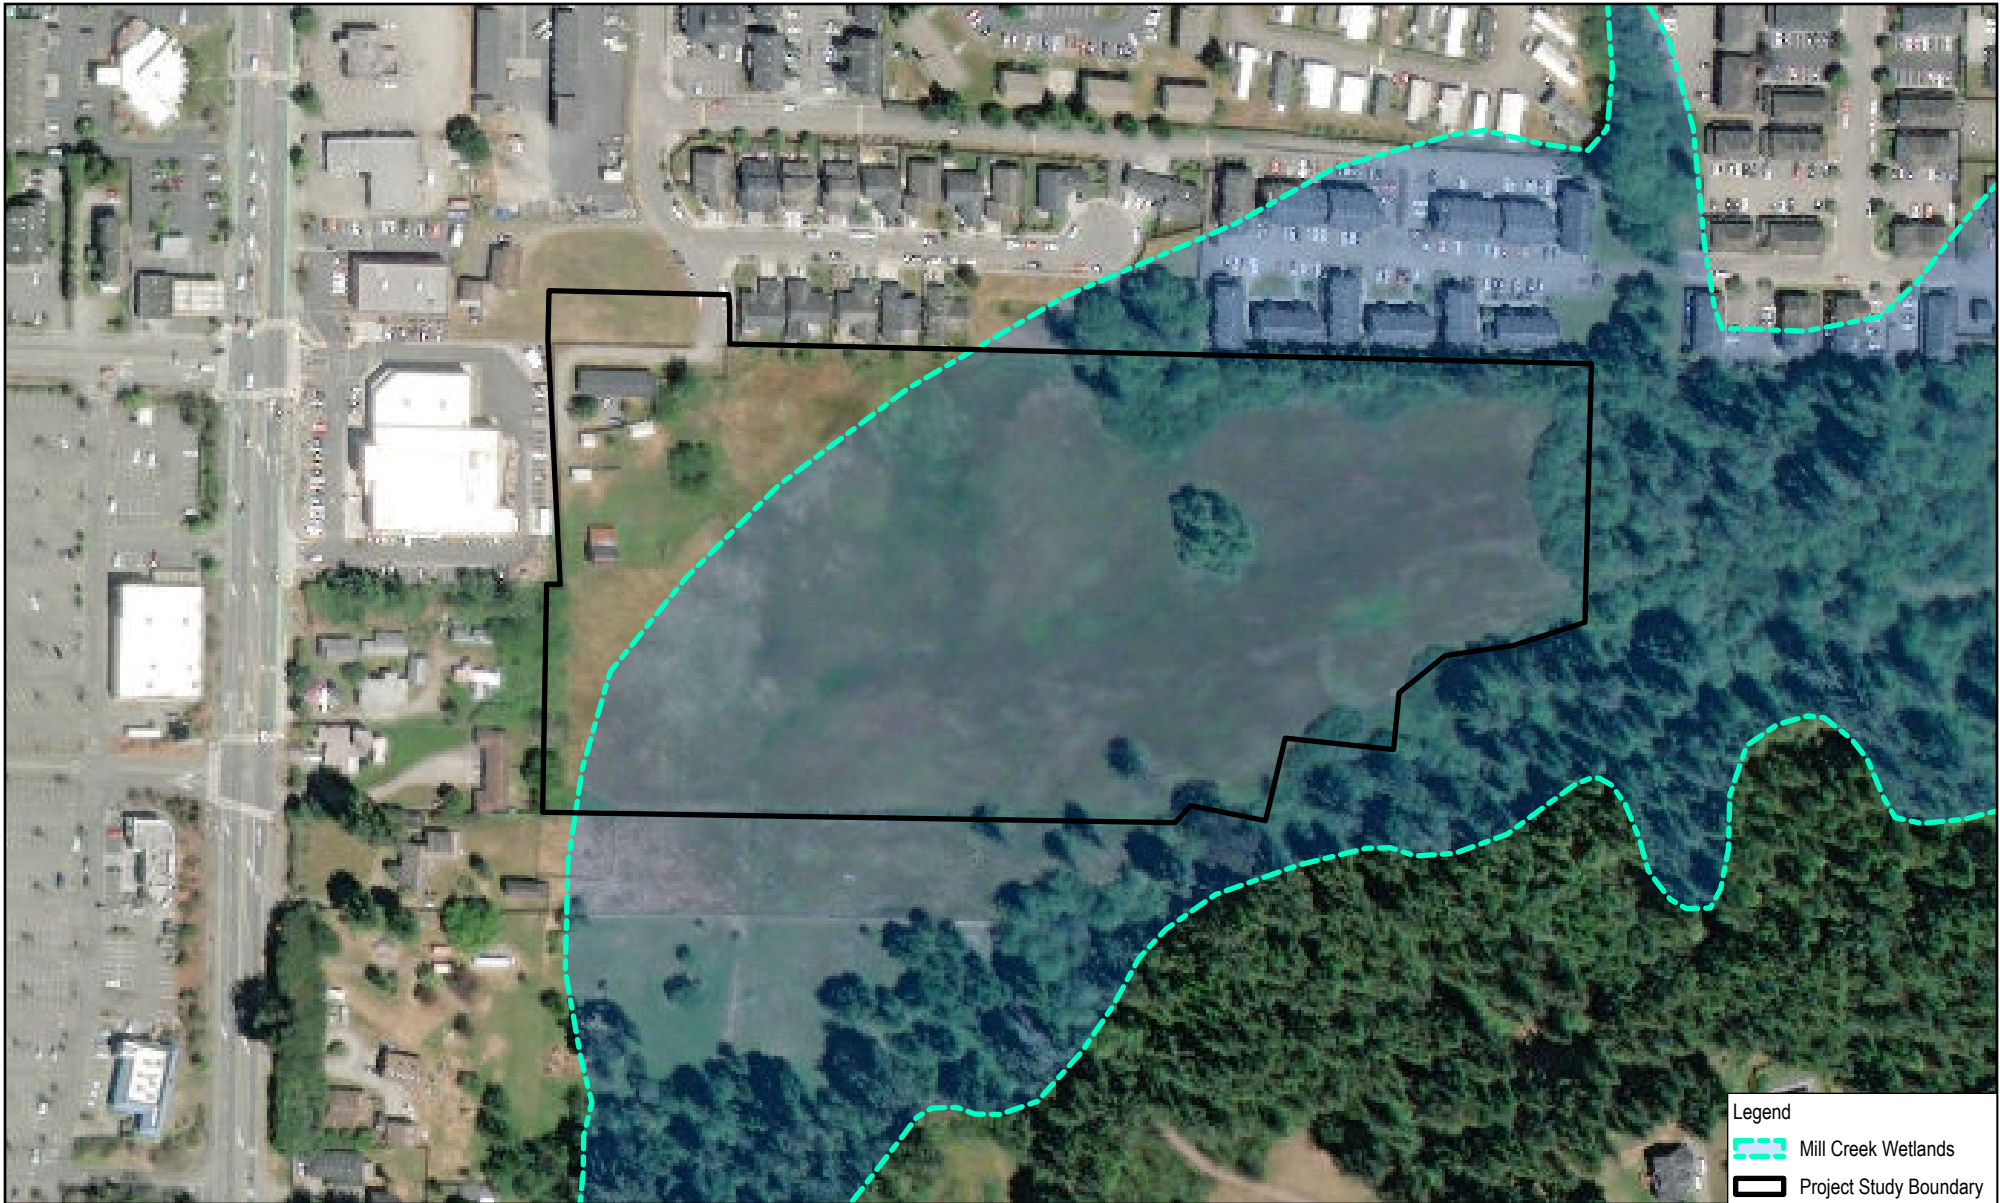
FIGURE 5

Mill Creek Wetland Overlay

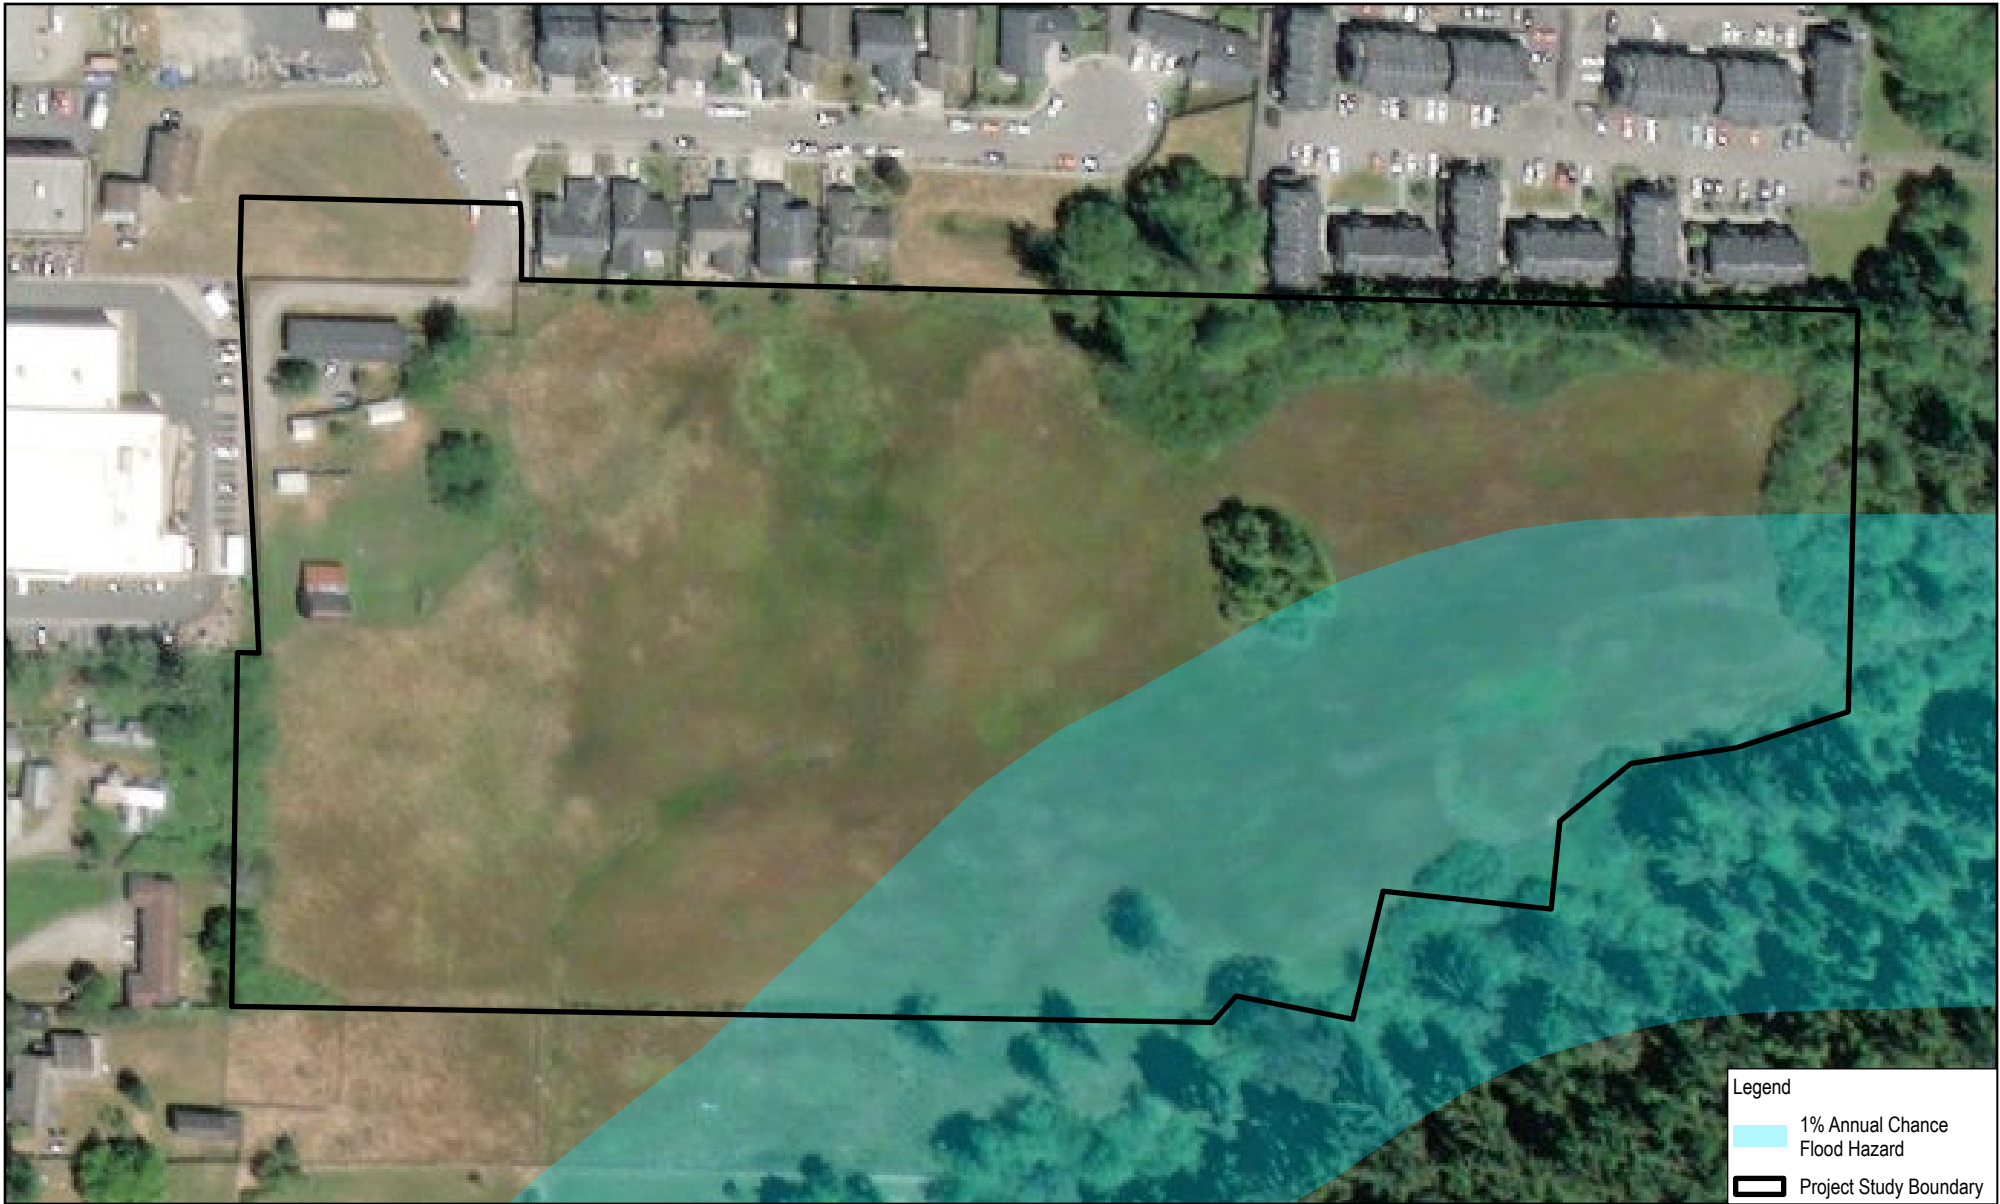
FIGURE 6

FEMA Floodplain

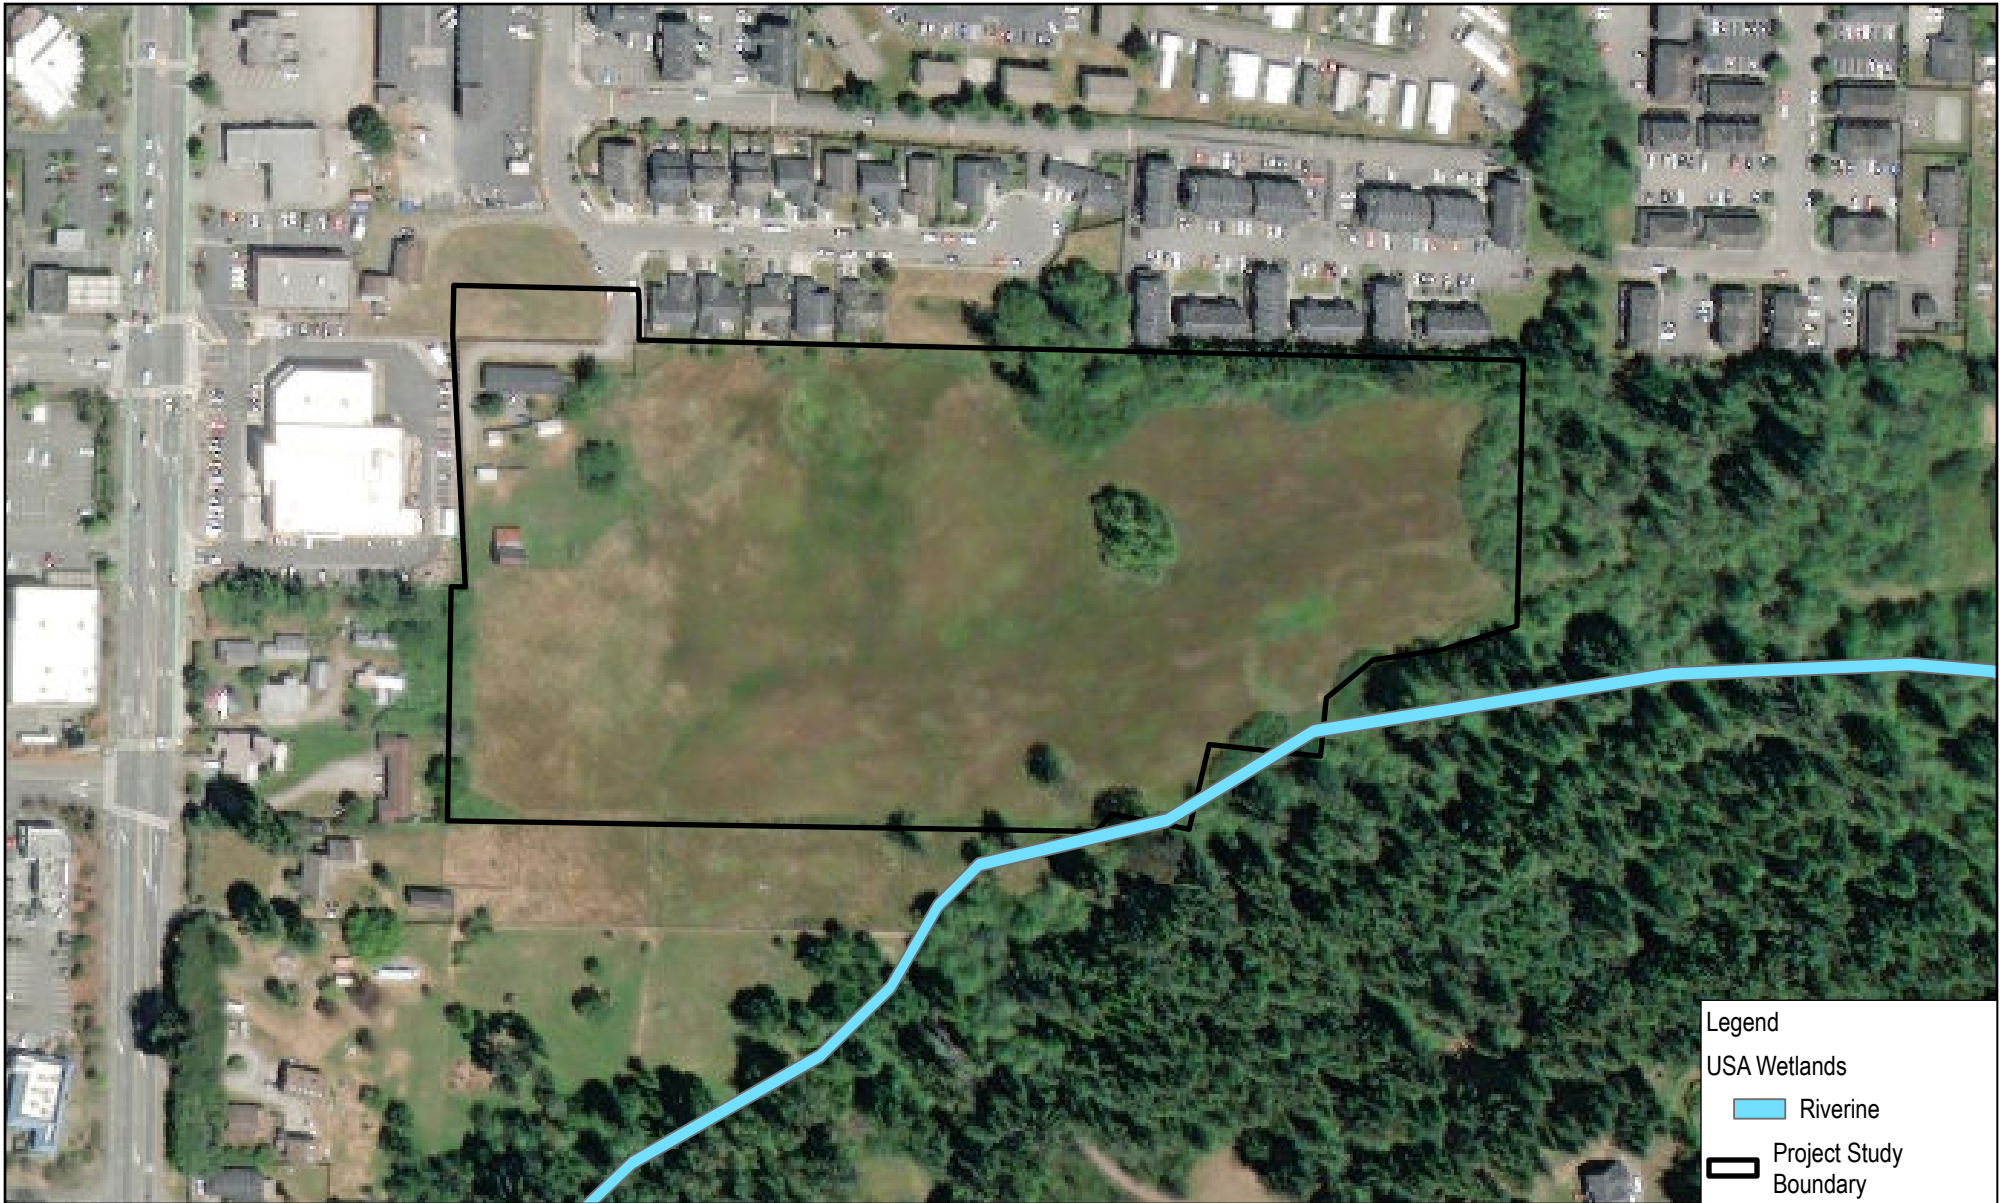
FIGURE 7

National Wetlands Inventory
