4 Wheel Properties LLC

Invasive Plant Management, Restoration

and Monitoring Plan

APNs #210-071-001, #210-054-008, and #210-062-007

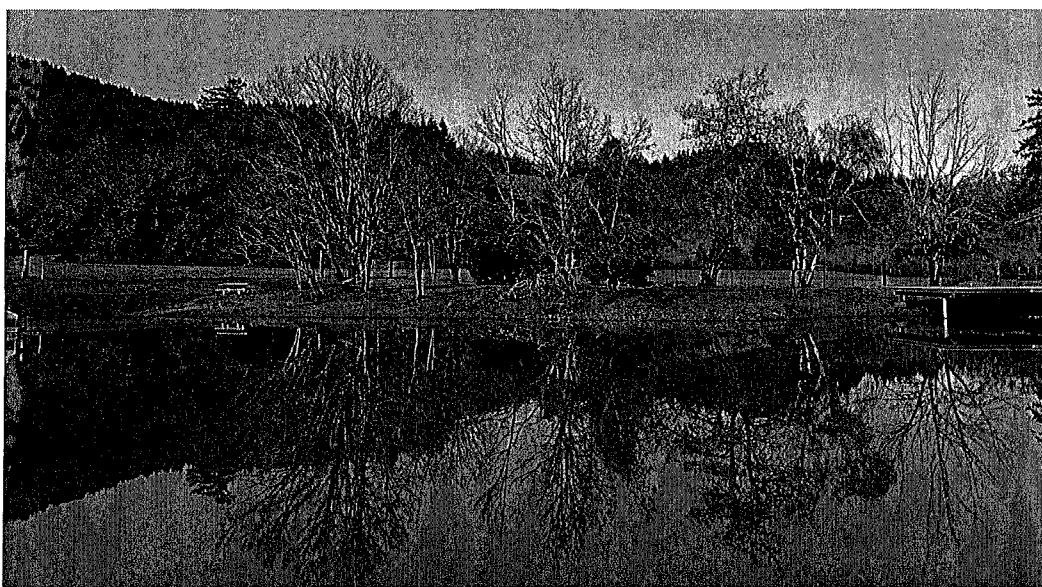
The on-stream pond near the residence is located in open grassland on an altered stream course. Cultivated Port Orford cedar and invasive black locust trees are planted around the pond. Some native willows are naturally recruiting to the edge of the pond, which was mostly bare, with patches of pasture grasses and pennyroyal. The culverts at the inlet and outlets on a class II watercourse are failing and must be replaced (Road Points 5 and 6). The culverts should be replaced according to specifications in the LSAA. The inlet and outlet should be rocked with 12" – 18" diameter rock. The pond shall not be stocked with fish. The pond was evaluated on 1/30/2020. The water clarity was low, but high numbers of invertebrates that indicate high water quality (caddisflies, water boatmen) were present along the edge of the pond. The pond is likely high quality habitat and potential breeding habitat for the western pond turtle and northern red legged frogs. The foothill yellow legged frog also has the potential to use this site. When surveyed under winter conditions, the pond maintained relatively low temperatures. At 11am on 1/30/20, the stream running into the pond was 49 degrees F, the pond was 50 degrees F, and the shallow water coming out of the pond outlet was elevated to 51 degrees F. With low vegetation cover, the pond has the potential to increase water temperatures substantially during the summer, which may negatively impact habitat quality for native amphibians and sensitive aquatic invertebrates found in the area.

Photo 3. The pond at Site K is on-stream, and native habitat enhancement is recommended.

At least 20 native riparian shade trees such as white alder, California buckeye, big leaf maple, Oregon ash, or black cottonwood should be planted around the pond edge where they may provide shaded native habitat. Invasive black locust trees on the northern pond edge are in poor health. Black locust trees have the potential to spread to the natural environment and alter native vegetation communities. The nine black locust trees should be removed and replaced with native trees such as the riparian trees listed above or Oregon white oak or Douglas fir in upland areas. Native willows (such as arroyo willow, Sitka willow, or shining Pacific willow) should also be planted in saturated soil approximately every ~6-10 feet around the edge of the pond. Some willows appeared to be naturally recruiting to the pond edge, and these should be supplemented by planting where bare areas remain. Willow cuttings may be sourced onsite or from a local nursery. Areas for recreational access to the pond may be left clear of vegetation. Willows are expected to improve water quality and habitat quality for native amphibians, western pond turtles, songbirds, and waterfowl. Willows should also be planted between the outlet culvert and road along channel leading the away from the pond to improve the quality of water flowing back into the stream channel (Photo 7). Herbaceous native wetland plants such as small-fruited bulrush or spreading rush may also be planted as desired in lieu of willows. The area should be surveyed for invasive American bullfrogs annually according to CDFW guidelines. Amphibian surveys targeting the CESA Candidate foothill yellow-legged frog and other sensitive species are recommended prior to work on the inlet and outlet.

- a) Cut down invasive black locust trees on the northern edge of the pond and replace them with at least 9 native trees (potential species listed in Table 1).
- b) Complete all recommended culvert replacements, earthwork, etc.
- c) Plant native willows along the saturated edge of the pond every ~6-10 feet.

d) Plant 20 native riparian trees approximately 5-20 feet back from the saturated edge of the pond.

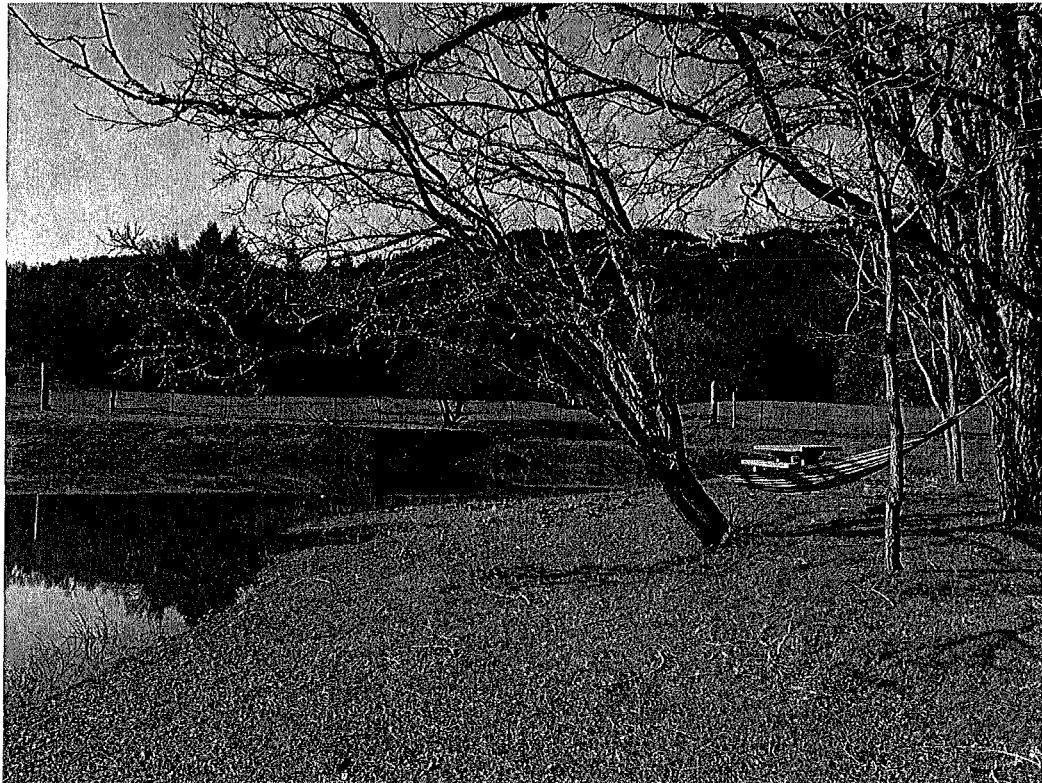
Photo 4. Invasive black locust trees (seen here in winter) to be removed from the pond area may be identified by their cascade of white pea-like flowers and seed pods.

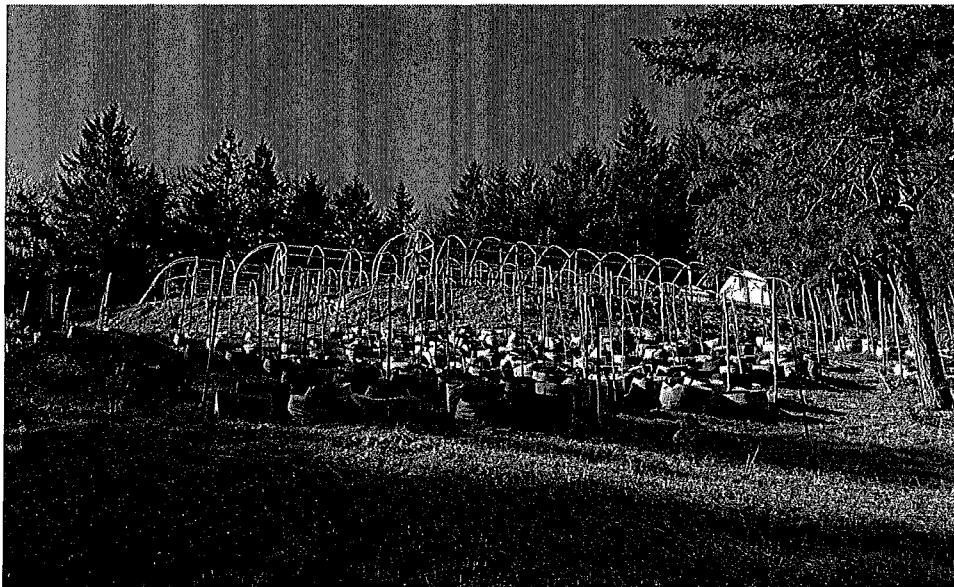
The pre-existing and cultivation site is located on an upland slope within mixed coniferous forest. This 130' x 170' site was converted for cannabis cultivation by 2012. The site is currently occupied by 4 greenhouses. Surrounding vegetation includes Douglas fir and black oak, with a minor amount of other hardwoods. It is recommended that the cultivation is relocated from the steep forested slope to the open flat grassland closer to Hwy 36. All cultivation materials should be removed. It is recommended that a portion of the site is rocked to be used as an emergency access vehicle turnaround. The rest of the site should be planted with Douglas fir or other upland tree species found in the area.

Photo 6. Site I includes greenhouses on the graded landing and outdoor cultivation on the surrounding slope. This shall be replaced with an emergency access turnaround and planting Douglas fir on the slope.

- Remove green houses and all cultivation related materials from the site.
- Rock an emergency access turnaround, ~50' x 50'
- Maintain all existing vegetation in the surrounding area. No grading required.
Maintain outsloped log landing.
- Straw mulch all bare soil within 100 feet created from the removal process

e) Slash piles and woody debris piles present on site may be loped and scattered across the site.

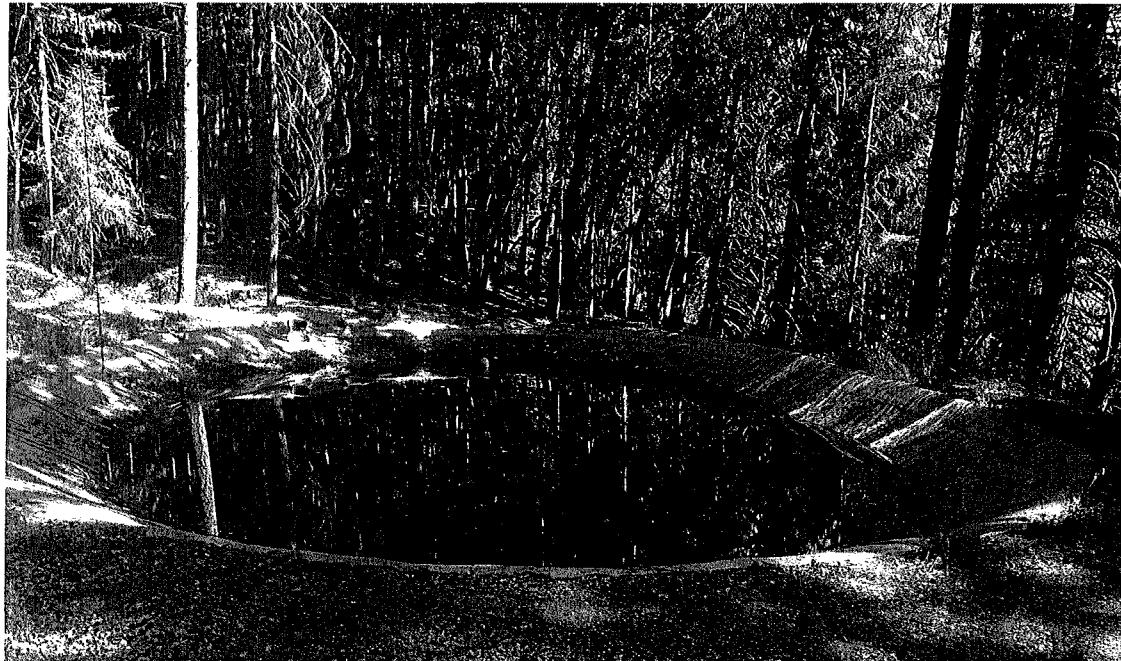
Conversion Site B2 is an on-stream pond within the forested slope. The site was first converted for a recreational pond (90' by 62') between 2014 and 2016. Surrounding vegetation includes Douglas-fir and black oak, with a minor amount of other hardwoods. The pond and fill material to create the earthen dam expands the site to 95' x 116'. The pond is failing with the flex pipe eroding the earthen fill. The pond has been recommended to be removed, contoured and planted with trees. Work should take place during dry conditions in the summer to early fall.

Photo 8. The onstream pond in the forested area.

- a) Remove existing pond outlet, the earthen dam and relief culvert structures.
- b) Excavate and align the 90' channel to grade. Spoils from excavation shall be placed within the southern section of the pond and feathered into to the slope.
- c) Slope the watercourse banks back to a 1: 1.5 ratio and compact.
- d) Straw mulch all bare soil within 100 feet of the watercourse.
- e) Slash piles from past logging may be lopped and scattered across the site to reduce rill erosion.
- f) Restoration work shall occur on dry rainless periods between June 1st and October 15th

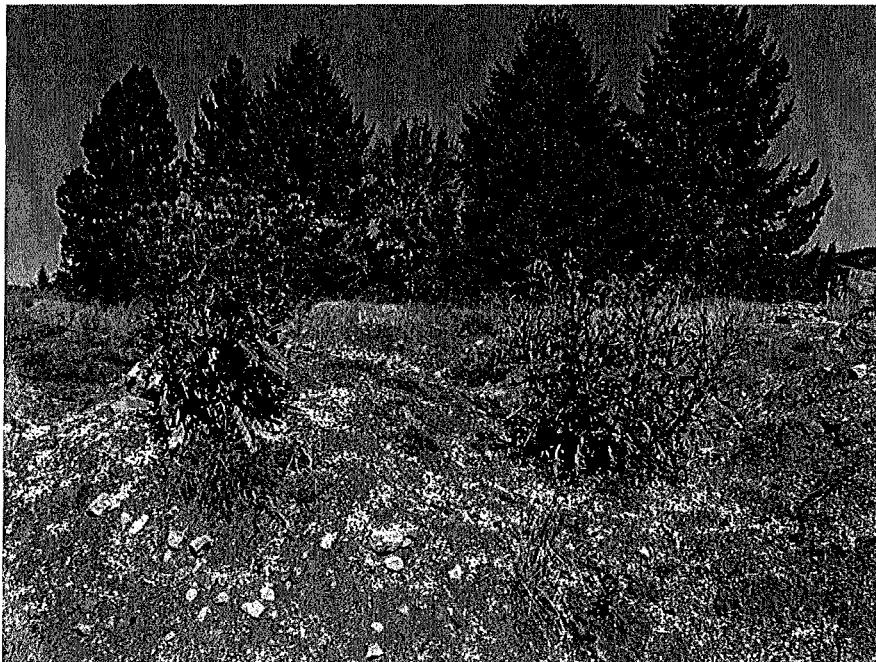
At the end of each growing season, potting soil and other organic materials should be composted in a designated covered compost pile surrounded by a barrier to prevent erosion. During site visits, a large compost pile was observed to be supporting many weedy and invasive plants, most notably bull thistle. Nutrient-rich, disturbed bare soil can become hotspots for invasive plants and other weedy species to thrive and disperse to other areas of the property where they may degrade native habitat quality. Bull thistles should be pulled in the spring before they go to seed. The compost pile should be kept covered at all times to suppress any other invasive species and prevent nutrient-rich runoff and erosion to the surrounding area.

Photo 9. Invasive bull thistle thriving in an uncovered compost pile near Proposed Site A1.

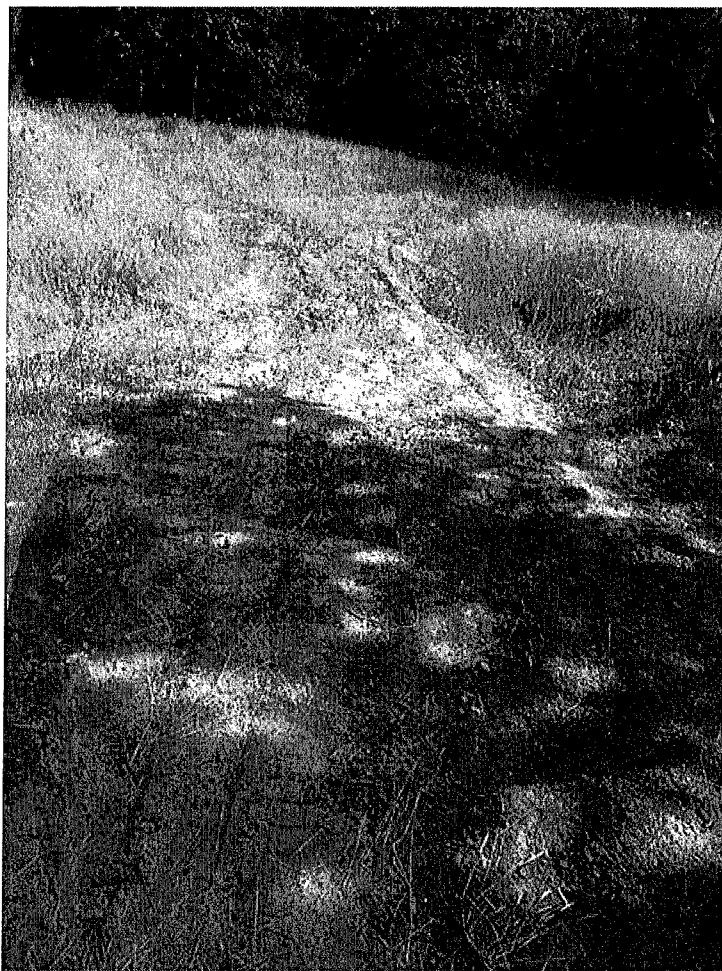
This upper site contains >30% slopes. The area should be abandoned, and the graded area should be restored to the natural contour. The water storage bladder and all cultivation materials should be removed. This 40' x 80' site was first graded for a log landing prior to 2004. The site has been graded several times since 2004. The site was converted for cannabis cultivation in 2014 and is currently abandoned. The site is located in a partially oak woodland grassy meadow.

Surrounding vegetation includes Douglas fir and black oak and tan oak, with a minor amount of other hardwoods. Fill failure is present and it is recommended that the failing material be pulled and the site planted. The road system is a dirt road and can only be used seasonally.

Photo 10. Site H was located along a seasonal road.

- a) Failing perched fill material (25' by 50'). Pull back fill material to 1.5:1 ratio slope to prevent further failure.
- b) Douglas-fir trees or other upland native tree species shall be planted in the disturbed area.
- c) Trees shall be planted the first winter following completion of the earth work.
- d) Remove all cultivation related materials and all other garbage.

e) Any remaining disturbed fill should be seeded with a native grass mix such as Pacific Coast Seed Erosion Control Mix prior to the Nov. 15 winterization deadline.

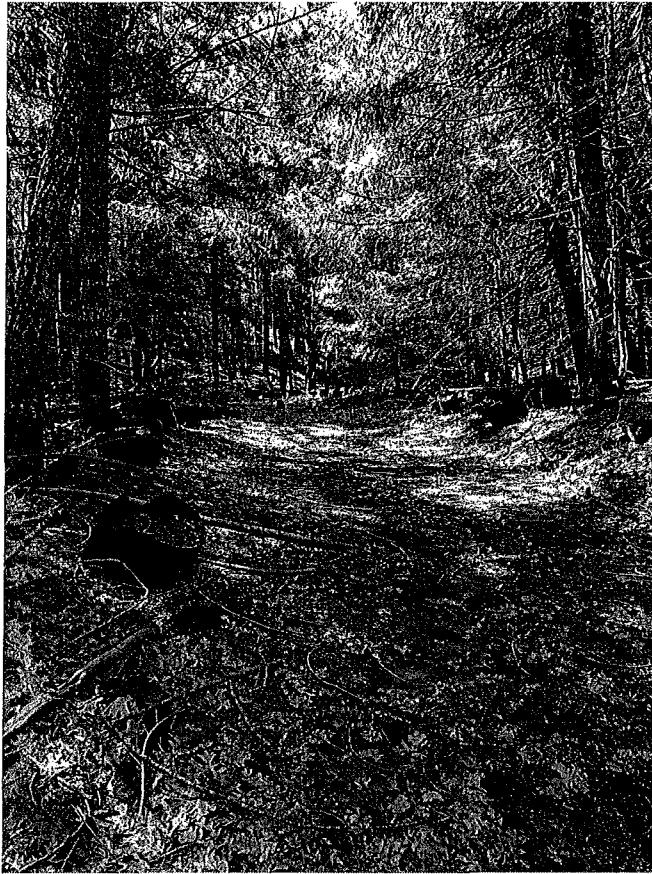
Photo 11. Cultivation materials need to be removed from the spur road. Potting soil should be composted in a designated covered compost pile, and other materials should be stored in sheds or taken to the dump.

Former cultivation materials scattered along the mid-slope road should be removed. All pots, potting soil, and other cultivation materials and debris must be removed from the road and properly stored or taken to the dump. Potting soil and other materials should not be left in areas not designated for cultivation.
