**Sordal 4 Wheel Properties, LLC**  
**Restoration, Invasive Plant Management,**  
**and Monitoring Plan**

APN 210-054-008.

Prepared by  
Stephen Hohman and  
Kelsey McDonald  
2/20/2020

For  
Hohman and Associates  
Hydesville, CA

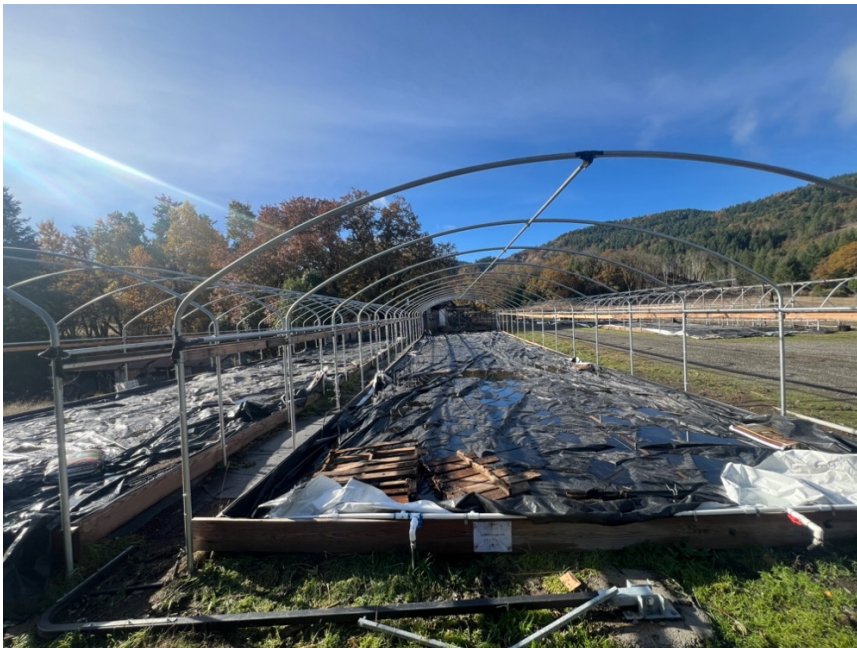
Photo 1. (site E)

The pre-existing and cultivation site is located on 1% slope. This 130' x 170' site was converted for cannabis cultivation by 2012. The site is currently occupied by 4 greenhouses. Surrounding vegetation includes grassland and black oak, with a minor amount of other hardwoods. The proposed move would be to an environmentally superior location, further away from the creek, although site e is not in a riparian zone. This site would benefit from having PG&E rather than small gas generators that produce higher greenhouse gas and noise pollution that disturbs wildlife. Botany, archeology, owl, raptor, wetland surveys have all been done and have no conflict.

- a) Remove green houses and all cultivation related materials from the site.
- b) Maintain all existing vegetation in the surrounding area. No grading required. Maintain outsloped log landing.
- c) Straw mulch all bare soil within 100 feet created from the removal process

1. All cultivation materials shall be removed.
2. Grass seed evenly.

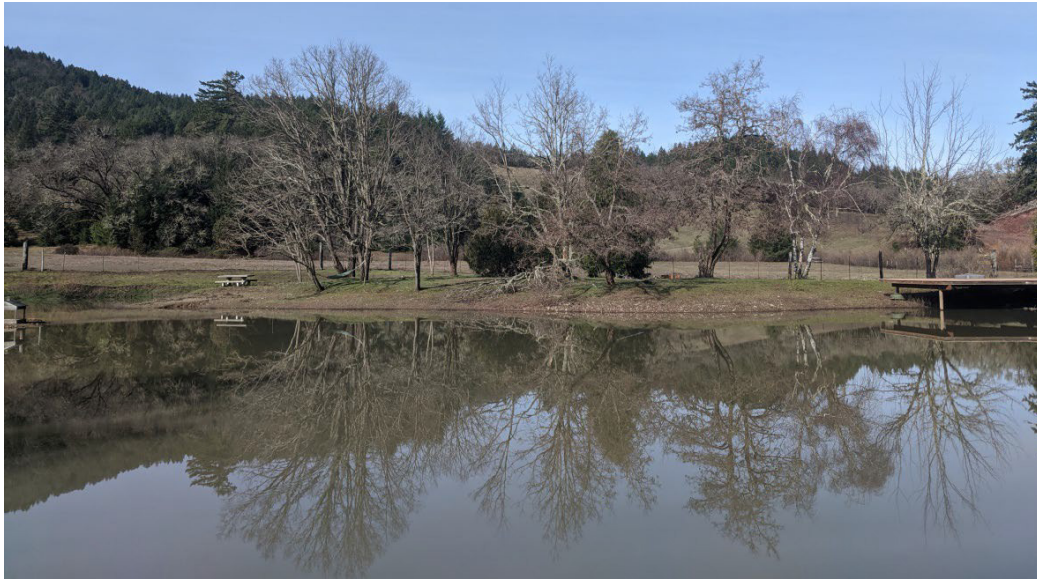
The on-stream pond near the residence is located in open grassland on an altered stream course. Cultivated Port Orford cedar and invasive black locust trees are planted around the pond. Some native willows are naturally recruiting to the edge of the pond, which was mostly bare, with patches of pasture grasses and pennyroyal. The culverts at the inlet and outlets on a class II watercourse are failing and must be replaced (Road Points 5 and 6). The culverts should be replaced according to specifications in the LSAA. The inlet and outlet should be rocked with 12” – 18” diameter rock. The pond shall not be stocked with fish. The pond was evaluated on 1/30/2020. The water clarity was low, but high numbers of invertebrates that indicate high water quality (caddisflies, water boatmen) were present along the edge of the pond. The pond is likely high quality habitat and potential breeding habitat for the western pond turtle and northern red legged frogs. The foothill yellow legged frog also has the potential to use this site. When

surveyed under winter conditions, the pond maintained relatively low temperatures. At 11am on 1/30/20, the stream running into the pond was 49 degrees F, the pond was 50 degrees F, and the shallow water coming out of the pond outlet was elevated to 51 degrees F. With low vegetation cover, the pond has the potential to increase water temperatures substantially during the summer, which may negatively impact habitat quality for native amphibians and sensitive aquatic invertebrates found in the area.

Photo 2. The pond at Site K is on-stream, and native habitat enhancement is recommended.

At least 5 native riparian shade trees such as white alder, California buckeye, bigleaf maple, Oregon ash, or black cottonwood should be planted around the pond edge where they may provide shaded native habitat. Native willows (such as arroyo willow, Sitka willow, or shining Pacific willow) should also be planted in saturated soil approximately every ~10-20 feet around the edge of the pond. Some willows appeared to be naturally recruiting to the pond edge, and these should be supplemented by planting where bare areas remain. Willow cuttings may be sourced onsite or from a local nursery. Areas for recreational access to the pond may be left clear of vegetation. Willows are expected to improve water quality and habitat quality for native amphibians, western pond turtles, songbirds, and waterfowl. Willows should also be planted between the outlet culvert and road along channel leading the away from the pond to improve the quality of water flowing back into the stream channel. Herbaceous native wetland plants such as small-fruited bulrush or spreading rush may also be planted as desired in lieu of willows. The area should be surveyed for invasive American bullfrogs annually according to CDFW guidelines. Amphibian surveys targeting the CESA Candidate foothill yellow-legged frog and other sensitive species are recommended prior to work on the inlet and outlet.

- a) Complete all recommended culvert replacements, earthwork, etc.
- b) Plant native willows along the saturated edge of the pond every ~10-20 feet.

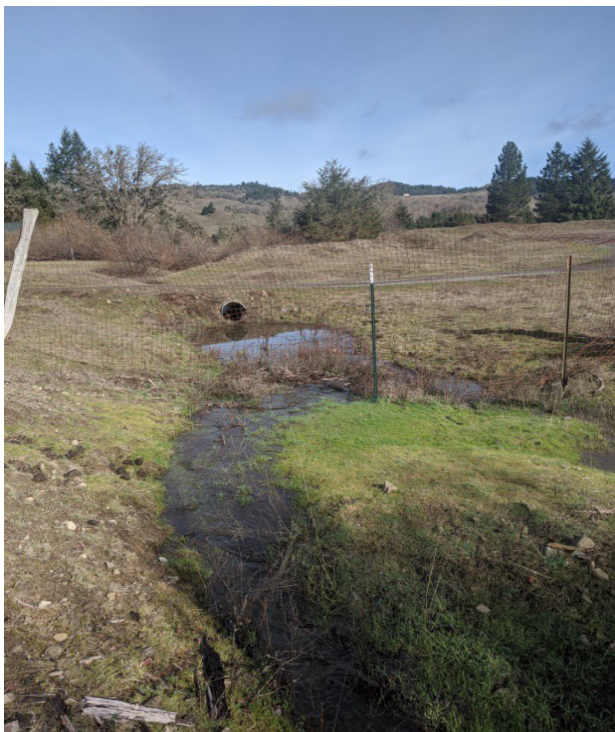
Photo 3. The outlet channel of pond k, should be rocked and revegetated with native willows.

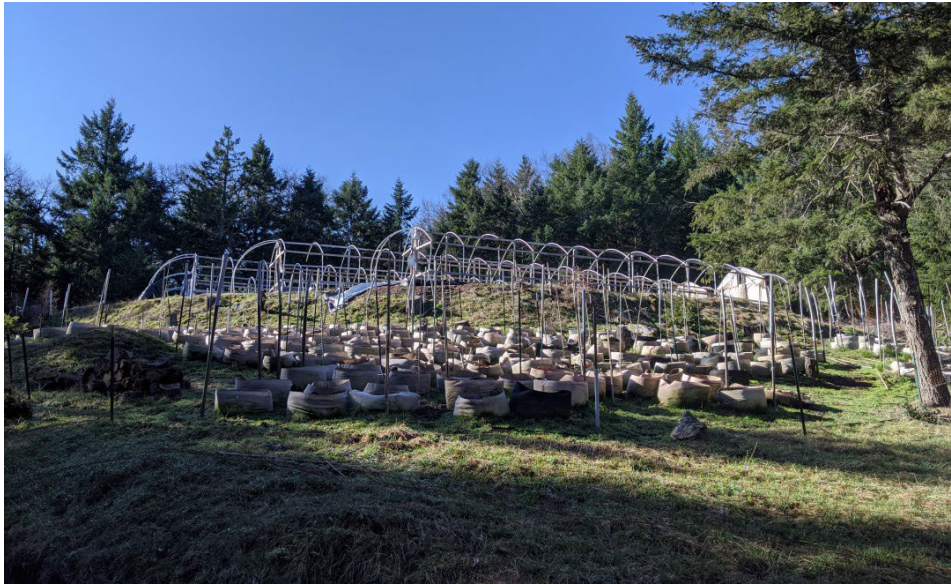
The pre-existing and cultivation site is located on an upland slope within mixed coniferous forest. This 130' x 170' site was converted for cannabis cultivation by 2012. The site is currently occupied by 7 greenhouses and outdoor pots. Surrounding vegetation includes Douglas fir and black oak, with a minor amount of other hardwoods. It is recommended that the cultivation is relocated from the steep forested slope to the open flat grassland closer to Hwy 36. All cultivation materials should be removed. It is recommended that a portion of the site is rocked to be used as an emergency access vehicle turnaround.

Photo 4. Site I includes greenhouses on the graded landing and outdoor cultivation on the surrounding slope. This shall be replaced with an emergency access turnaround and grass seeding sloped banks.

- d) Remove green houses and all cultivation related materials from the site.
- e) Maintain all existing vegetation in the surrounding area. No grading required. Maintain outsloped log landing.
- f) Straw mulch all bare soil within 100 feet created from the removal process

3. All cultivation materials shall be removed.
4. The area will have a rocked safety turnaround area.

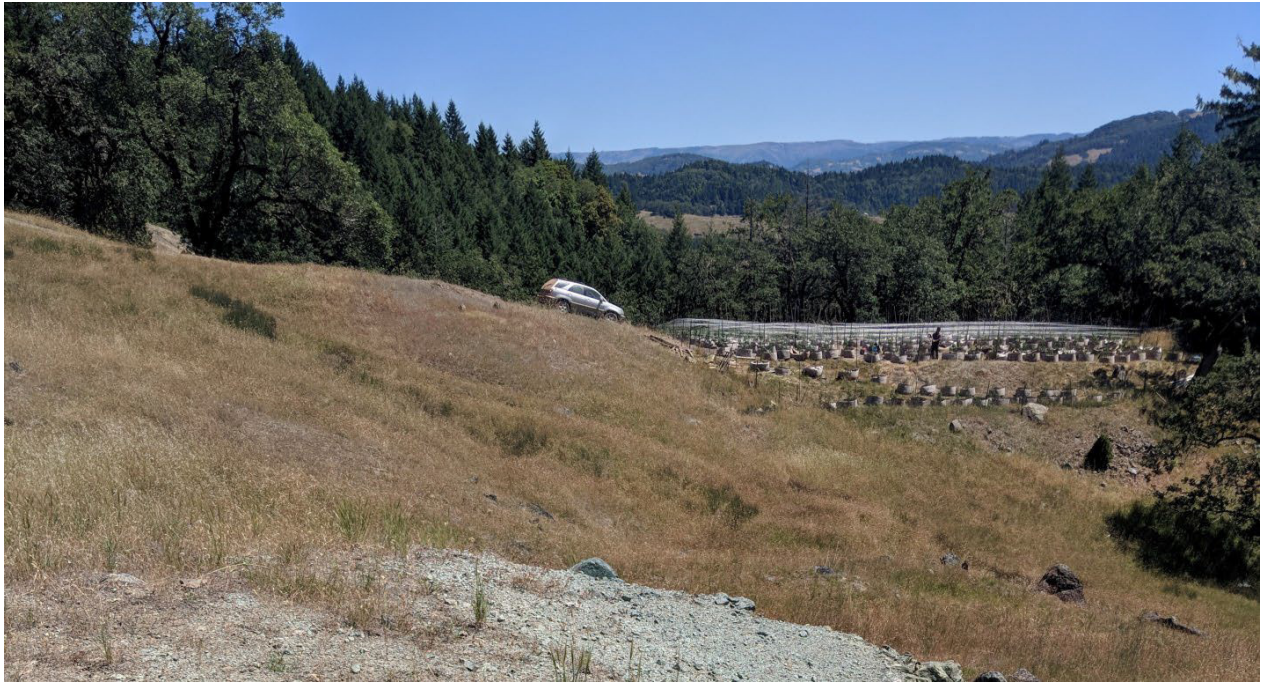
The mid-slope site is located on >15% slope with poor access via steep jeep trails. This 86' x 100' site was first converted for cannabis cultivation around 2012 when aerial imagery shows an outdoor garden was planted. Several greenhouses have occupied the site over the years, but currently no greenhouse is present. The site is located on the edge of oak woodland and a grassy meadow with some serpentine soils. Serpentine soils should be left undisturbed in the remediation process. Surrounding vegetation includes Douglas- fir, and mixed oak woodlands. The road system can only be used seasonally. It is recommended that the site be removed and the flat grass seeded. The road should be water barred, and all cultivation materials should be removed from the slope.

Photo 5. Site M cultivation site should be remediated and restored by planting grass. The nearby serpentine area is characterized by a blue-green tinge, and this area should be avoided.

- a) Remove all cultivation related materials from the site.
- b) Maintain all existing vegetation. No grading required. Maintain outsloped flat.
- c) Straw mulch all disturbed bare soil within 100 feet and seed with a native grass seed mix such as Pacific Coast Seed Native Erosion Control Mix.

1. All cultivation materials will be removed.
2. Spread native grass seed.
