A Biological Assessment for Commercial Cannabis Cultivation

Chad Mussey
PO Box 1932
Redway, CA 95560
APN 223-032-004

Brit O'Brien - Wildlife Biologist
O'Brien Biological Consultants
2407 Frank St.
Eureka, CA 95501
707.845.6627

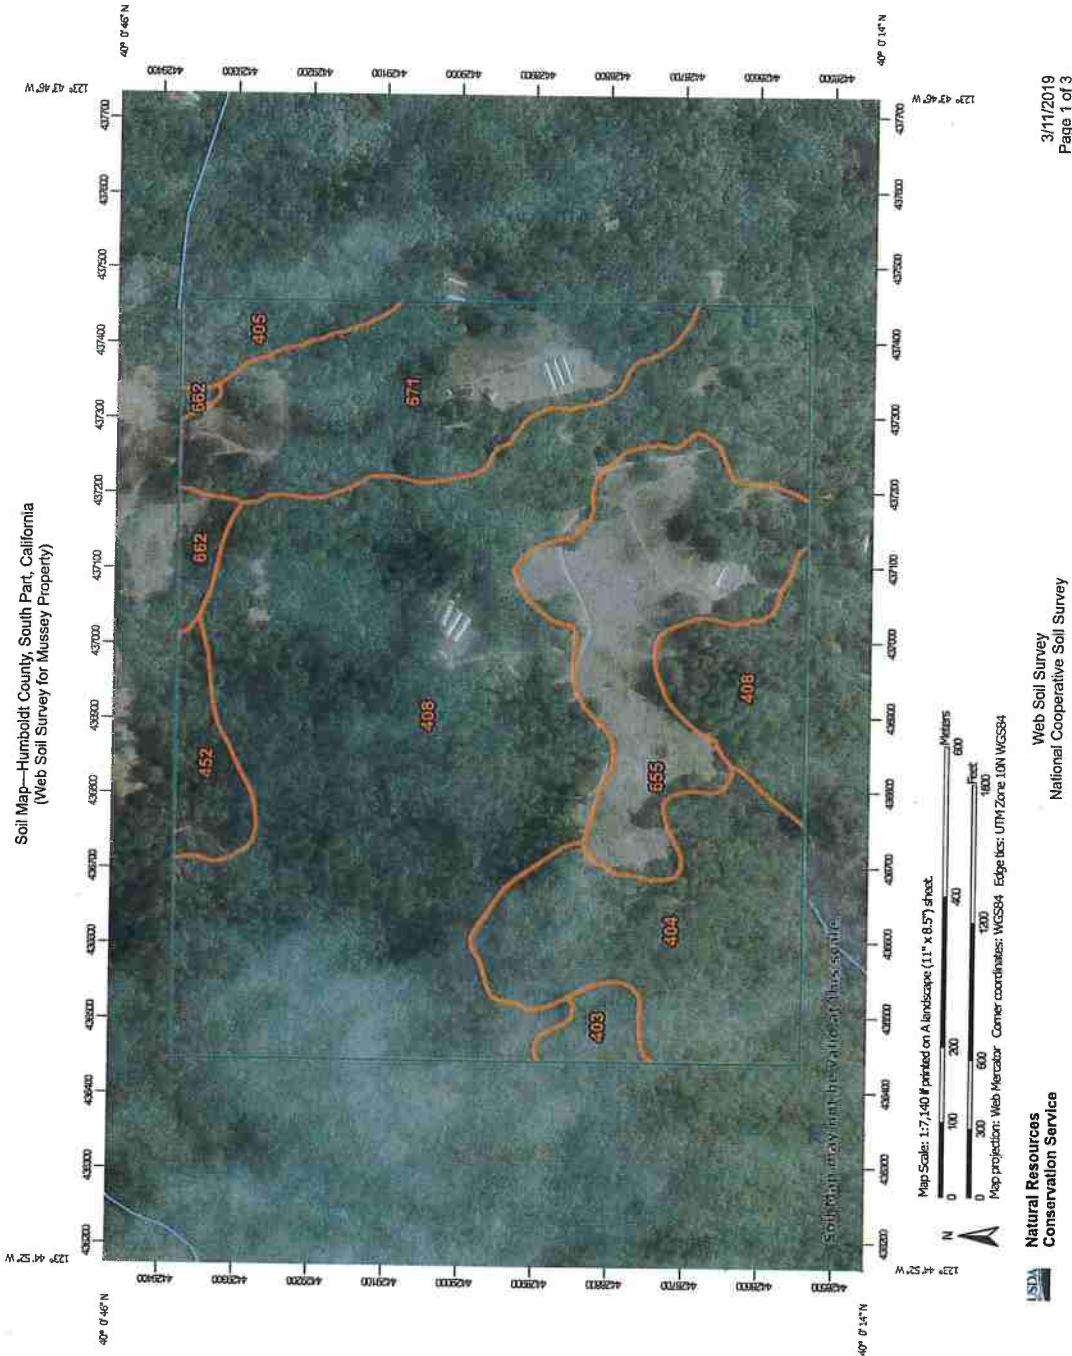
Figure 4. Web Soil Survey

The BAA may contain 8 different soil types: Holohan-Hollowtree complex, 50-75% slopes; Tannin-Wohly-Rockyglen complex, 30-50% slopes, Holohan-Hollowtree-Casabonne complex, 9-30% slopes and 30-50% slopes (MLRA 5), Burgsblock-Coolyork-Tannin complex, 30-50% slopes, Yorknorth-Witherell complex, 15-30% and 30-50% slopes, and Coolyork-Yorknorth complex, 5-30% slopes (Figures 3, 3A, 3B).

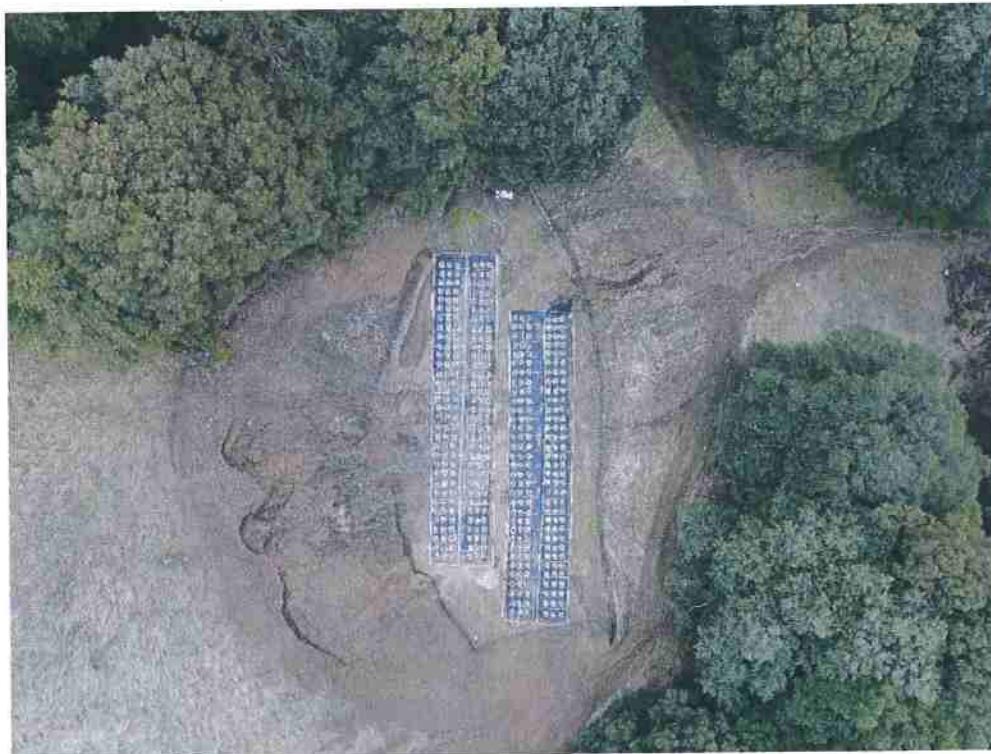
The cannabis cultivation will take place in existing greenhouses and outdoor facilities located on four sites throughout the parcel (Photos 1-4). Site 4 (photo 4) along the southern boundary of the property will be removed and the site will undergo remediation to restore the natural slope and vegetation and to prevent any further erosion. The existing cultivation site 1 in the northeast corner of the property will be relocated to prevent encroachment on the 100 foot the buffer distance to a Class II creek (Photo 1). The existing cultivation areas currently in use contain a total cultivation area of approximately 36,640 square feet.

4.0 Photo of Cultivation Site 4 (Remediation Site)

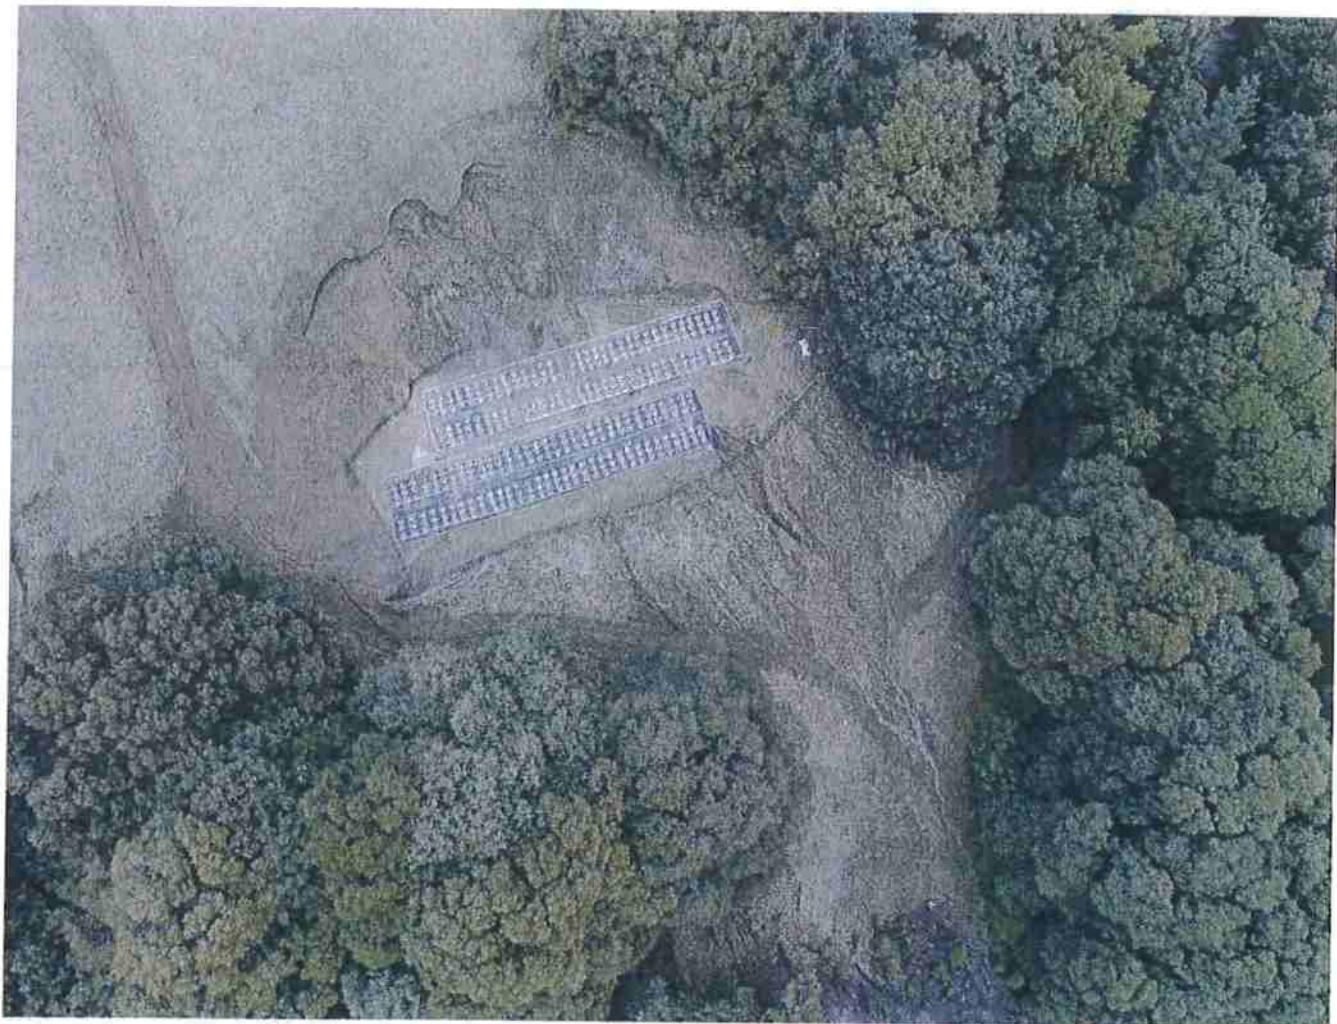
The cut and fill construction of the cultivation site (terrace) on this landslide complex has triggered cut-bank failures as seen on the attached photos. Inadequate drainage of emergent shallow groundwater from the Franciscan mélange, in combination with storm-water runoff, have severely eroded the fill-slope resulting in a small debris torrent as seen on the attached photos.

Picture 1: Cultivation site proposed for relocation. Note cut-slope failures above the site, and fill-slope erosion and debris torrent below the site. Photo date 3-1-2019.

As a Third-Party representative to the Water Board, Timberland Resource Consultants recommends relocating the 5,200 ft² of existing cultivation located along the southern, east-west property boundary into the footprint of the existing cultivation site presently comprised of three 24-ft by 120-ft greenhouses located along the eastern property boundary.

The cultivation site shall be fully decommissioned and returned to pre-existing contours per an approved Grading Permit from Humboldt County. The access road shall be waterbarred to a spacing consistent with a "high" Erosion Hazard Rating per 14CCR 914.6. The access road was previously used for logging in association with THP 1-01-128 HUM and may be needed again in the future. The access road in question contains no cuts and fills and therefore full decommissioning is not needed. Installation of large, maintenance-free drainage structures (waterbars) will suffice until the road grows over with vegetation. An approved Grading Permit shall include an Erosion Control Plan, which addresses the treatment of bare mineral. Native grasslands surround the cultivation site and grasses will naturally spread vegetatively through rhizomes below the soil, and via seed production. However, revegetation of the site with native grasses is recommended per the following Revegetation Plan.

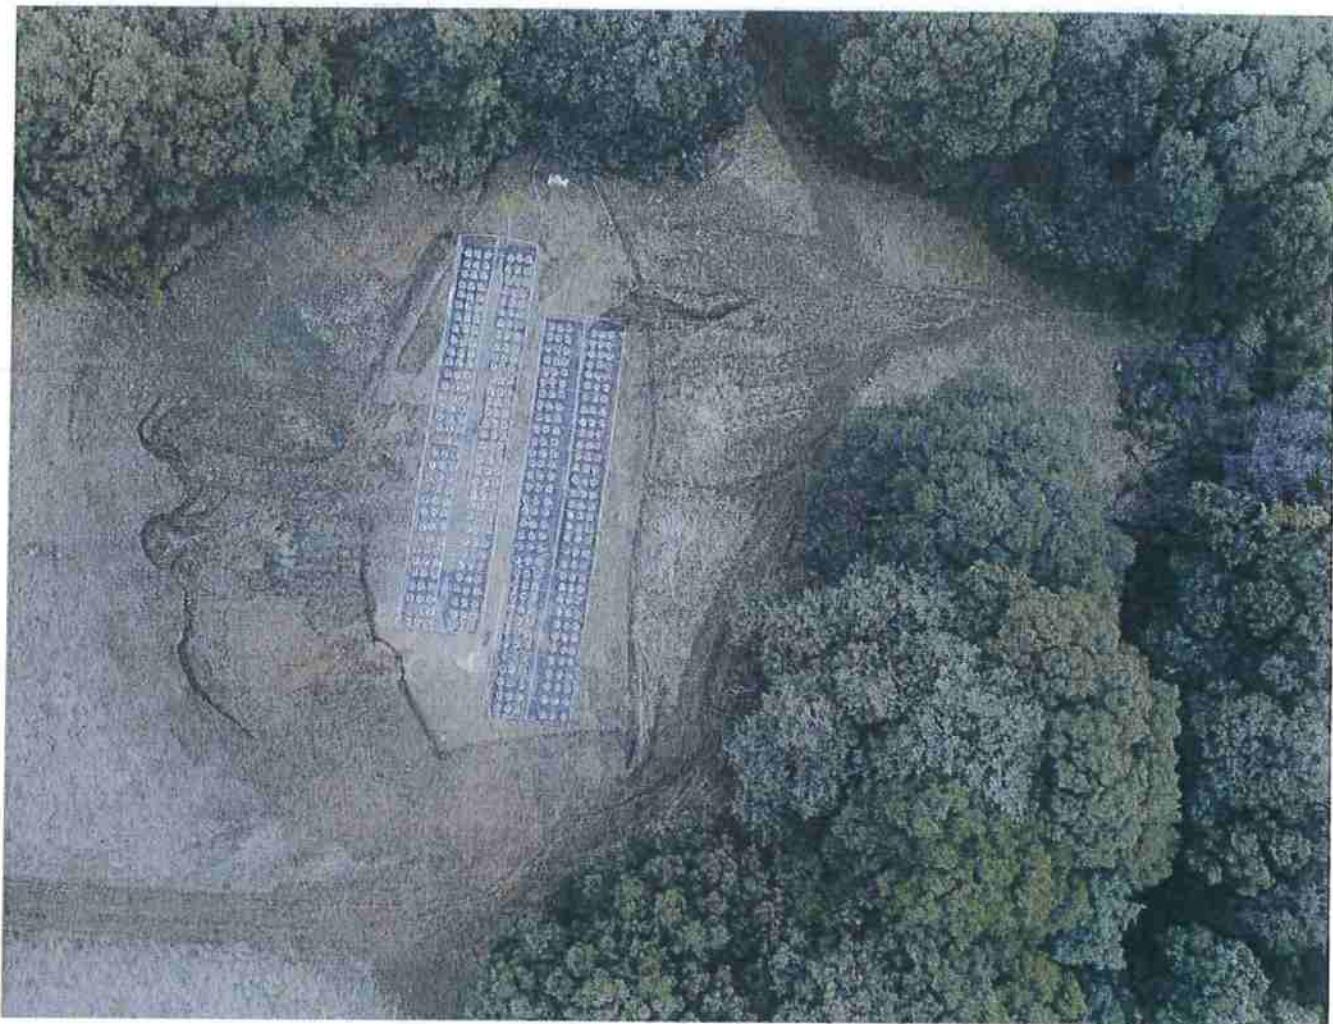
Picture 2: Cultivation site proposed for relocation. Note cut-slope failures above the site, and fill-slope erosion and debris torrent below the site. Photo date 3-1-2019.

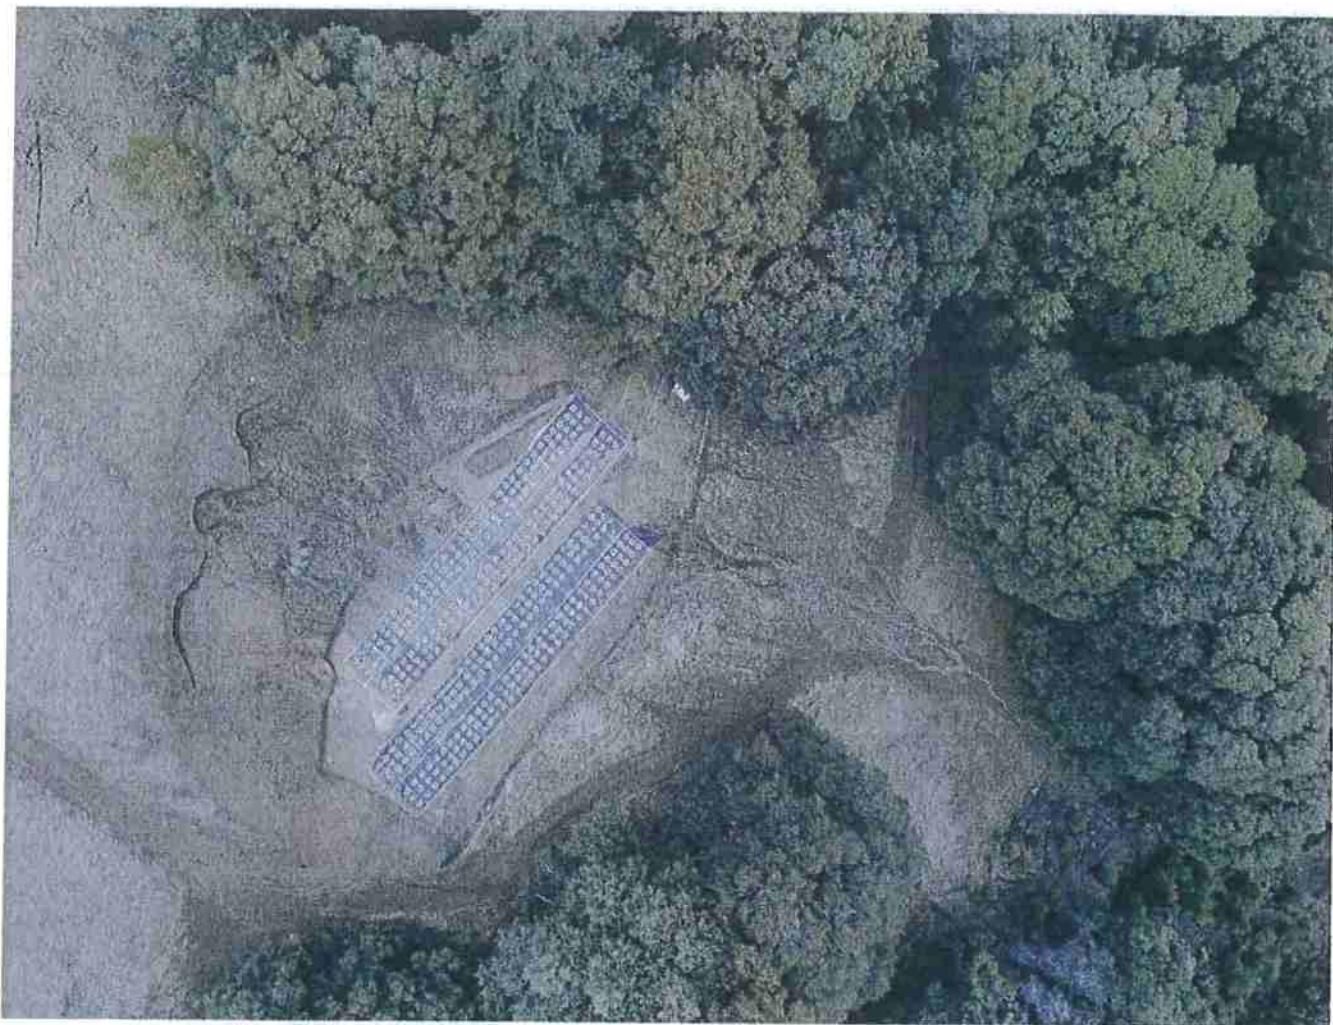
Picture 3: Cultivation site proposed for relocation. Note cut-slope failures above the site, and fill-slope erosion and debris torrent below the site. Photo date 3-1-2019.

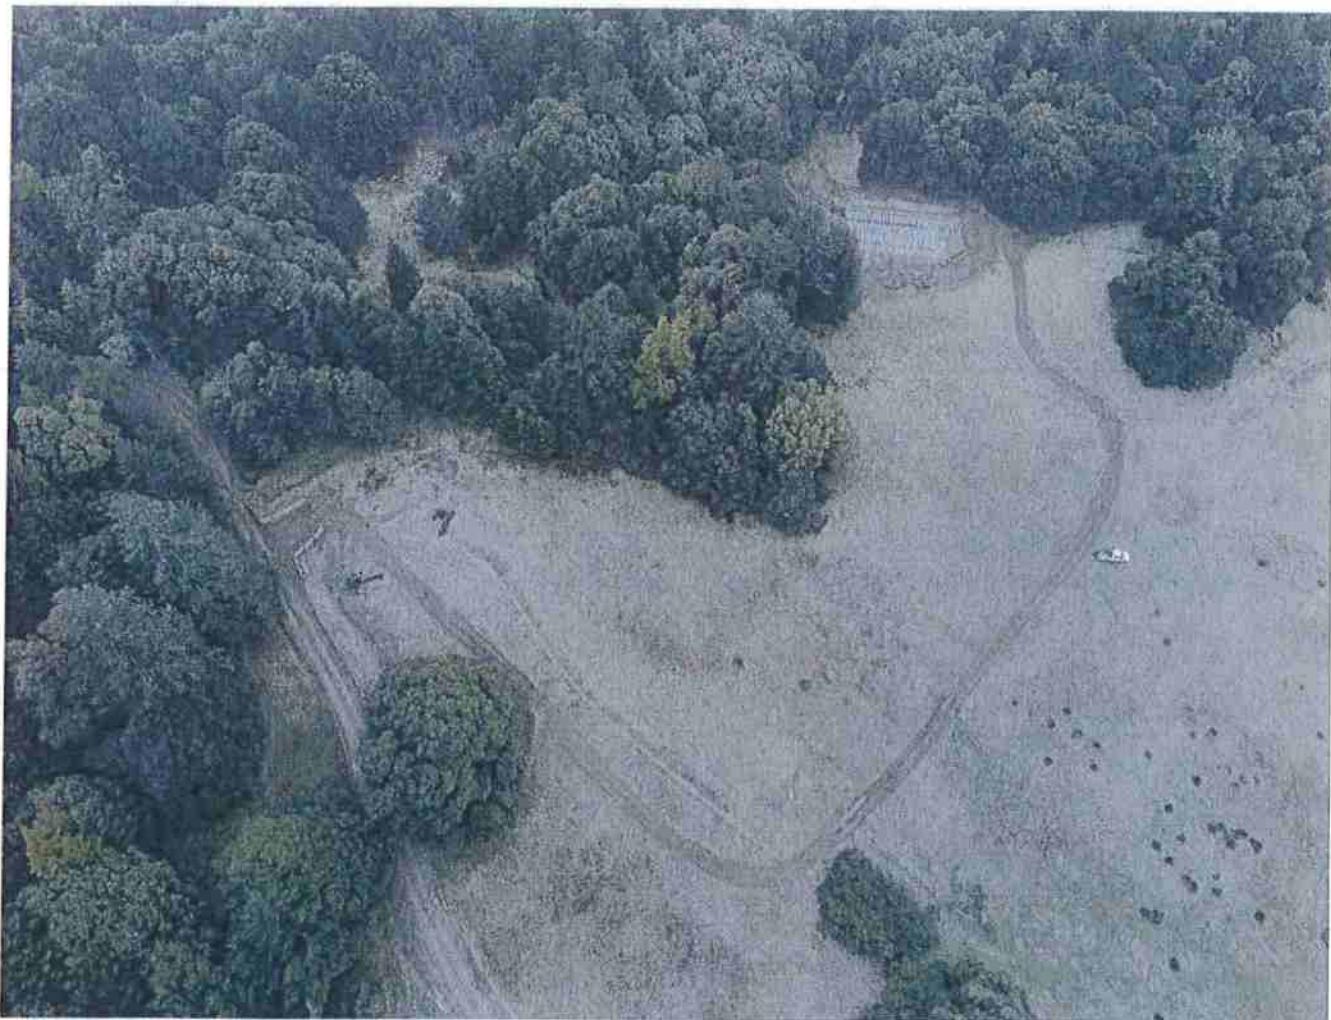
Picture 4: Seasonal road accessing the cultivation site proposed for relocation and restoration. The access road shall be abandoned via the installation of waterbars to a spacing consistent with a "high" Erosion Hazard Rating per 14CCR 914.6. Photo date 3-1-2019.

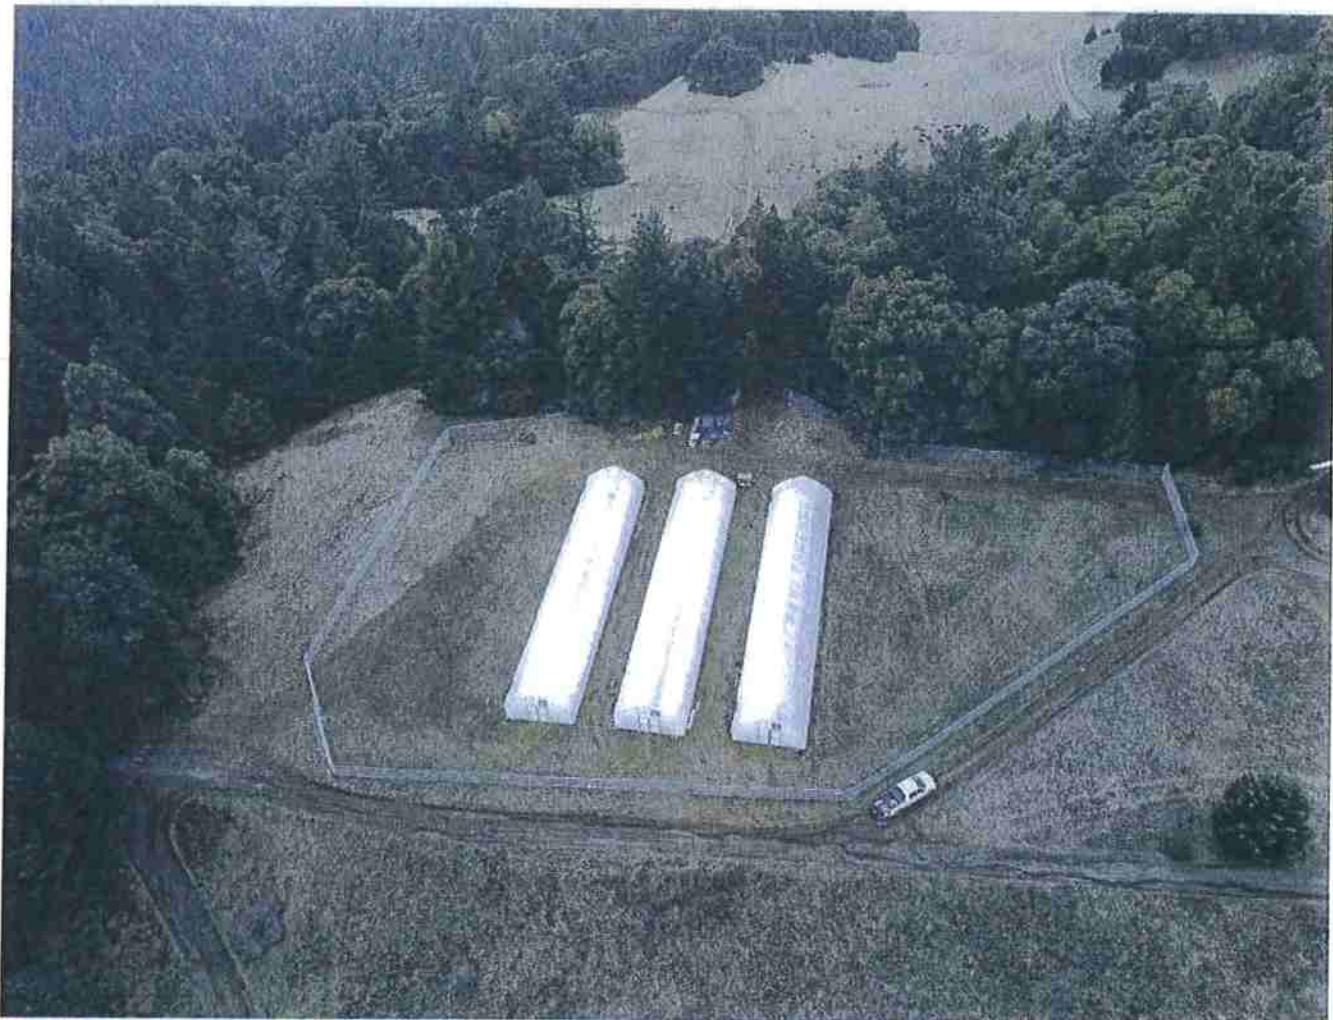
Picture 5: The proposed relocation area presently comprised of three 24-ft by 120-ft greenhouses located along the eastern property boundary. The cultivation site located on the landslide is proposed to be relocated within the fenced area of this site. Photo date 3-1-2019.

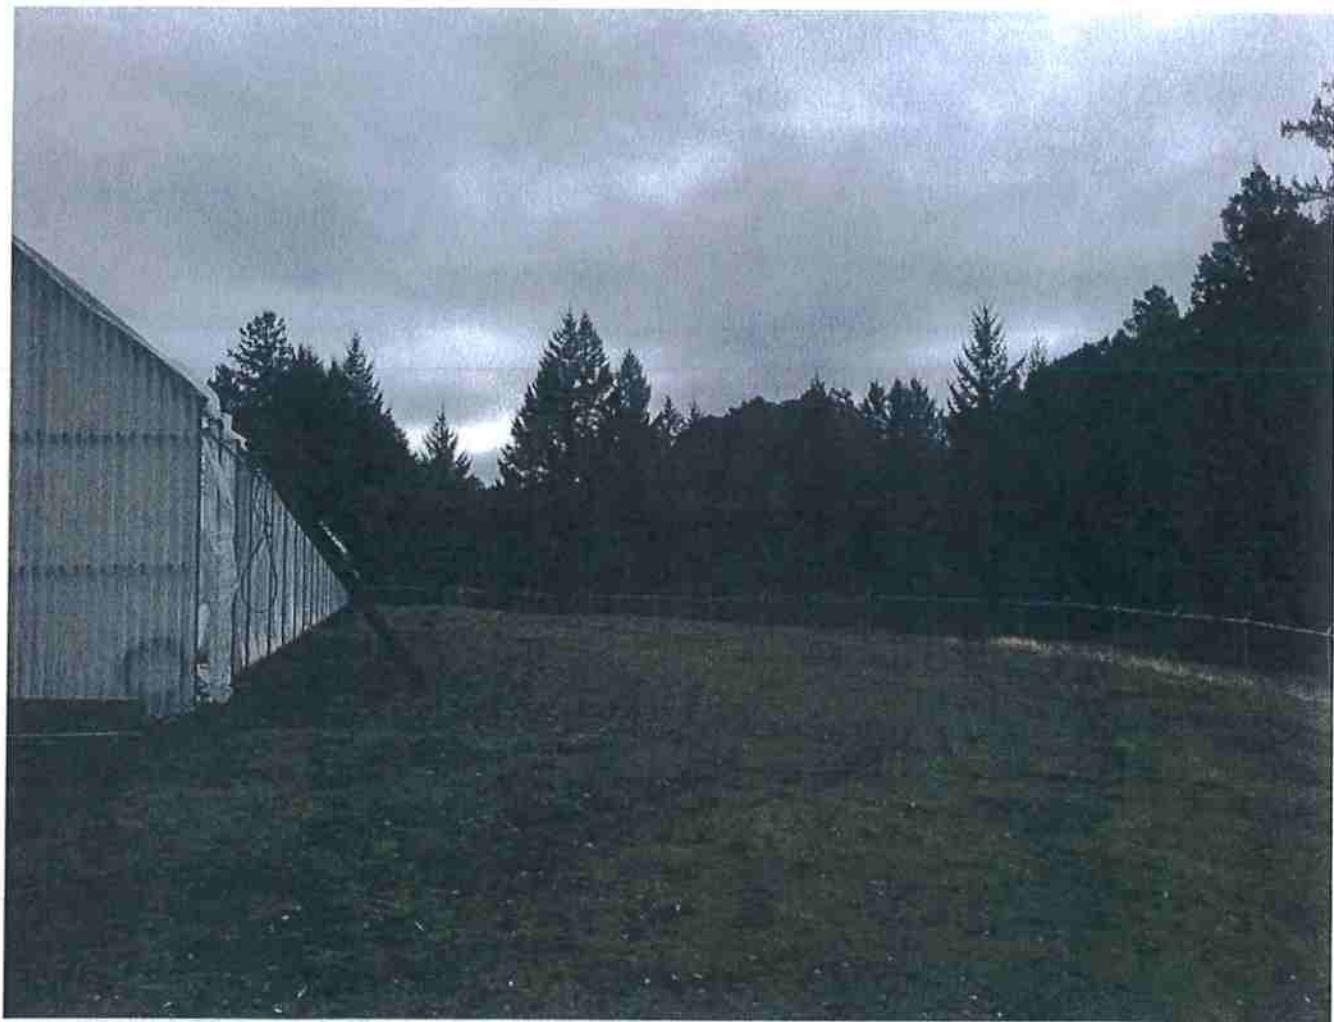
Picture 6: Proposed relocation area; the portion of which is located south of the southern-most existing greenhouse. Photo date 3-1-2019.

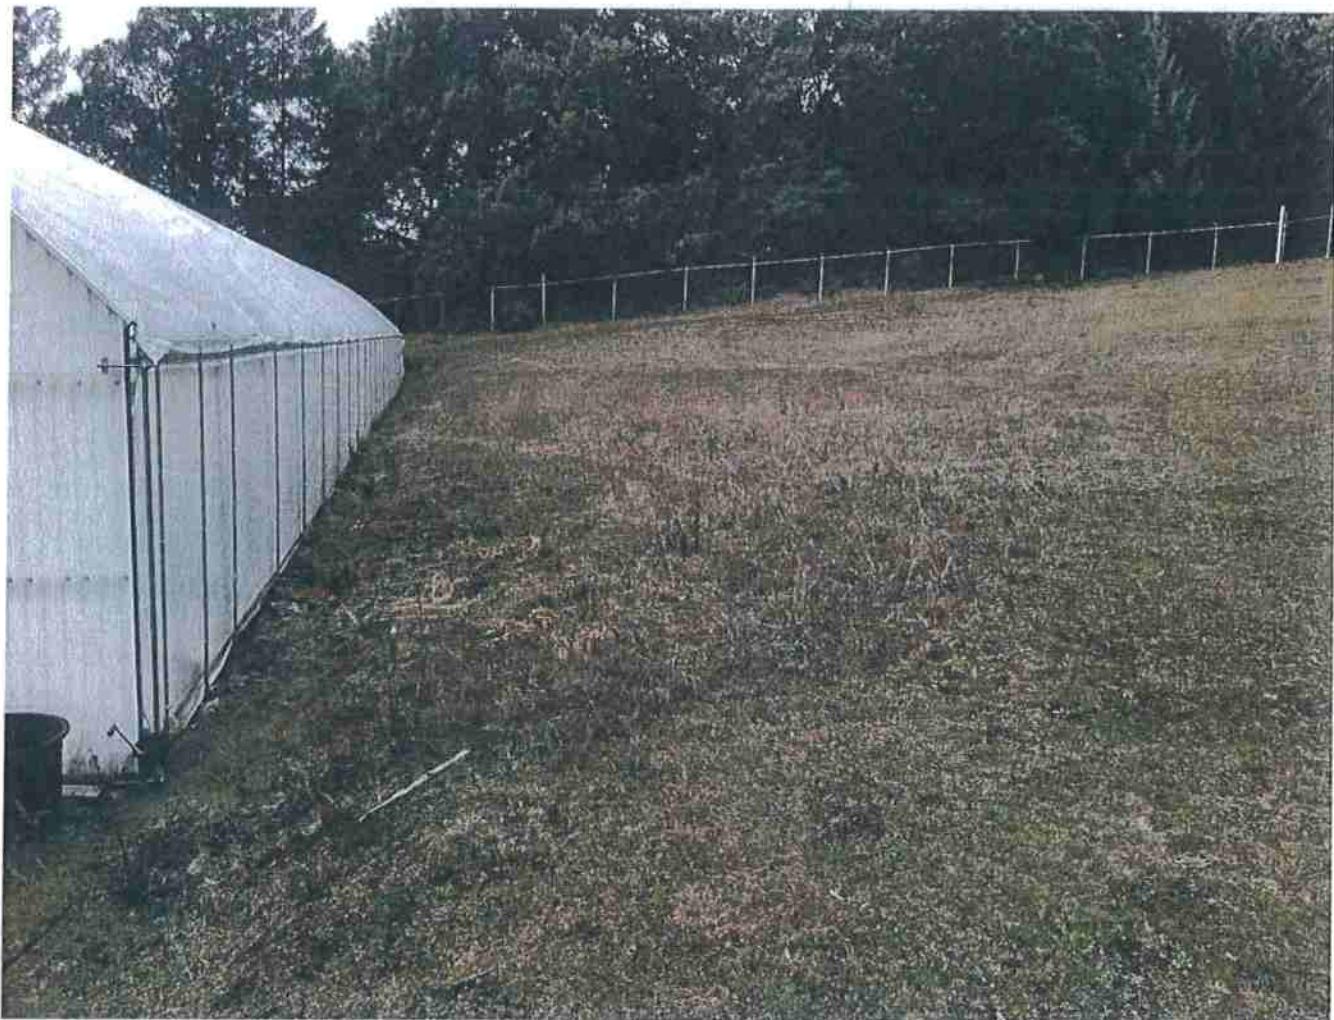
Picture 7: Proposed relocation area; the portion of which is located north of the norther-most existing greenhouse. Photo date 3-1-2019.
