PLAN OF OPERATION

Project: Drewry Rock Quarry
Renewal of Permit #CUP-19-92/SMP-02-92

RECLAMATION PLAN
FOR
BELL SPRINGS ROCK QUARRY
February 1993

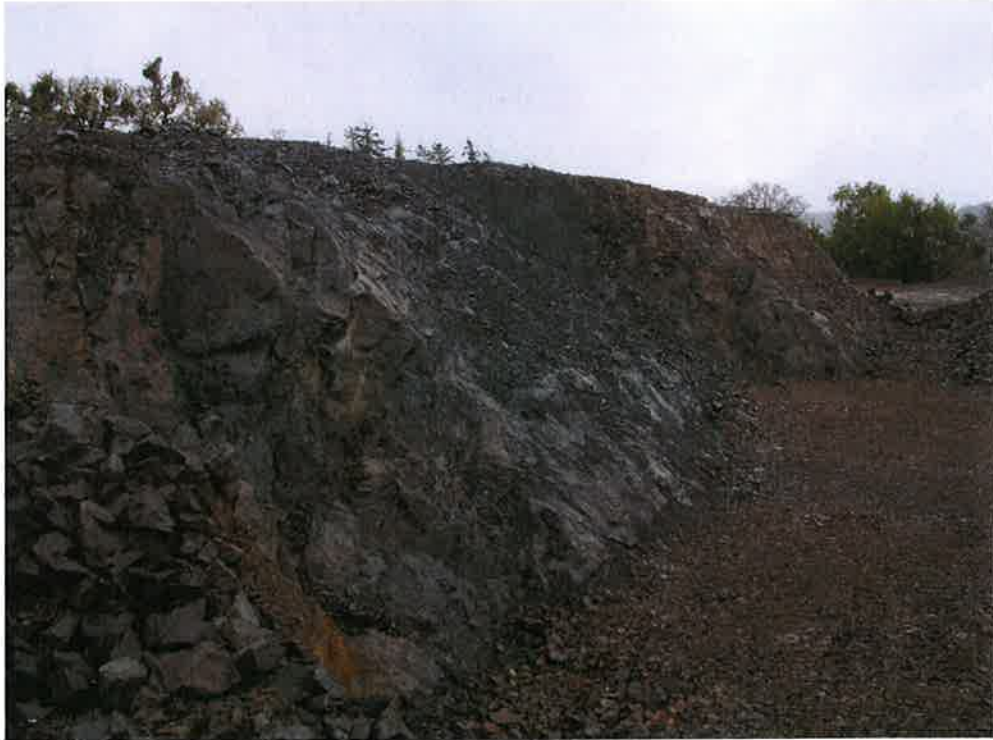
#3 – Looking South at Quarry Face (February 21, 2008)

The quarry face is currently approximately 20-25 ft high, with the elevation of the top of the face approximately three ft lower than the top of the hill.

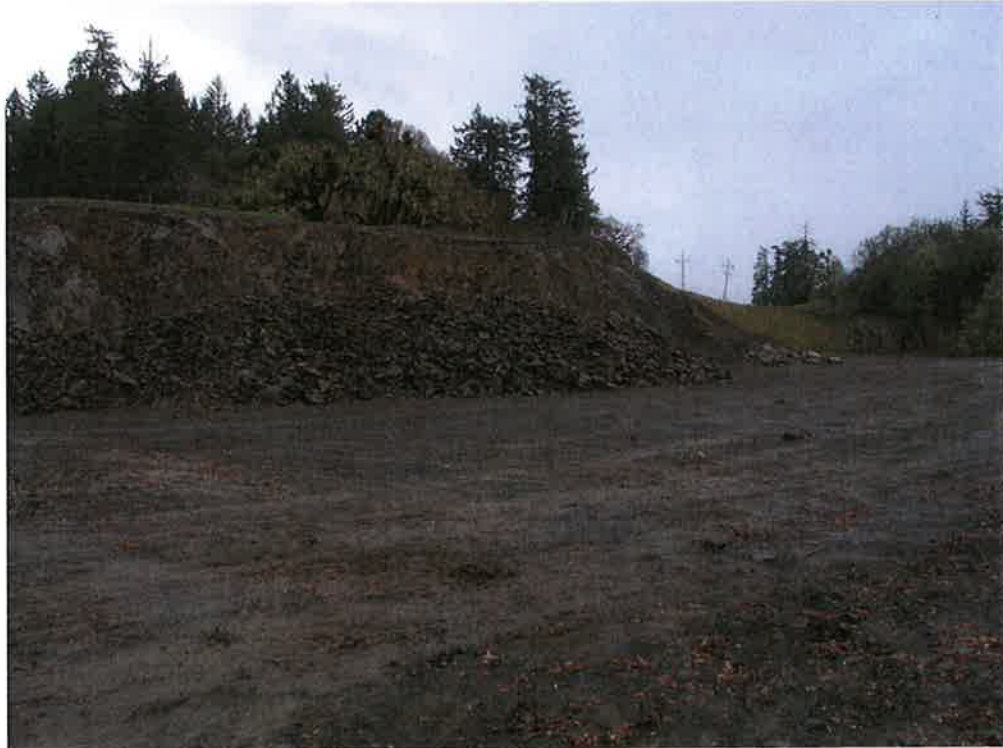
#4 – Overview of Quarry Face (February 21, 2008)

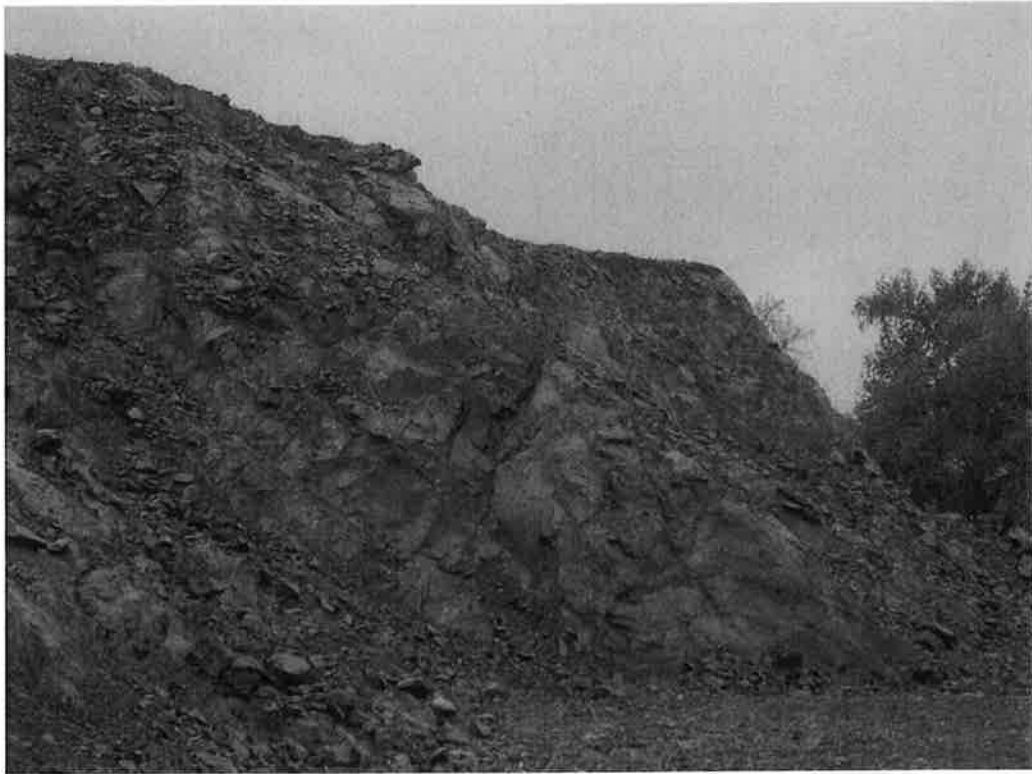
#5 – Quarry Face (Hard Rock Area) (February 21, 2008)

Following each extraction, the quarry face will be left with a slope of 1:1 (except for hard rock outcrops). The floor will be regraded flat as necessary, with a depression located in the center where rainfall runoff from the face and floor will accumulate and evaporate or percolate into the ground. Containment berms will be repaired or reconstructed as necessary to keep runoff from flowing down the west hillside toward Tom Long Creek (0.4 mile below the quarry). These berms will be revegetated as needed using fast-growing native grass seed and mulched.

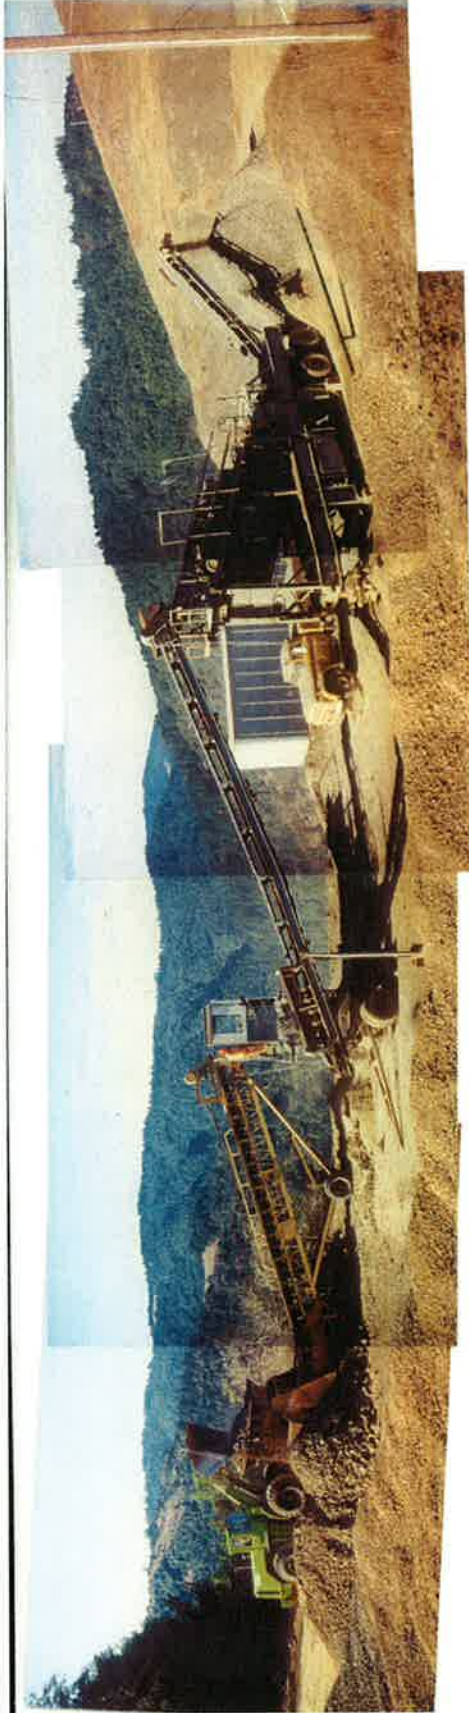
**Crusher Assembly in Operation
(Drewry Rock Quarry, 1993)**

A portable crusher assembly, consisting of jaw and cone crushers, conveyors, and a generator trailer (see Appendix 1, Figure 4) will be temporarily located on the quarry floor between the quarry face and permanent stockpile area. Rock from the temporary stockpiles will be transported to the crusher via front-end loader. Crushed rock will then be transferred to the permanent stockpile. Once crushing activities are completed, the crusher assembly will be dismantled and removed from the area.

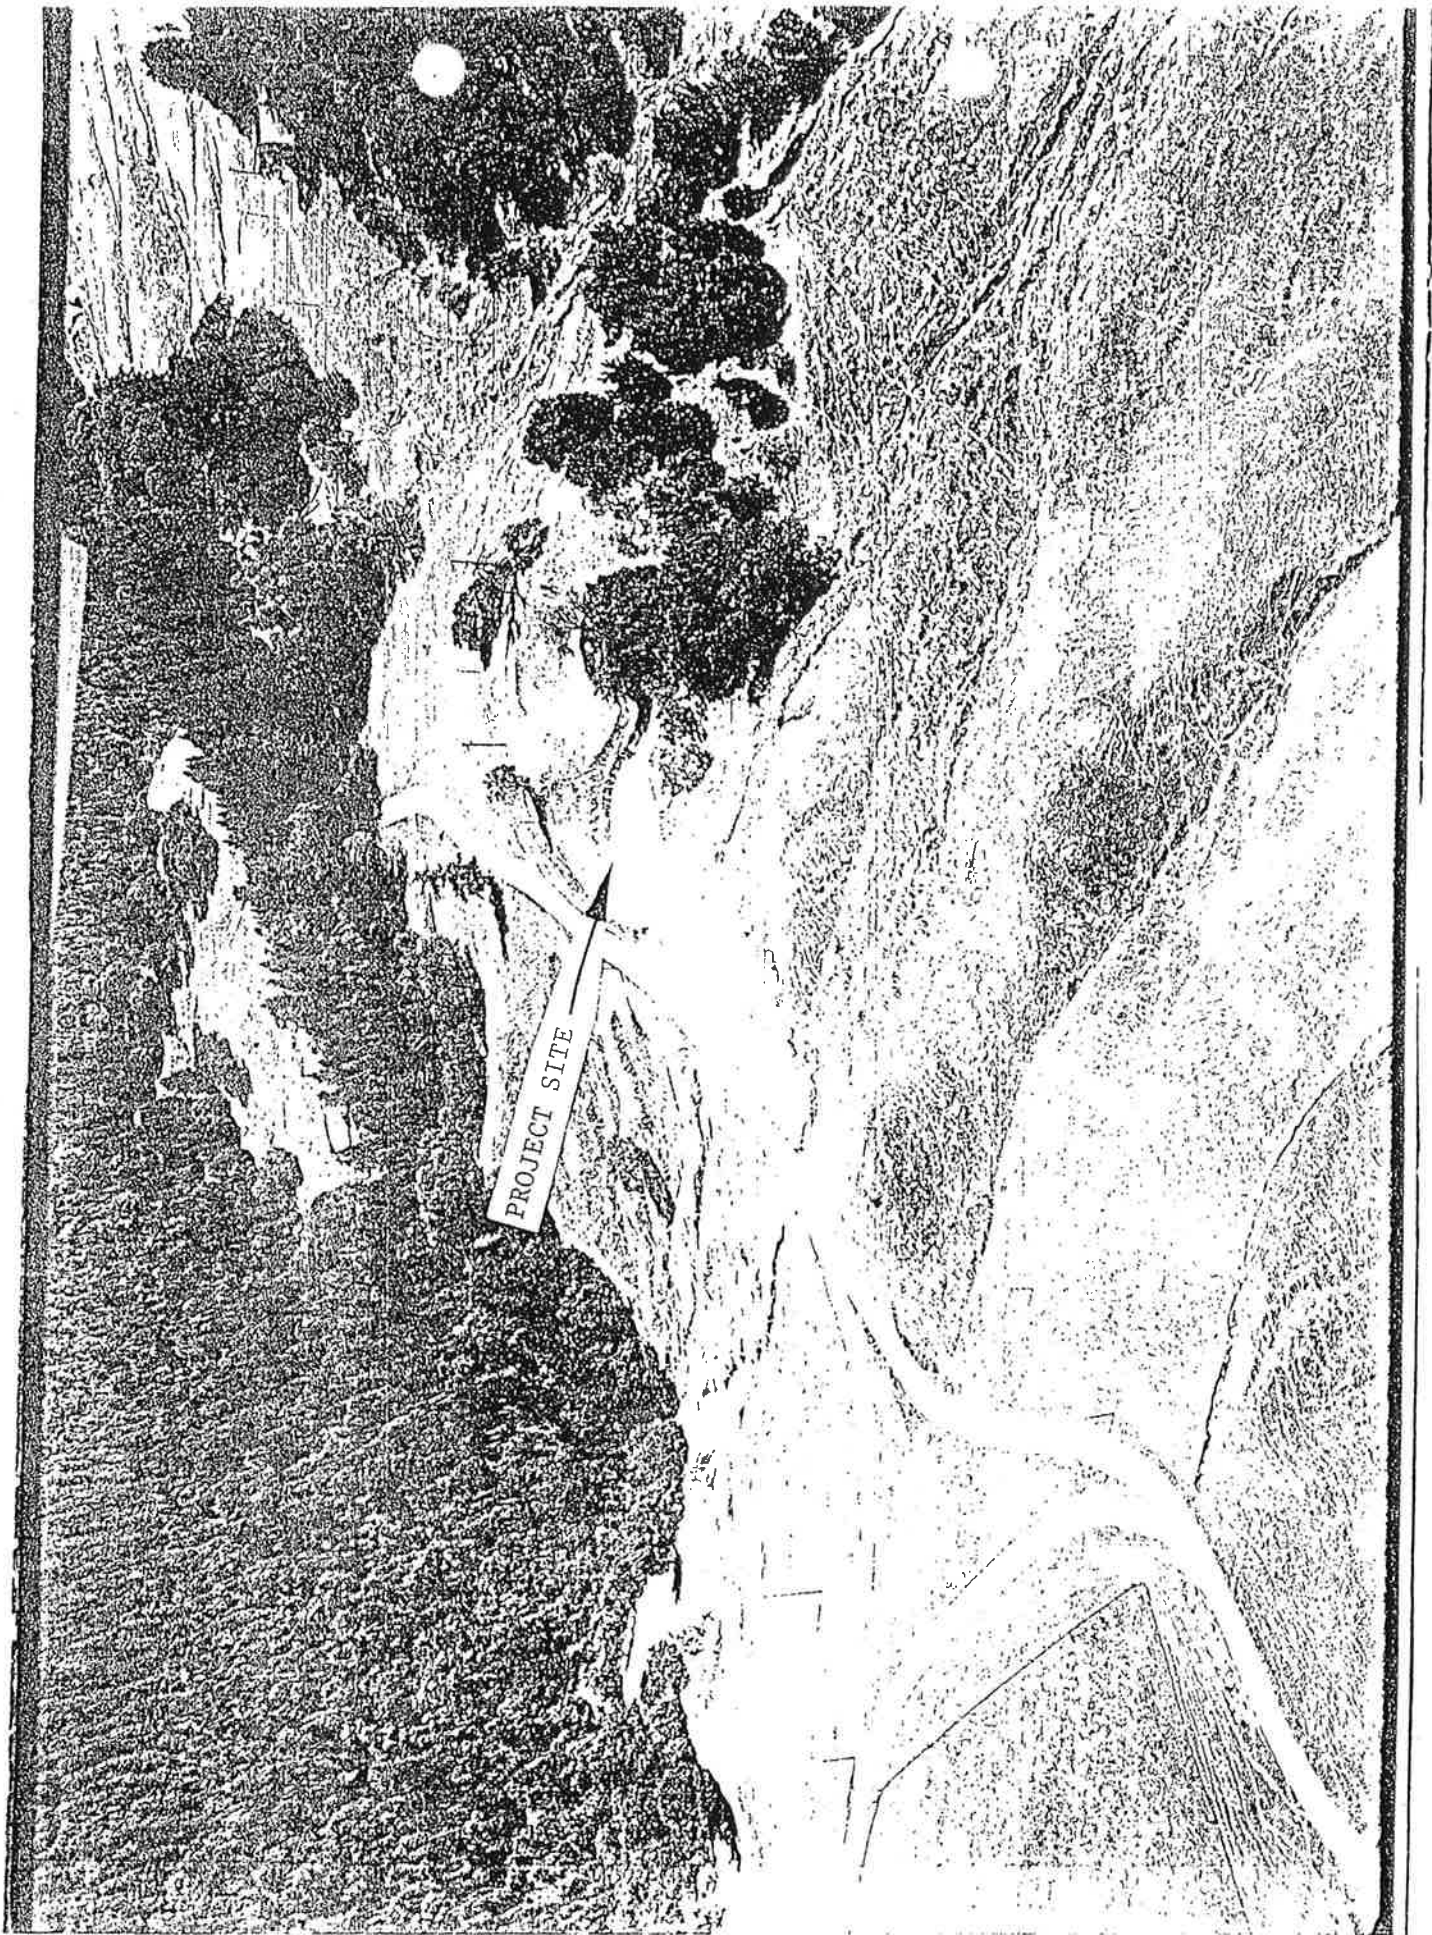
Figure 5 - Aerial Photograph of Bell Springs Rock Quarry 09/07/92.

To hold environmental impacts to an insignificant level, rock is removed only from the center of the original mound. The original exterior slopes and vegetation remain untouched. This method is creating a horseshoe shaped pit surrounded by the original vegetation and slopes.

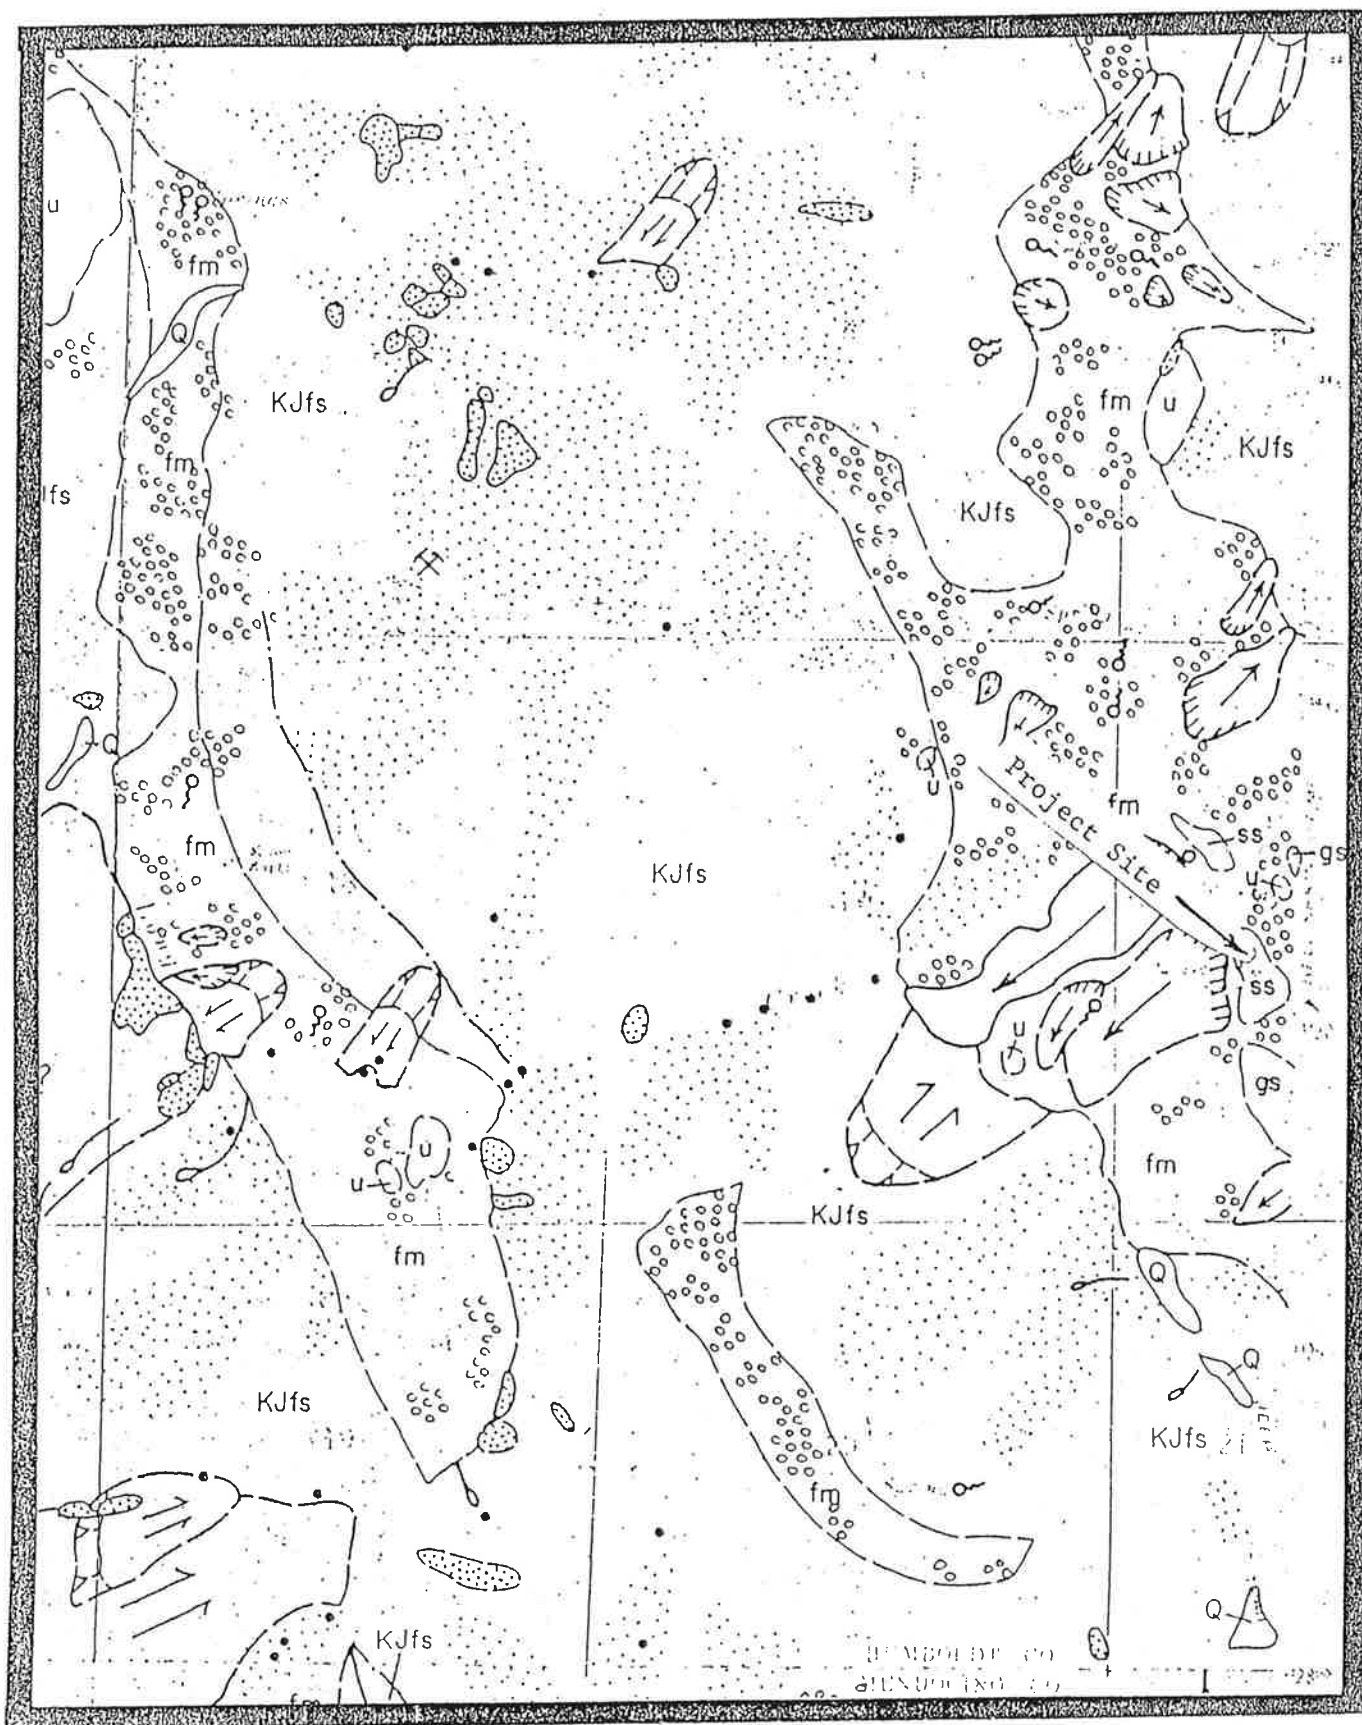
Figure 6 - Portion of 7.5 Minute USGS Harris Quadrangle Map showing geologic features at project site.
Scale 1" = 2,000'

Geology.--This mountain region of the Eel River basin consists of Franciscan melange which is a highly sheared unit composed of a matrix of sheared massive sandstone. The rock in the quarry itself consists of graywacke and sandstone which has been determined by the Materials Lab to be of excellent quality for road maintenance purposes. Typically, Franciscan melange consists of a rolling hummocky terrain highly susceptible to mass movement in which the melange boulders form scattered knobs that protrude out of grassland and grass-oak woodland. Figure 6 is a portion of the 7.5 minute Harris Quadrangle Map showing the project site. The SS indicates the sandstone and shale rock types found here. There is an earthflow symbol shown to the south and west of the site. Quarrying activity here over the past 40 years has had no known effect on earth movement. This data was compiled by Thomas E. Spittler, Geologist, California Division of Mines & Geology, 1984.
