RECLAMATION PLAN

**MONUMENT QUARRY
CA MINE ID #91-12-0025**

(Humboldt County)

Amended December 2025

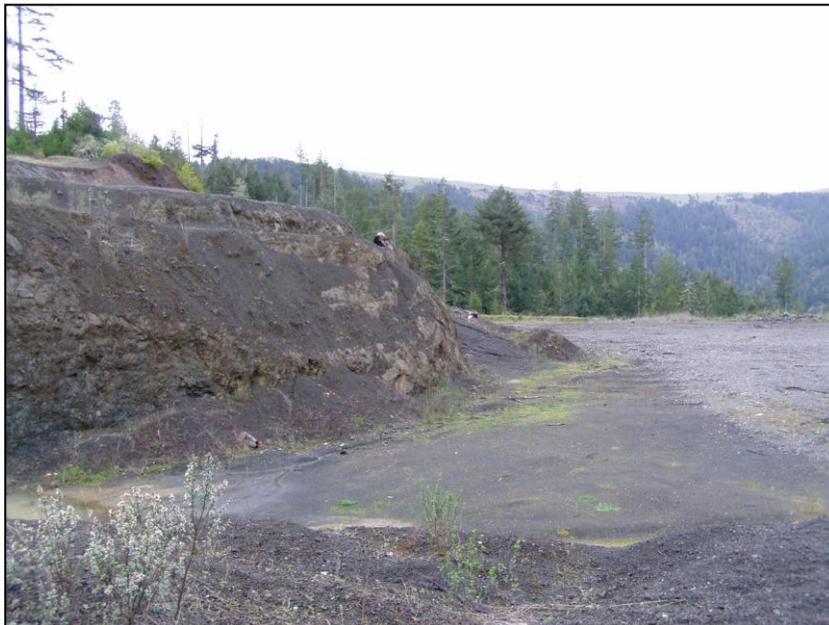
Looking Southwest from the Quarry Floor (2010)

The quarry was originally developed along an exposed shale ridgetop that separates Atwell Creek on the west from Dean Creek on the east, both tributaries to the main-stem, Eel River. The estimated volume of material available in 1995 was >100,000 yd³. Operations between 1955 and 1995 removed 25,000-30,000 yd³ from the site, resulting in the quarry floor and face that existed when the site was first permitted. Currently the quarry face is approximately 180 feet (ft) long x 22 ft high. There is an 18 ft wide ramp that serves as a catch bench at the top of the lower face. The upper face is set back from the lower face by the catch bench and is about 26 ft in height. The quarry floor is about 1.5 acres in area, and the combined area of gravel stockpiles is about 0.23 acre.

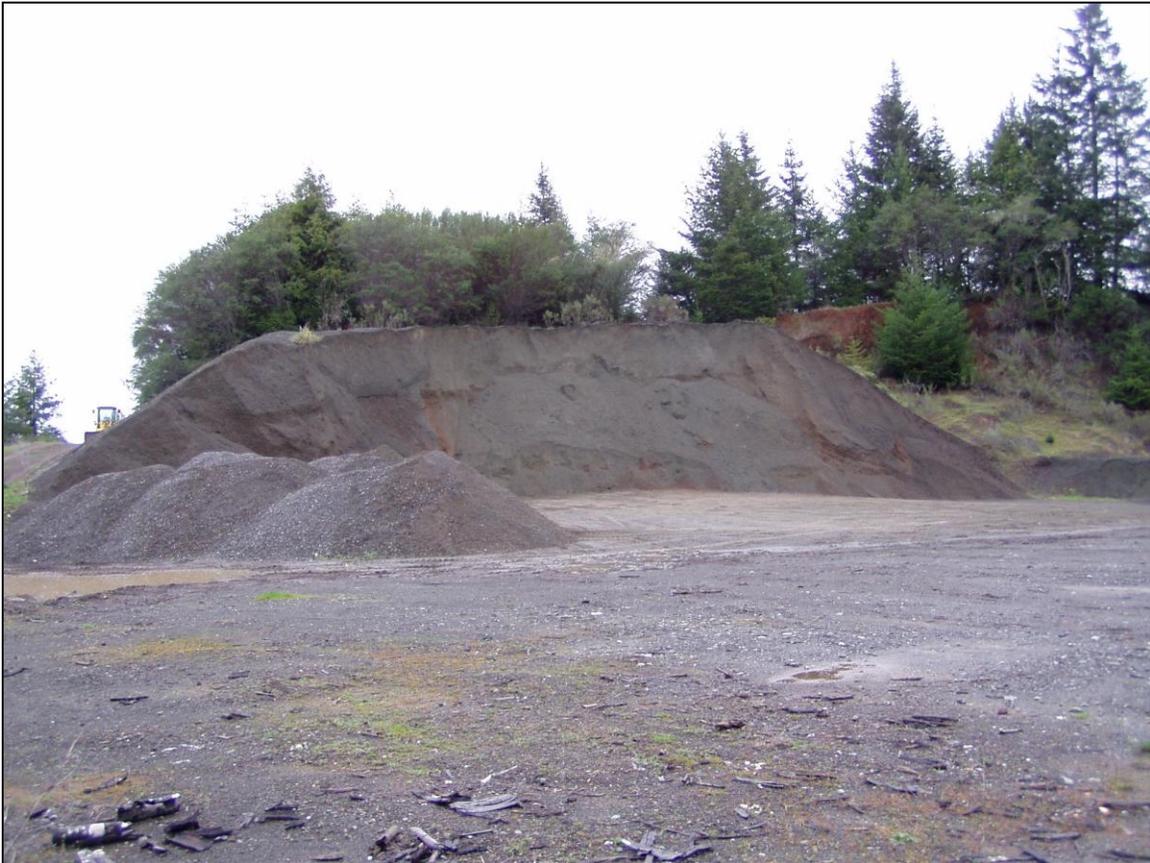
Looking Northwest towards Stockpile (2010)

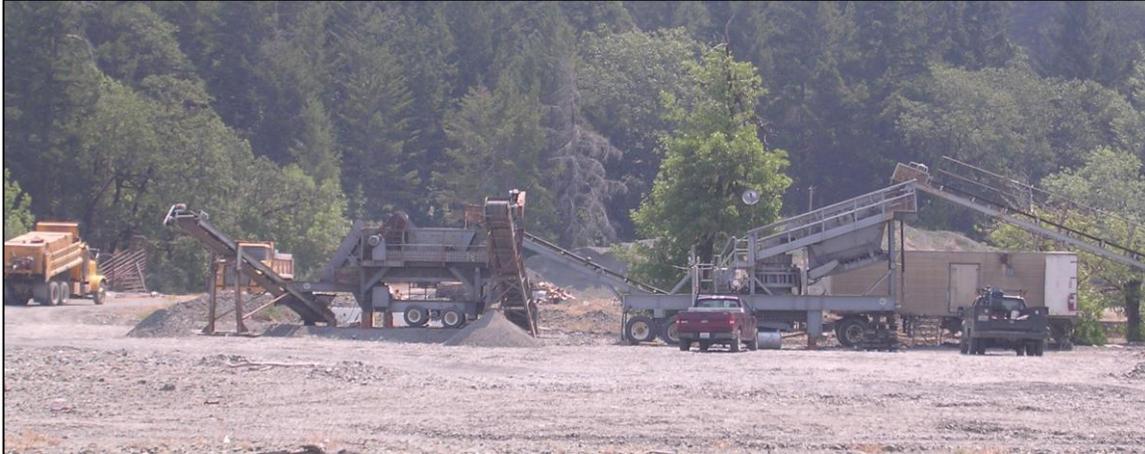
Crusher in Operation (Charles Bar 2008)

A portable crusher assembly, consisting of jaw and cone crushers, conveyors, and a generator trailer will be temporarily located on the quarry floor. Quarried rock will be transported to the

crusher via front-end loader. Processed rock will be sorted and placed onsite in stockpiles and will later be utilized for road maintenance and winter storm damage repair projects. Once crushing activities are completed, the crusher assembly will be dismantled and removed from the area.
