Hearing Date: October 7, 2021
To: Humboldt County Planning Commission
From: John H. Ford, Director of Planning and Building Department
Subject: **Humboldt County Department of Public Works Coastal Development Permit**
Record Number PLN-2021-17402
Assessor's Parcel Numbers (APNs) n/a-State Highway 255 Right of Way
Manila area

Project: A Coastal Development Permit application for Humboldt County Department of Public Works to develop a Class I bike path (also known as shared use path or multi-use trail) along the western side of the Highway 255 corridor in the Manila area. The project would start near the Pacific Avenue intersection (Post Mile 3.64) and terminate north of the Carlson Drive intersection (Post Mile 4.24) for a total length of 0.6 miles. The bike path is designed as a paved, 10-foot-wide surface with two, two-foot-wide shoulders offset variable distances from the edge of the highway shoulder. The project includes 150 feet of concrete sidewalk along Pacific Avenue, a crosswalk near the Pacific Avenue/Peninsula Drive intersection, two light standards near Pacific Avenue, crosswalks at Lupin Avenue and Carlson Drive, and on-site wetland creation. The purpose of the project

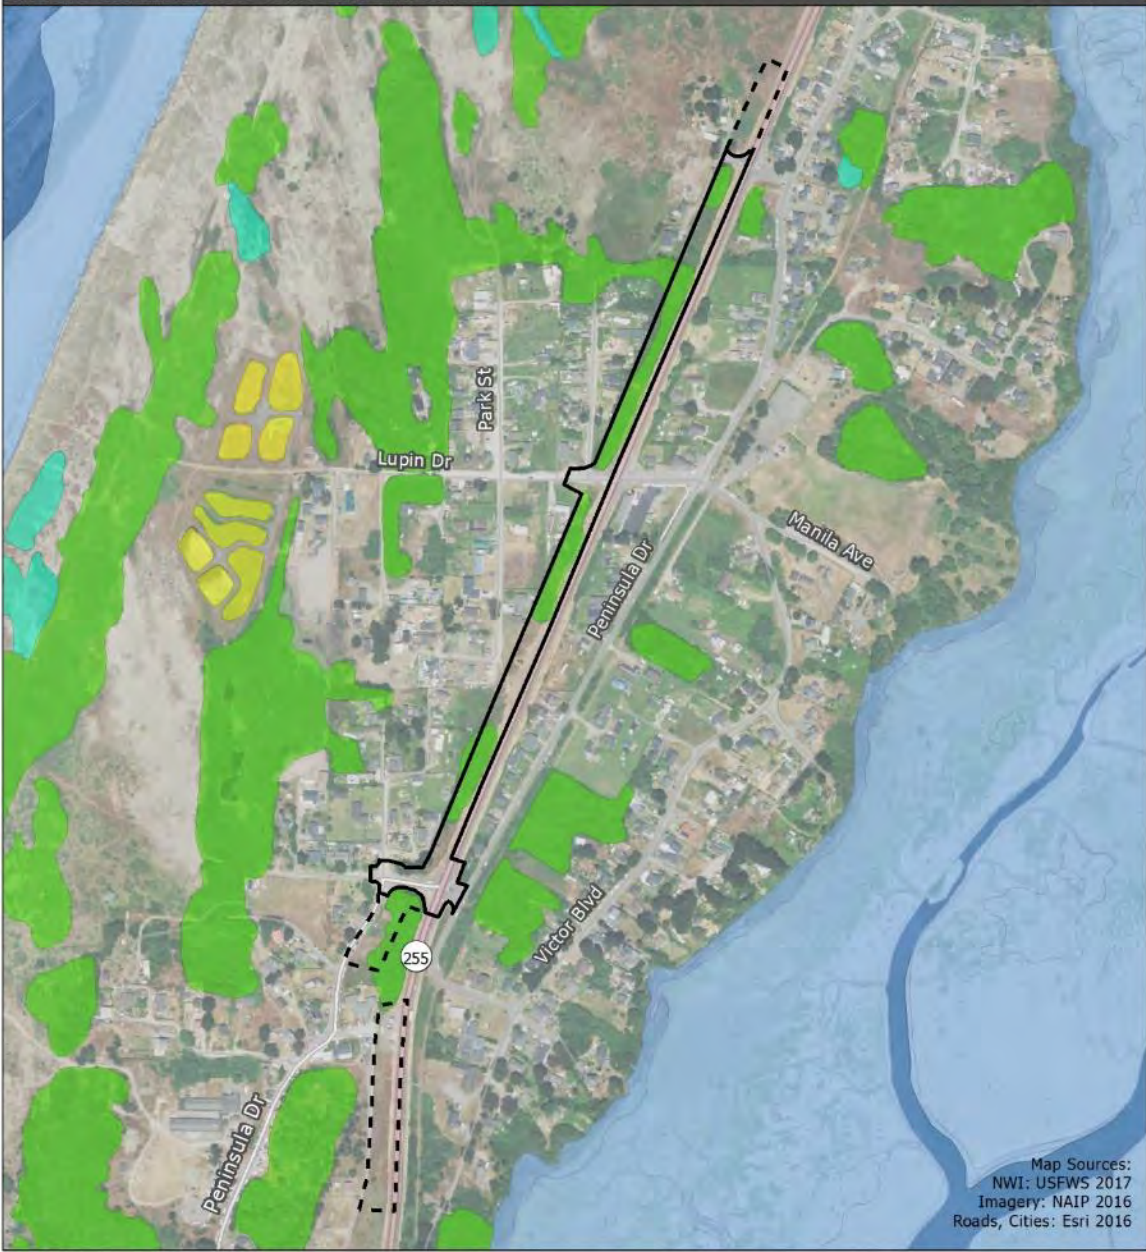
The *NWI Wetlands Mapper* shows palustrine scrub-shrub wetlands located throughout the Survey Area (Figure 2).

National Wetlands Inventory
