# Biological and Wetland Assessment—Revision 1

Garberville Sanitary District  
Robertson/Wallan/Hurlbutt Tanks  
Replacement Project

**October 2023**

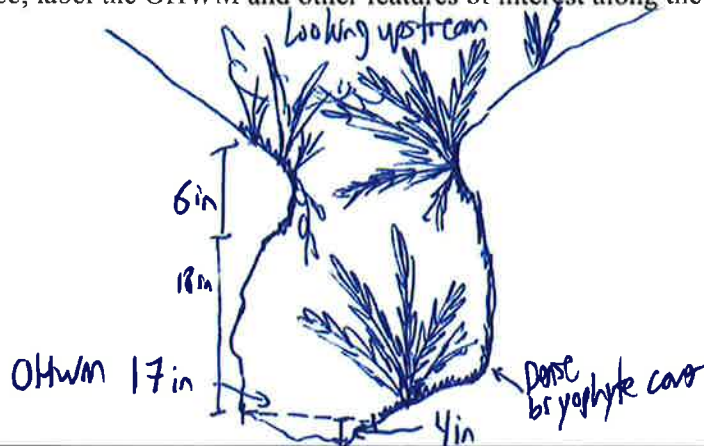
OHWM 17 in across, 4 in. above  
thalweg

**Break in Slope at OHWM:** ☐ Sharp ( $> 60^\circ$ ) | ☒ Moderate ( $30-60^\circ$ ) | ☐ Gentle ( $< 30^\circ$ ) | ☐ None

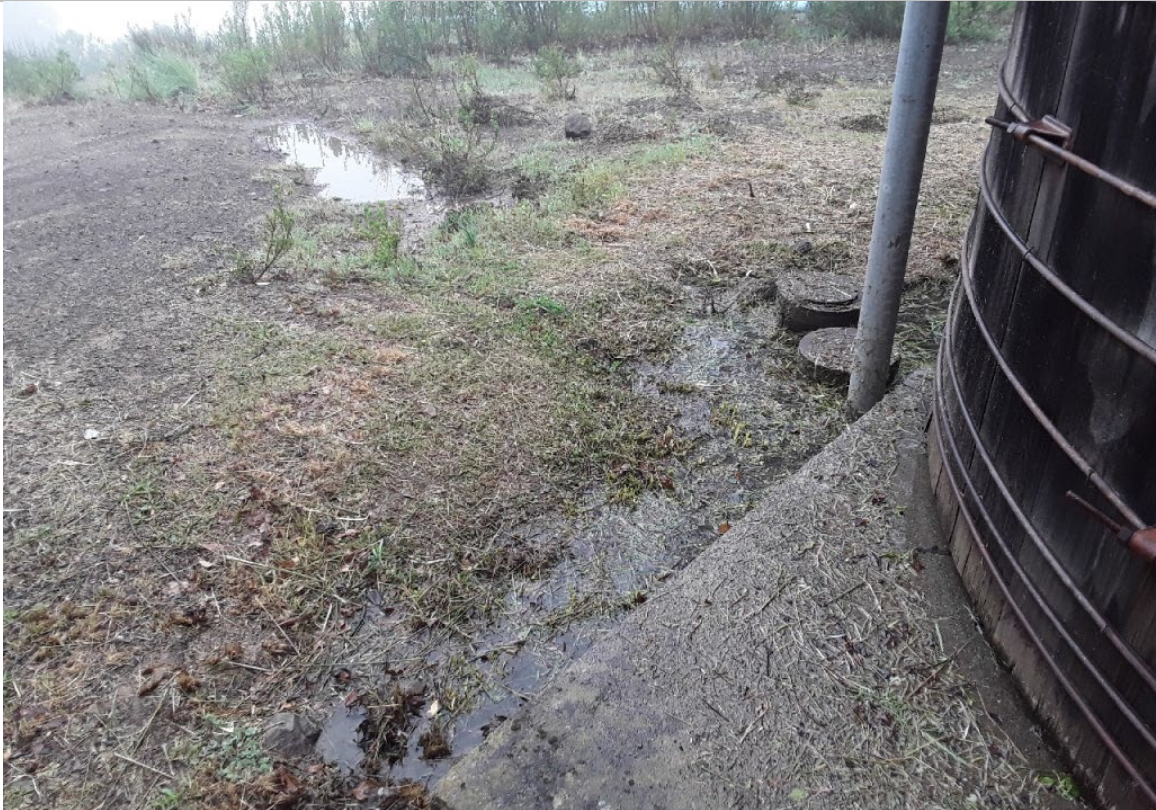
**Photo 1: Wallan tank site looking south. Note upland conditions around the tank with pooled water from tank leak. This area was not considered wetland due to the completely artificial conditions and lack of hydrophytes and hydric soils. Photo taken April 19, 2022.**

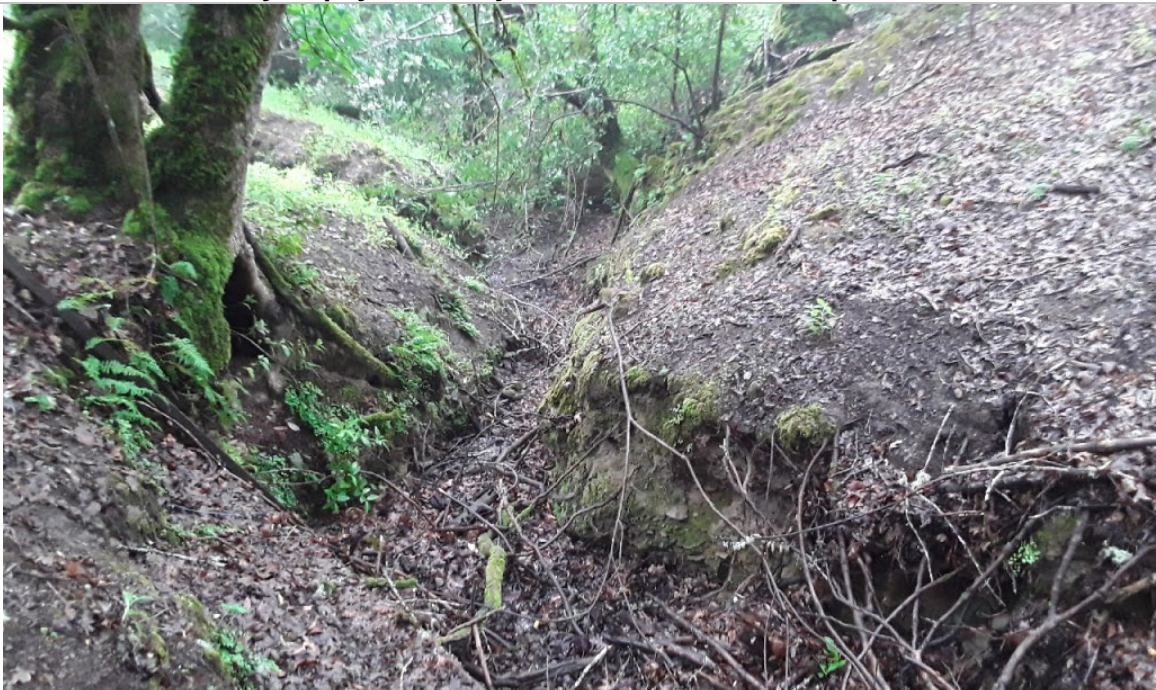
**Photo 2: Stream #1, looking upstream (North). Note steep sloping ravine and eroded stream channel. Intermittent stream flow lines are temporarily obscured by litter and debris from forested slopes. Photo taken April 19, 2022.**

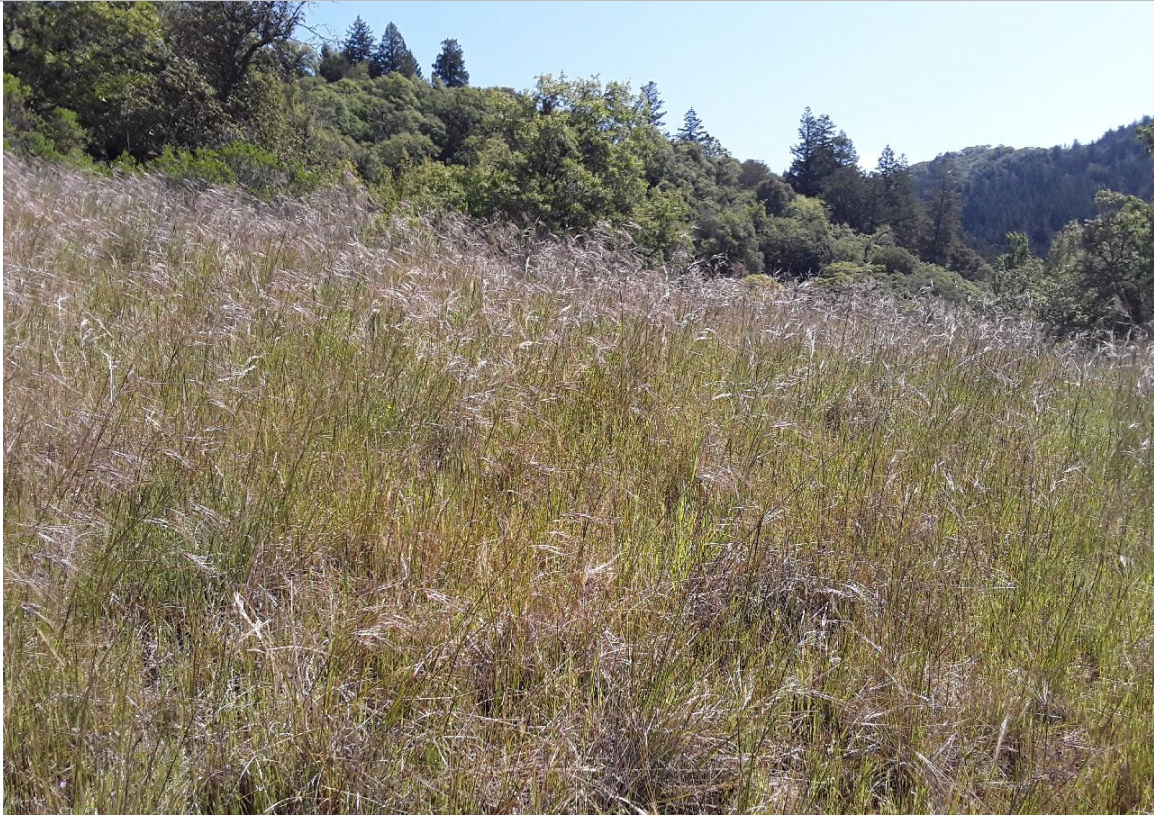
**Photo 5: Purple needlegrass grassland representative conditions, looking east near the Wallan Tank site. Note dense cover by purple needlegrass and abundant seed production. Photo taken April 27, 2022.**

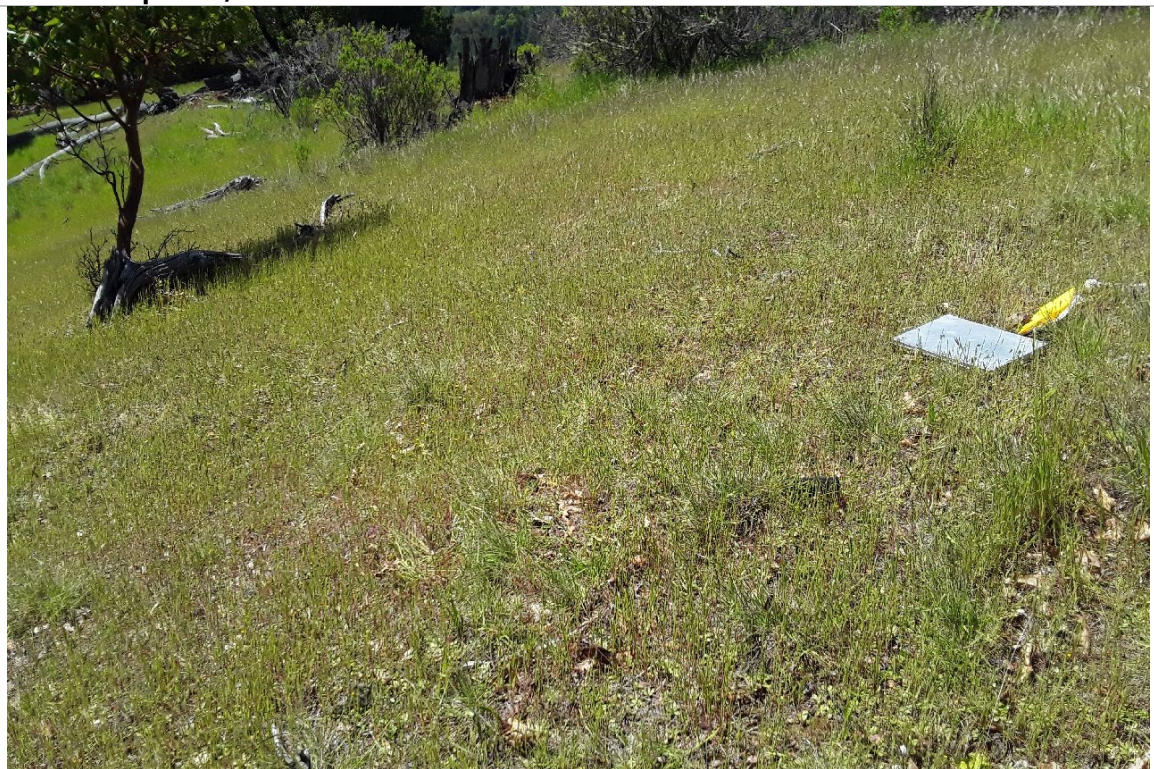
**Photo 6: California oatgrass meadow looking south. California oatgrass is dominant within this area near the Wallan Tank site. Photo taken April 27, 2022.**

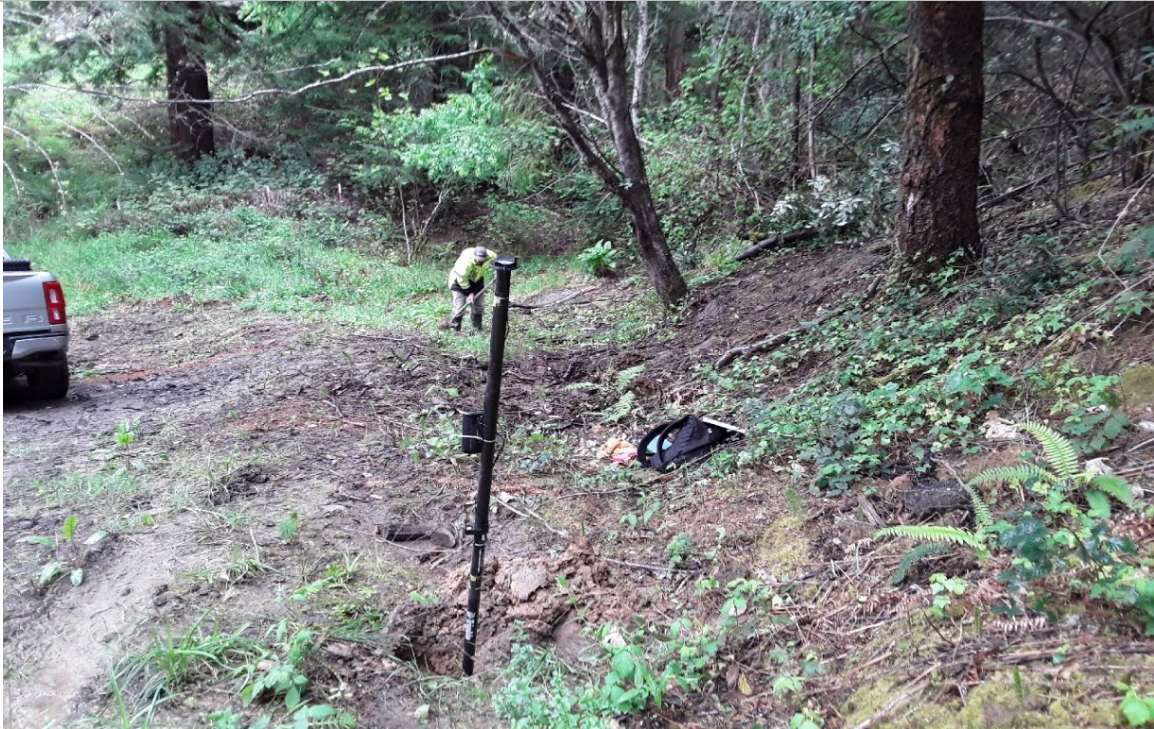
**Photo 9: Looking east across Wetland #5 within the vicinity of TP10. Wetland conditions are contained within a shallow swale and are likely connected to Stream #2 and culvert in the topographic low point visible beyond the wetland scientist. Photo taken April 19, 2022.**

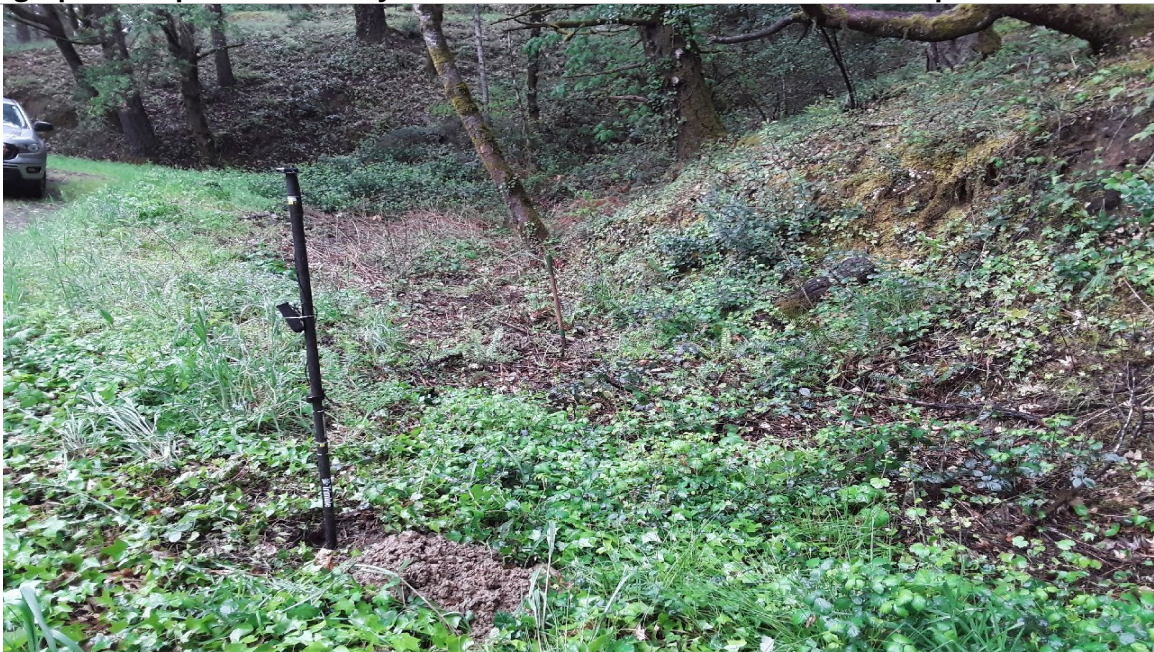
**Photo 10: Looking east toward Wetland #6. TP13 location (upland) shown by survey rod and wetland TP12 location shown by shovel. Melville Drive occurs immediately left of the photo which has created the basin containing the wetland. Photo taken April 19, 2022.**

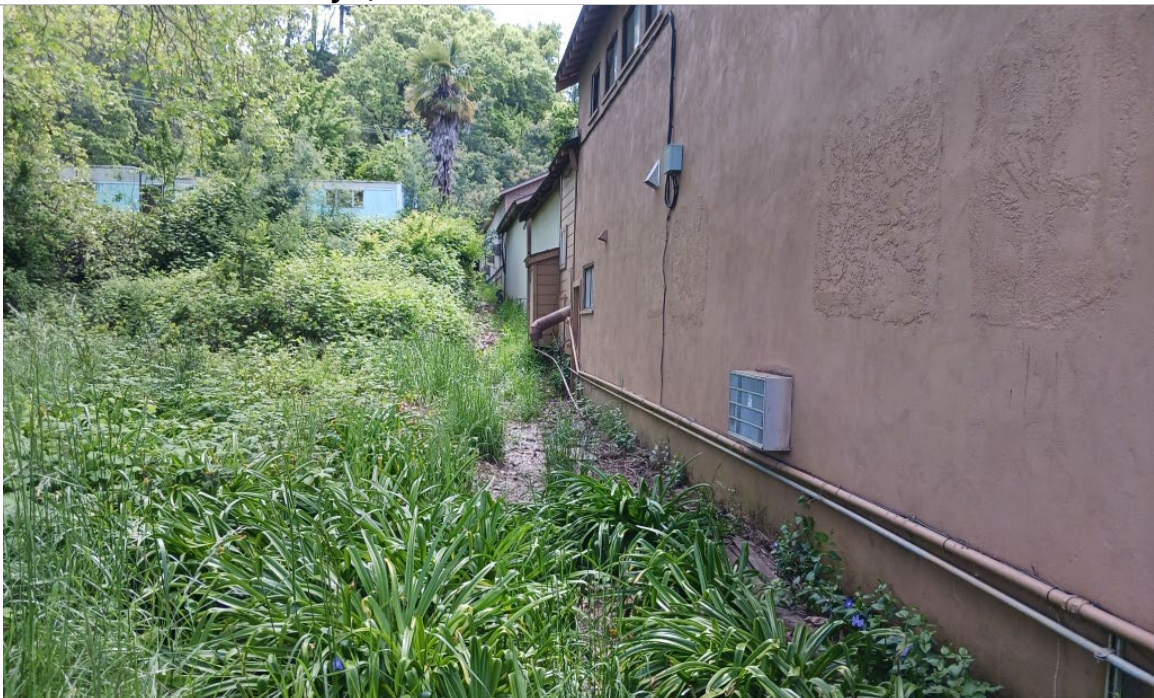
**Photo 12: Looking south toward the drainage swale between the motel and trailer park visible upslope. Wetland #7 is in the left side of the photo. Note developed and disturbed nature of the area. Photo taken May 9, 2023.**

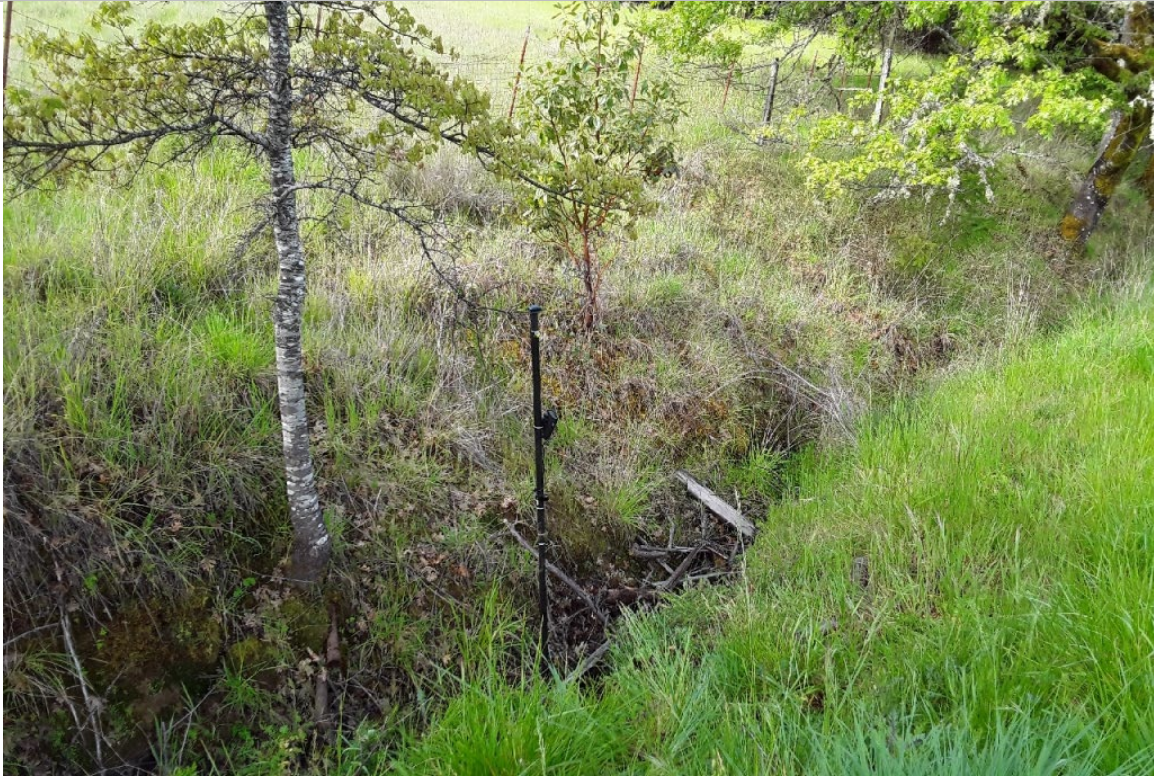
**Photo 17: Stream #4 headwaters, looking downslope (southeast) within the vicinity of OHWM point 2 (at survey rod). Note stream is contained within a partially excavated swale. OHWM indicators begin just upslope of the OHWM delineation point. Photo taken April 15, 2022.**

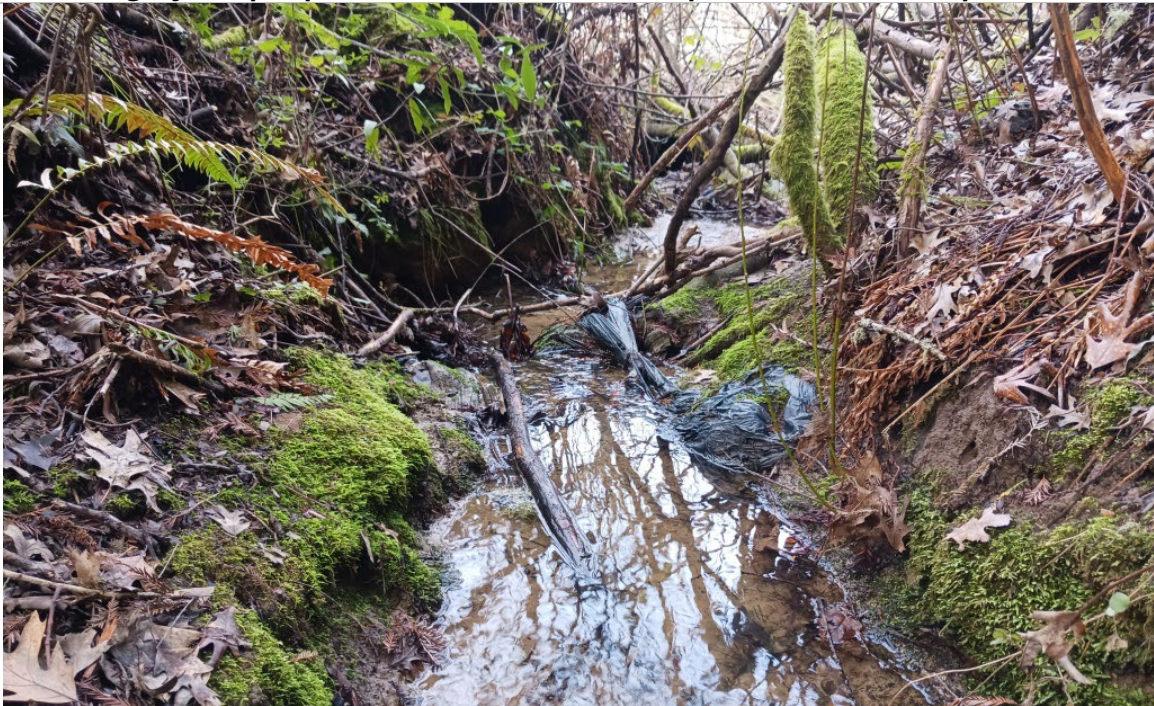
**Photo 18: Stream #5 looking downstream within vicinity of OHWM 4. The culvert under U.S. Highway 101 is barely visible in the upper center of the photo. Note well defined channel. Flows are likely intermittent but were present during the delineation. Photo taken February 17, 2023.**
