RE: Relocation of the Cultivation Area in Pond Setback on APN: 217-401-011

Aquatic Resources Delineation

Homestead Collective Weed Company
(APN: 217-401-011)

August 2020

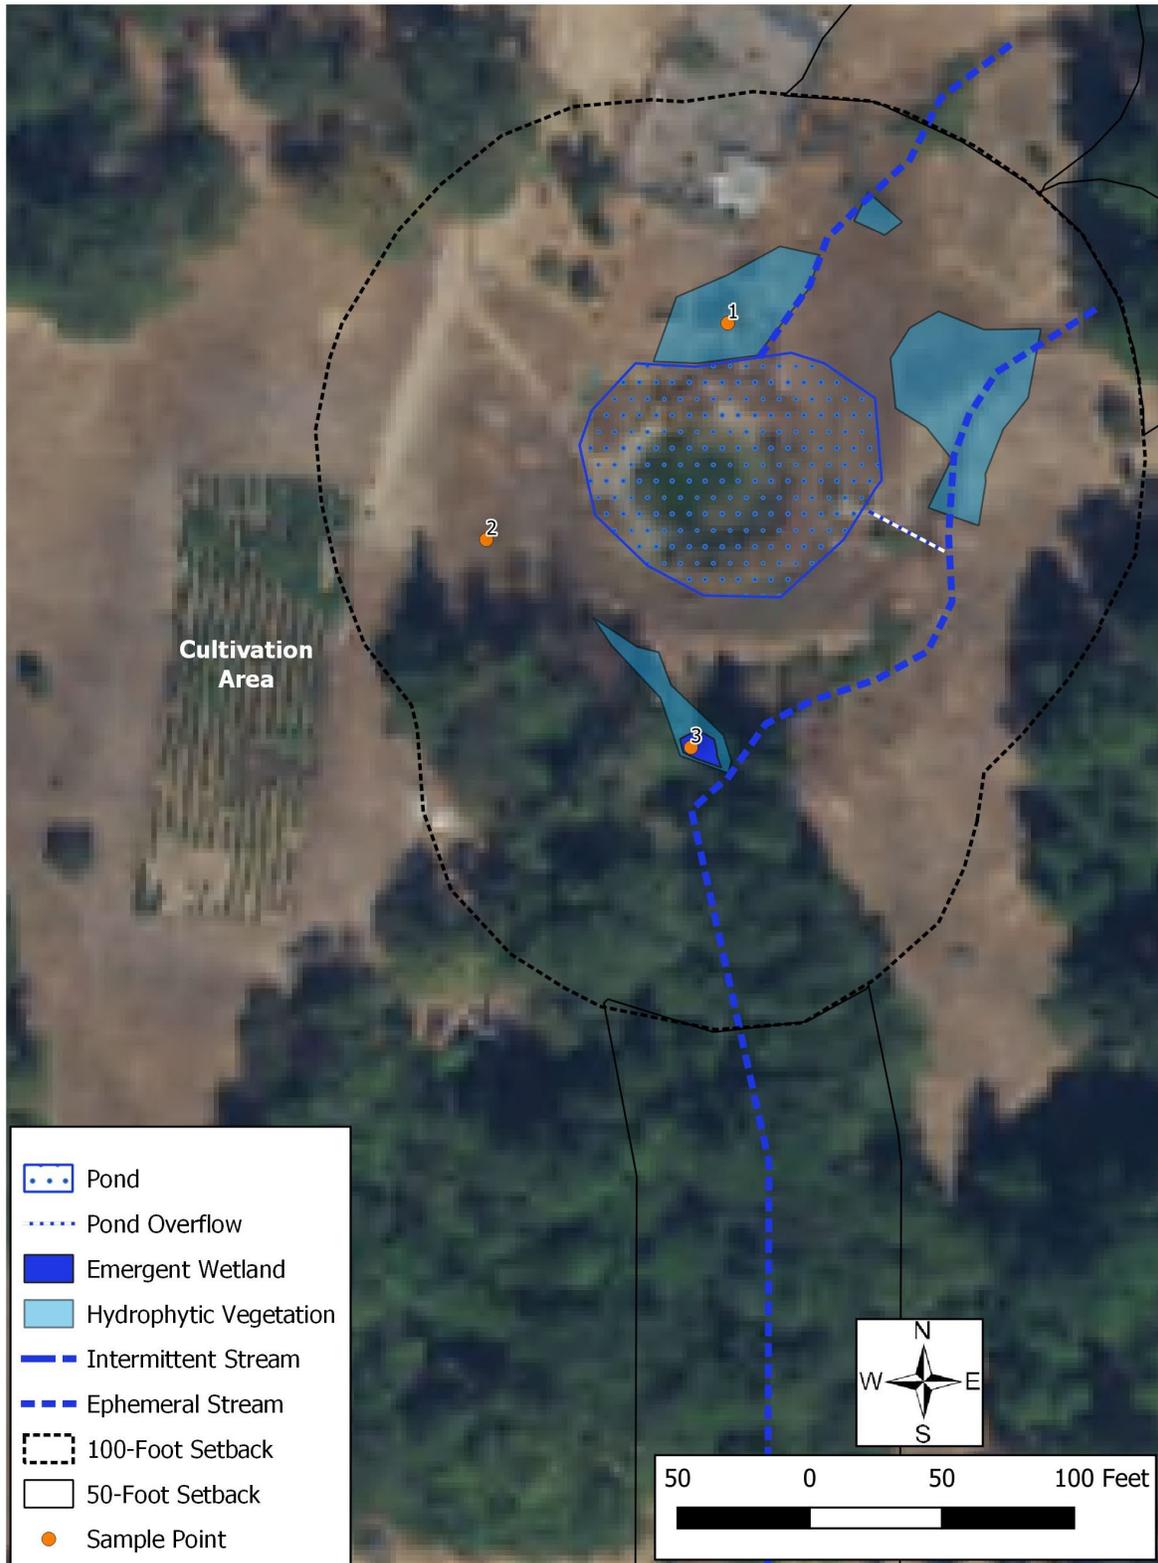
Figure 2. Aquatic Resources Map.

Aquatic features identified in the study area include a small wetland (approximately 100 square feet), two ephemeral streams, and the pond (Figure 2). There are additional areas that have hydrophytic vegetation, but do not meet the three-parameter wetland definition. Representative photos are provided in Appendix C.

A 100-foot setback from the pond and 50-foot setbacks from the ephemeral streams are shown in Figure 1. The small wetland is over 130 feet from the cultivation area. Both *Humboldt County General Plan* (Humboldt County (2017) and *Cannabis Cultivation Policy* (State Water Resources Control Board 2019) require 50-foot setbacks from ephemeral watercourses. The pond is constructed, but now includes aquatic habitat that has a connection the adjacent stream. Approximately 368 square feet of the cultivation area is within 100 feet of the pond. The northeast edge of the cultivation area is approximately 85 feet from the top of the bank of the pond. However, there is a road between the cultivation area and the pond, and the cultivation area is on the west side of the ridge (the pond is on the east side), thus any nitrogen rich runoff or other pollutants would move west towards Basin Creek away from the pond. It is the opinion of the consultant that moving a portion of the cultivation area is not necessary to protect the pond. Basin Creek is over 340 feet from the cultivation area.

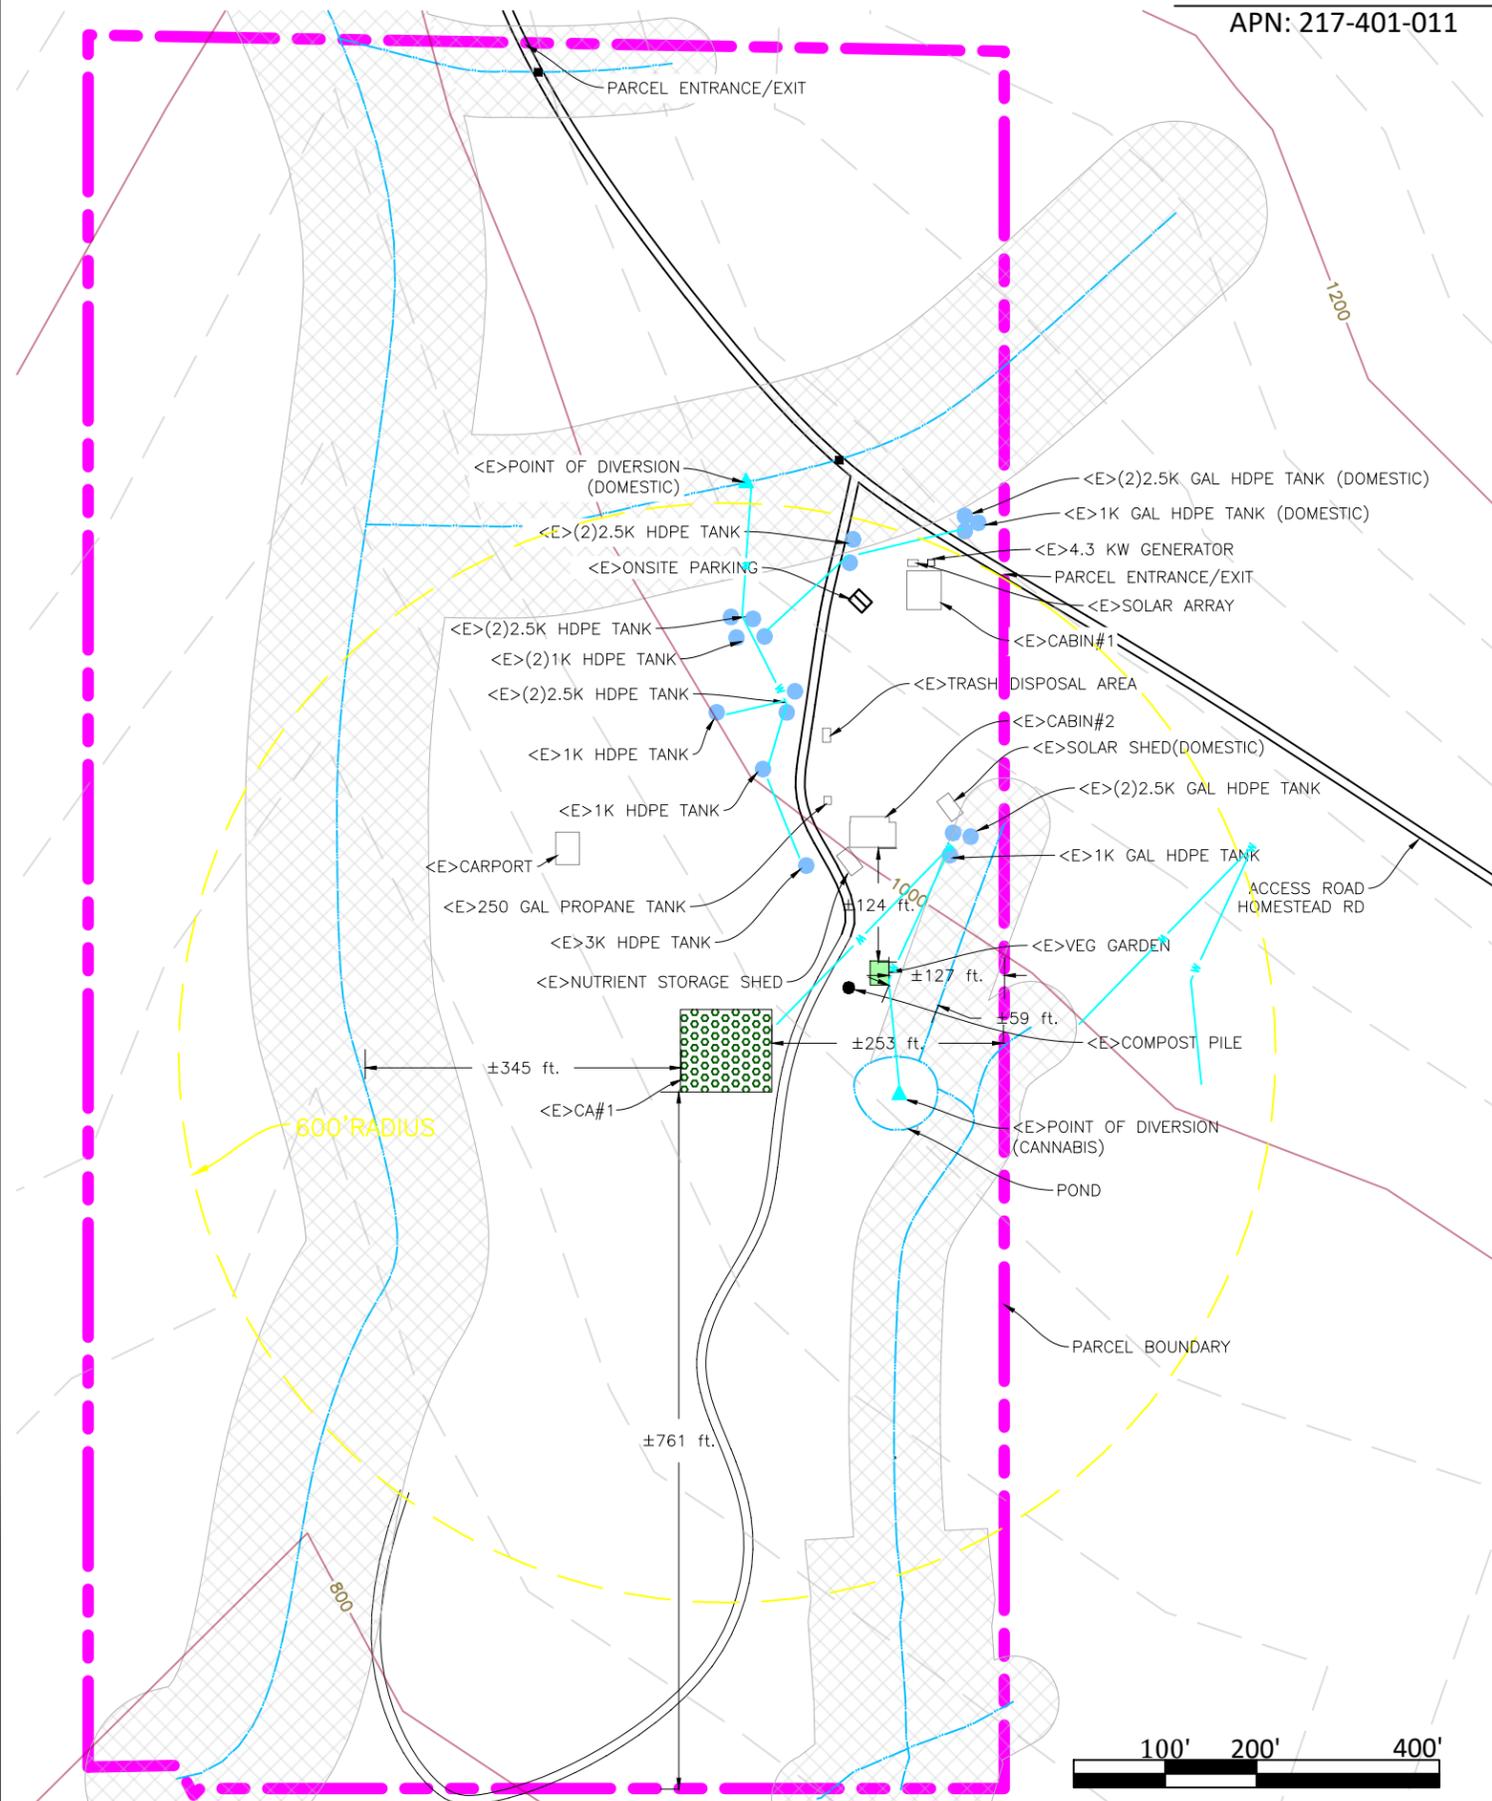
PARCEL OVERVIEW

UNNAMED CLASS II STREAM WITH REQUIRED 100 FT BUFFER
UNNAMED CLASS III STREAM WITH REQUIRED 50 FT BUFFER

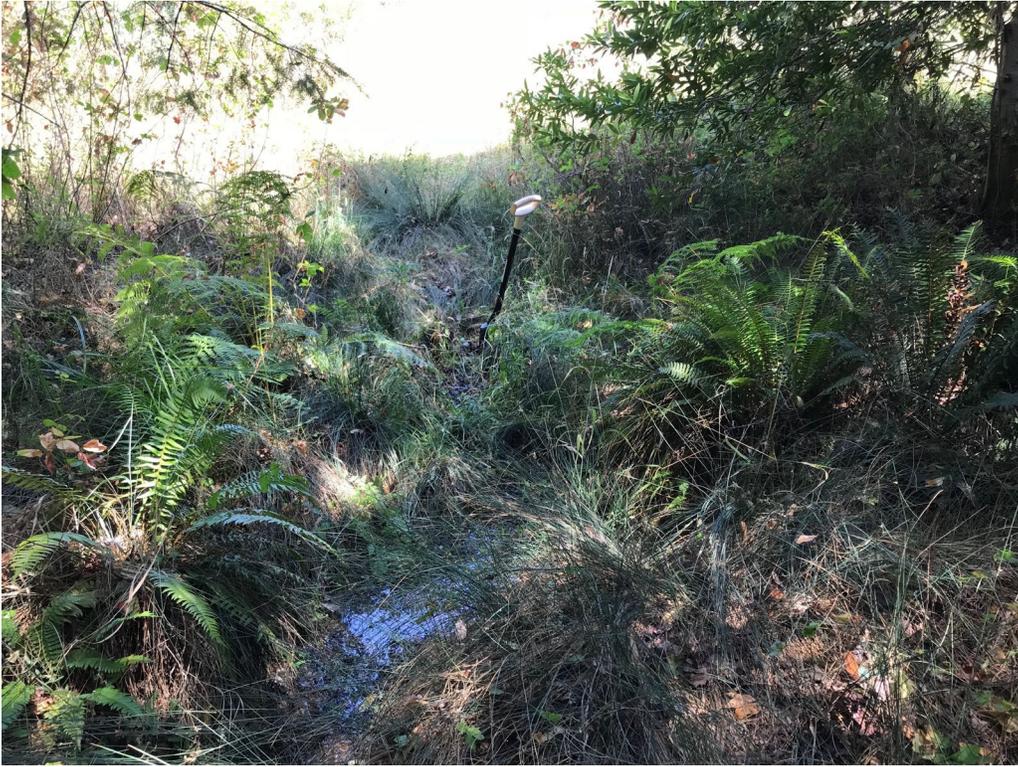
Photo 1. Small wetland near base of the pond levee.

The small wetland is near the base of the pond levee. The wetland has hydrophytic vegetation dominated by spreading rush (*Juncus patens* [FACW]) and poison oak (*Toxicodendron*

diversilobum [FAC]). Other plants include pennyroyal (*Mentha pelugium* [OBL]), lady fern (*Athyrium filix-femina* [FAC]), and velvet grass (*Holcus lantana* [FAC]). There is a tree canopy over the wetland, but the trees are not rooted in the feature. The soil color was 10yr 4/1 with distinct and prominent 7.5yr 5/6 redox concentrations; this meets hydric soil indicator F3 (Depleted Matrix). The soil was saturated to the surface. There was also shallow surface water in a portion of the feature. Wetland hydrology indicators present included A1 (Surface Water), A2 (High Water Table), and A3 (Saturation). It was not clear if the water is groundwater or water leaking from the pond above.

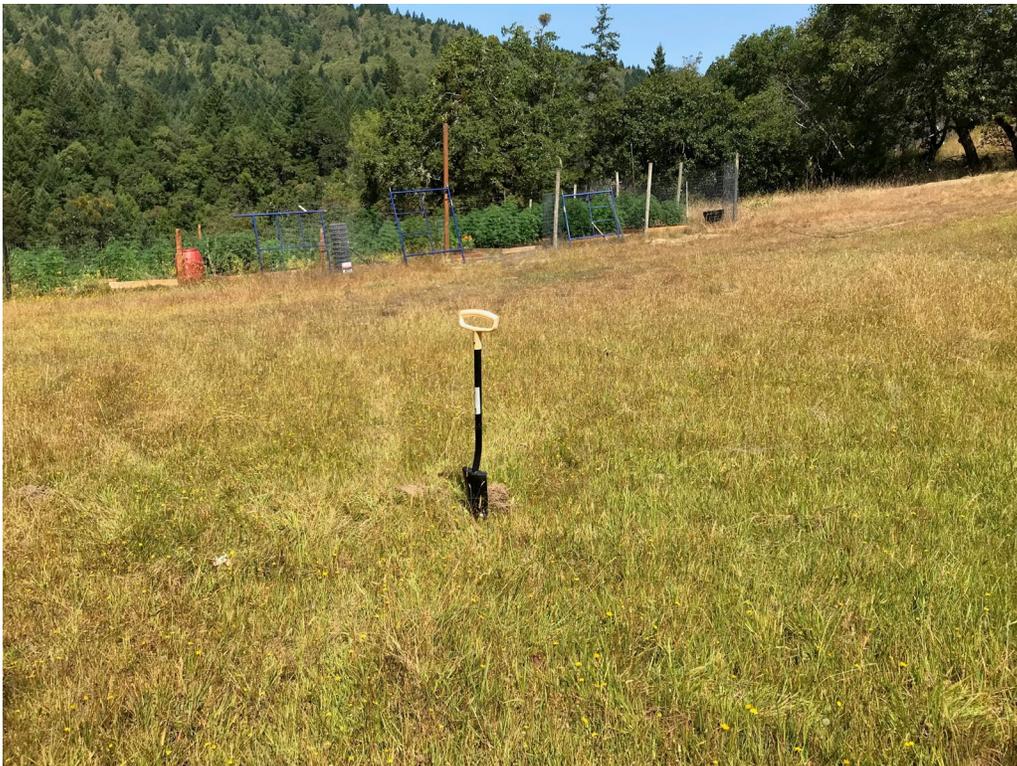
Photo 2. Upland grassland adjacent to the cultivation area.

The adjacent upland habitat includes grasslands and mixed conifer and hardwood stands. The grasslands are dominated by non-native herbaceous plants including sweet vernal grass (*Anthoxanthum odoratum* [FACW]), rough cat's-ear (*Hypochaeris radicata* [FACU]), and English

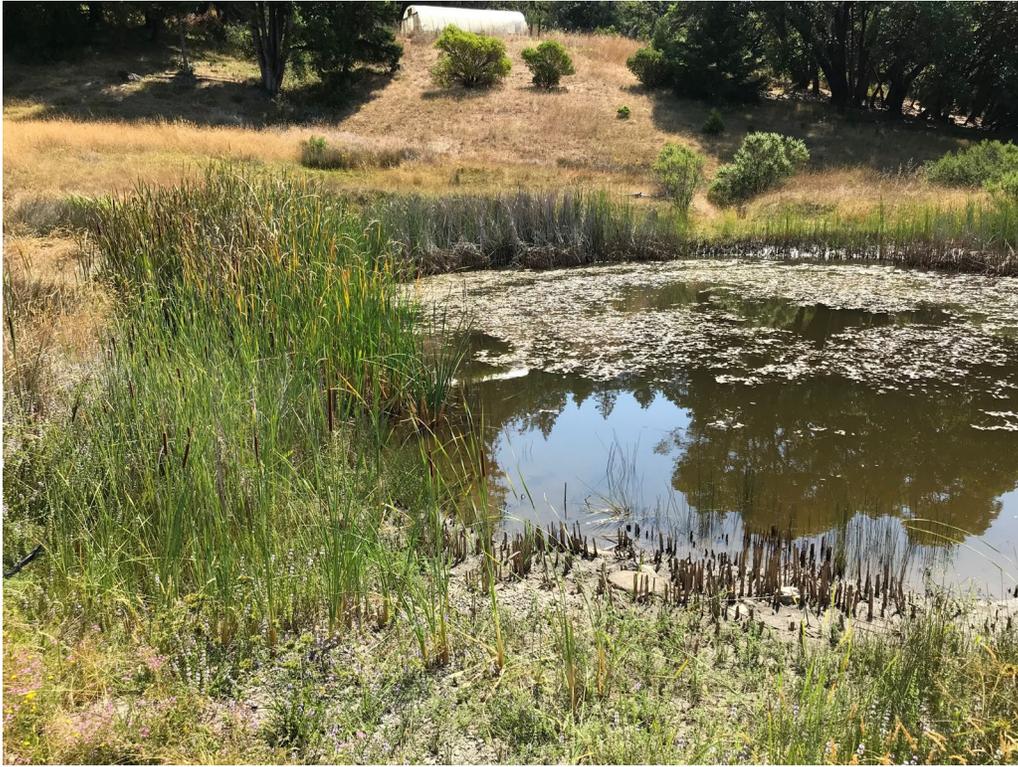
Photo 3. Pond with cattails and pondweed.

The pond had surface water and floating and emergent hydrophytic vegetation. Associated plants include pondweed (*Potamogeton* sp. [OBL]), cattail (*Typha latifolia* [OBL]), water plantain (*Alisma lanceolatum* [OBL]), spike rush (*Eleocharis* sp. [OBL or FACW]), and nutsedge (*Cyperus eragrostis* [FACW]). Google Earth images indicate the pond was constructed between 2006 and 2009. The 2006 image shows the stream channel that feeds the pond continuing south through what is now the pond and converging with the eastern stream, although the confluence is obscured by trees (Appendix D). The area appears to be upland other than the streams, with some associated vegetation, possibly spreading rush or stands of coyote brush, although the resolution of the photo is not adequate to make a definitive determination.

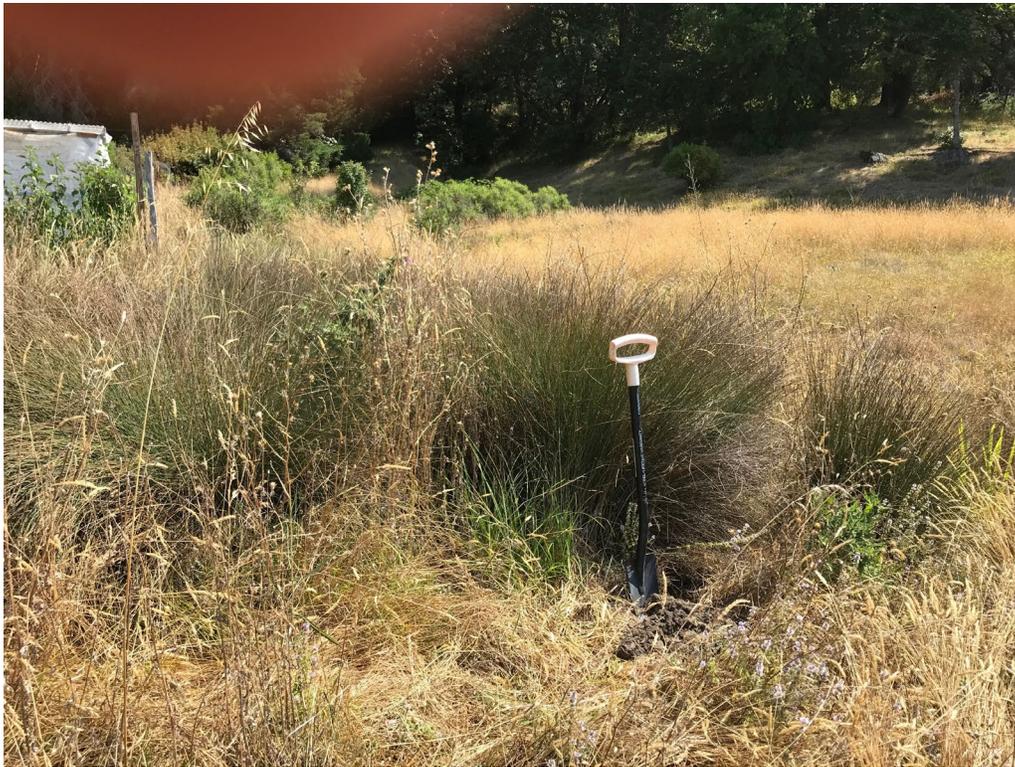
Photo 4. Stand of spreading rush (*Juncus patens*) in area that lacks other wetland indicators.

Approximately 5,008 square feet of area adjacent to the ephemeral streams has hydrophytic vegetation but lacks indicators of hydric soil or wetland hydrology. These areas are generally dominated by spreading rush (*Juncus patens* [FACW]). Other associated plants include pennyroyal (*Mentha pelugium* [OBL]), sweet vernal grass (*Anthoxanthum odoratum* [FACW]), Italian thistle (*Carduus pycnocephalus* [UPL]), and bull thistle (*Cirsium vulgare* [FACU]). The July site visit was in the dry season and lack of wetland indicators like saturated soil was expected. However, the *Regional Supplement to the Corps of Engineers Wetland Delineation Manual Western Mountains, Valleys, and Coast Region (Version 2.0)* (Army Corps 2010) provides many other wetland hydrology indicators that can be used in the dry season. The soil color was 10yr 2/2 with no redox features or other indicators of hydric soil. It is likely these areas are wetter than adjacent areas with non-hydrophytic vegetation during periods with heavy rainfall, but the frequency and duration of soil saturation is not sufficient to create hydric soil, thus these areas do not meet the three-parameter wetland definition.
