HUMBOLDT COUNTY DEPARTMENT OF PUBLIC WORKS  
ROAD EVALUATION REPORT

Applicant Name: Organic Humboldt Inc. APN: 214-233-002

Road Name: Wood Ranch Road (complete a separate form for each road)

# Road Evaluation Documentation (APN:214-233-002) – Wood Ranch Road

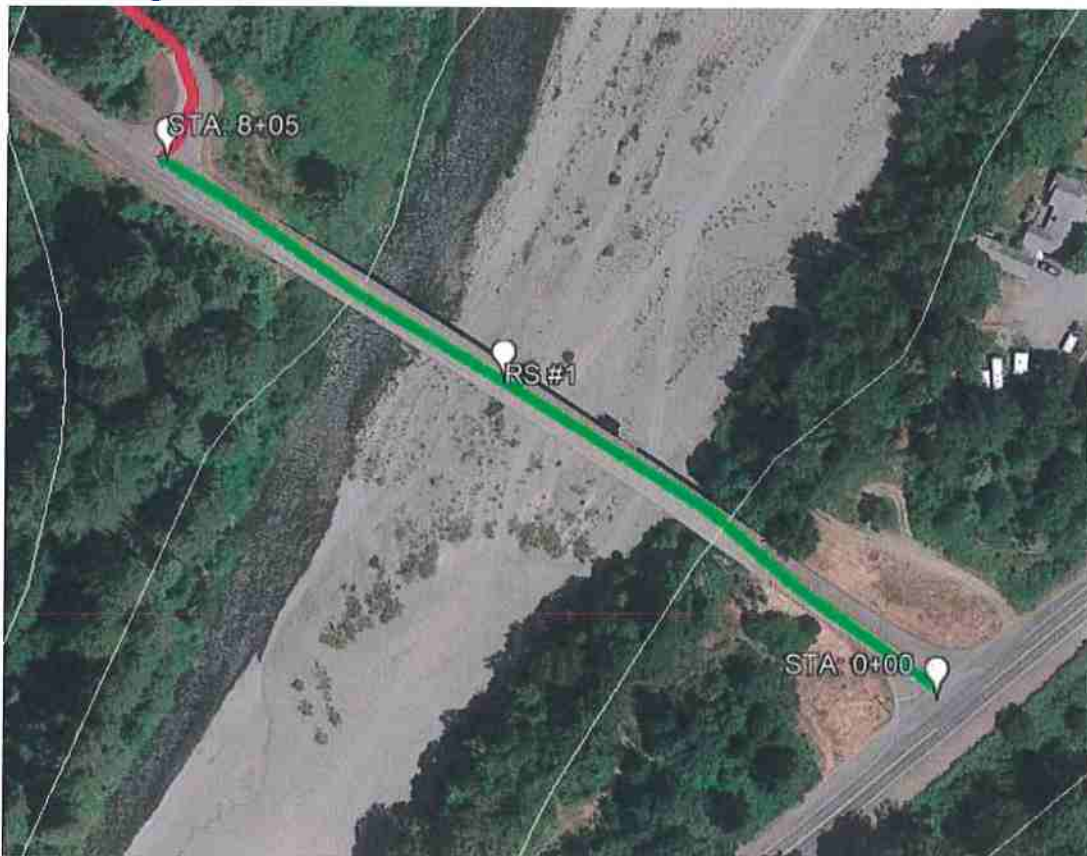
*Figure 2: Aerial view RS #1.*

Starting STA: 0+00  
Ending STA: 8+05  
Length: 0.15 miles  
Typical Width: 20+ feet

Paved road with center divider, no substantial curves, meets category 4 standard.

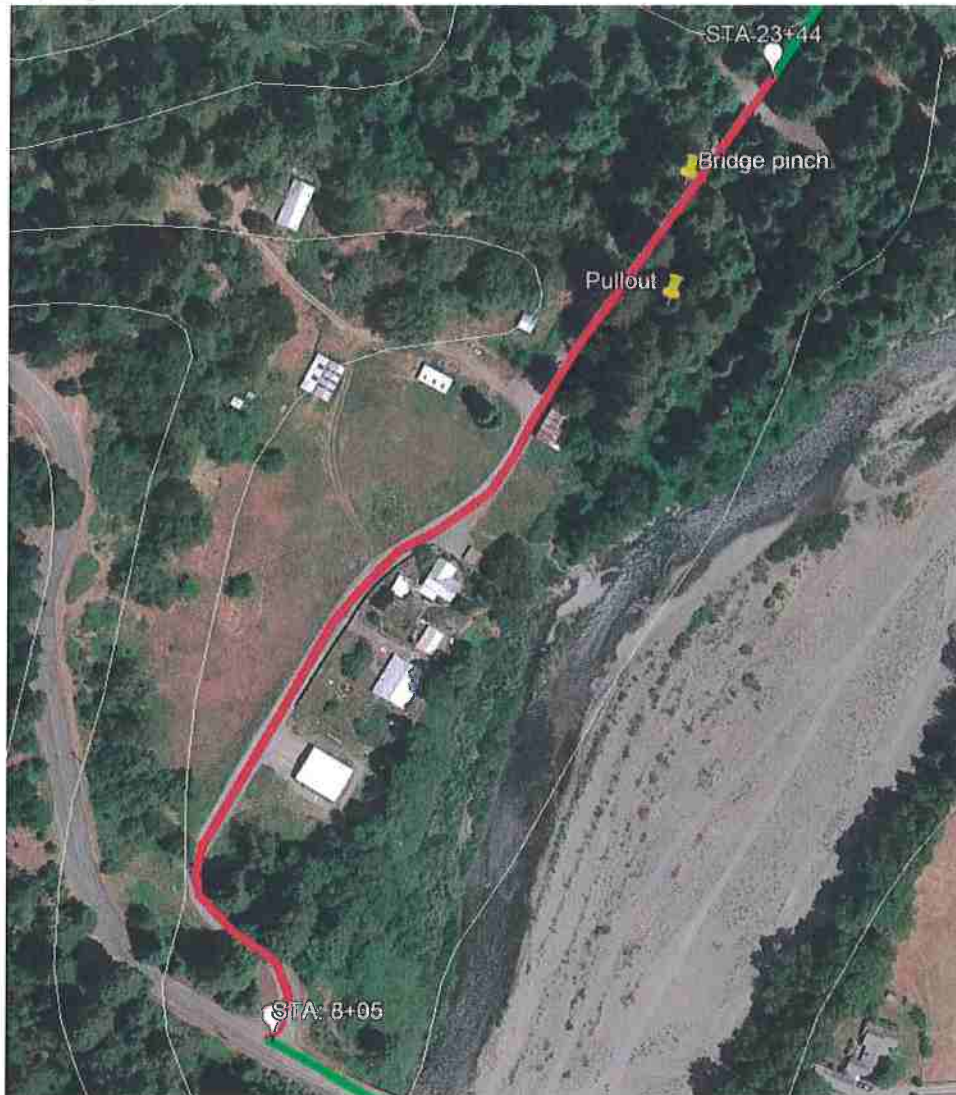
Starting STA: 8+05  
Ending STA: 23+44  
Length: 0.29 miles  
Typical Width: 20+ feet  
Average Grade: 0%

Turnouts: Present and sufficient for one pinch point over a bridge.

Description: Gravel road in good condition, no substantial curves, meets category 4 equivalent standard.

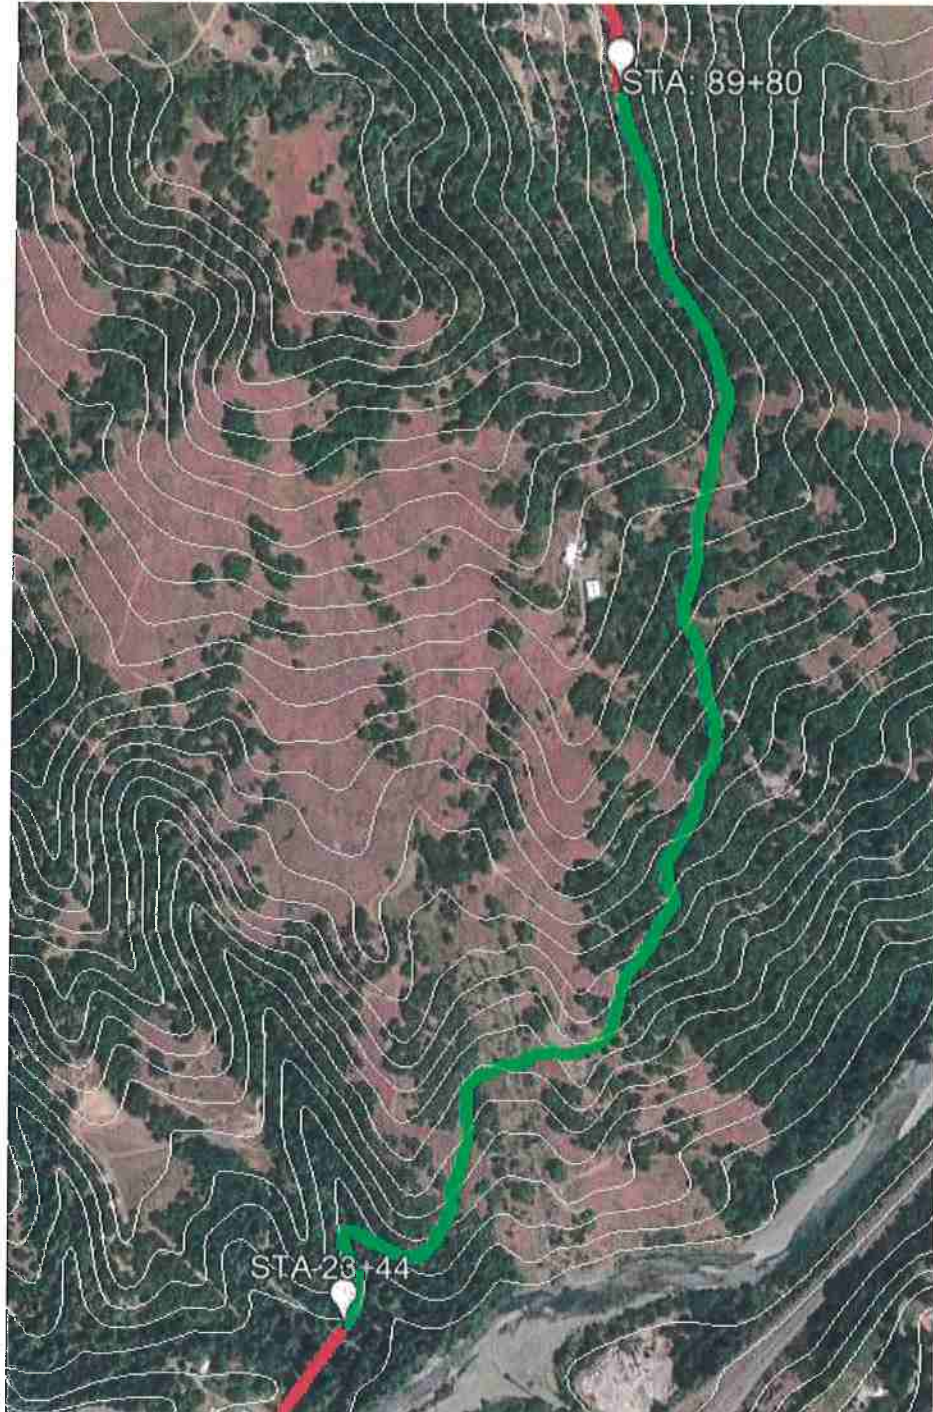
Figure 5: RS#3 aerial view

Starting STA: 23+44  
Ending STA: 89+80  
Length: 1.26 miles  
Typical Width: 20+ feet  
Average Grade: 10.5%

Turnouts: Several significant turnouts are present but not required to pass traffic. No notable pinch points.

Gravel road in good condition, generally gentle curves except for one curve with approximate a radius of approximately 40 feet; meets category 4 equivalent standard. This road section terminates at a fork in the road.

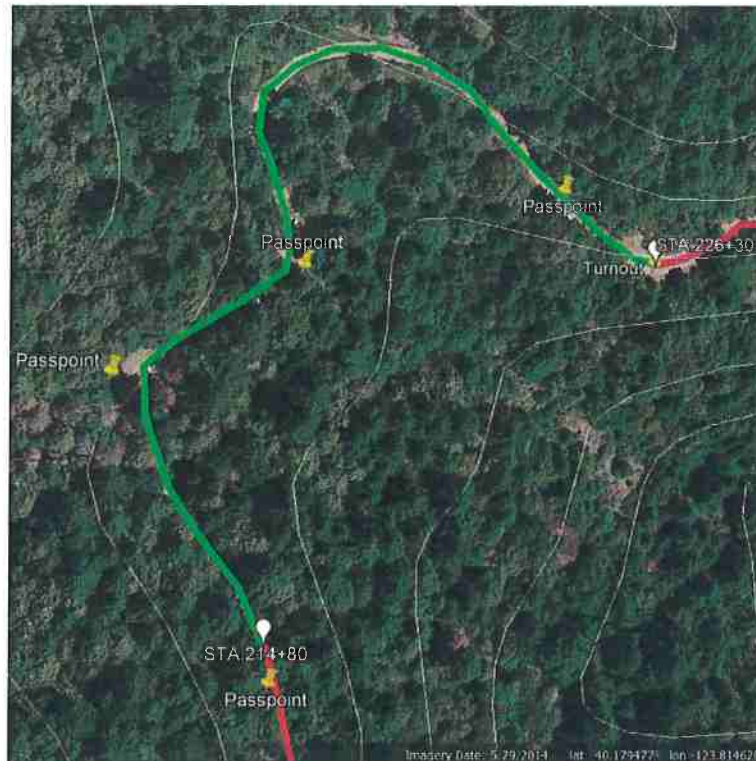
Figure 18: RS#9 aerial view

Gravel road in good condition intended for single vehicle travel. There are three major curves with minimum radii of approximately 65-feet and mild slopes with good visibility. There are no driveways but 4 locations, mapped above present along the segment which may allow vehicles to pass. The road section does not meet the category 4 equivalent on the basis of insufficient average road width.

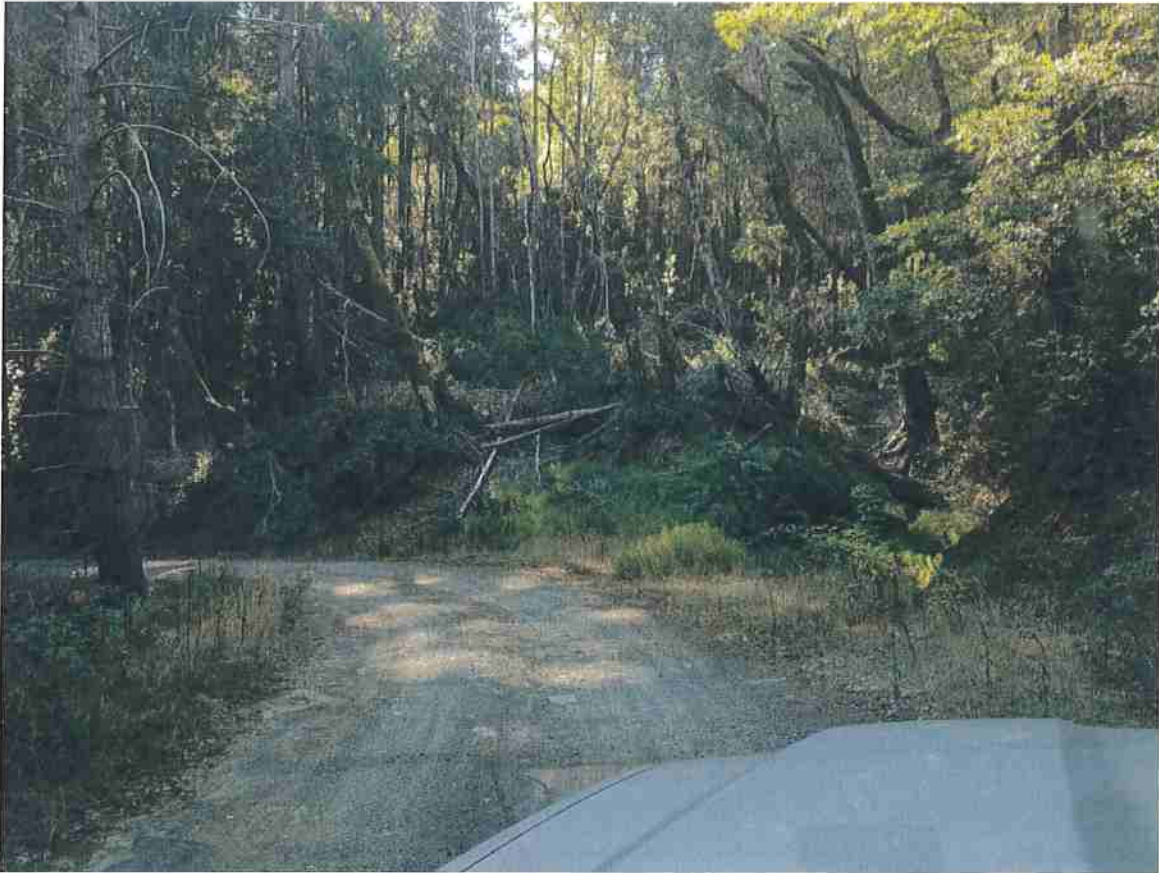
*Figure 19: Road Segment #9, typical section with small turnout to the right which may allow vehicles to pass.*

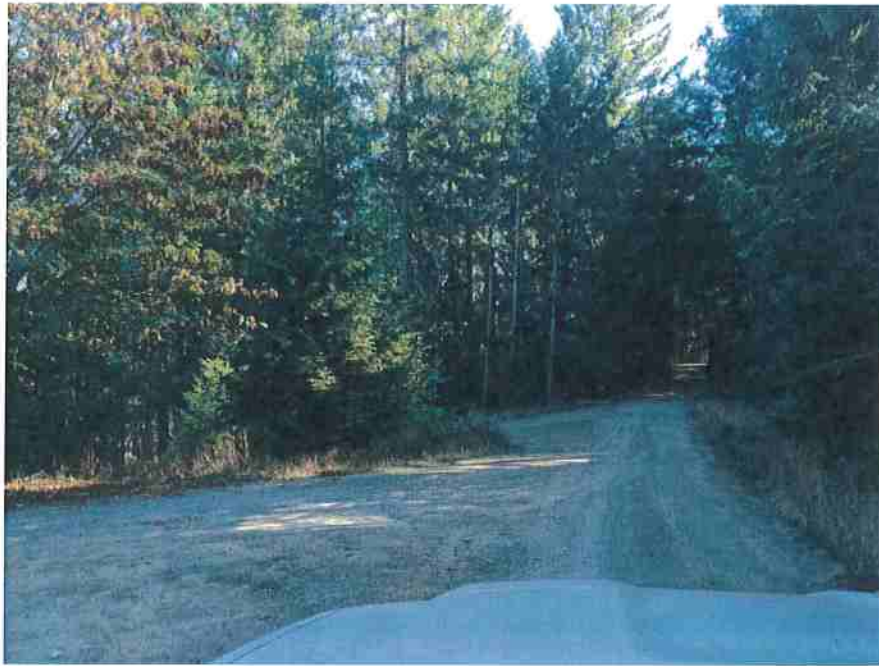
*Figure 21: Road segment #10 ground view heading South with turnout to the left.*
